**CITY OF INGLESIDE  
REGULAR CITY COUNCIL MEETING  
AGENDA  
JUNE 9, 2026  
6:30 PM**

Report on November 01, 2025, Hailstorm Damage to City of Ingleside Buildings.

### Building Damage Analysis Survey and Report

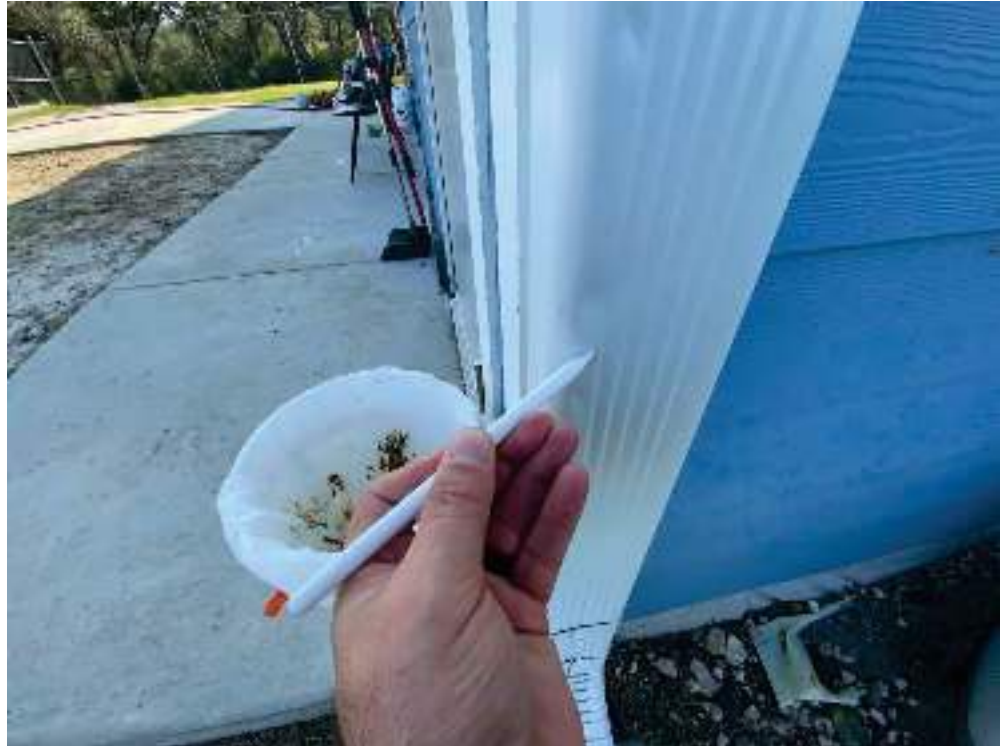
- 11 Location 002/002-003/Exterior -  
11-IMG\_3065  
Date Taken: 11/25/2025

hail damage to downspout

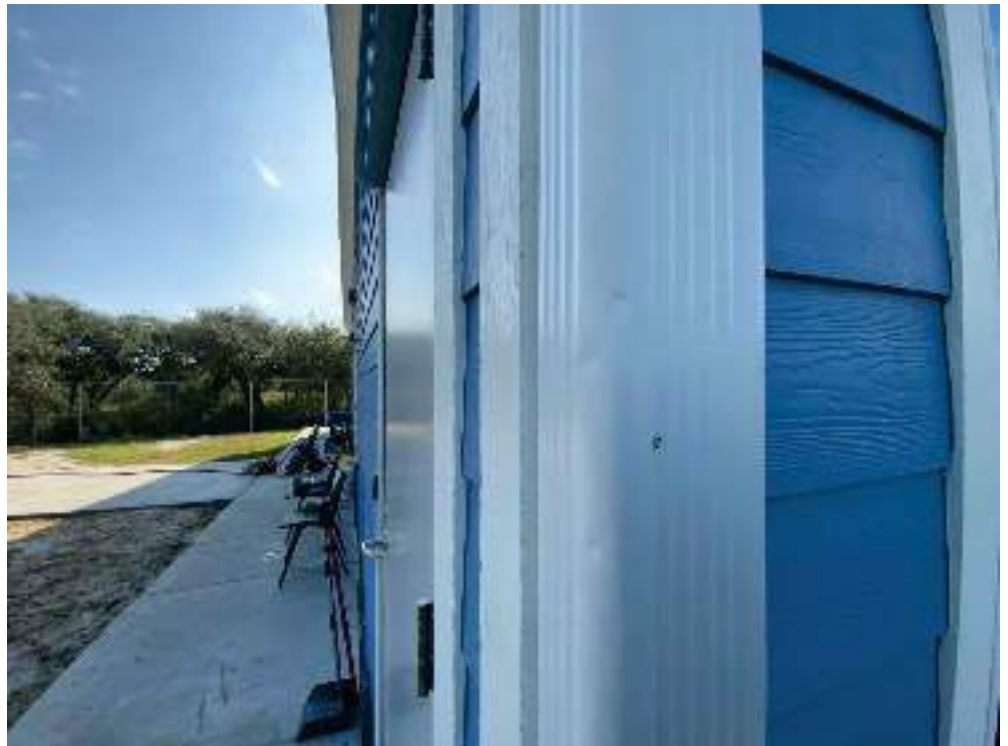
- 12 Location 002/002-003/Exterior -  
12-IMG\_3064  
Date Taken: 11/25/2025

hail damage to downspout

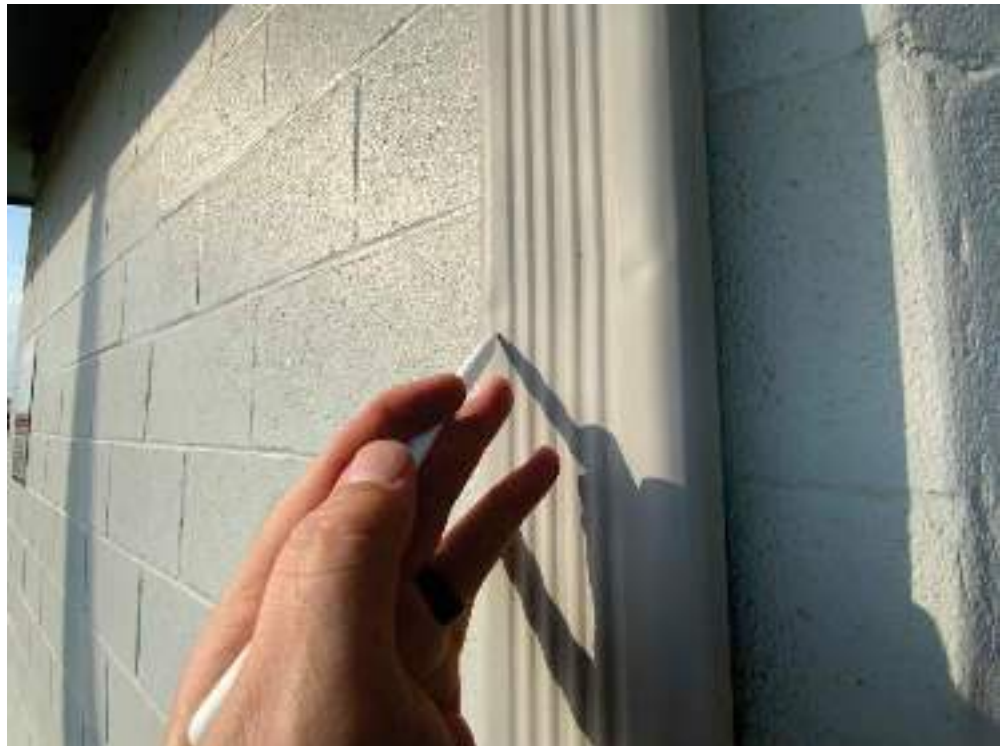
- 22 Location 004/004-003/Exterior -  
22-IMG\_2784  
Date Taken: 11/24/2025

damage to down spouts

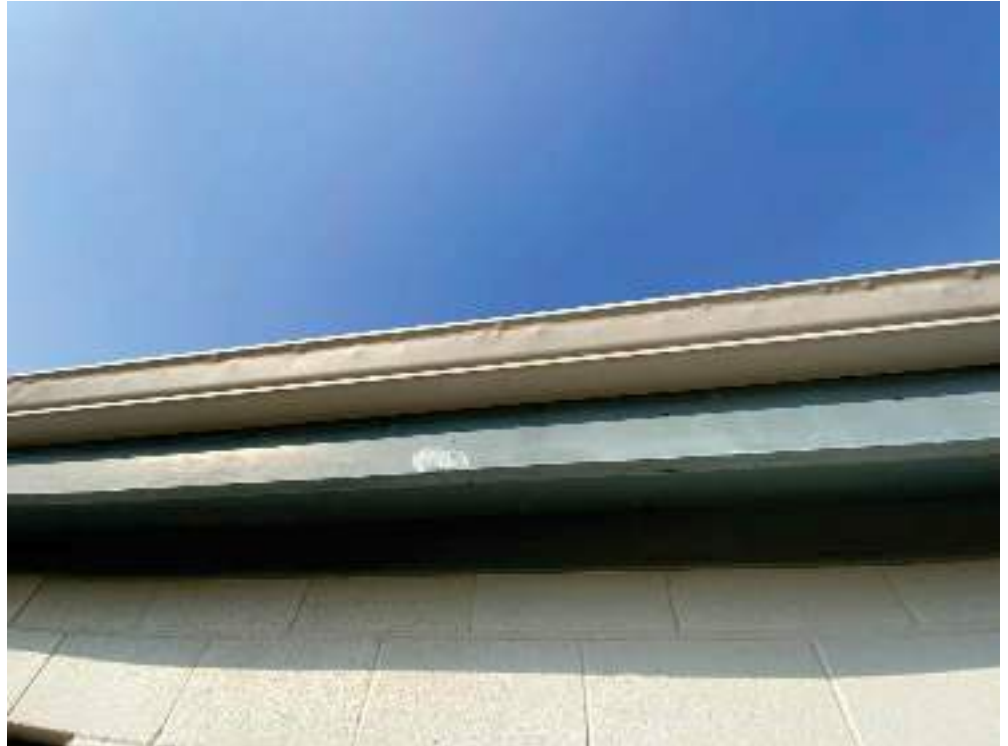
- 23 Location 004/004-003/Exterior -  
23-IMG\_2785  
Date Taken: 11/24/2025

damage to gutters

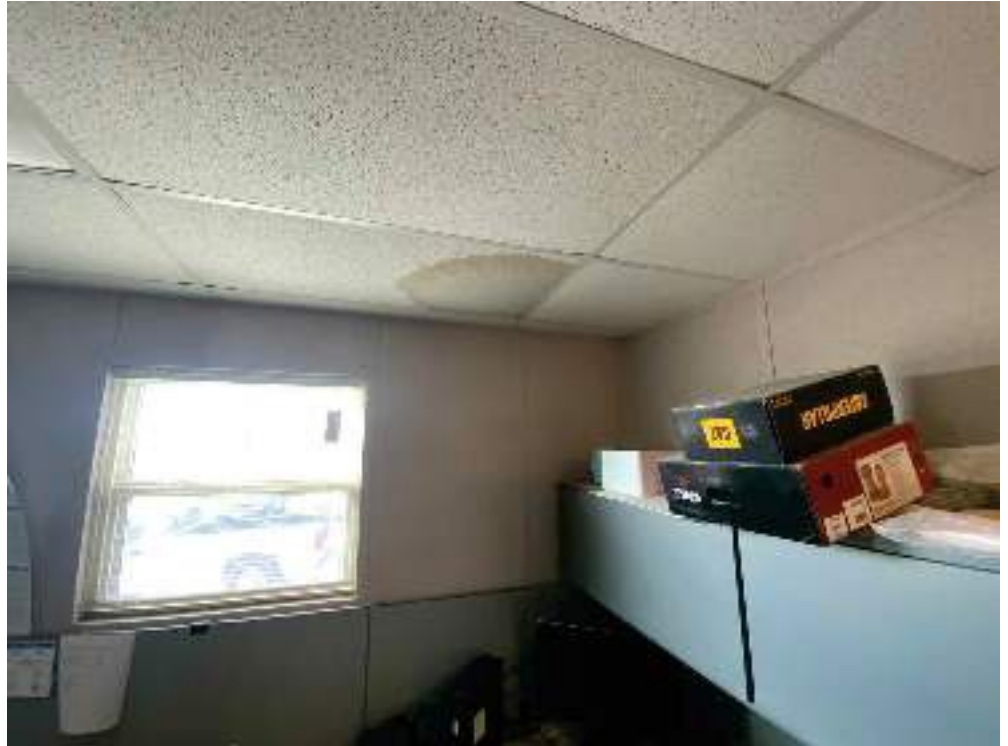
- 75 Location 008/008-008/Interior - 75-  
IMG\_2971  
Date Taken: 11/25/2025

ceiling water stains

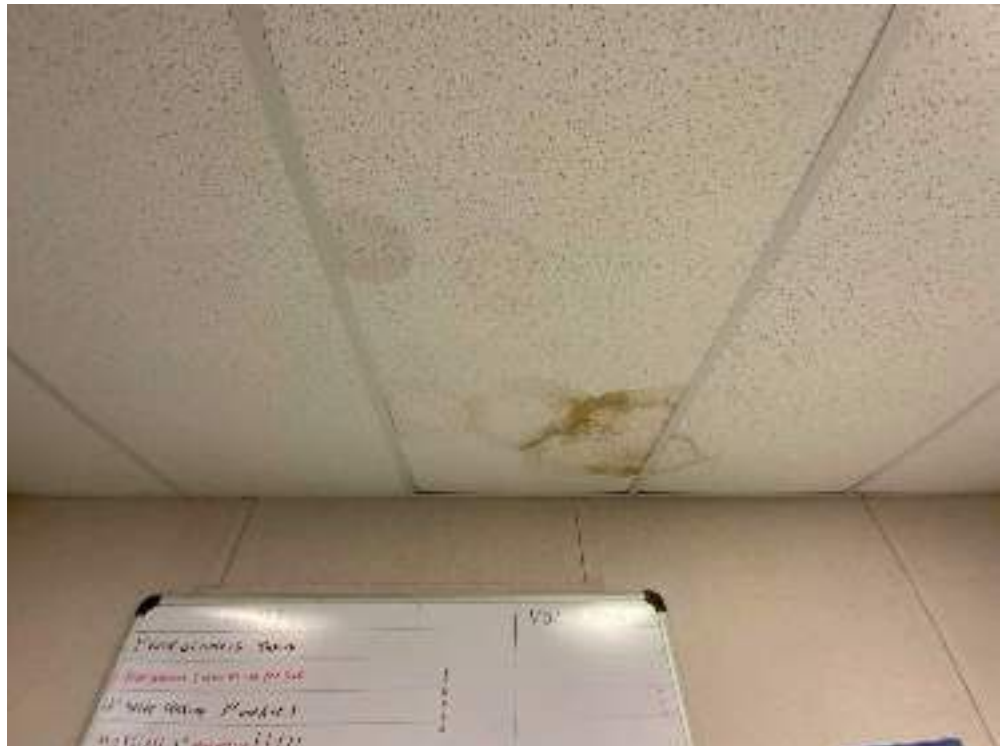
- 76 Location 008/008-008/Interior - 76-  
IMG\_2980  
Date Taken: 11/25/2025

ceiling water stains

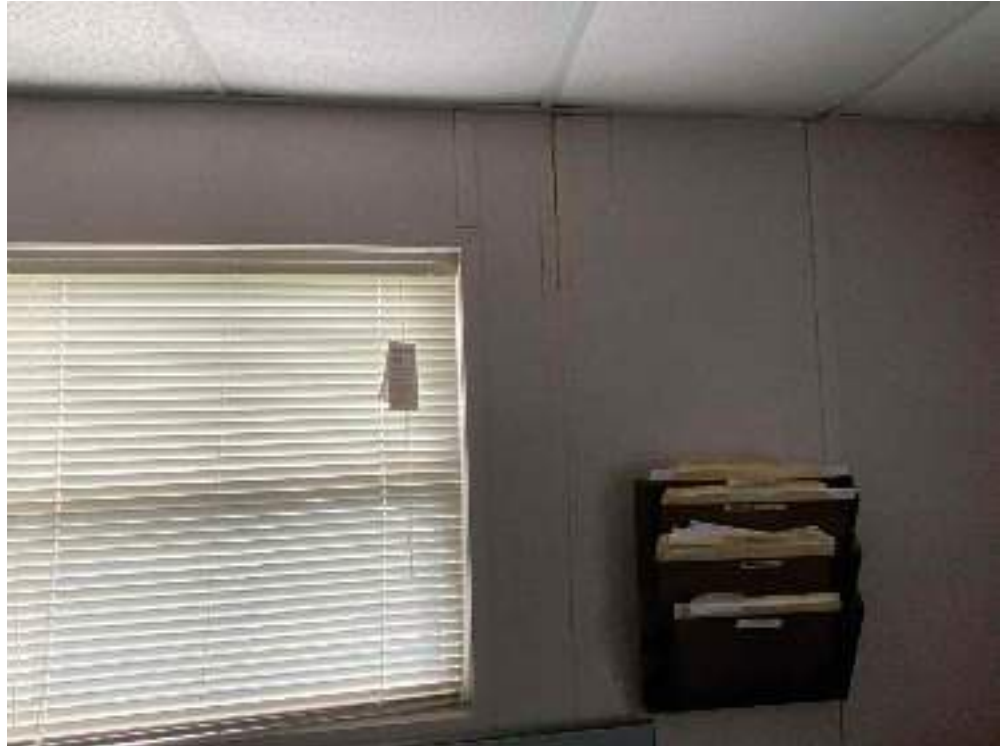
- 77 Location 008/008-008/Interior - 77-  
IMG\_2976  
Date Taken: 11/25/2025

water stains on wallpaper

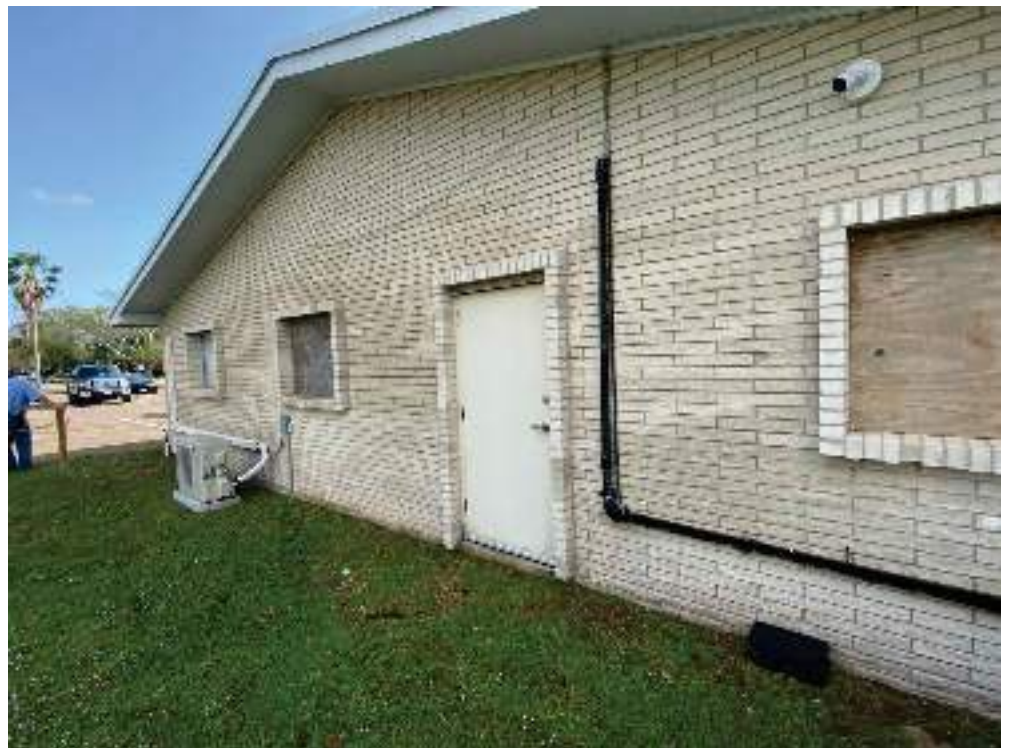
- 84 Location 010/010-001/Exterior -  
84-IMG\_2426  
Date Taken: 11/24/2025

two windows broken out by hail  
boarded up by insured

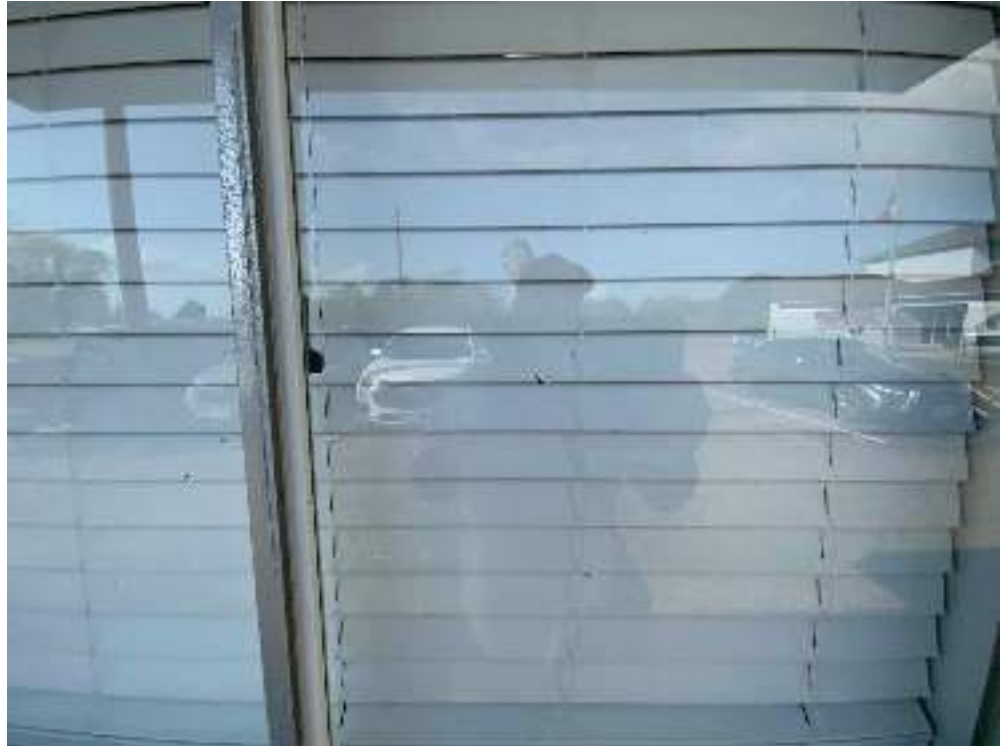
- 85 Location 010/010-001/Exterior -  
85-IMG\_2438  
Date Taken: 11/24/2025

window cracked by hail

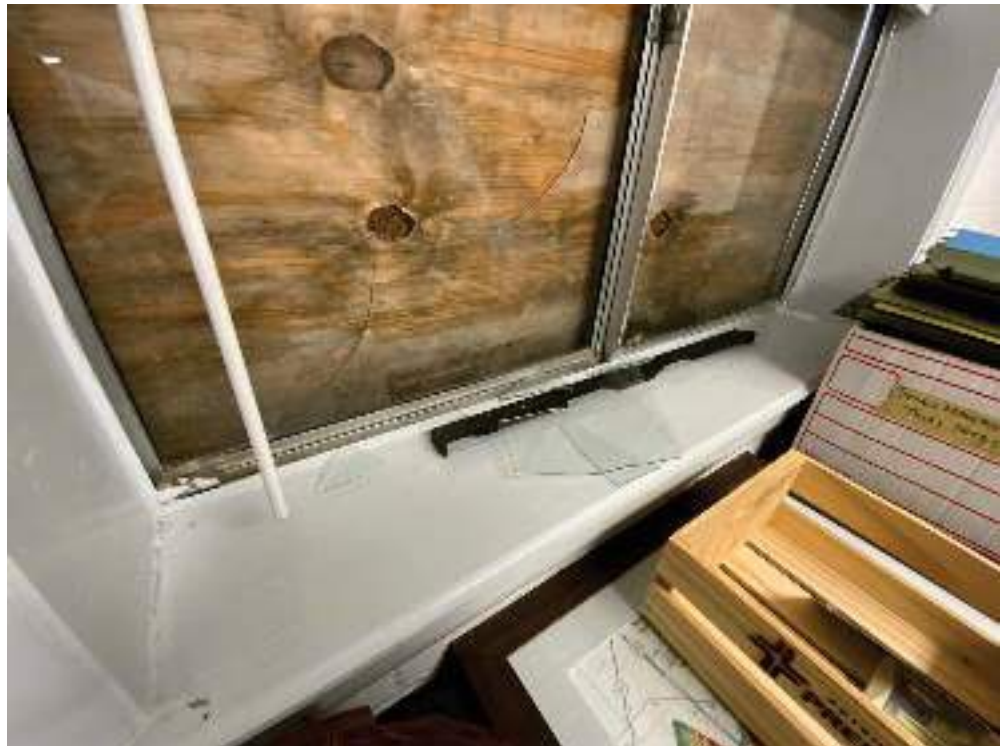
conference room broken window

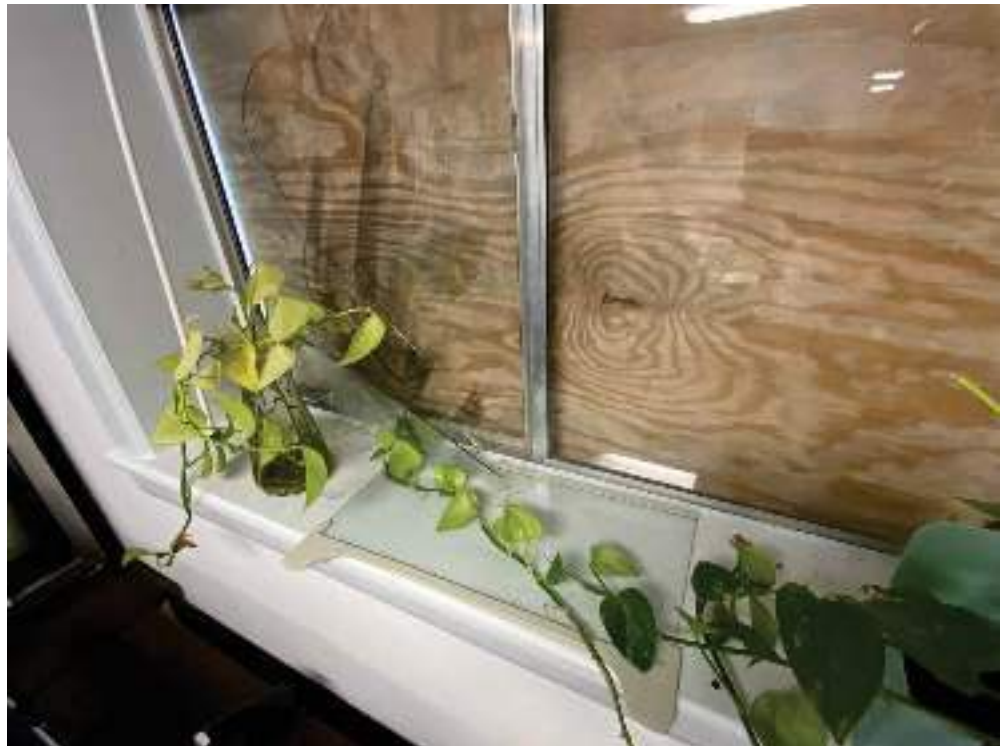
90 Location 010/010-001/Interior - 90-  
IMG\_2446  
Date Taken: 11/24/2025

office broken window

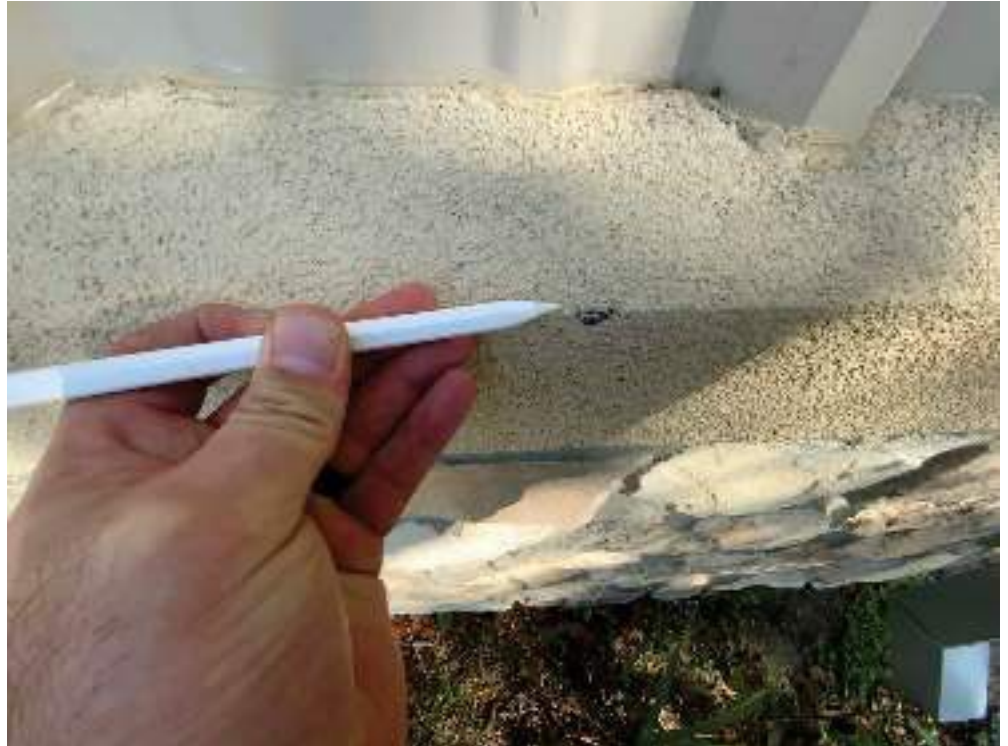
- 95 Location 011/011-001/Exterior -  
95-IMG\_2550  
Date Taken: 11/24/2025

This building is a steel framed metal building with an exterior cladding of metal and stone with a decorative eifs band. The roof is a metal roof system. Visible hail damage was observed to the eifs band around the building. No other visible hail damage was observed. The damages have been accounted for in the attached ROM.

eifs band damaged

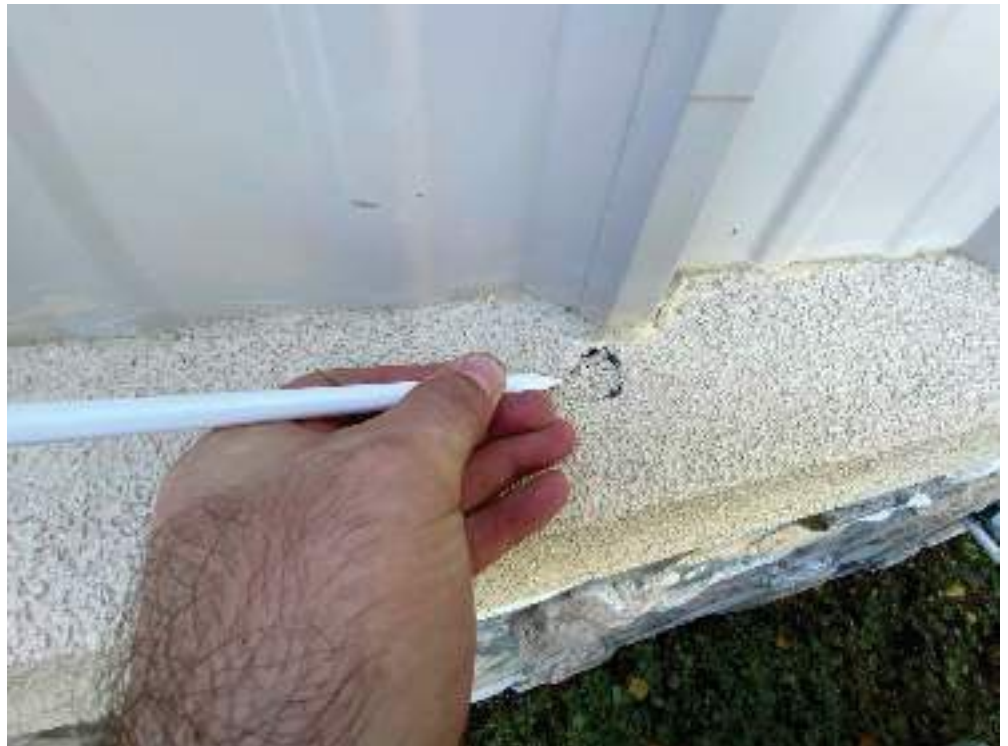
- 96 Location 011/011-001/Exterior -  
96-IMG\_2571  
Date Taken: 11/24/2025

eifs band damaged

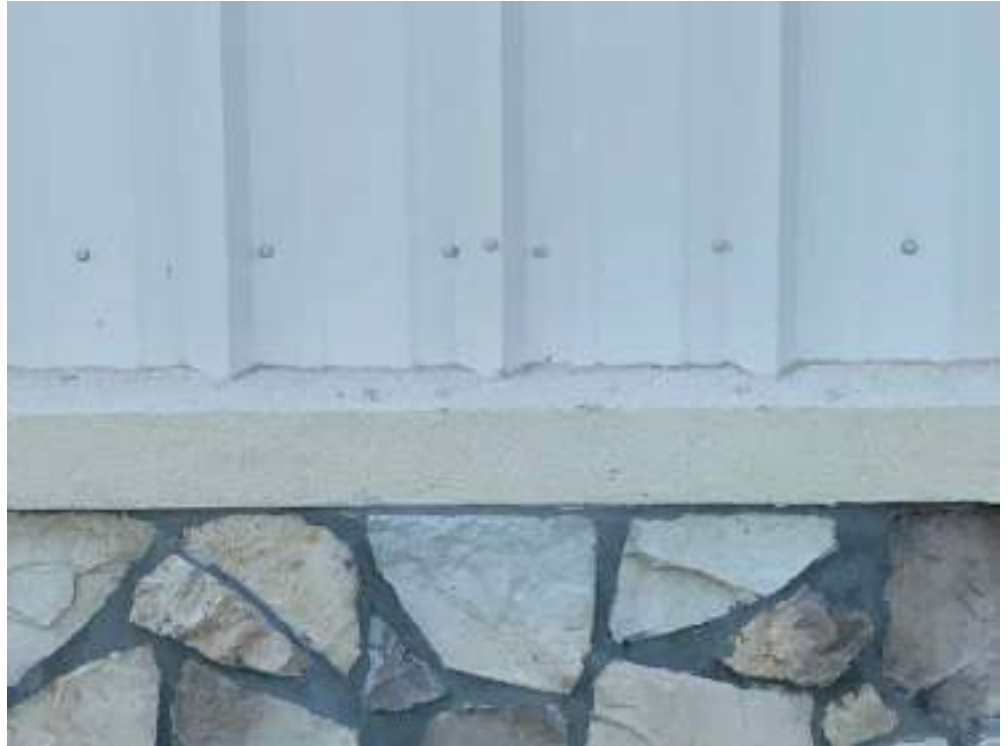
- 97 Location 011/011-001/Exterior -  
97-IMG\_2574  
Date Taken: 11/24/2025

eifs band damaged

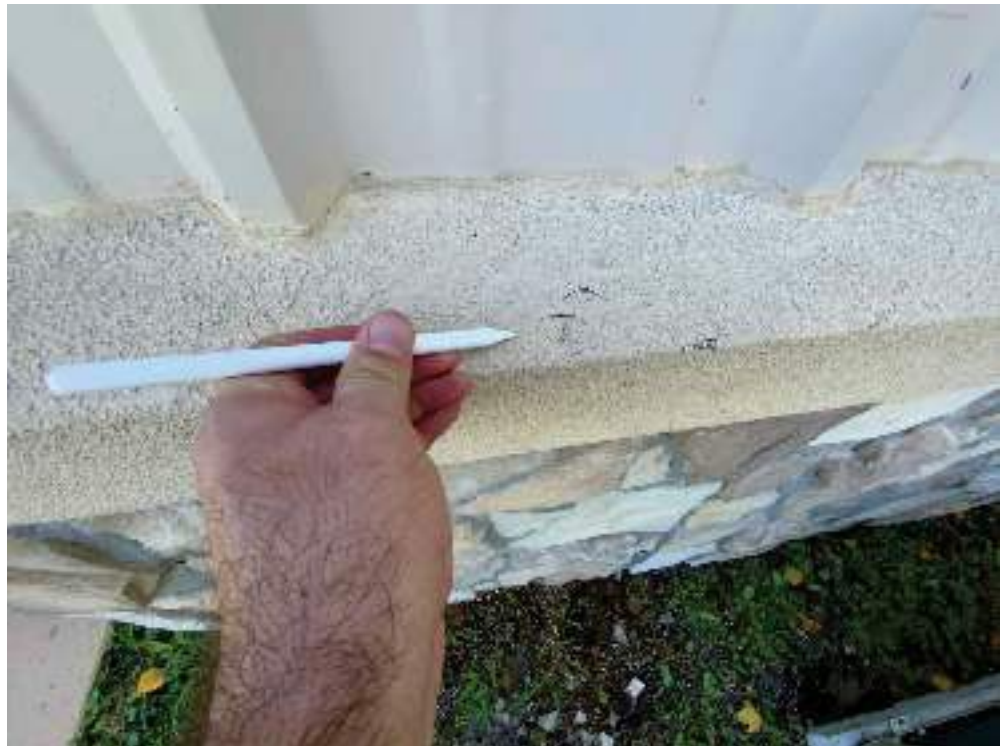
- 98 Location 011/011-001/Exterior -  
98-IMG\_2569  
Date Taken: 11/24/2025

eifs band damaged

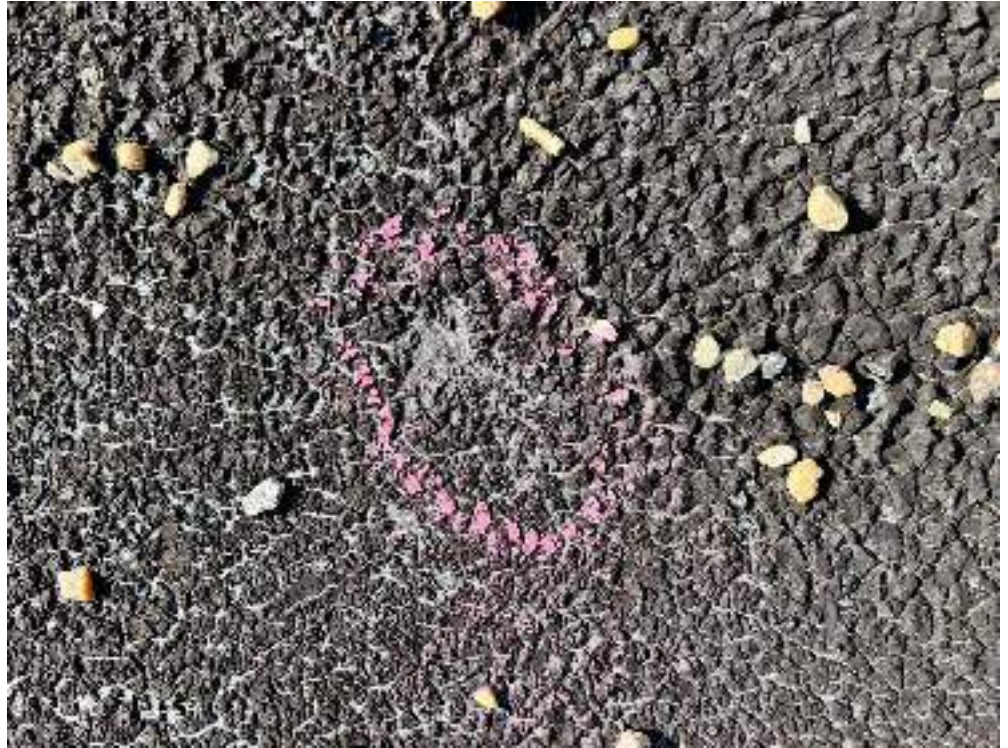
hail damage to built up roofing

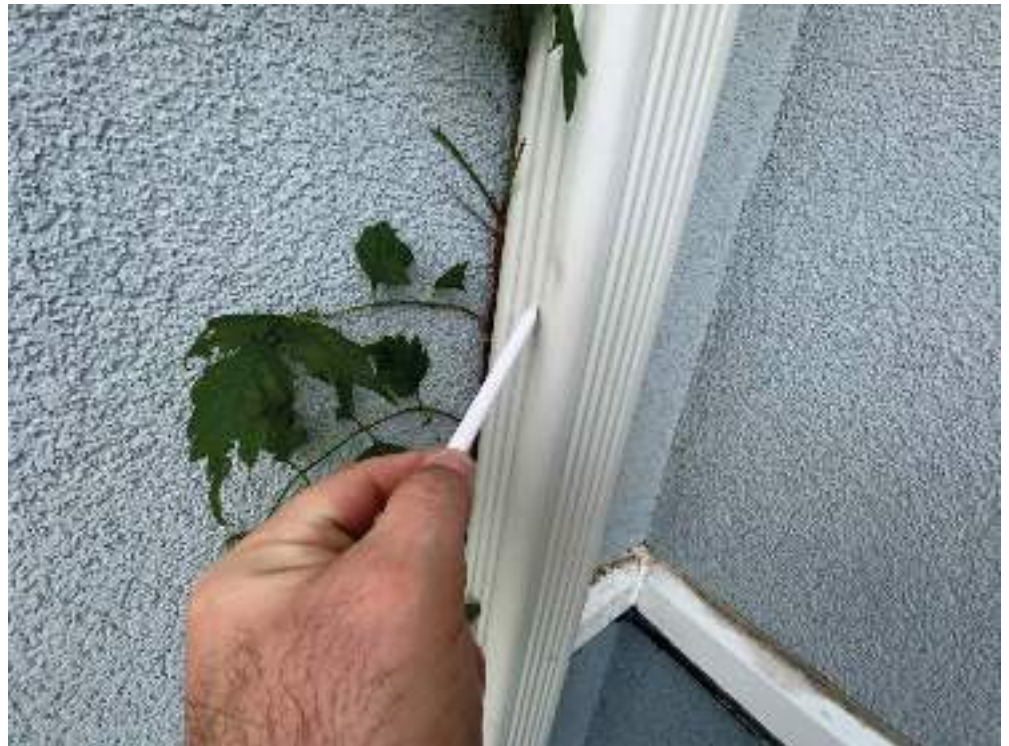
hail damage to downspout

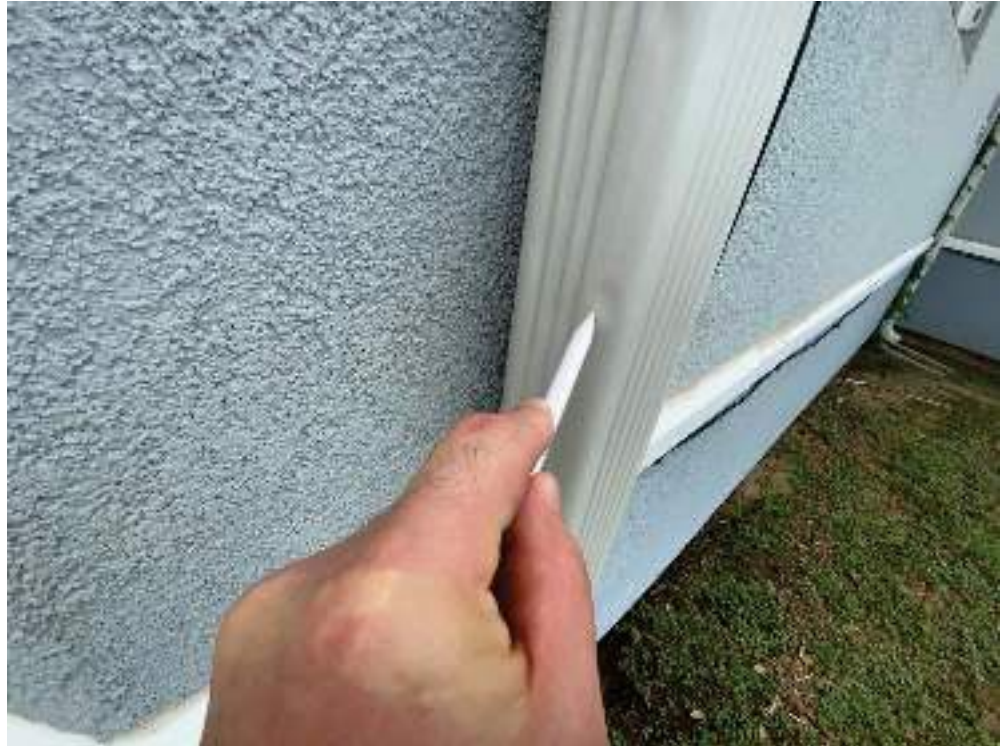
111 Location 013/Exterior - 111-IMG\_2480

hail damage to downspout

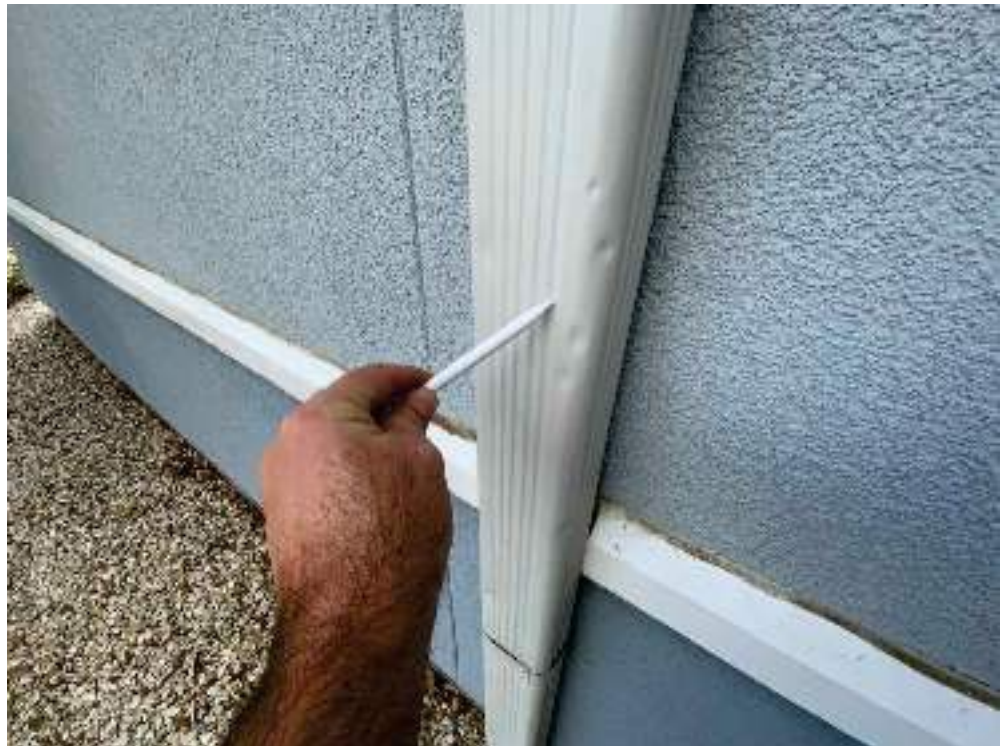
112 Location 013/Exterior - 112-IMG\_2495

hail damage to downspout

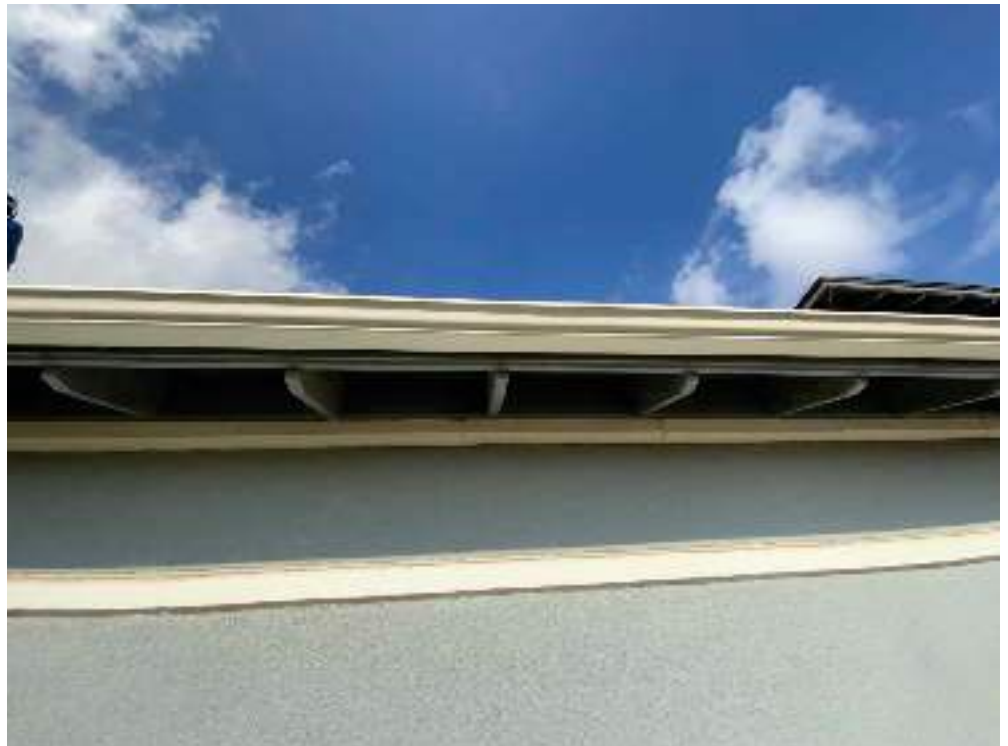
hail damage to gutters

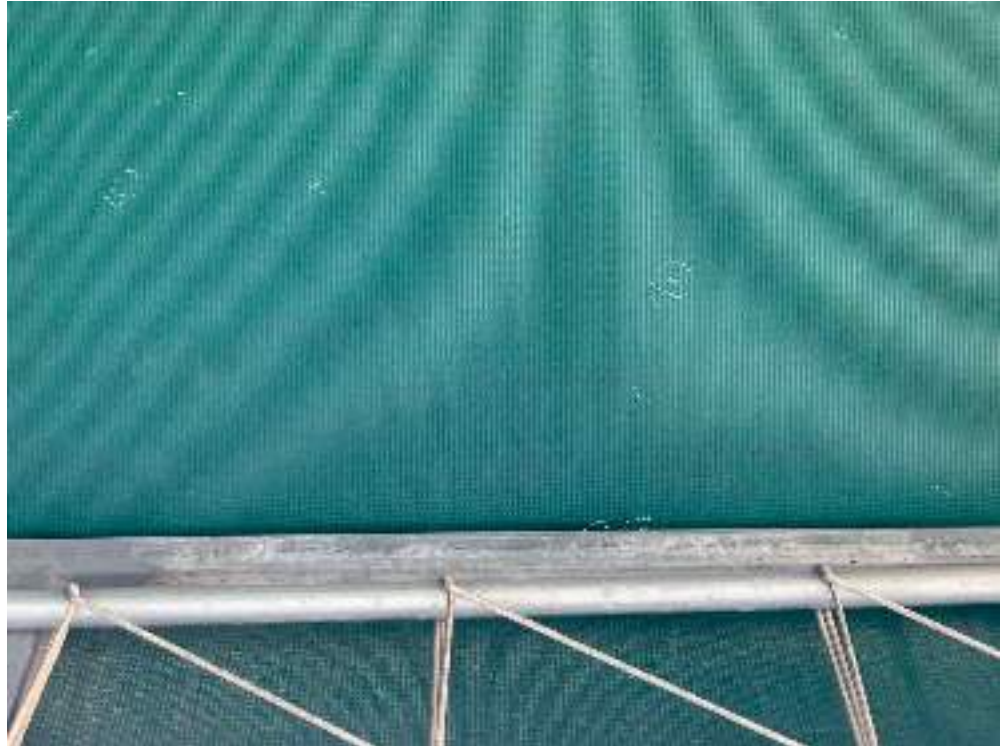
hail damage to canvas awning

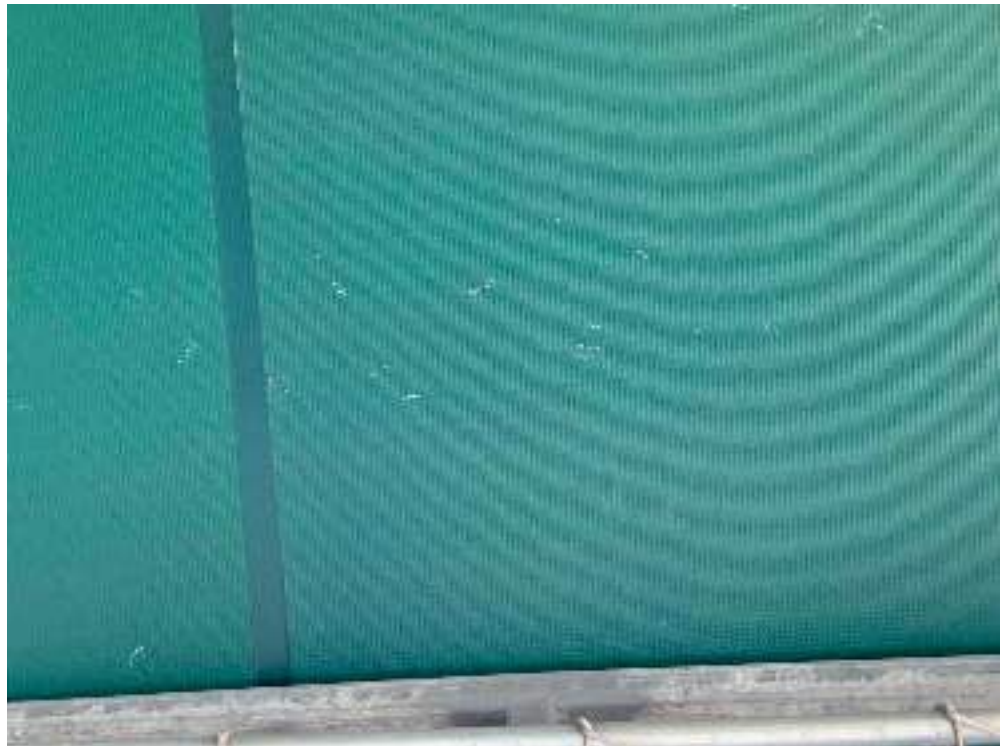
120 Location 014/014-001 - 120-IMG\_2722

hail damage to canvas awning

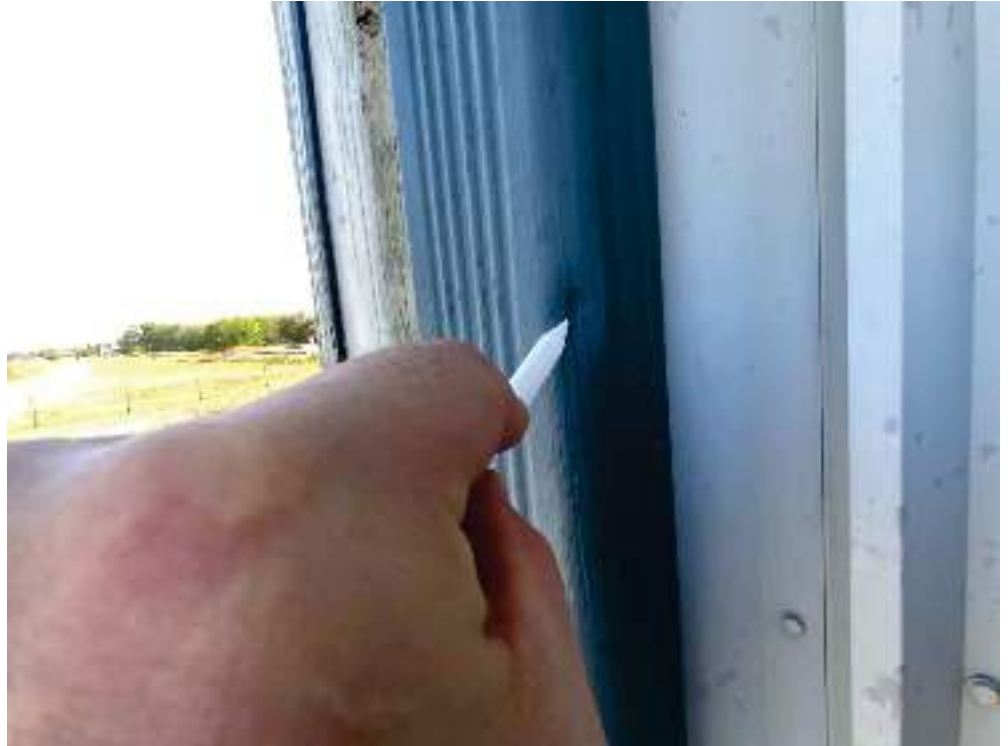
downspout hail damage

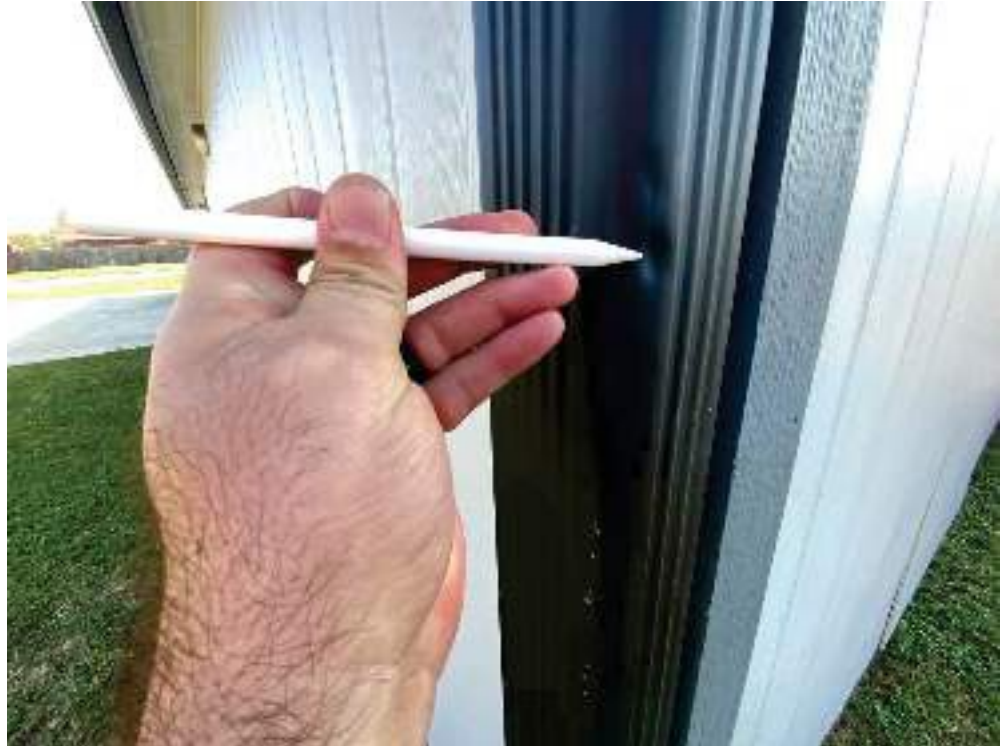
downspout with hail damage

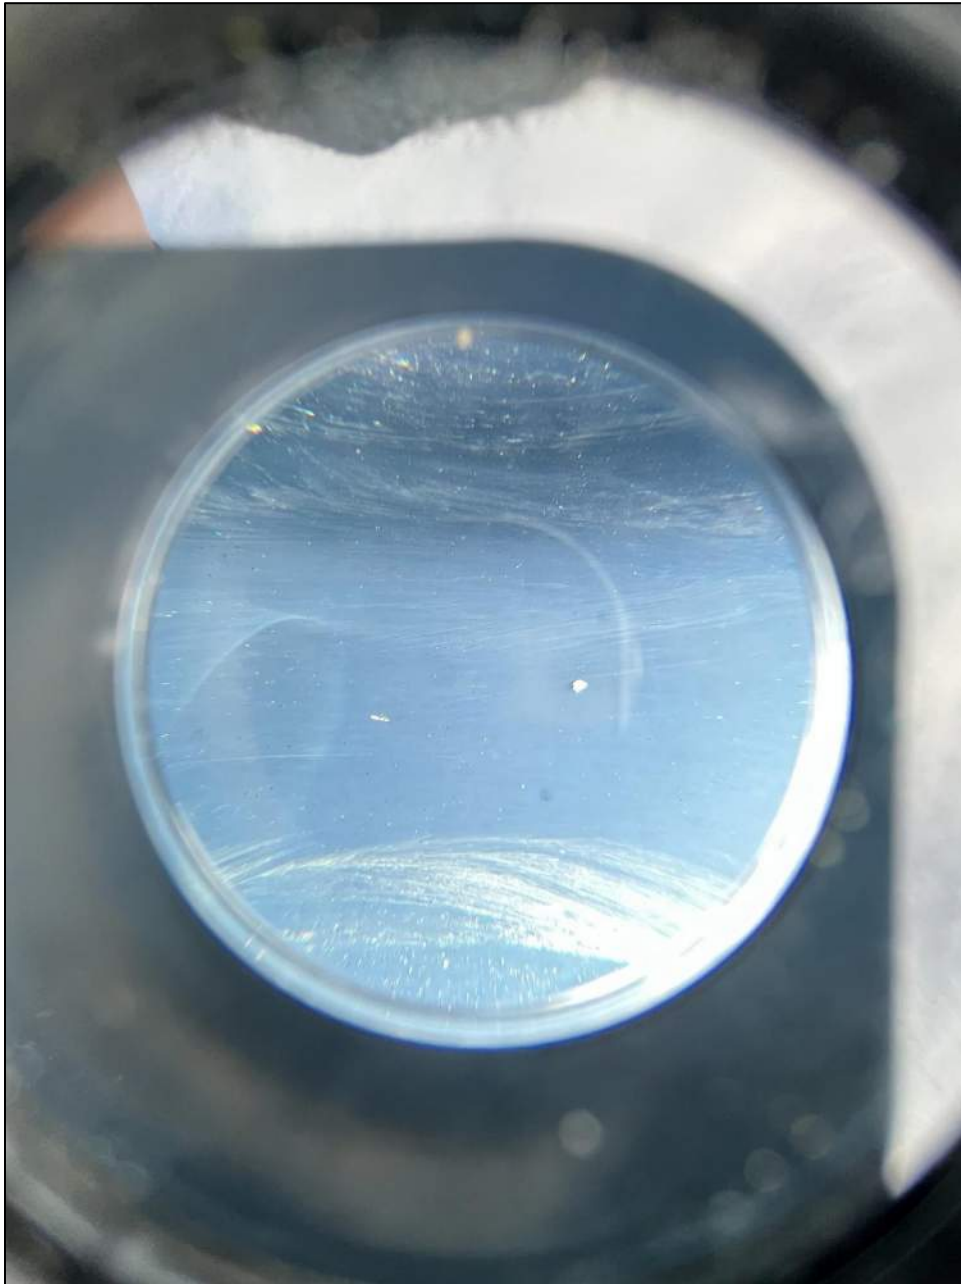
**Photo 128:** Hail denting on north slope had maximum inner diameter of less than 1/2 inch consistent with impact from 1-inch hail.

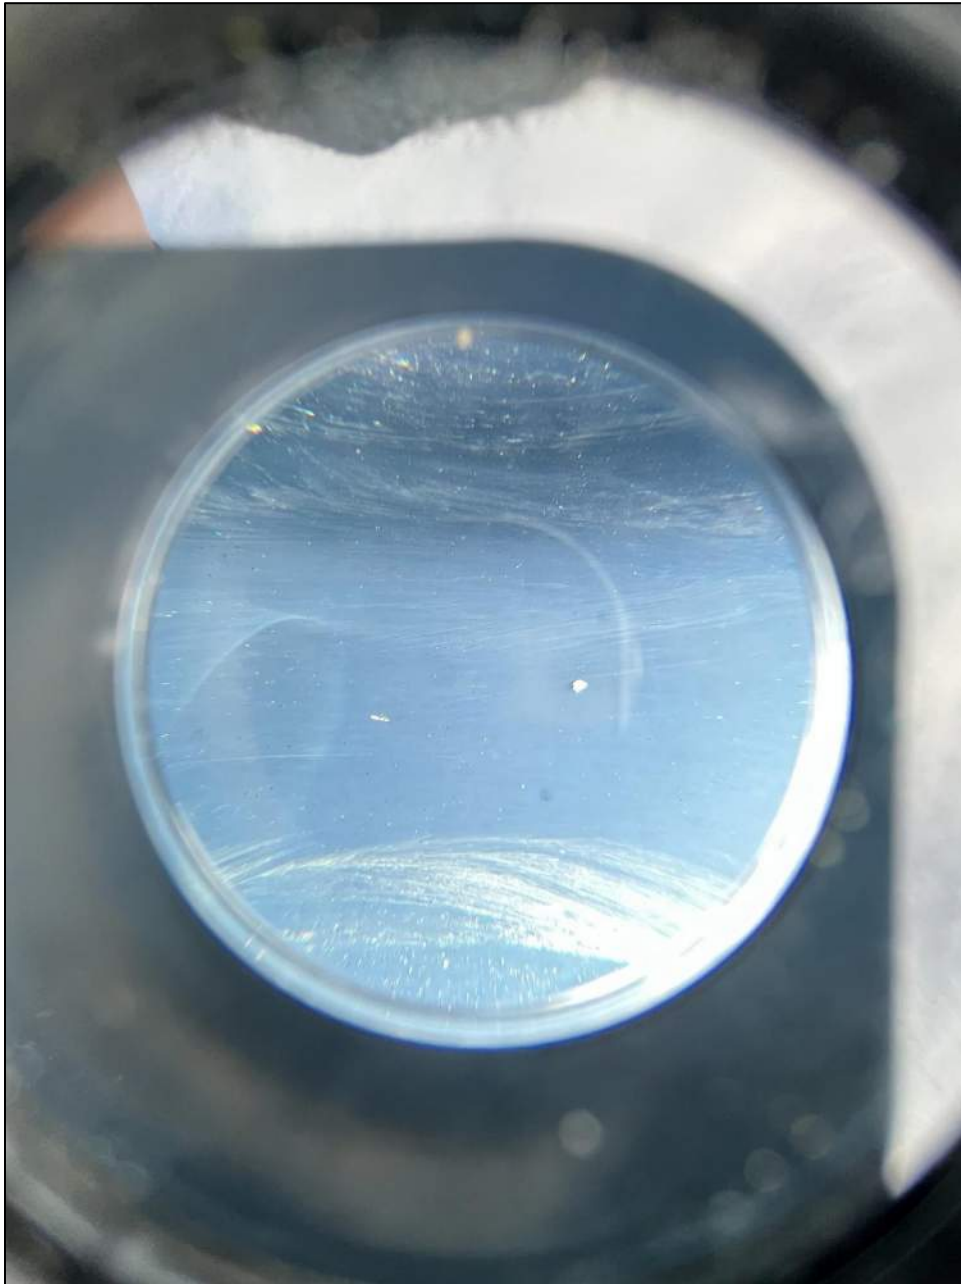
**Photo 128:** Hail denting on north slope had maximum inner diameter of less than 1/2 inch consistent with impact from 1-inch hail.

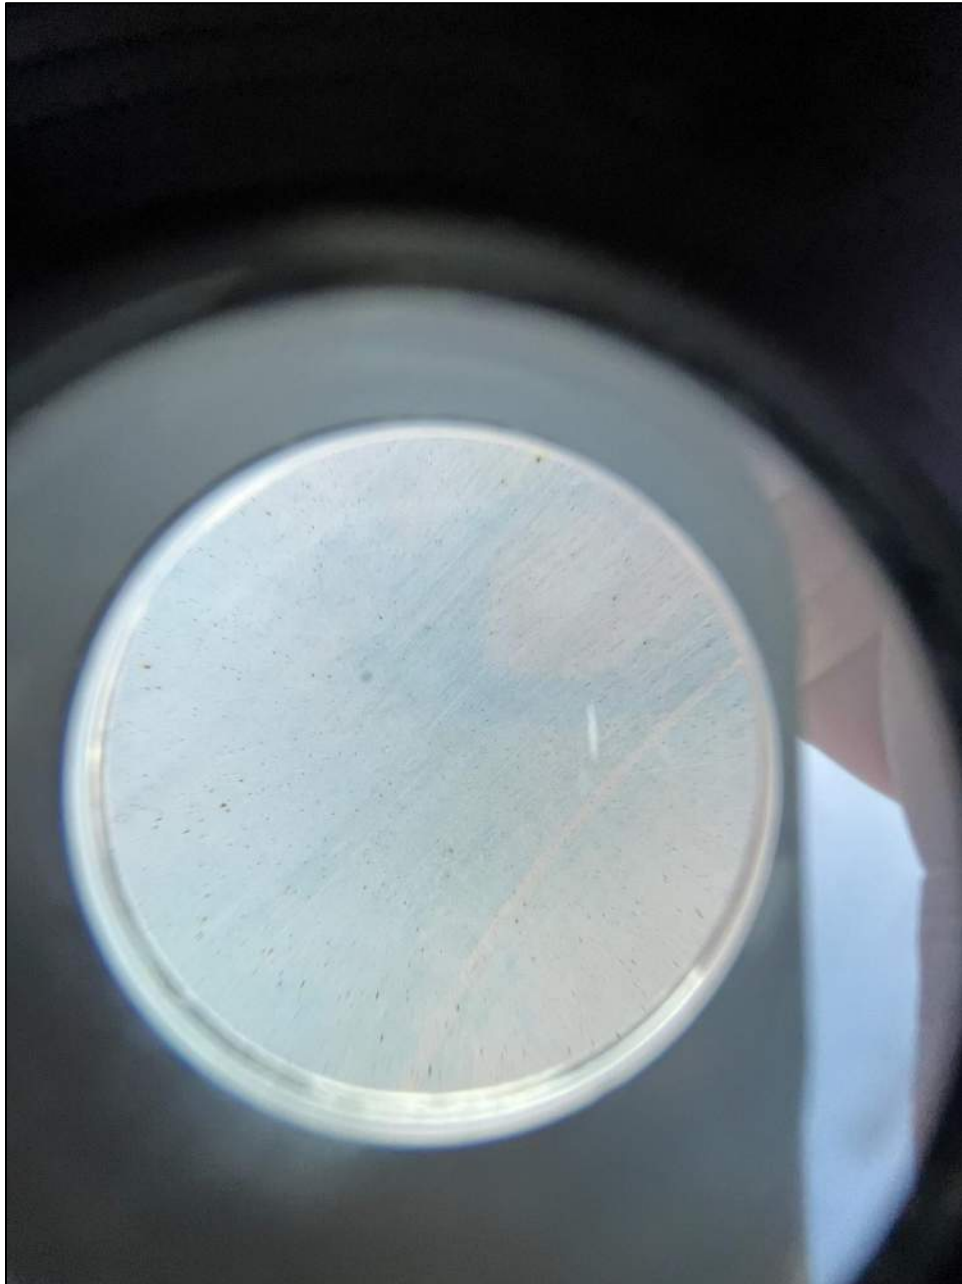
**Photo 21:** Hail denting identified on closure trim along south rake.
