**CITY OF INGLESIDE  
REGULAR CITY COUNCIL MEETING  
AGENDA  
JUNE 9, 2026  
6:30 PM**

Report on November 01, 2025, Hailstorm Damage to City of Ingleside Buildings.

### Building Damage Analysis Survey and Report

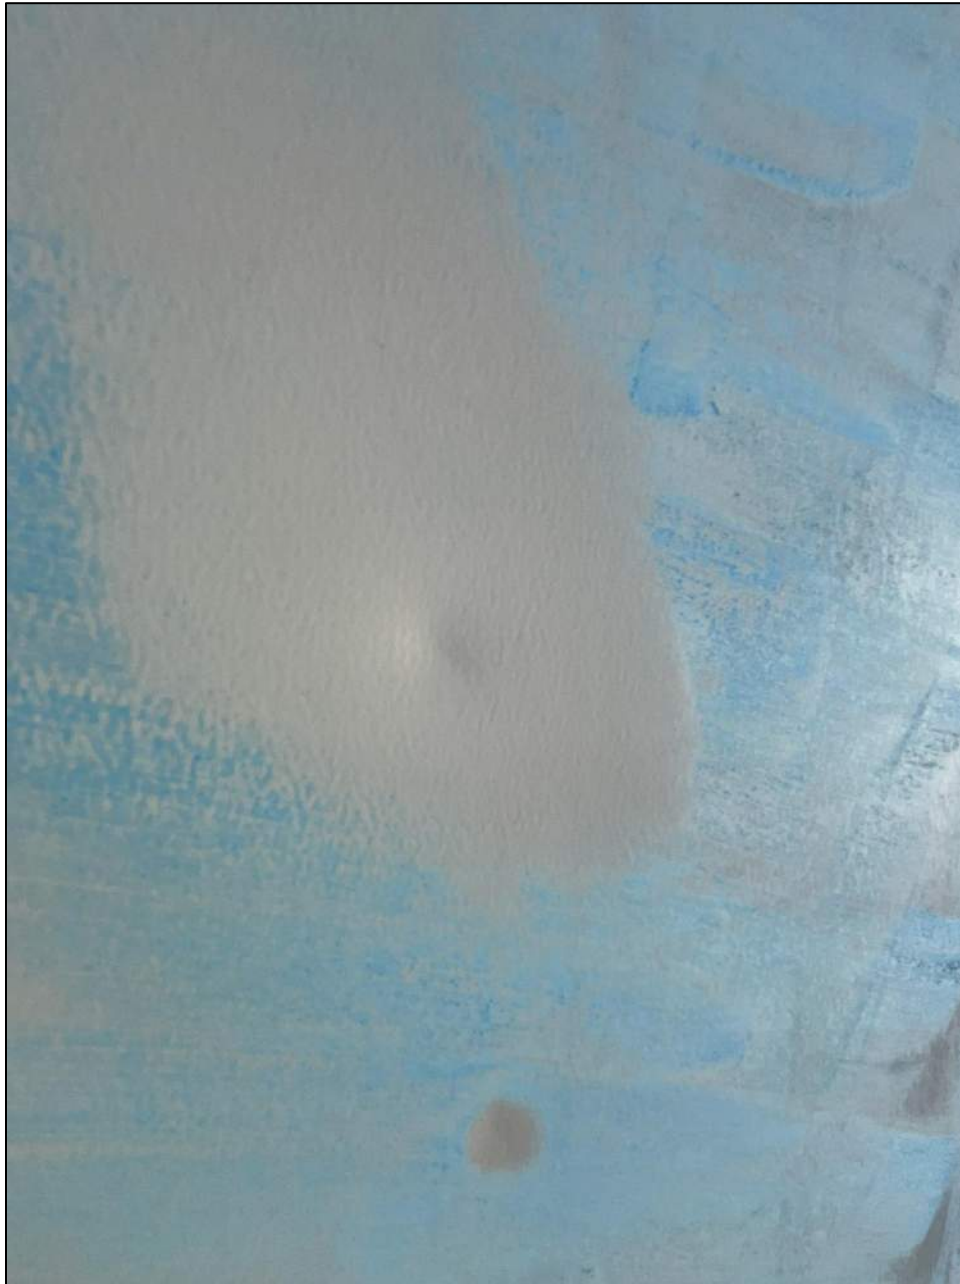
**Photo 67:** Dented ridge panel above the fire department. No coating disruptions were observed at the dents.

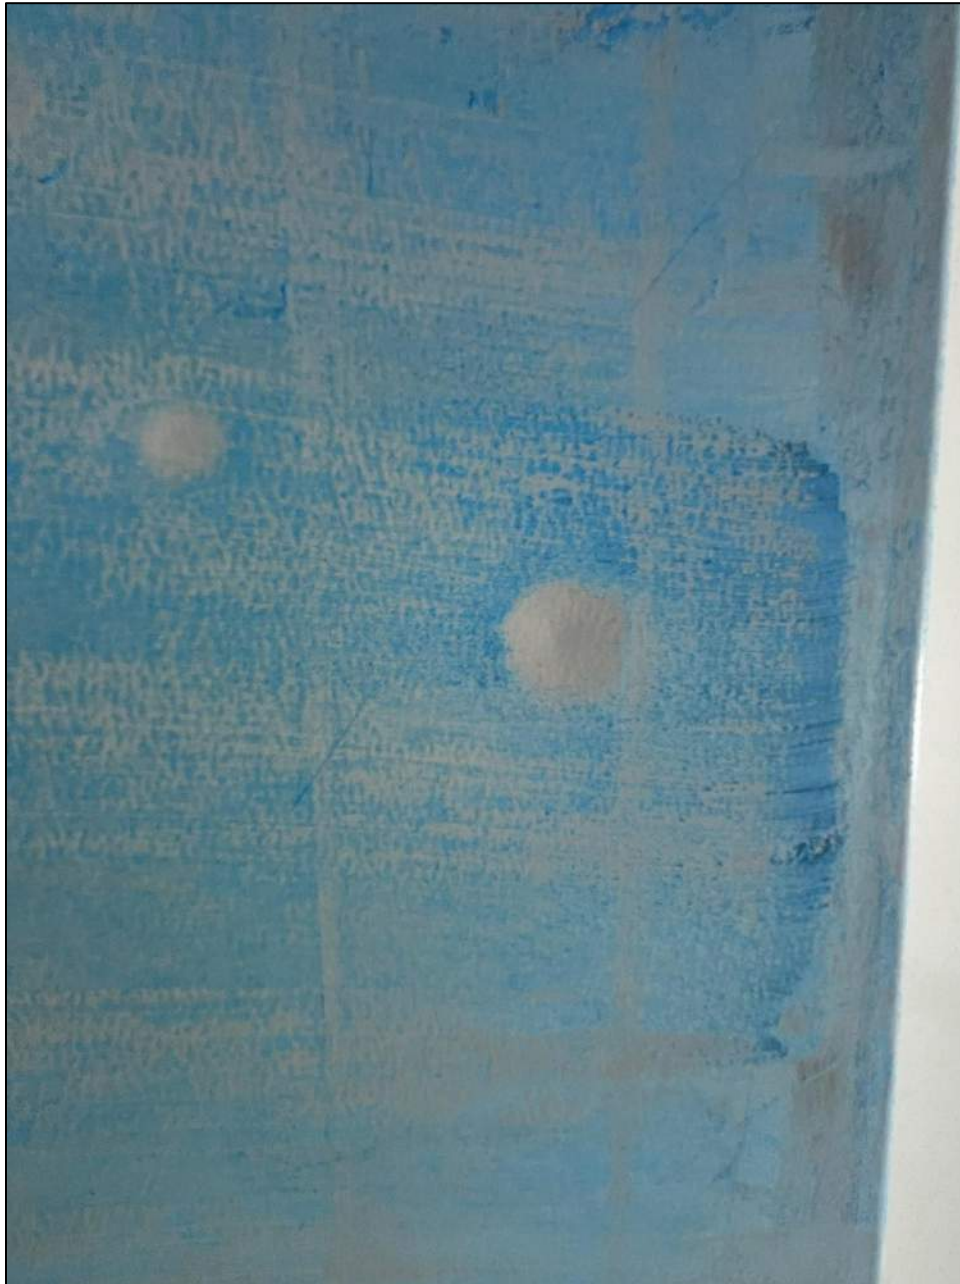
**Photo 68:** Dented ridge panel above the fire department. No coating disruptions were observed at the dents.

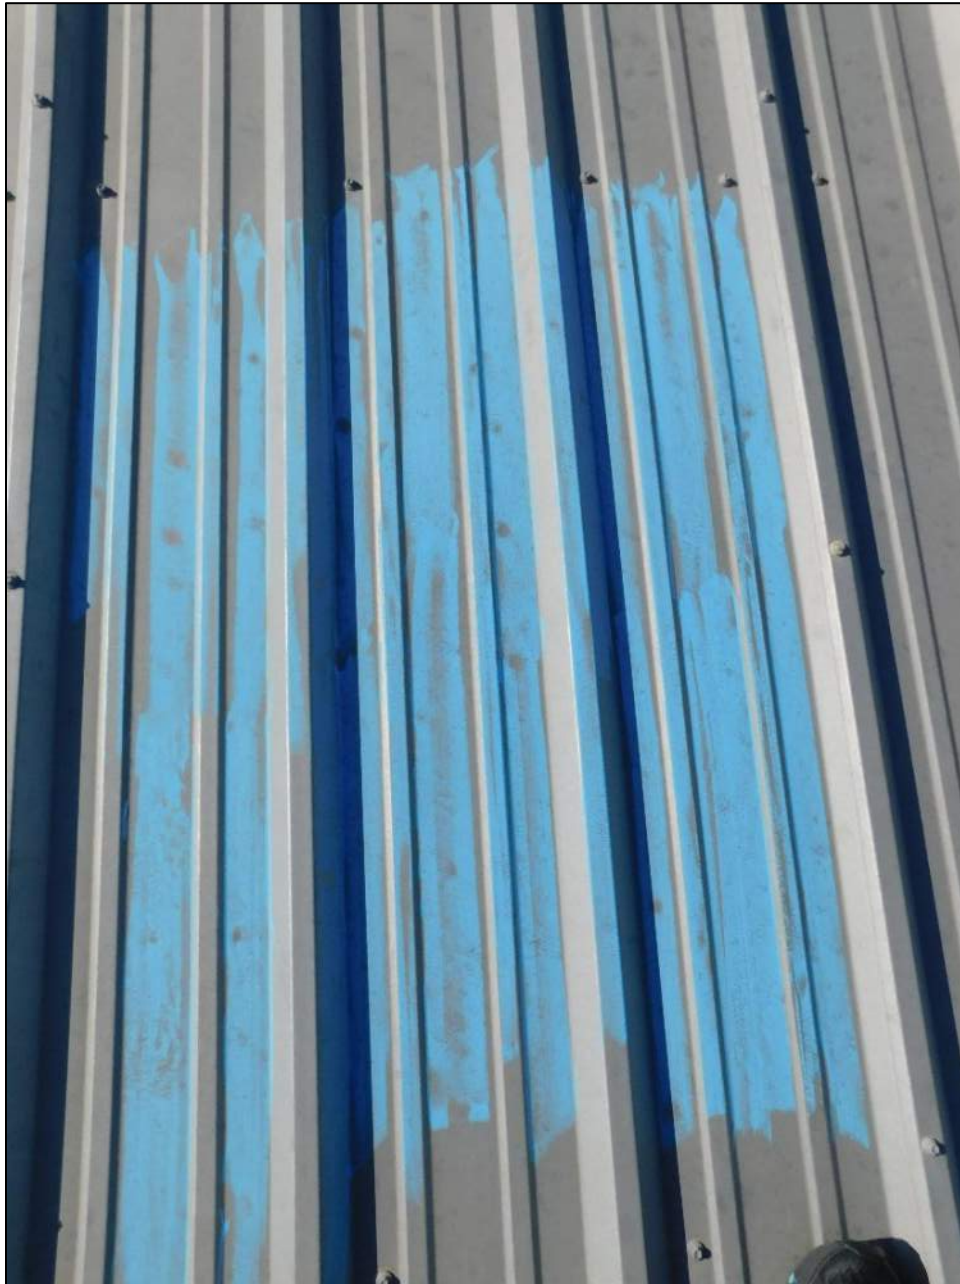
**Photo 103:** Hail denting on the closure metal exhibited no disruptions to the surface coating.

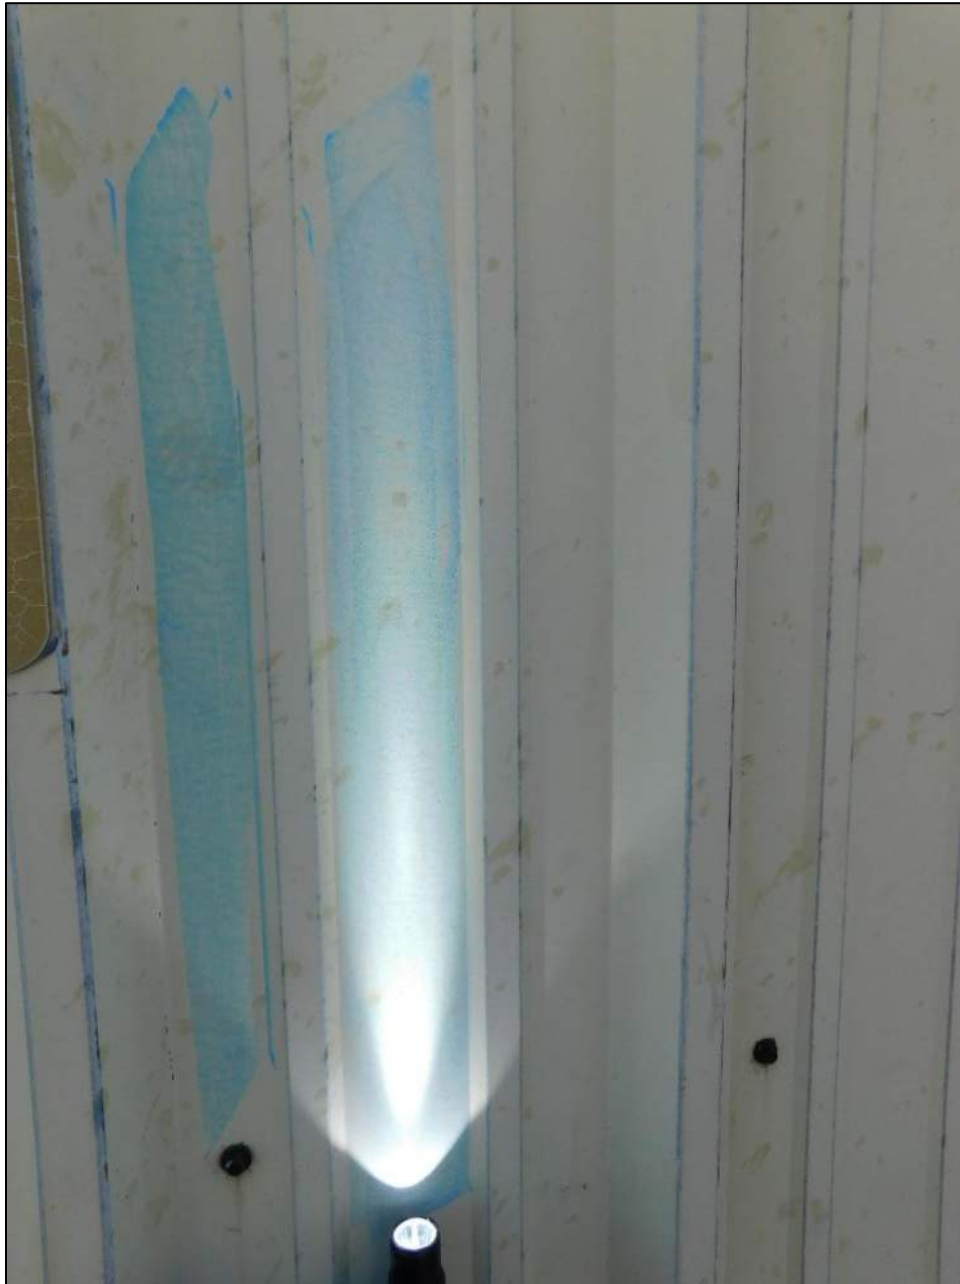
**Photo 15:** Wall panel mechanical denting and corrosion at the bottom of the south wall.

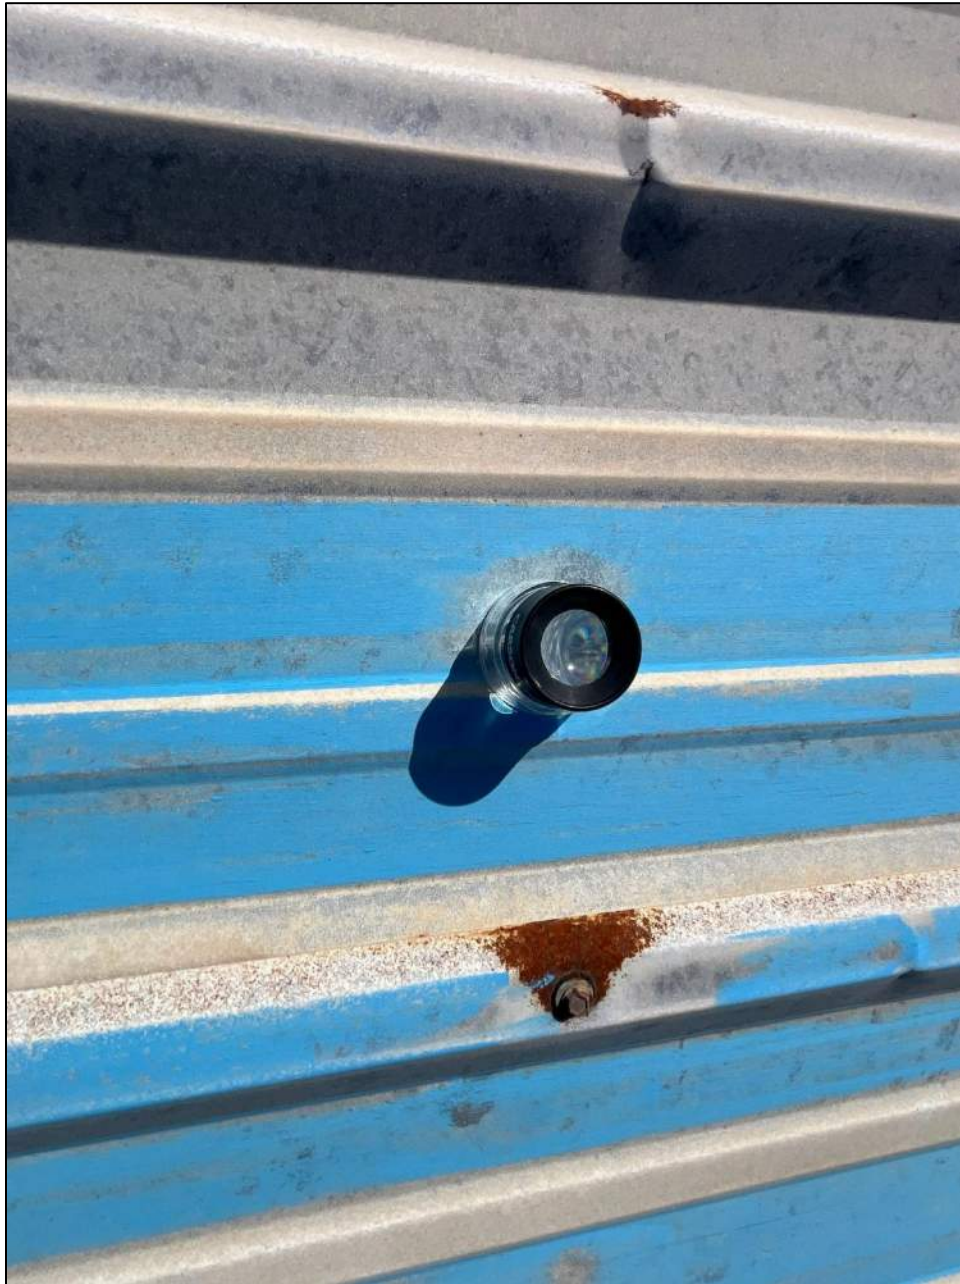
**Photo 26:** Denting observed on the metal roof panels had inner diameters of less than 1/2 inch.

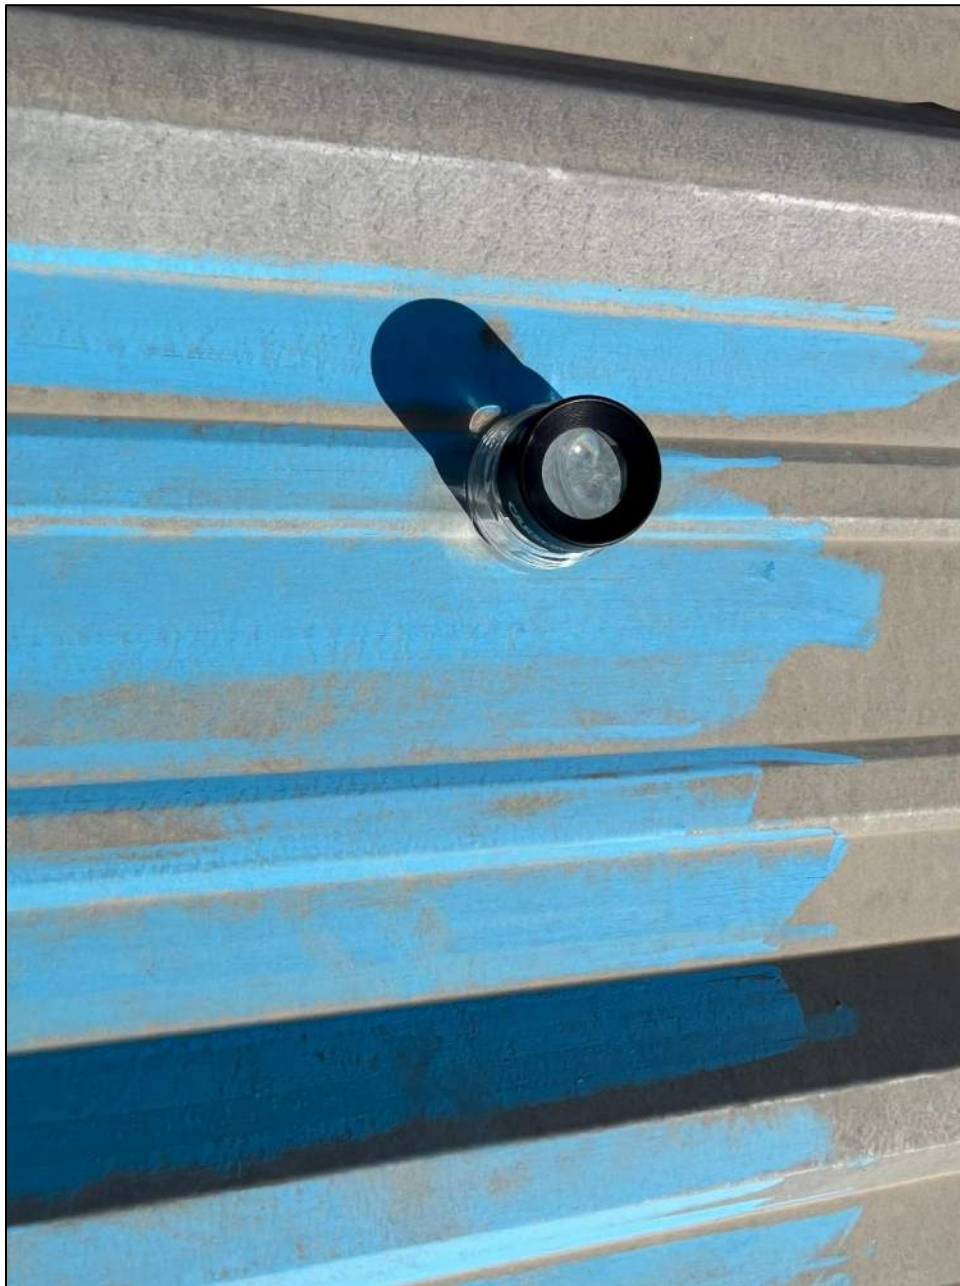
**Photo 95:** Hail denting in the roofing panels had a inner diameter of less than 3/8 inch.

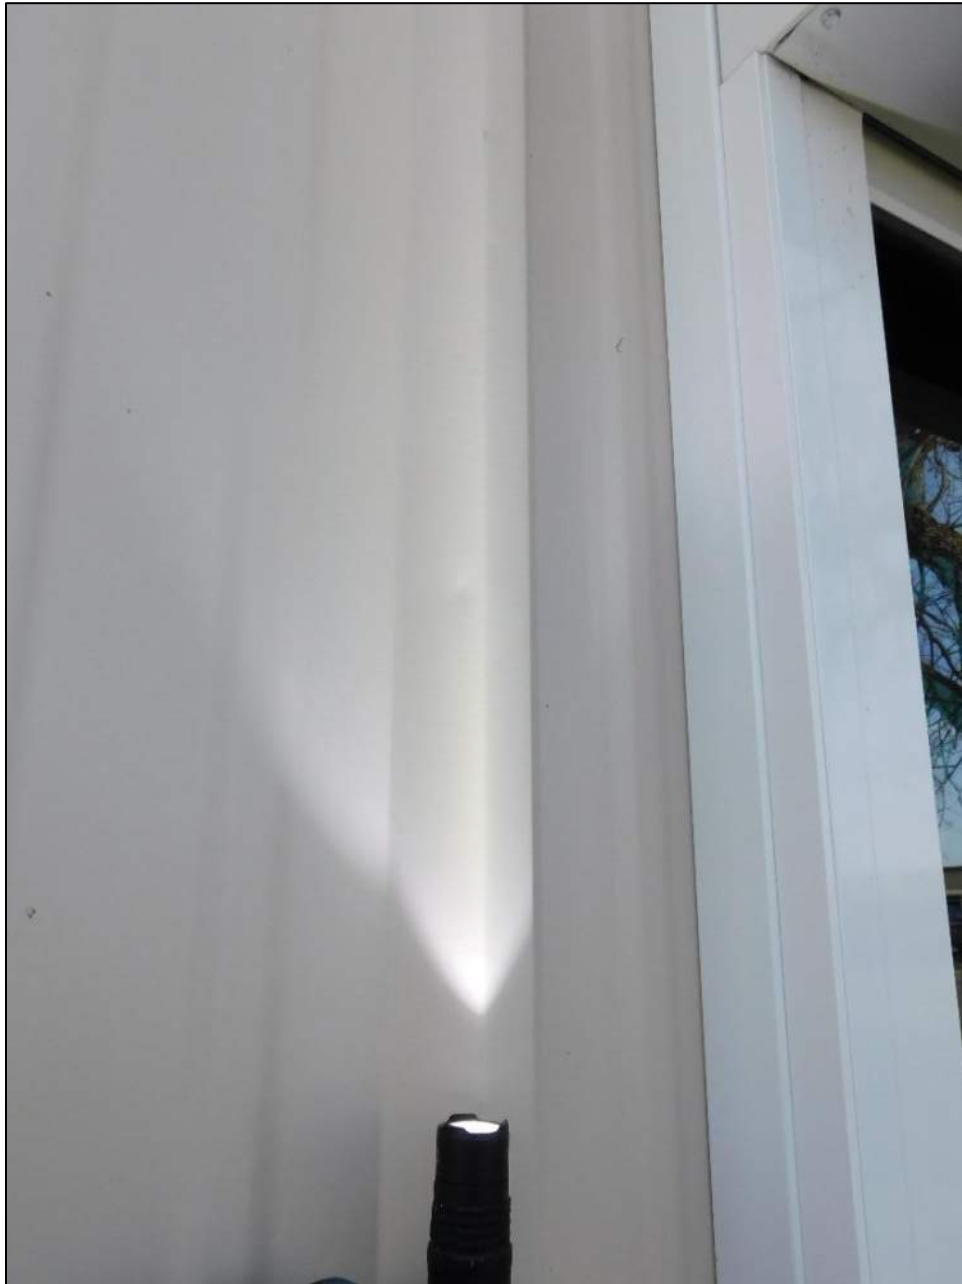
**Photo 11:** Isolated slight denting was observed on the west wall panels under directional lighting.

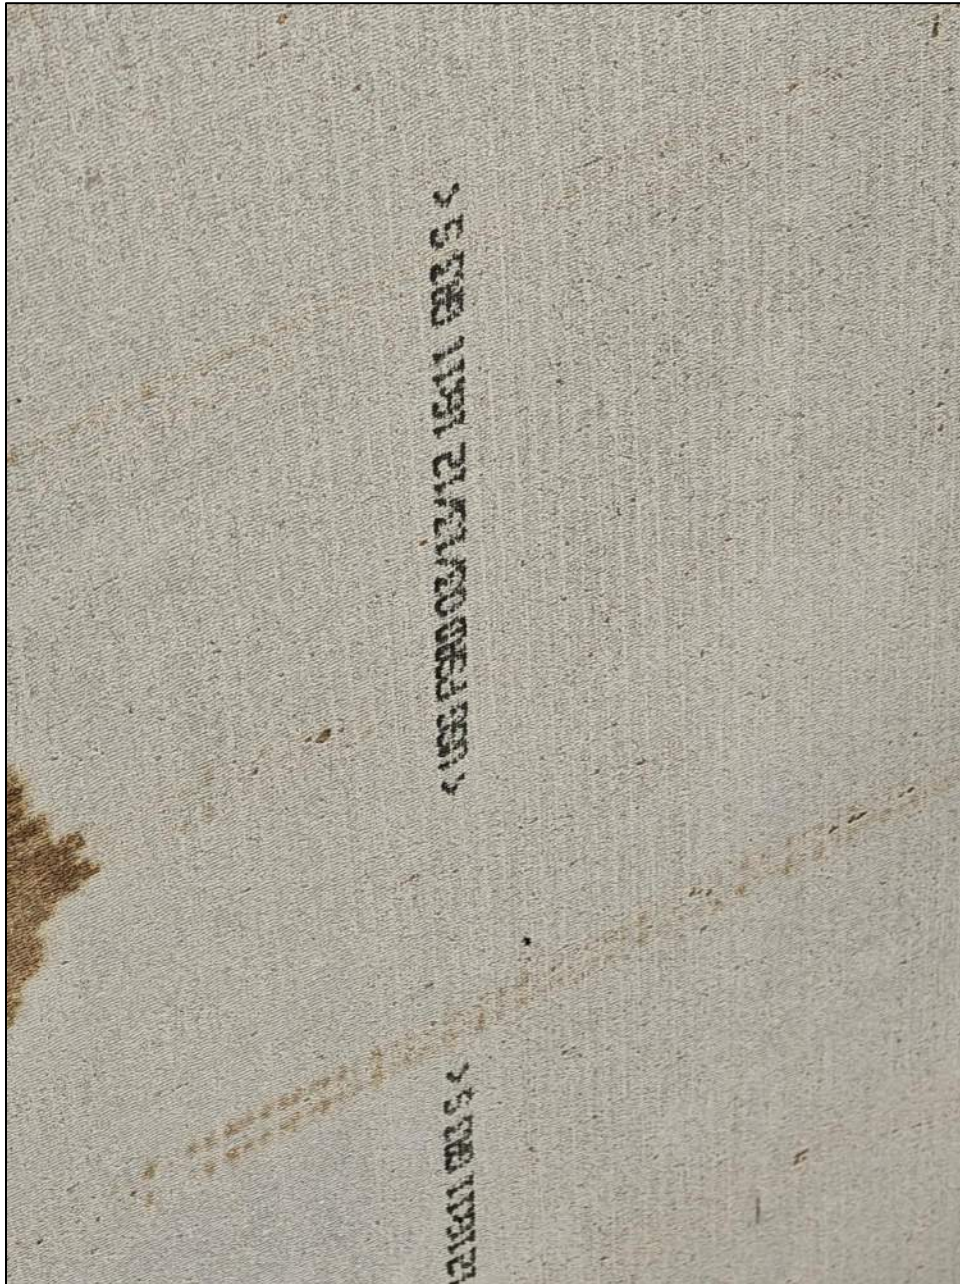
**Photo 40:** The stained ceiling tile was made in 2012 and exhibited multiple concentric rings of stains.
