**CITY OF INGLESIDE  
REGULAR CITY COUNCIL MEETING  
AGENDA  
JUNE 9, 2026  
6:30 PM**

Report on November 01, 2025, Hailstorm Damage to City of Ingleside Buildings.

### Building Damage Analysis Survey and Report

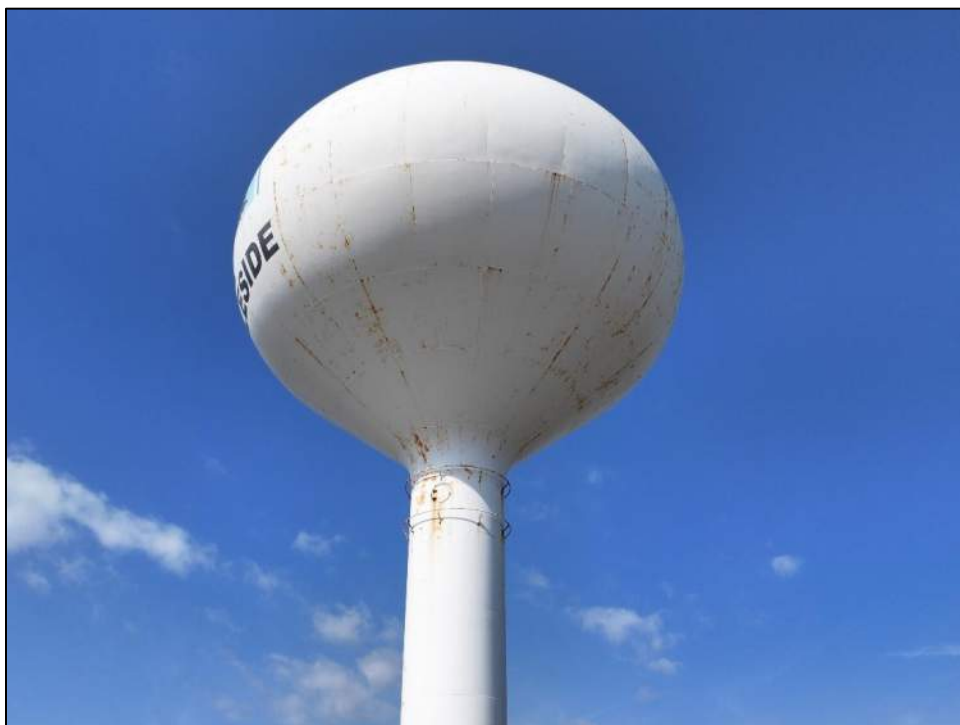
**Photo 4:** Underside of the tank exhibited widespread rusting.

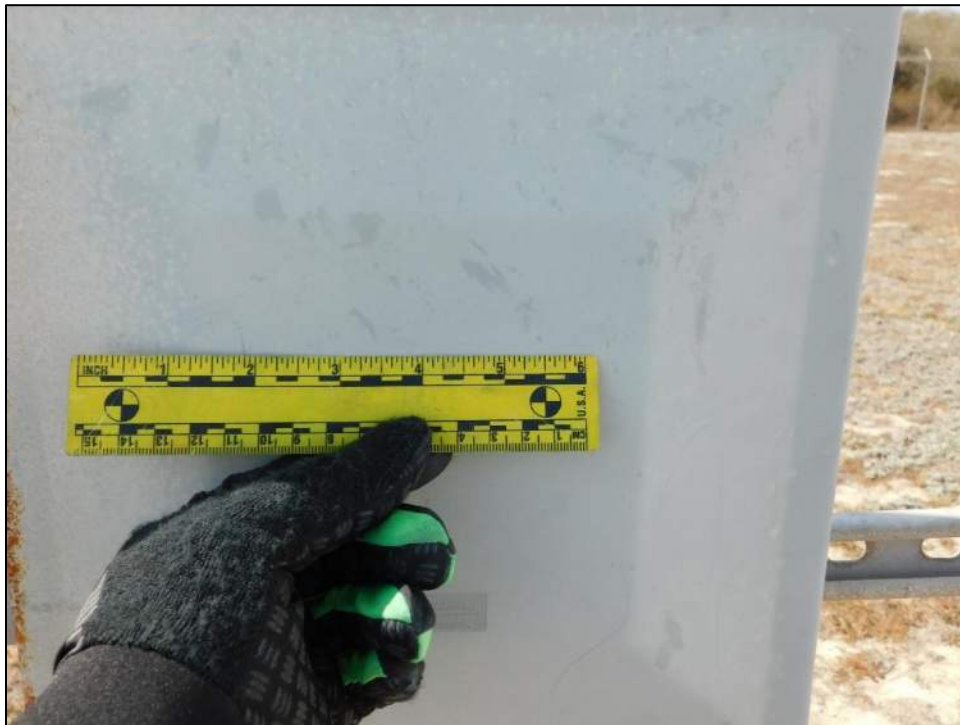
**Photo 5:** Hail spatter on nearby electrical panels indicative of 1-inch hail.

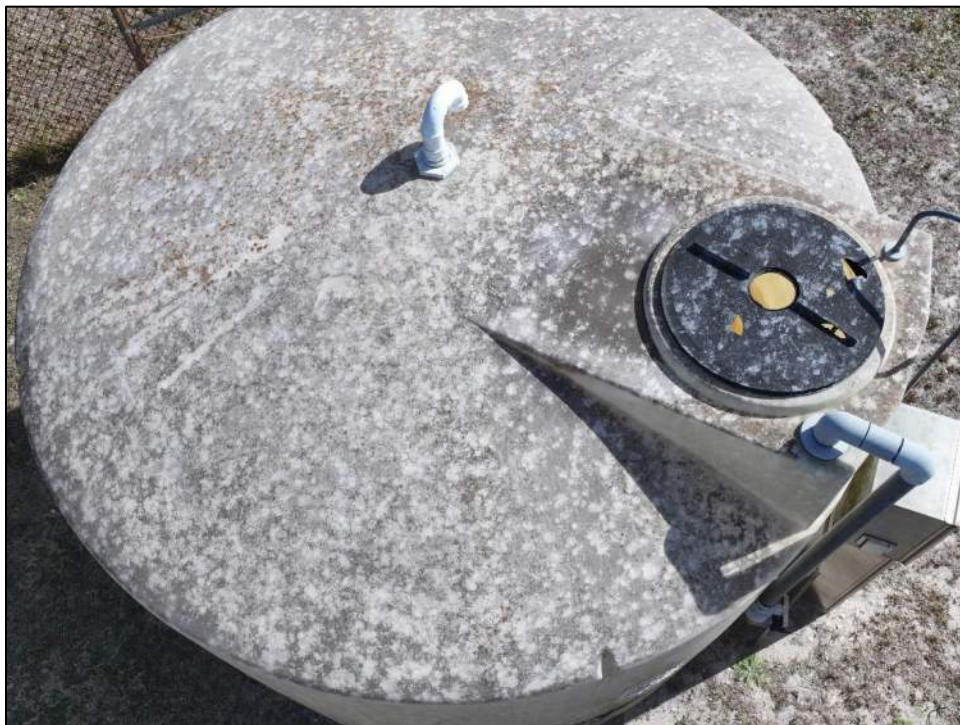
**Photo 6:** Hail spatters on nearby vinyl water tank consistent with 1.0- to 1.5-inch hail.

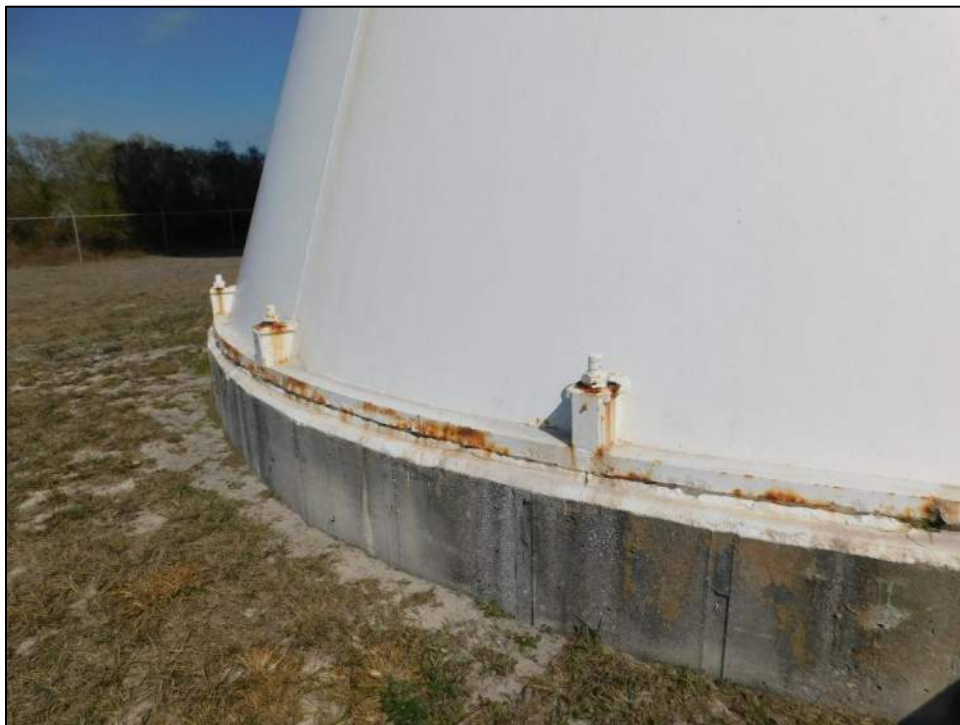
**Photo 8:** Base attachment to concrete foundation remained intact.

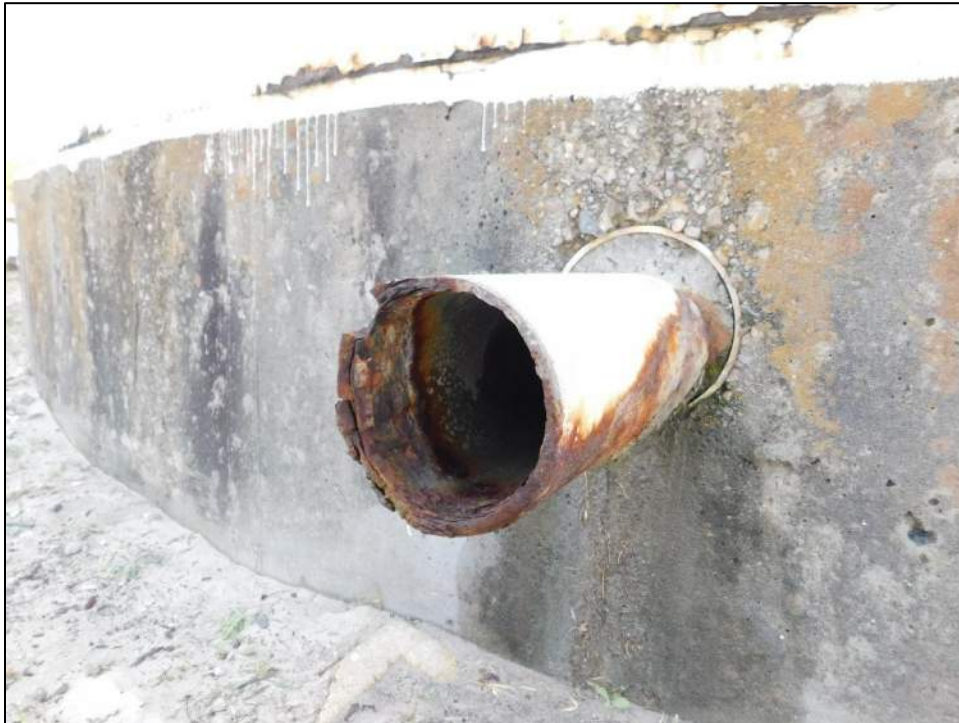
**Photo 9:** Close view of severely corroded drain pipe through the concrete foundation.

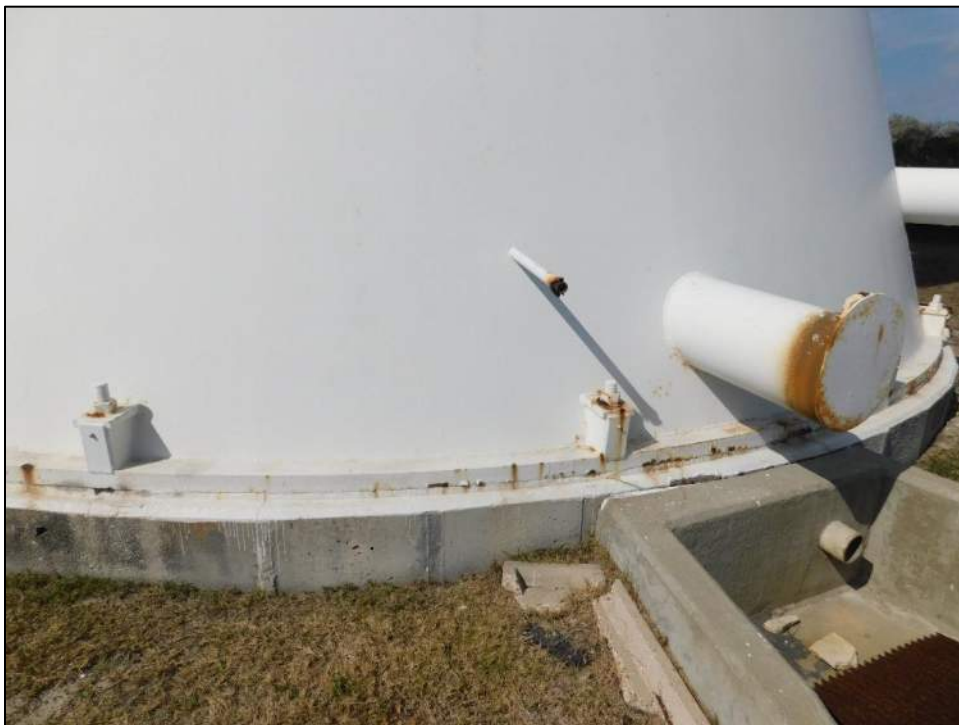
**Photo 10:** Corroded drain pipe.

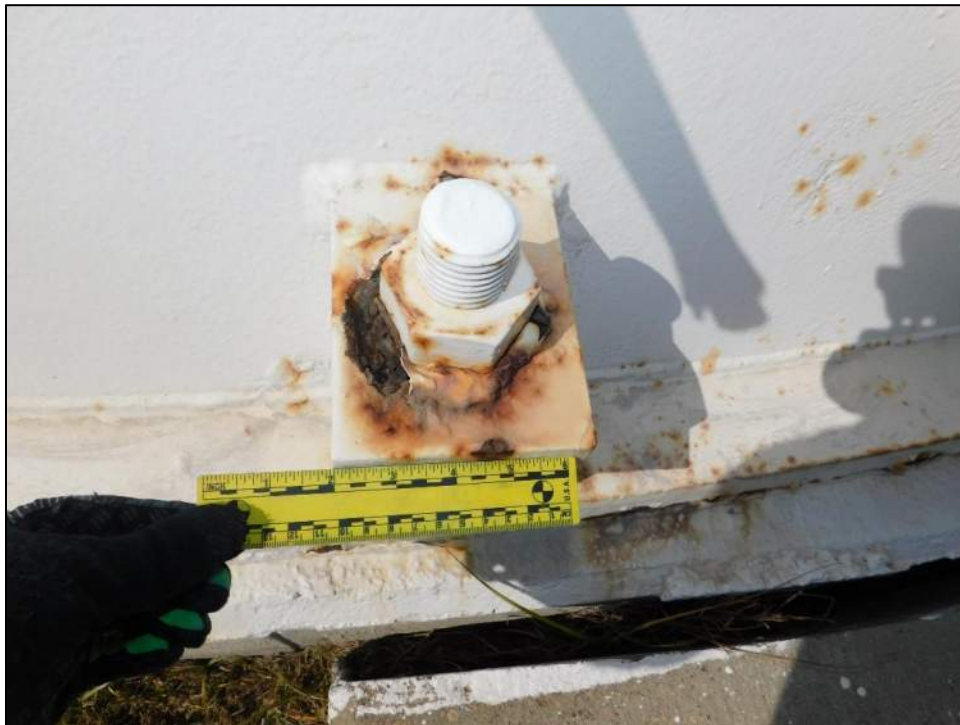
**Photo 11:** Typical view of corroded anchor plate.

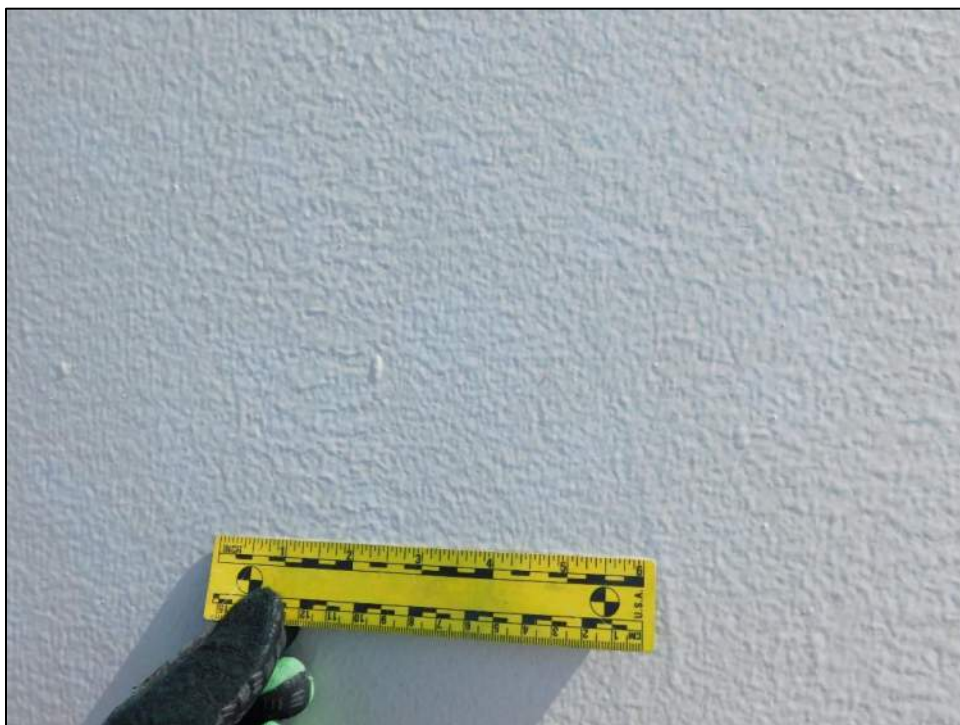
**Photo 12:** Surface coating of tank stem remained intact.

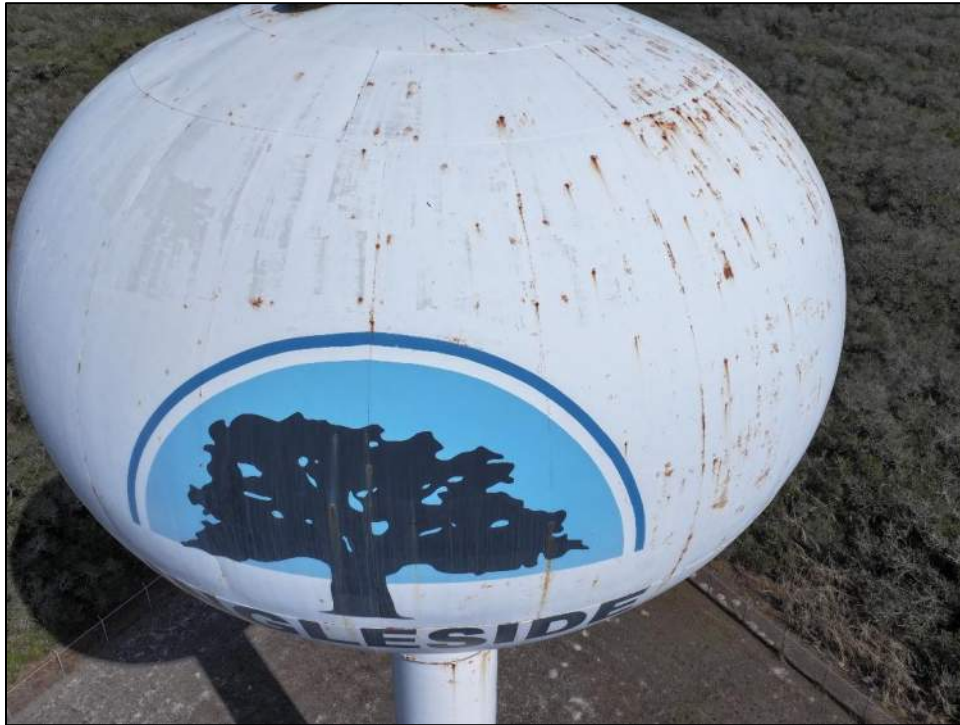
**Photo 13:** Southwest elevation. South elevation exhibited widespread rusting and steel corrosion.

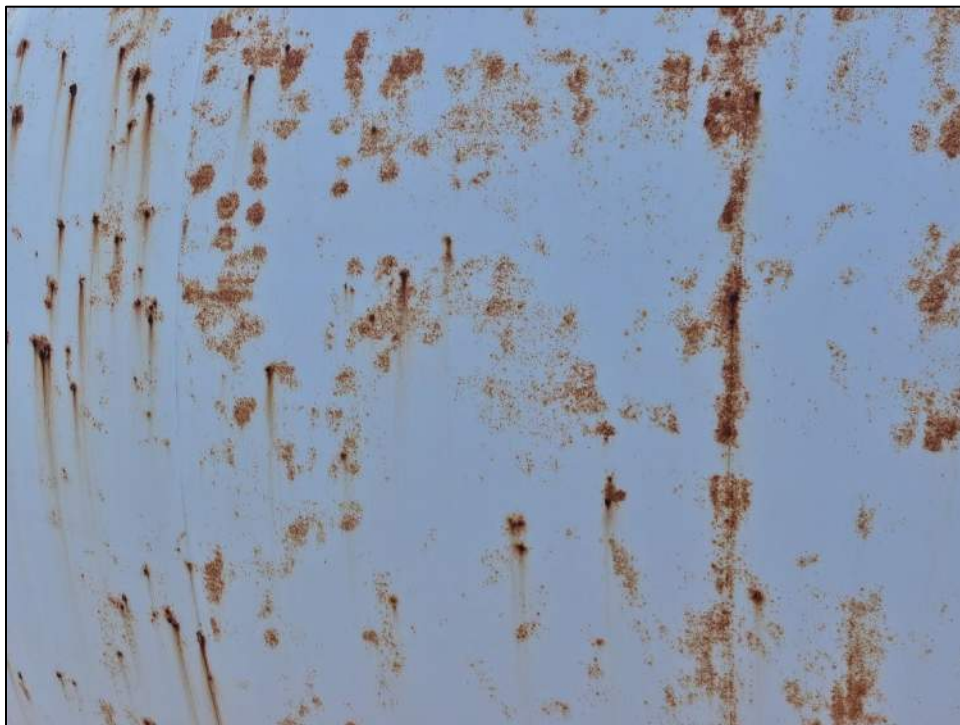
**Photo 14:** Close-up of typical rusting.

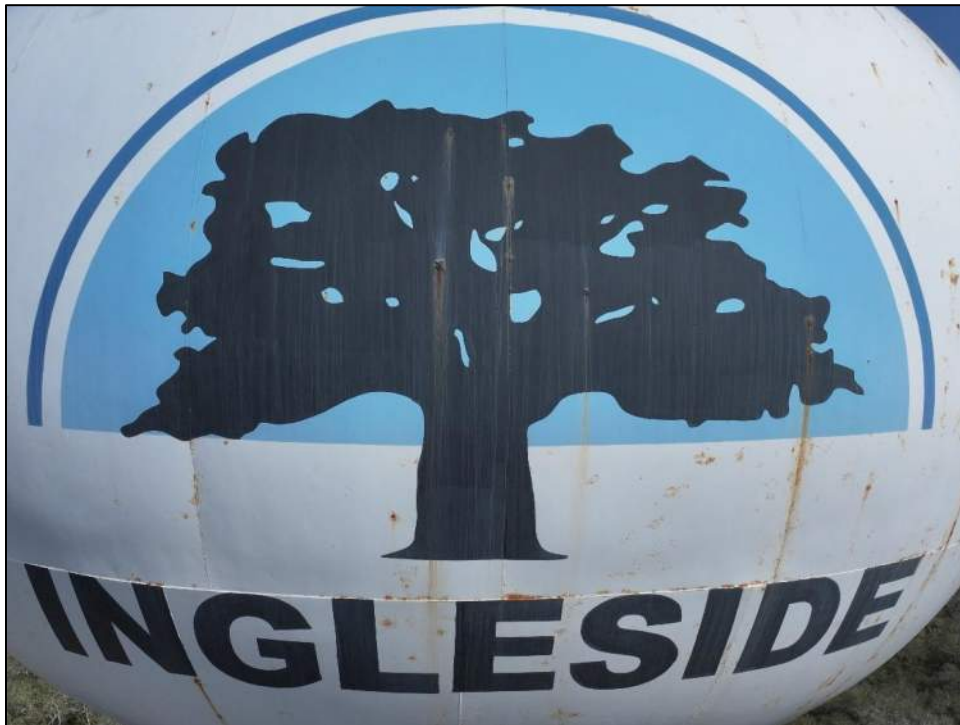
**Photo 15:** No coating disruption to painted surface.

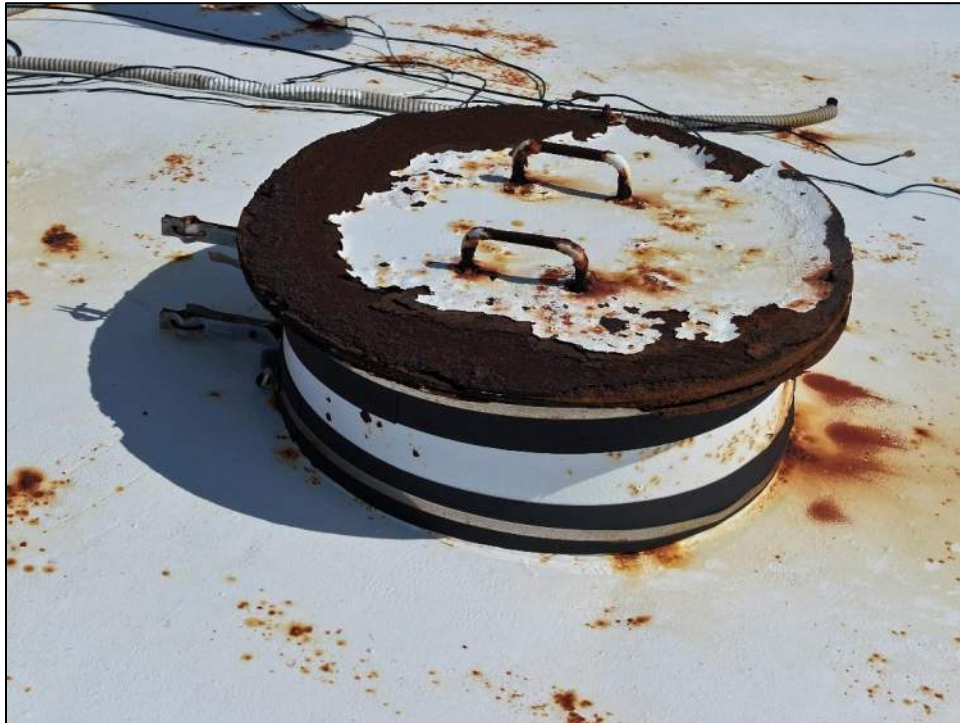
**Photo 17:** Vent coverings on the top of the tanks were severely corroded.

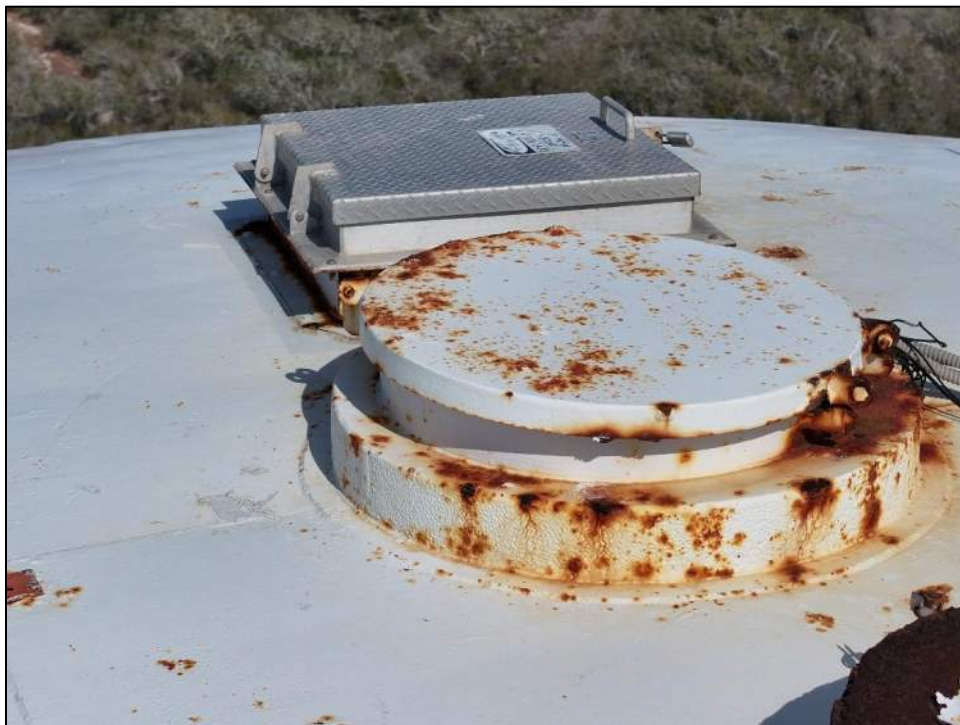
**Photo 18:** Steel plate vent coverings remained otherwise intact.

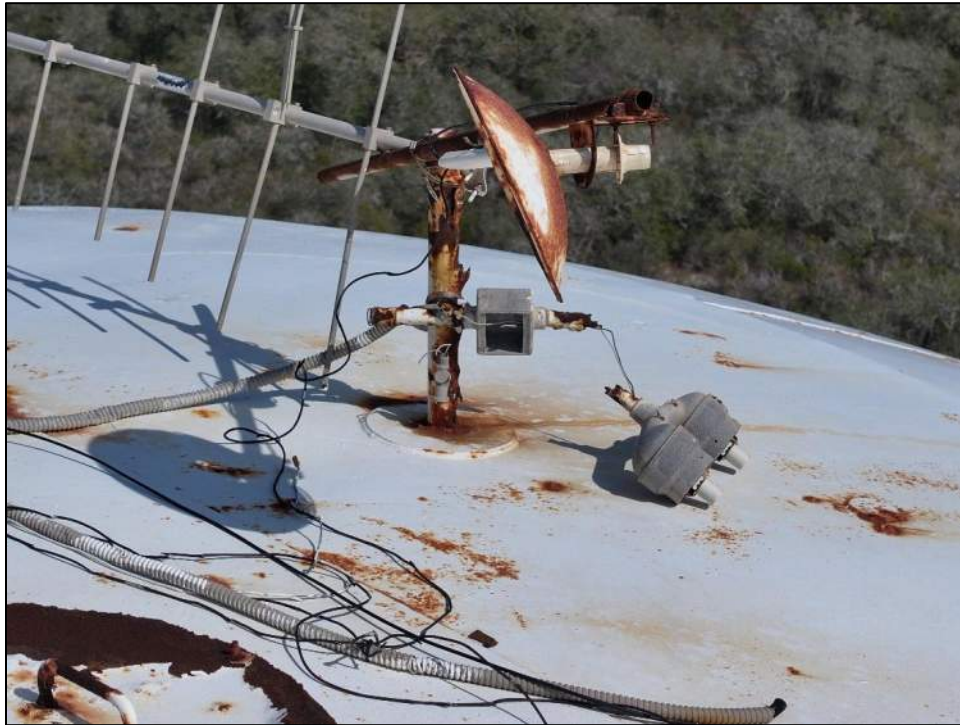
**Photo 19:** Corrosion of roof-mount tubing resulted in detached fixtures unrelated to hail impact.

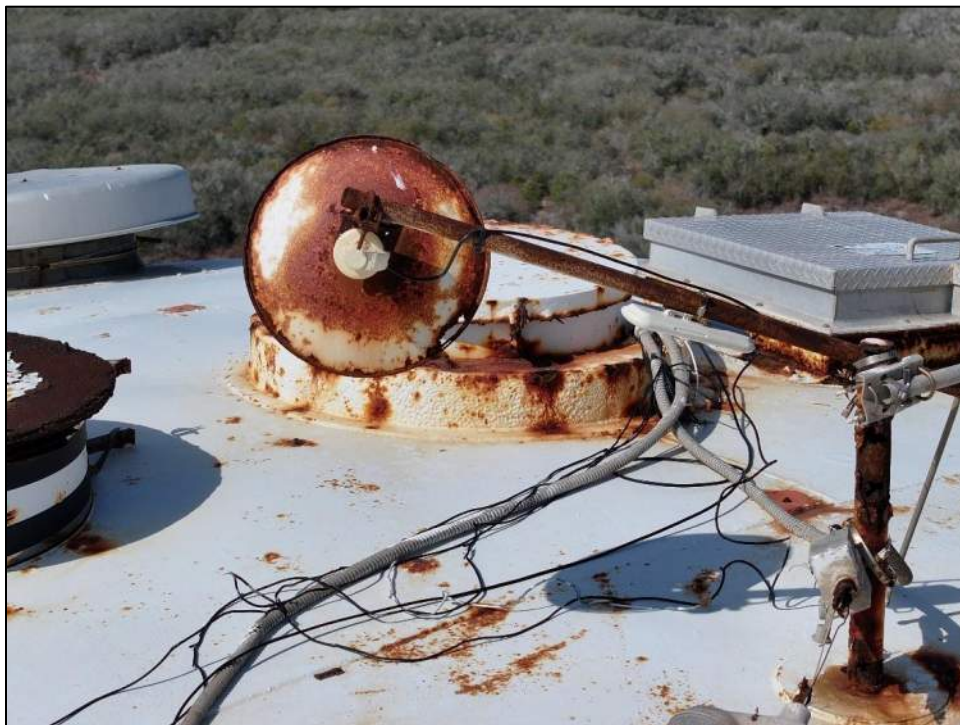
**Photo 20:** Additional view of severe corrosion on rooftop apparatus.

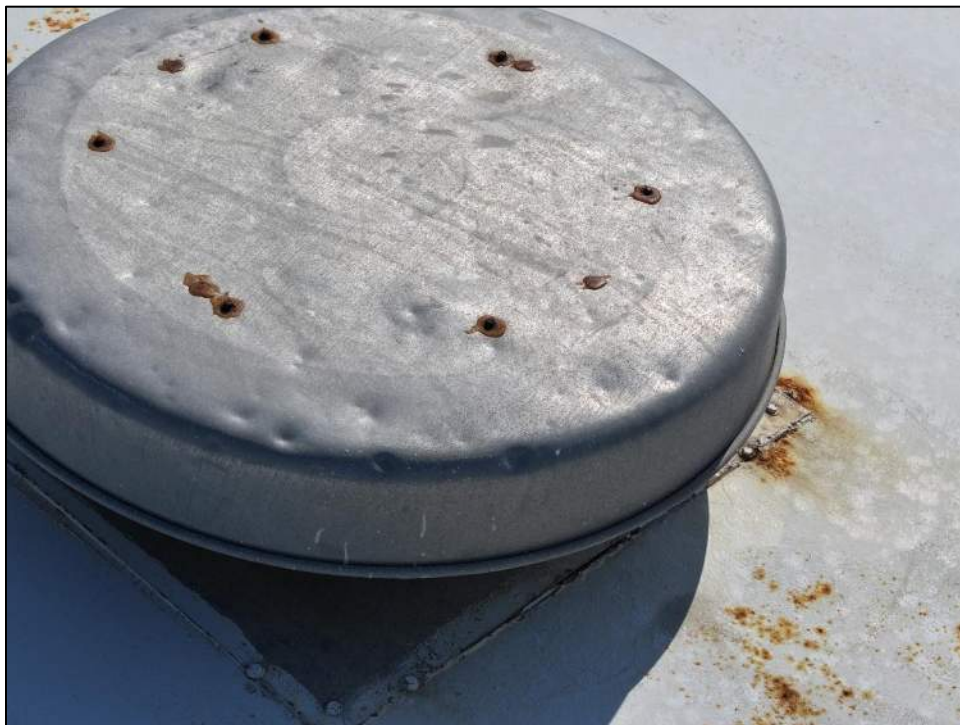
**Photo 22:** Hail denting on circular aluminum vent cover were consistent with recent hail impact.

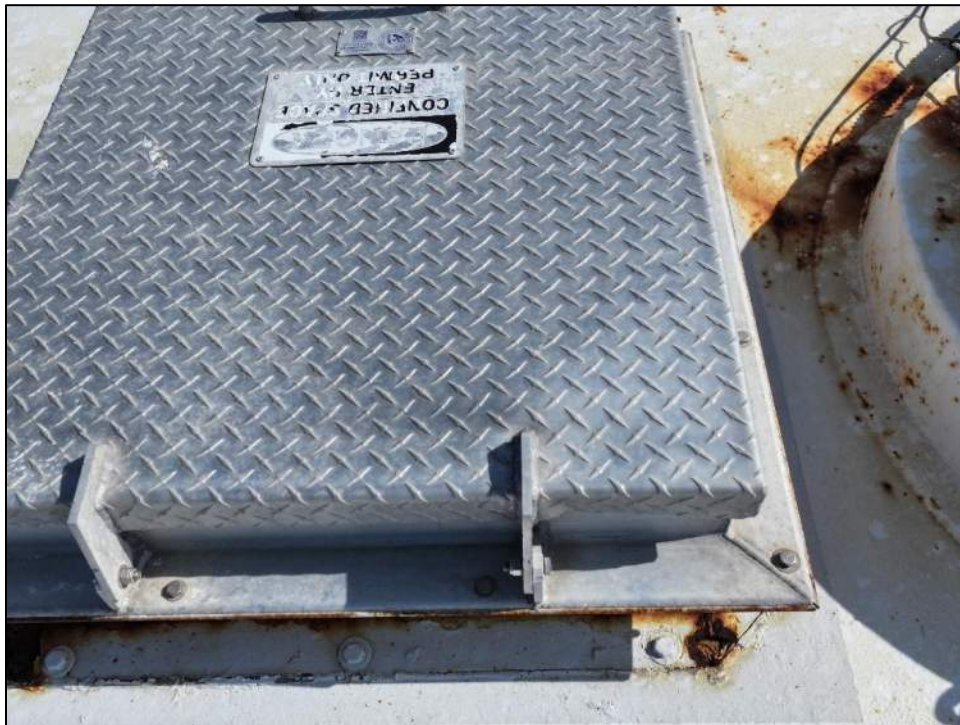
**Photo 23:** Embossed square access doors on roof remained intact.

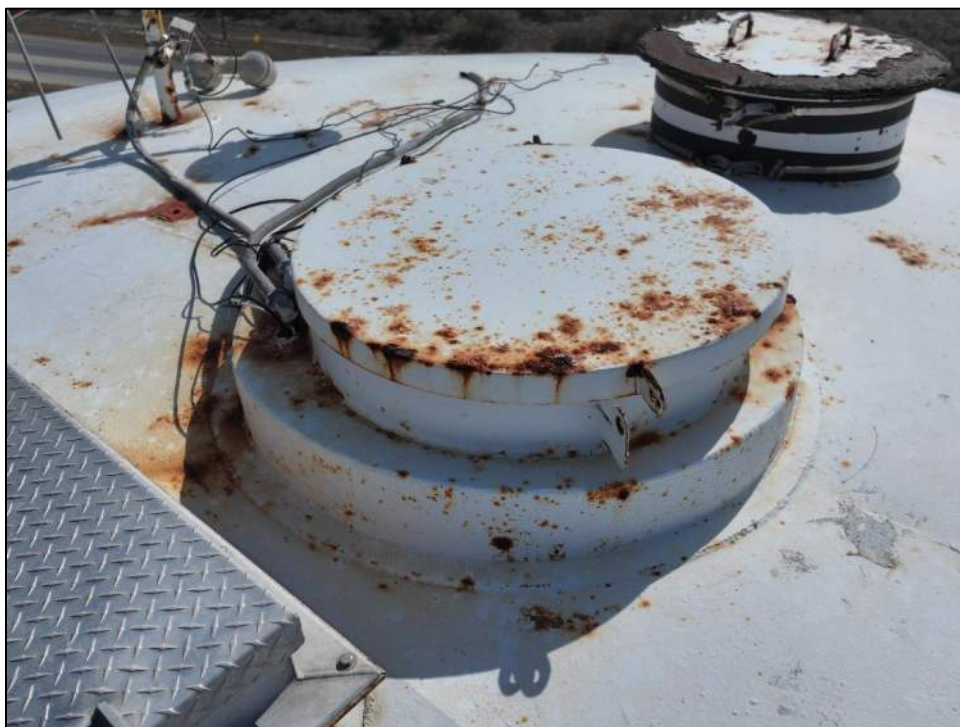
**Photo 24:** Steel plate vent coverings remained structurally intact. Wiring remained undisturbed.

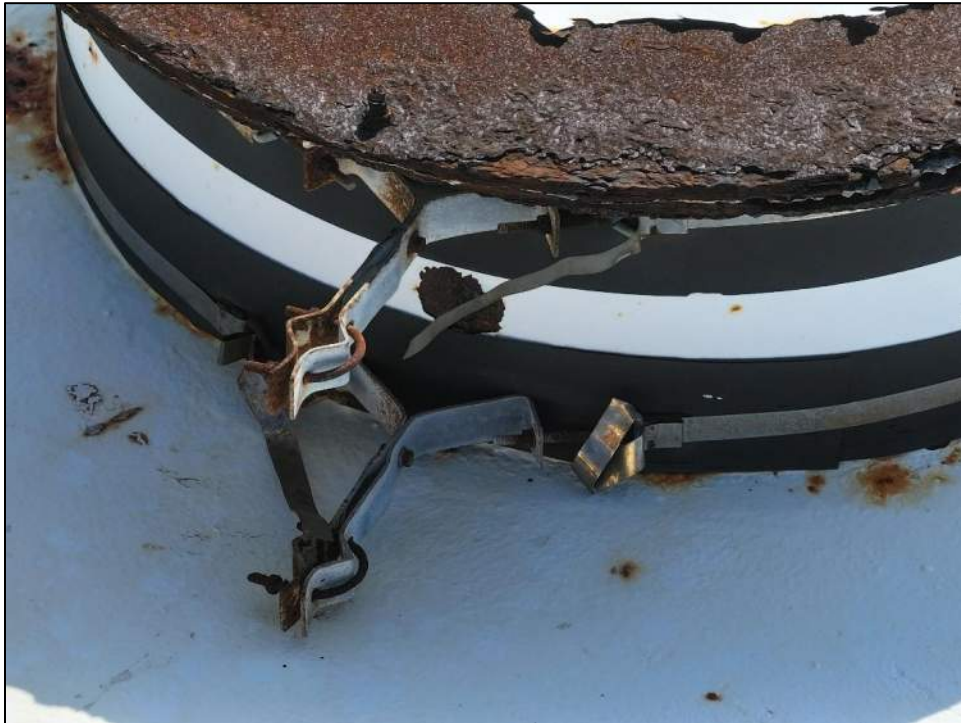
**Photo 25:** Close-up of corroded vent cover steel plates unrelated to hail effects.

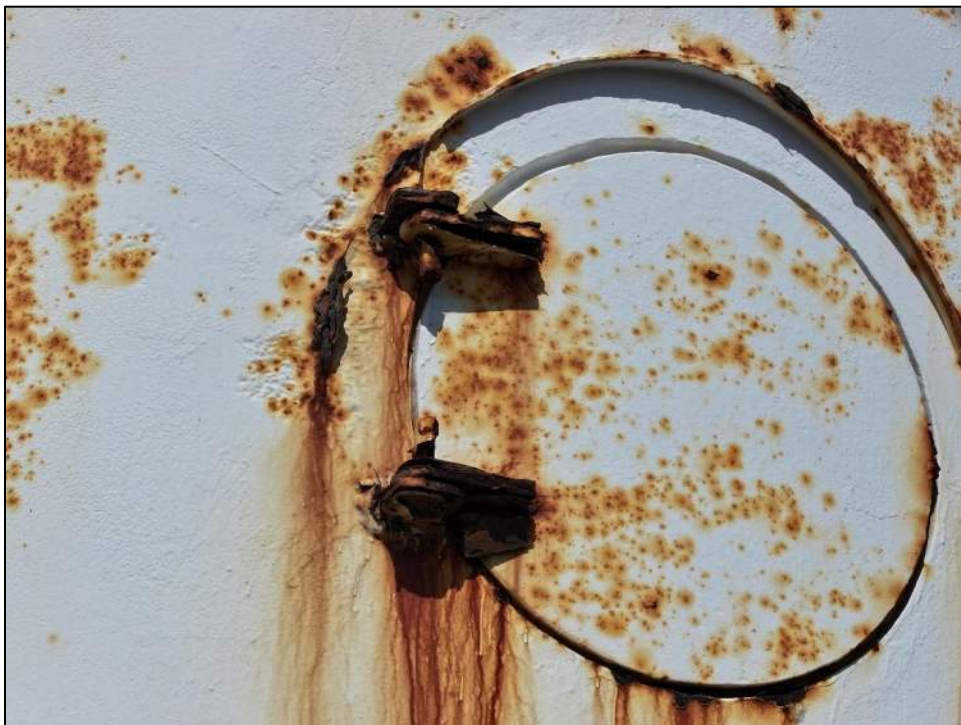
**Photo 26:** Close-up of the severely corroded side door and hinges.

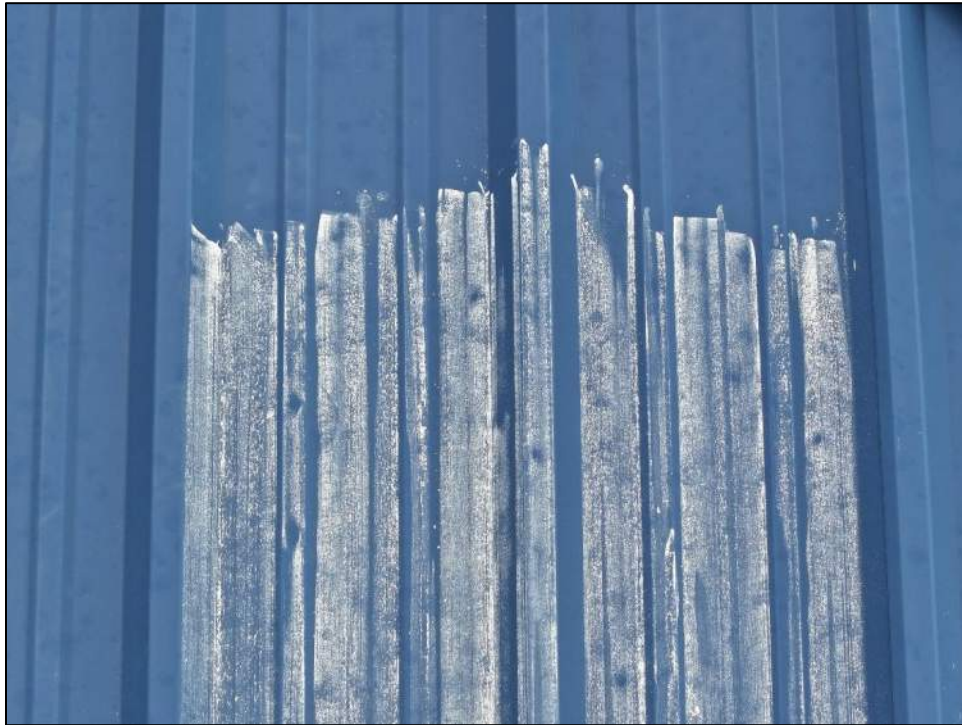
**Photo 5:** Close-up of the hail denting. The dents were generally shallow with an inner diameter of less than 3/8 inch.

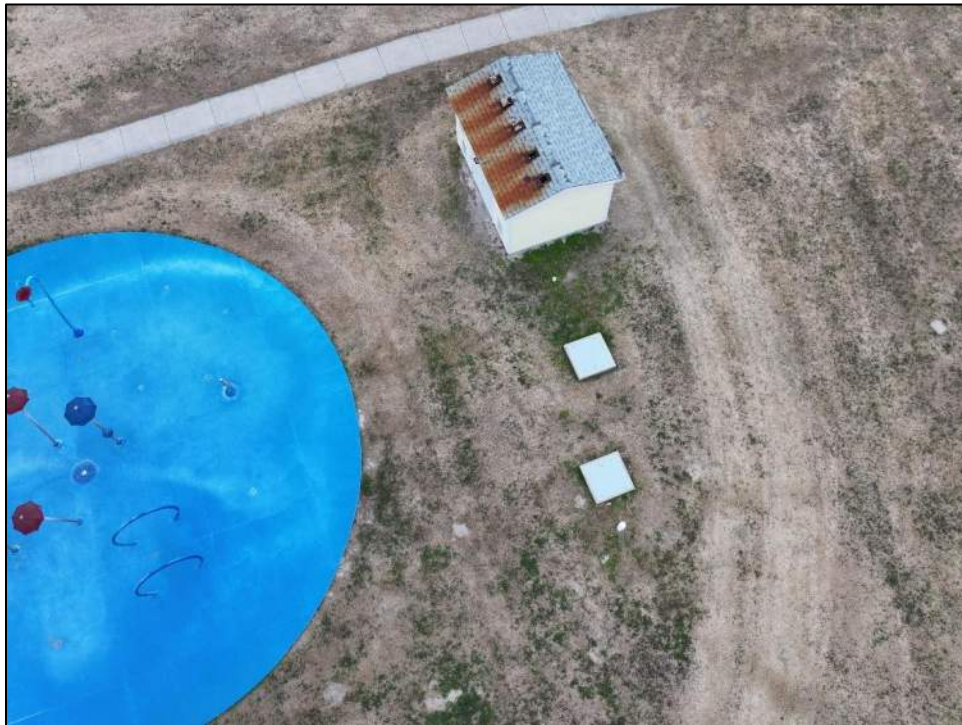
**Photo 6:** Deteriorated tool shed west of the splashpad.

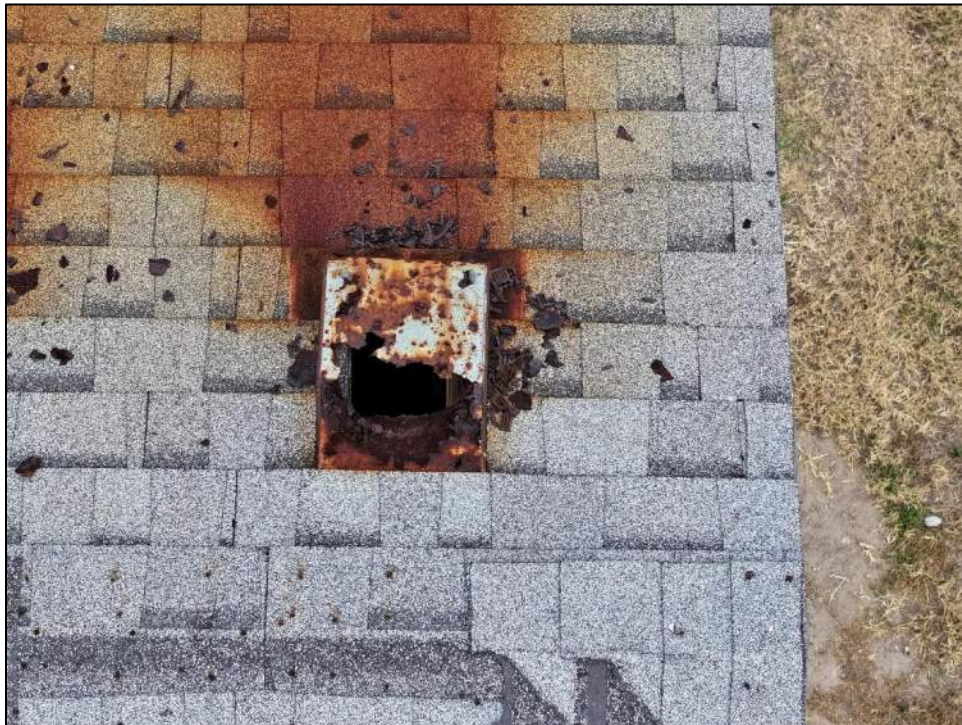
**Photo 8:** Deteriorated ridge vents.

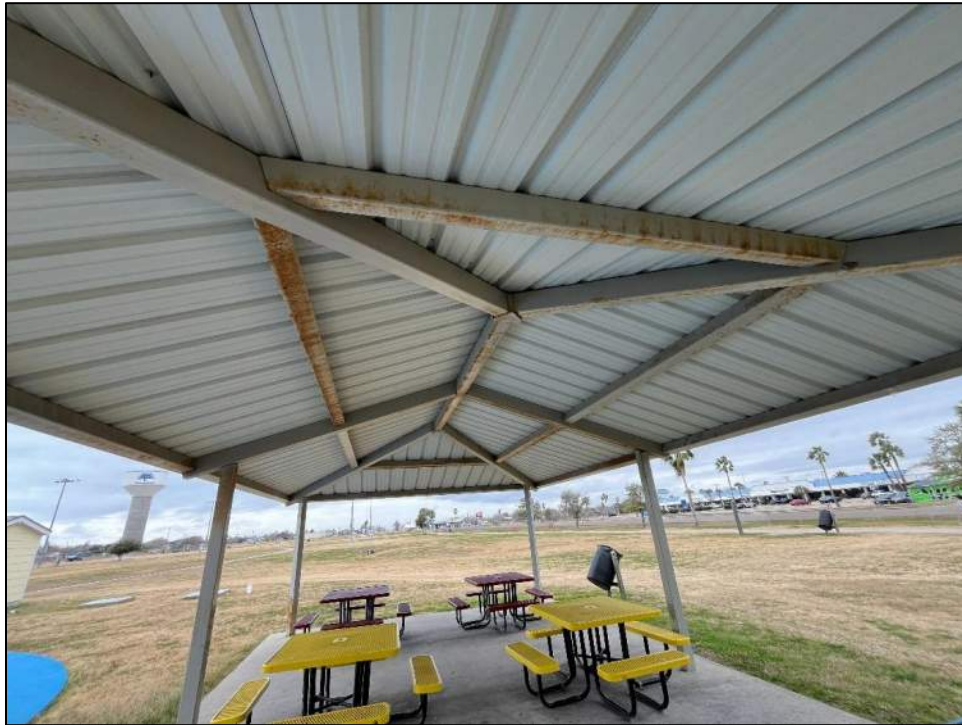
**Photo 9:** Underside view of the pavilion structure. Tube steel frames remained intact in addition to rusting.

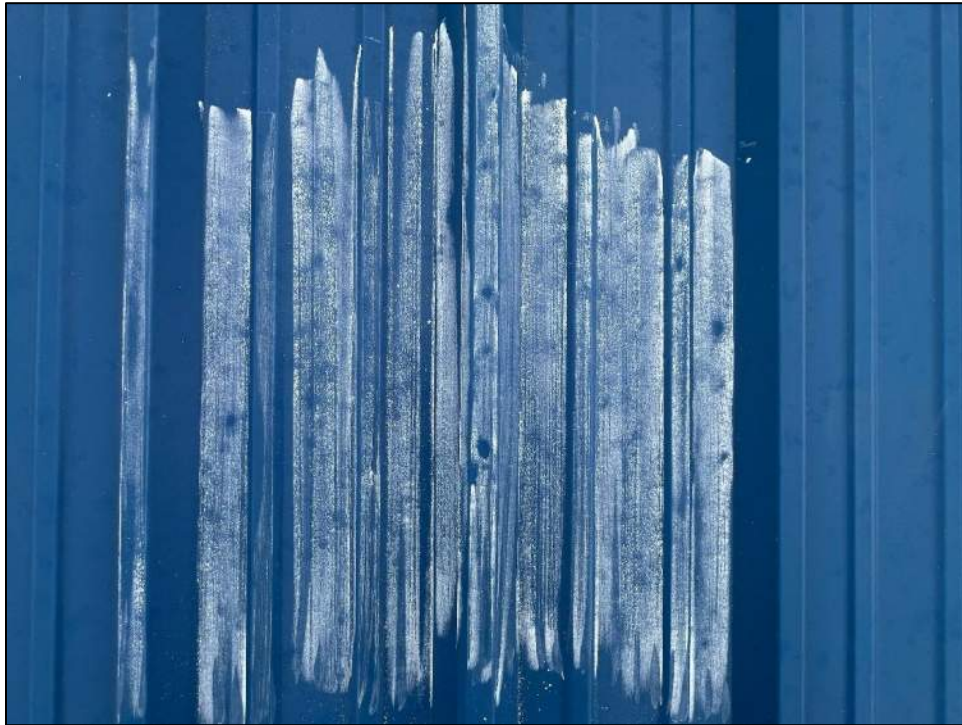
**Photo 11:** Close-up of the hail denting on north slope. No coating disruptions were observed.

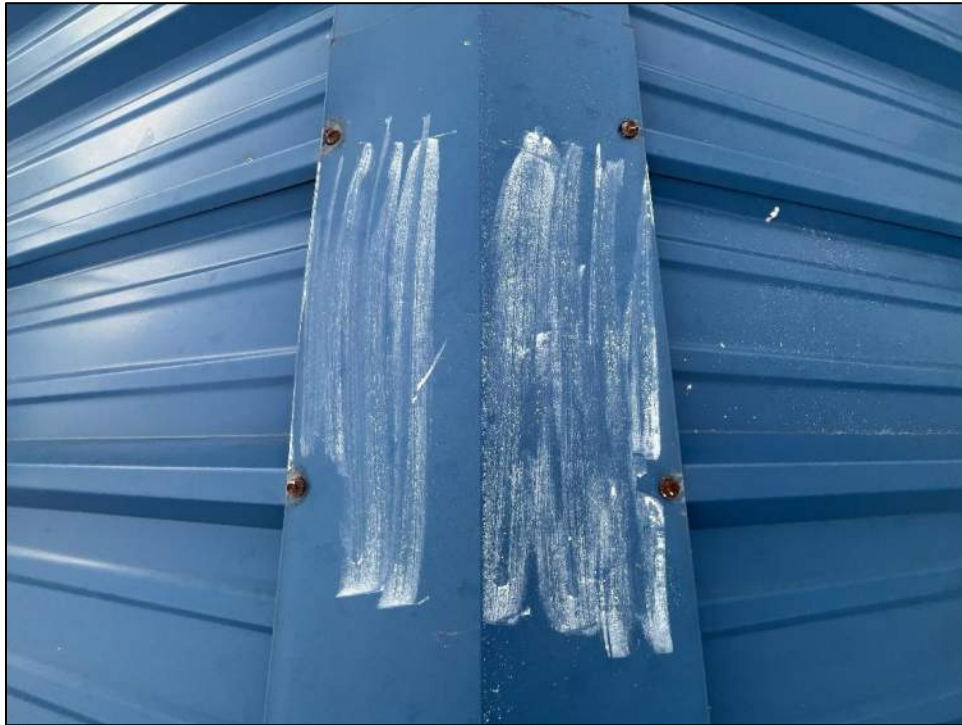
**Photo 17:** Ridge caps exhibited slight denting. Note the rusted fasteners.

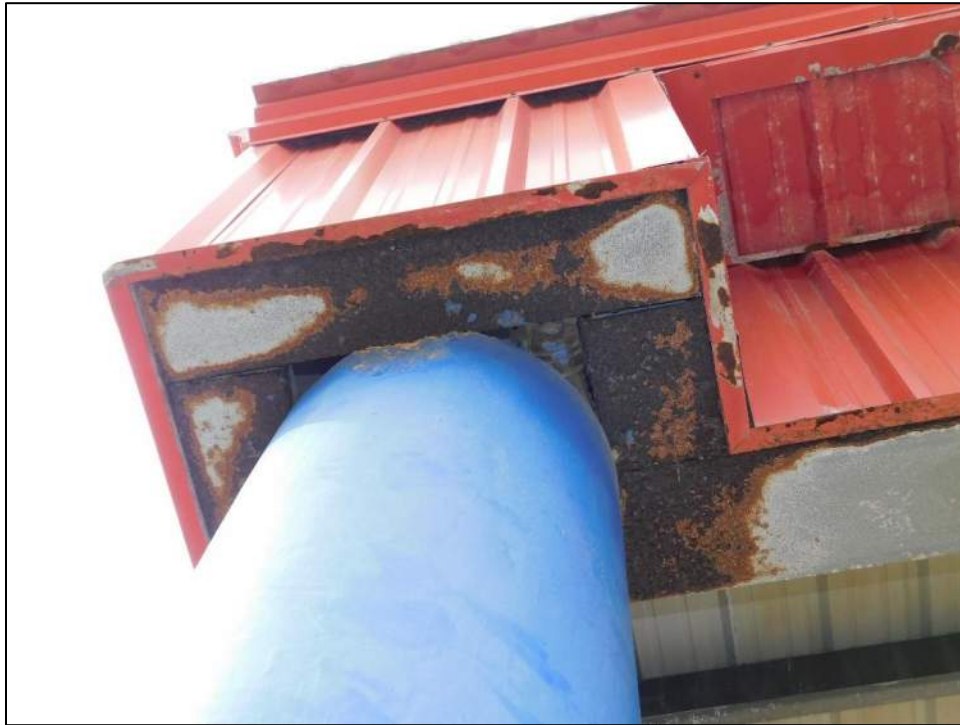
**Photo 19:** Typical corrosion of metal soffit above concrete columns beneath the sports court roof.

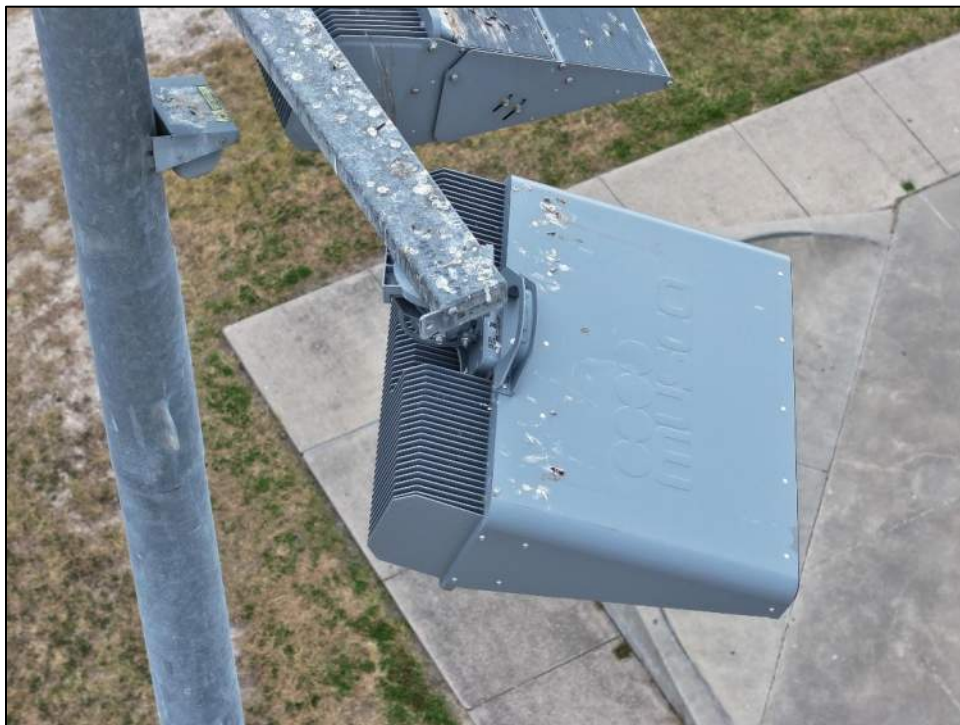
**Photo 22:** Nearby pole lights were not fractured or dented.

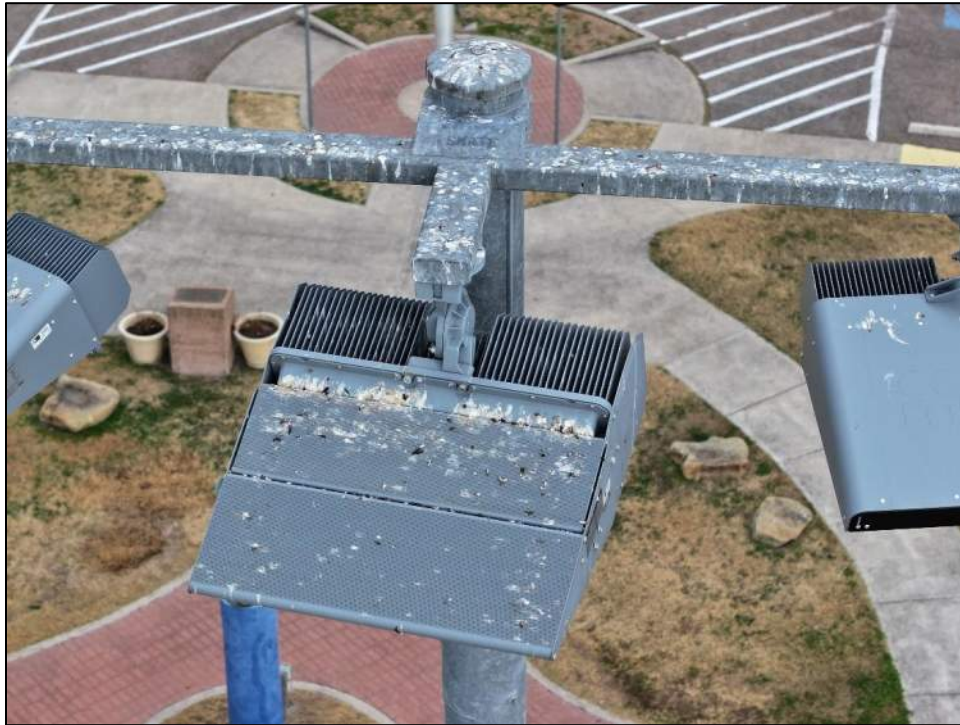
**Photo 23:** Nearby pole lights were not fractured or dented.

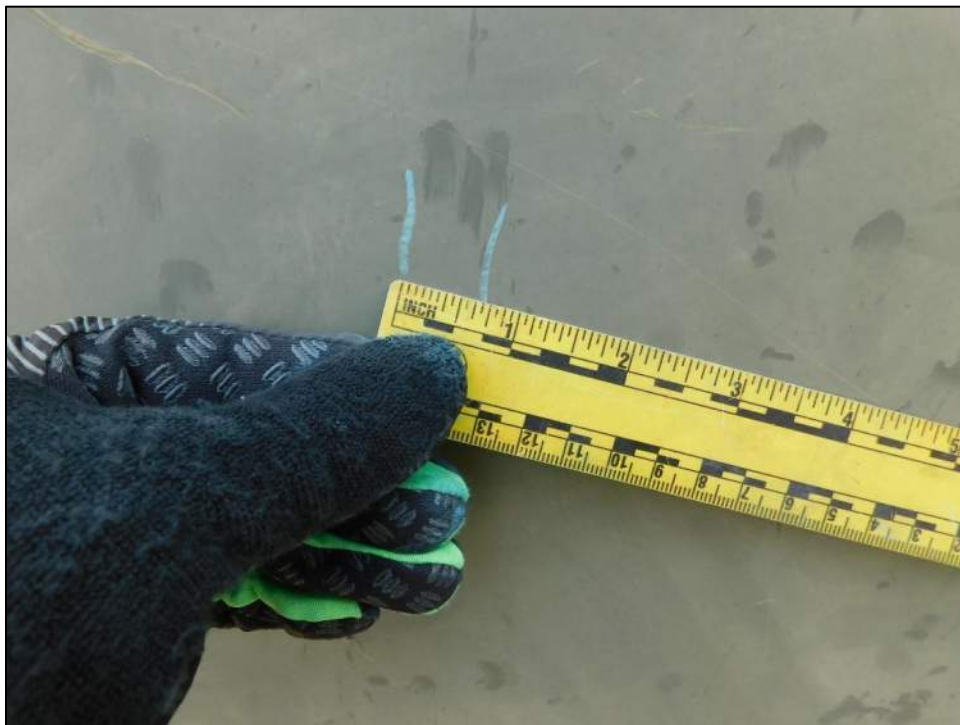
**Photo 28:** Hail spatters consistent with 0.75- to 1.0-inch hail on north-facing surfaces.

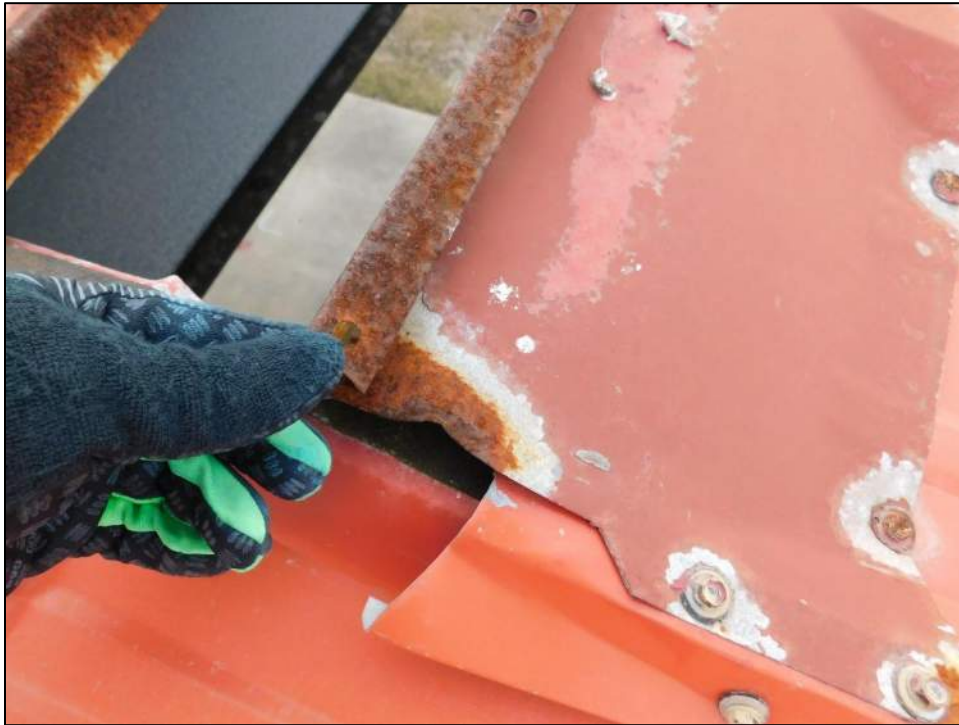
**Photo 34:** Corroded ridge vent curb.

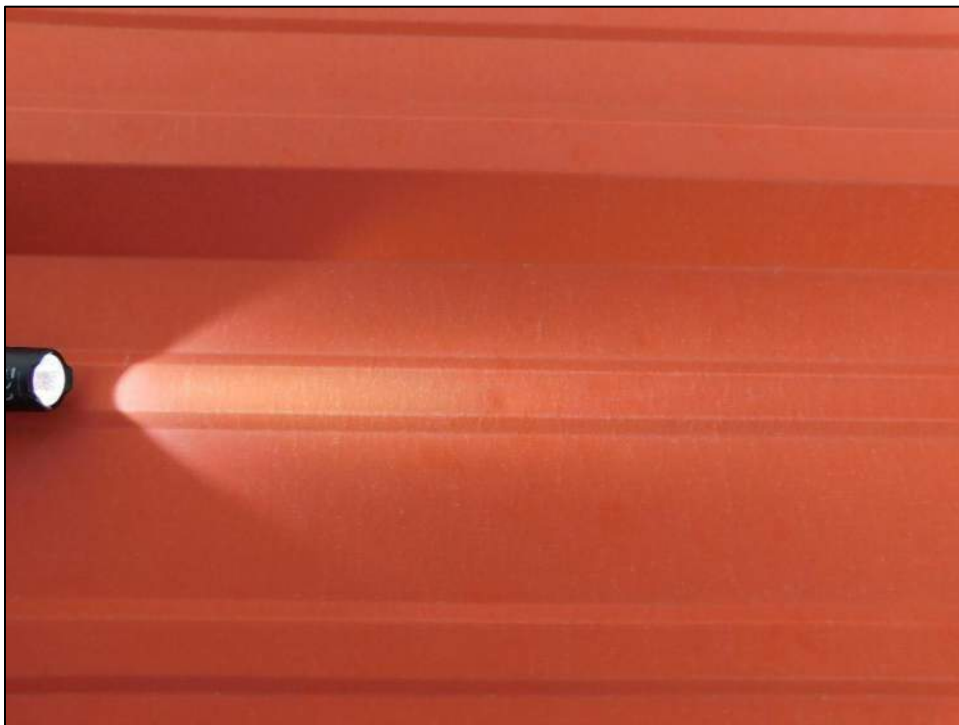
**Photo 35:** Slight denting on west slope consistent with hail impact.
