**CITY OF INGLESIDE  
REGULAR CITY COUNCIL MEETING  
AGENDA  
JUNE 9, 2026  
6:30 PM**

Report on November 01, 2025, Hailstorm Damage to City of Ingleside Buildings.

### Building Damage Analysis Survey and Report

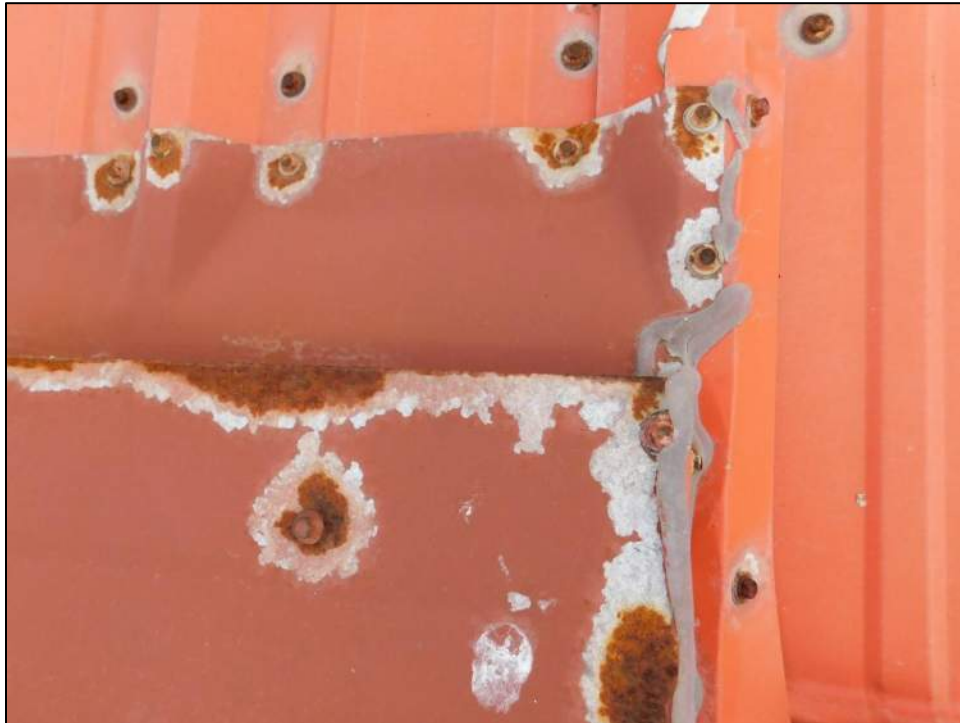
**Photo 36:** Widespread steel corrosion along other ridge vents.

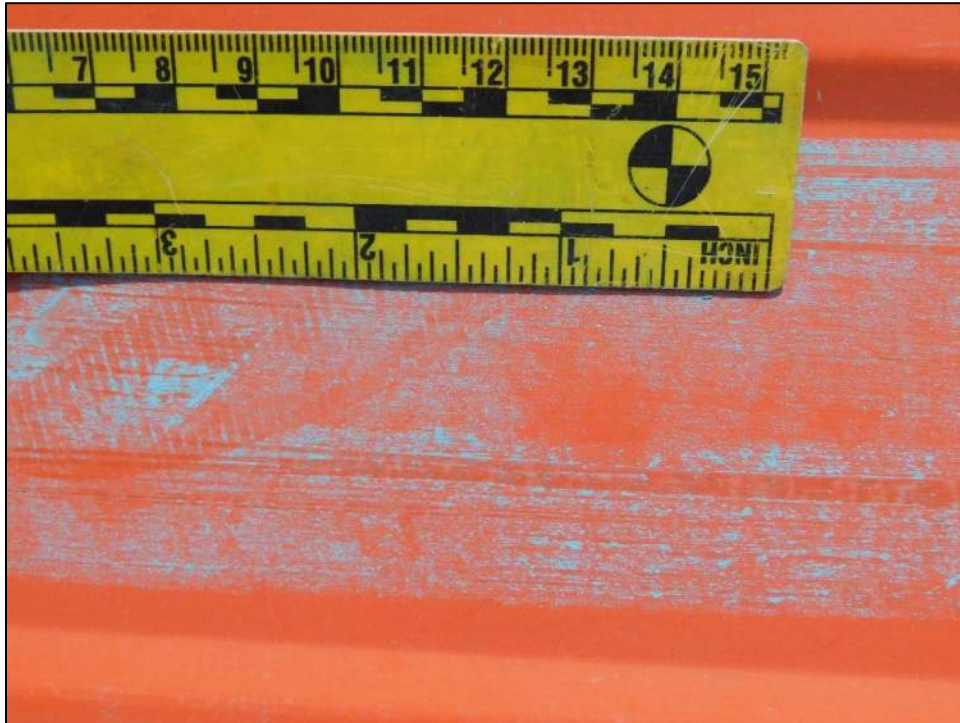
**Photo 40:** Denting inner diameter was less than 1/2 inch. No coating disruptions were observed.

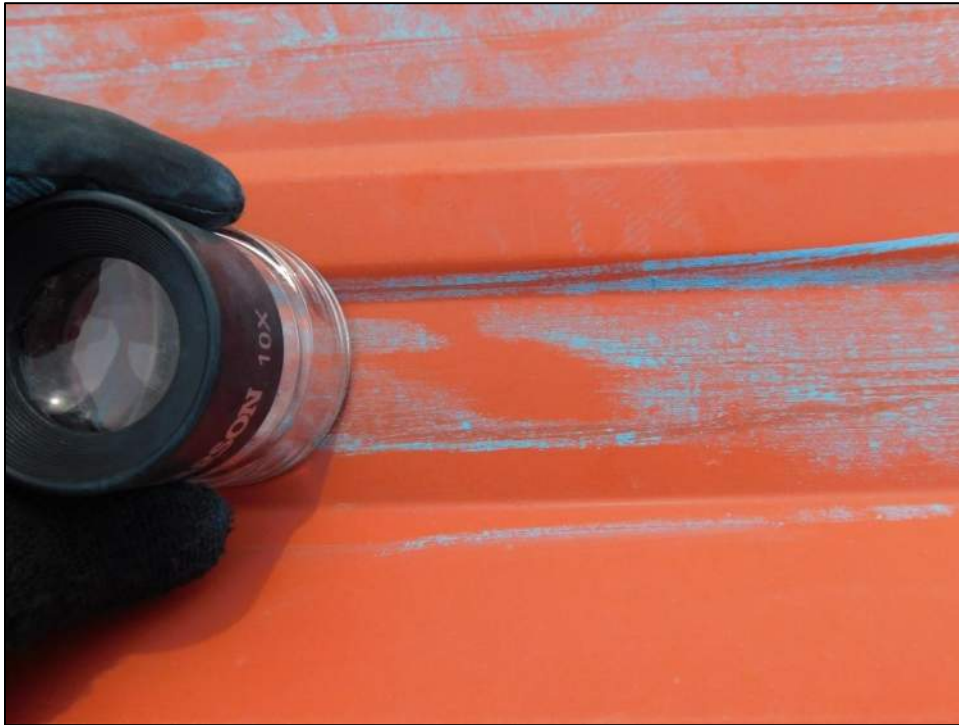
**Photo 42:** Denting inner diameter was less than 1/2 inch. No coating disruptions were observed.

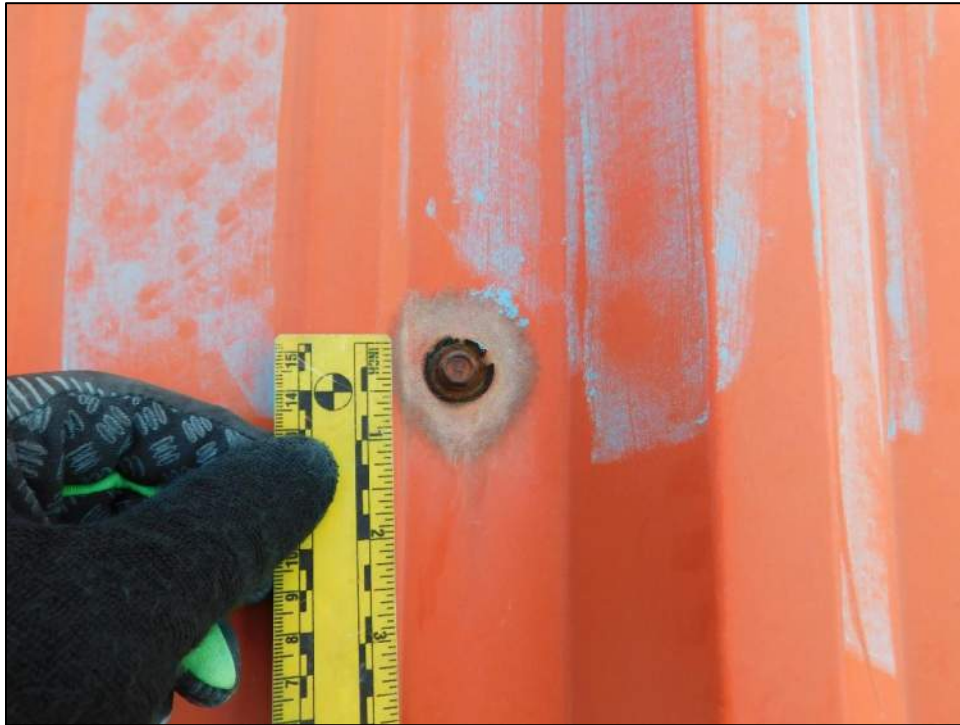
**Photo 44:** Typical fastener corrosion unrelated to hail impacts.

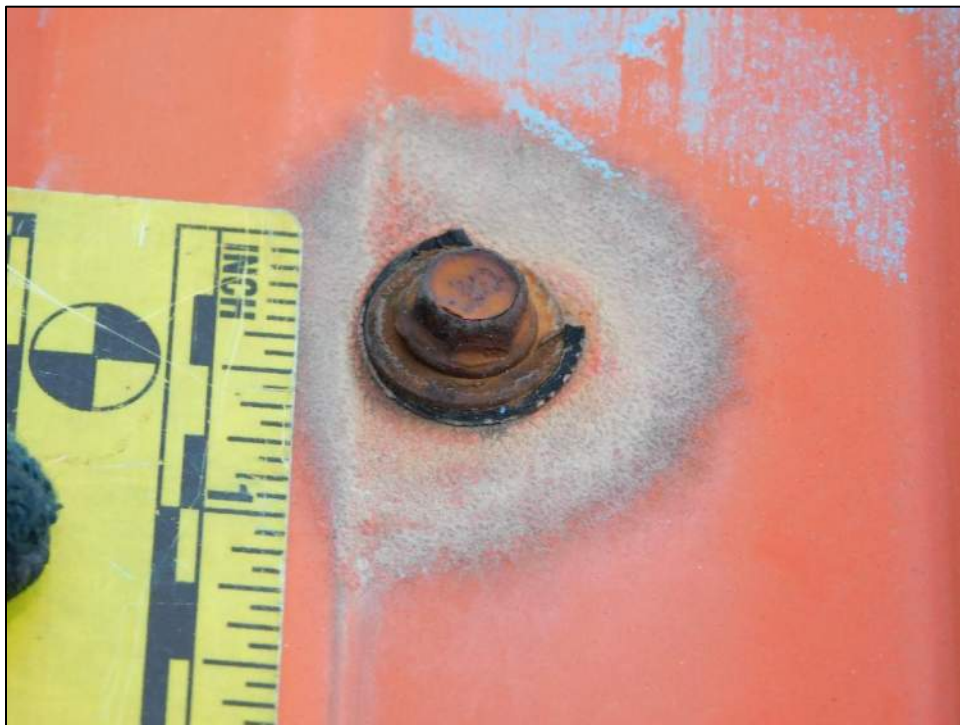
**Photo 45:** Close-up of fastener corrosion and gasket deterioration due to aging.

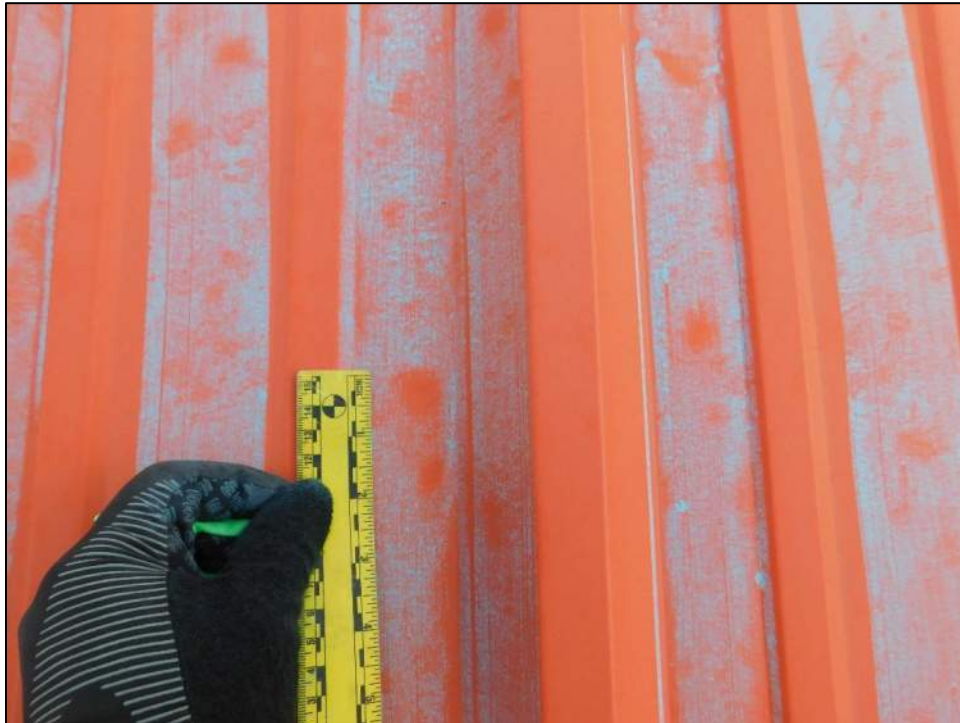
**Photo 46:** West slope indentations were similarly 1/2-inch in maximum inner diameter with coating disruptions observed.

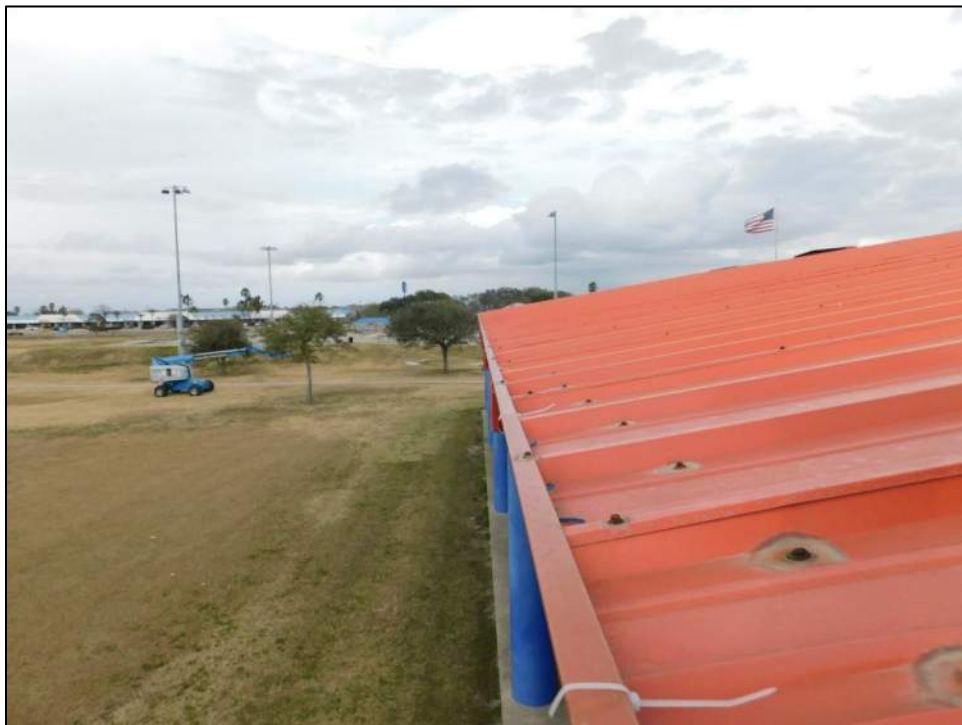
**Photo 49:** Gutters along west roof eave remained intact.

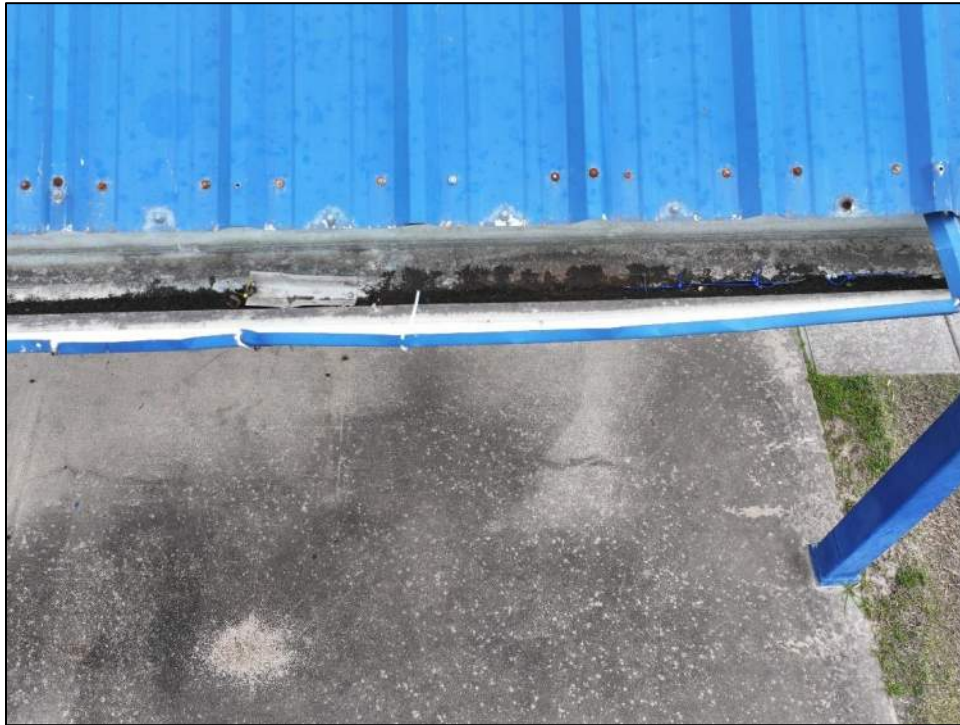
**Photo 52:** Mechanical damage to gutter along north slope eave.

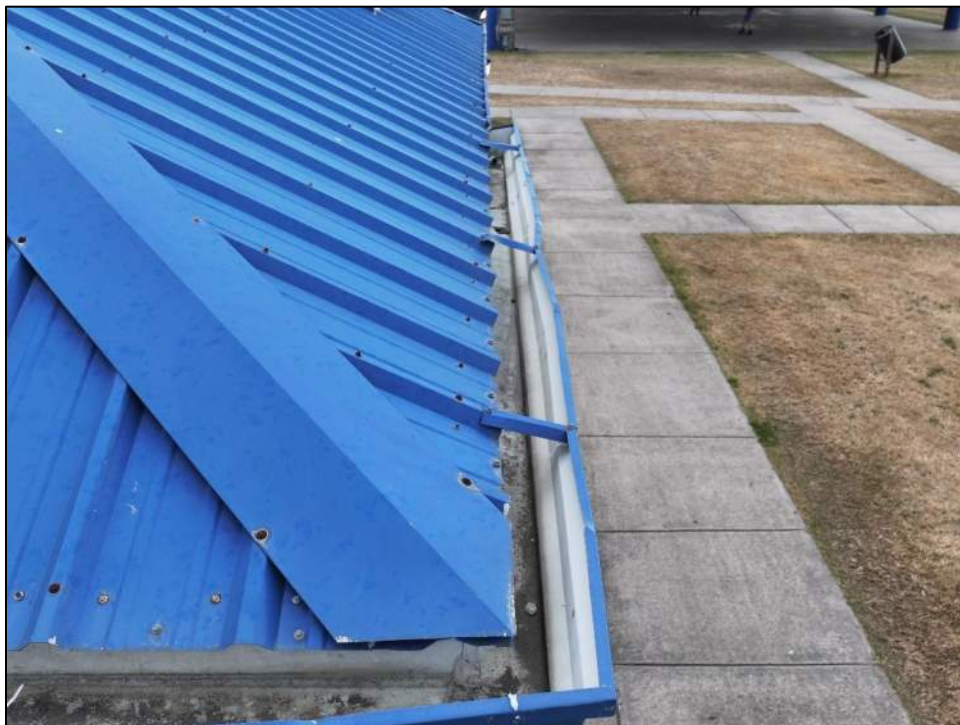
**Photo 53:** Mechanically deformed gutter along west slope eave.

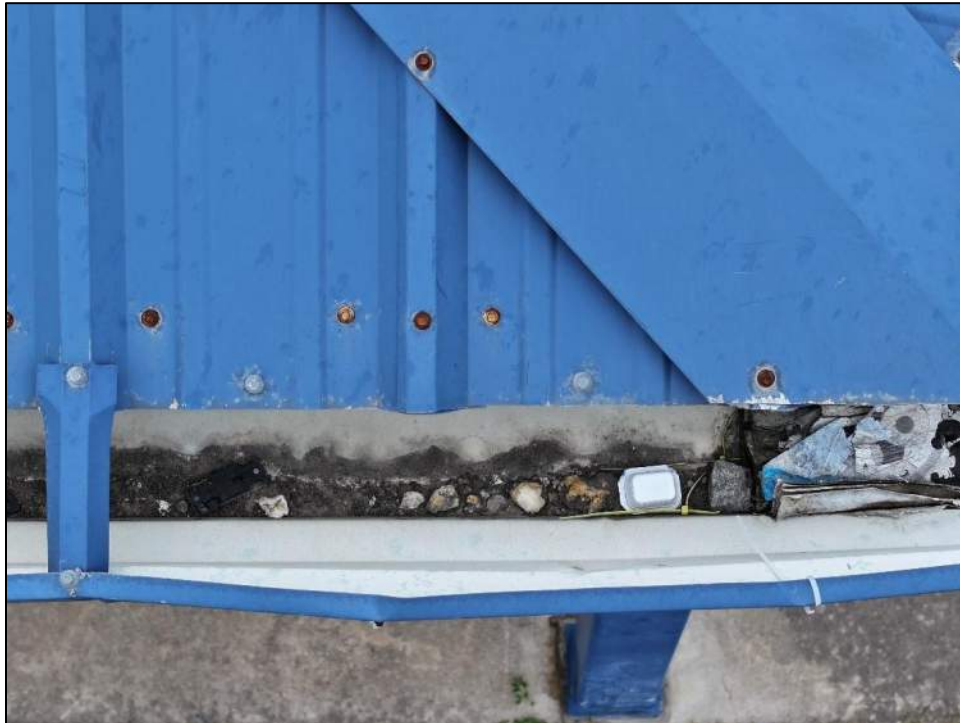
**Photo 54:** Debris accumulation in gutter above northeast downspout.

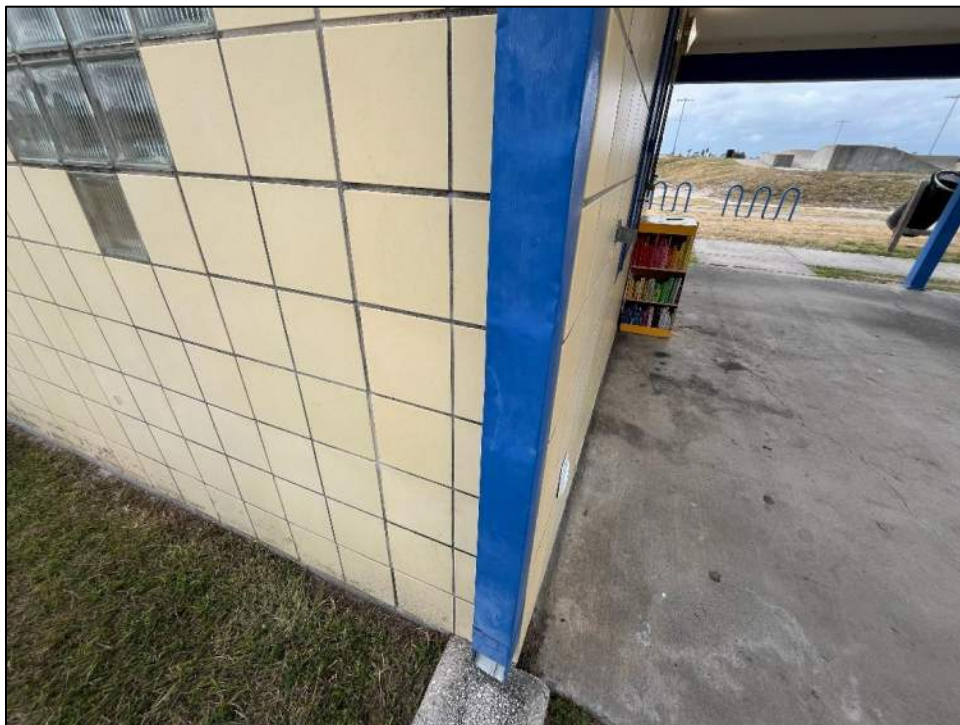
**Photo 59:** Mechanically deformed downspout on east wall where no hail impacts were observed.

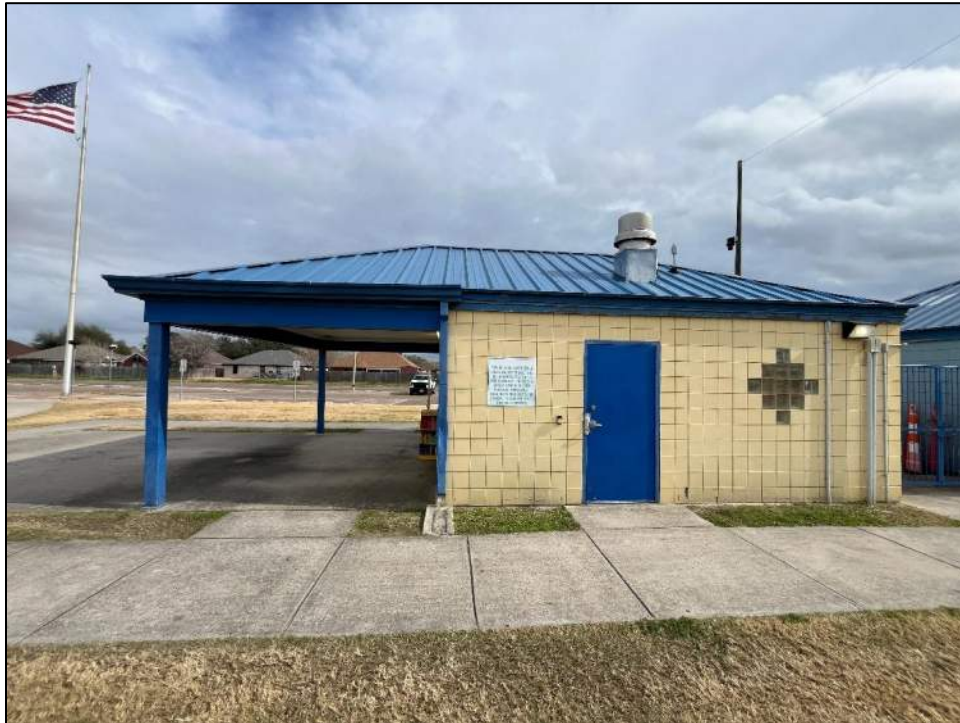
**Photo 62:** West elevation. No glass masonry units were fractured.

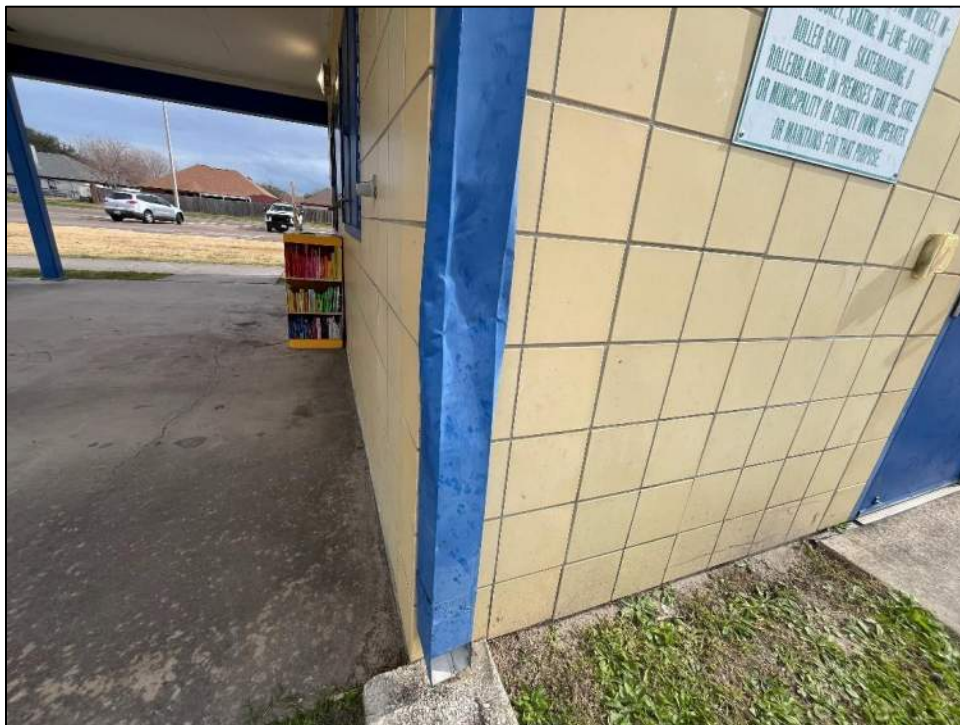
**Photo 63:** Mechanically deformed downspout on west wall that was inconsistent with hail impact.

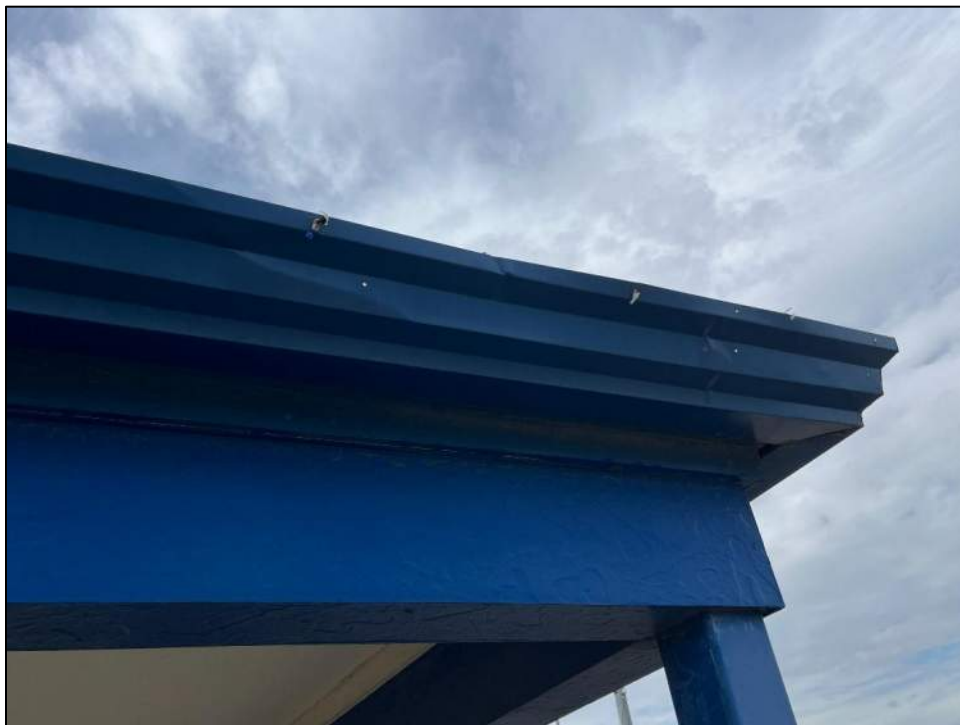
**Photo 65:** Mechanically deformed gutter.

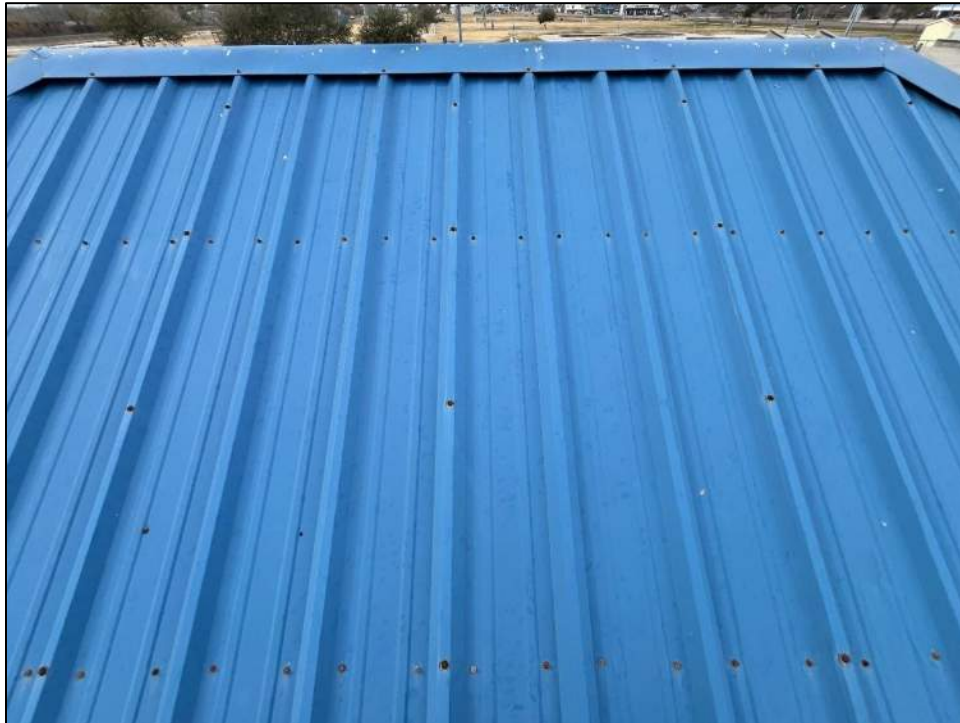
**Photo 66:** East slope overview. Note corroded fasteners throughout the slope.

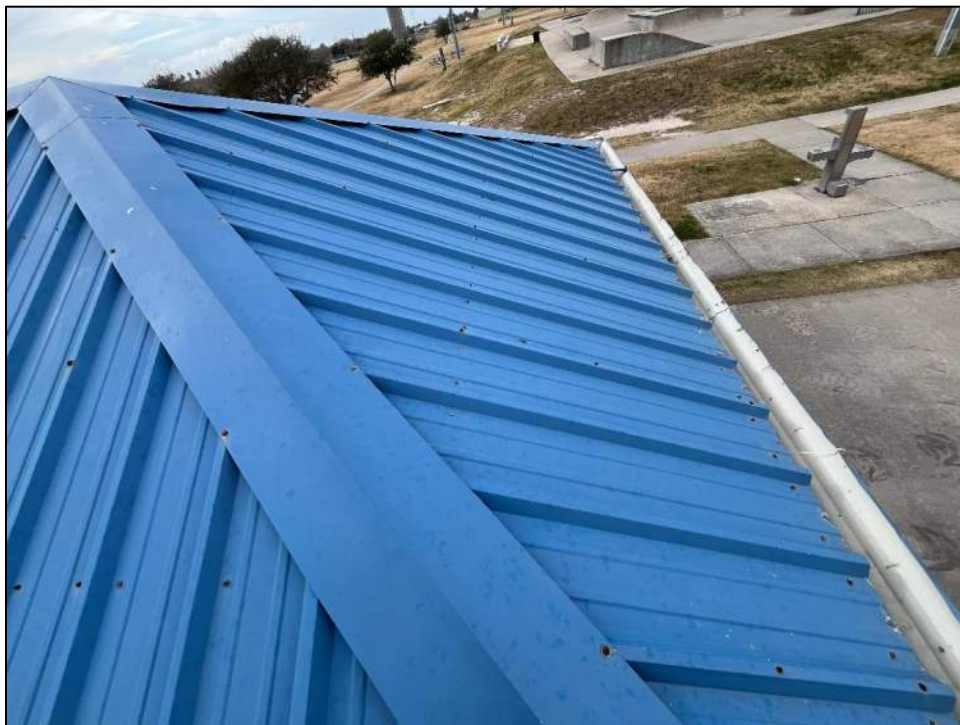
**Photo 67:** North slope and ridge cap were not deformed or displaced.

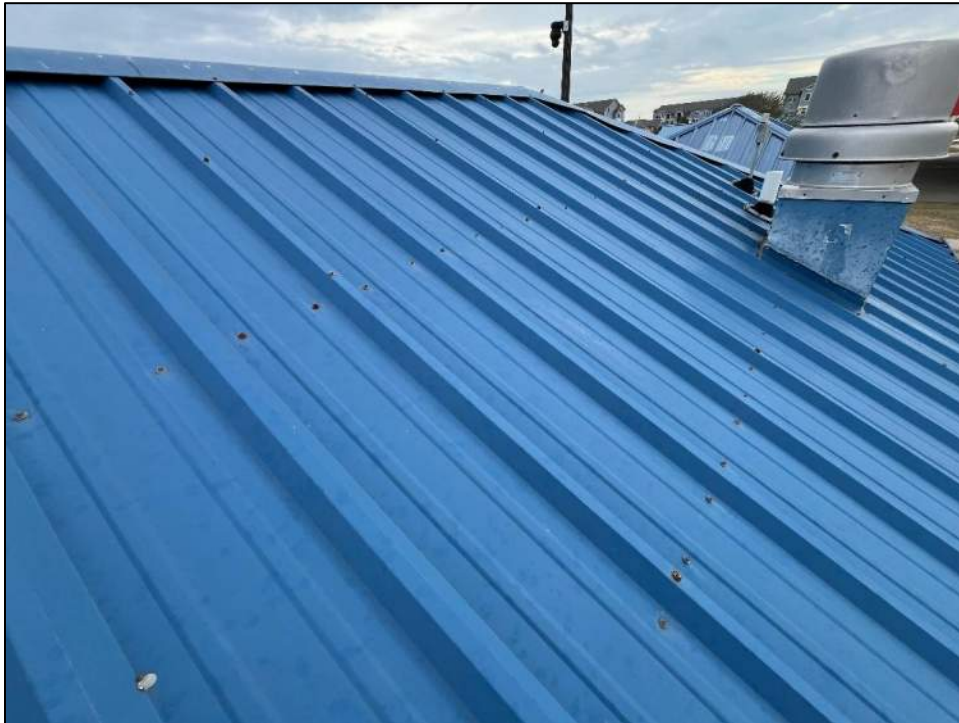
**Photo 68:** West slope. Note widespread fastener corrosion.

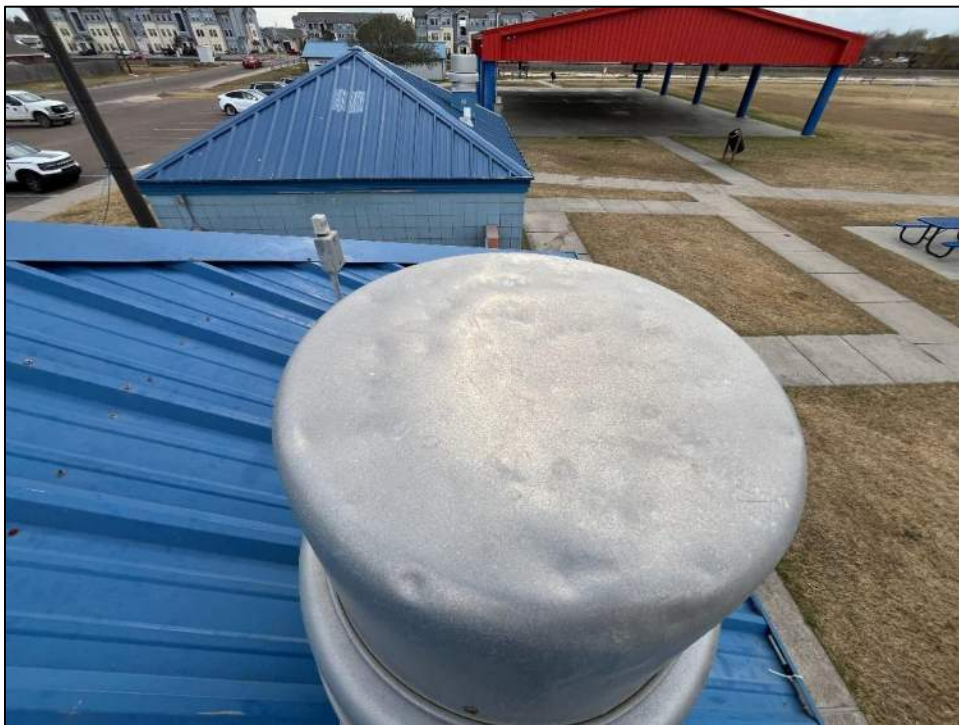
**Photo 69:** Dented vent hood consistent with hail impact.

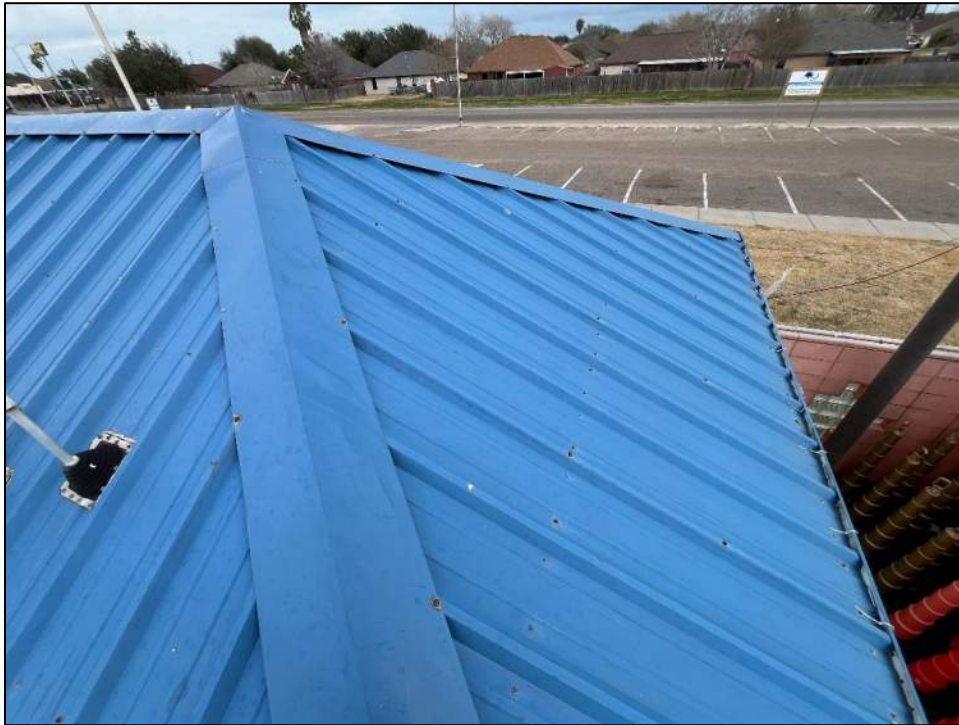
**Photo 70:** South slope. Note widespread fastener corrosion.

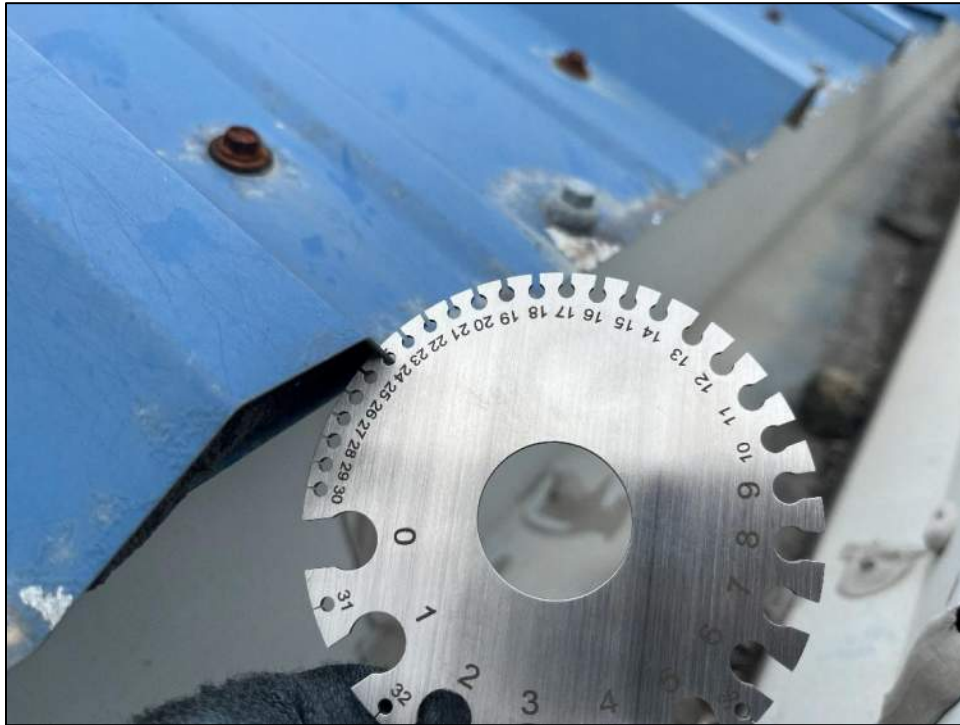
**Photo 72:** 24 gauge metal R-panel thickness.

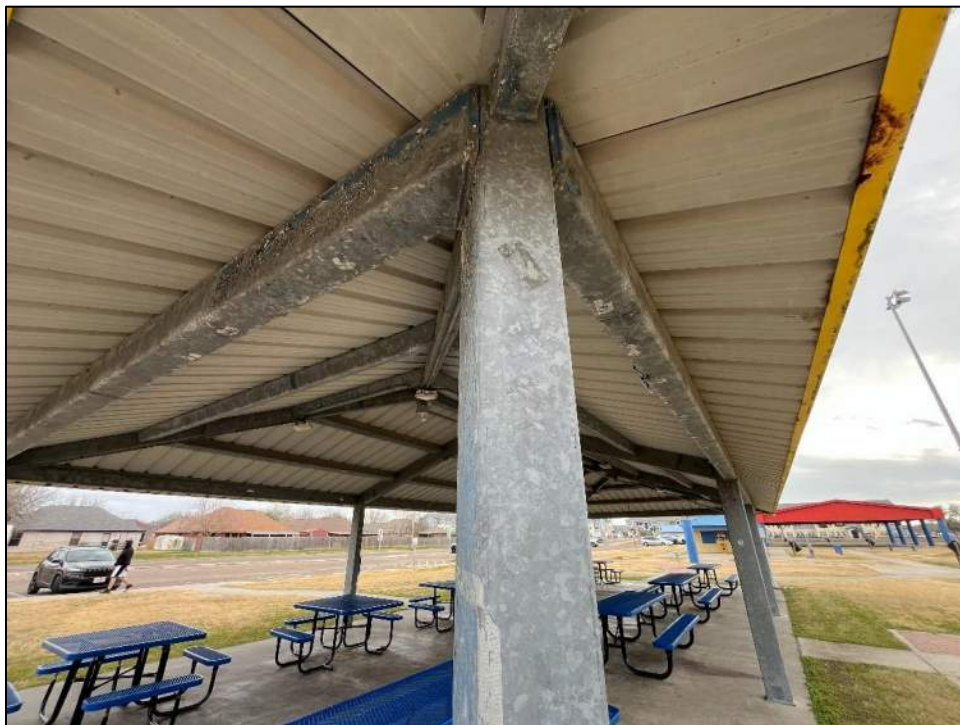
**Photo 79:** Tube steel framing remained intact.

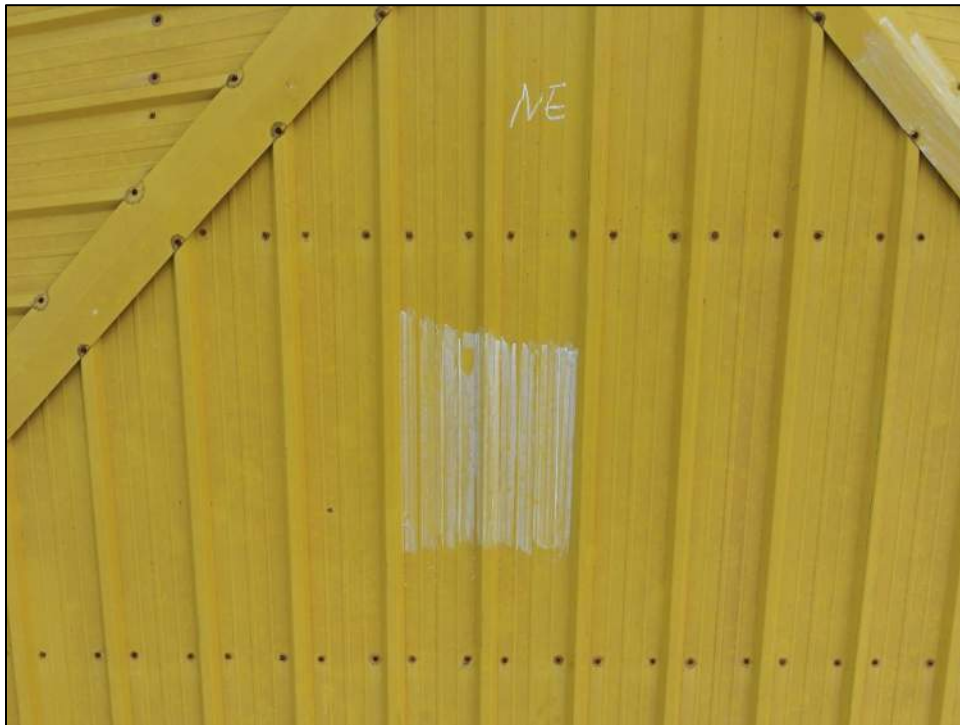
**Photo 80:** North slope. Note fastener corrosion.

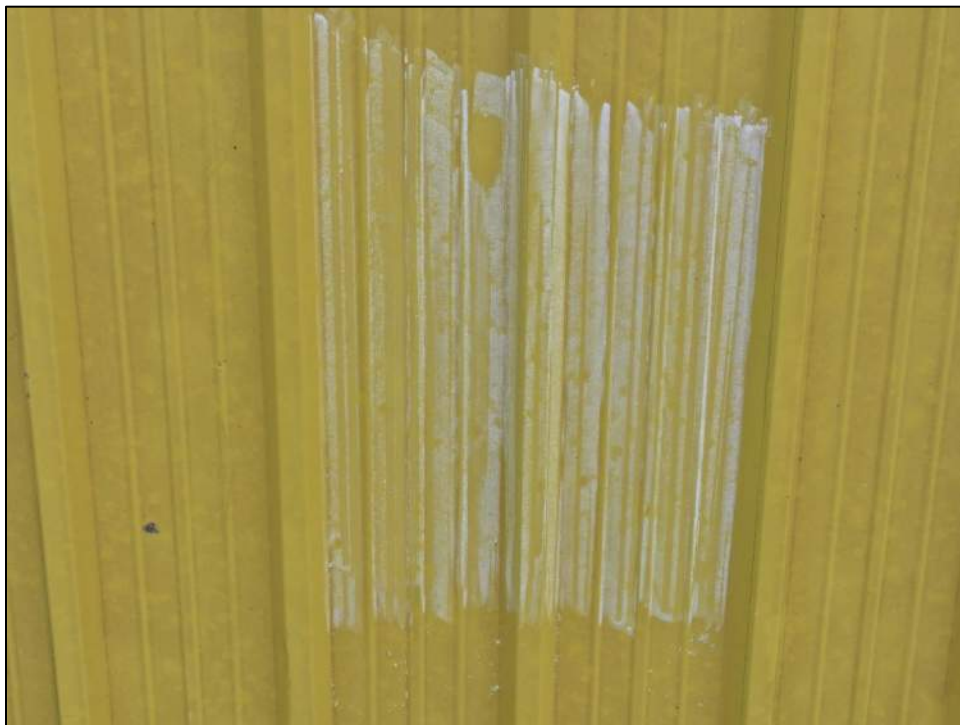
**Photo 81:** Denting consistent with hail impact was observed. No coating disruptions were observed at the dents.

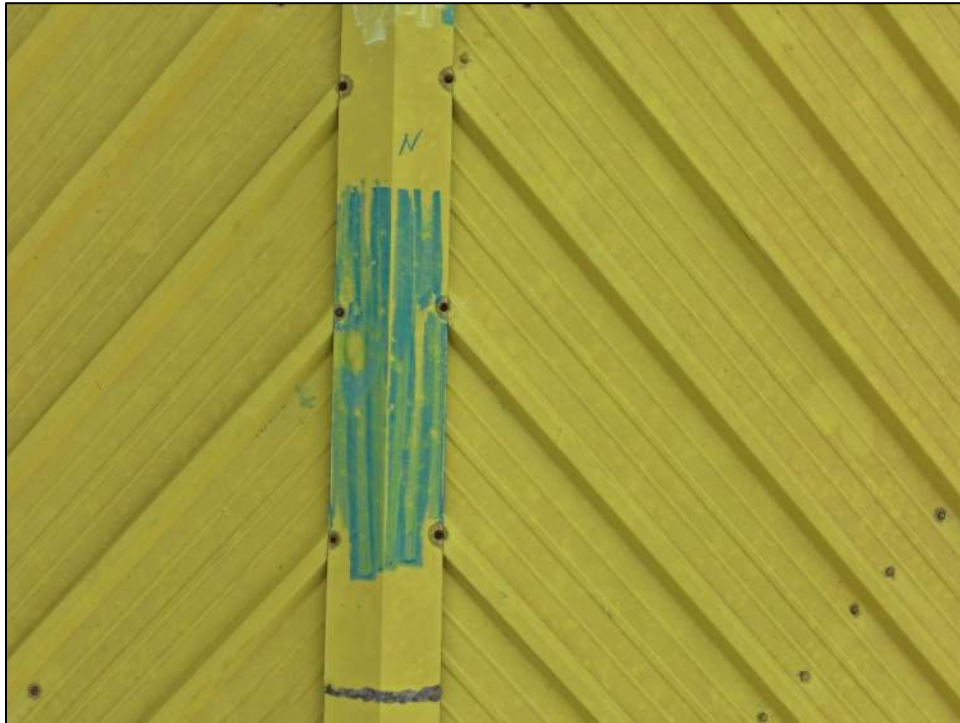
**Photo 82:** Dents in north-facing ridge cap were consistent with recent hail impact.

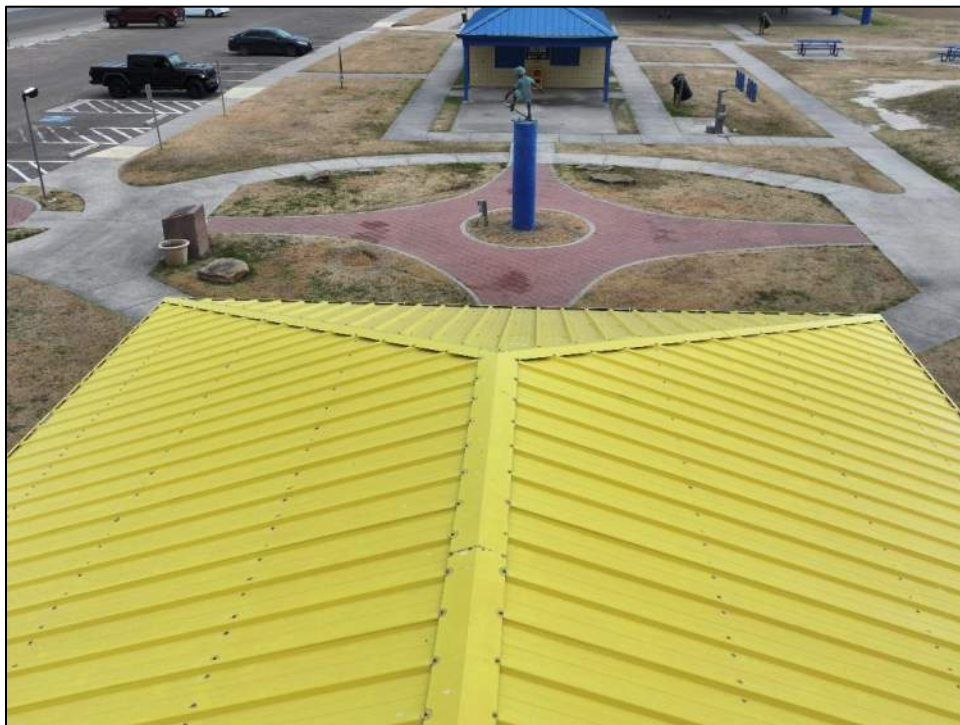
**Photo 83:** Ridge and hip caps were not displaced or uplifted.

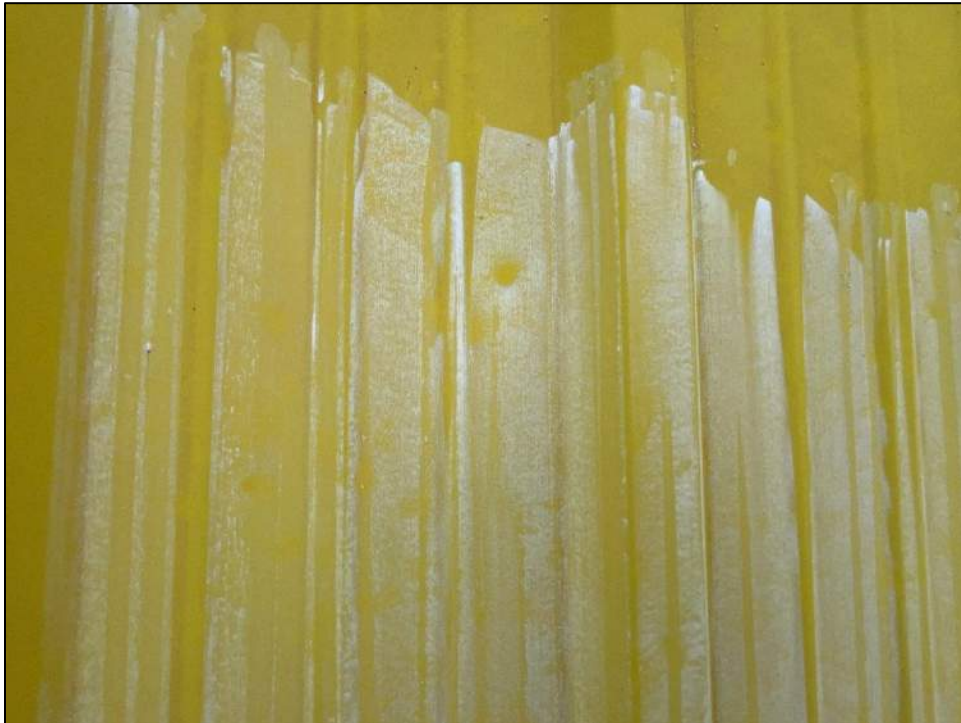
**Photo 84:** Inner diameter of hail dents on north slope were less than 1/2 inch.

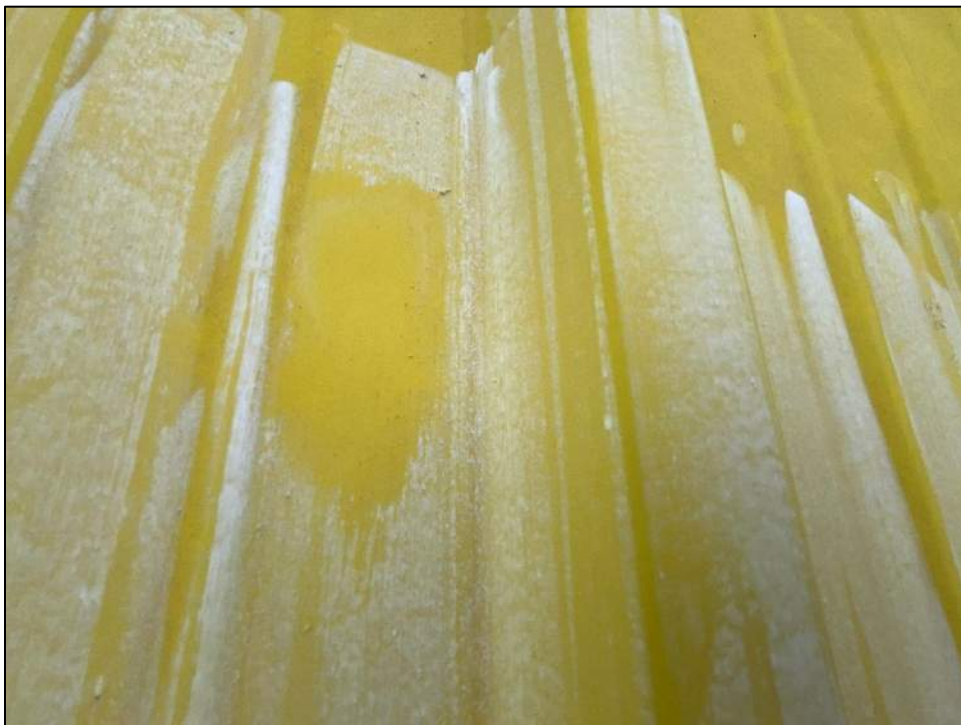
**Photo 85:** No coating disruptions were observed at the hail dents.

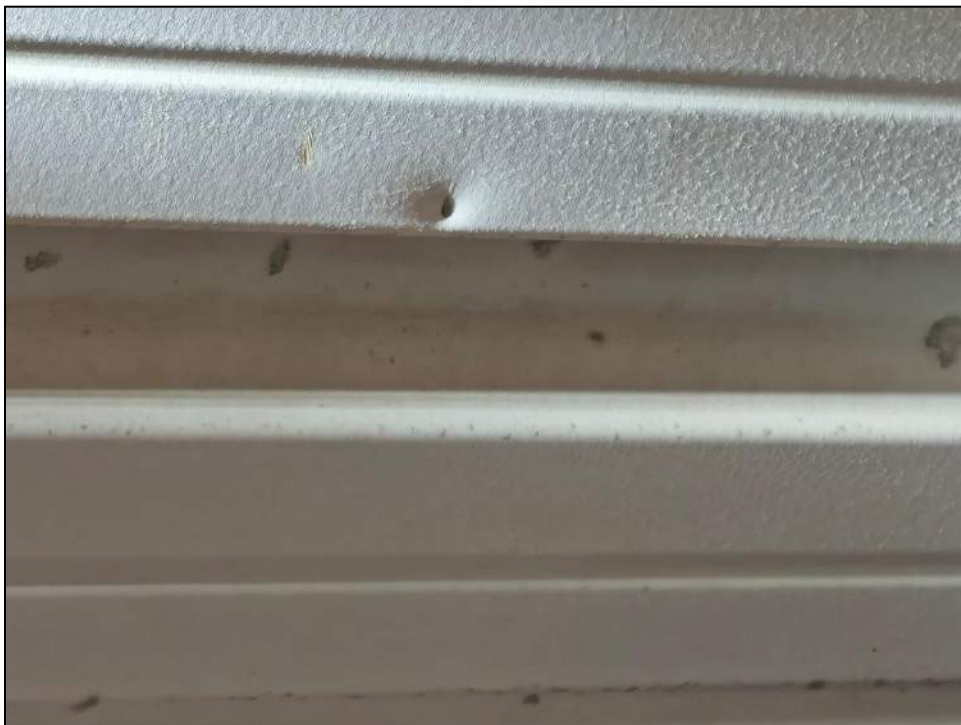
**Photo 89:** Close-up view of the underside of the metal roof deck with the upward denting.

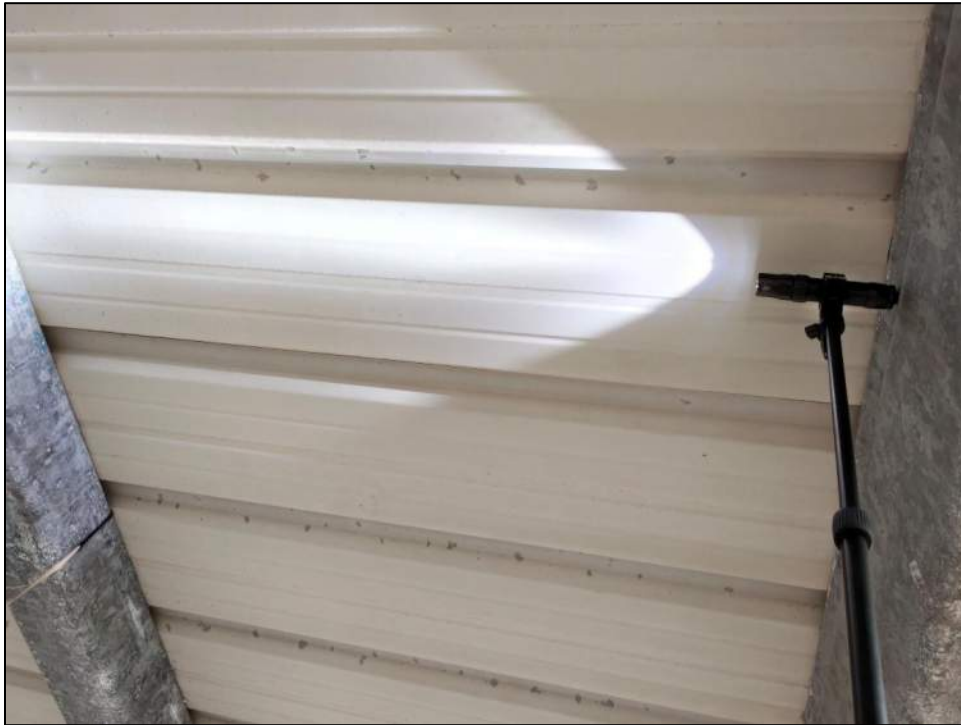
**Photo 90:** Denting to east slope were significantly less than west slope.

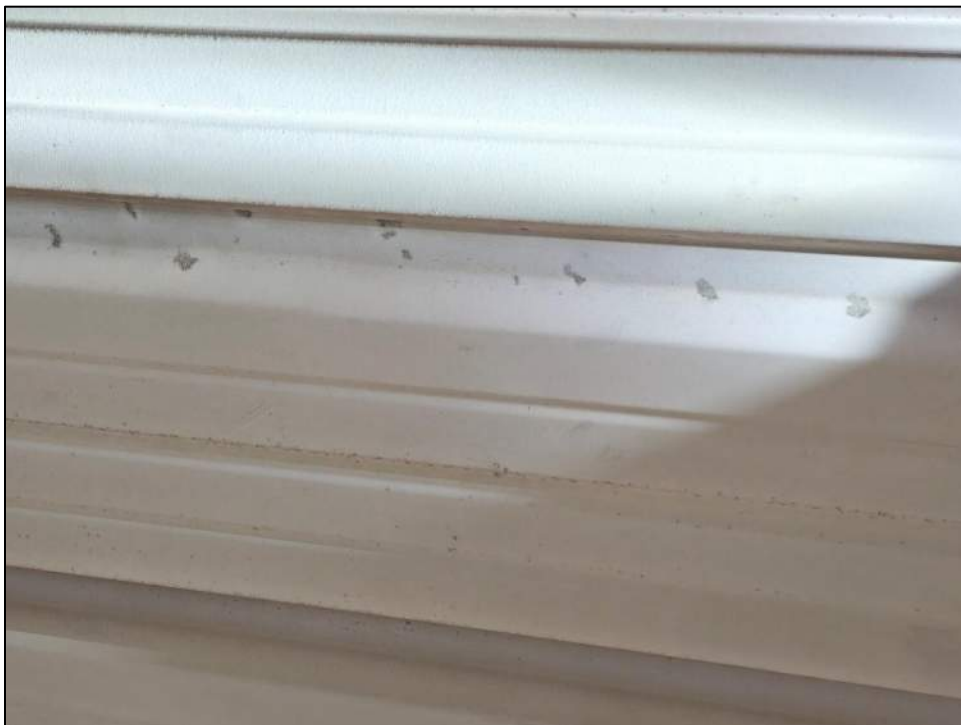
**Photo 91:** Denting to east slope were significantly less than west slope.

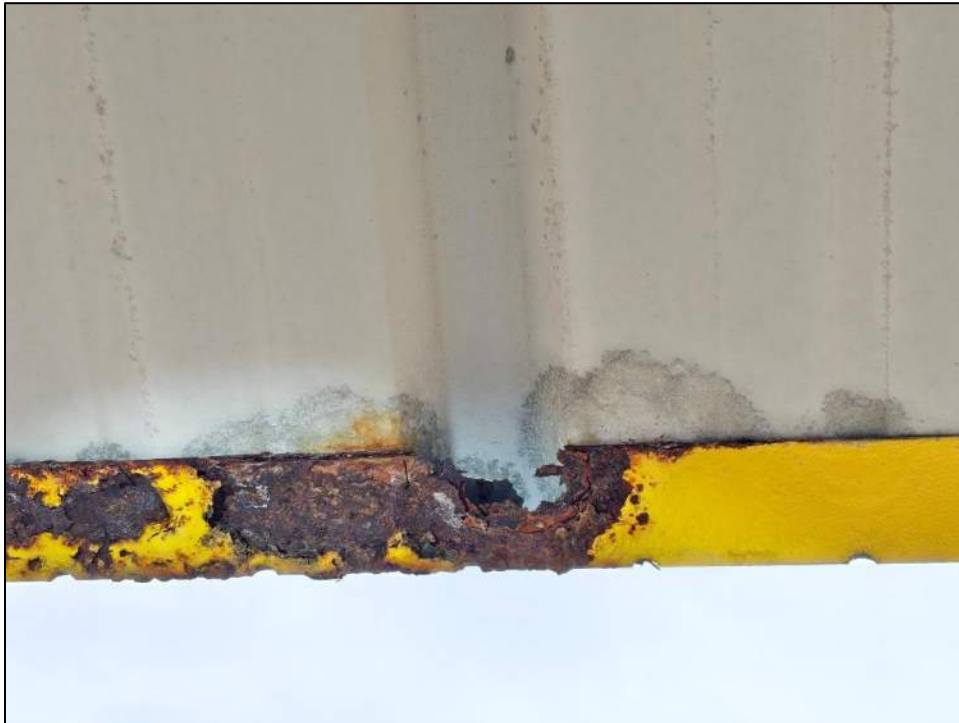
**Photo 93:** Typical closure metal corrosion along roof eaves.

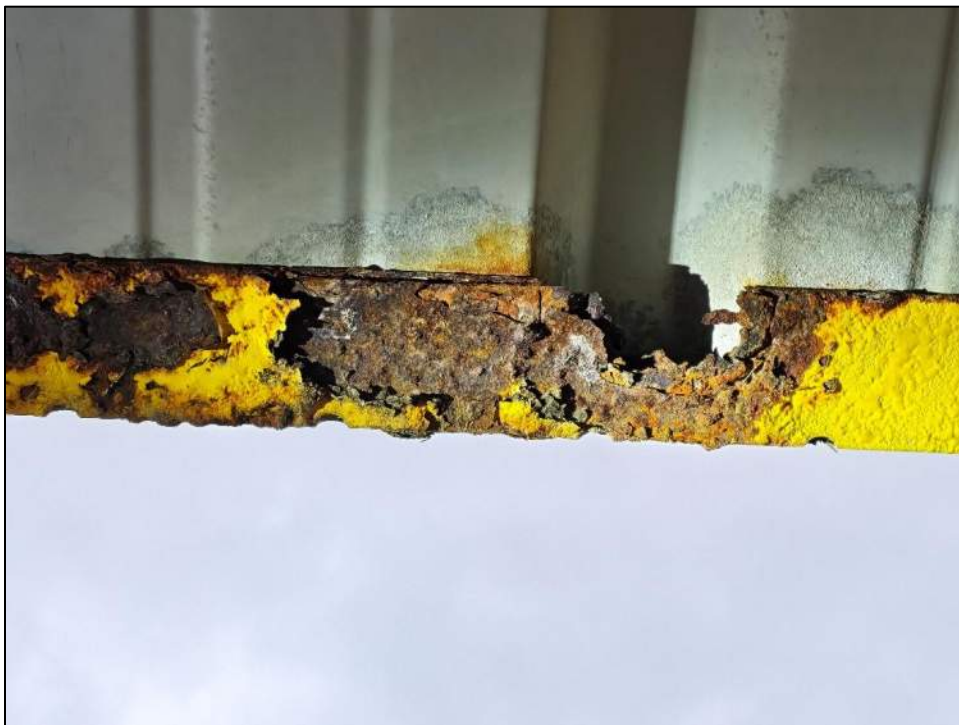
**Photo 94:** Typical closure metal corrosion along roof eaves.
