**CITY OF INGLESIDE  
REGULAR CITY COUNCIL MEETING  
AGENDA  
JUNE 9, 2026  
6:30 PM**

Report on November 01, 2025, Hailstorm Damage to City of Ingleside Buildings.

### Building Damage Analysis Survey and Report

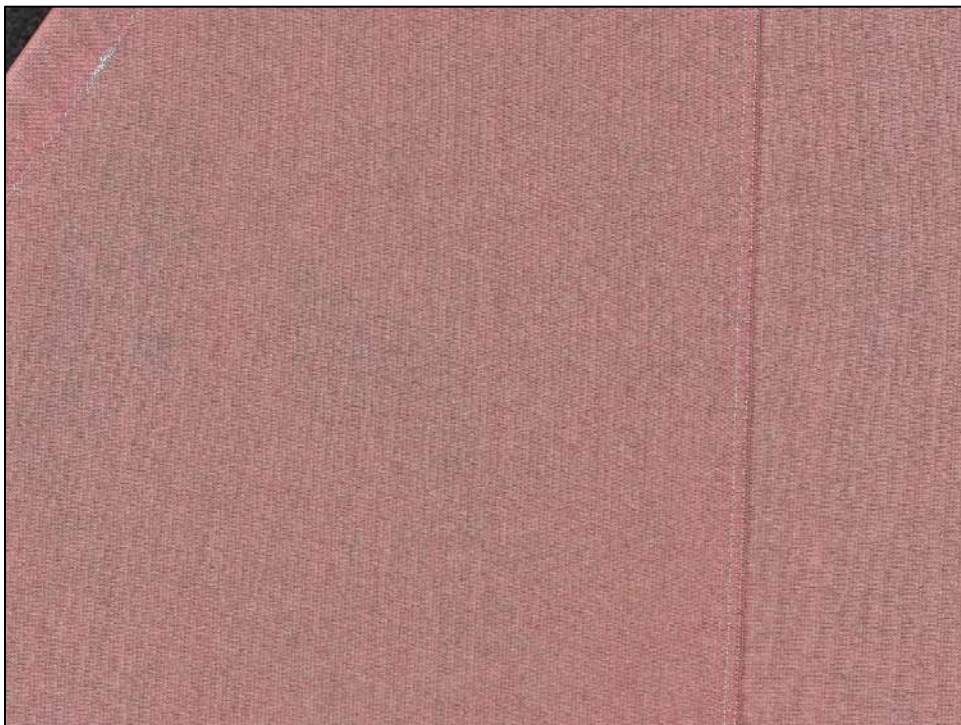
**Photo 100:** Close-up of the fabric. No fractures consistent with hail impact were observed.

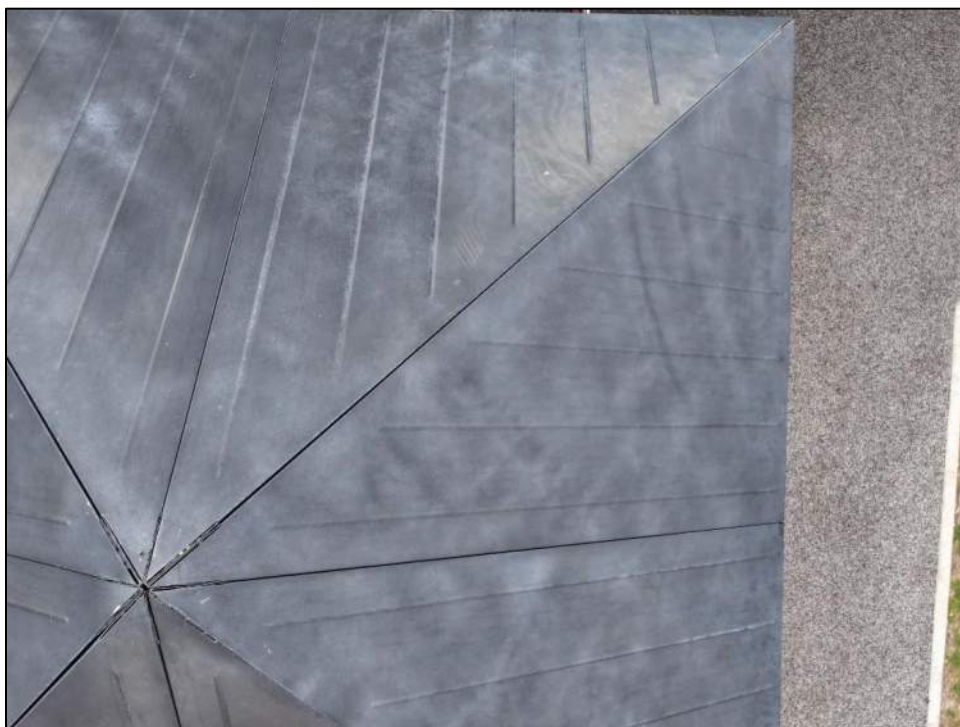
**Photo 104:** The roof is made of steel plates. No hail impact indentations were observed.

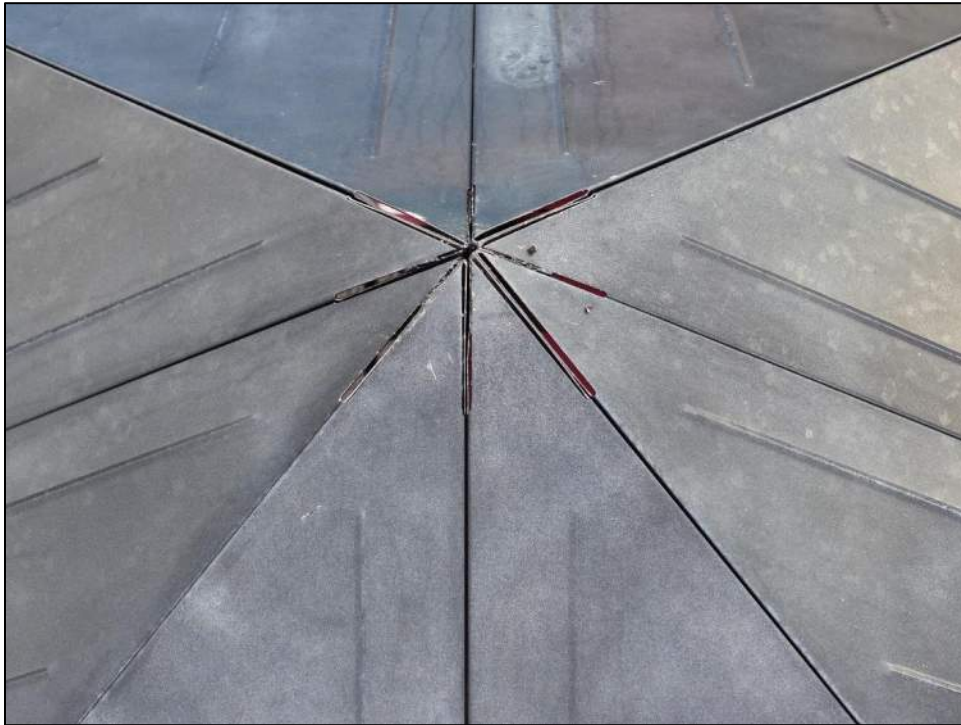
**Photo 105:** The roof is made of steel plates. No hail impact indentations were observed.

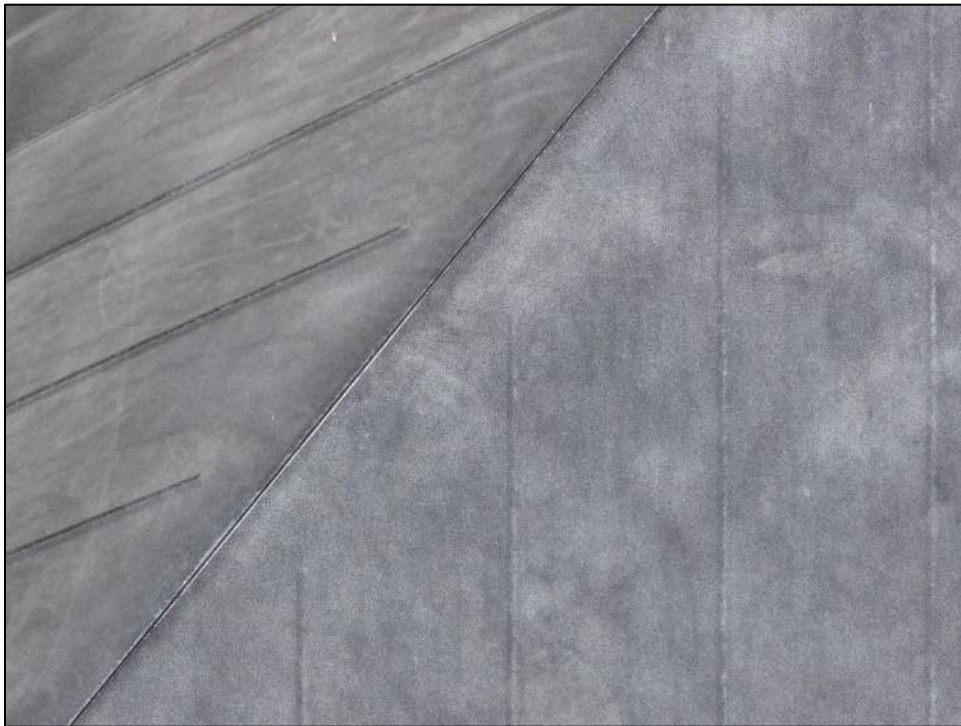
**Photo 106:** The roof is made of steel plates. No hail impact indentations were observed.

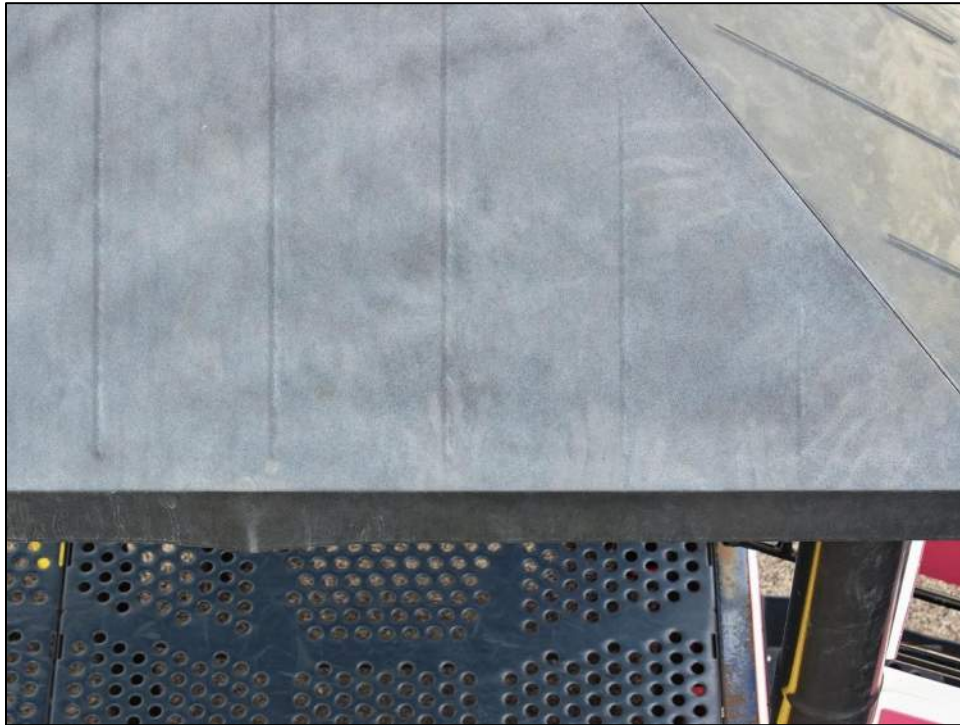
**Photo 107:** The roof is made of steel plates. No hail impact indentations were observed.

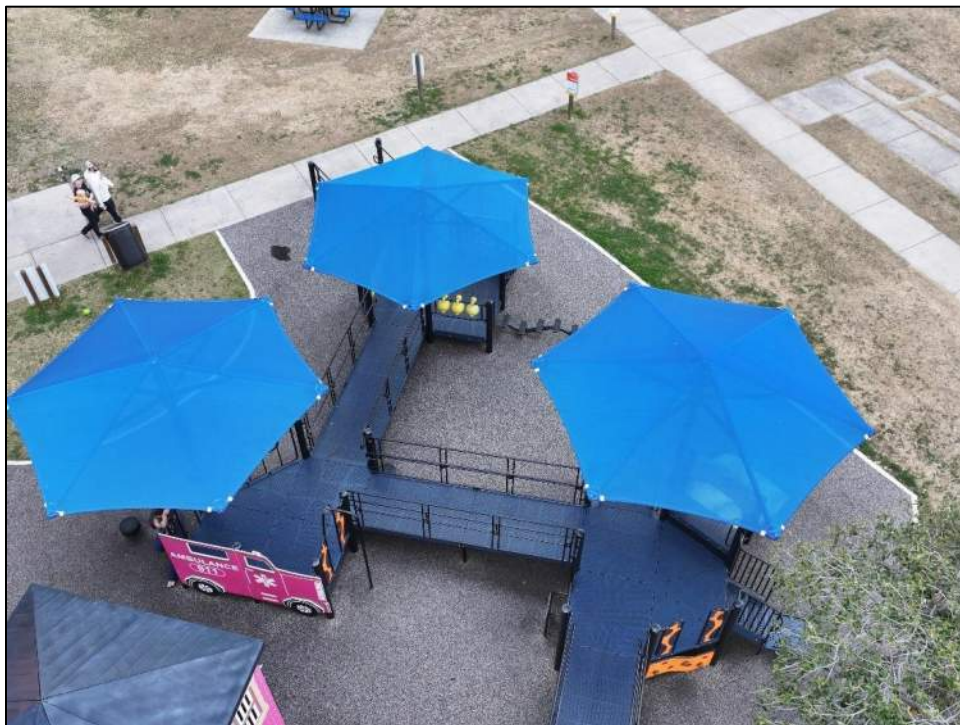
**Photo 108:** No punctures were observed in the smaller canopies.

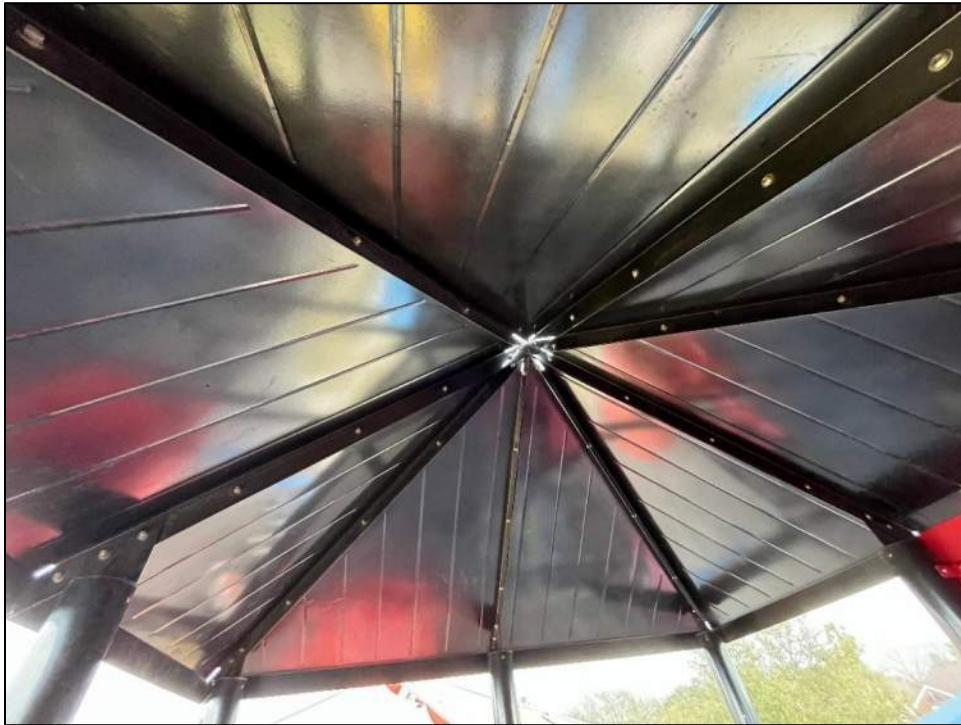
**Photo 115:** Underside of the metal plate roof were absent of any hail impact indentations.

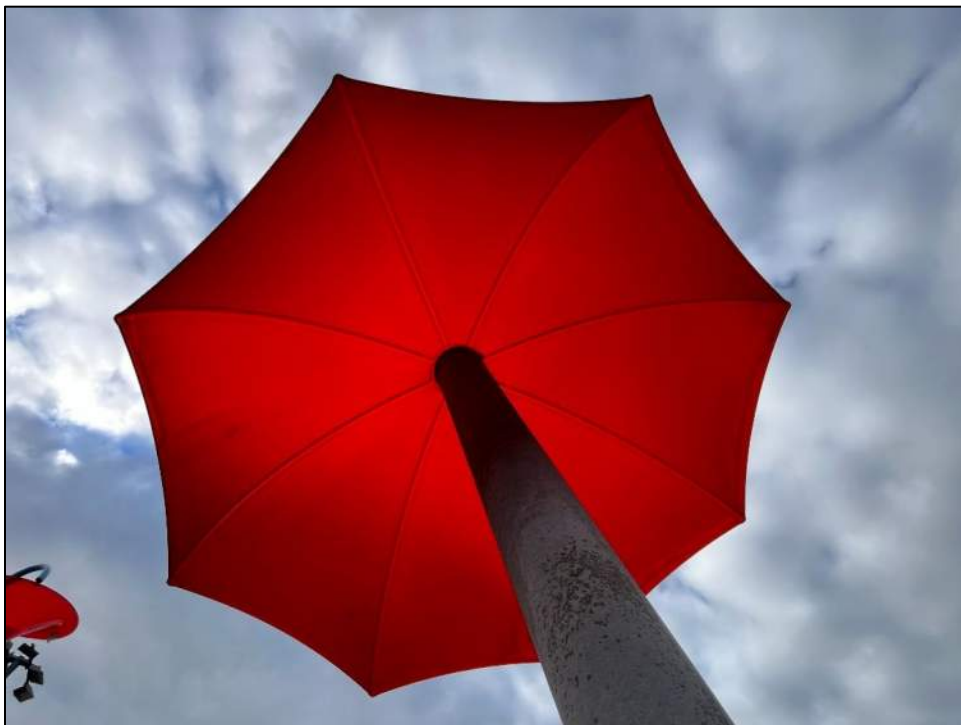
**Photo 116:** No fractures observed under the vinyl water features at the splashpad.

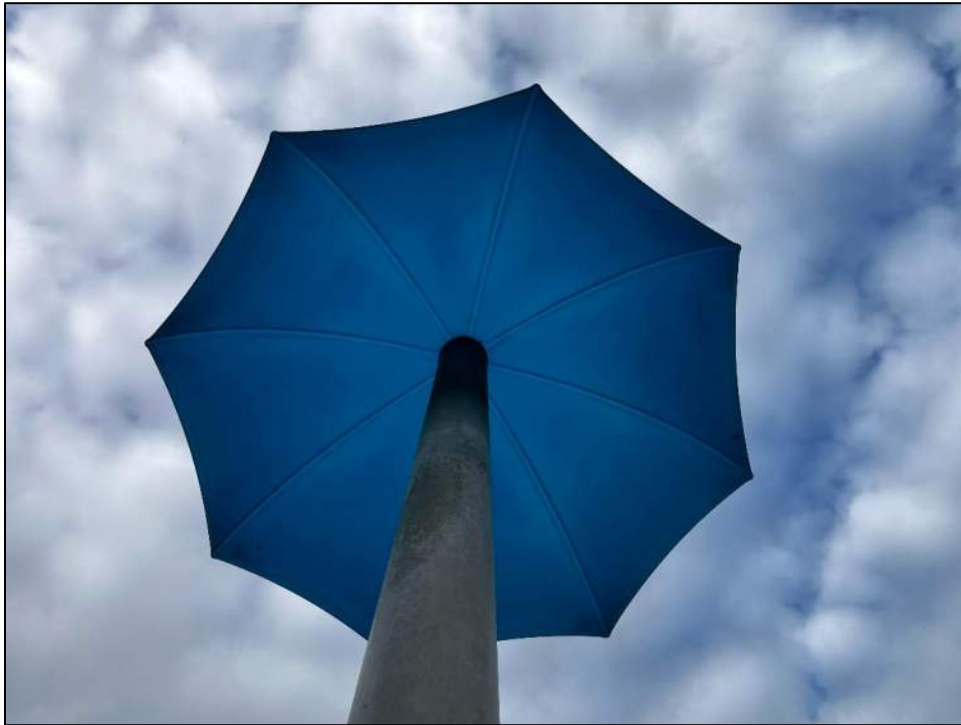
**Photo 117:** No fractures observed under the vinyl water features at the splashpad.

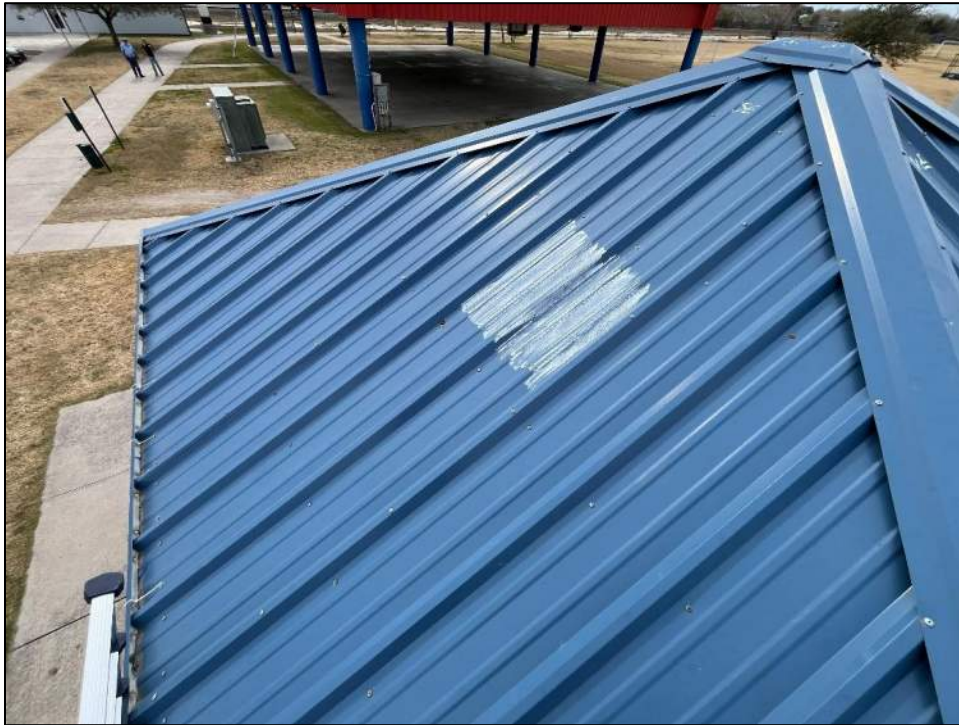
**Photo 125:** East slope. Eave closure remained intact.

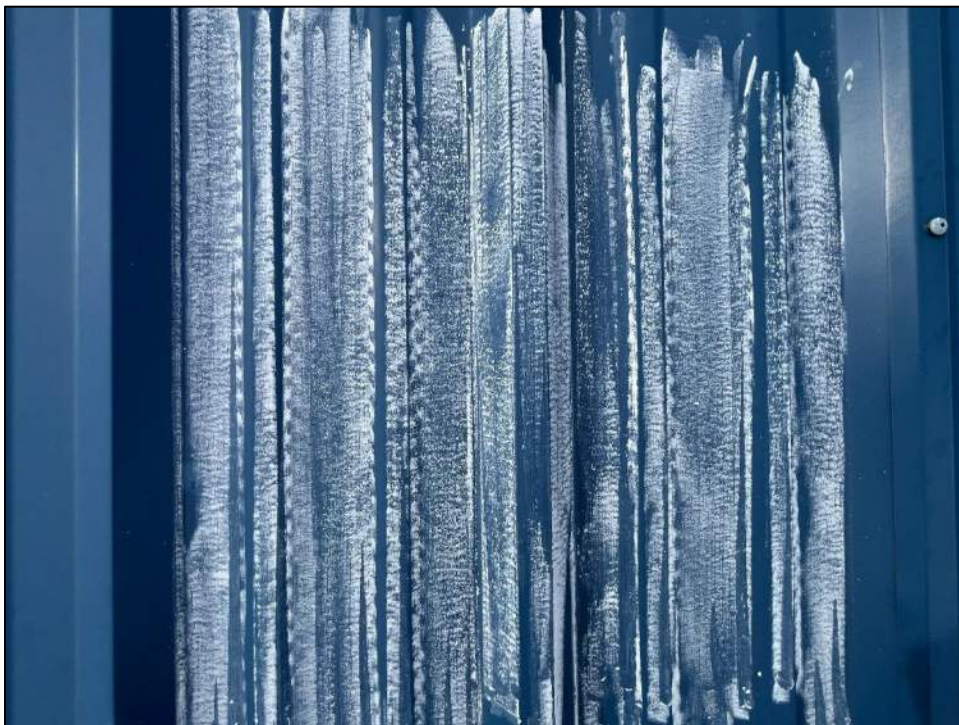
**Photo 126:** Hail denting on east slope was minimum compared to west and north slopes.

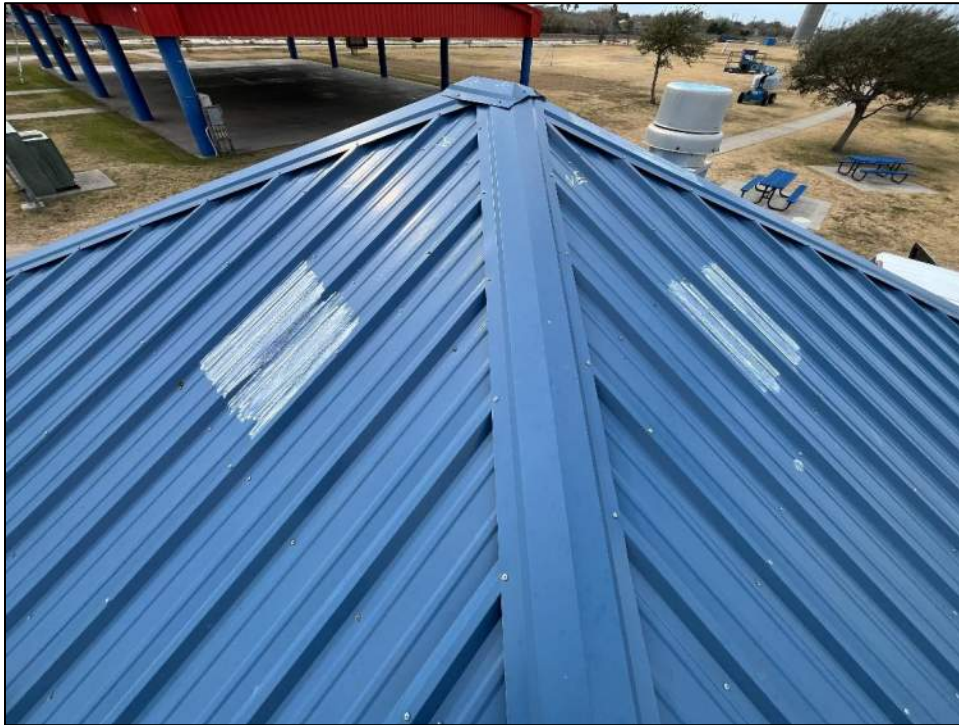
**Photo 127:** Ridge and hip caps remained fastened.

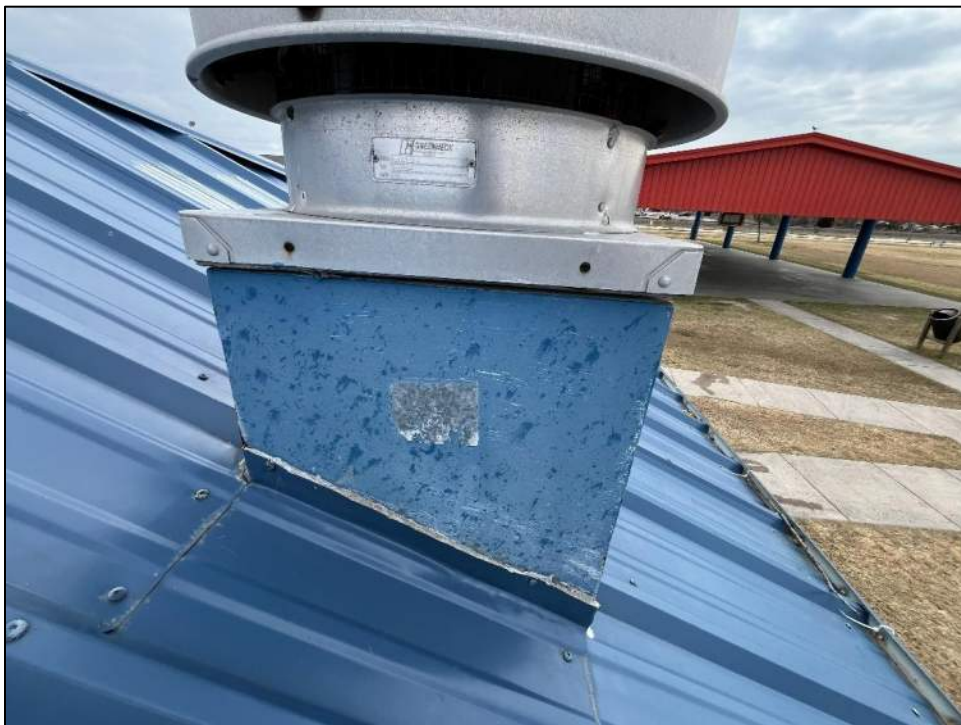
**Photo 131:** Hail spatters on north-facing curb of a vent hood on the west slope.

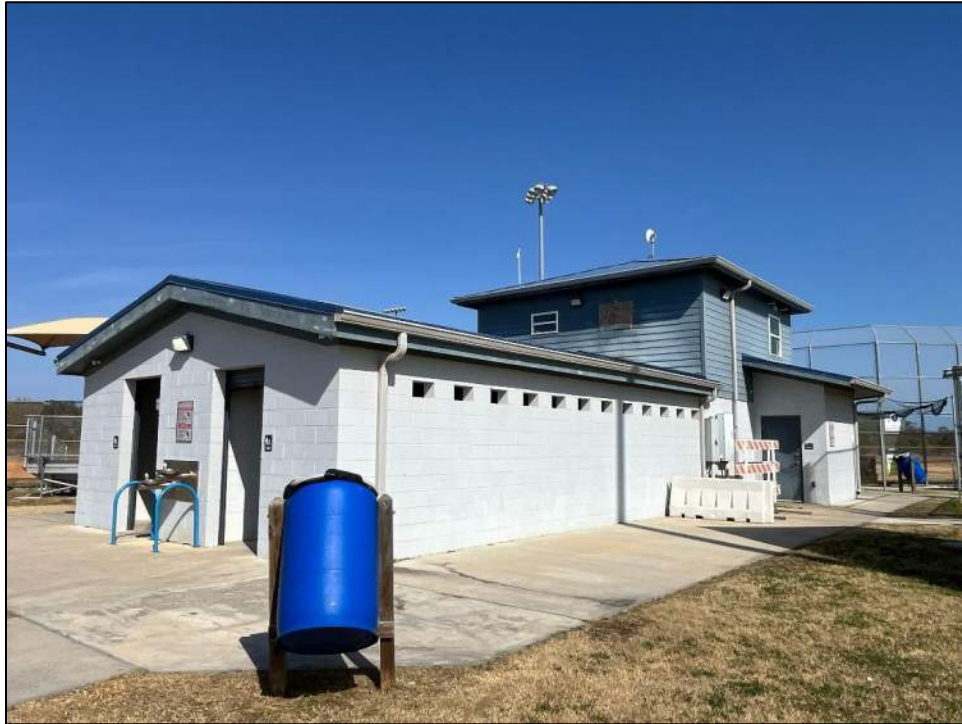
**Photo 1:** Front (west) and south elevations.

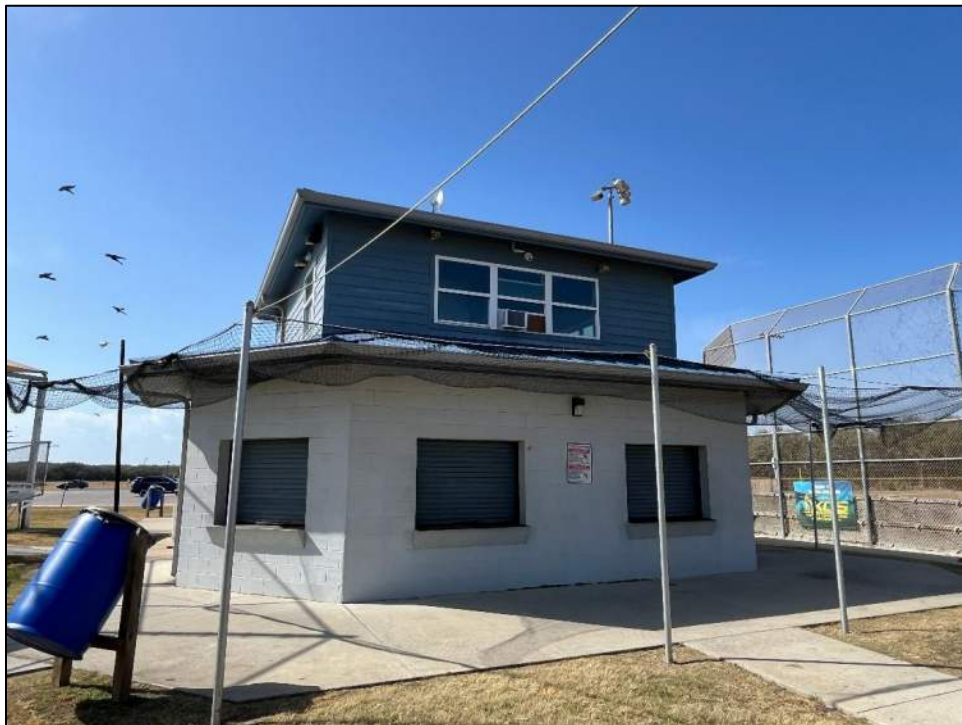
**Photo 2:** East (rear) elevation).

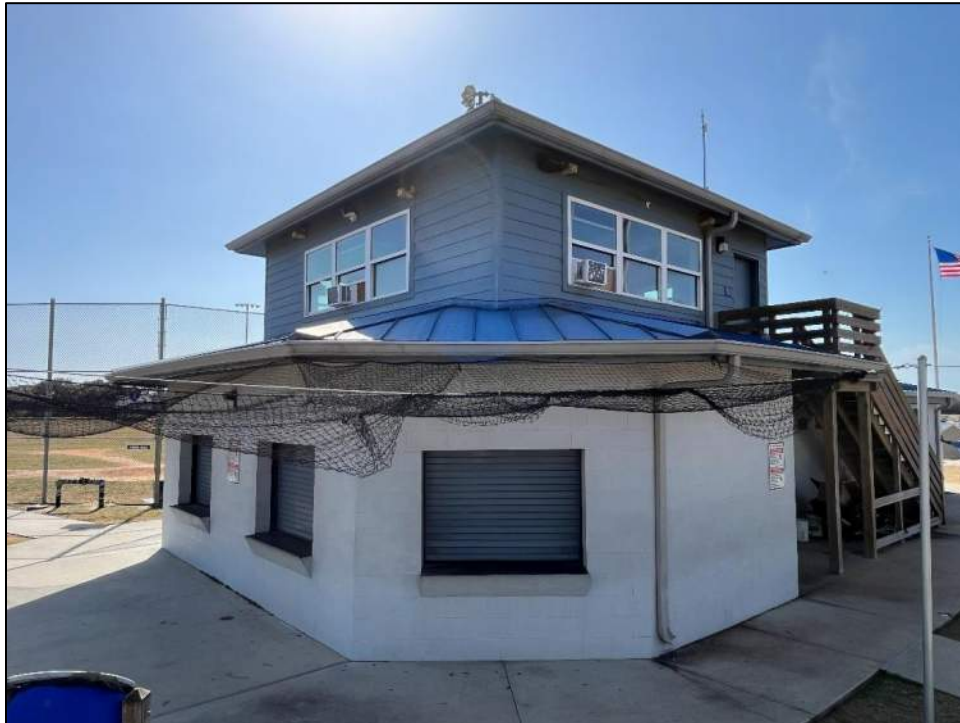
**Photo 3:** Rear and north elevations. Windowpanes remained intact. No displaced gutters or downspouts were observed.

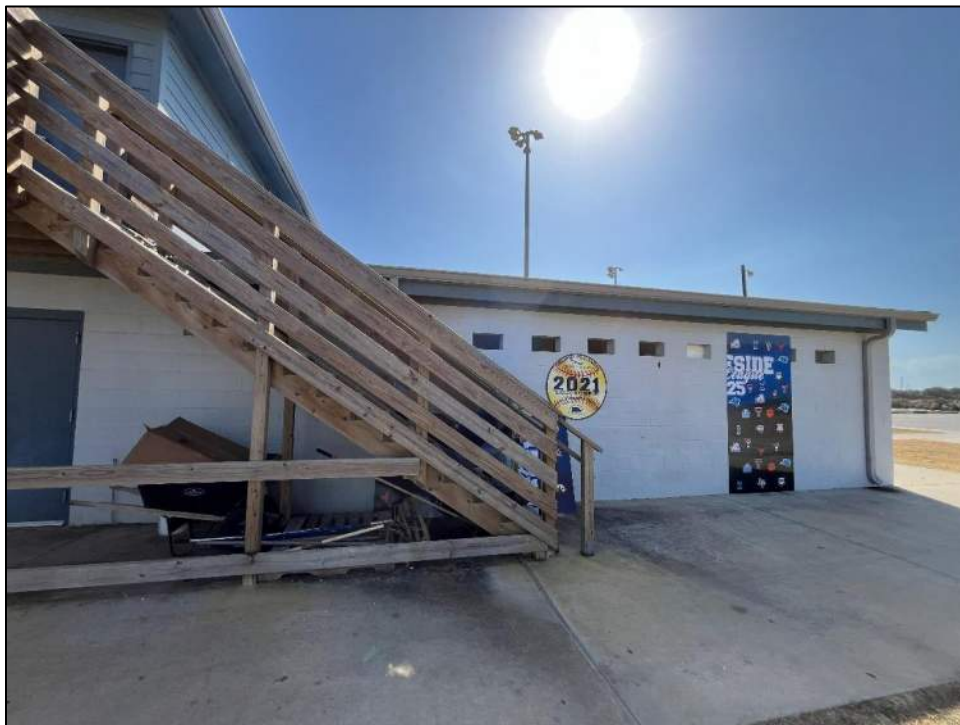
**Photo 4:** West elevation. Wooden stairs facing west exhibited hail spatters.

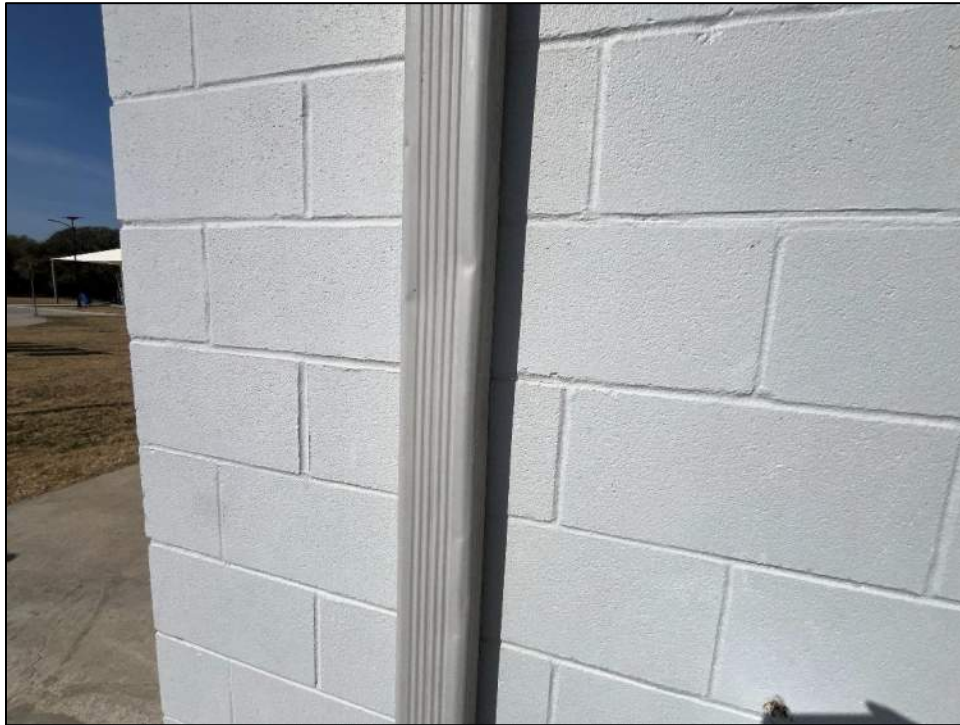
**Photo 5:** Mechanical denting to a downspout attached to the south wall inconsistent with hail impact.

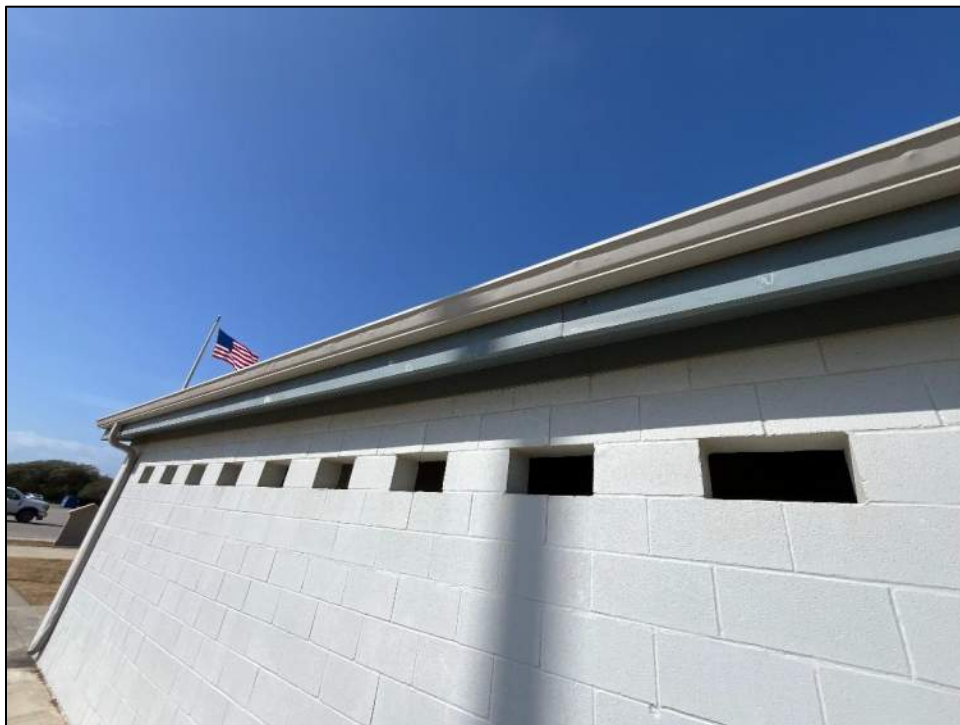
**Photo 6:** Gutter walls facing north exhibited outward denting consistent with the November 1, 2025 hail impact.

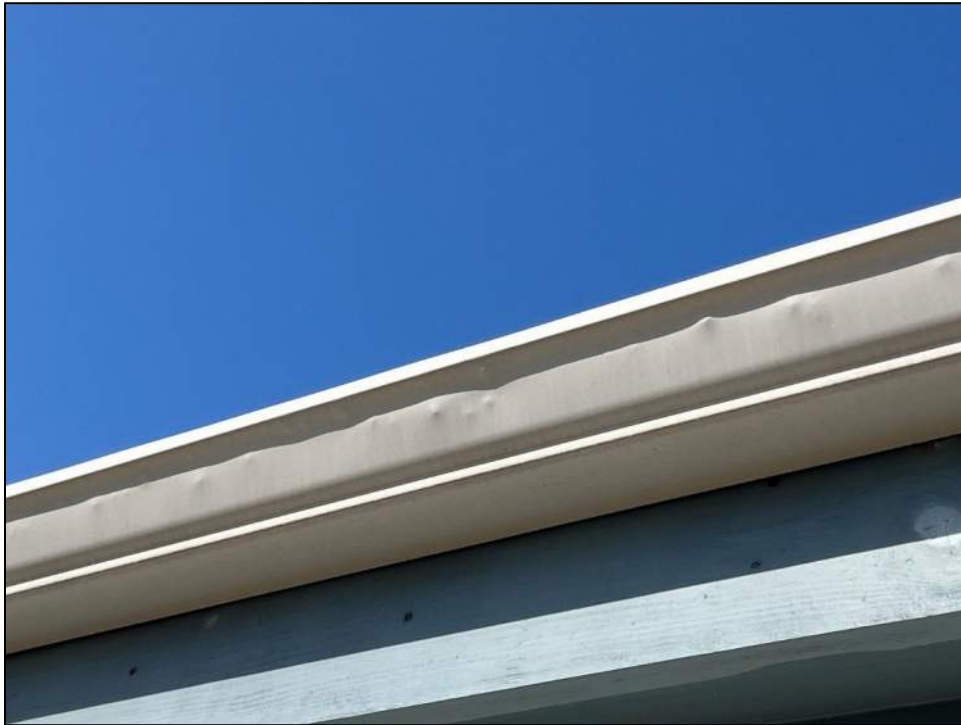
**Photo 7:** Close-up of the hail denting to the gutter walls.

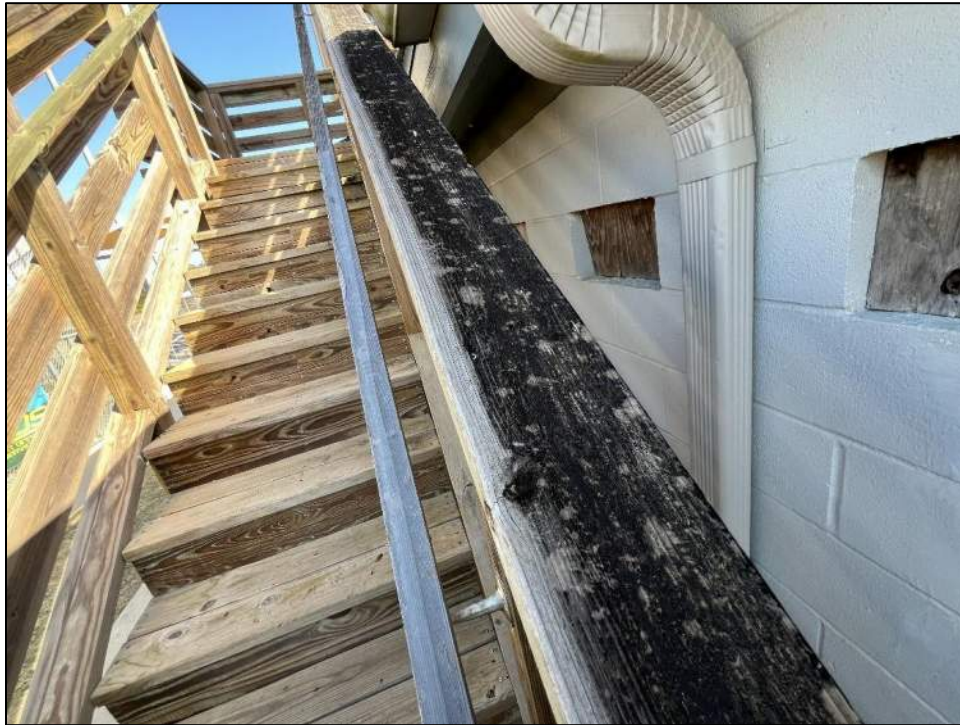
**Photo 9:** Close-up of hail spatters on algae covered wooden hand rails.

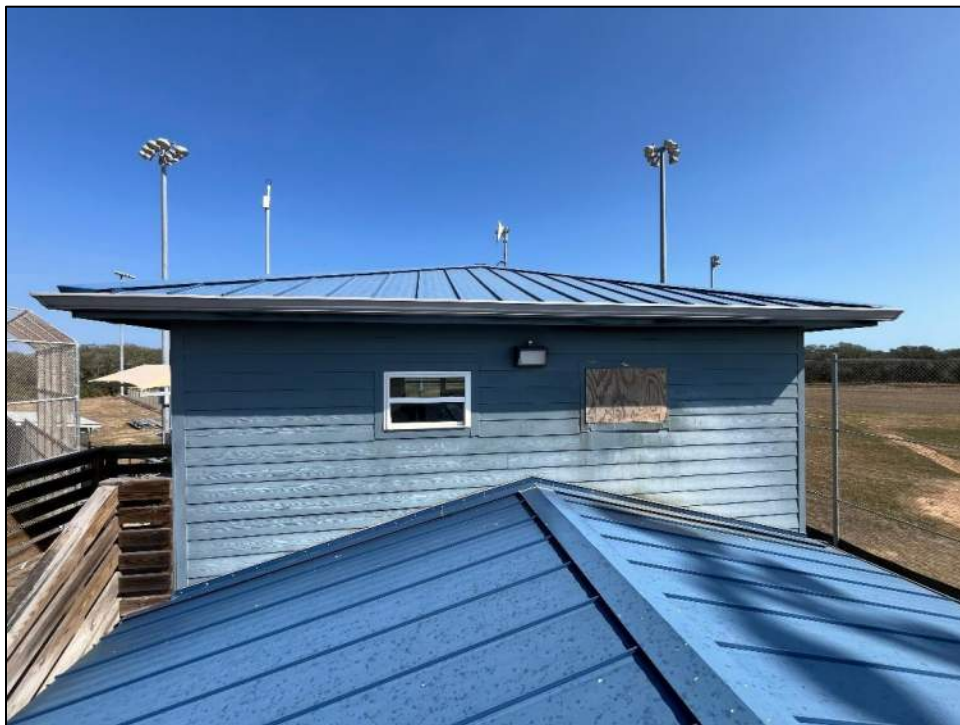
**Photo 10:** Coated Standing seam metal roof panels exhibited spatters and denting on all primary slopes.

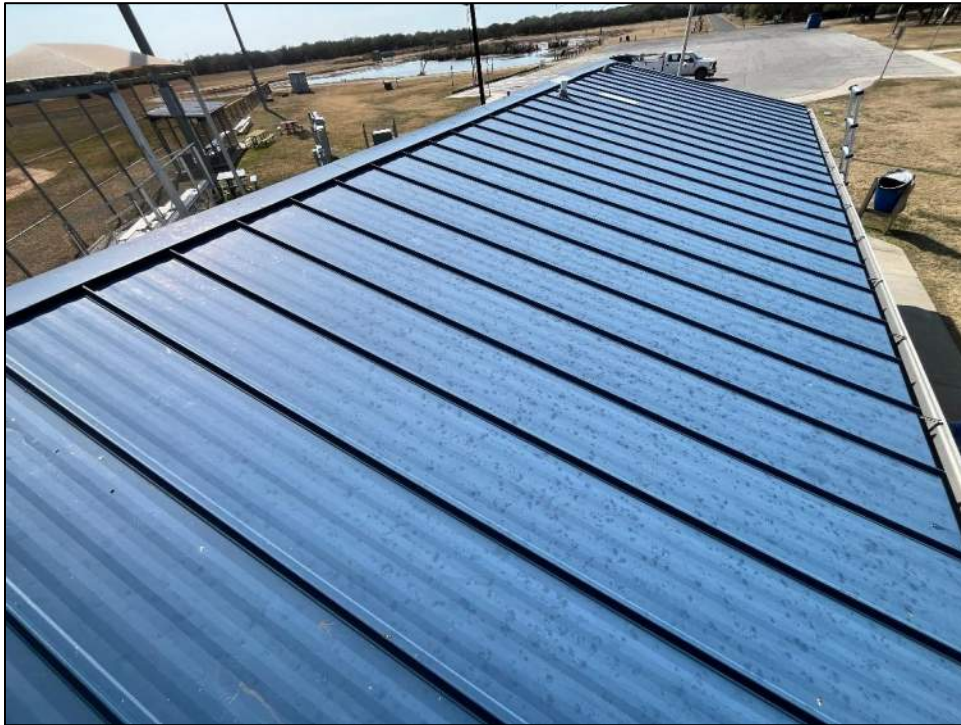
**Photo 11:** Hail denting and spatters on north slope were more severe than east and south slopes.

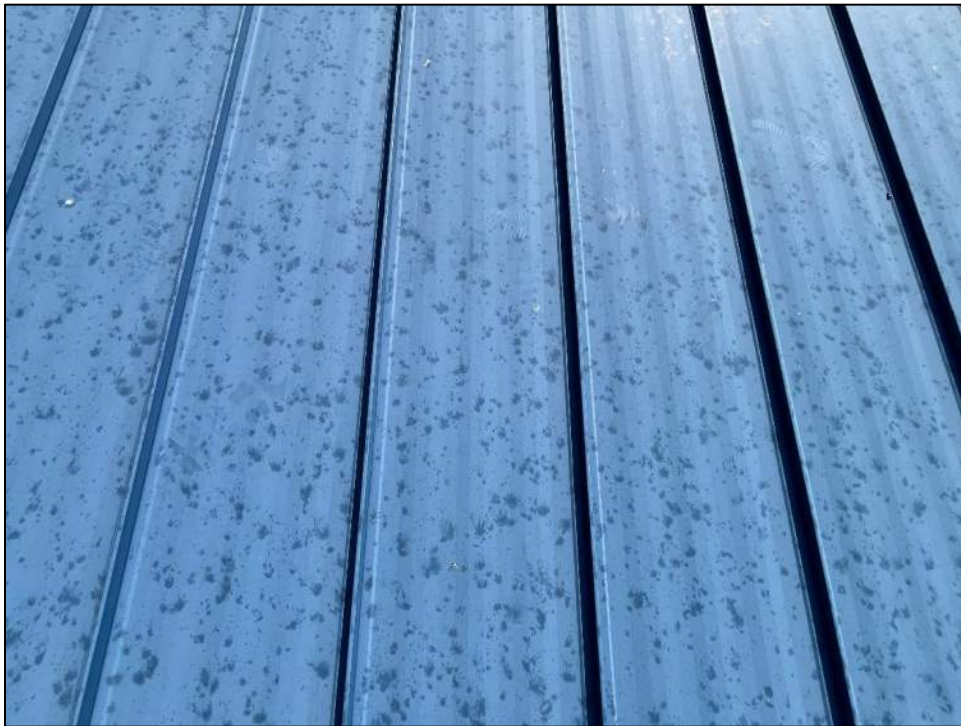
**Photo 12:** Hail spatters on north slope were consistent with 1.0- to 1.5-inch hail.

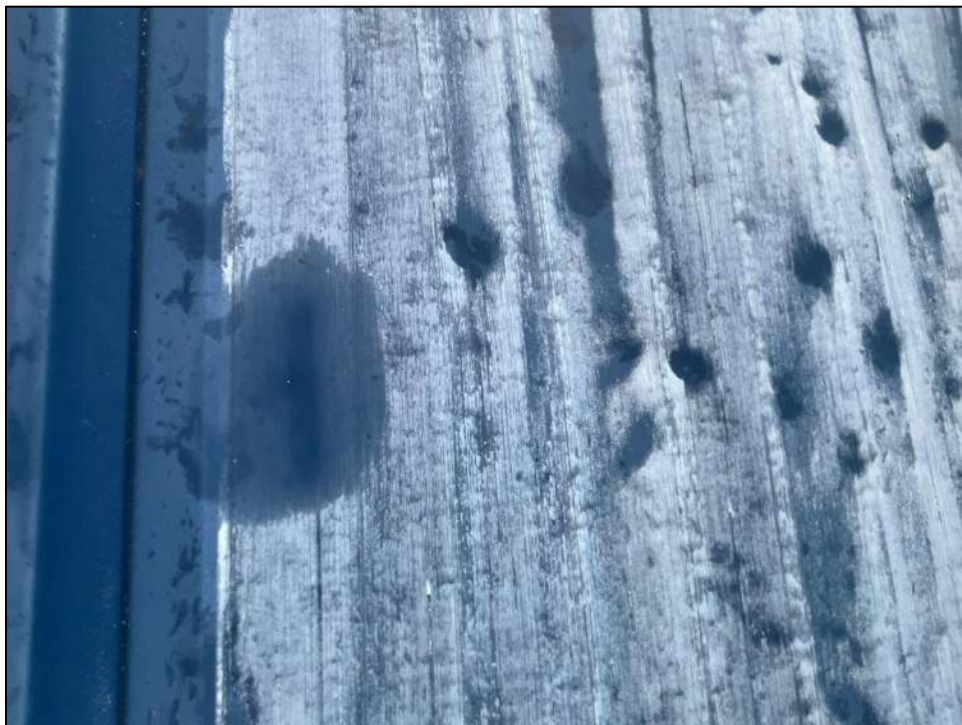
**Photo 14:** No coating disruptions were observed at the hail dents.

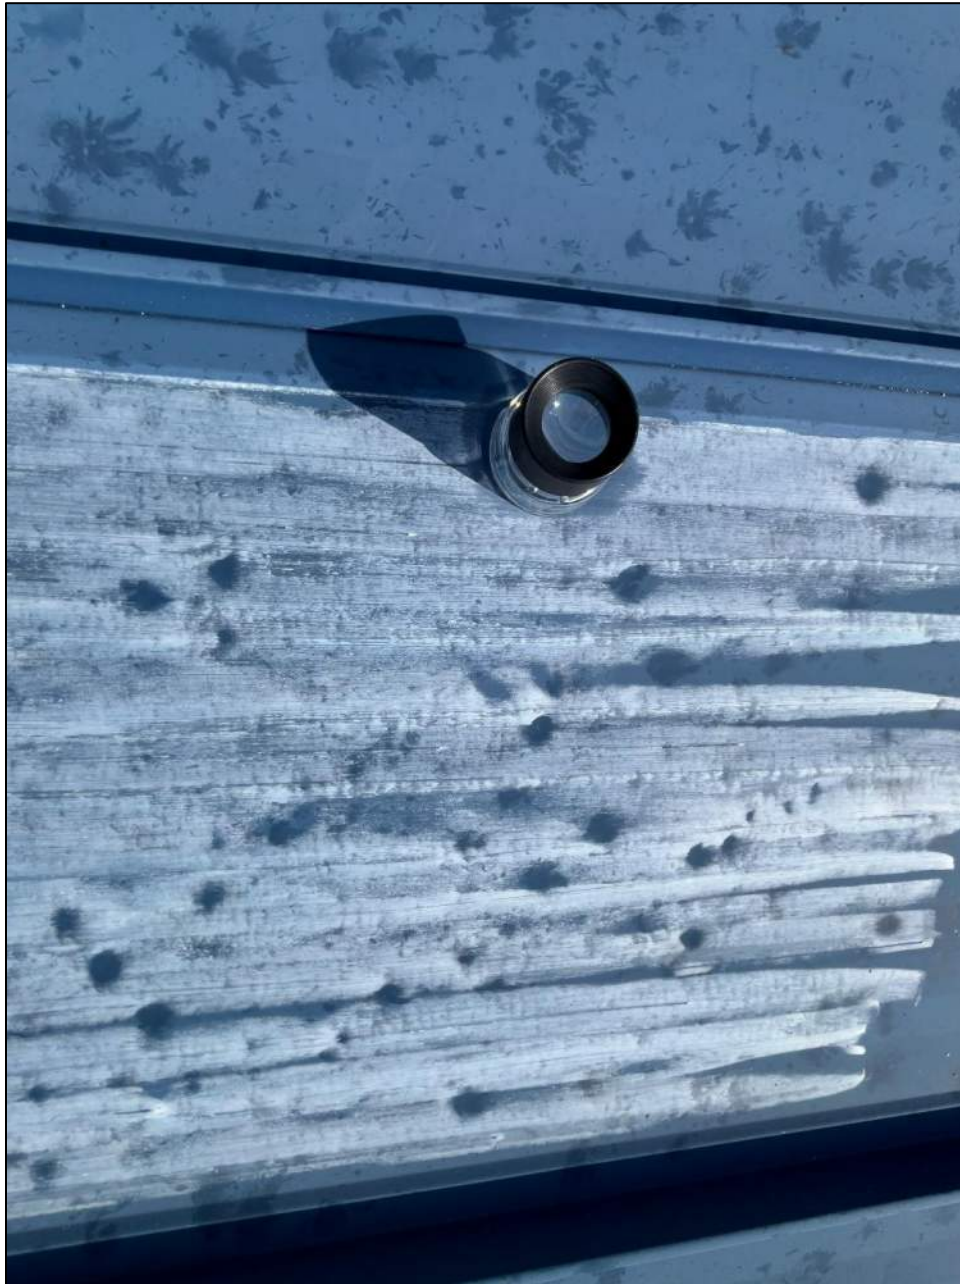
**Photo 15:** Magnifier inspection was conducted on the largest hail spatters.

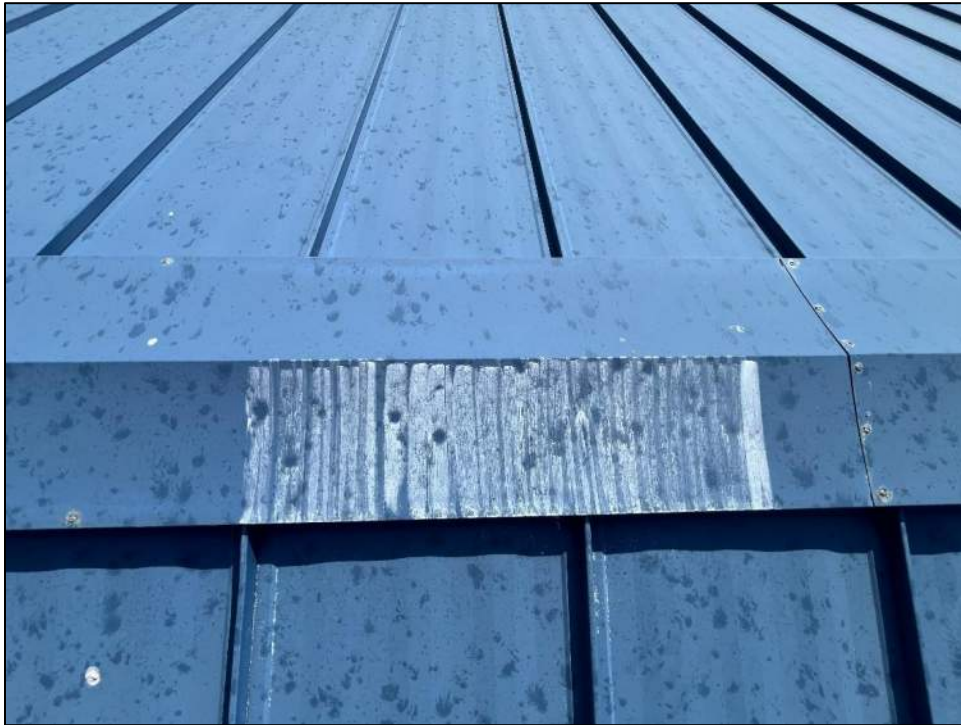
**Photo 17:** Hail denting was similarly observed along ridge caps.

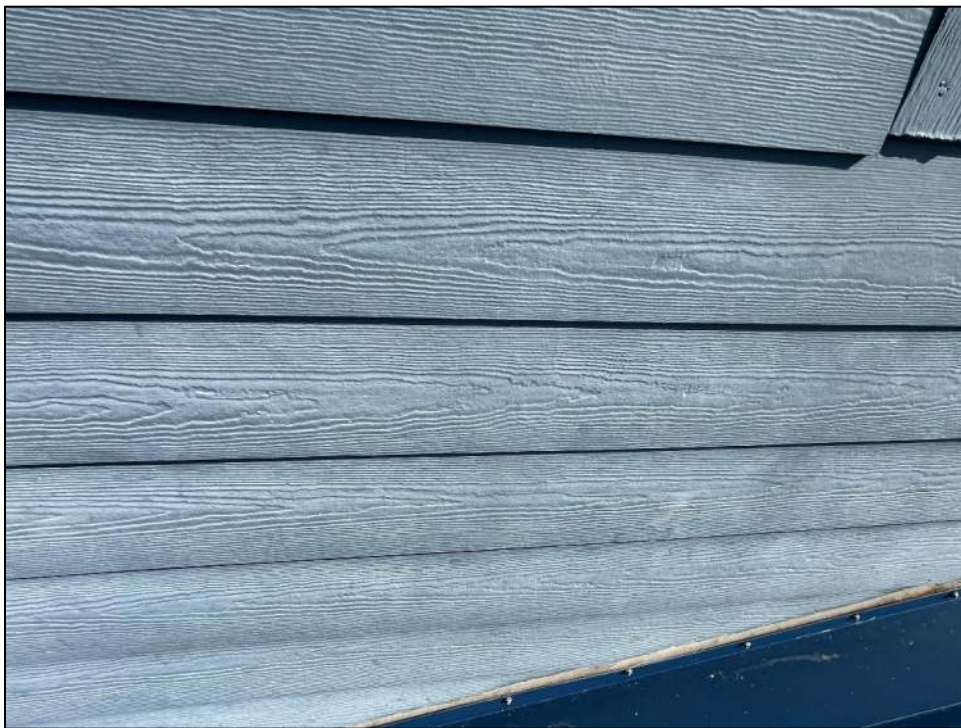
**Photo 18:** No impact chipping was observed on the painted lap siding along south elevation (west elevation).

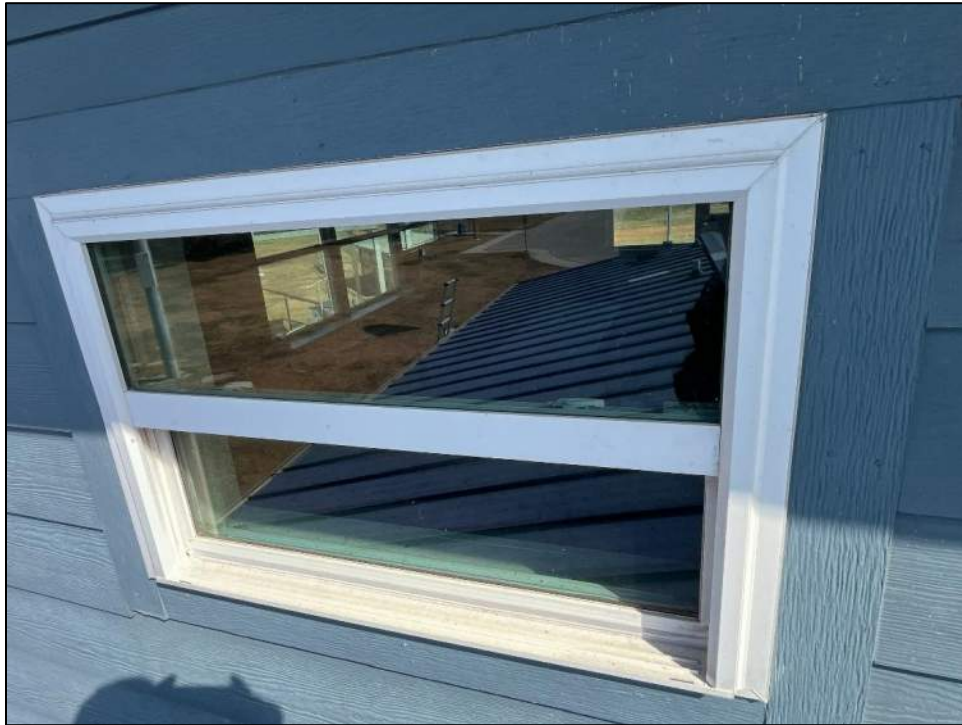
**Photo 19:** Windows remained intact (west elevation).

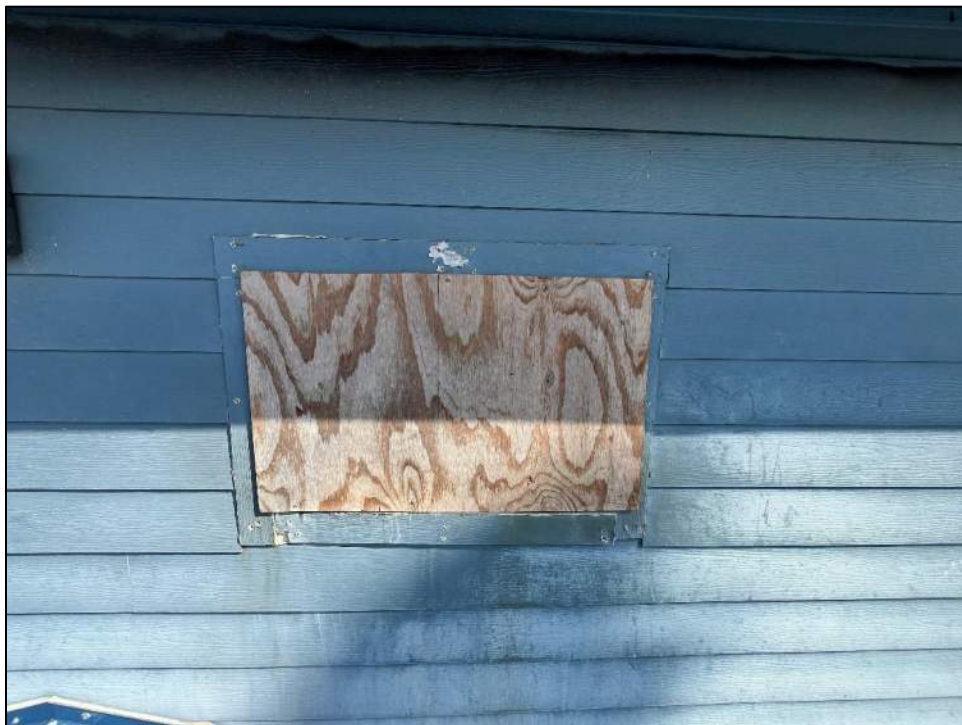
**Photo 20:** Pre-existing plywood boarding of a formerly AC-housing window on west wall.

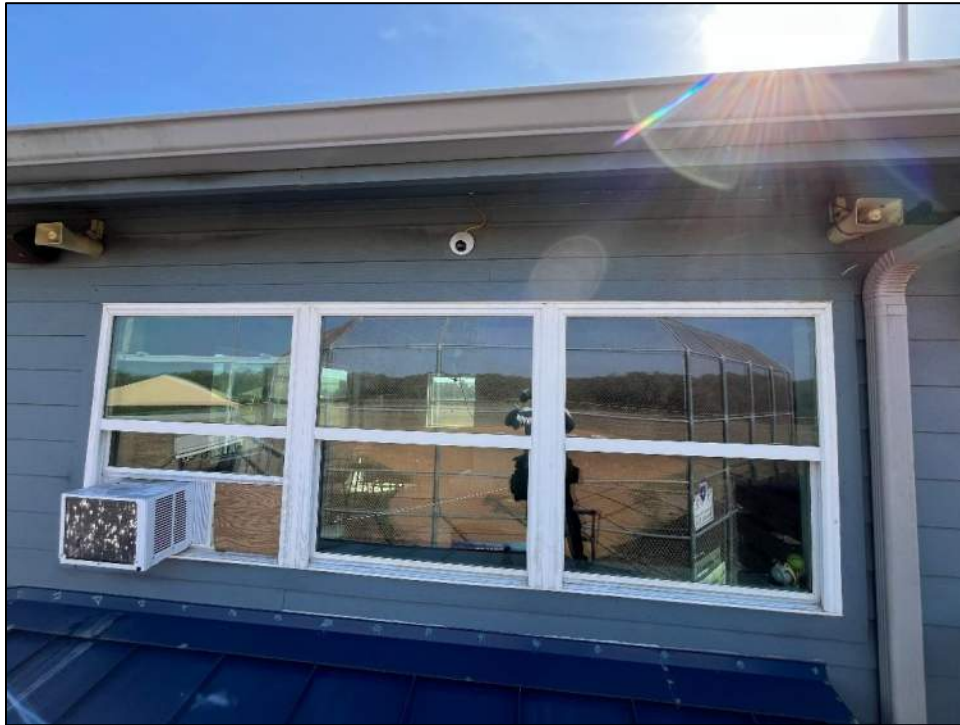
**Photo 21:** North wall windows remained intact Windows AC exhibited denting to condenser coils.
