**CITY OF INGLESIDE  
REGULAR CITY COUNCIL MEETING  
AGENDA  
JUNE 9, 2026  
6:30 PM**

Report on November 01, 2025, Hailstorm Damage to City of Ingleside Buildings.

### Building Damage Analysis Survey and Report

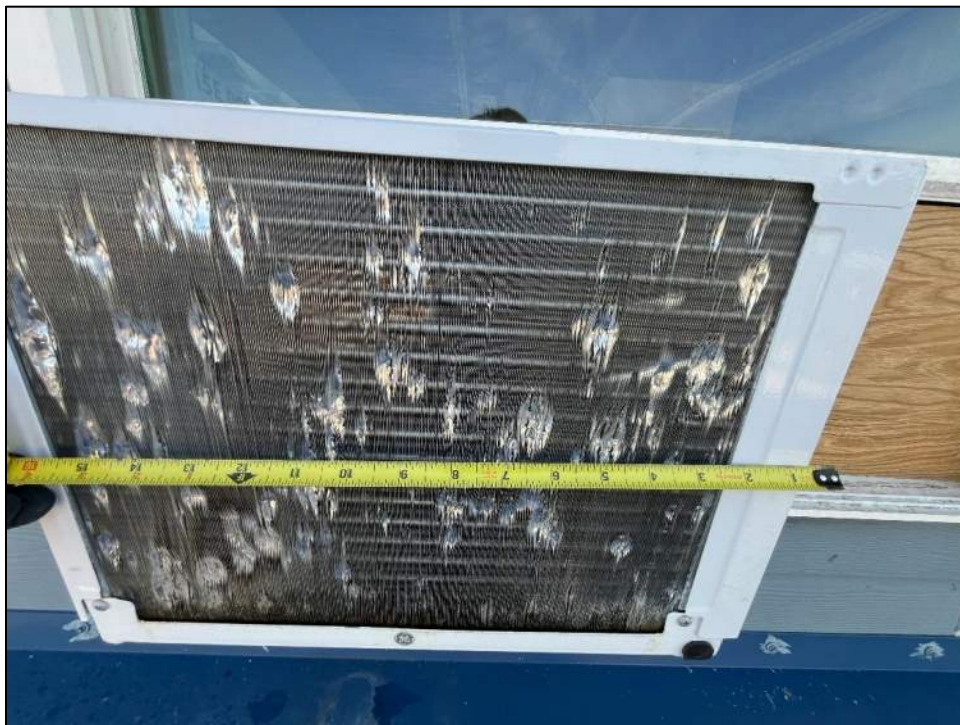
**Photo 22:** Largest hail dentings on the window AC coils directly facing the impact of hail were consistent with 1.5-inch-diameter hail.

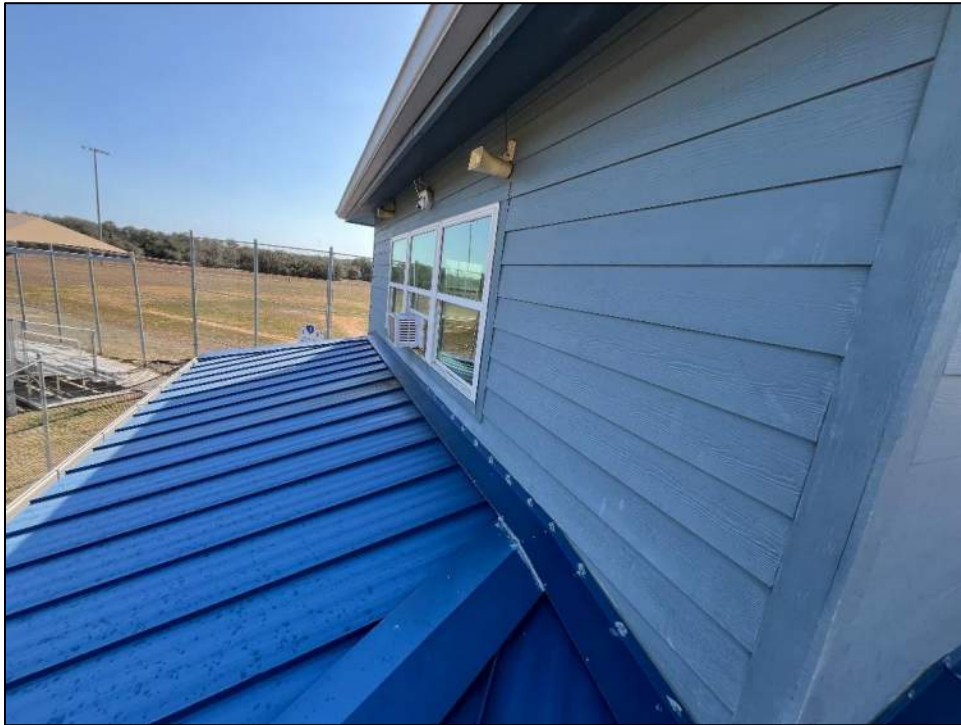
**Photo 23:** East-facing walls and windows remained absent of hail spatters.

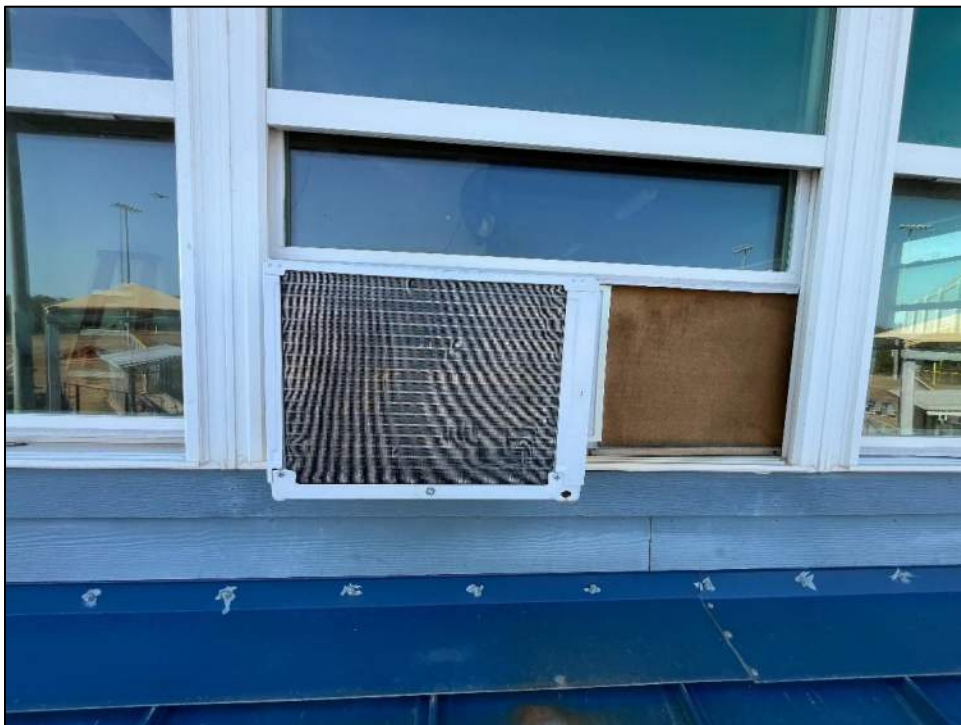
**Photo 24:** Window AC unit in east-facing window were absent of hail denting.

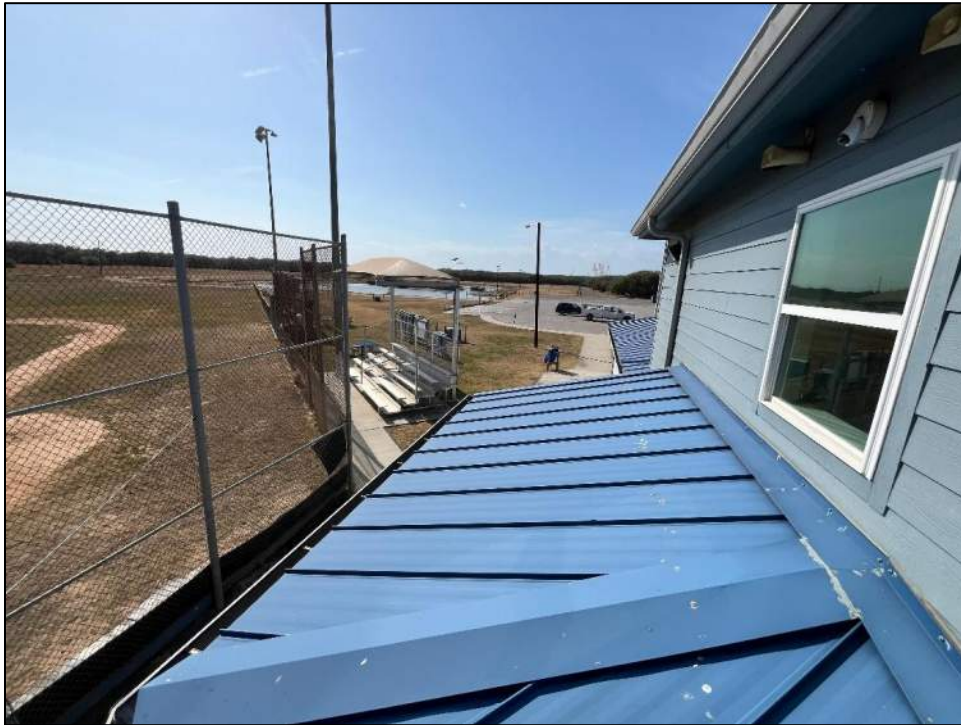
**Photo 25:** Lower half-octagonal apron roofing facing east were absent of hail spatters.

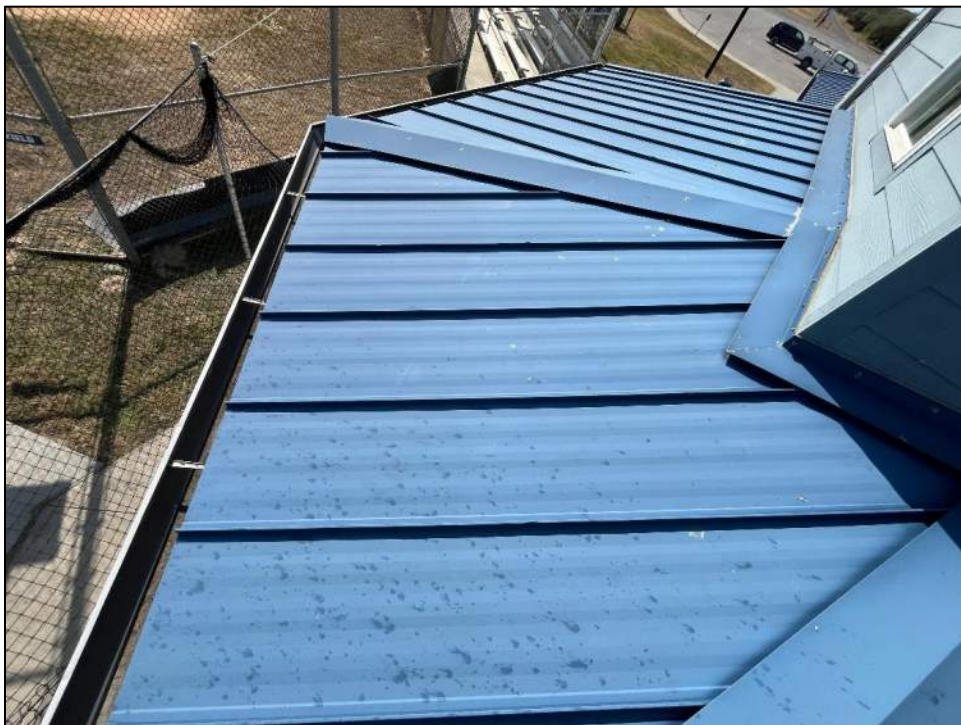
**Photo 26:** Significantly less hail spatters on east-facing apron slopes.

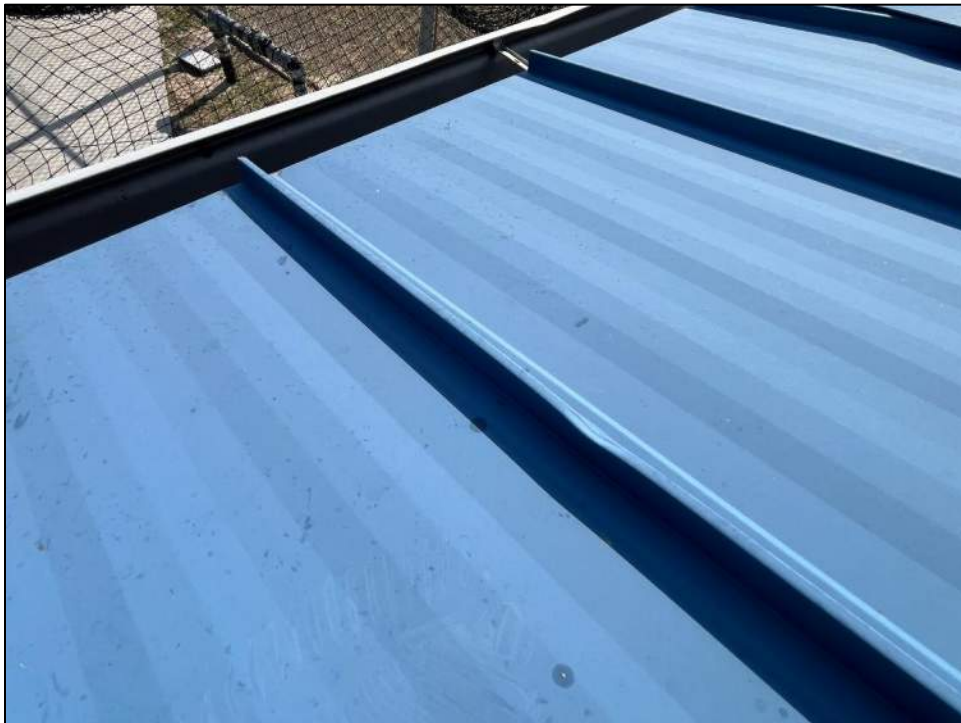
**Photo 28:** Deformed seam absent of hail impact.

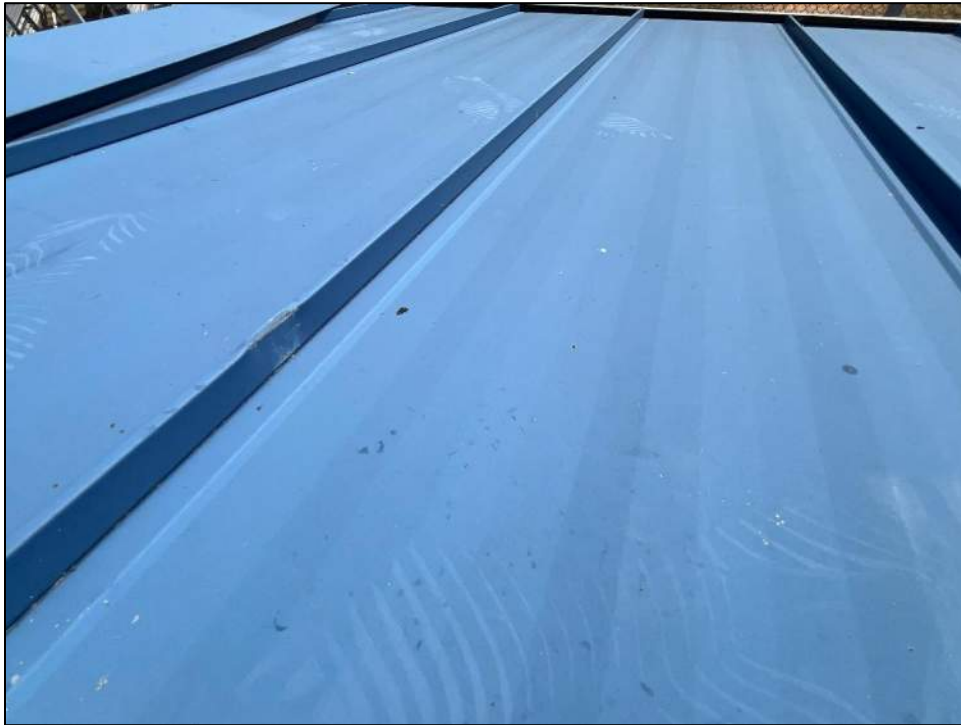
**Photo 29:** Scrapes caused localized coating damage and surface rusting.

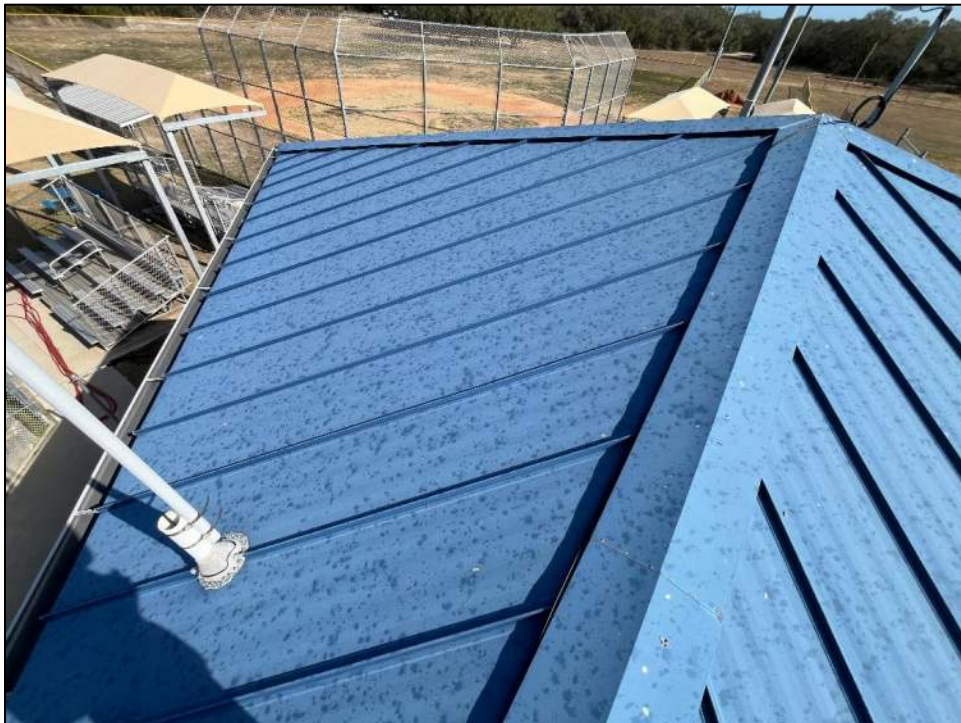
**Photo 30:** Widespread hail spatters observed on the high roof.

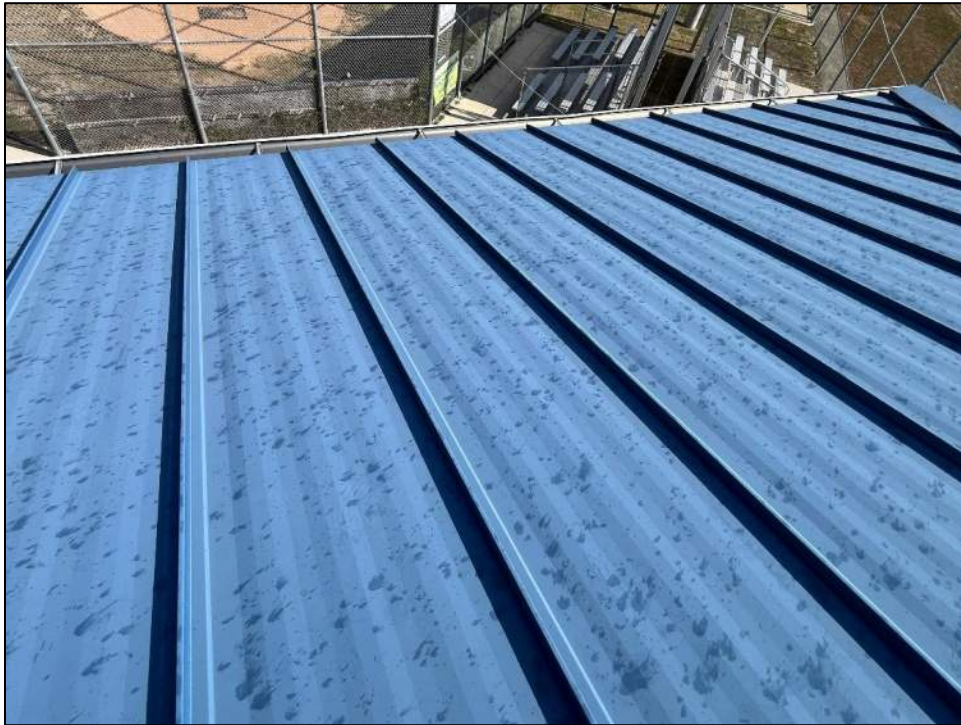
**Photo 31:** Widespread hail spatters observed on the high roof.

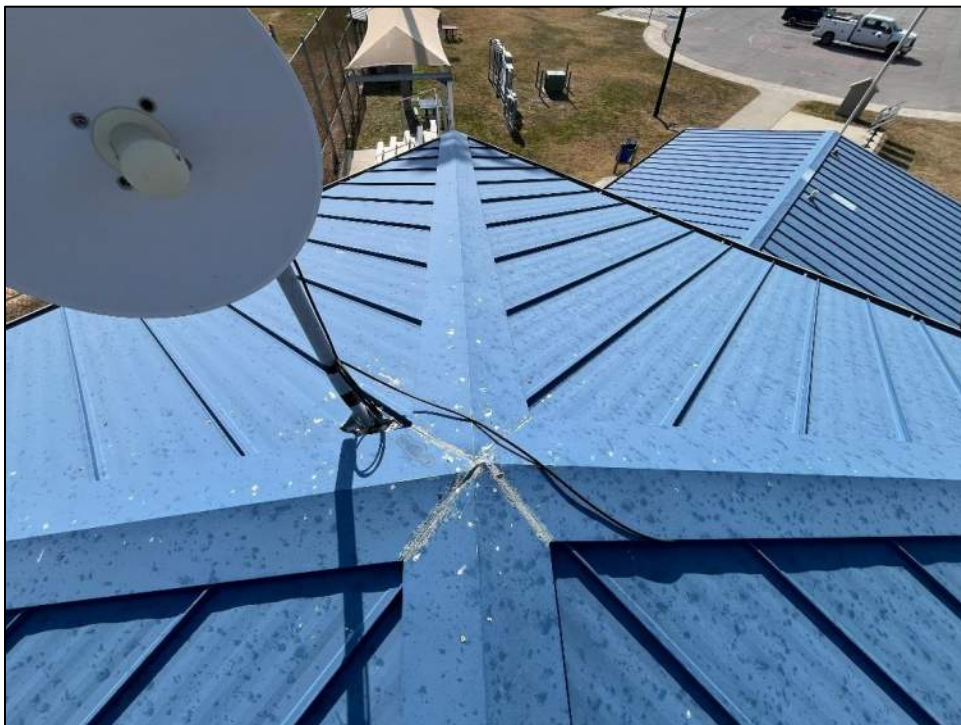
**Photo 32:** Rooftop appurtenances were not displaced or detached.

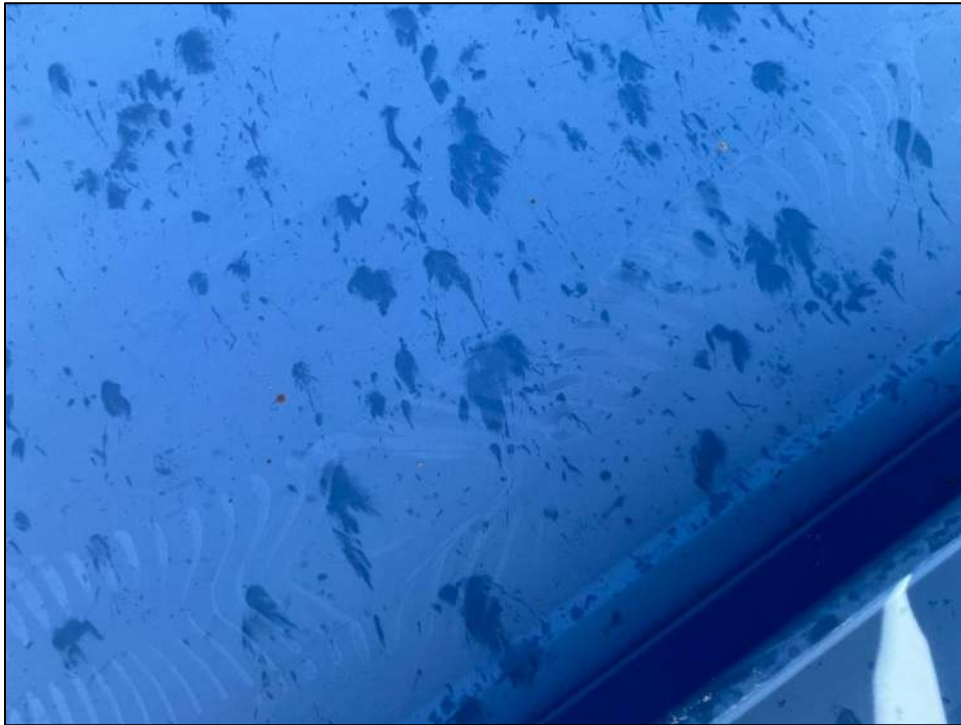
**Photo 33:** Close-up of hail spatters on high roof.

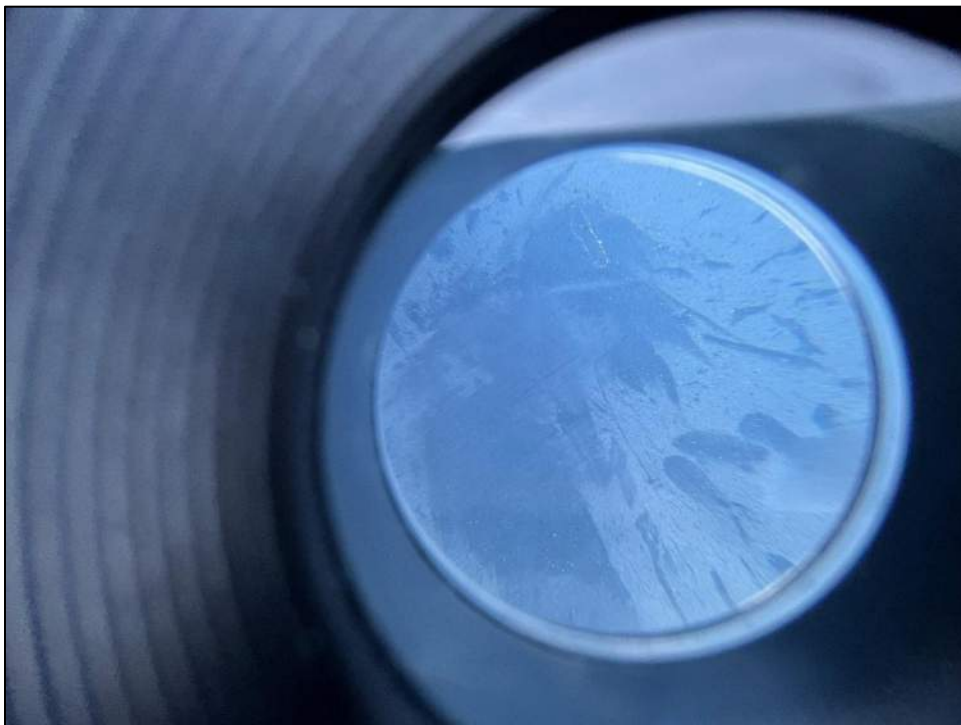
**Photo 34:** No coating disruptions were observed.

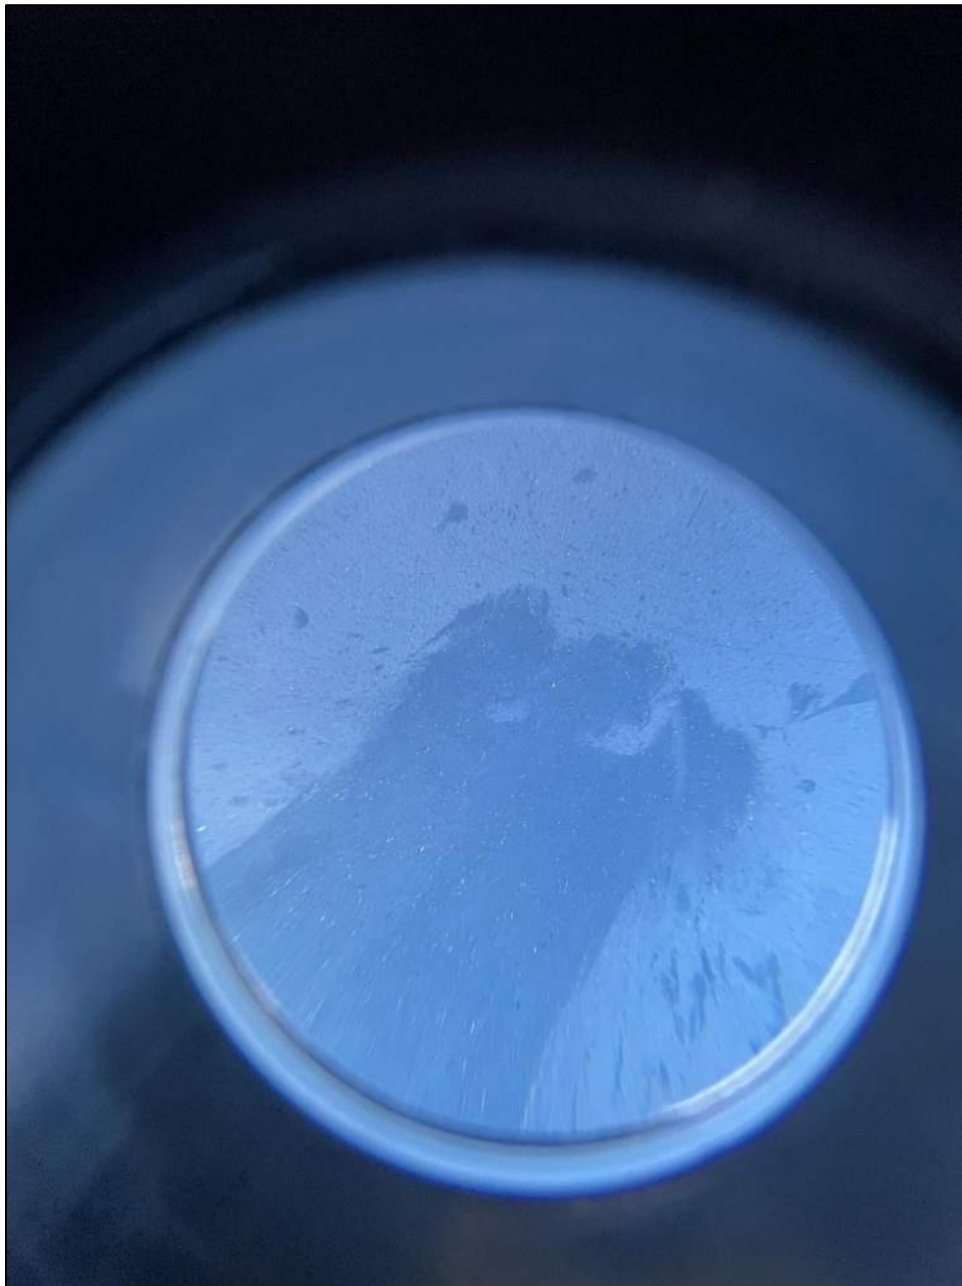
**Photo 35:** No coating disruptions were observed.

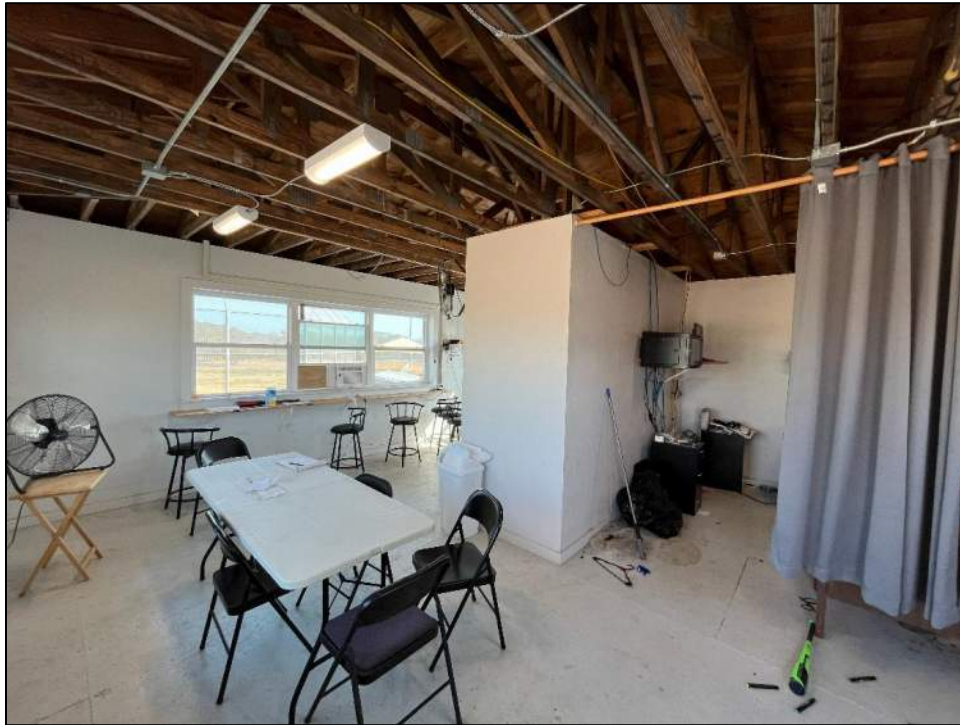
**Photo 36:** Interior space of the upper floor was inspected. No evidence of recent water infiltration was observed.

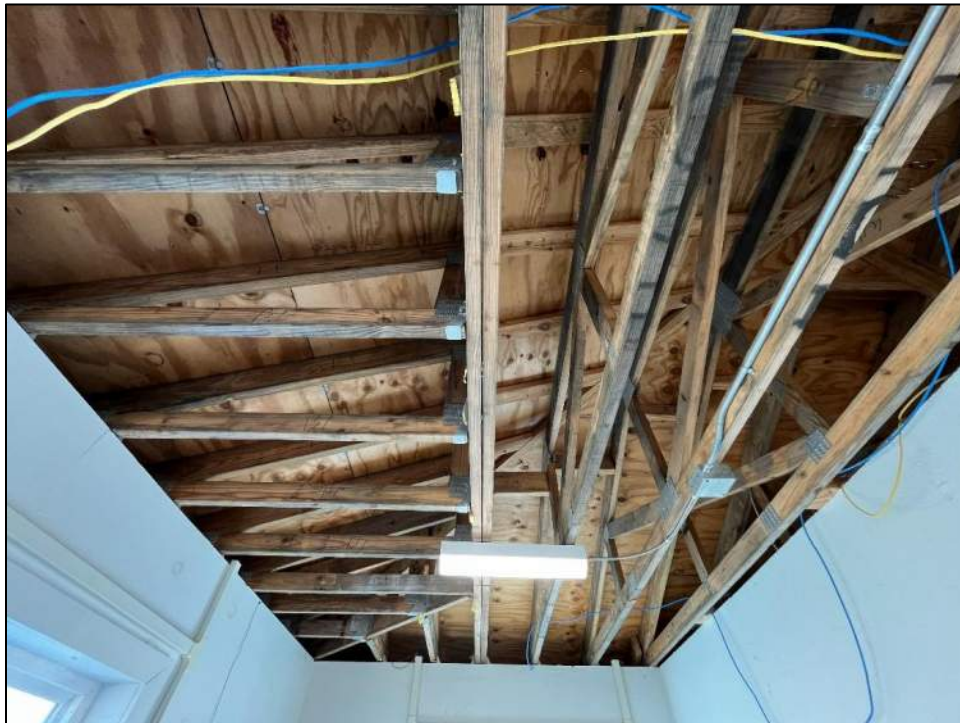
**Photo 37:** Plywood roof deck above the 2nd floor space were absent of recent moisture stains.

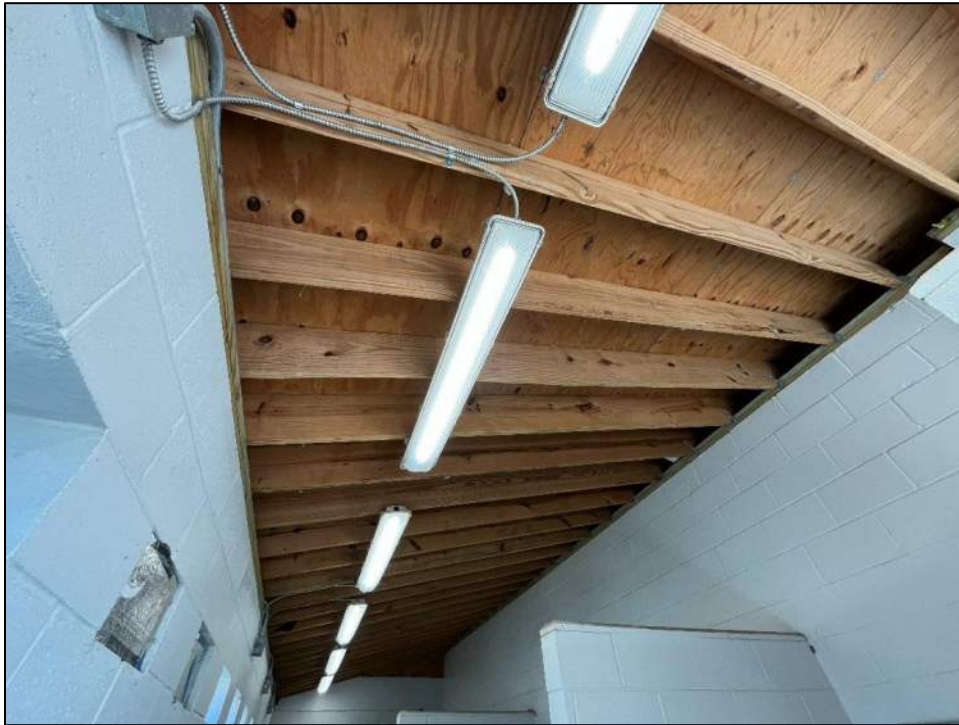
**Photo 38:** Restroom ceiling deck remained in sound conditions.

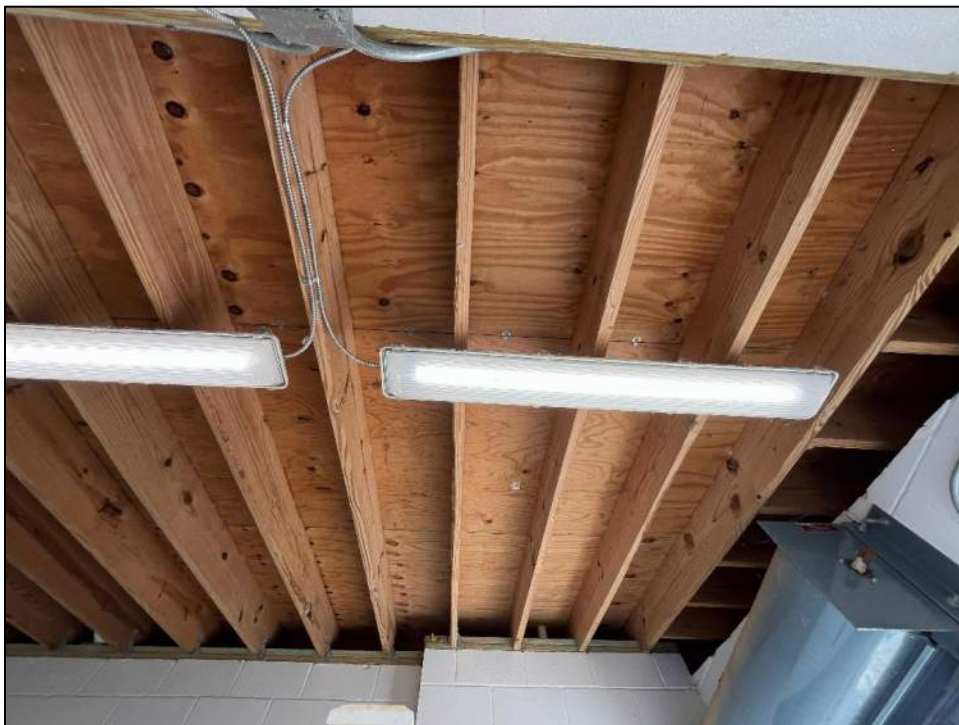
**Photo 39:** Plywood roof deck above the restroom were absent of recent moisture stains.

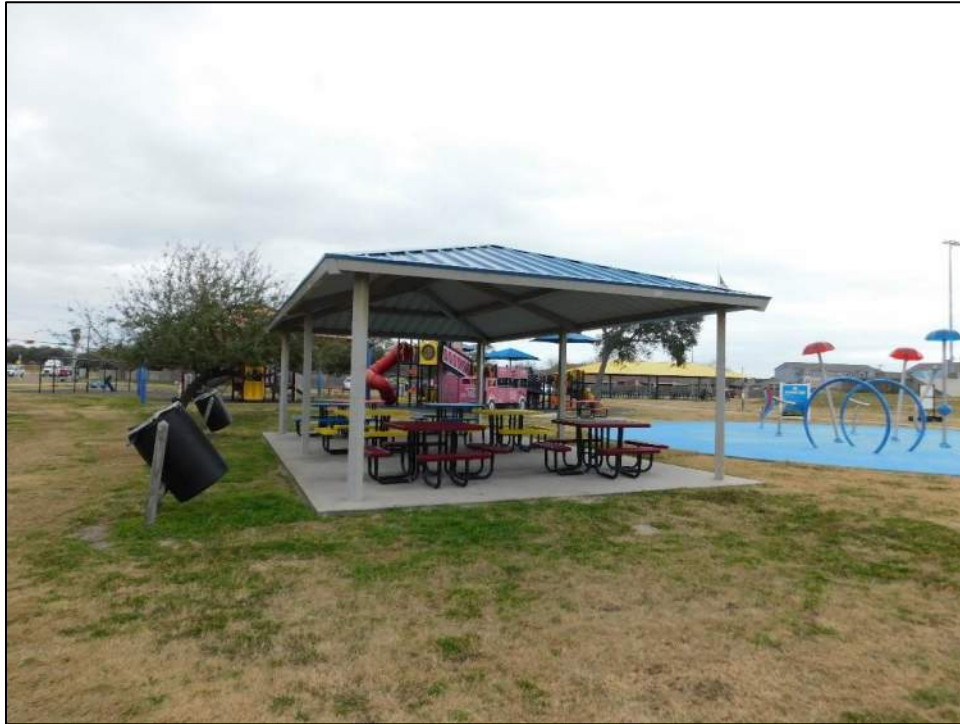
**Photo 1:** East elevation of the splashpad pavilion.

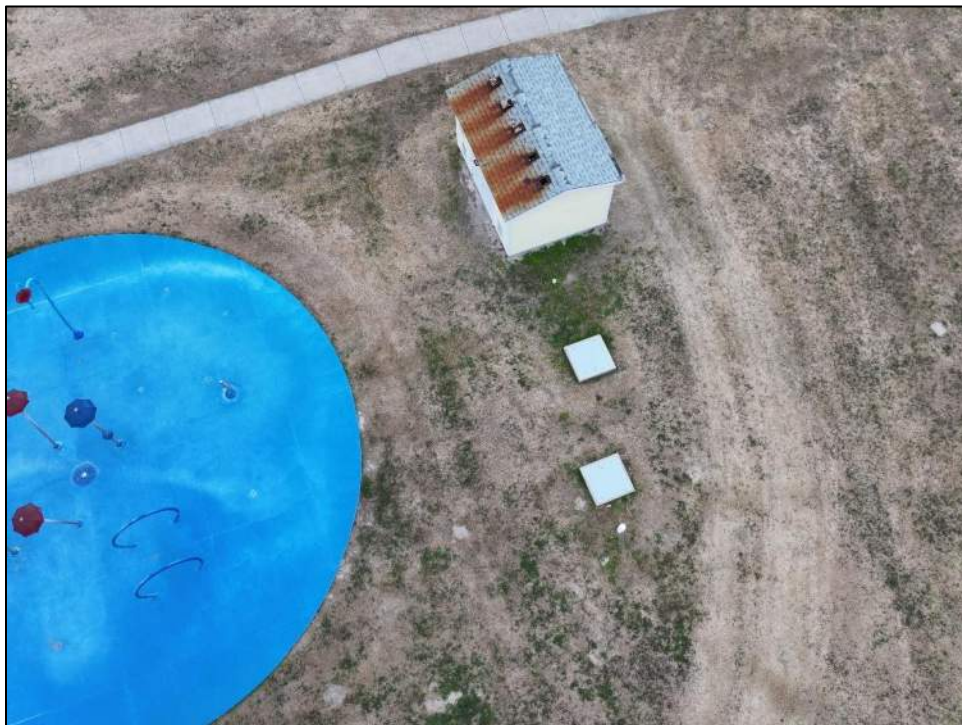
**Photo 6:** Deteriorated tool shed west of the splashpad.

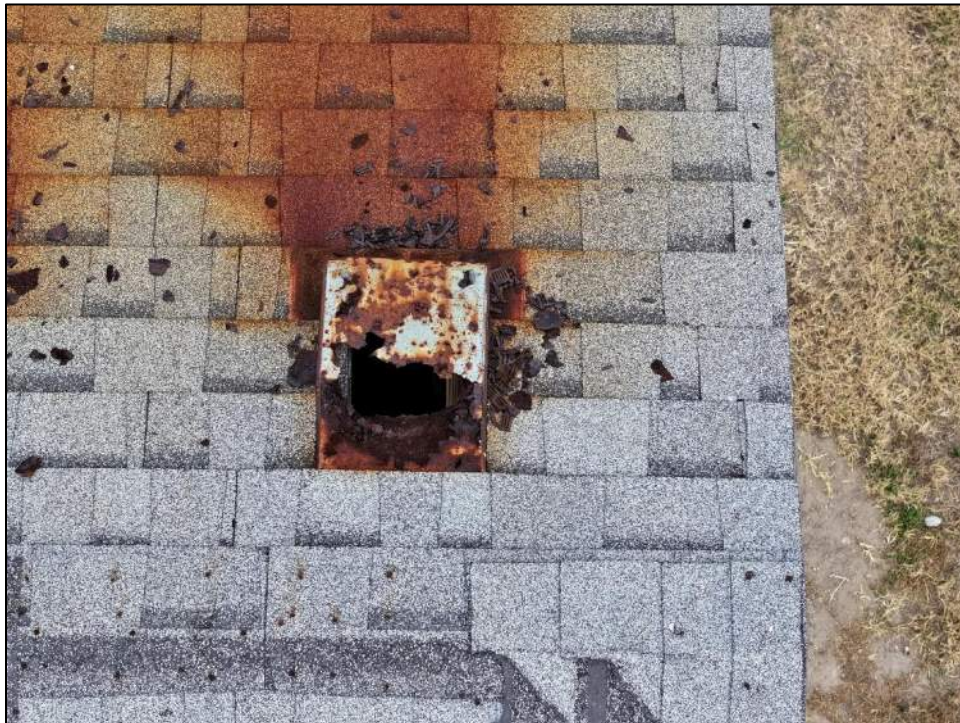
**Photo 8:** Deteriorated ridge vents.

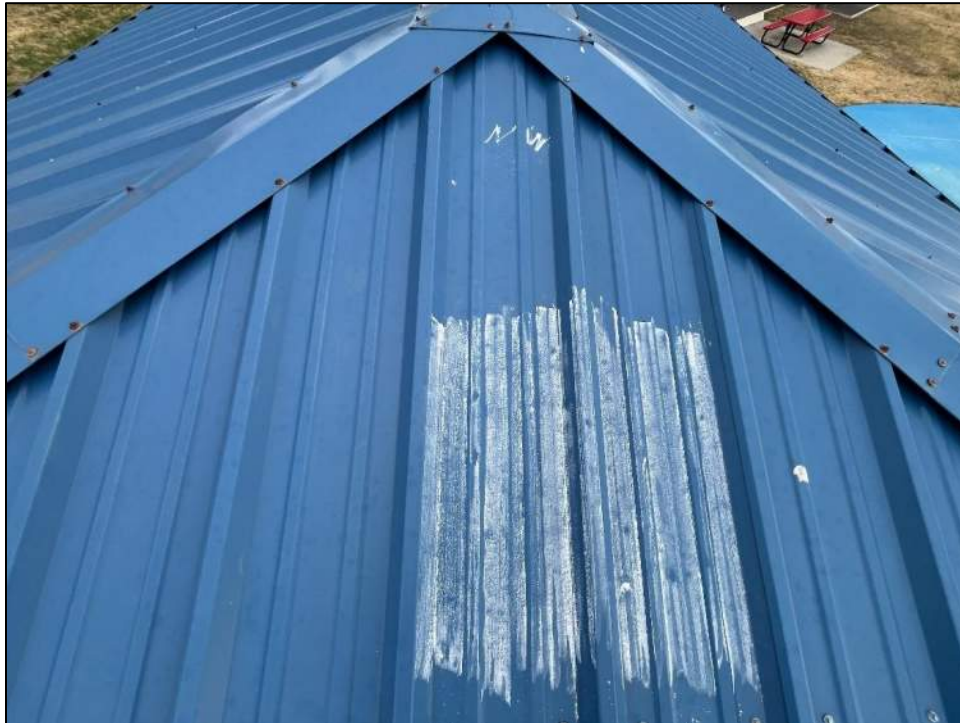
**Photo 13:** Hail spatters and denting observed on west slope indicative of 1-inch hail.

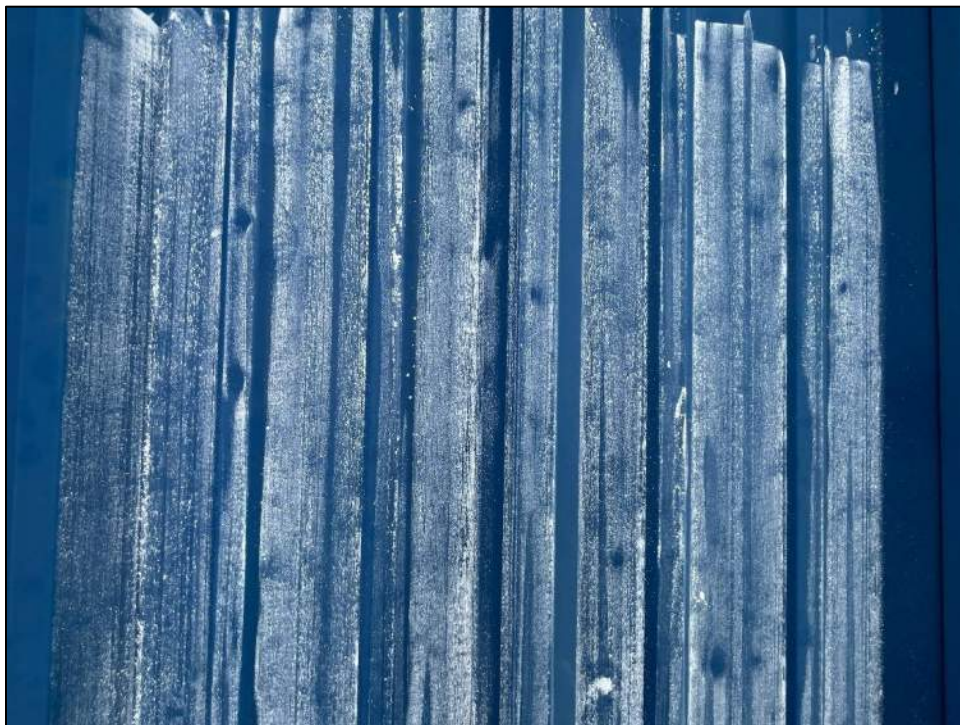
**Photo 14:** Close-up of the hail denting. The dents were generally shallow with an inner diameter of less than 3/8 inch.

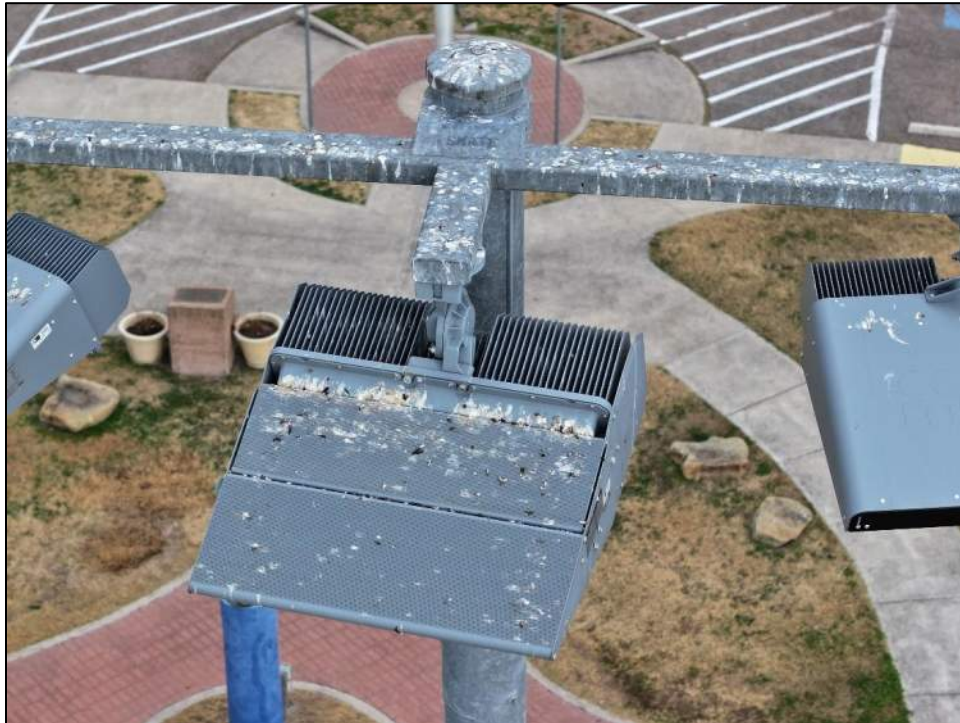
**Photo 23:** Nearby pole lights were not factured or dented.

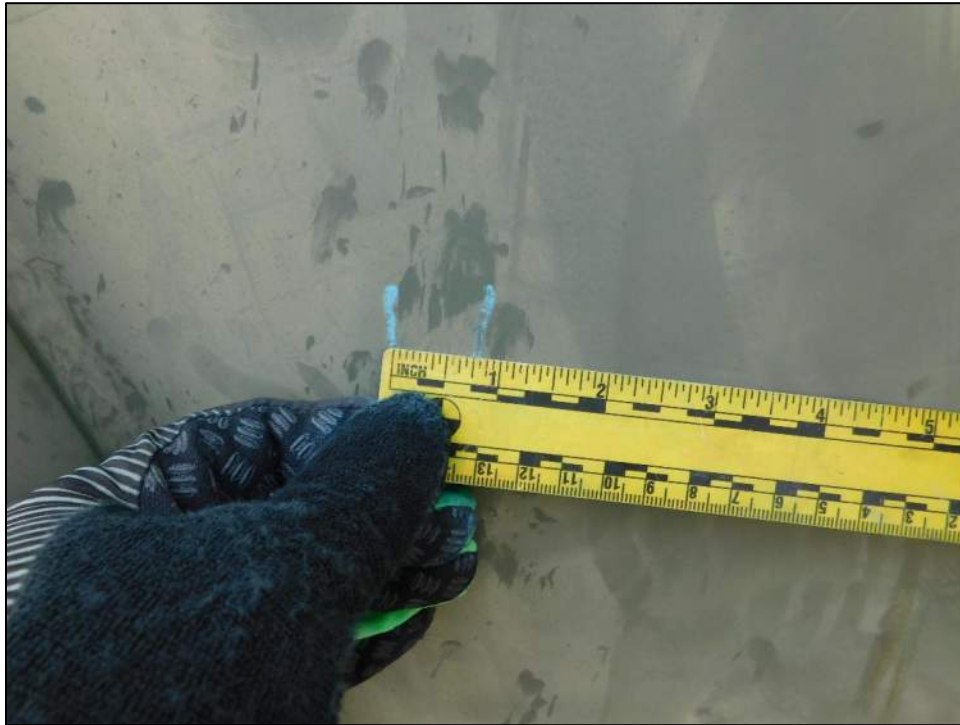
**Photo 29:** Hail spatters consistent with 0.75- to 1.0-inch hail on west-facing surfaces.

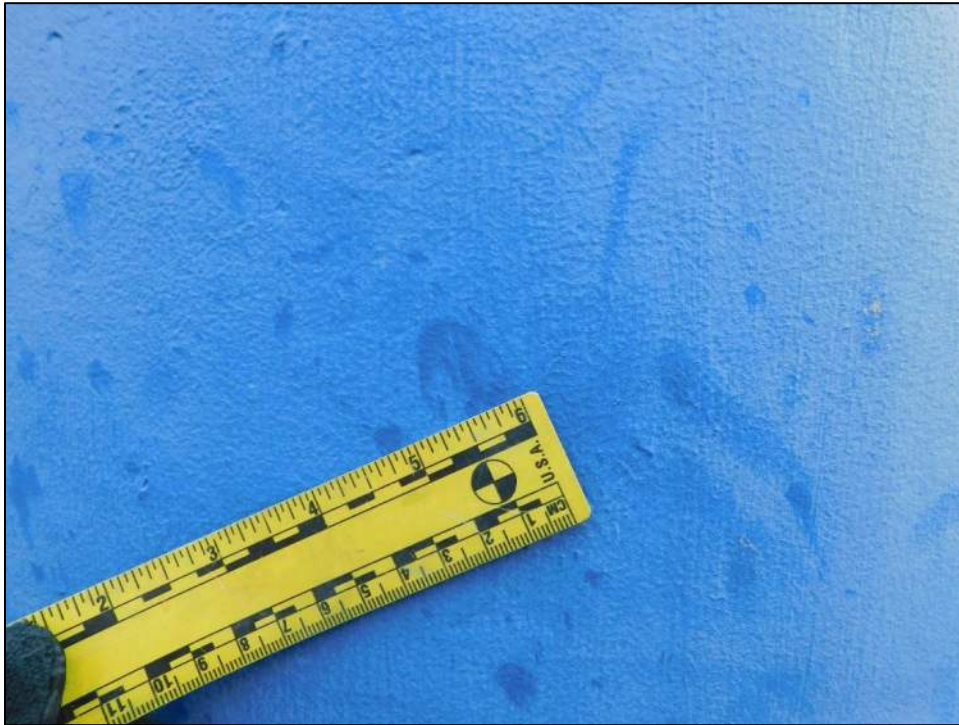
**Photo 31:** Hail spatters consistent with 0.75- to 1.0-inch hail on west-facing concrete column surface.

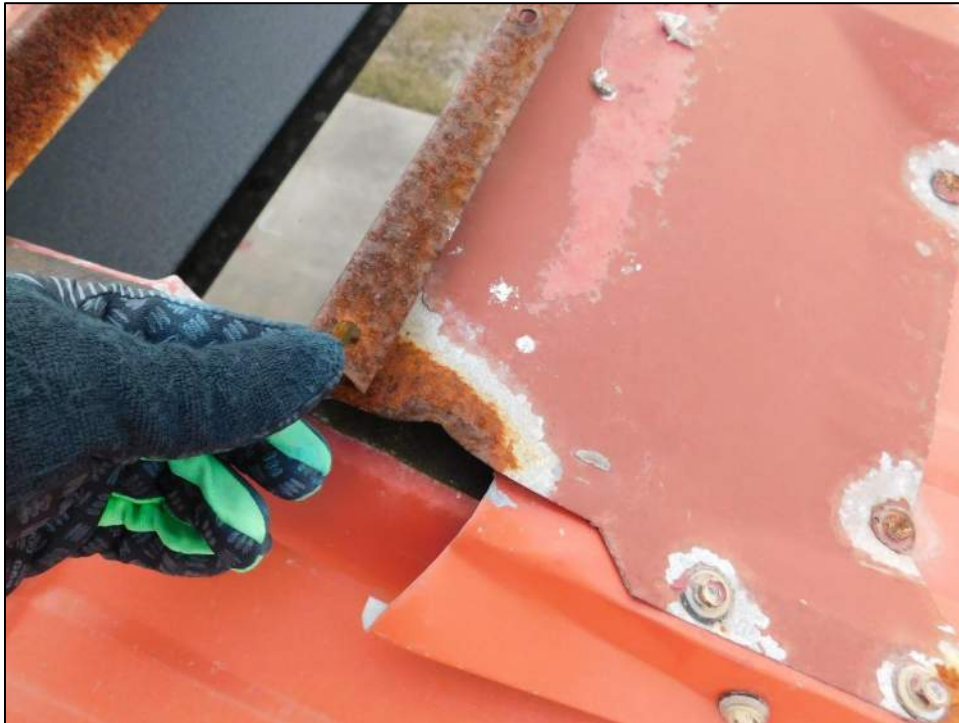
**Photo 34:** Corroded ridge vent curb.

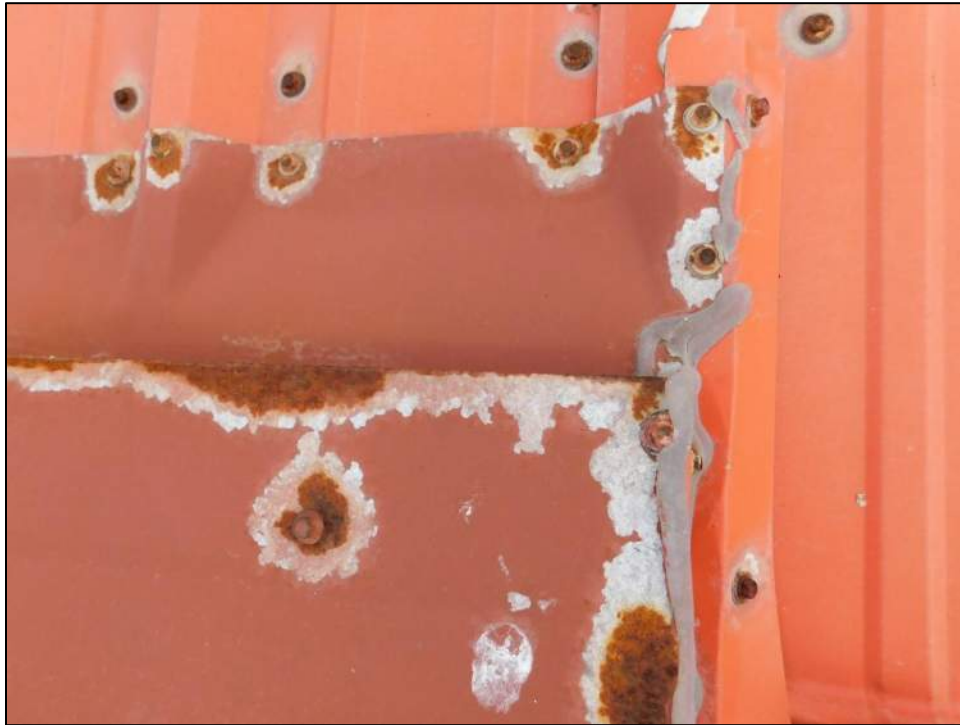
**Photo 36:** Widespread steel corrosion along other ridge vents.

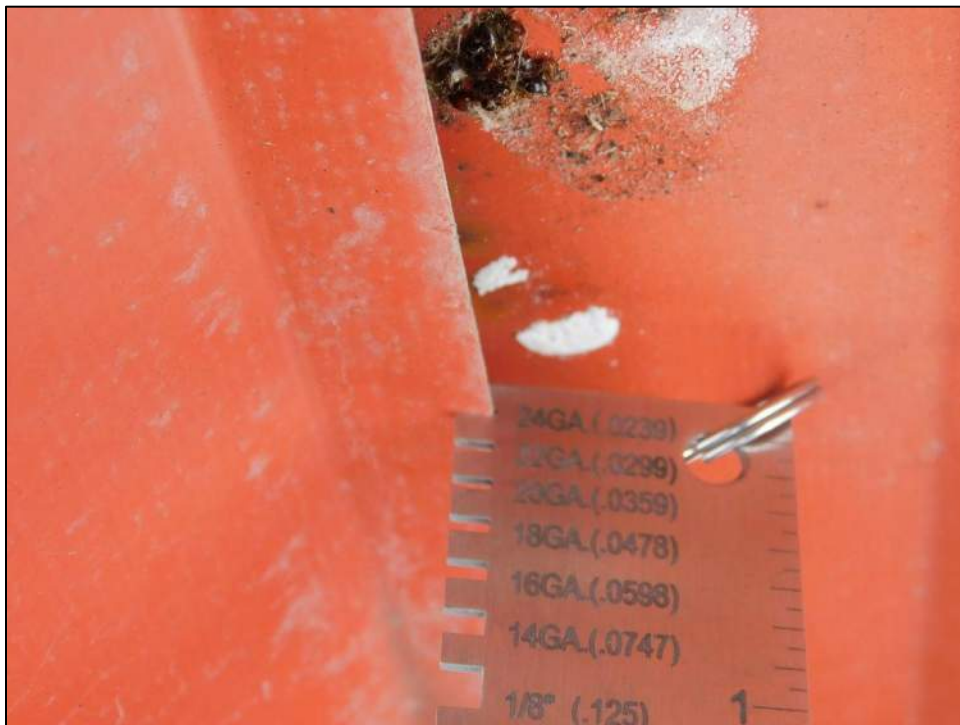
**Photo 37:** 24 Gas metal thickness.

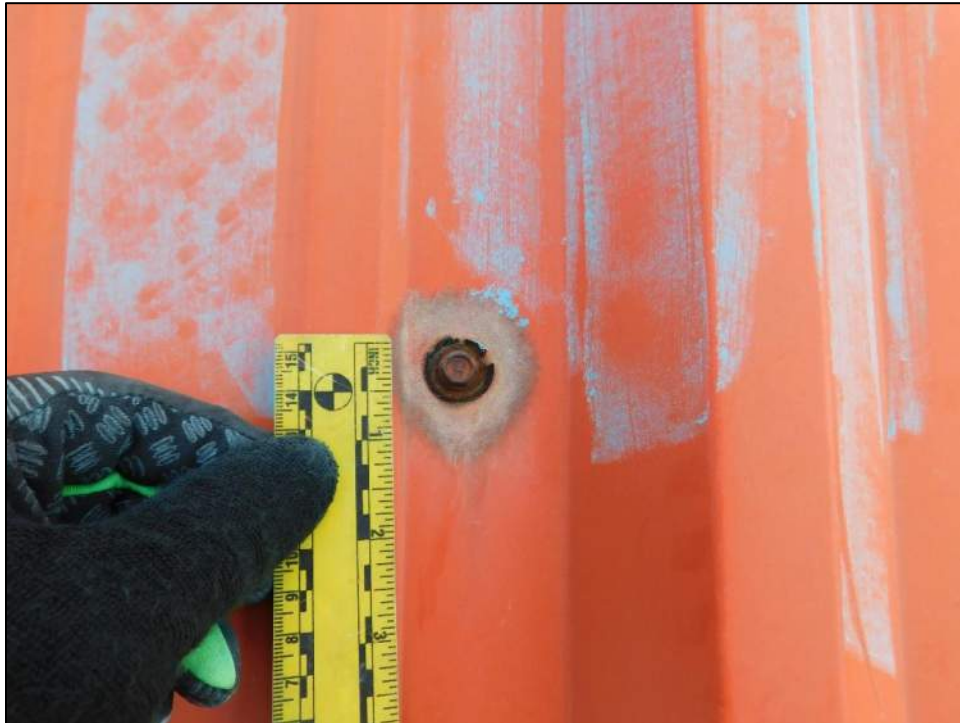
**Photo 44:** Typical fastener corrosion unrelated to hail impacts.

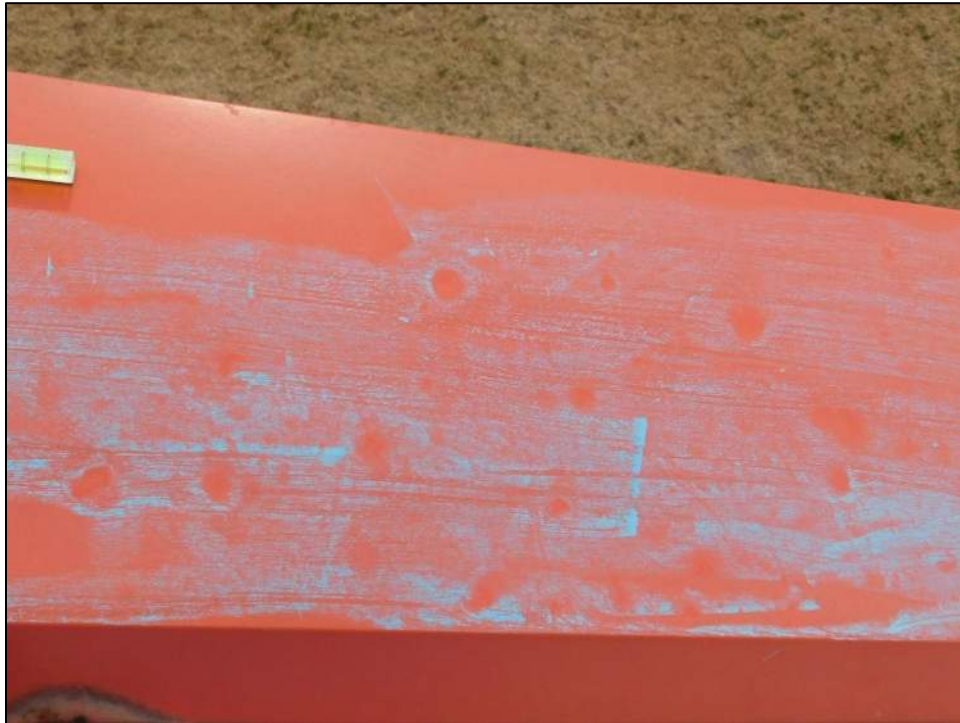
**Photo 50:** Indentations on gable end rake closures were dented absent of coating disruptions.

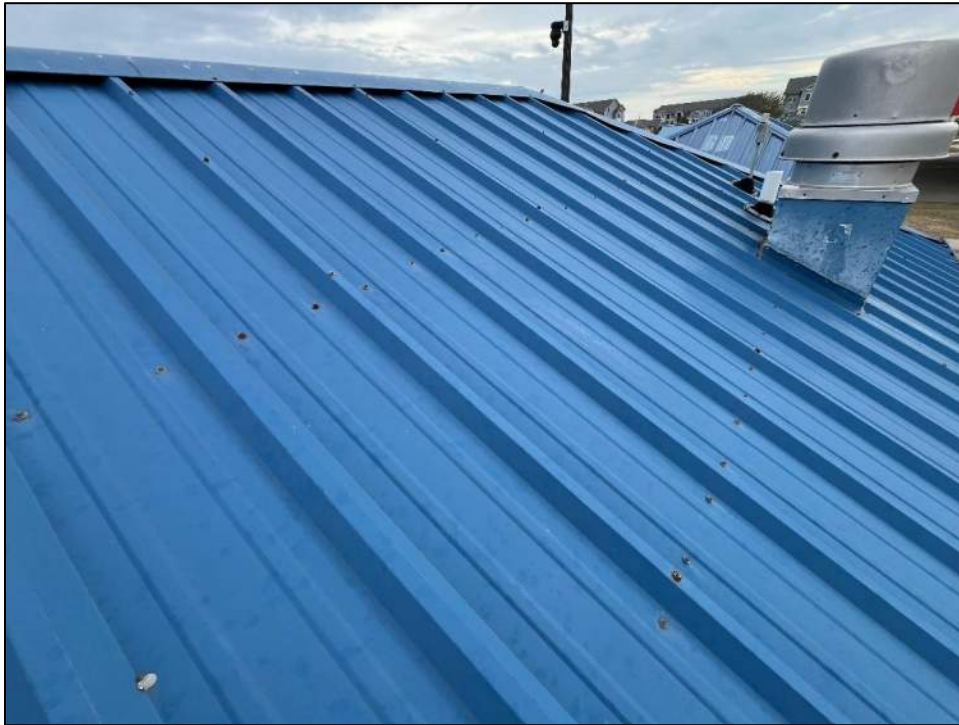
**Photo 68:** West slope. Note widespread fastener corrosion.
