**CITY OF INGLESIDE  
REGULAR CITY COUNCIL MEETING  
AGENDA  
JUNE 9, 2026  
6:30 PM**

Report on November 01, 2025, Hailstorm Damage to City of Ingleside Buildings.

### Building Damage Analysis Survey and Report

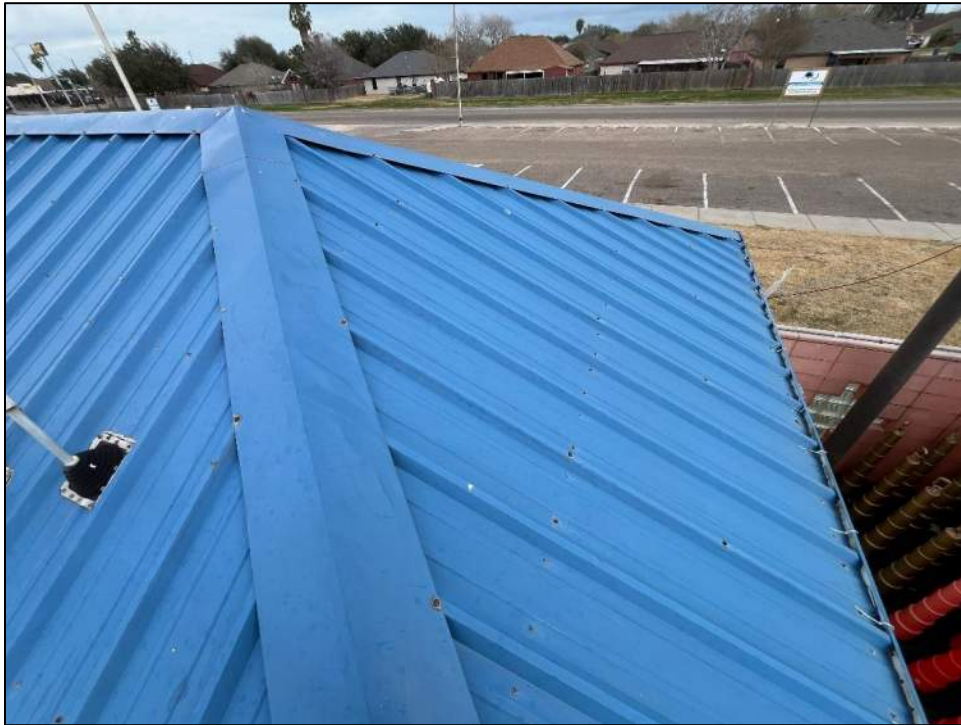
**Photo 70:** South slope. Note widespread fastener corrosion.

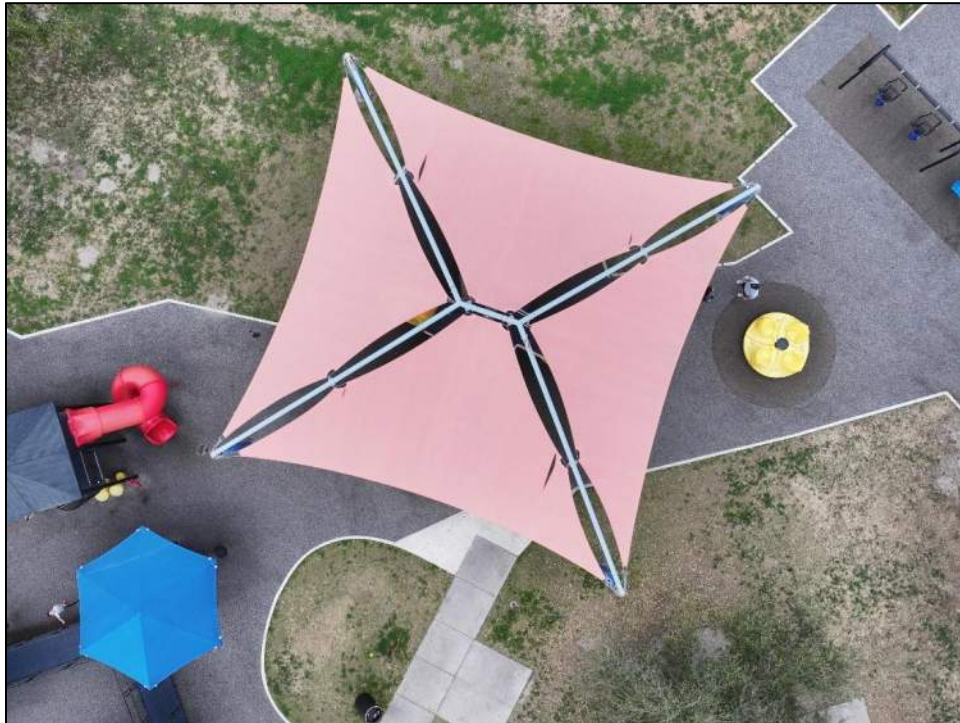
**Photo 97:** Top view of the HDPE fabric canopy. Note three tears at anchorage points.

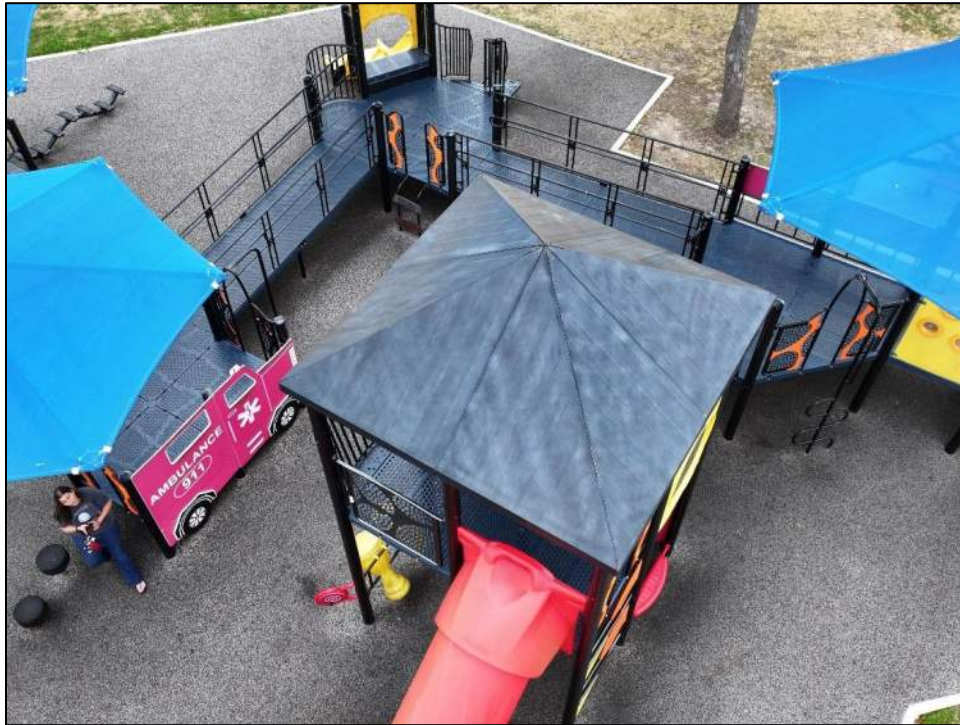
**Photo 103:** Top view of the playset metal roof.

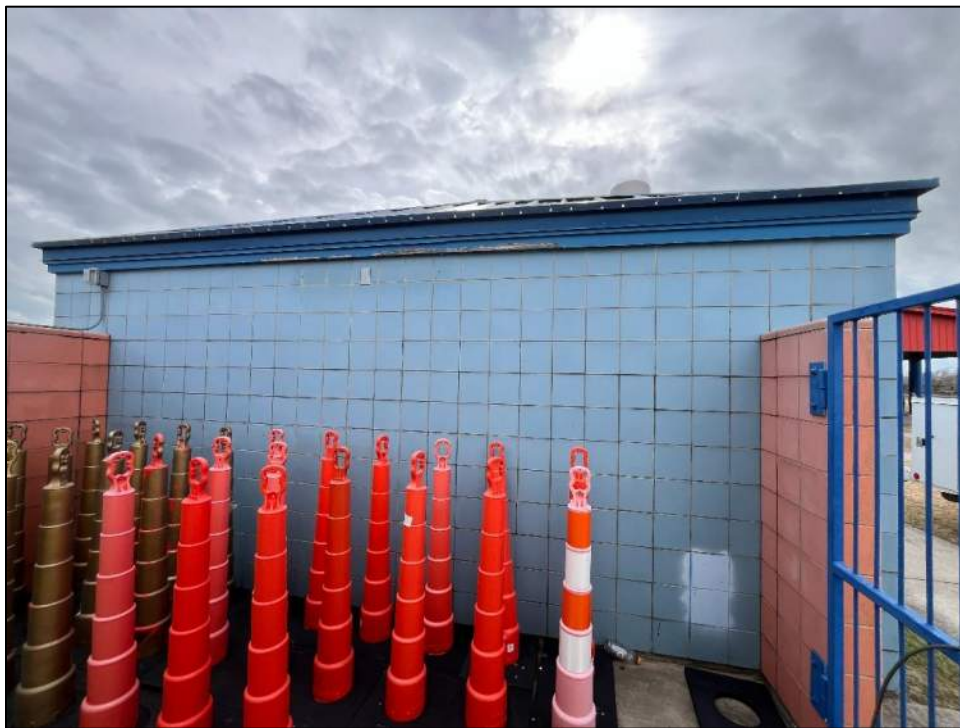
**Photo 124:** North (rear) elevation. No fractured tiles were observed.

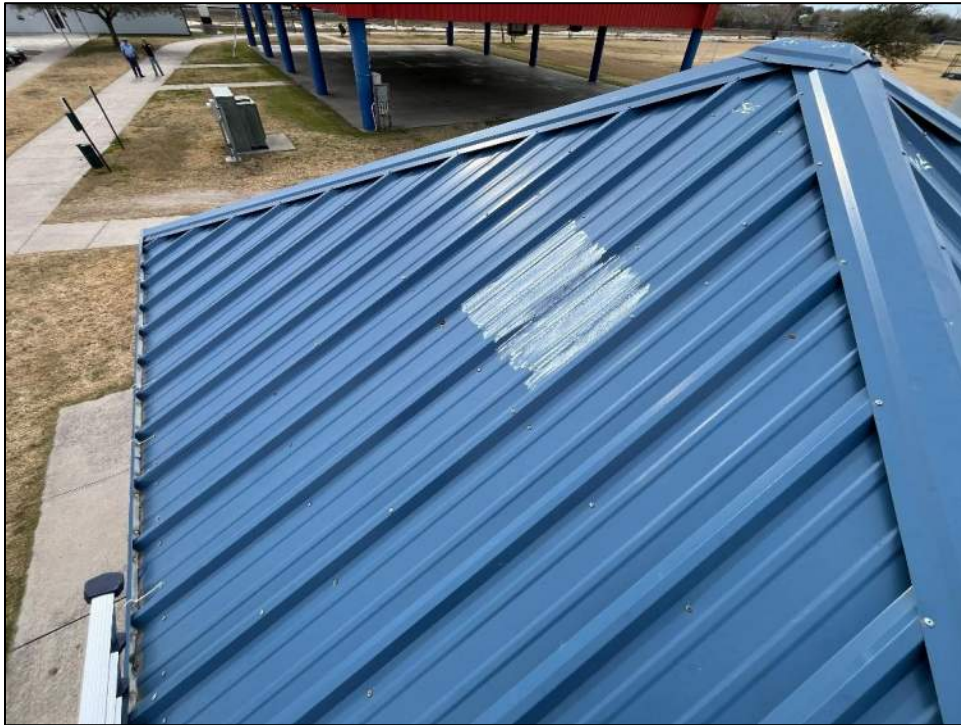
**Photo 125:** East slope. Eave closure remained intact.

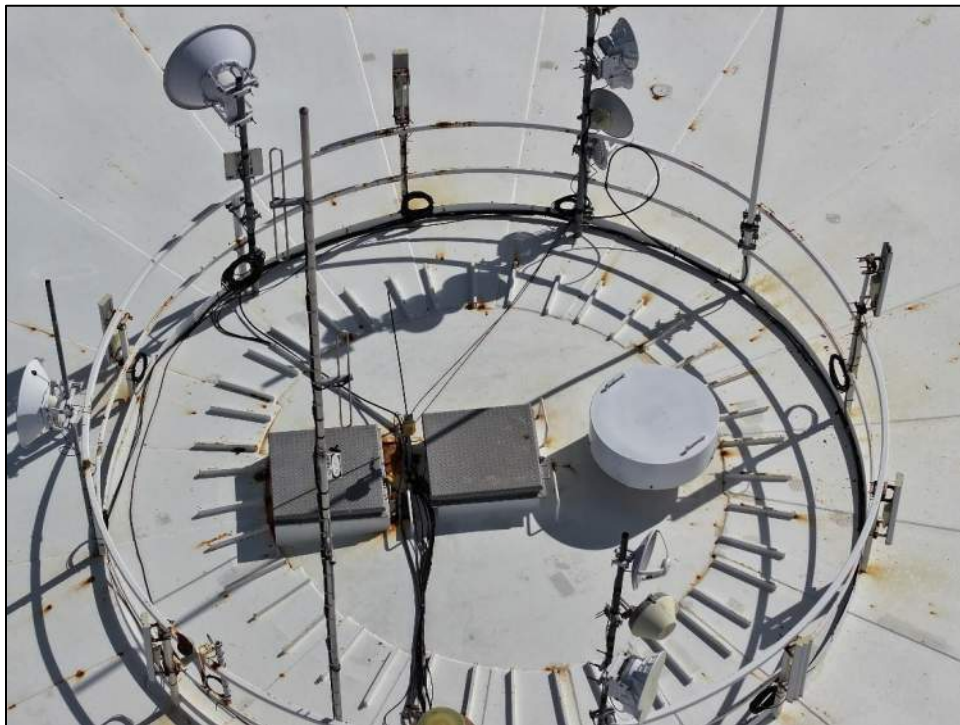
**Photo 2:** Rooftop appurtenance remained attached to the circular ring frame and upright.

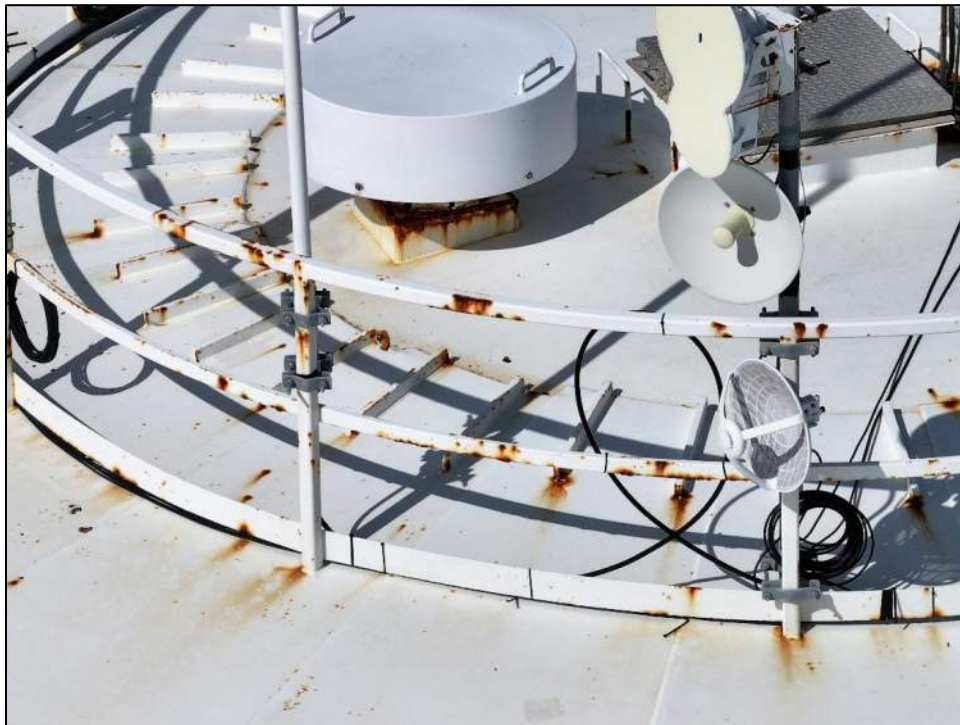
**Photo 3:** Typical corrosion of railing at rooftop.

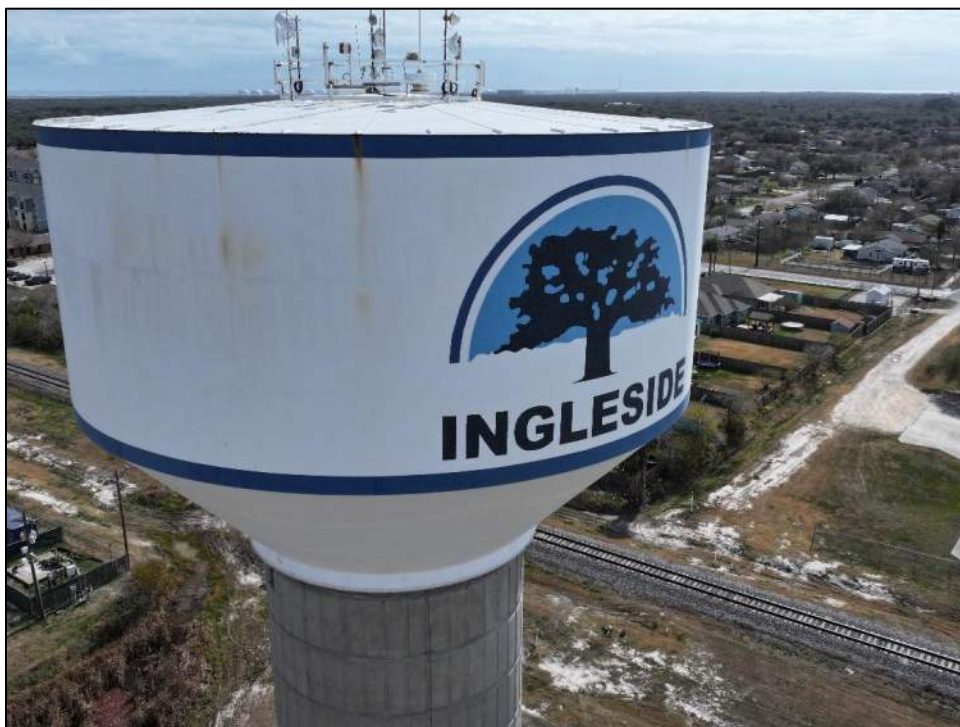
**Photo 4:** North elevation of the water tank.

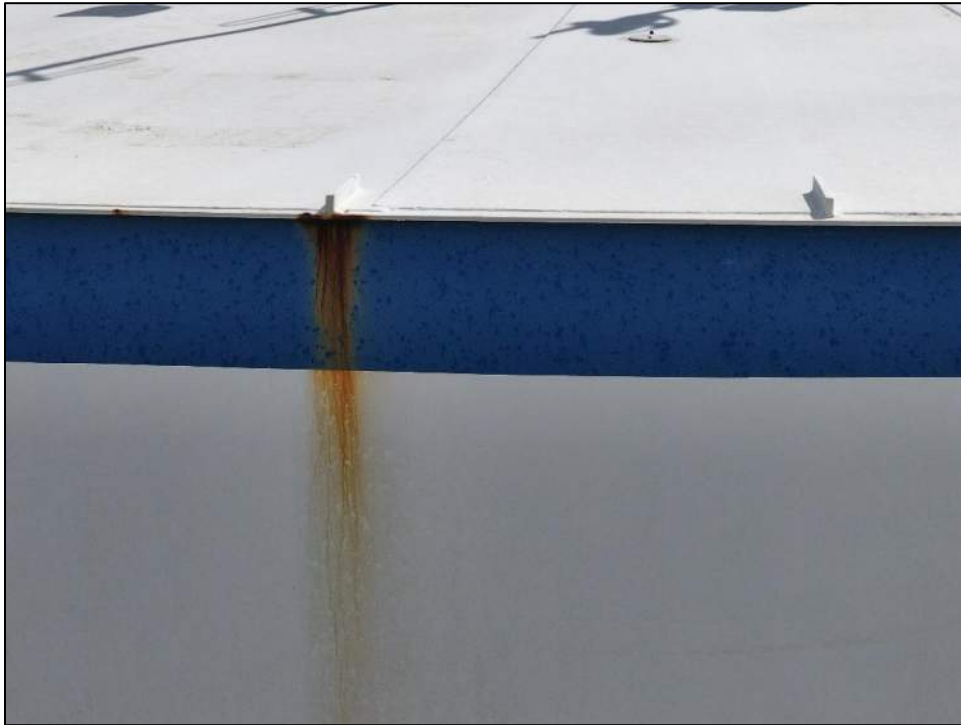
**Photo 5:** Hail spatter on tank wall and steel corrosion.

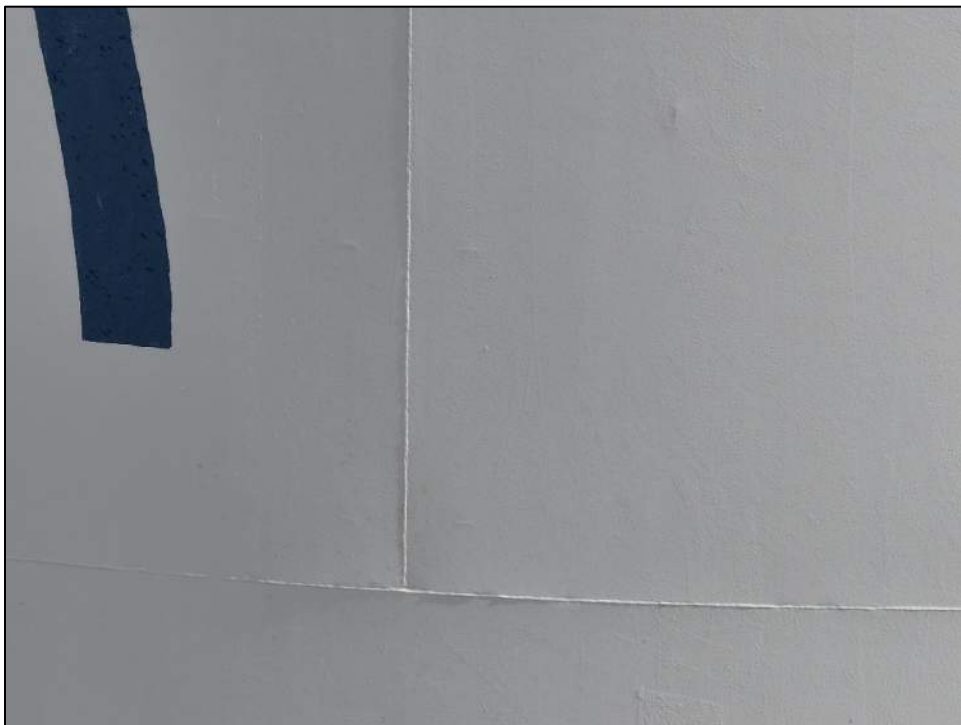
**Photo 6:** Wall surfaces remained intact from hail impact.

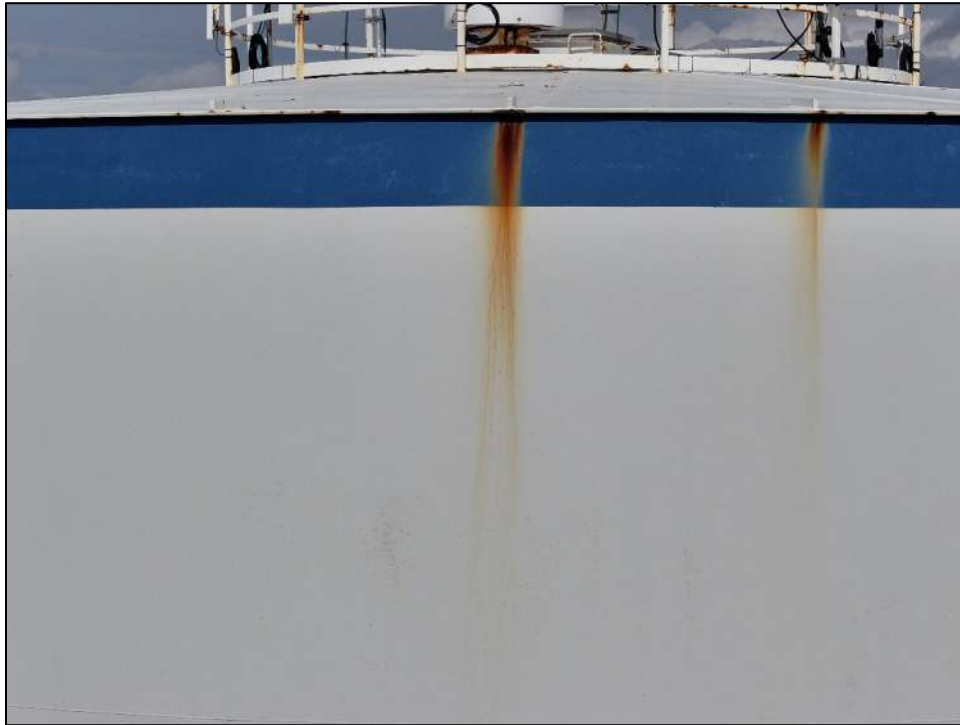
**Photo 7:** South elevation exhibited no hail spatters. Note steel corrosion.

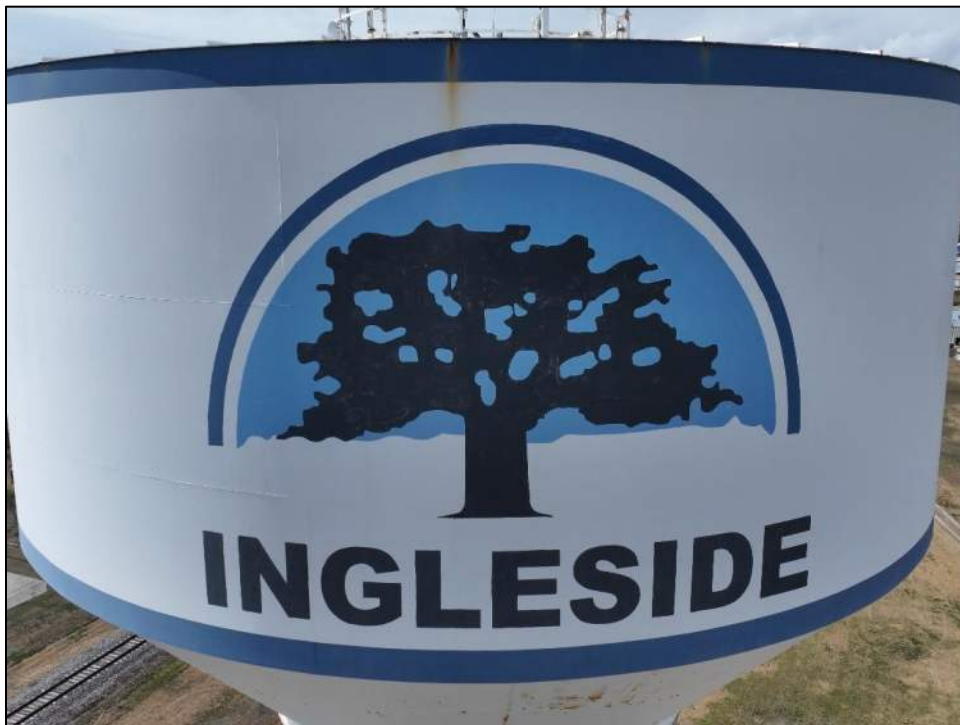
**Photo 8:** East-facing elevation remained intact.

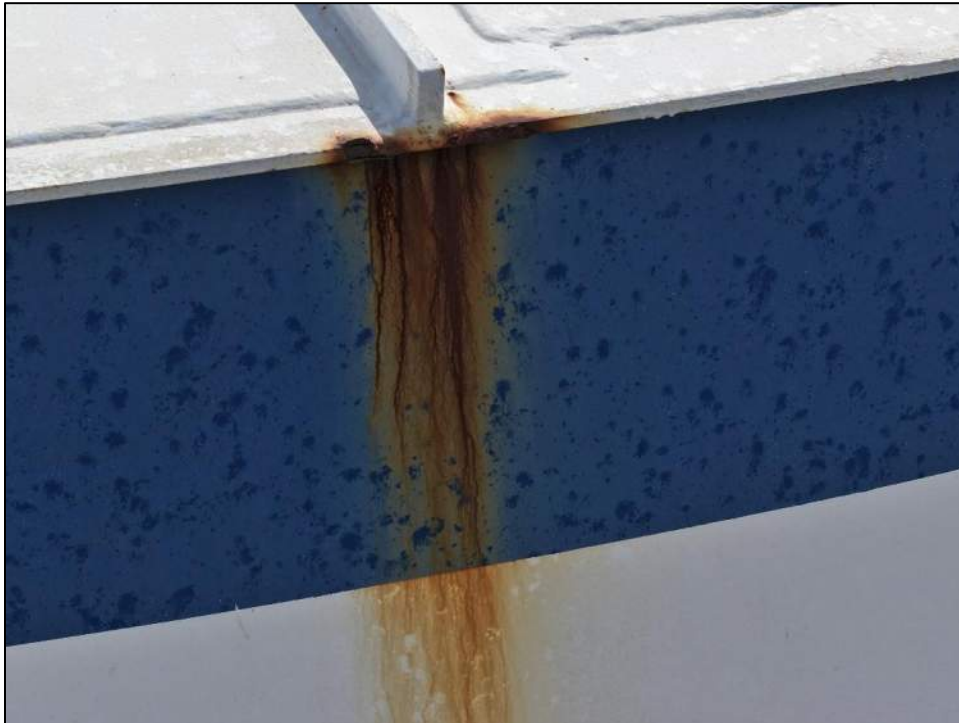
**Photo 9:** Close-up of West-facing tank wall with hail spatter marks consistent with approximately 1-inch hail. Note steel corrosion.

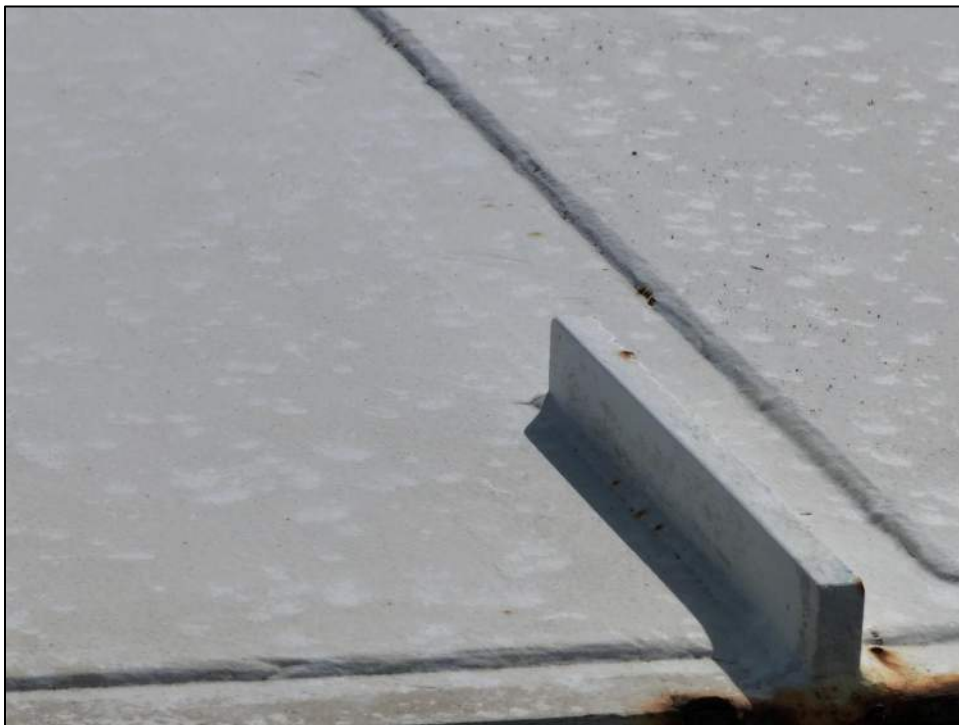
**Photo 10:** Rooftop spatters consistent with 1-inch hailfall.

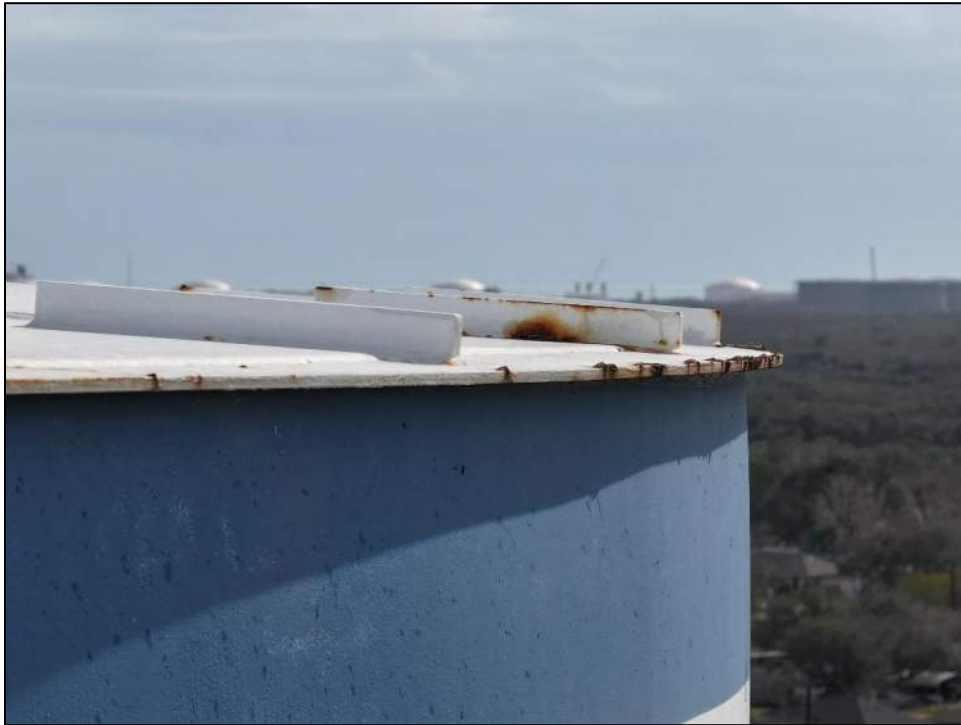
**Photo 11:** Tank roof plate was approximately 1/4-inch thick. Note edge corrosion.

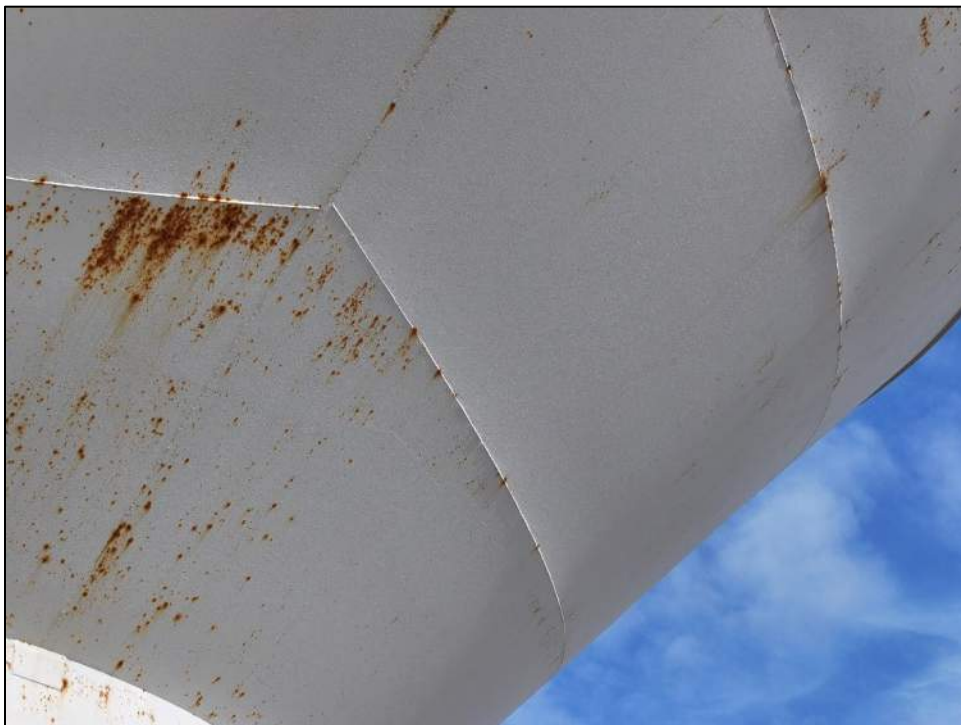
**Photo 12:** Rusting at surfaces of tank neck wall.

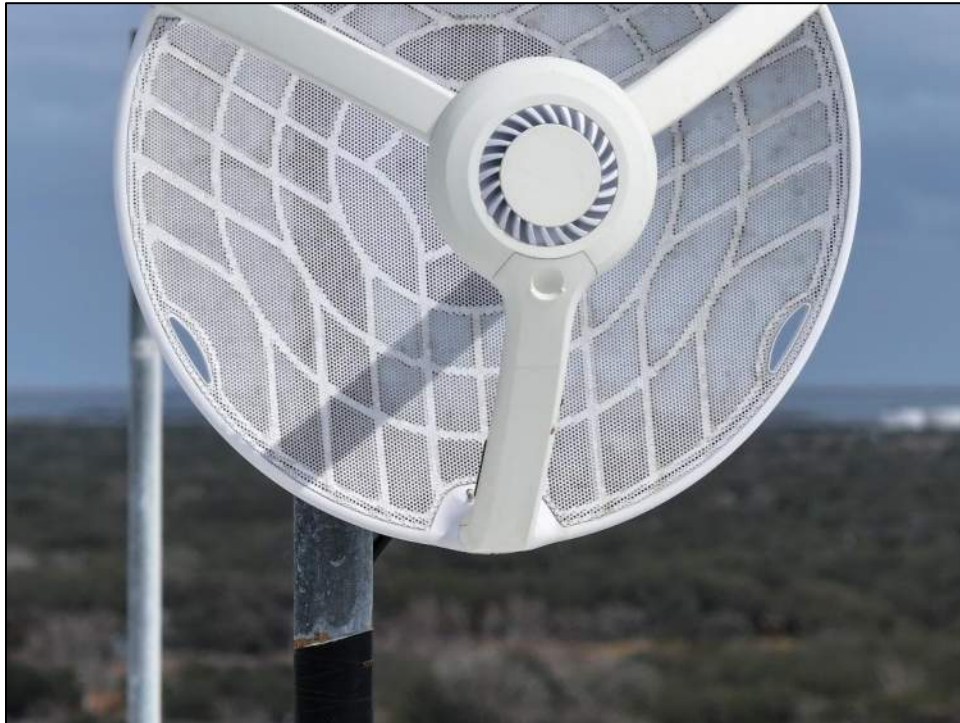
**Photo 13:** Rooftop appurtenances were not fractured by hail impact.

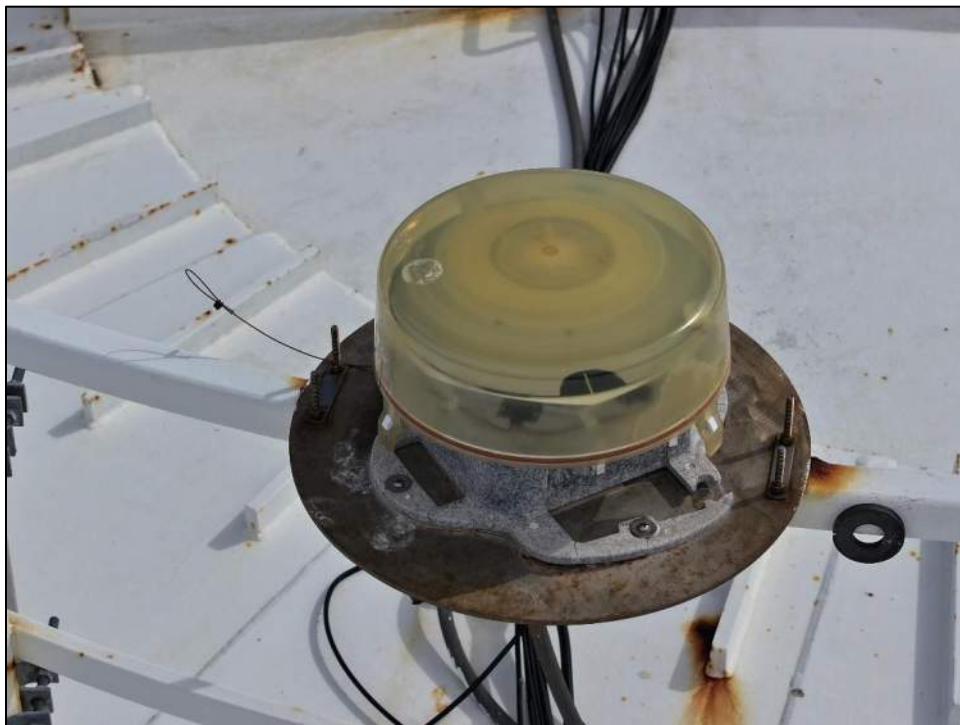
**Photo 14:** The polycarbonate casing of the aviation obstruction light were not fractured.

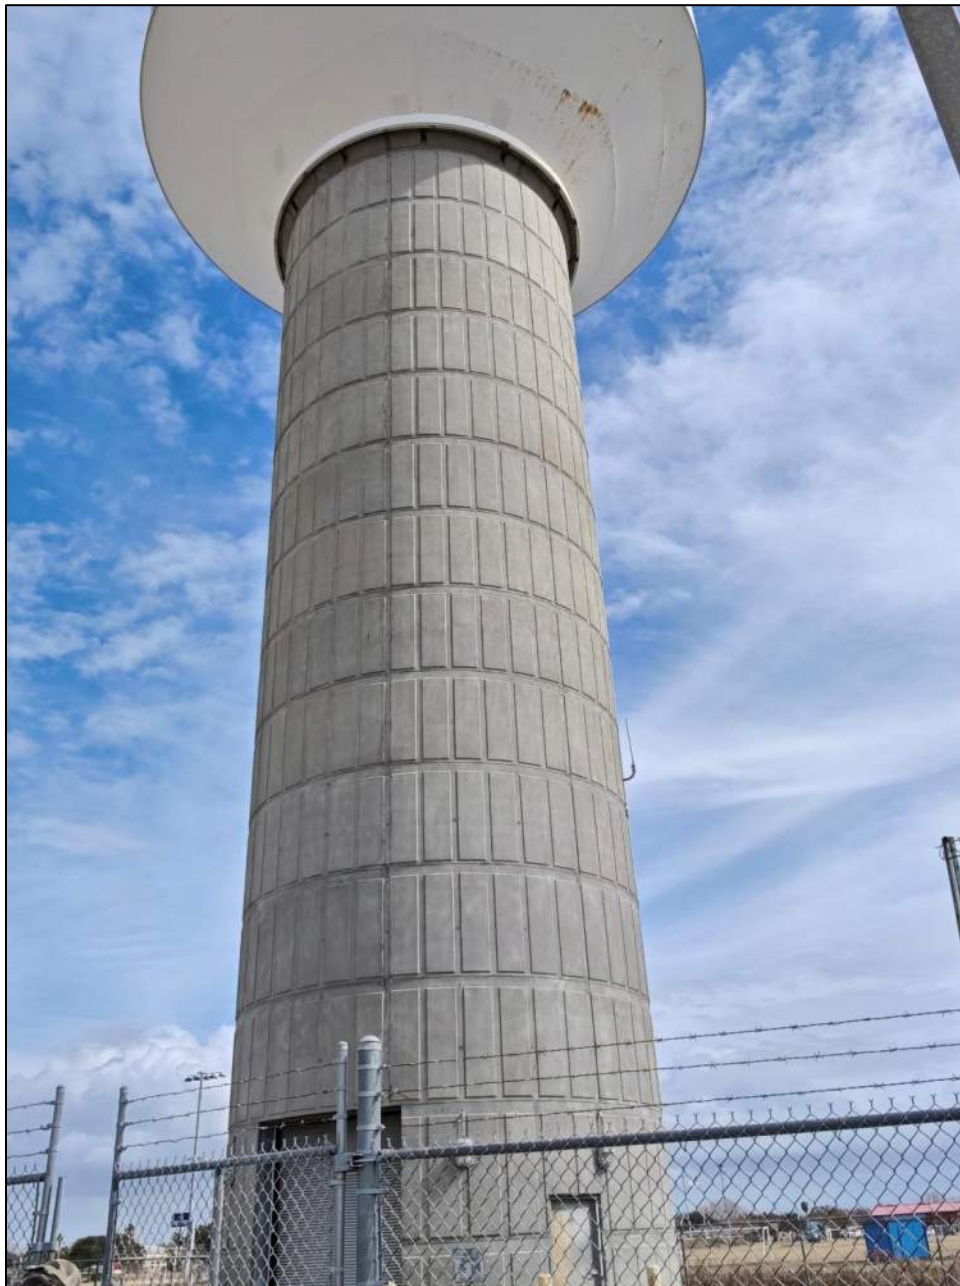
**Photo 15:** Overview of concrete pedestal of the water tower.

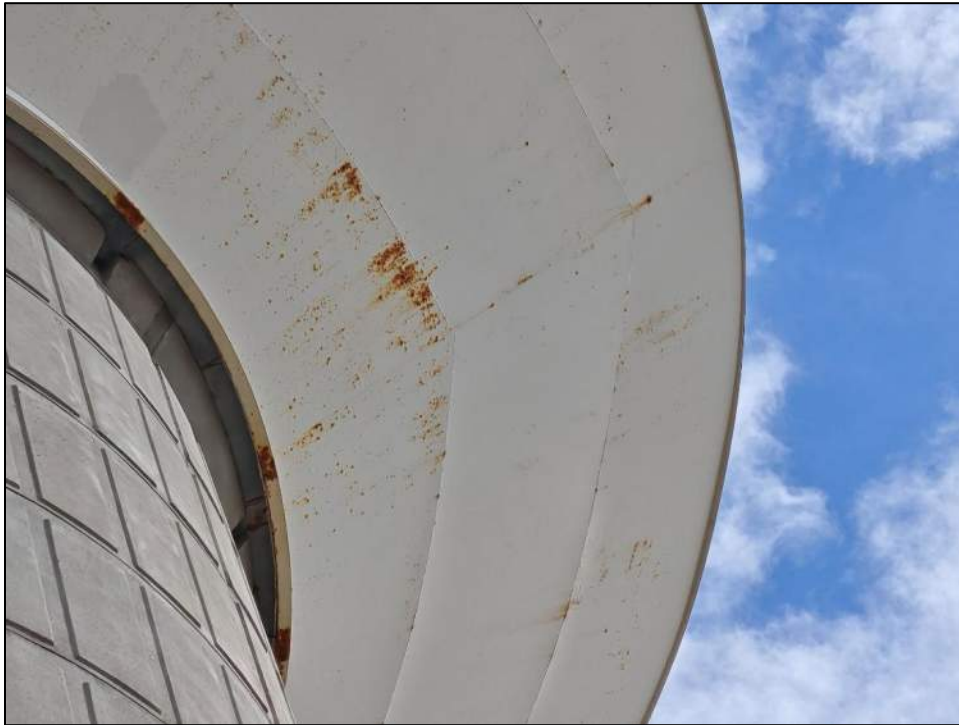
**Photo 16:** Underside of the tank bowl exhibited surface rusting.

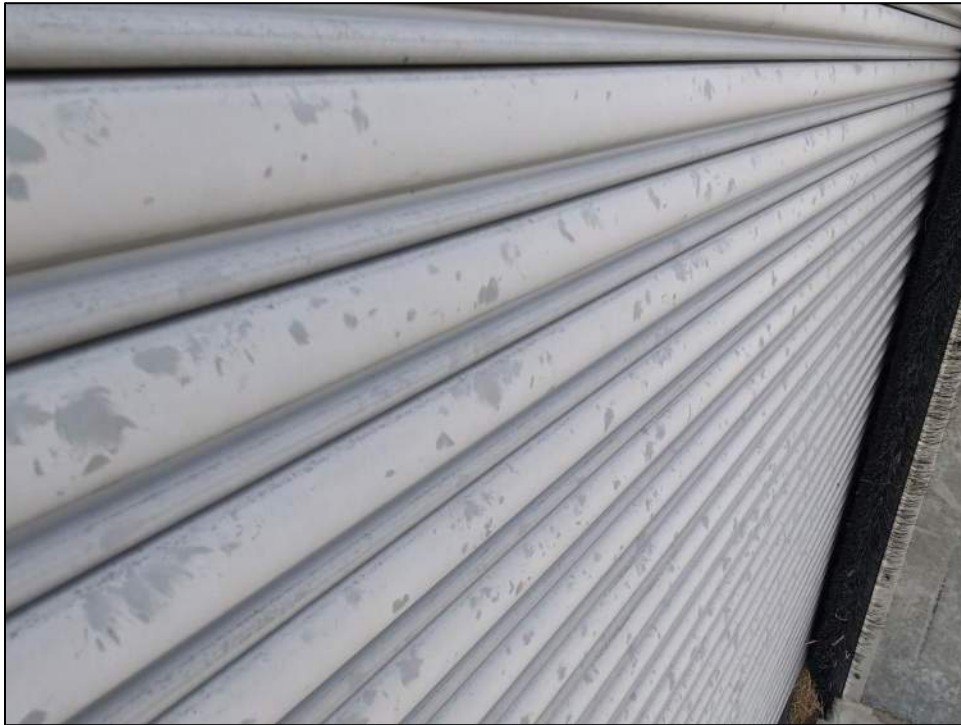
**Photo 18:** Hail spatters on the roll-up door were unaccompanied by indentations.

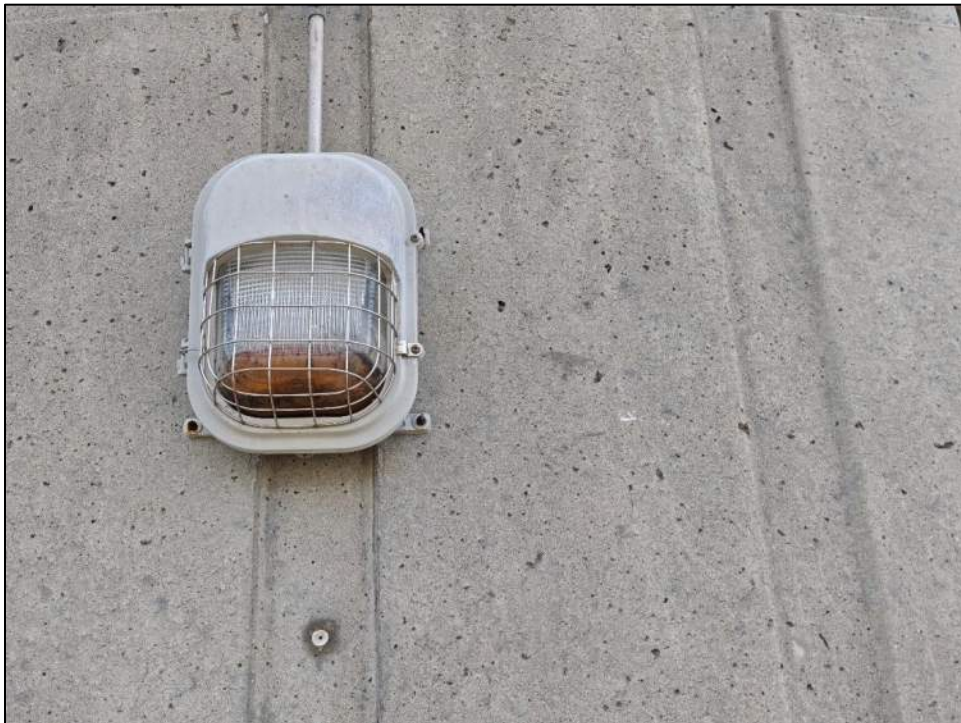
**Photo 19:** West-facing light fixture were not shattered.

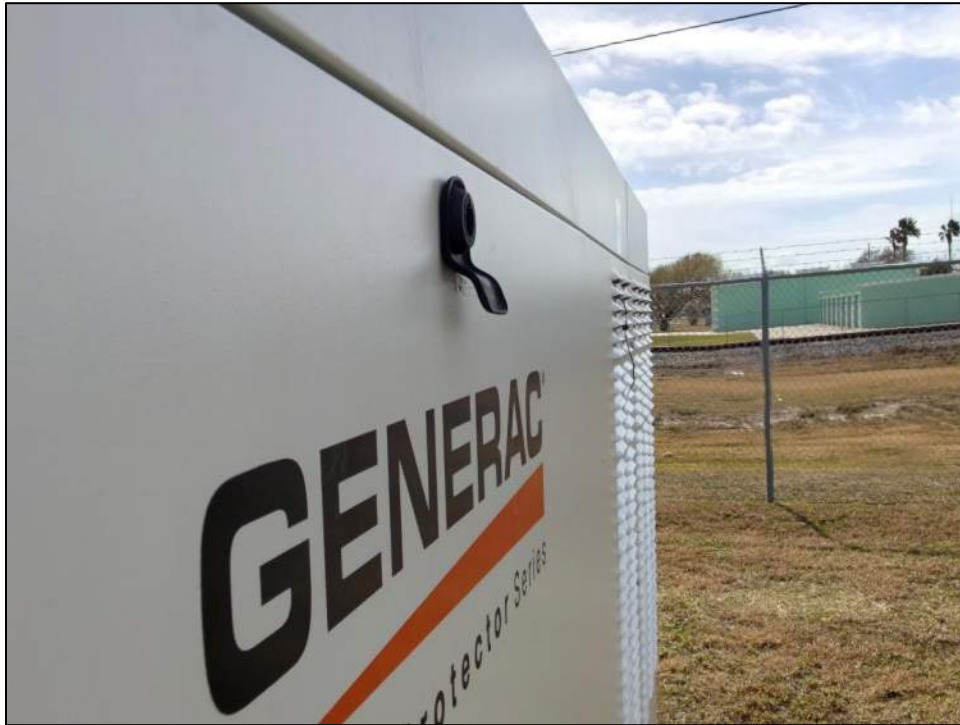
**Photo 20:** Ground-based generator wall casing remained free of denting.

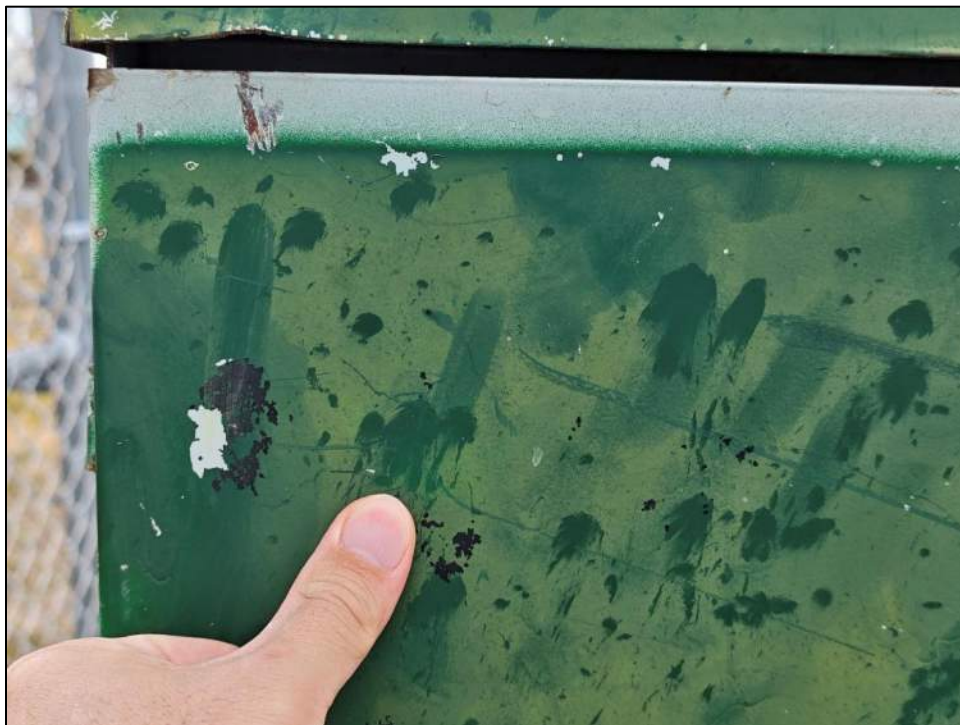
**Photo 21:** Hail spatters on nearby break panel box reflected approximately 1-inch hail.

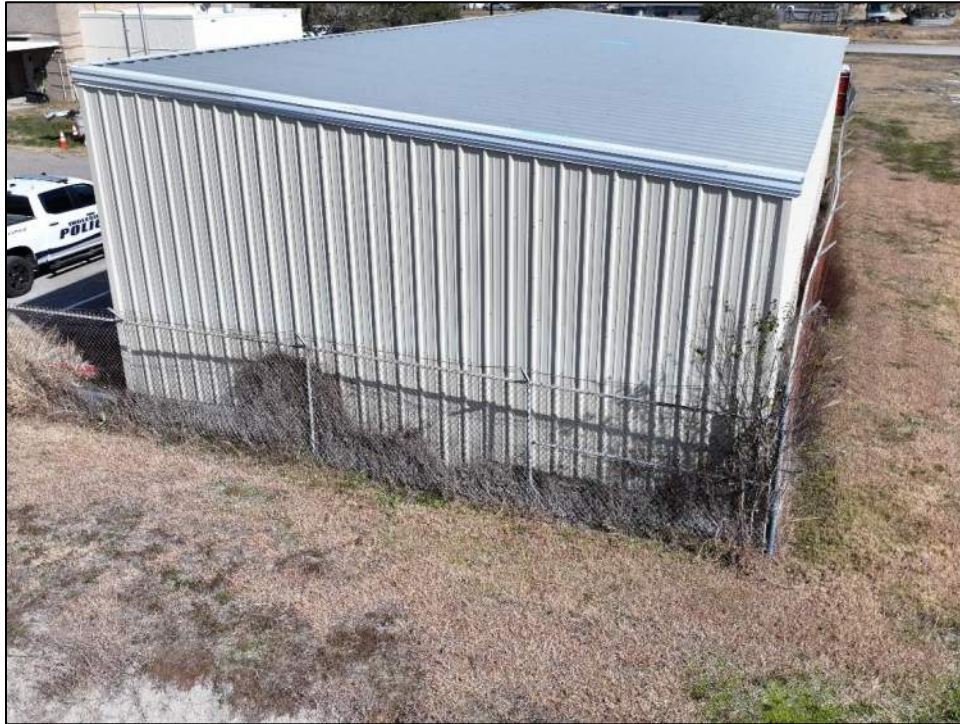
**Photo 1:** South (southwest) elevation of the police storage building.

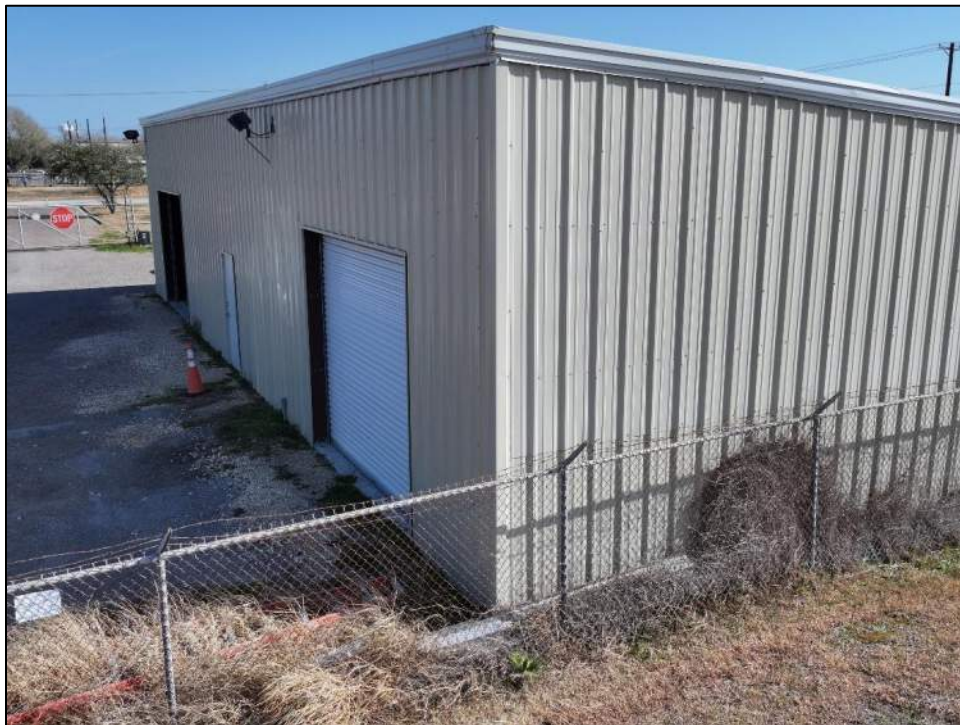
**Photo 2:** West elevation had 2 roll-up doors.

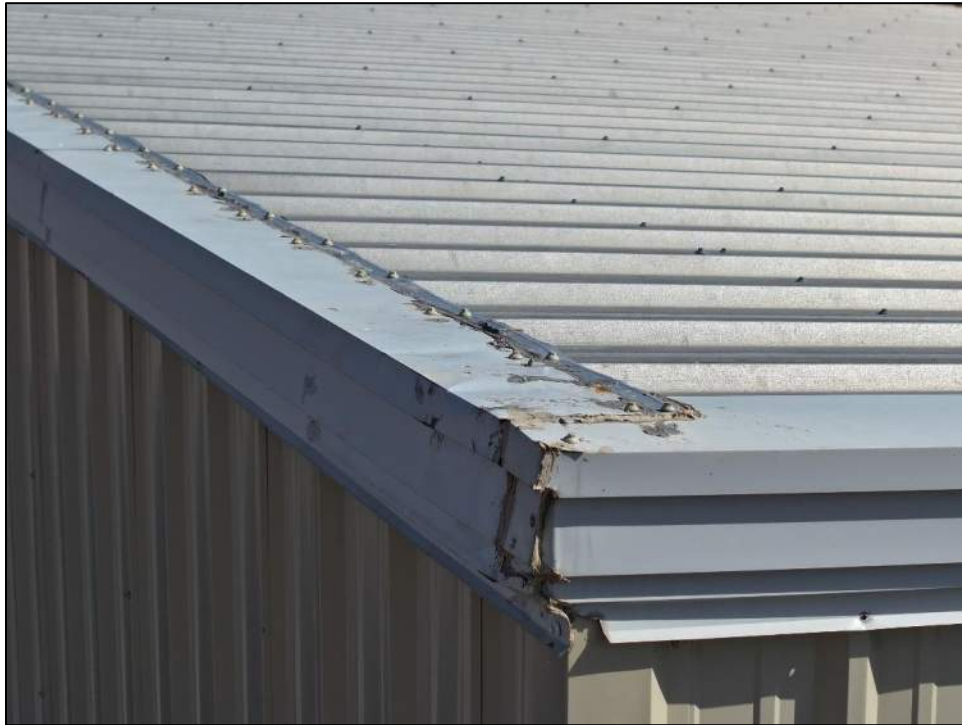
**Photo 3:** Sealant joints adjoining closure metals remained undisturbed.

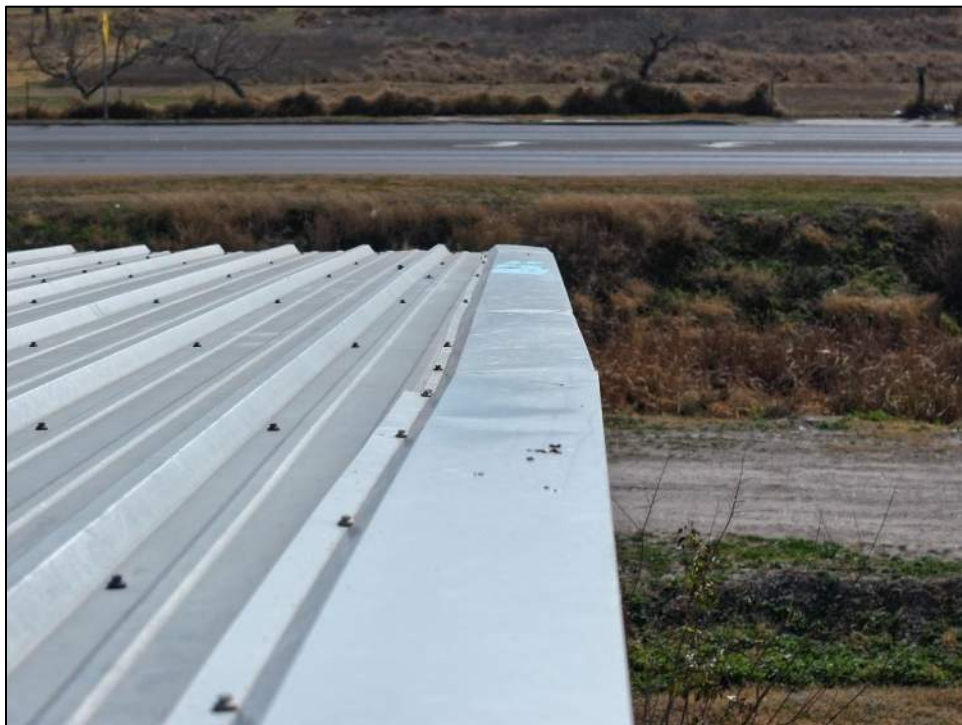
**Photo 4:** Hail denting visible on closure trim.

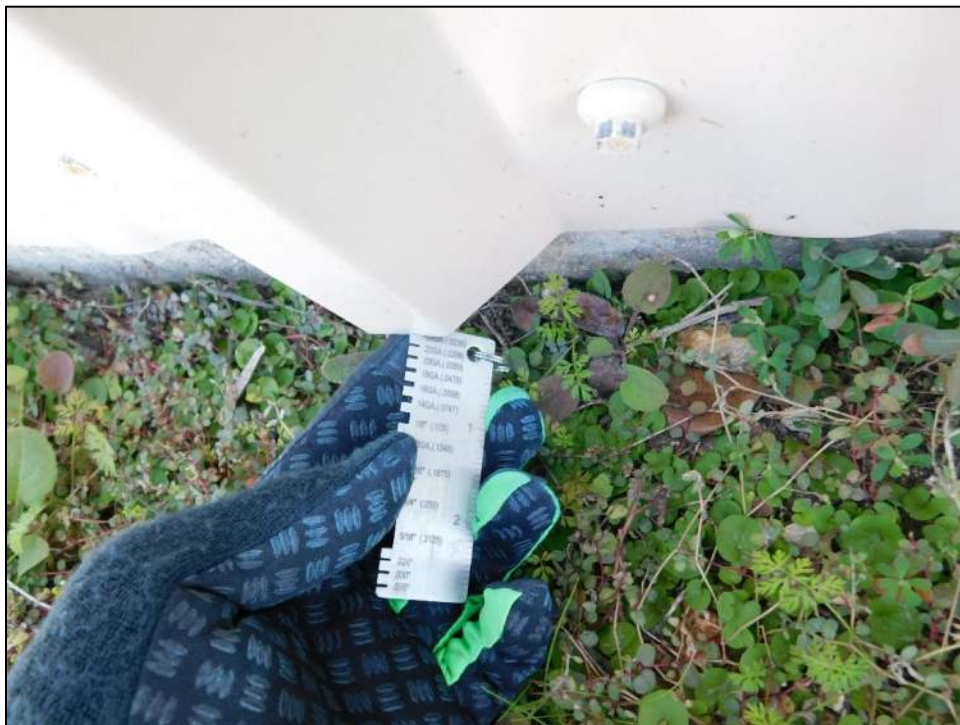
**Photo 8:** 24 gauge wall panels.

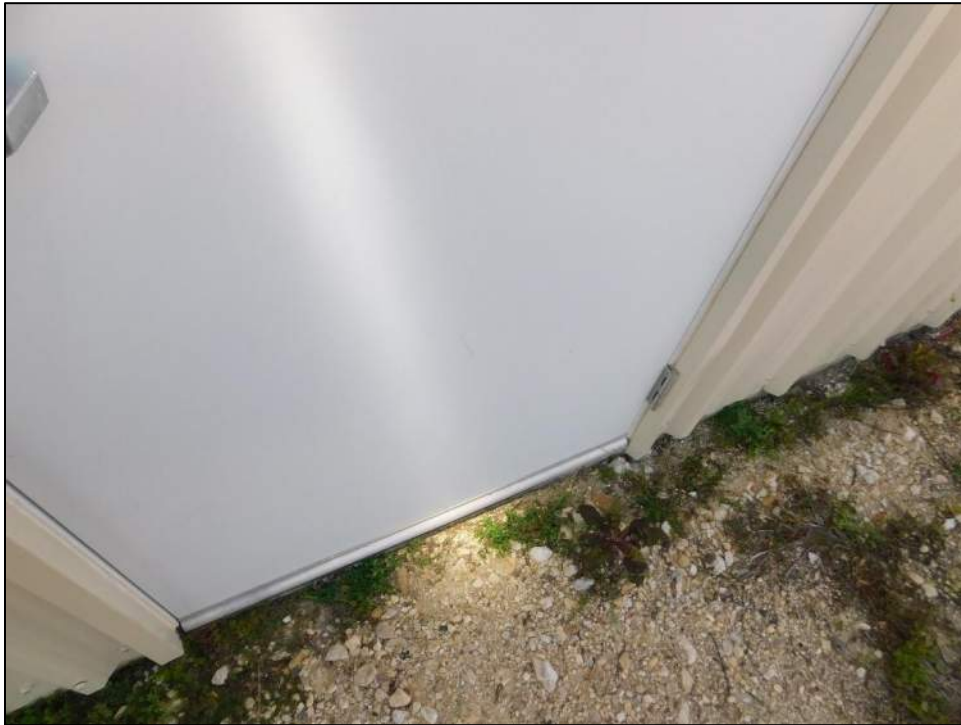
**Photo 9:** No hail denting on west-facing doors.

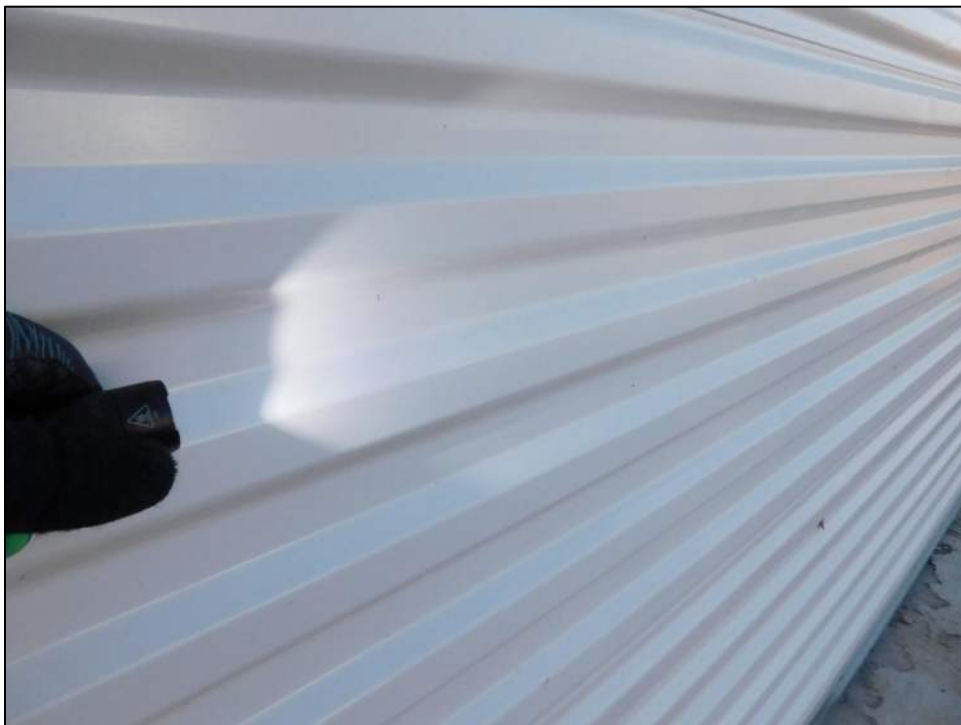
**Photo 10:** No hail denting on upper portion of roll-up doors.
