**CITY OF INGLESIDE  
REGULAR CITY COUNCIL MEETING  
AGENDA  
JUNE 9, 2026  
6:30 PM**

Report on November 01, 2025, Hailstorm Damage to City of Ingleside Buildings.

### Building Damage Analysis Survey and Report

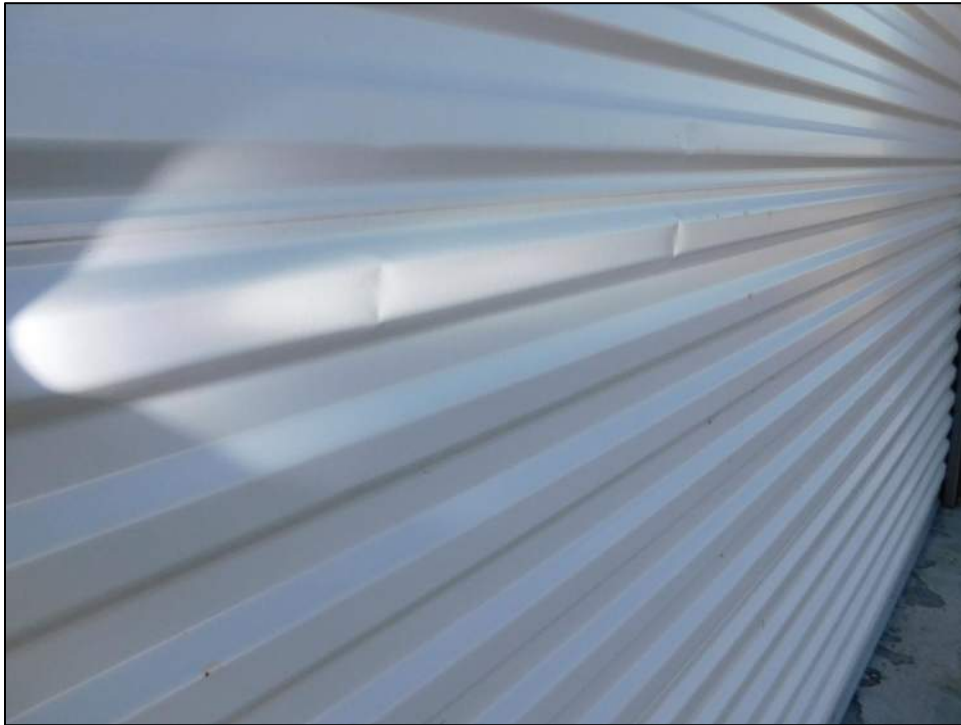
**Photo 11:** Creasing visible at the lower sections of the south roll-up door.

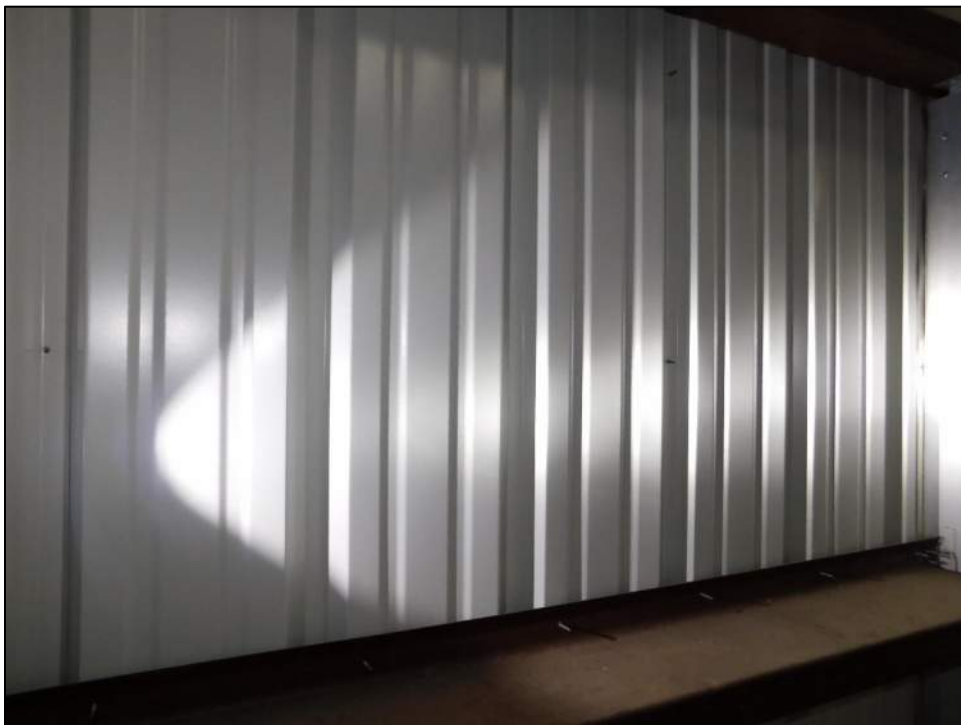
**Photo 12:** No hail denting visible on inside of west or north wall panels.

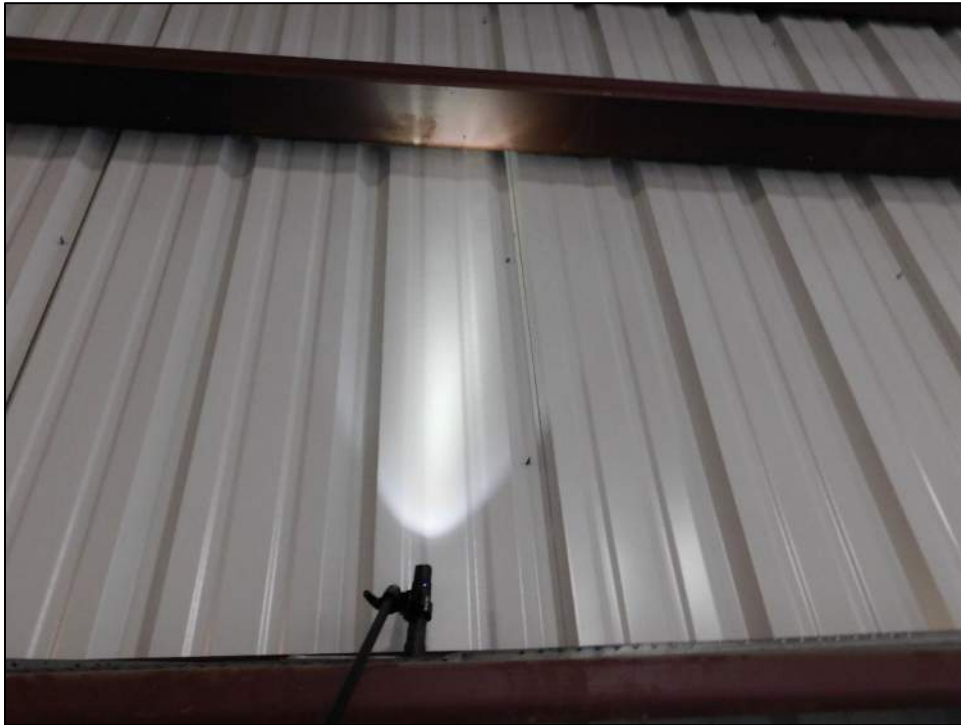
**Photo 13:** No hail denting visible on inside of west or north wall panels.

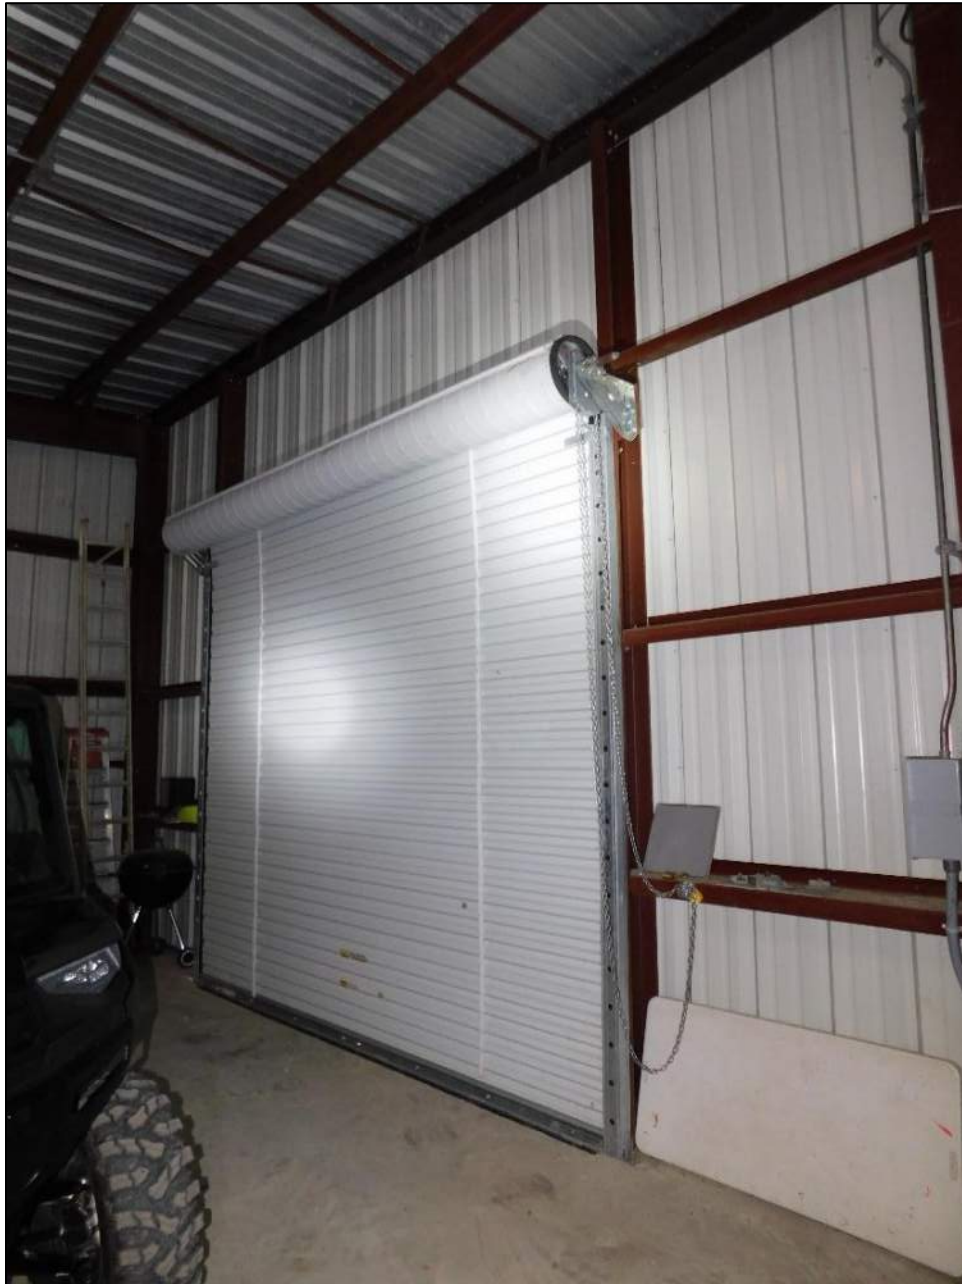
**Photo 14:** Inside view of the south roll-up door on the west wall.

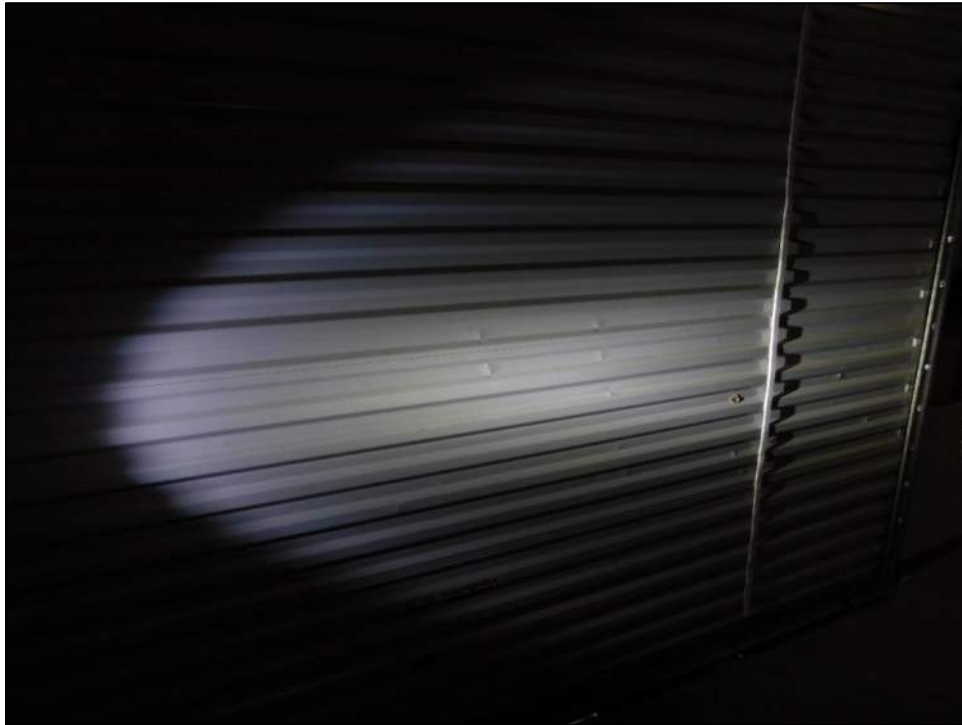
**Photo 15:** Creasing pattern and arrangement on the lower section of the roll-up was consistent with mechanical impact.

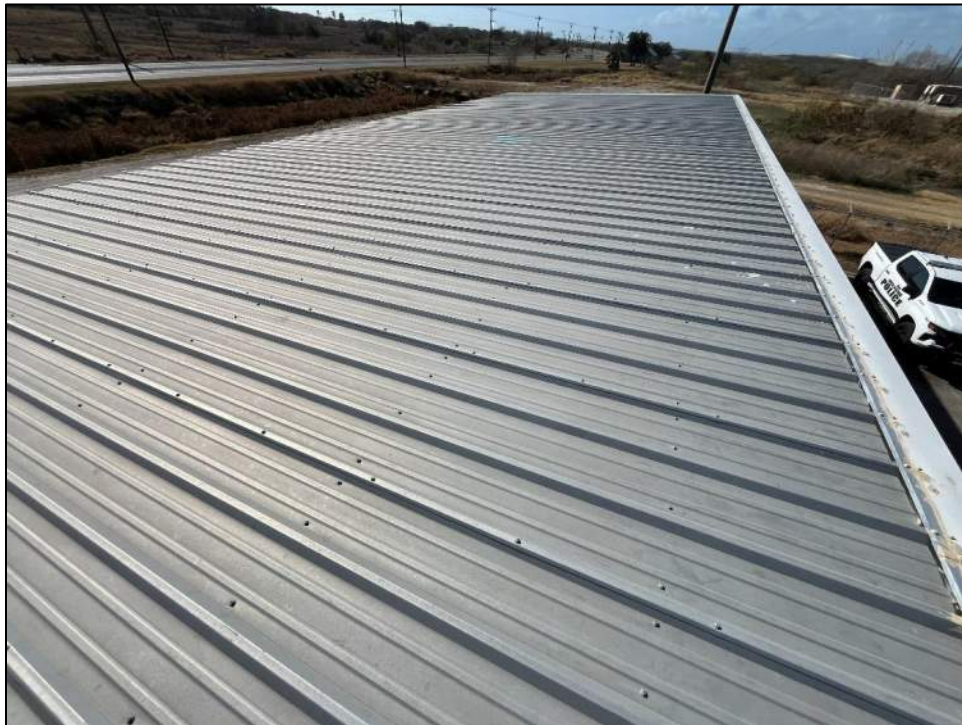
**Photo 16:** Roof overview (looking south).

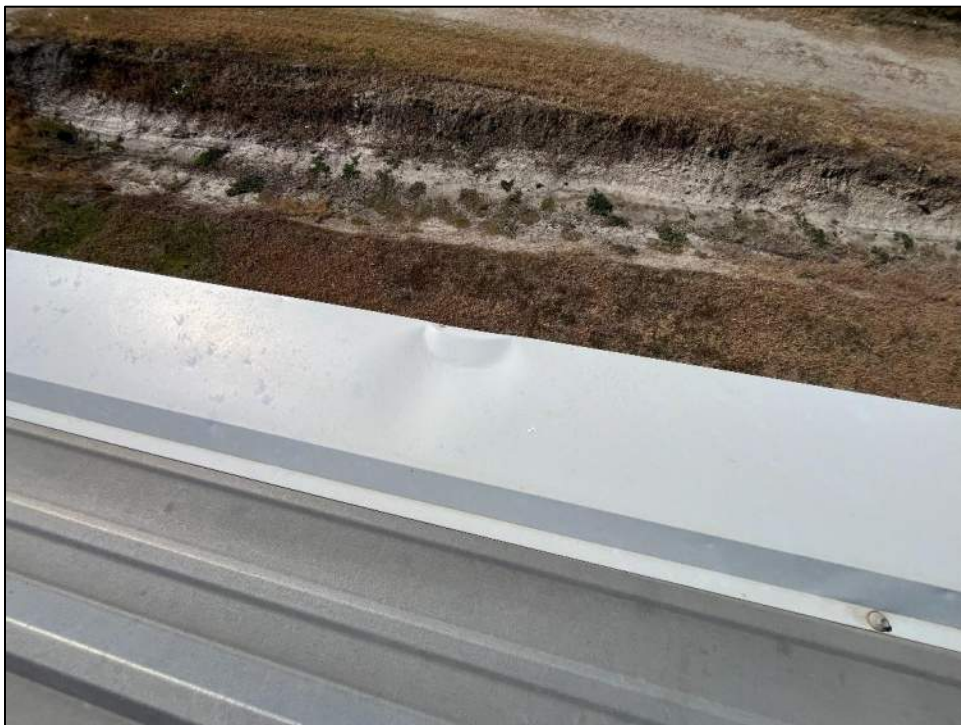
**Photo 20:** Edge crumpling along south roof rake consistent with mechanical impact.

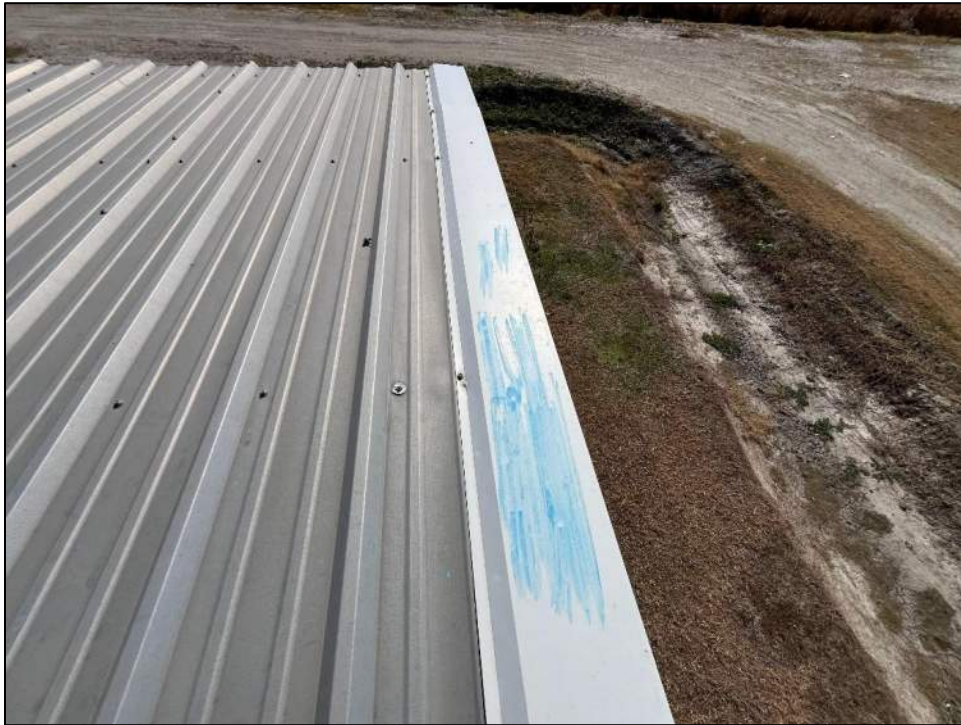
**Photo 21:** Hail denting identified on closure trim along south rake.

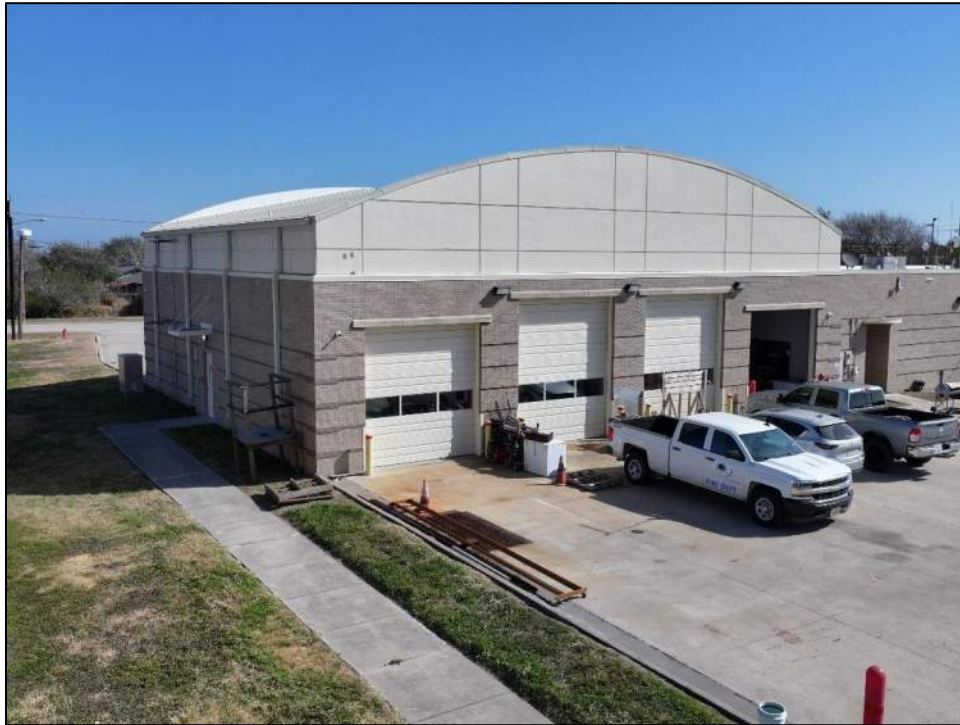
**Photo 29:** South (rear) elevation of the police department building.

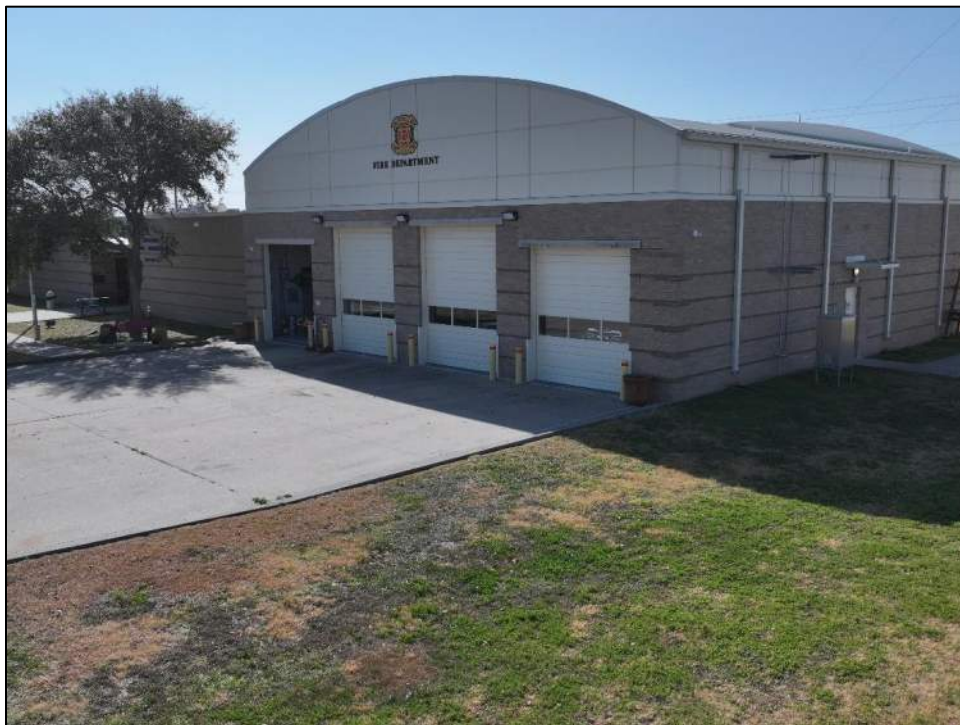
**Photo 30:** North (front) and west elevation of the fire department building.

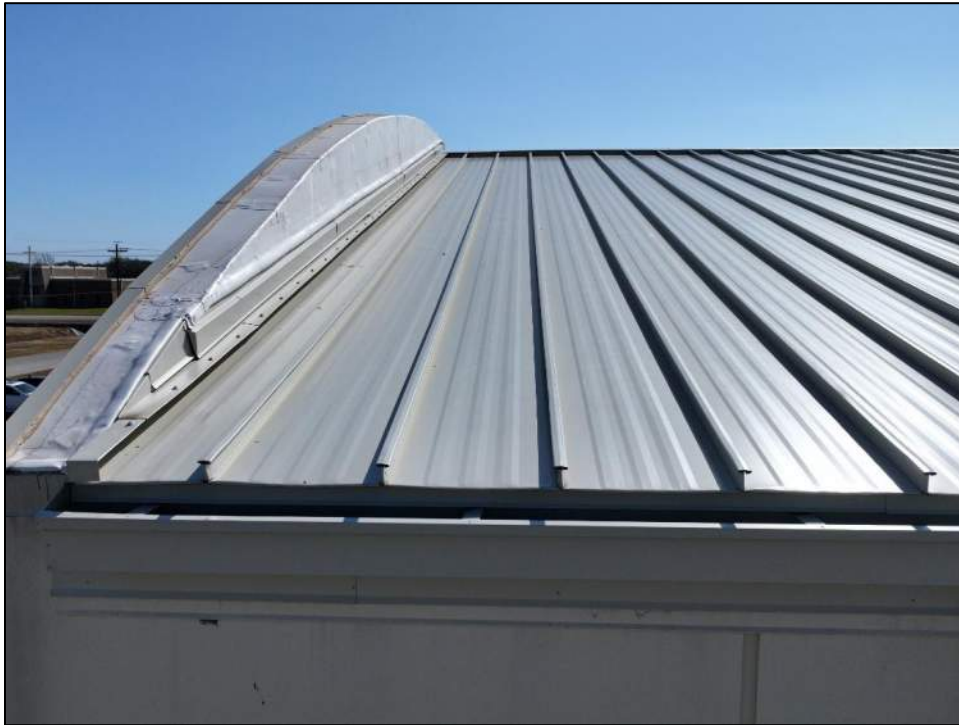
**Photo 31:** Double-lock standing seam of the metal roofing above the fire department was newly installed.

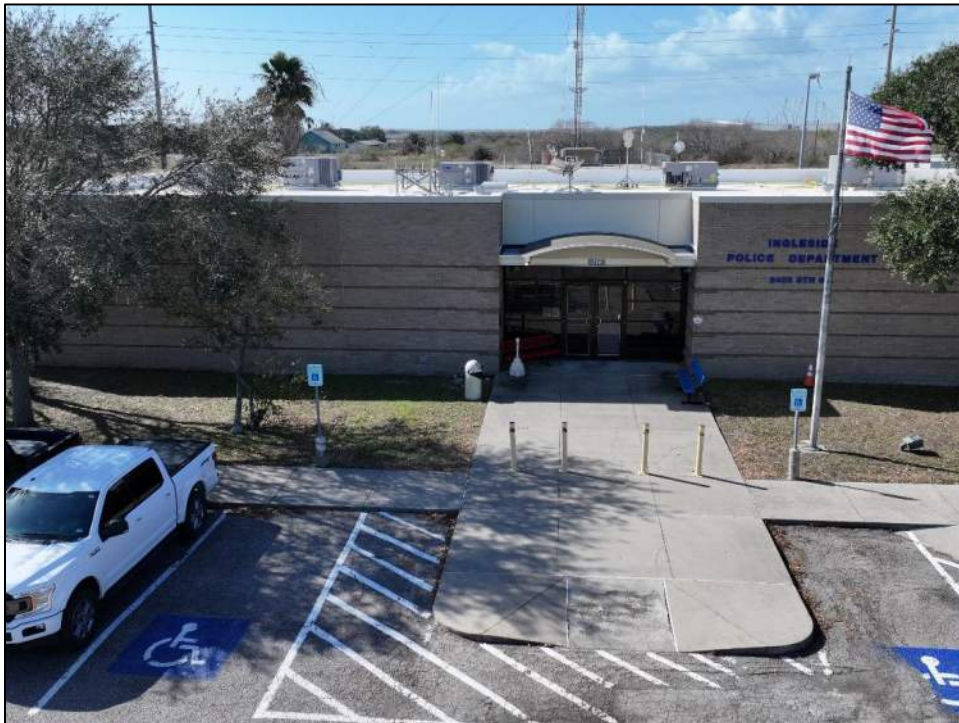
**Photo 32:** Front elevation of the police station building. The polycarbonate canopy above the front entry sustained hail impact fractures.

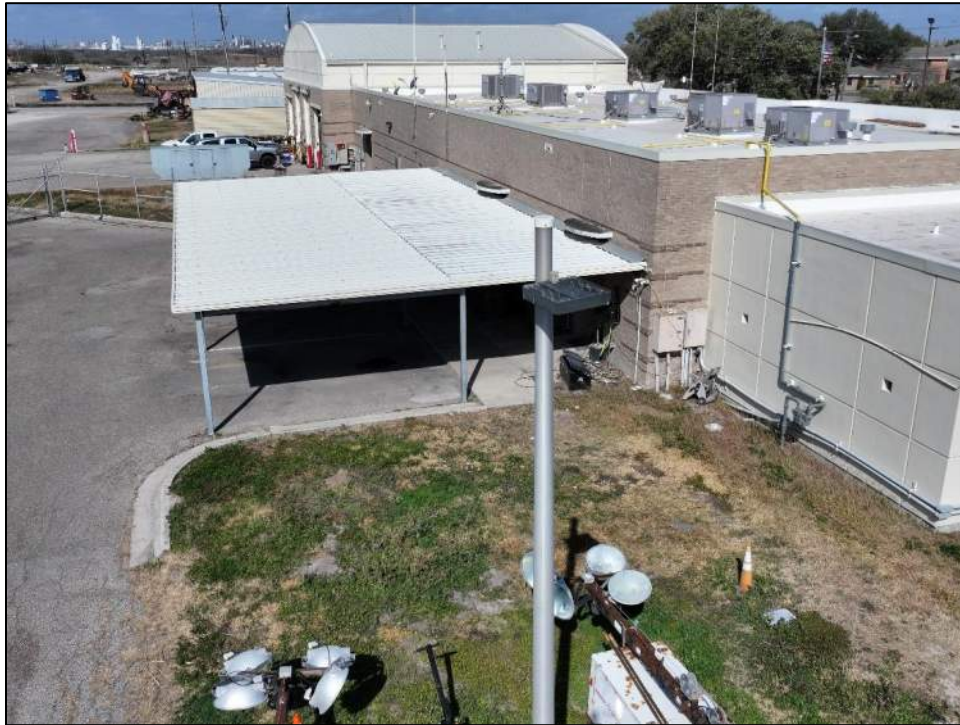
**Photo 33:** Rear elevation of the police station building.

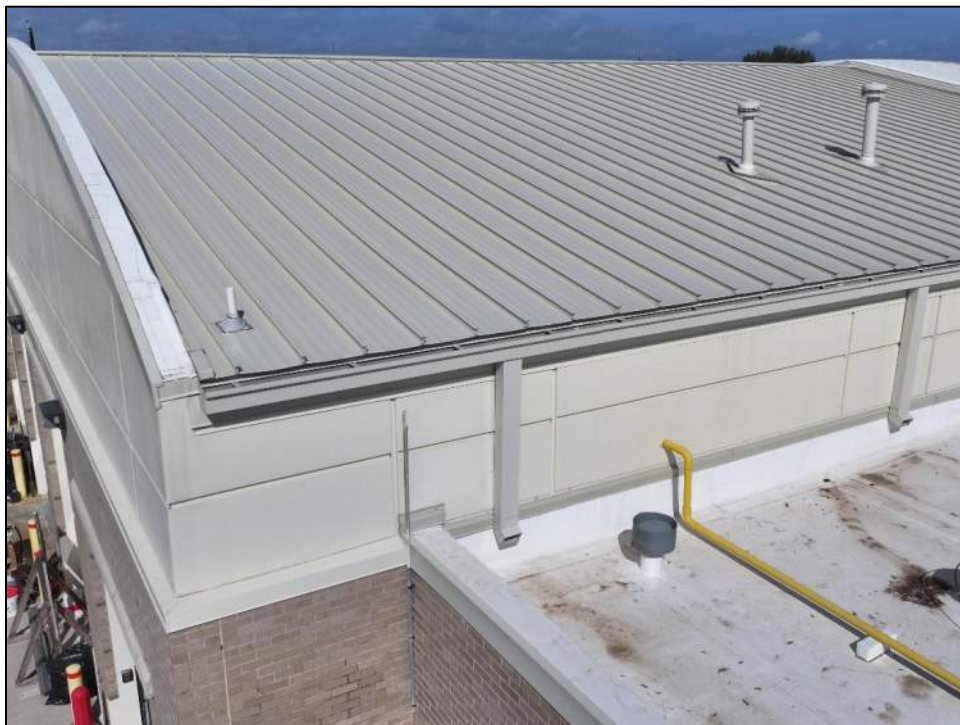
**Photo 34:** Downspouts on east kneewalls of the fire department remained intact

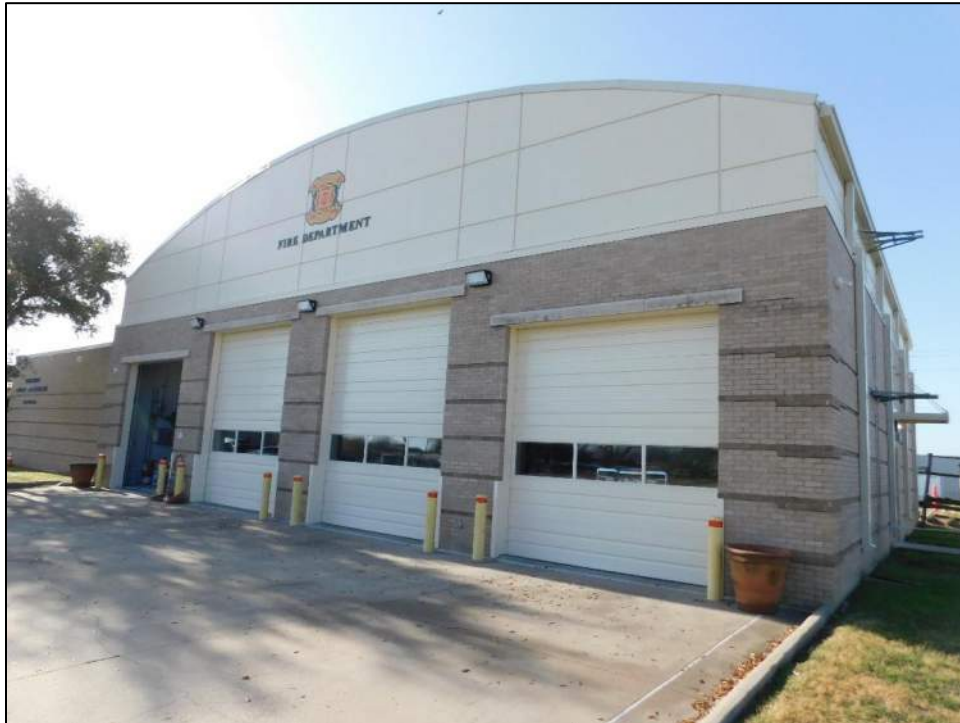
**Photo 35:** Front wall of the fire department had 4 roll-up doors that exhibited slight denting consistent with hail impact.

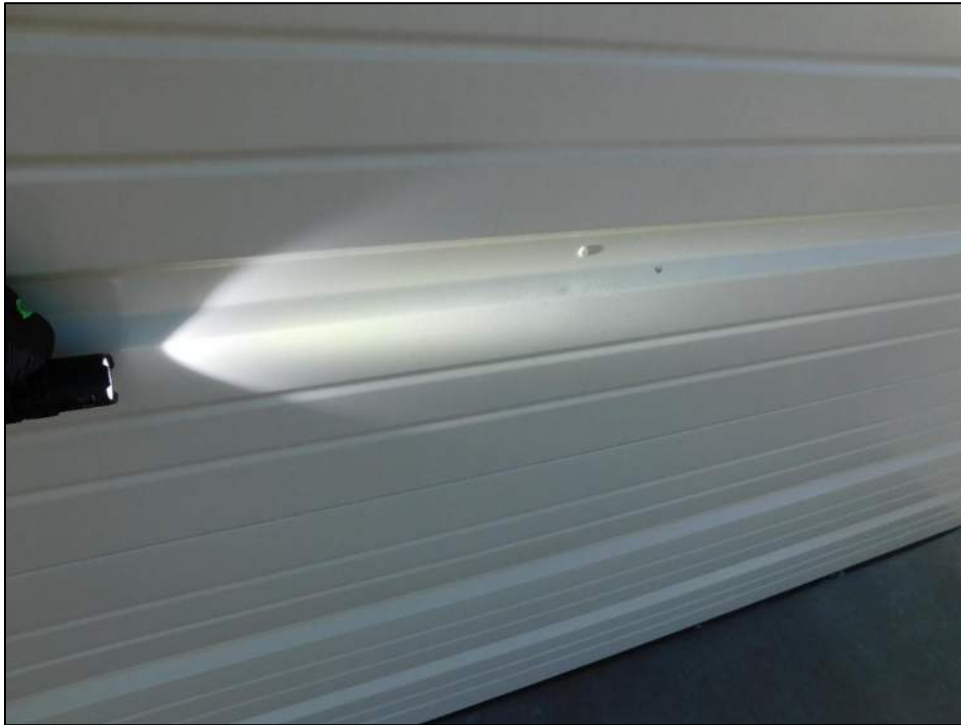
**Photo 37:** Slight denting on roll-up doors.

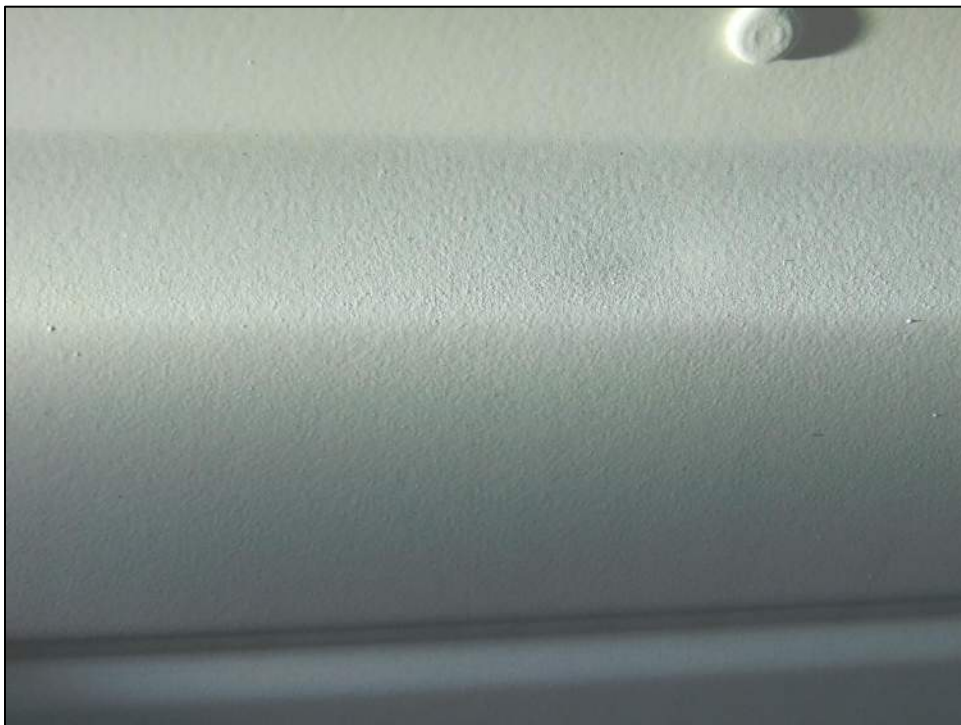
**Photo 38:** Close-up of the slight denting on the roll-up door consistent with hail impact. No coating disruptions were observed.

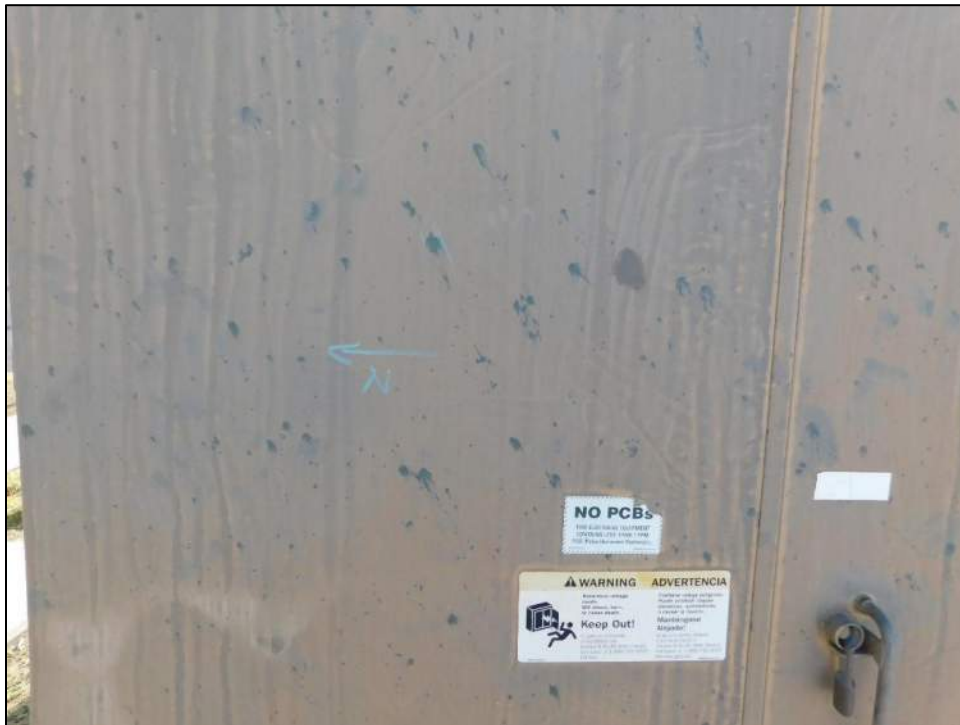
**Photo 41:** Transformer along rear side of the building exhibited hail spatters consistent with 1.25-inch at maximum size most being under 0.75 inches.

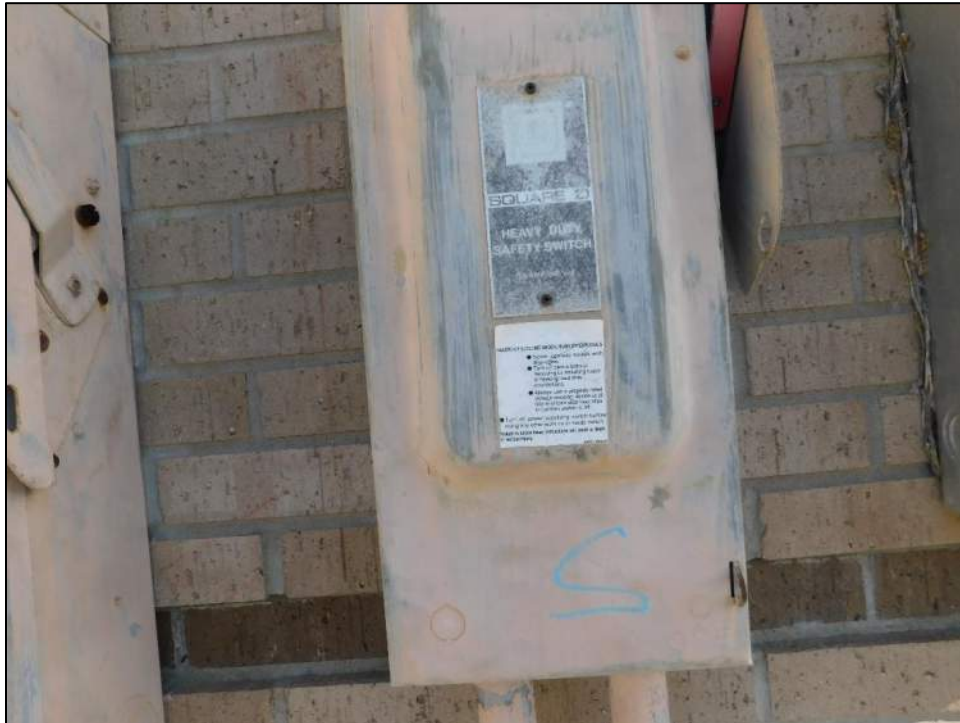
**Photo 43:** No hail spatter on south-face electrical safety switch boxes.

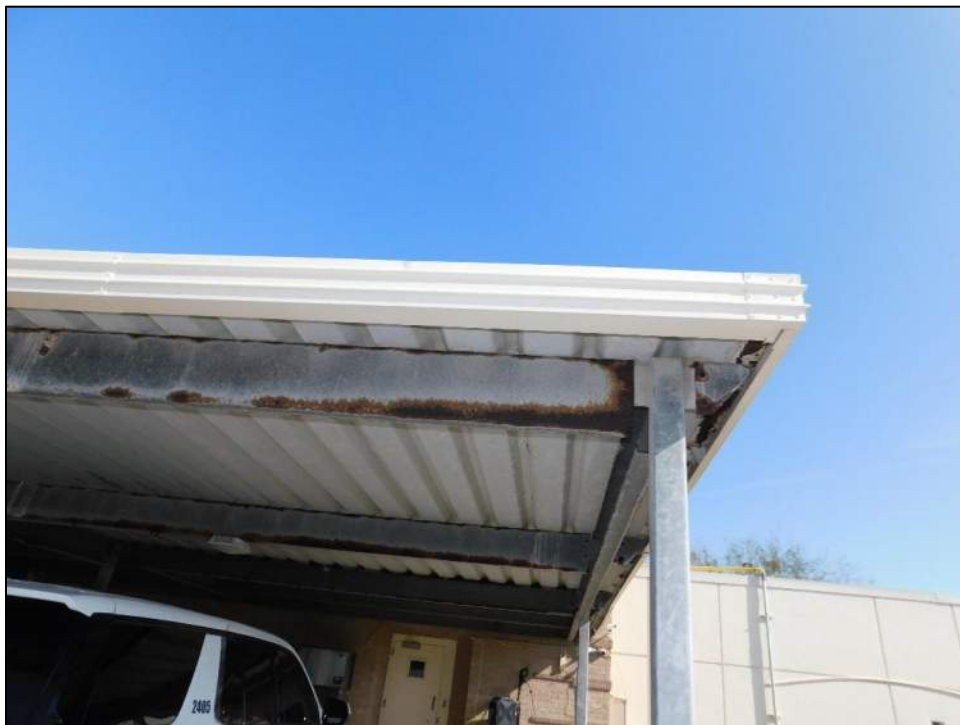
**Photo 44:** Corrosion was widespread on the carport structure and edge closures along the backside of the police department building.

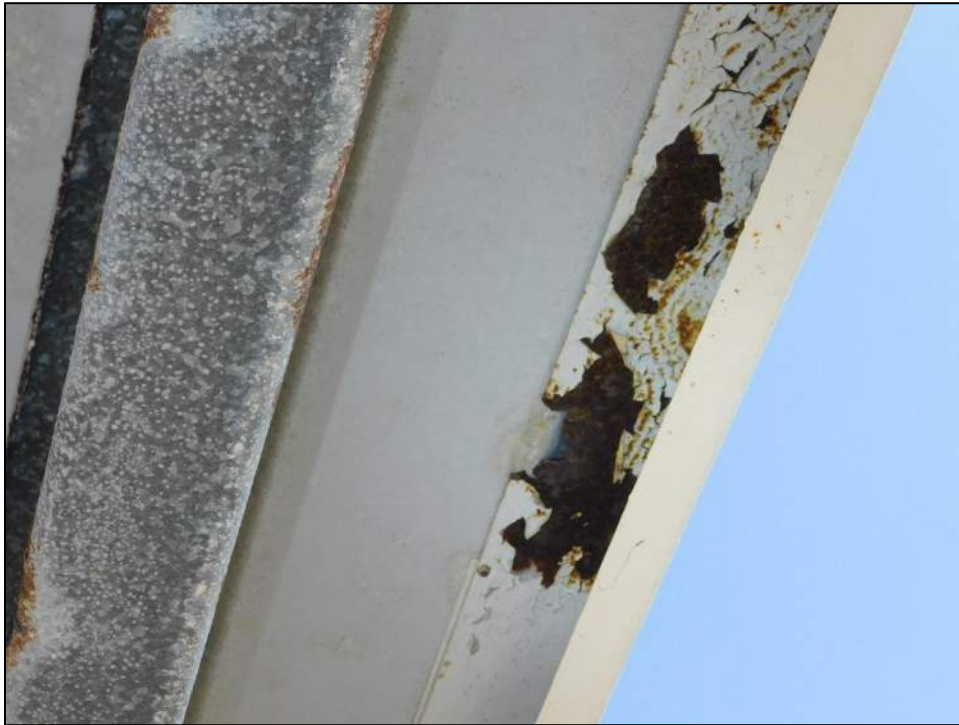
**Photo 45:** Corrosion was widespread on the carport structure and edge closures along the backside of the police department building.

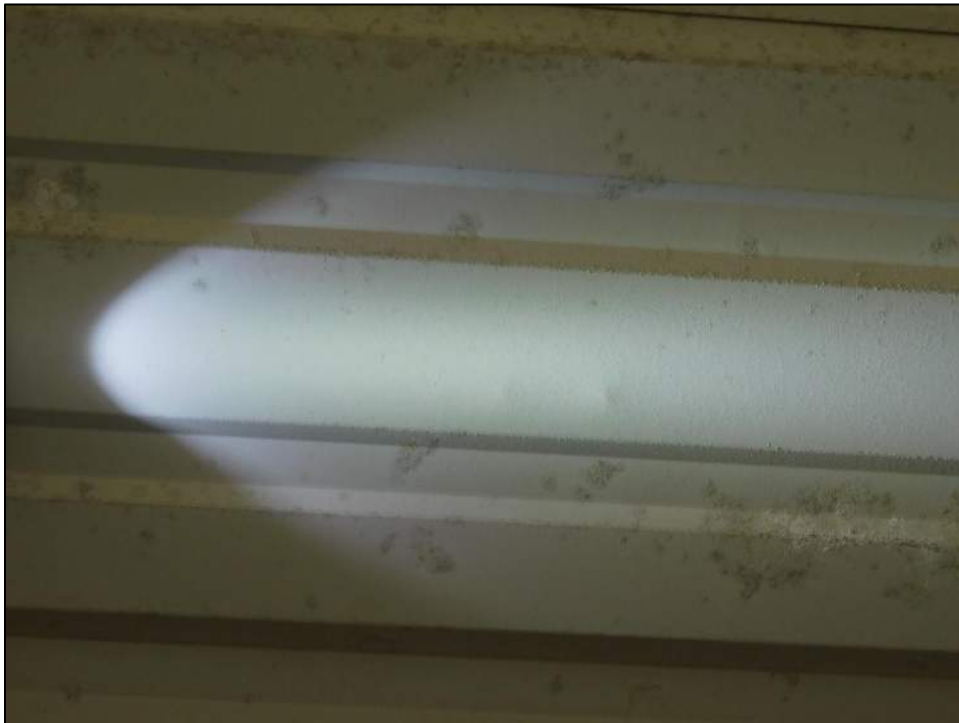
**Photo 46:** Denting on the underside of the carport metal roof panels consistent with hail impact.

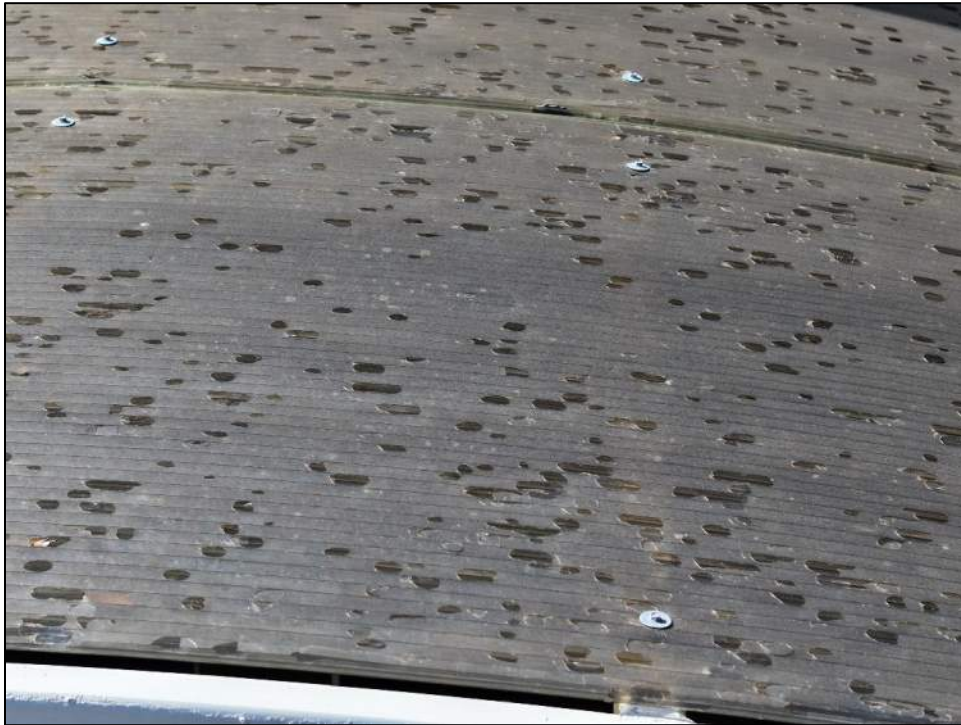
**Photo 47:** Close-up of the hail punctures to the polycarbonate canopy above the police station front entry.

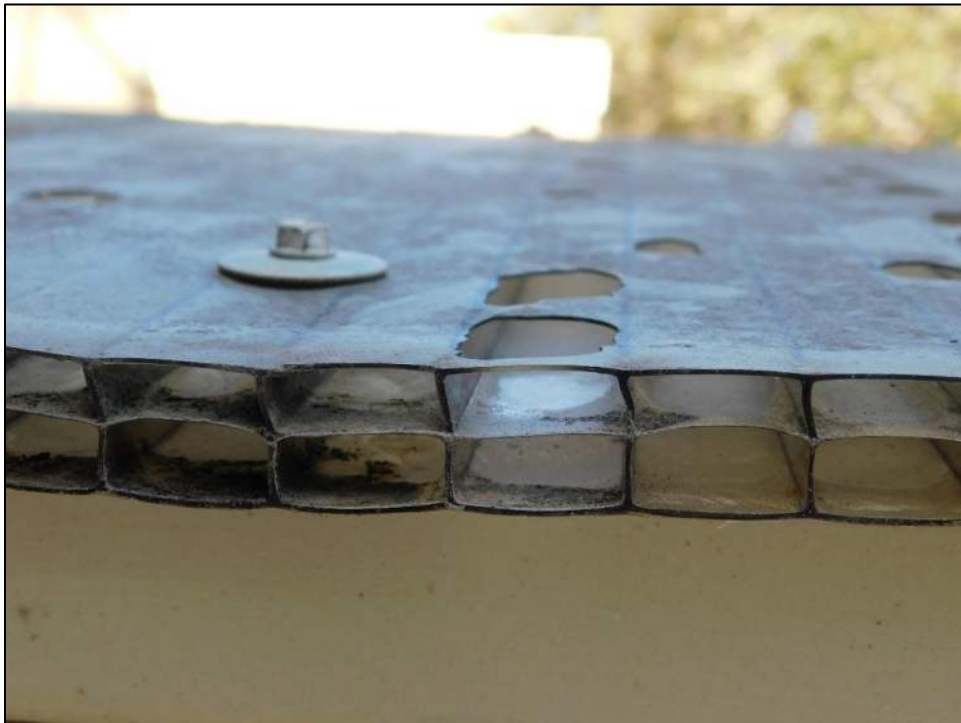
**Photo 48:** Close-up of the hail puncturing of the polycarbonate canopy above the police station front entry.

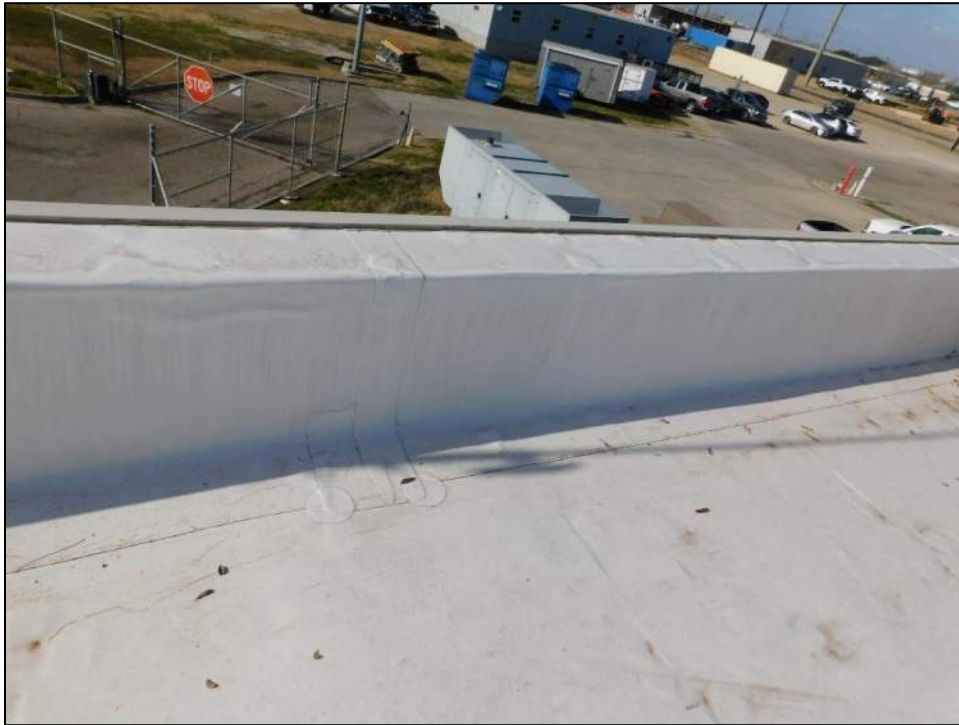
**Photo 49:** Parapet bases facing the direction of the hail impact were closely inspected for hail impact.

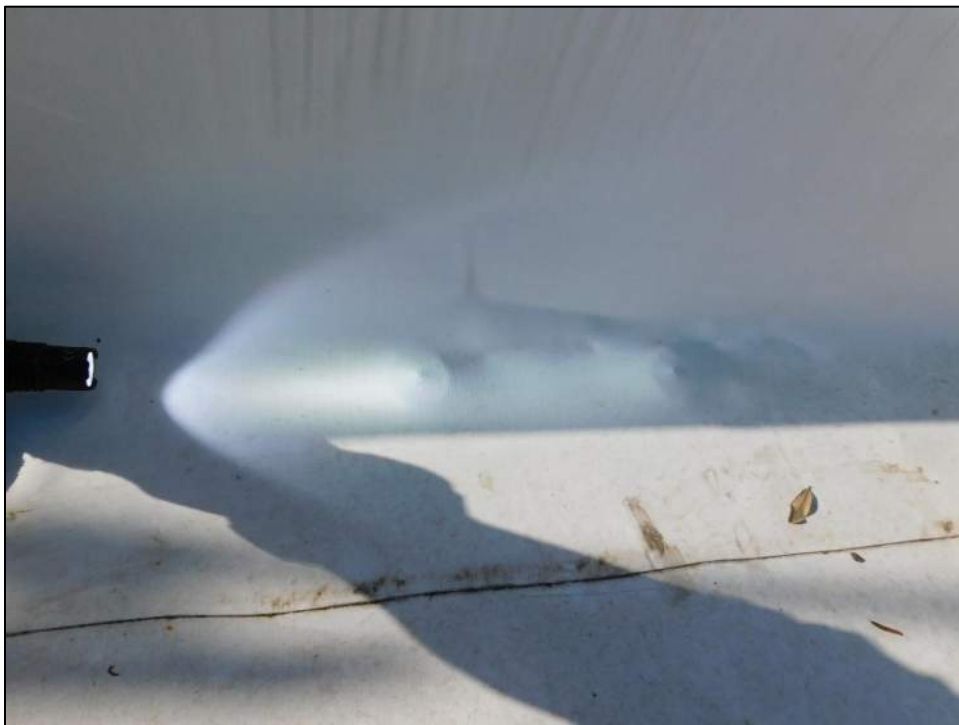
**Photo 50:** Parapet bases facing the direction of the hail impact were closely inspected for hail impact.

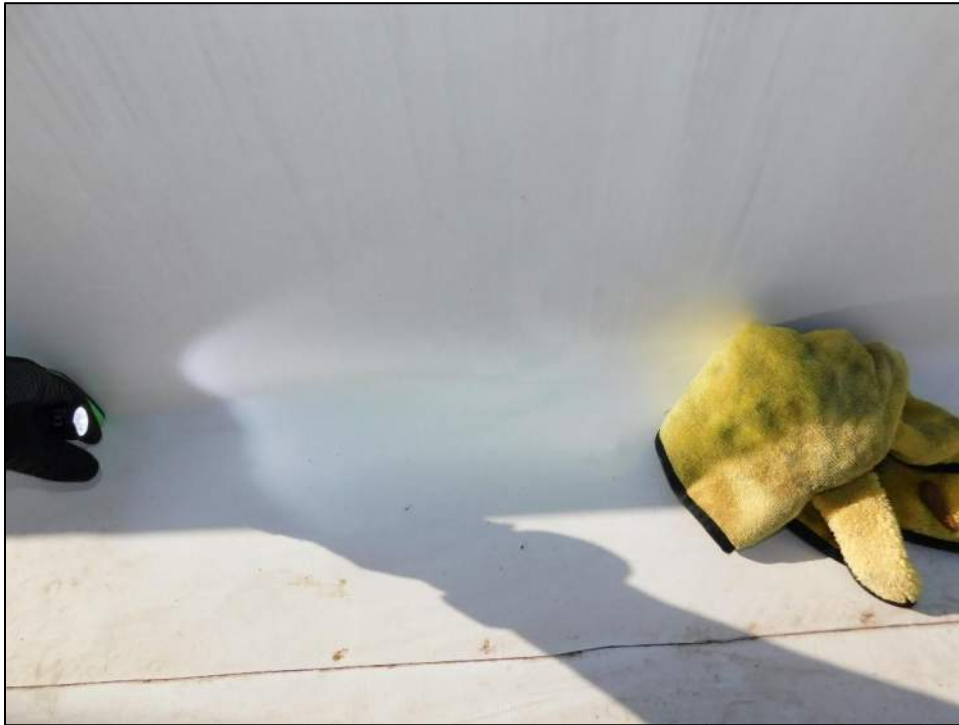
**Photo 51:** Parapet bases facing the direction of the hail impact were closely inspected after surface cleaning for hail impact.

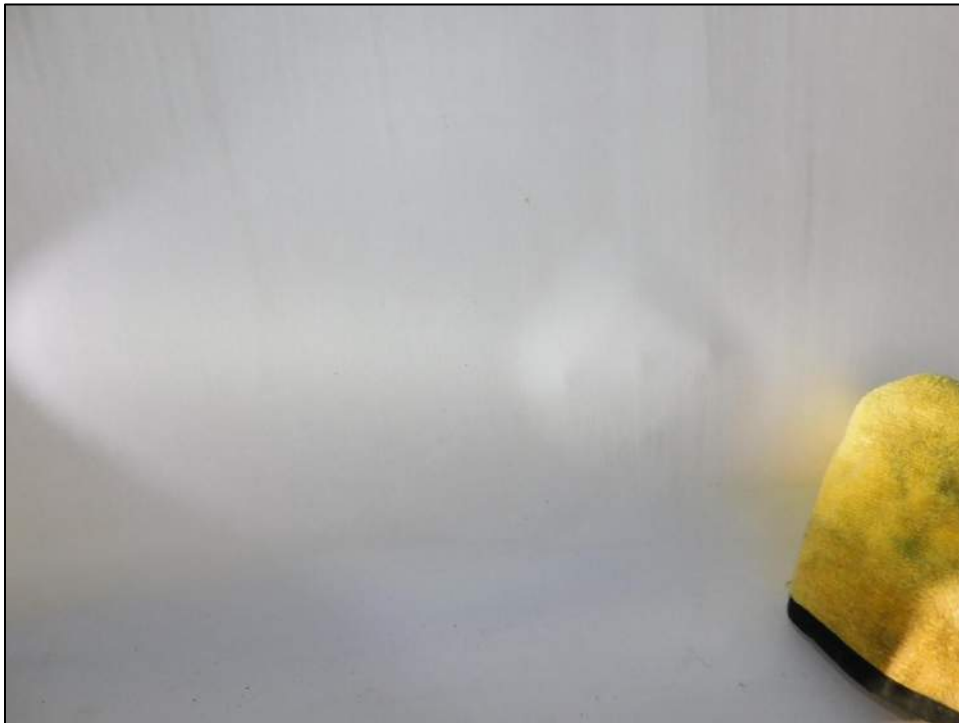
**Photo 52:** No hail impact dimpling puncture or surface disruptions were observed at the membrane flashing at the bases of the parapets.

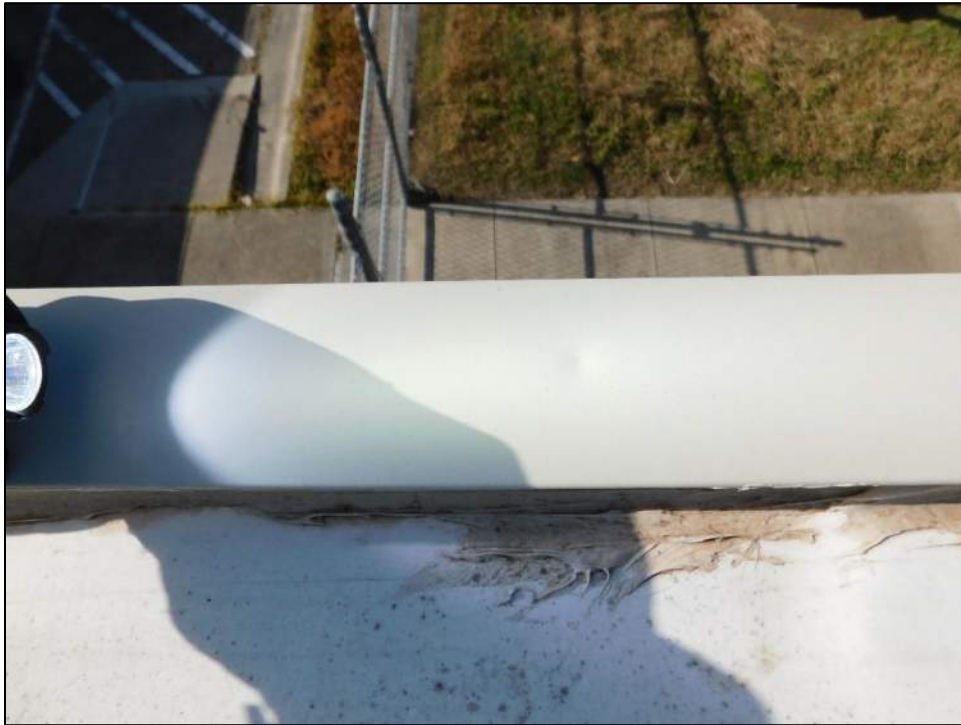
**Photo 53:** Metal coping along the top of the parapets exhibited slight hail denting absent of coating disruptions.

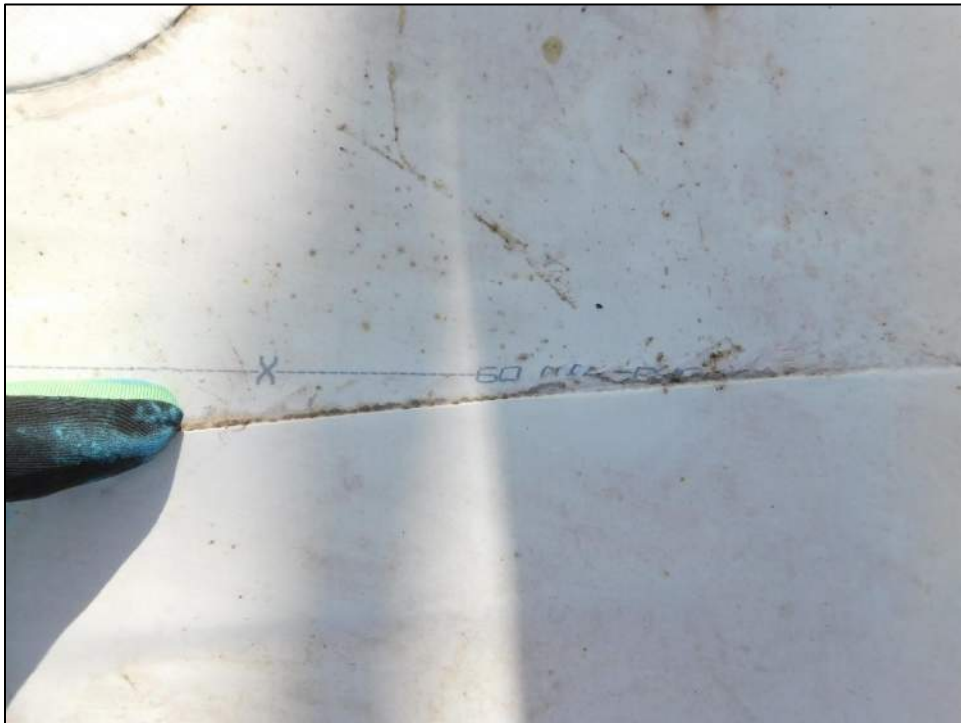
**Photo 54:** close-up of the 60-mill PVC marking.

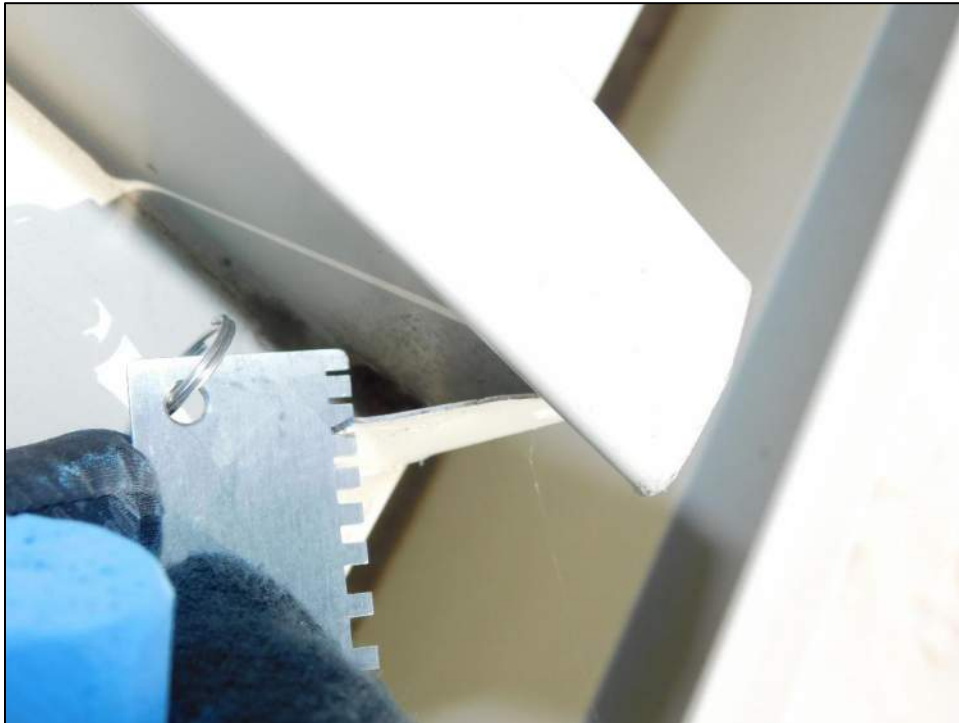
**Photo 55:** 20 to 22-gauge thickness recorded for the standing seam metal roofing of the fire department building.
