**CITY OF INGLESIDE  
REGULAR CITY COUNCIL MEETING  
AGENDA  
JUNE 9, 2026  
6:30 PM**

Report on November 01, 2025, Hailstorm Damage to City of Ingleside Buildings.

### Building Damage Analysis Survey and Report

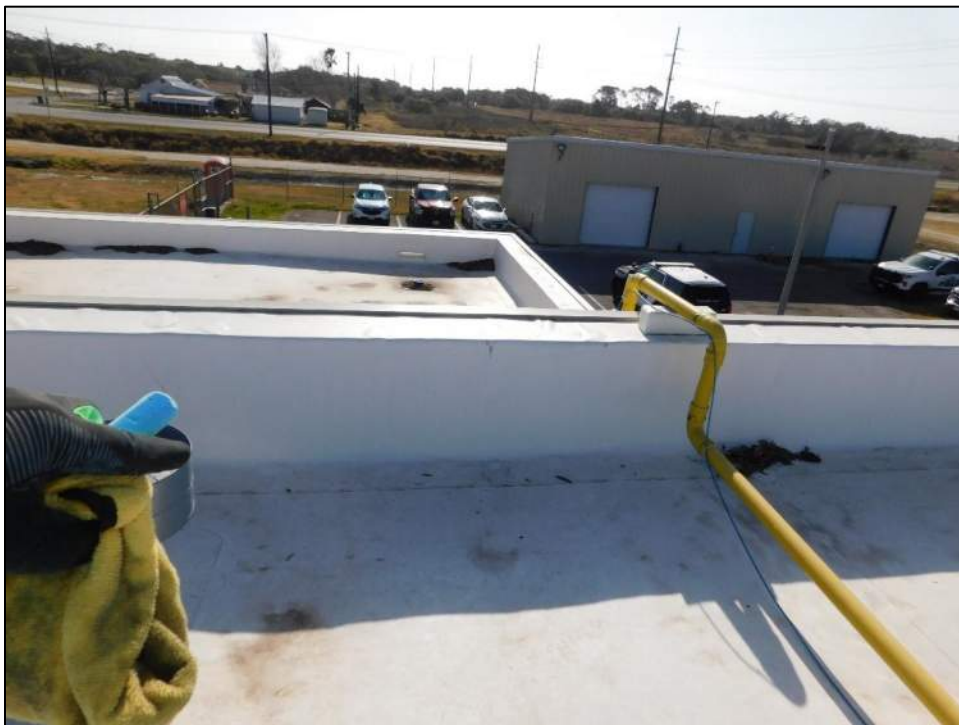
**Photo 60:** East parapets were closely examined along the base for potential hail impact.

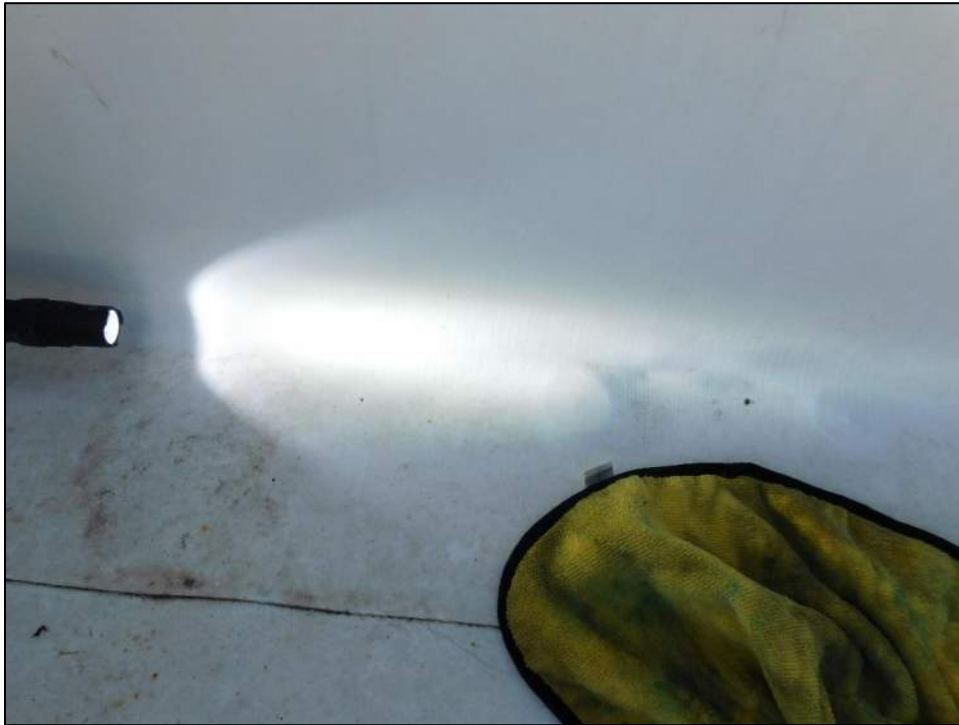
**Photo 61:** Parapet bases facing the direction of the hail impact were closely inspected after surface cleaning for hail impact.

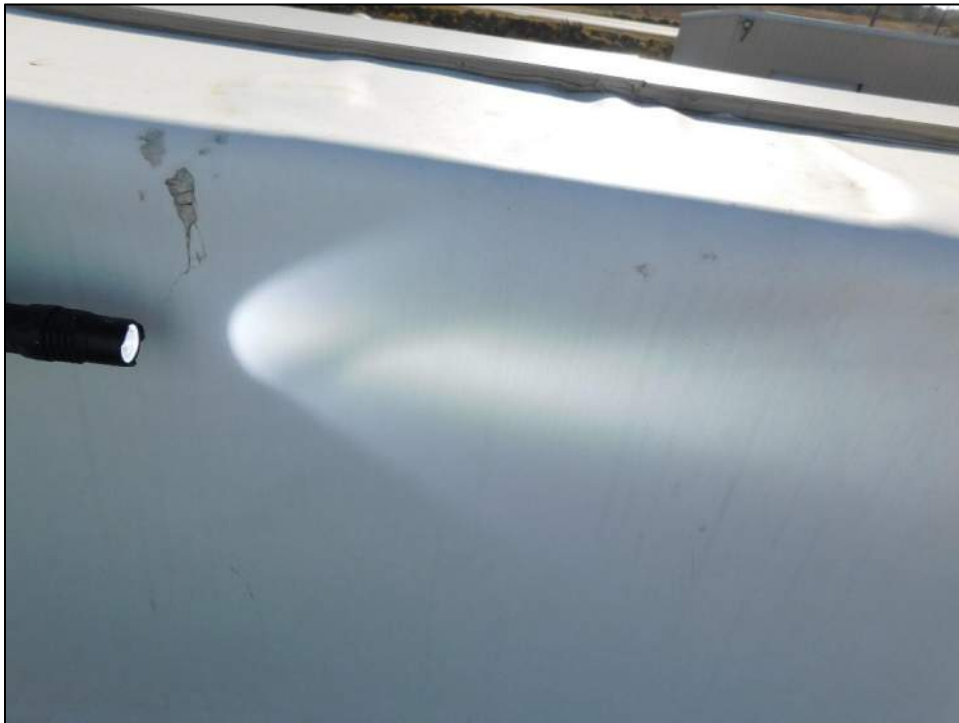
**Photo 62:** No hail impact dimpling puncture or surface disruptions were observed at the membrane flashing at the bases of the parapets.

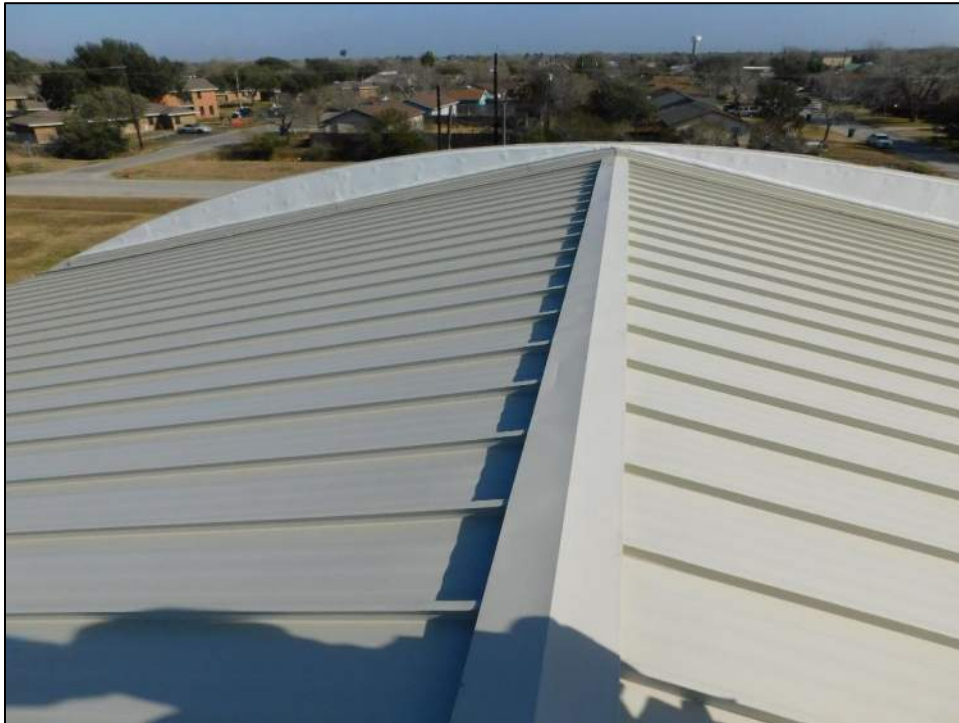
**Photo 63:** Metal ridge of the fire department building roof remained securely attached.

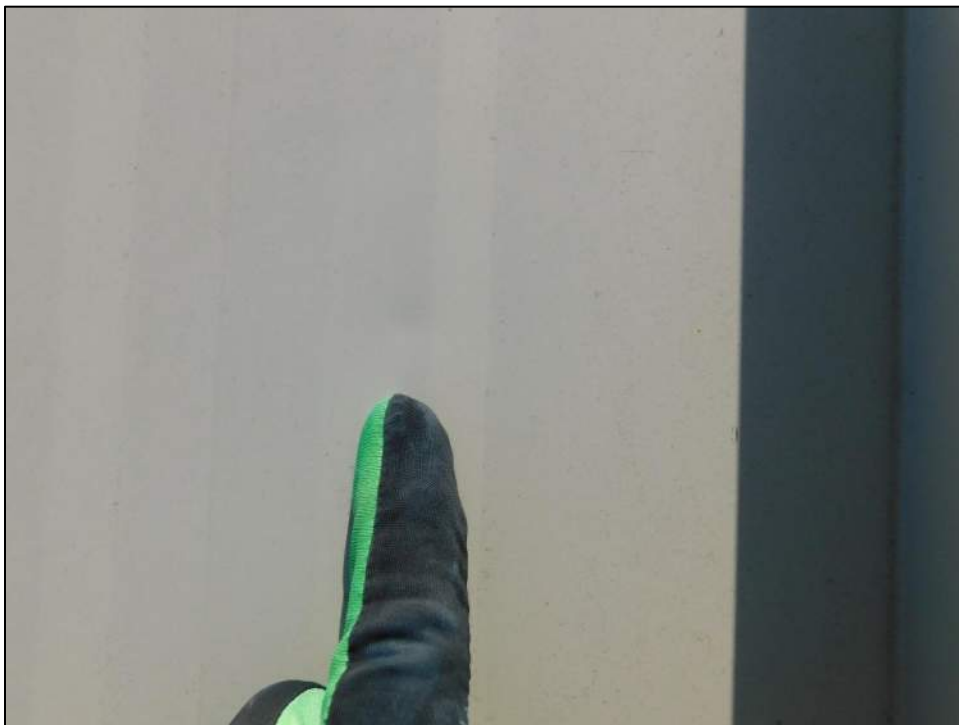
**Photo 64:** Close view of a hail dent on the fire department roof.

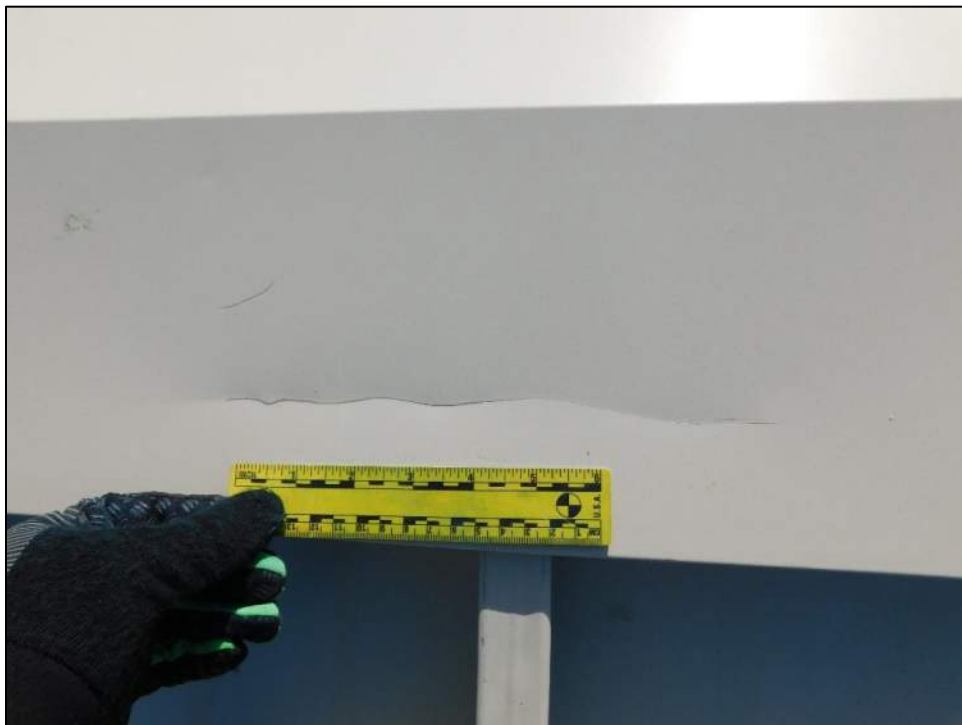
**Photo 66:** Typical mechanical scuff along the roof ridge that was irrelevant to hail impact.

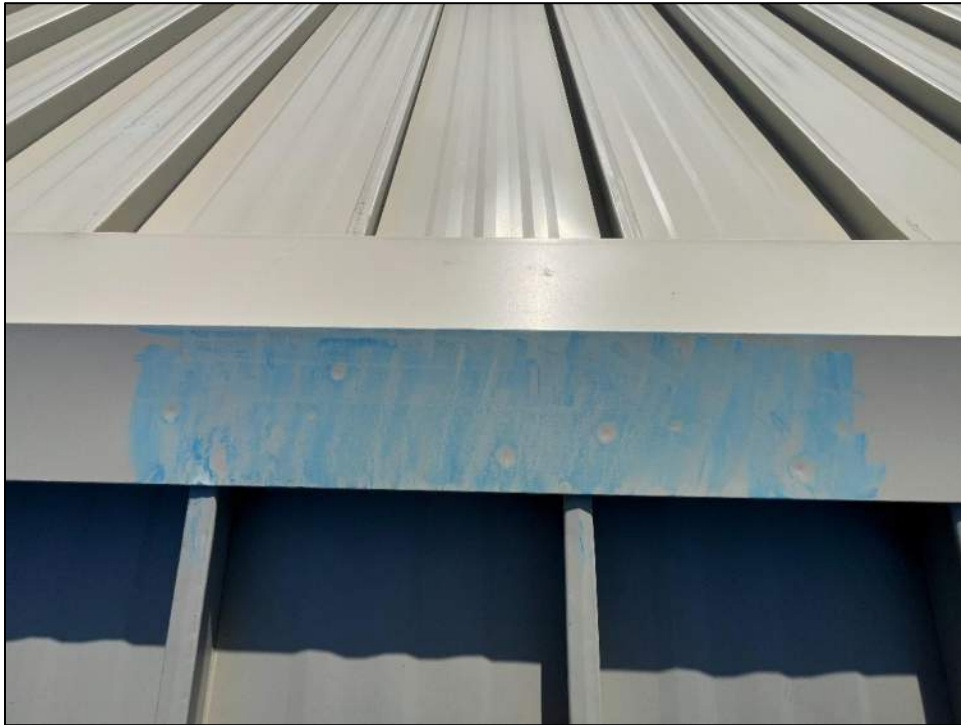
**Photo 67:** Dented ridge panel above the fire department. No coating disruptions were observed at the dents.

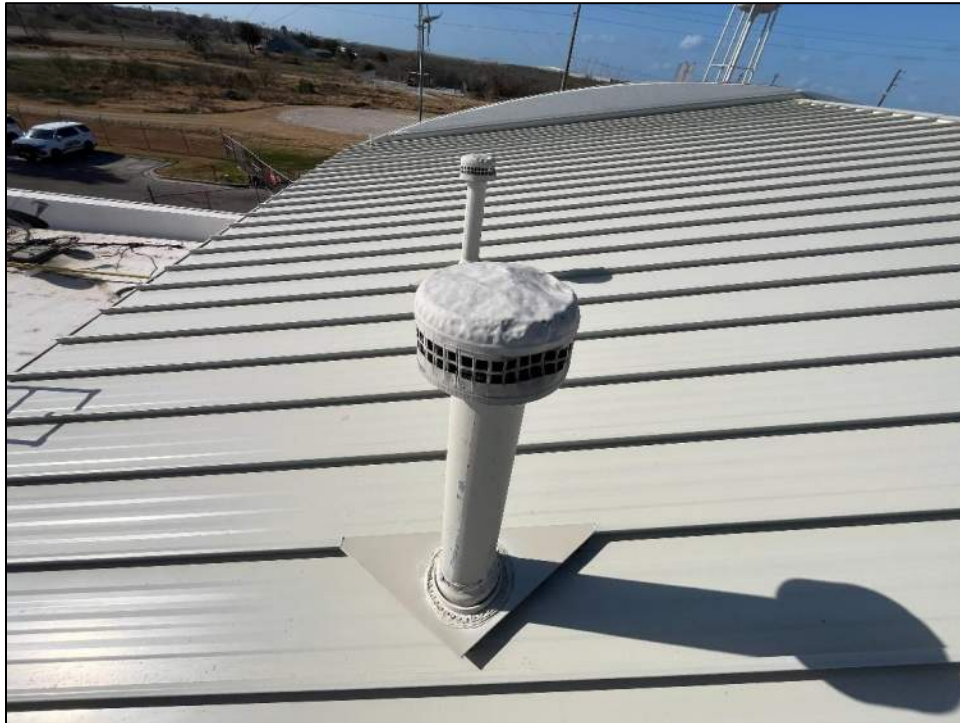
**Photo 70:** Dented aluminum mechanical exhaust vent on the east slope of the fire department roof consistent with hail.

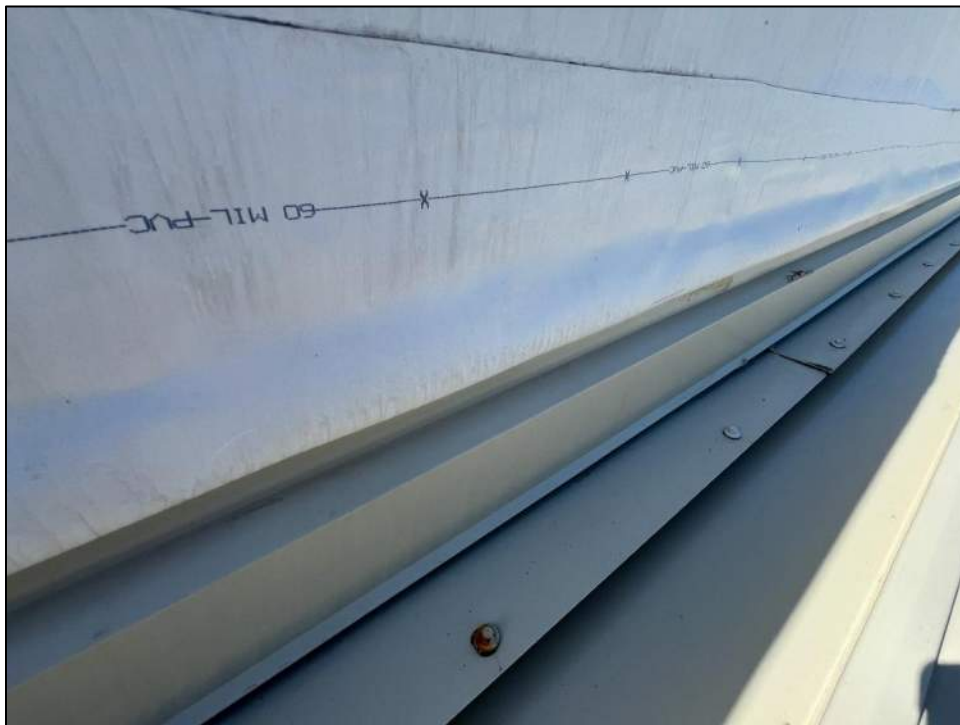
**Photo 71:** Intact PVC membrane at the base of the south kneewall above the fire department roof.

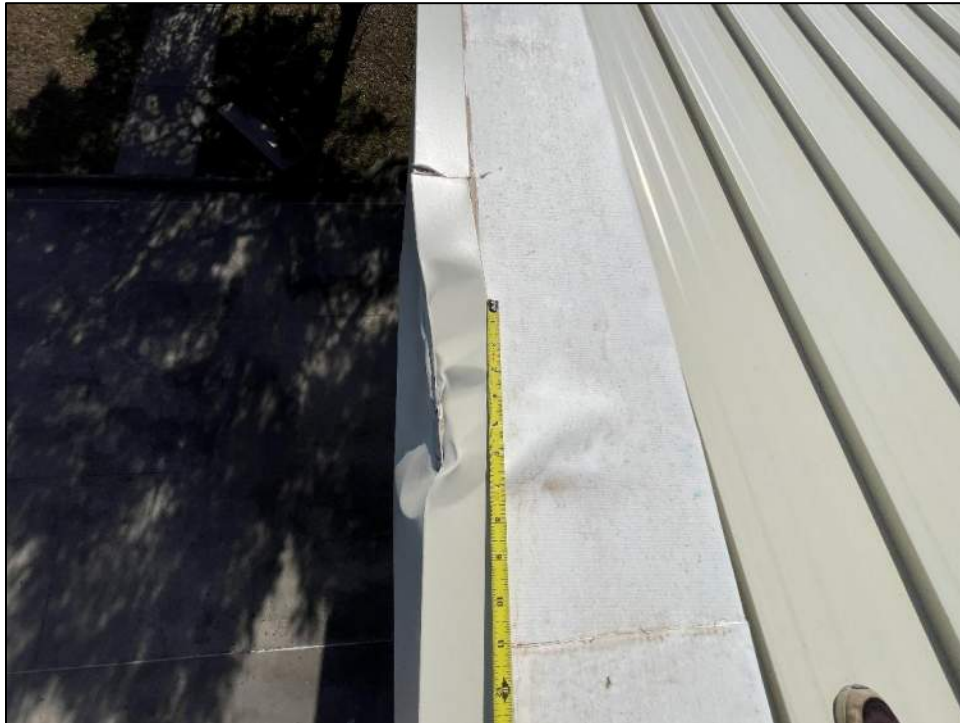
**Photo 72:** Mechanical denting to the north rake edge of the fire department roof that was inconsistent with hail impact.

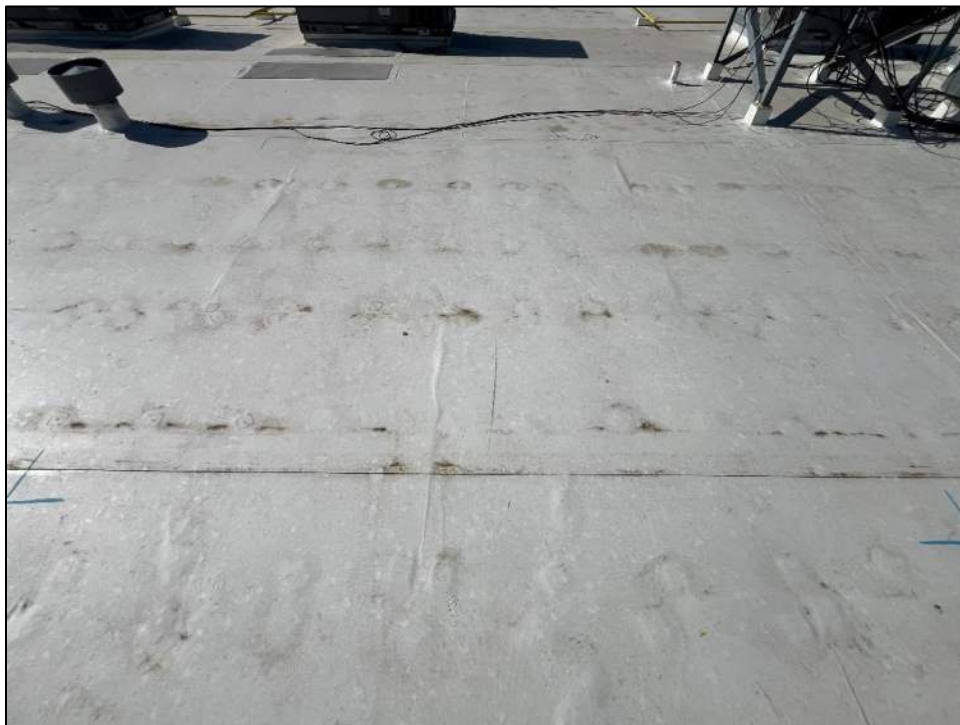
**Photo 73:** Test square on the PVC roof above the police department identified no hail impact fractures to the membrane.

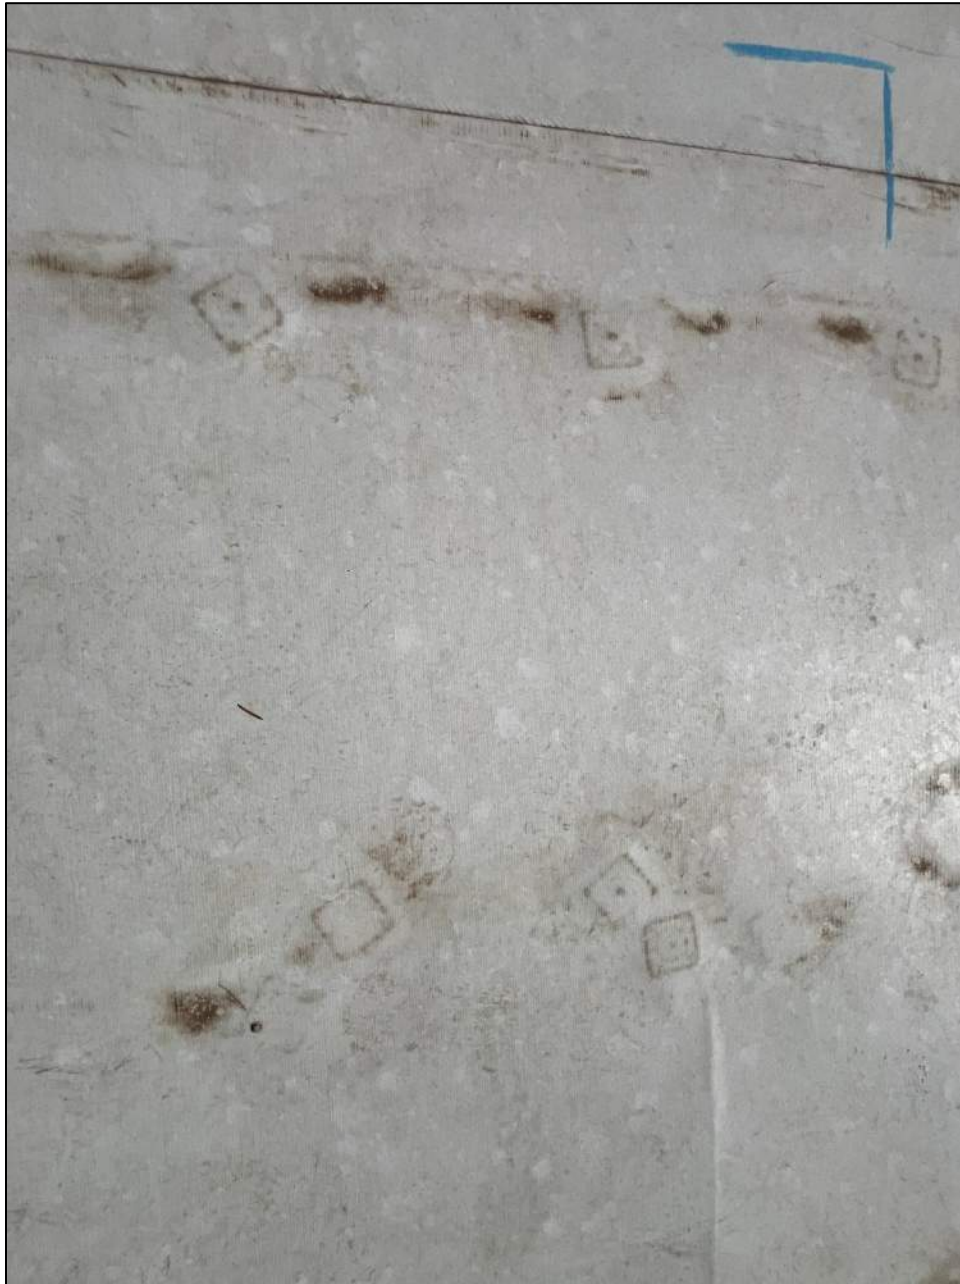
**Photo 76:** No impact fractures were observed at the tented membranes in the vicinity of stress plates.

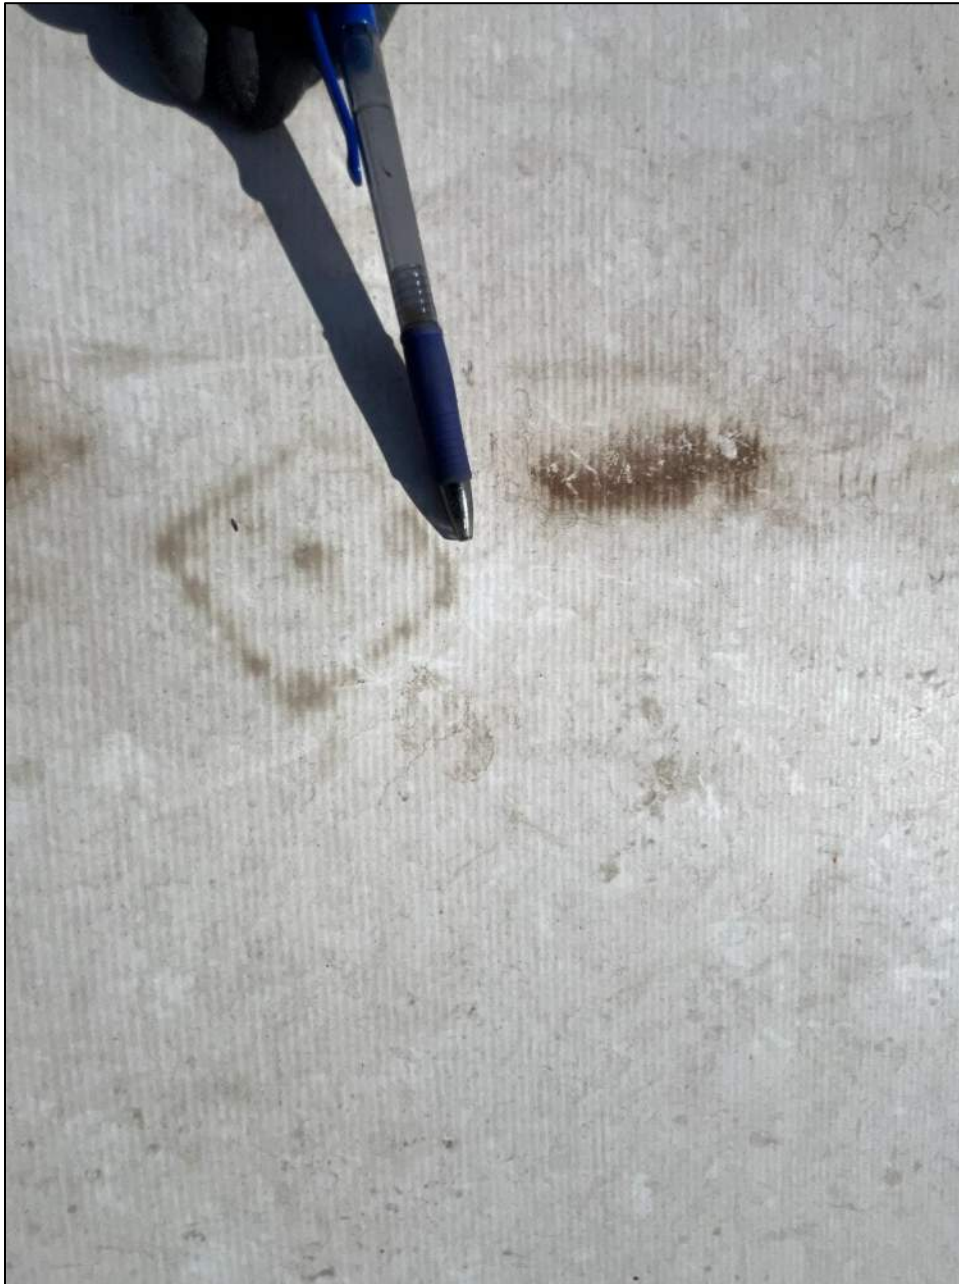
**Photo 77:** No impact fractures were observed at the tented membranes in the vicinity of stress plates.

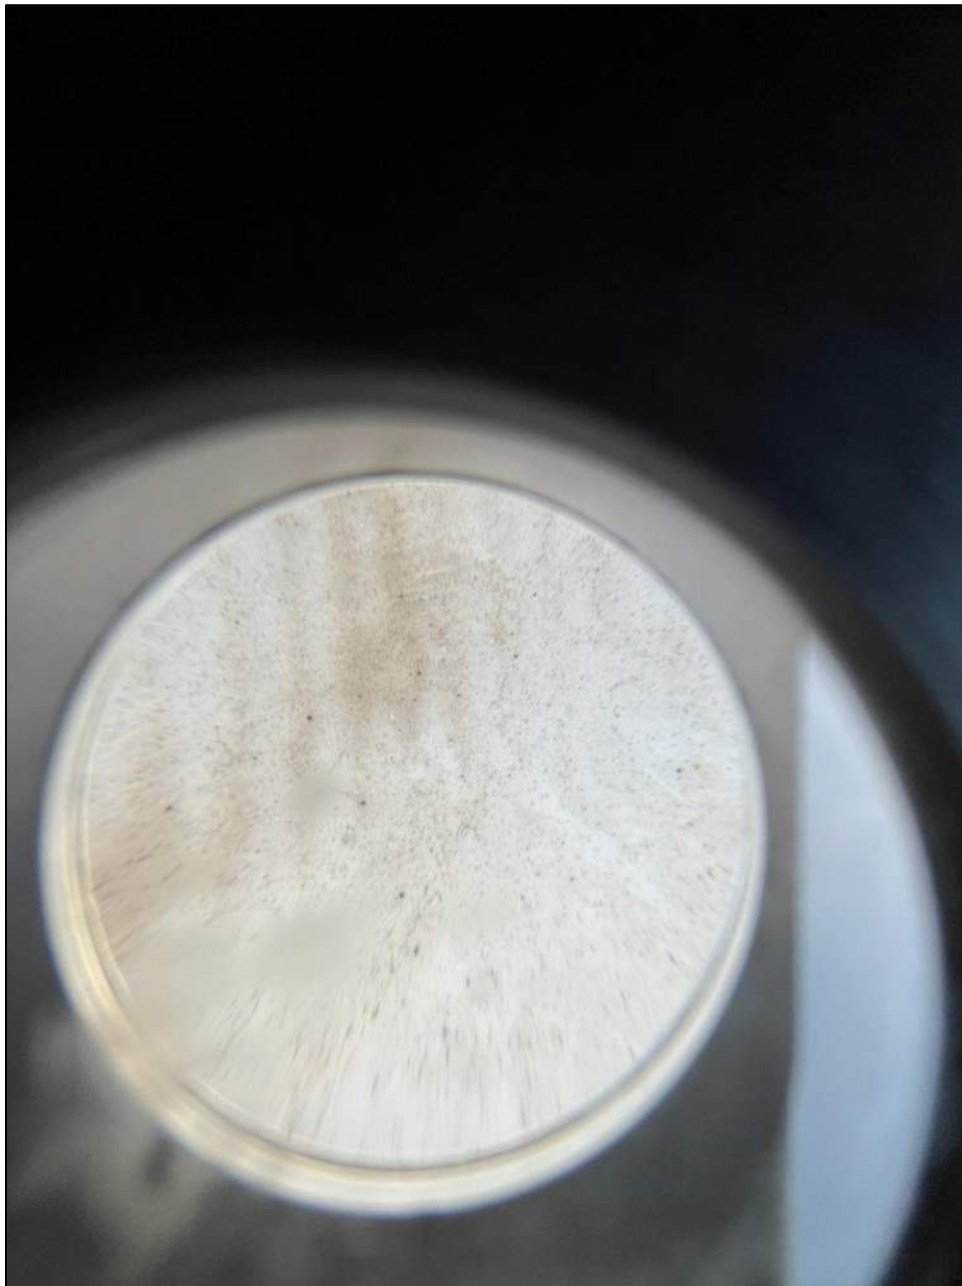
**Photo 78:** Microscope examination at the stress plates identified no PVC surface disruptions at spatters.

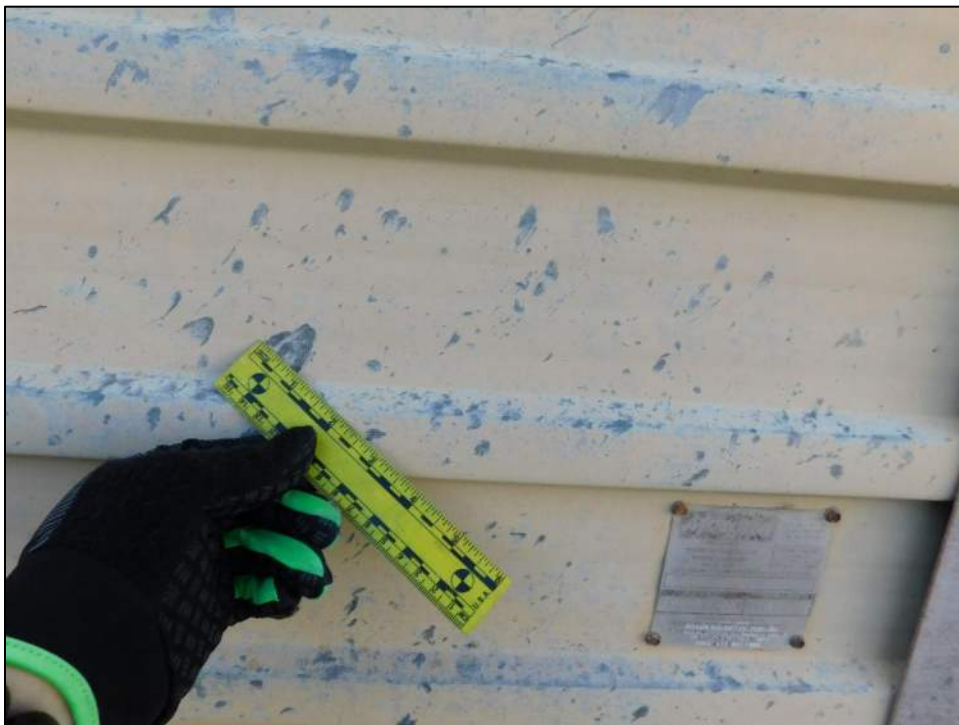
**Photo 87:** Hail spatters on front wall measured 1.0 inch in maximum size.

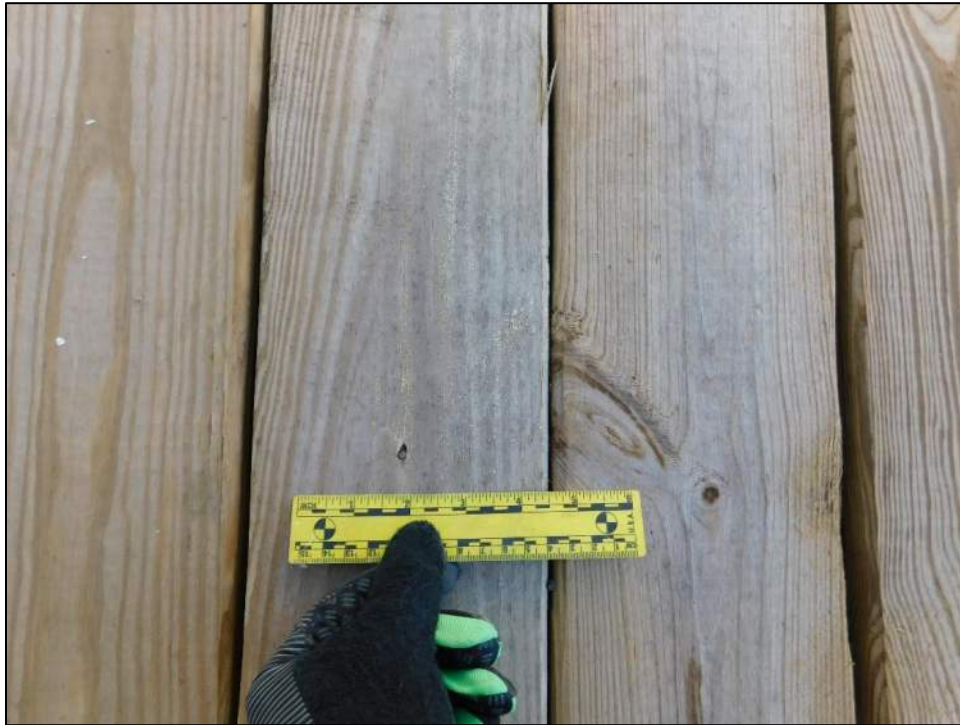
**Photo 88:** No crushed wood grains were observed on the wooden ramp.

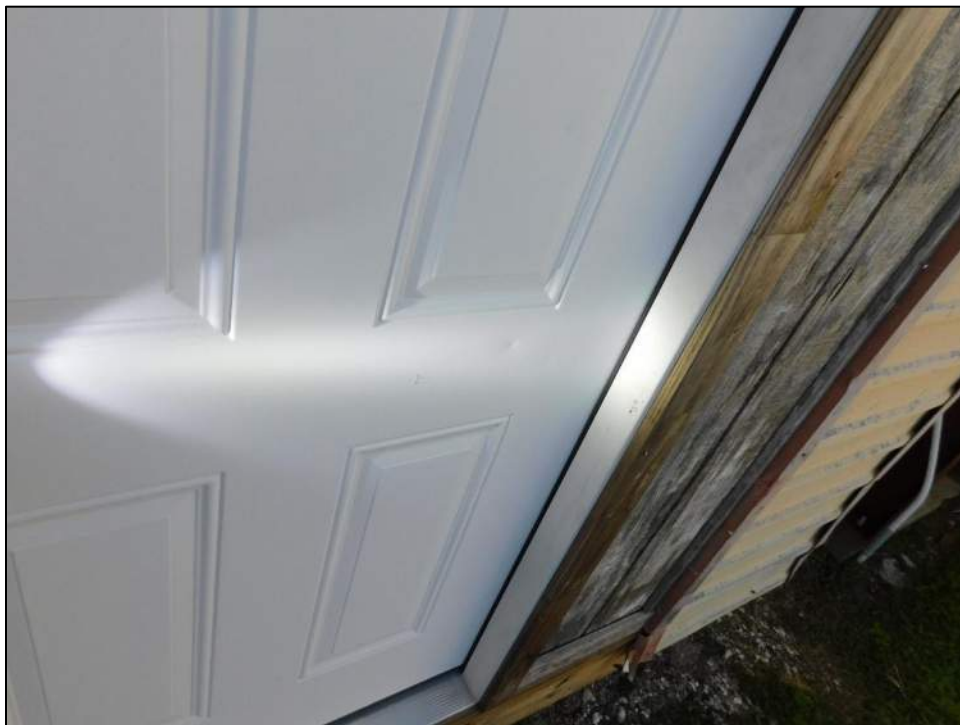
**Photo 89:** Isolated hail denting observed on the north-facing door of the storage building.

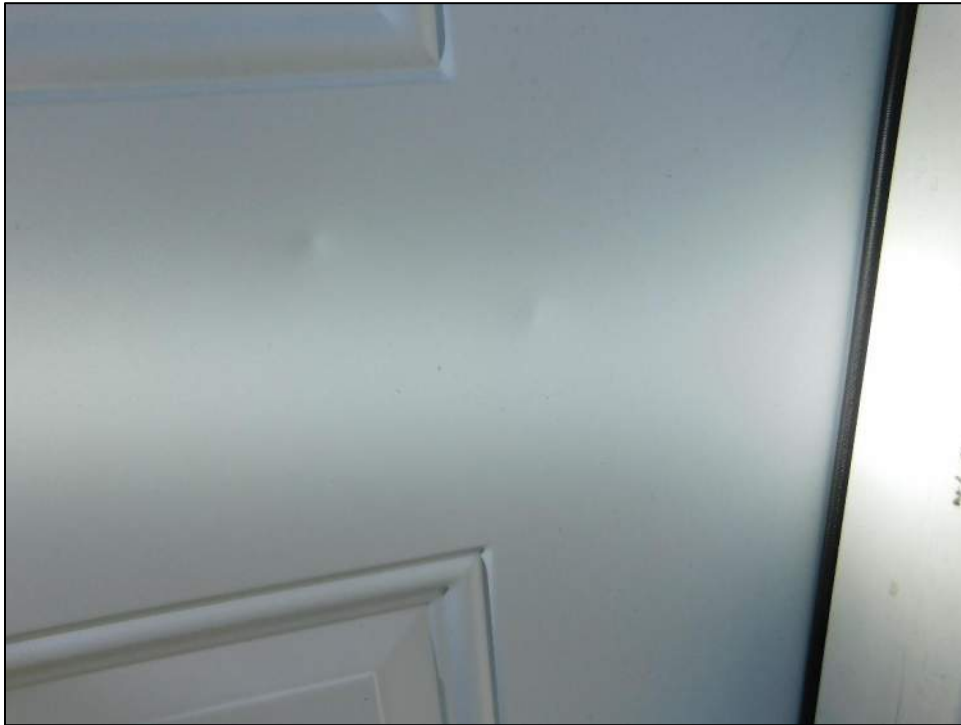
**Photo 90:** Closer view of the isolated denting on the front door consistent with hail impact.

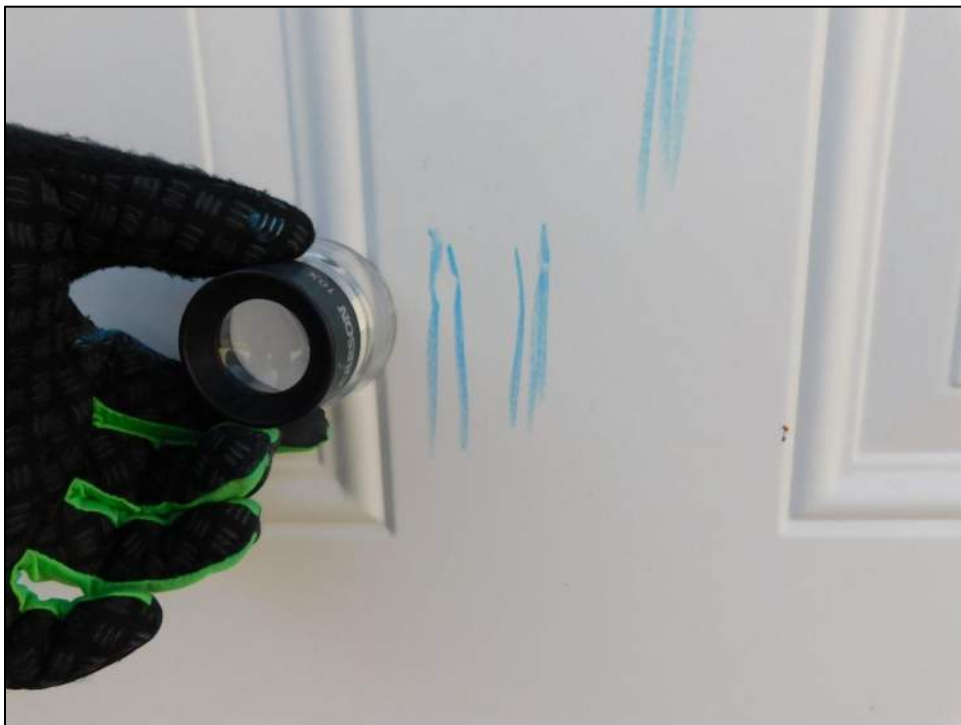
**Photo 91:** Closer view indicated no coating disruption to the dented door surface.

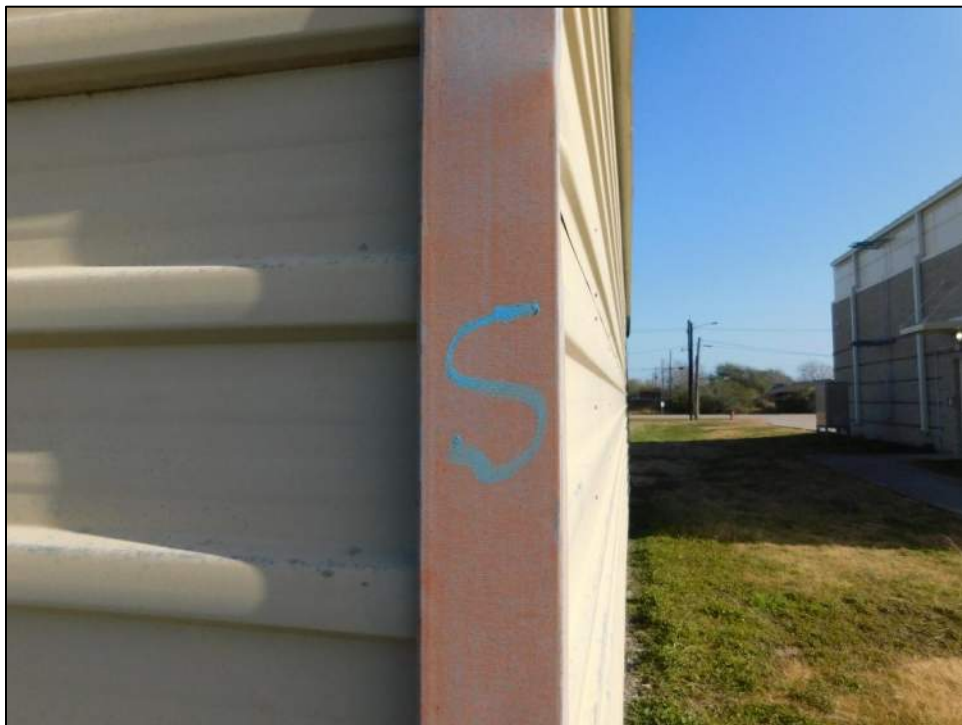
**Photo 93:** No hail spatters on south wall.

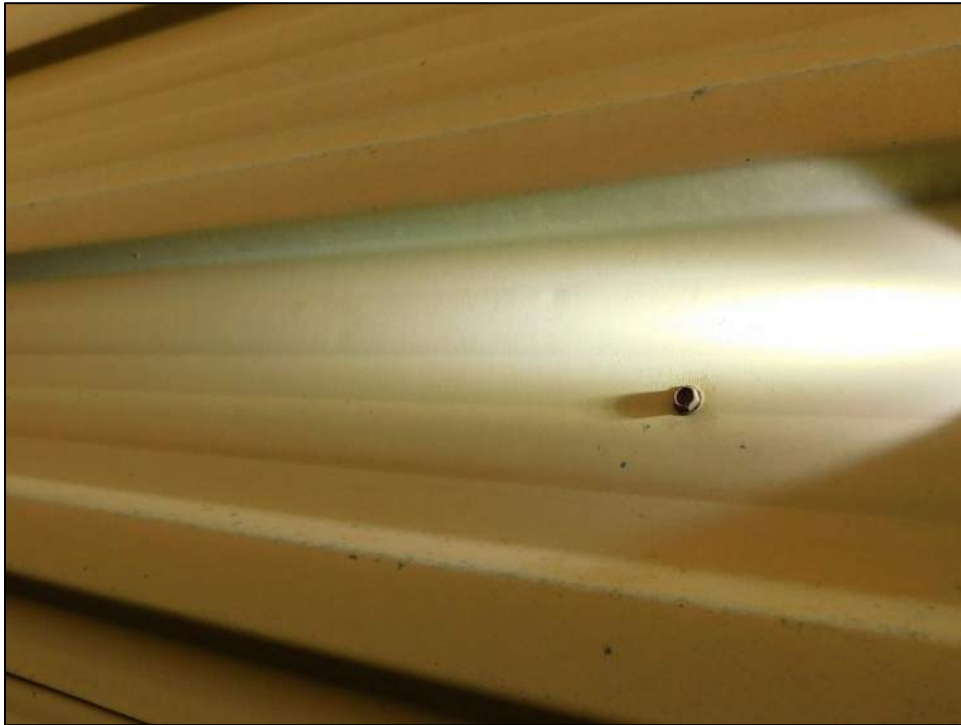
**Photo 94:** Slight denting observed on the west wall of the storage building.

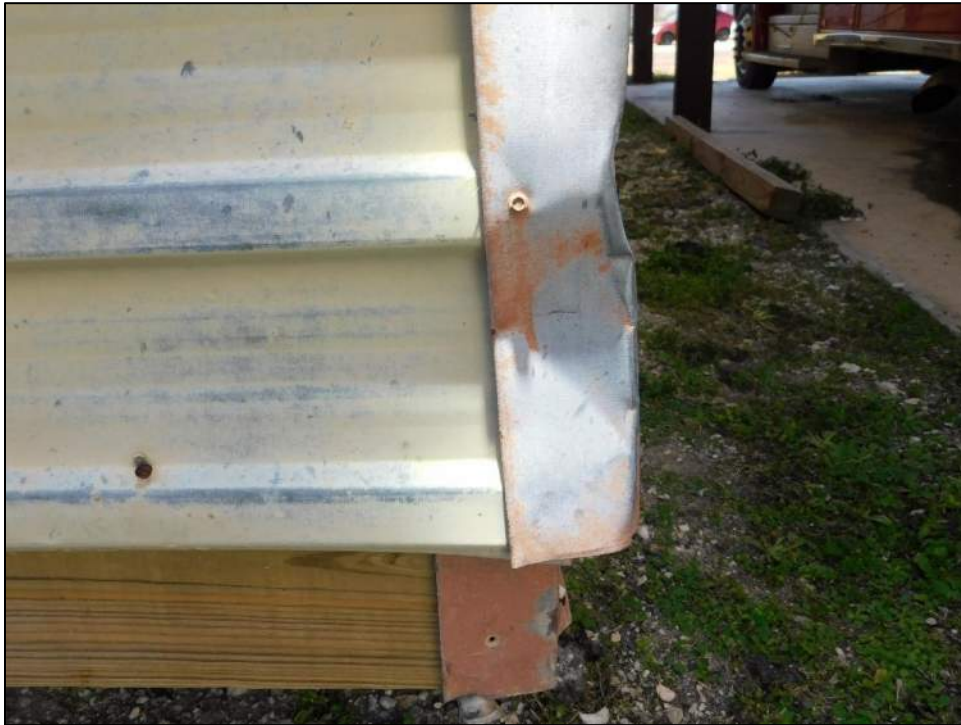
**Photo 96:** Crushed edge trim at northwest corner of the storage building that was inconsistent with hail impact.

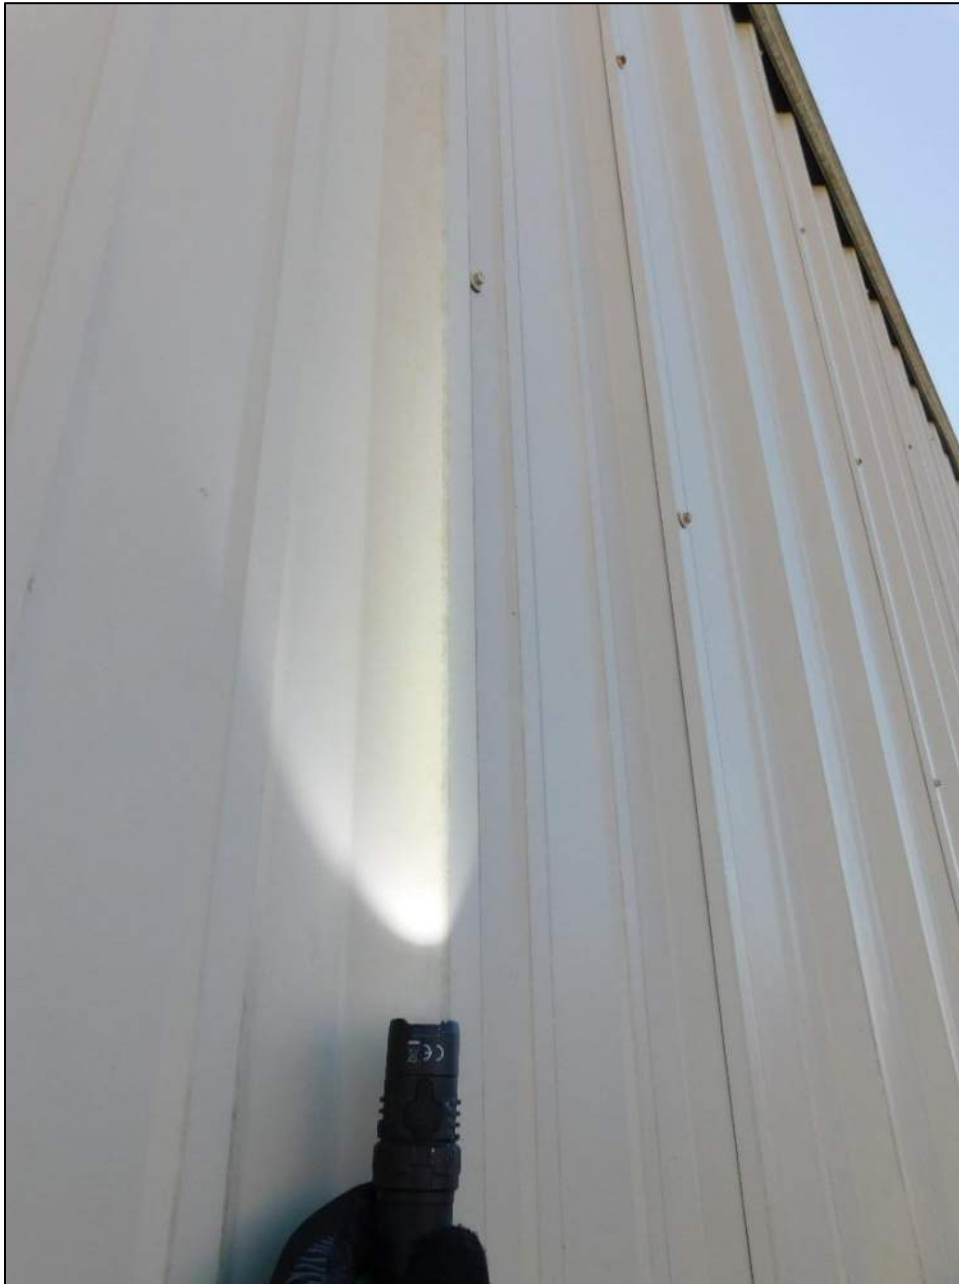
**Photo 98:** No hail indentations observed on the metal R-panel walls in the north elevation.

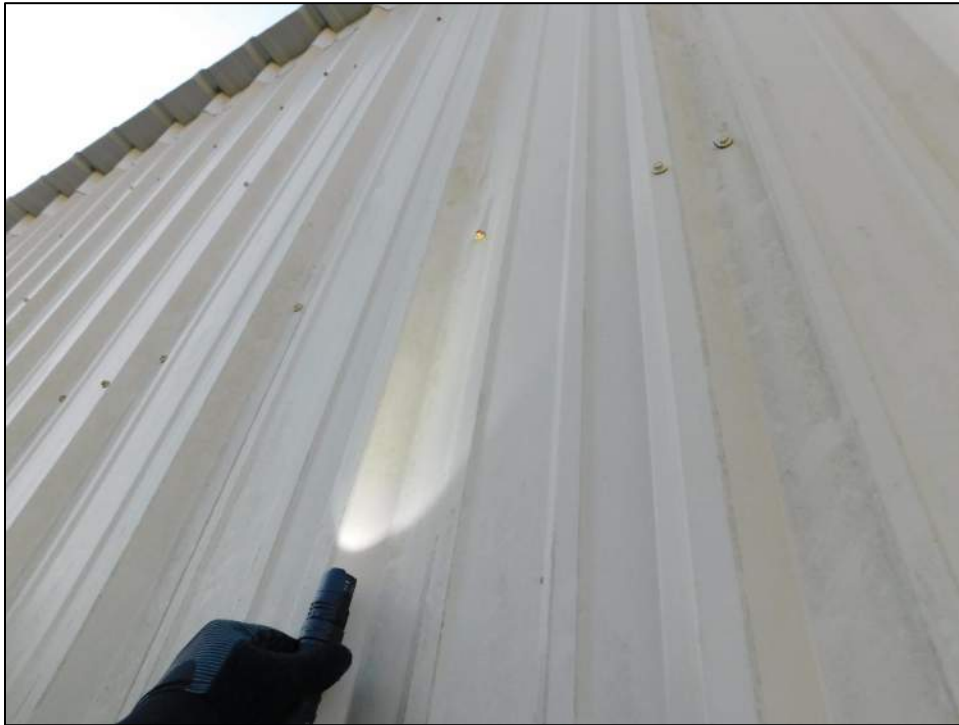
**Photo 99:** No hail indentations observed on the metal R-panel walls in the north elevation.

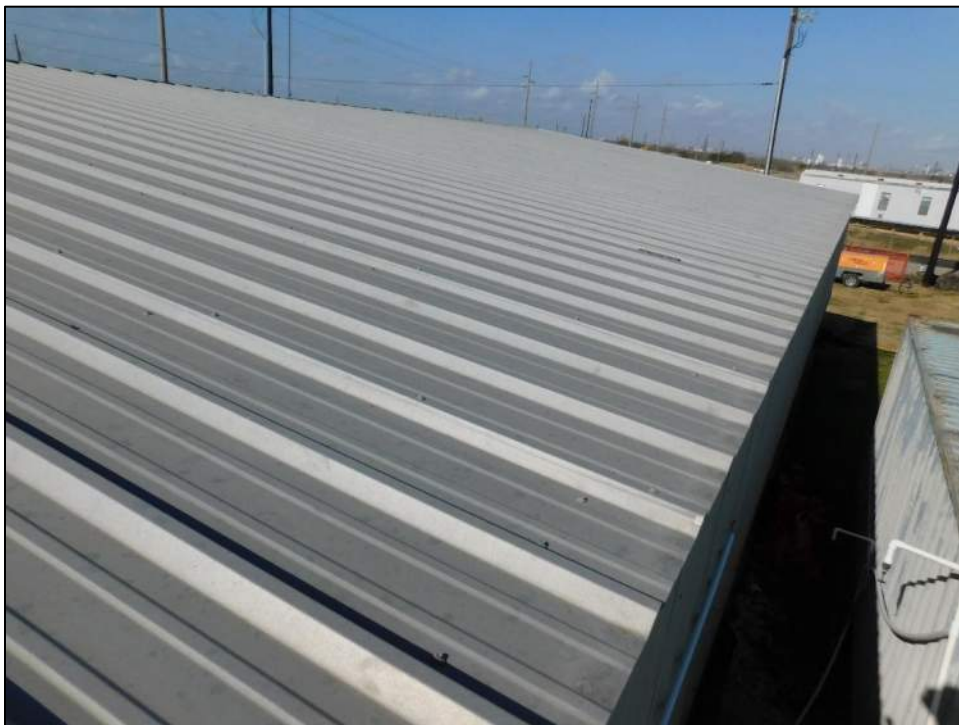
**Photo 100:** Roof overview. North roof eave remained linear and coplanar.

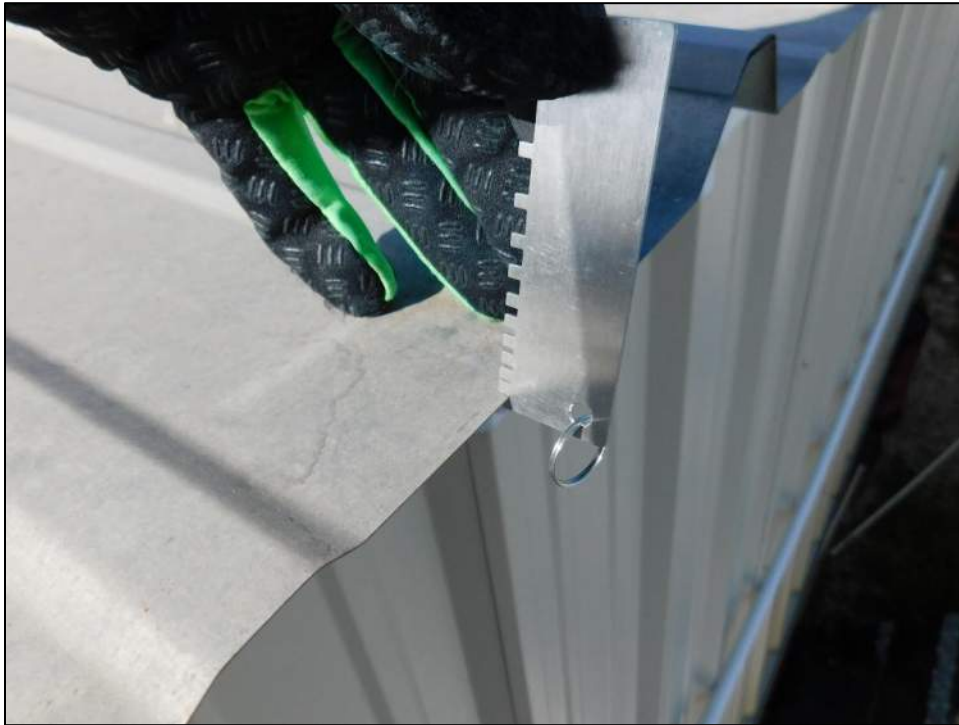
**Photo 101:** 24-gauge metal panel.

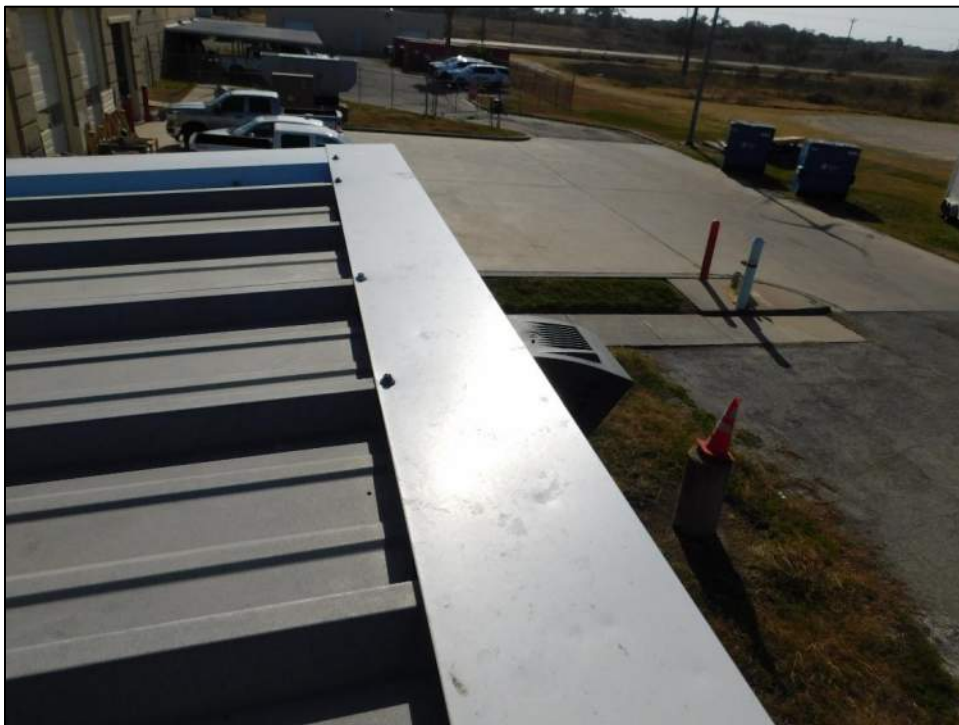
**Photo 102:** Dented closure along south roof eave consistent with hail impact.

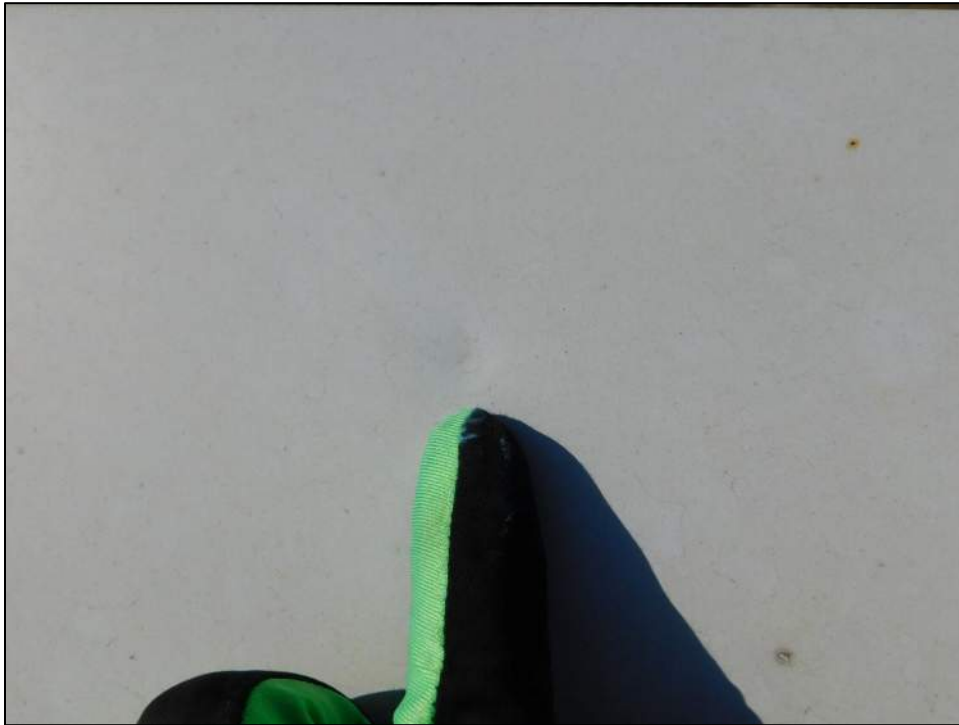
**Photo 103:** Hail denting on the closure metal exhibited no disruptions to the surface coating.

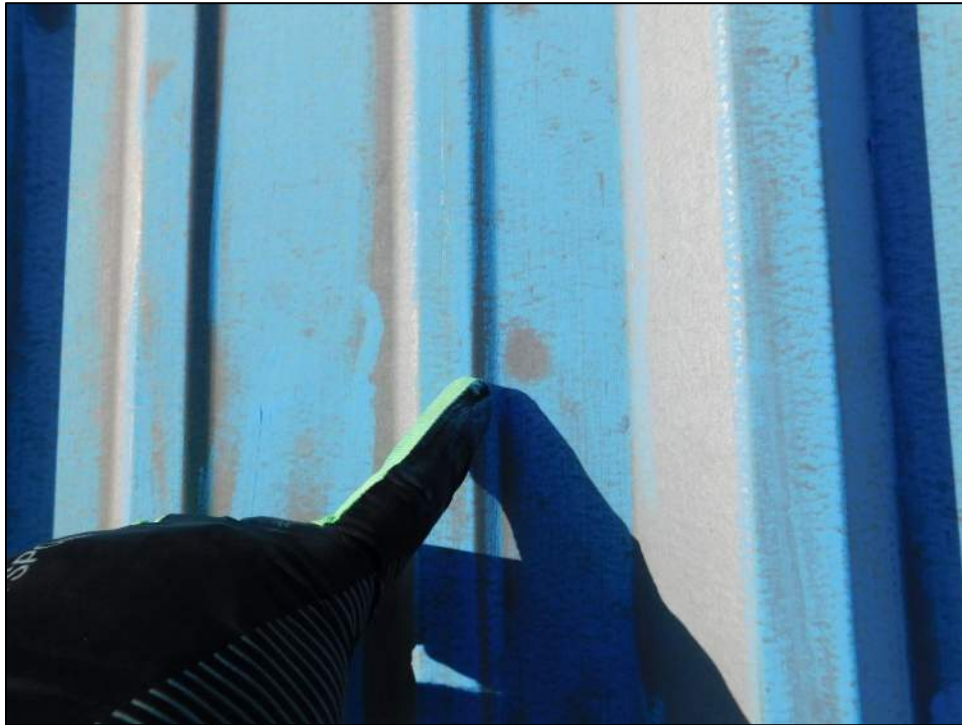
**Photo 105:** Hail denting observed on the galvalume metal roof decking had maximum inner diameter of less than 1/2 inch.
