**CITY OF INGLESIDE  
REGULAR CITY COUNCIL MEETING  
AGENDA  
JUNE 9, 2026  
6:30 PM**

Report on November 01, 2025, Hailstorm Damage to City of Ingleside Buildings.

### Building Damage Analysis Survey and Report

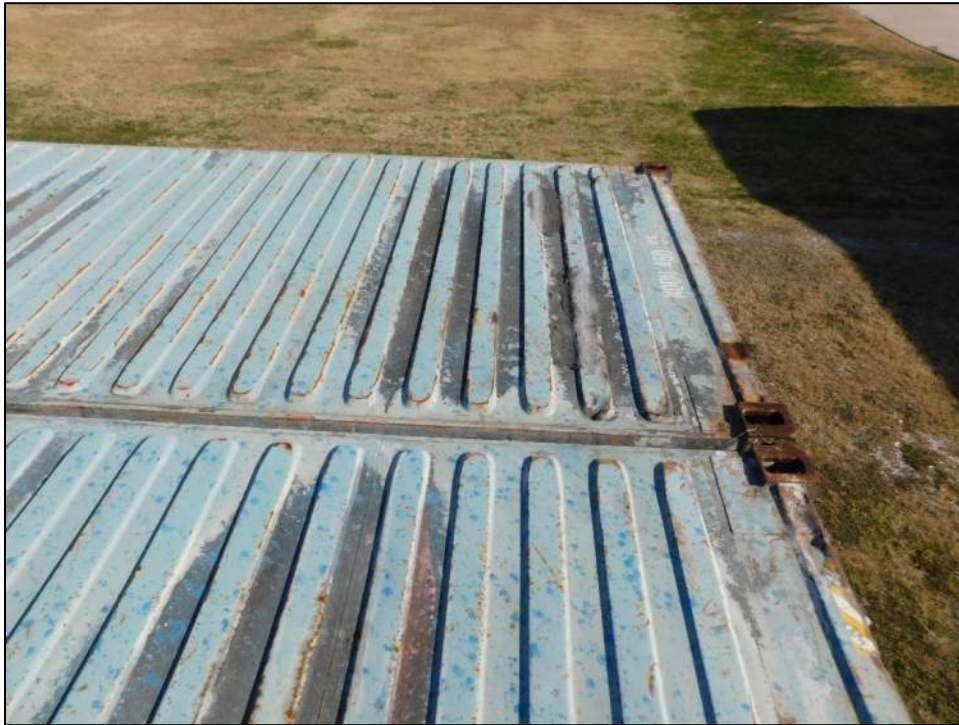
**Photo 109:** Container storage located along the north side of the vehicle storage building exhibited hail spatters widespread rusting.

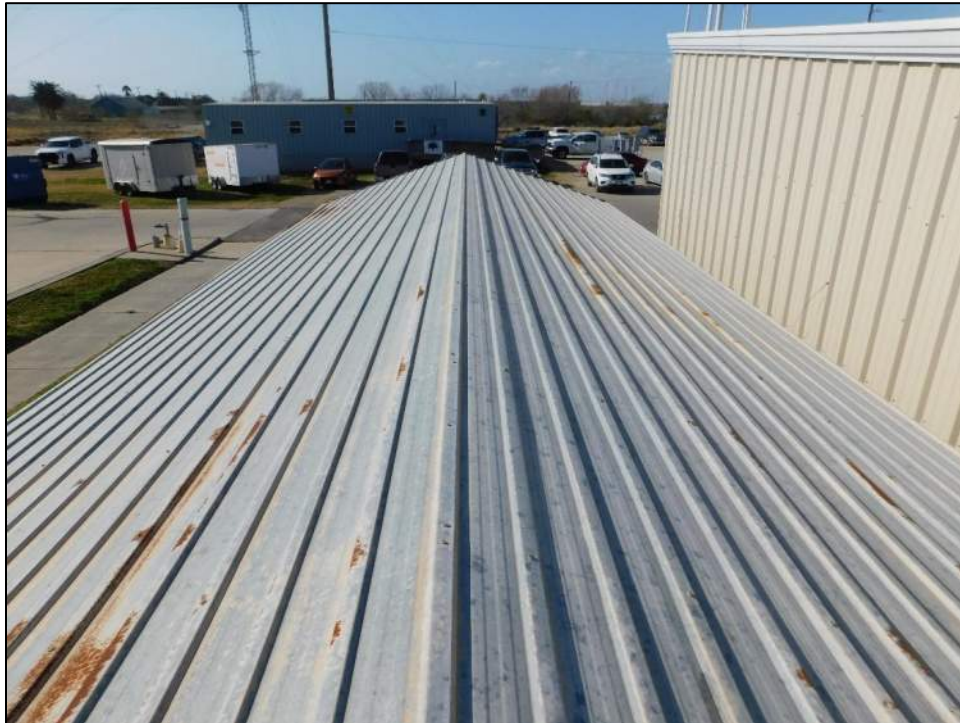
**Photo 111:** Roof of the storage building (relocated from east side of the police department building).

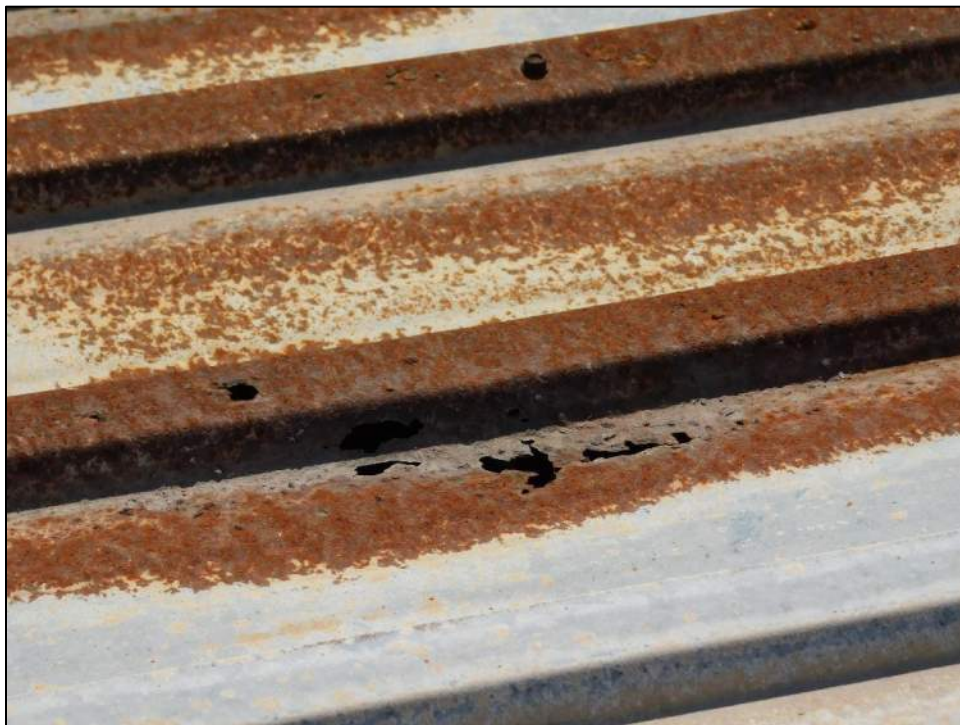
**Photo 112:** The storage building were severely corroded.

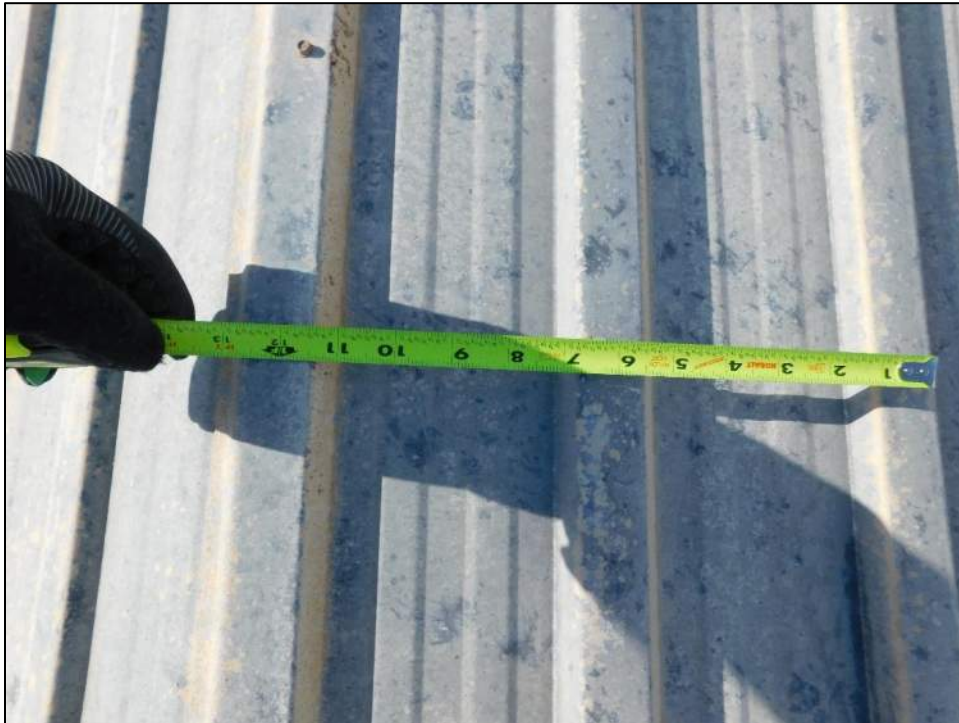
**Photo 113:** Spatter marks on the storage building roof reflect 1.0-inch hail.

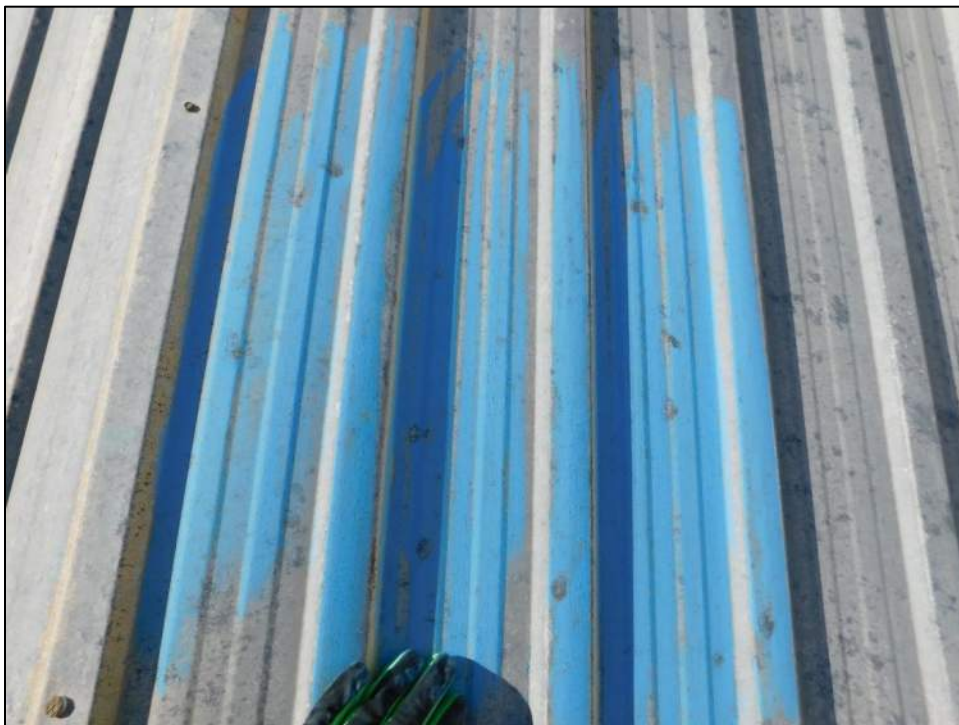
**Photo 114:** Hail denting on the storage building roof were less than 1/2 inch in inner diameter.

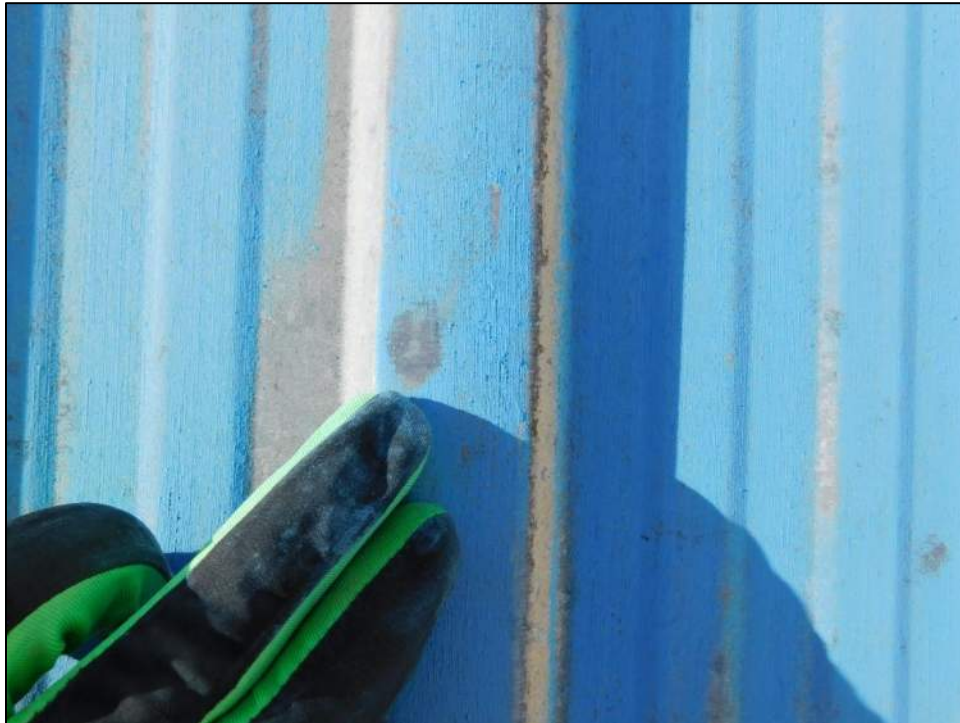
**Photo 115:** No coating disruptions were observed at the hail dents.

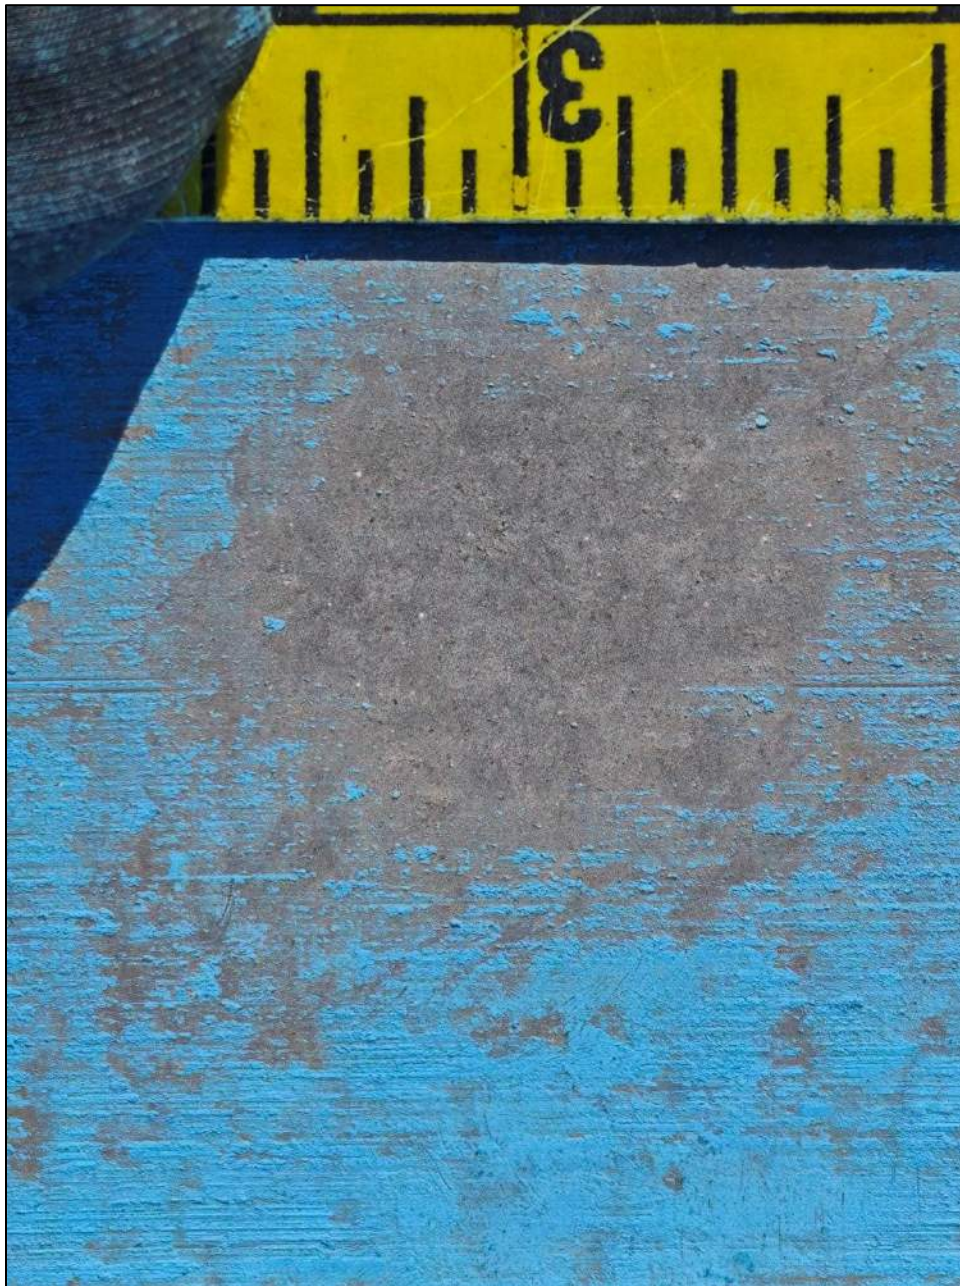
**Photo 117:** No coating disruptions were observed at the hail dents.

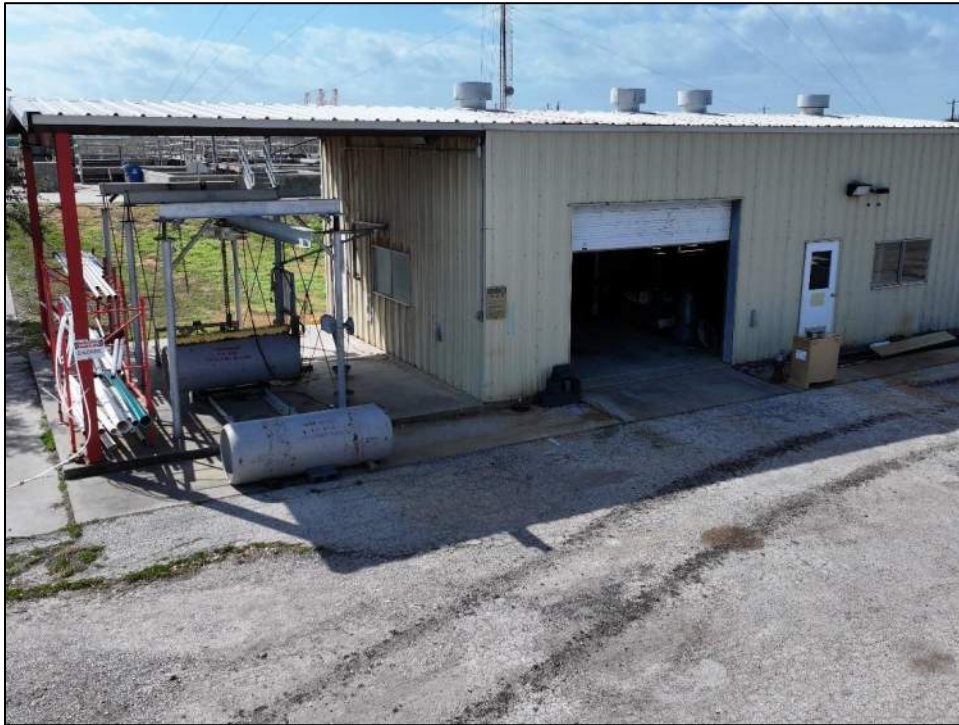
**Photo 1:** Front (north) elevation of the electrical (waste water pump room) building.

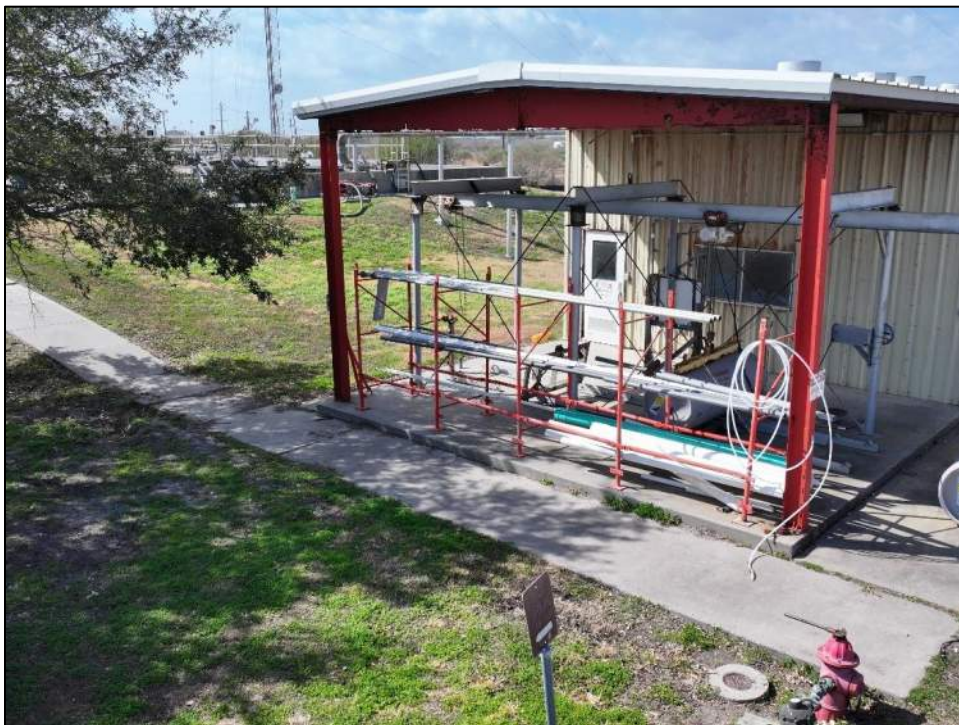
**Photo 2:** East canopy extension to the electrical building.

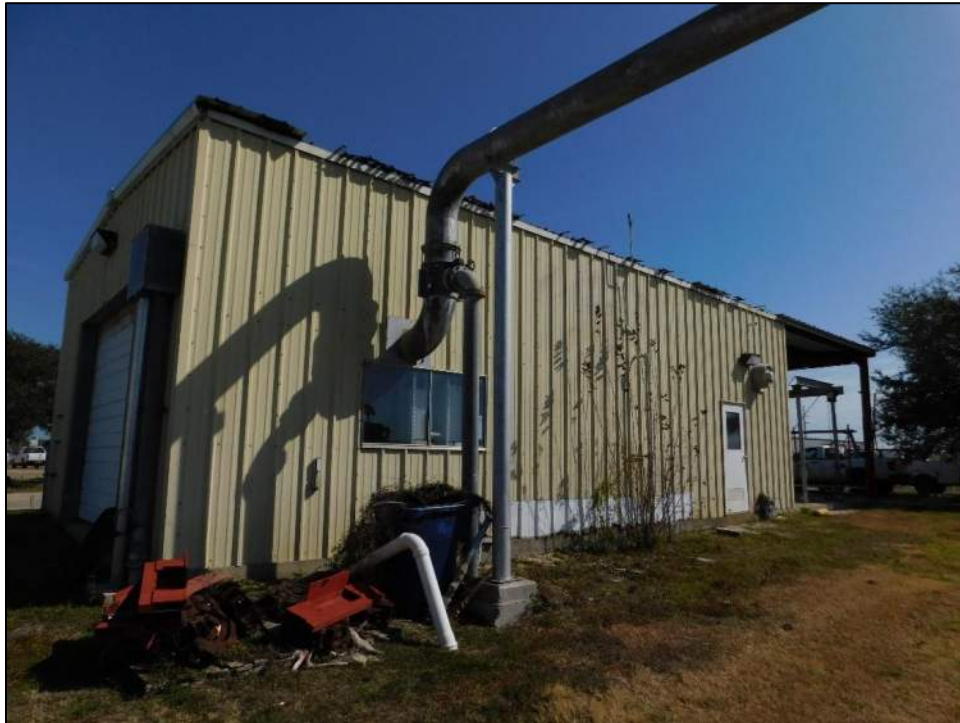
**Photo 5:** Rear (south) elevation.

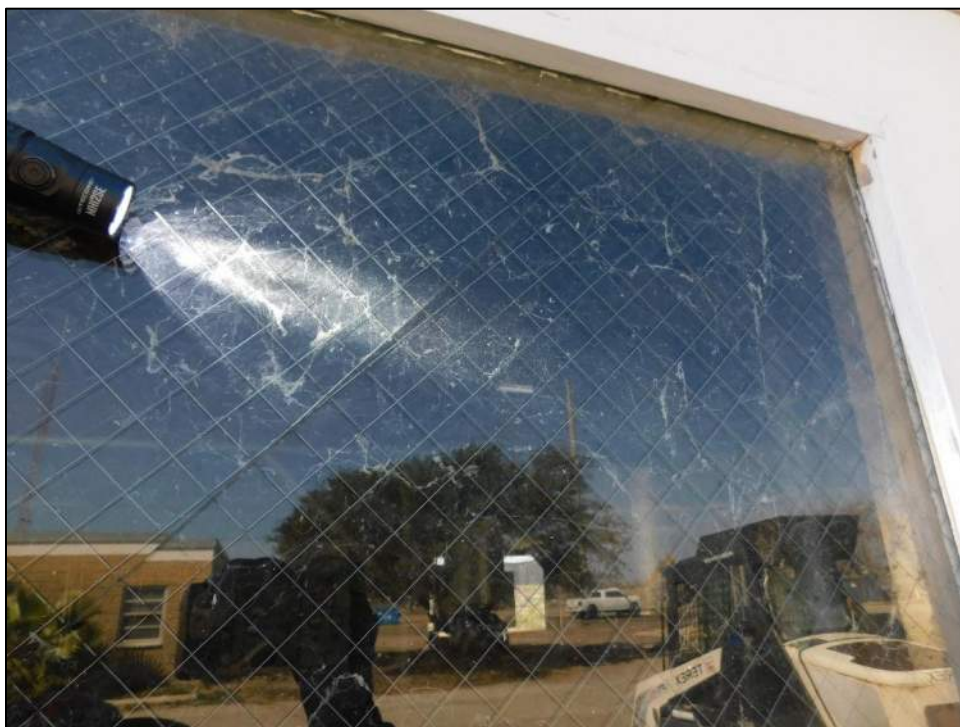
**Photo 6:** Cracked door glazing showed soiling along the crack edges.

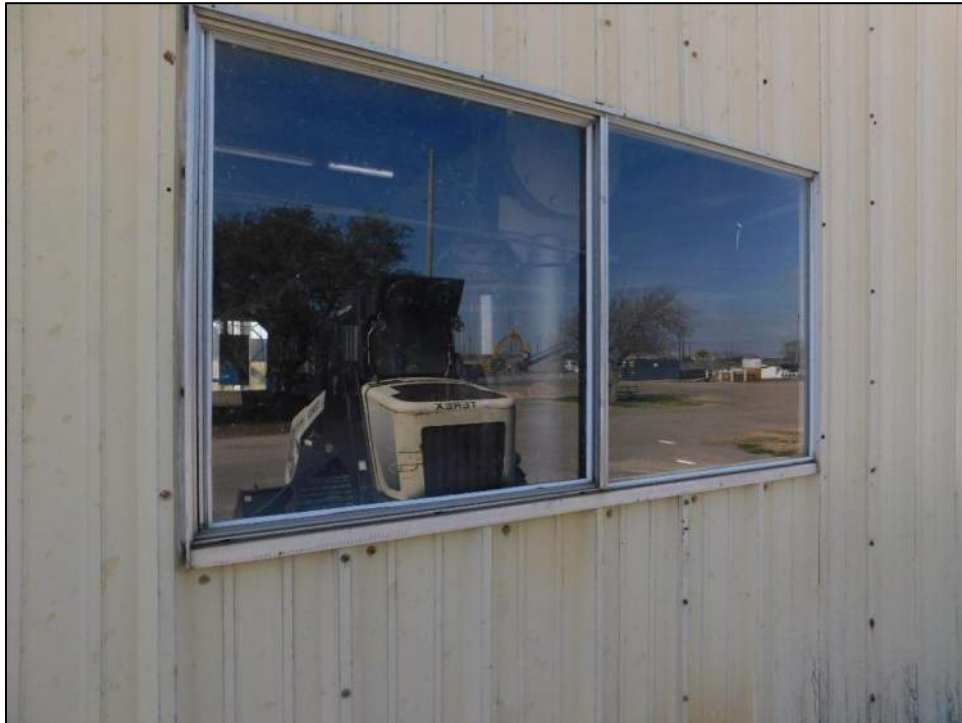
**Photo 7:** North wall windows remained intact.

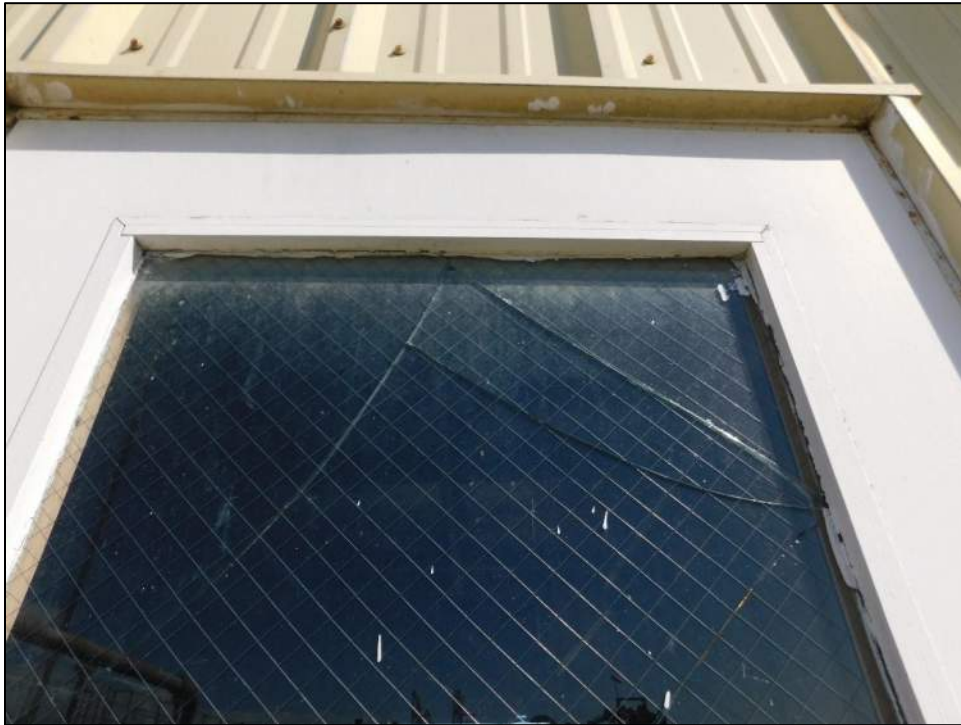
**Photo 12:** Cracked door glazing in the south (rear) wall unaffected by hail impact.

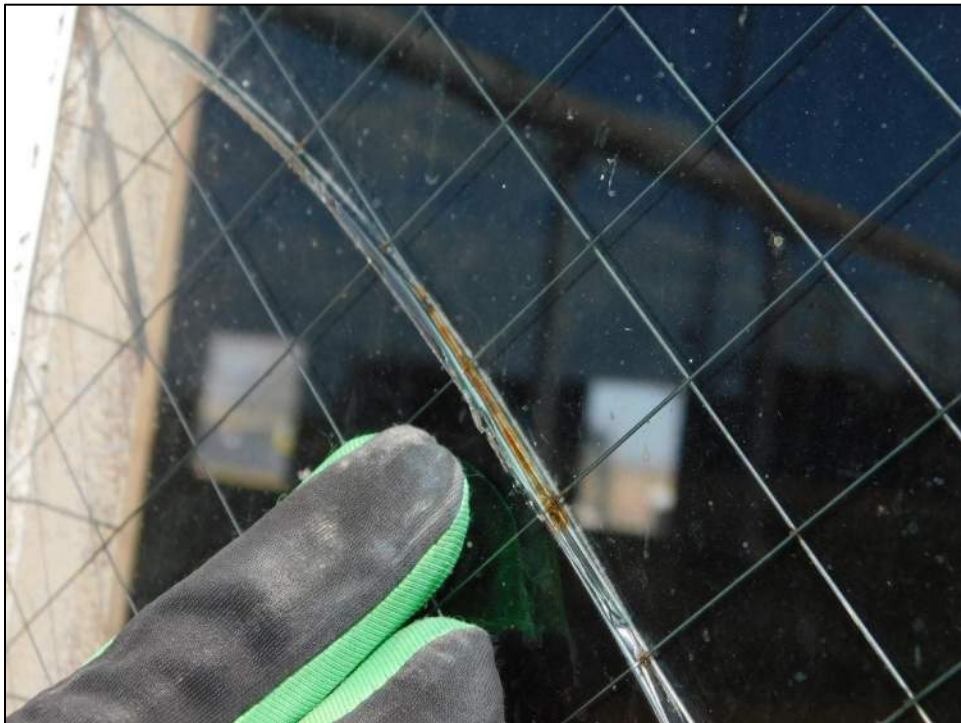
**Photo 13:** Close-up of the soiled and stained crack edges in the south door glazing cracks.

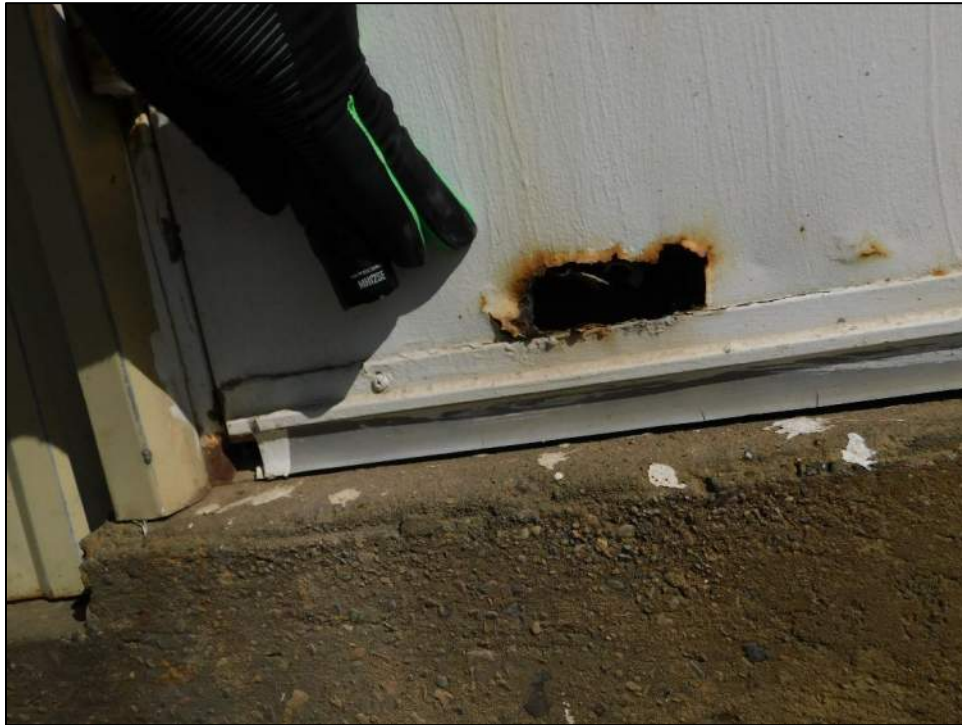
**Photo 14:** Corrosion at the bottom of the south entry door.

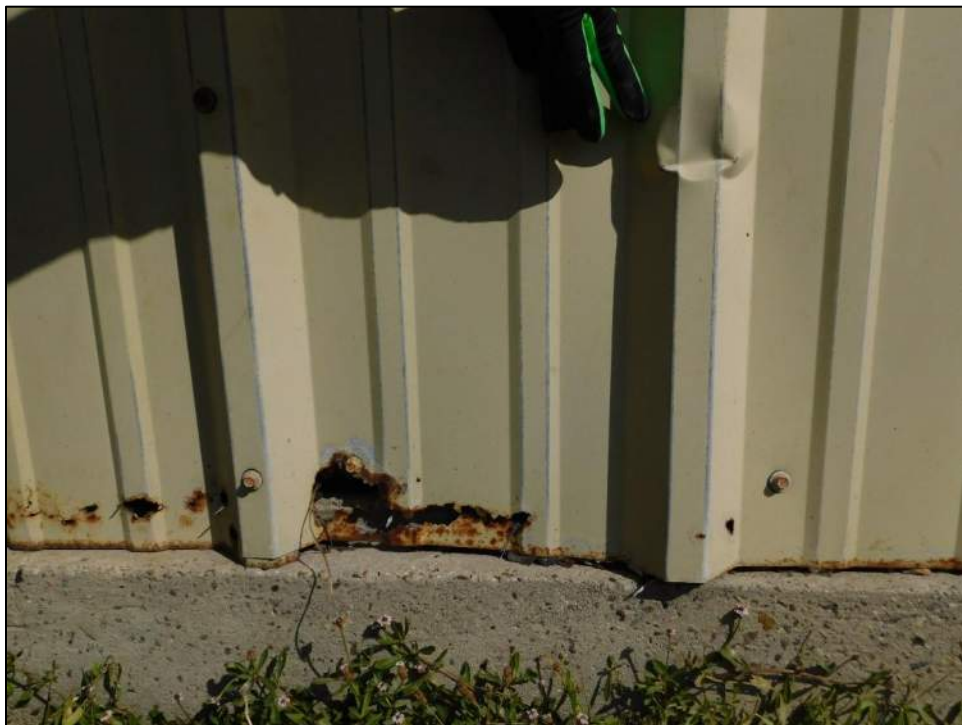
**Photo 15:** Wall panel mechanical denting and corrosion at the bottom of the south wall.

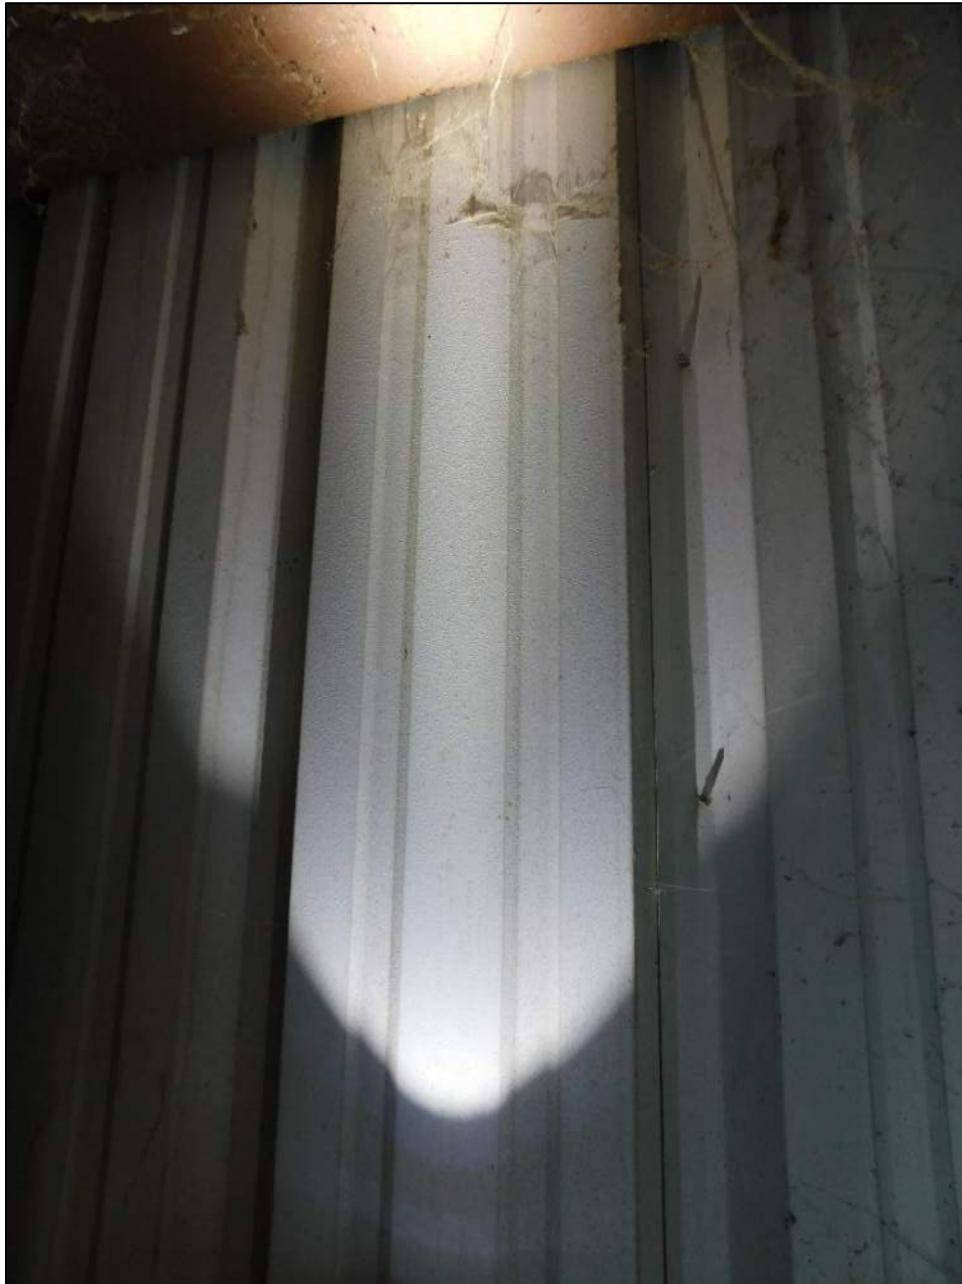
**Photo 17:** No hail denting observed on the interior surface of the north walls where hail spatters were observed on the exterior surfaces.

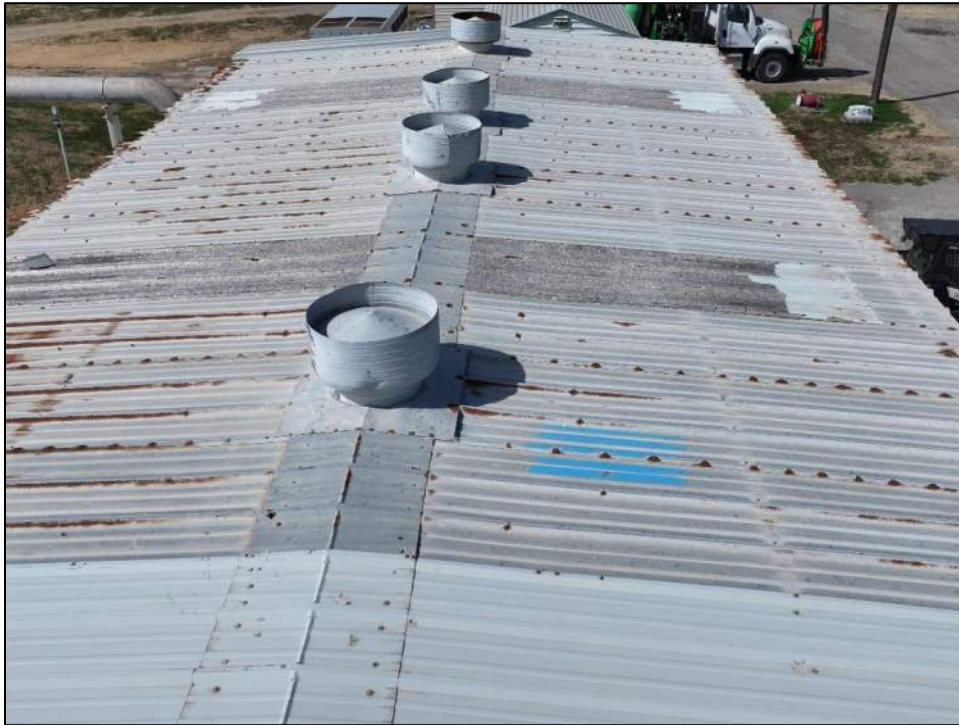
**Photo 18:** Roof overview. Note widespread corrosion deteriorated skylight panels (partially underlaid with metal panels) and panel overlays.

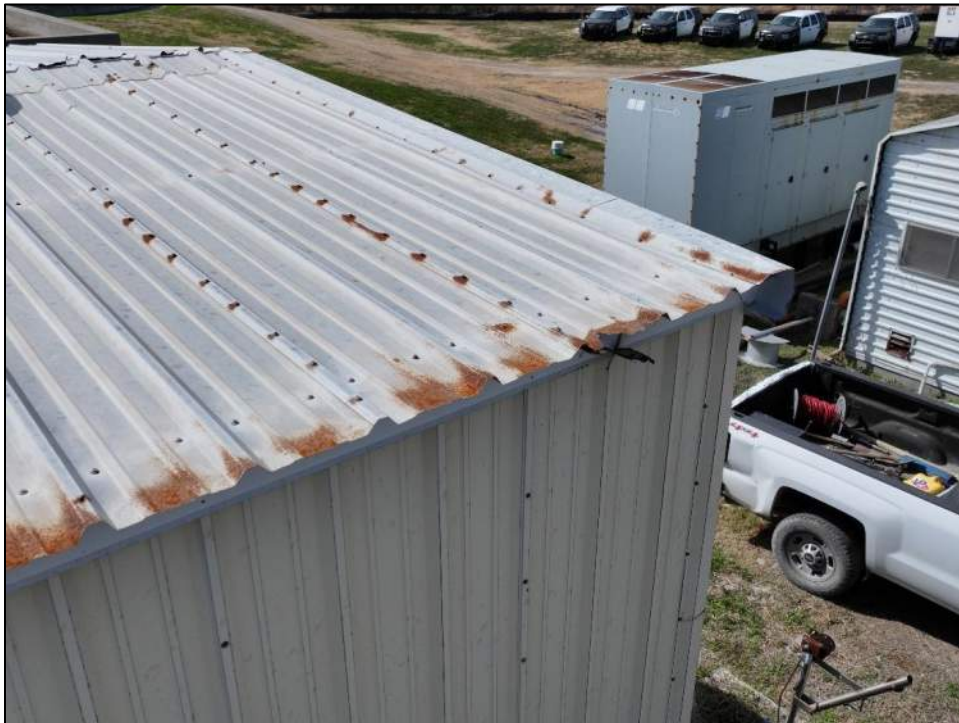
**Photo 19:** typical roof edge corrosion.

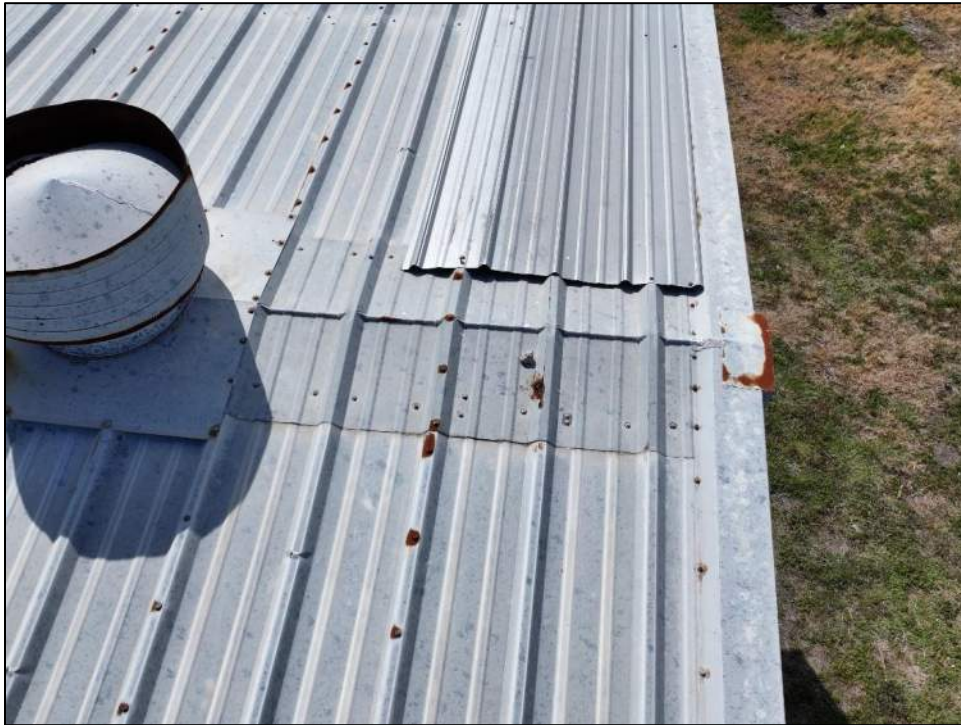
**Photo 20:** Partial panel (incompatible profile) overlay.

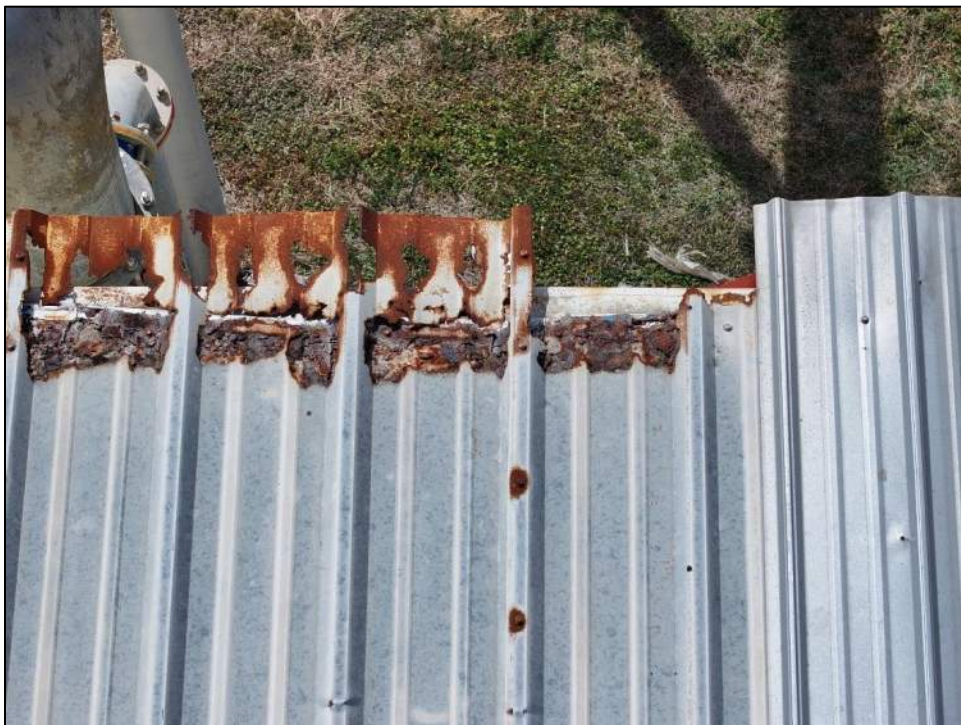
**Photo 21:** Severe south roof eave corrosion over south wall.

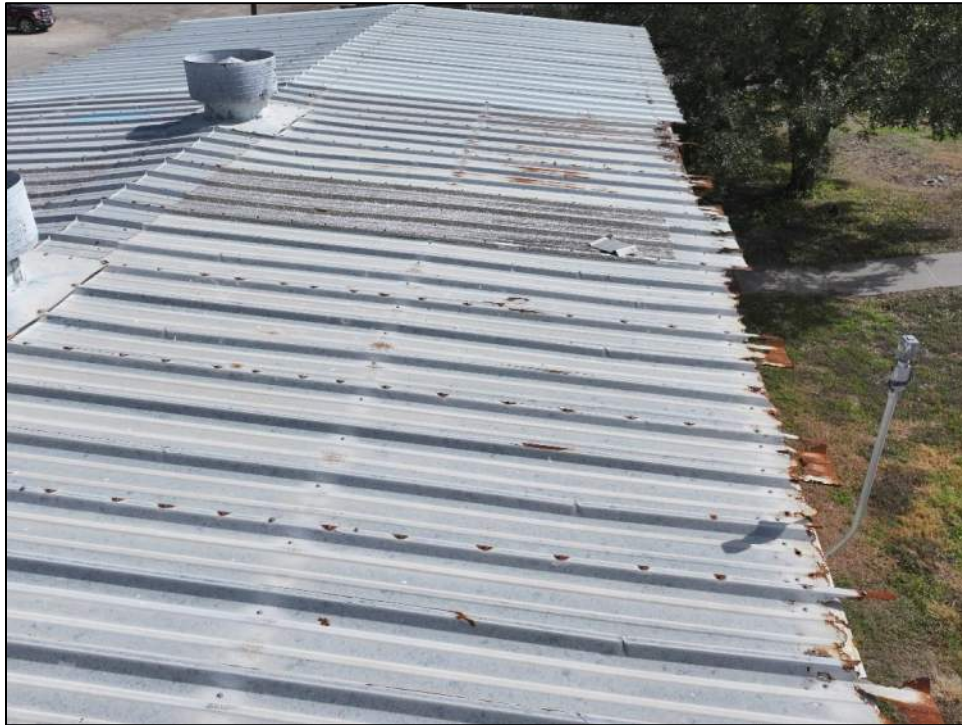
**Photo 22:** South slope overview. Note severe edge corrosion.

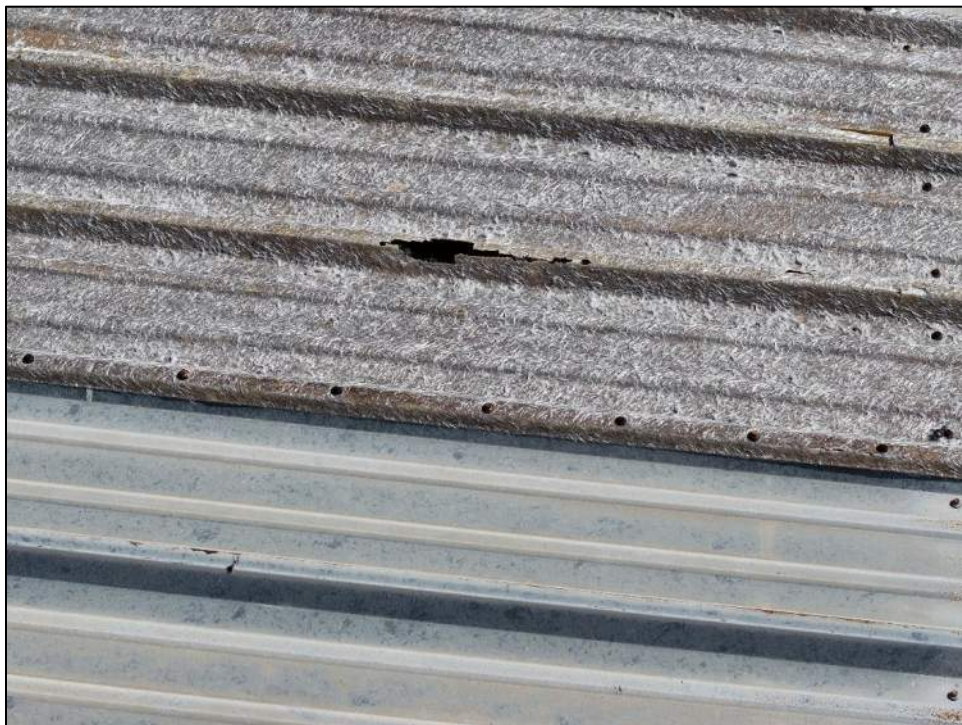
**Photo 23:** Skylight panels were highly deteriorated.

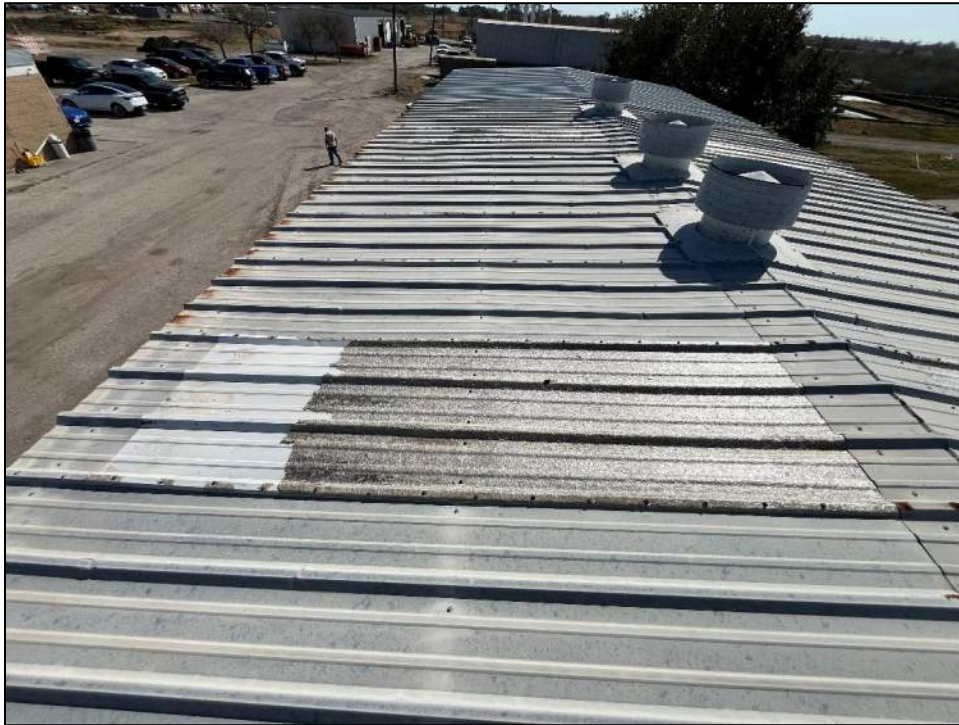
**Photo 24:** Deteriorated skylight panels were underlaid with metal panels.

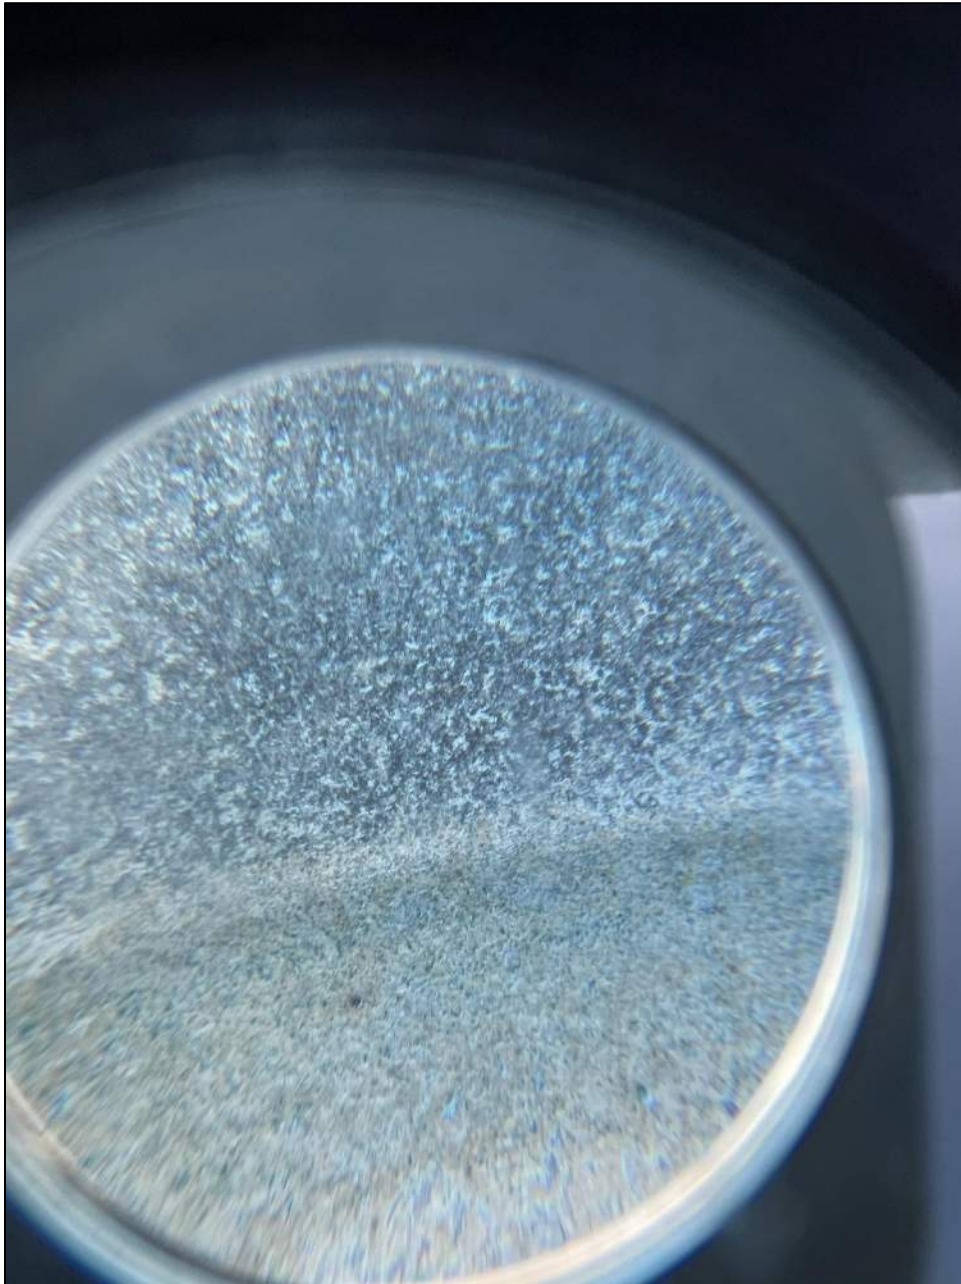
**Photo 27:** No coating disruptions were observed on the galvanized metal roof decking.

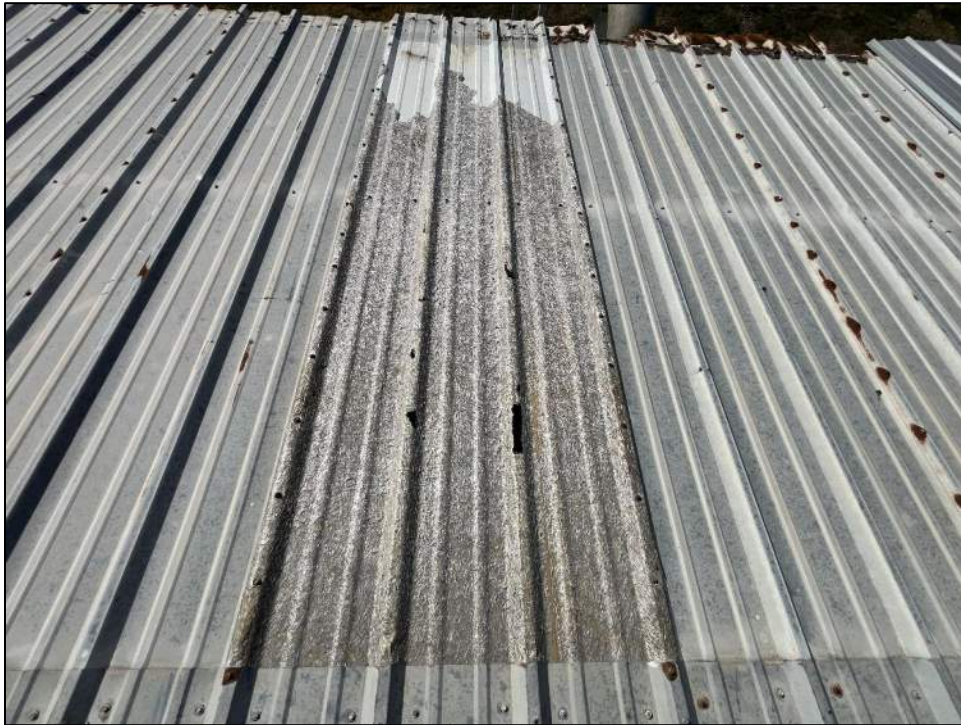
**Photo 28:** No coating disruptions were observed on the galvanized metal roof decking.

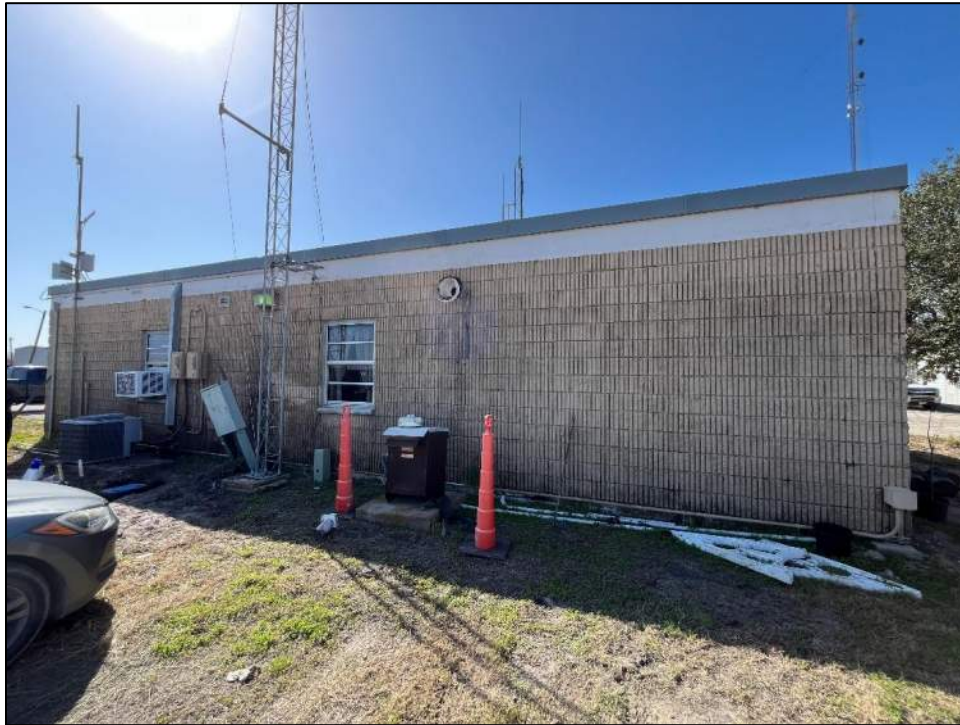
**Photo 37:** West elevation. Windows remained intact.

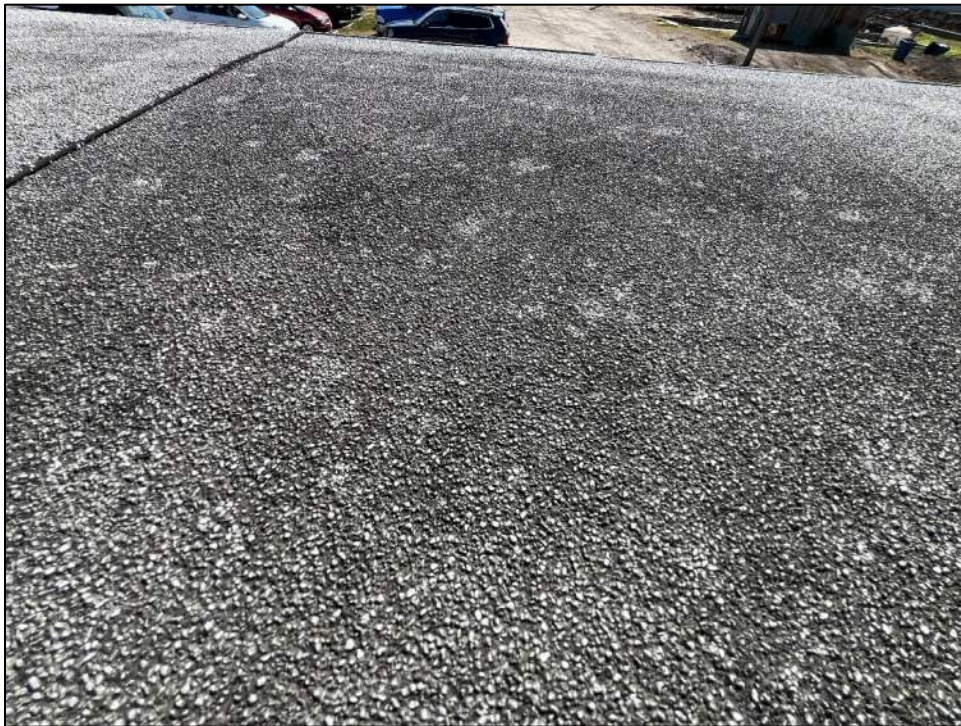
**Photo 44:** Largest hail spatter measured 1.13 inches (1-1/8) wide.

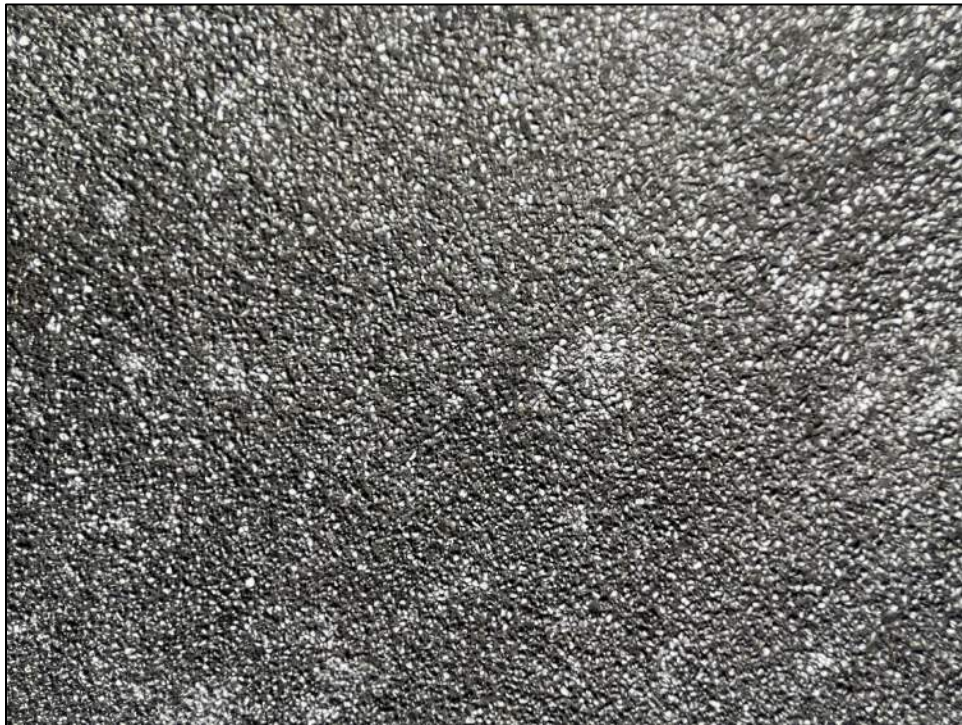
**Photo 46:** Microscope examination of the hail spatter exhibited no granule displacement due to hail impact.

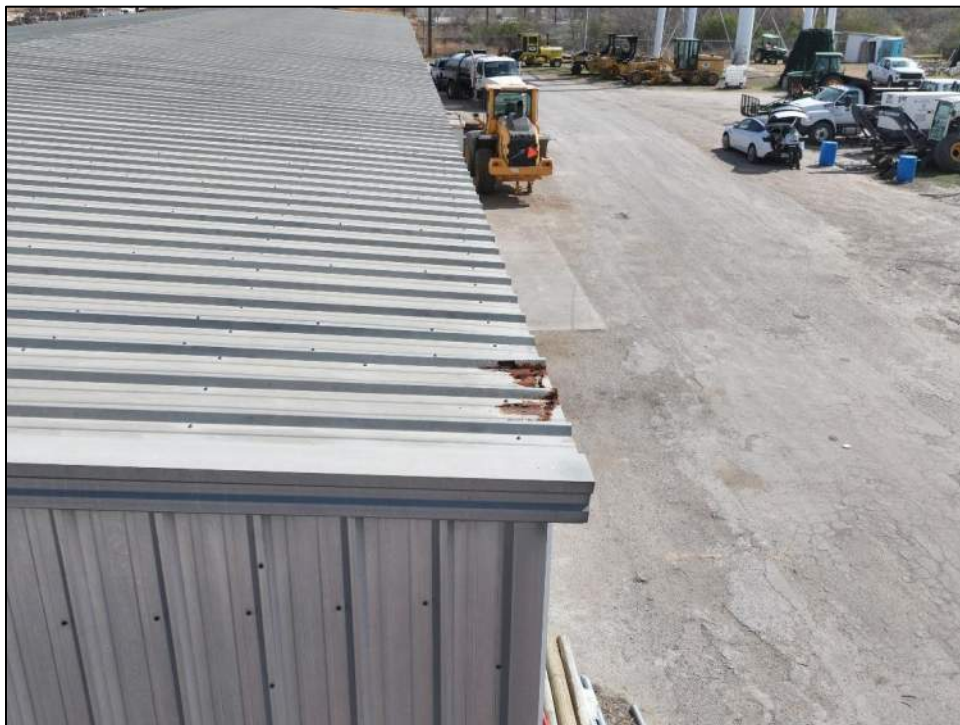
**Photo 54:** Corroded deck typically found at the four corners of the roof.
