**CITY OF INGLESIDE  
REGULAR CITY COUNCIL MEETING  
AGENDA  
JUNE 9, 2026  
6:30 PM**

Report on November 01, 2025, Hailstorm Damage to City of Ingleside Buildings.

### Building Damage Analysis Survey and Report

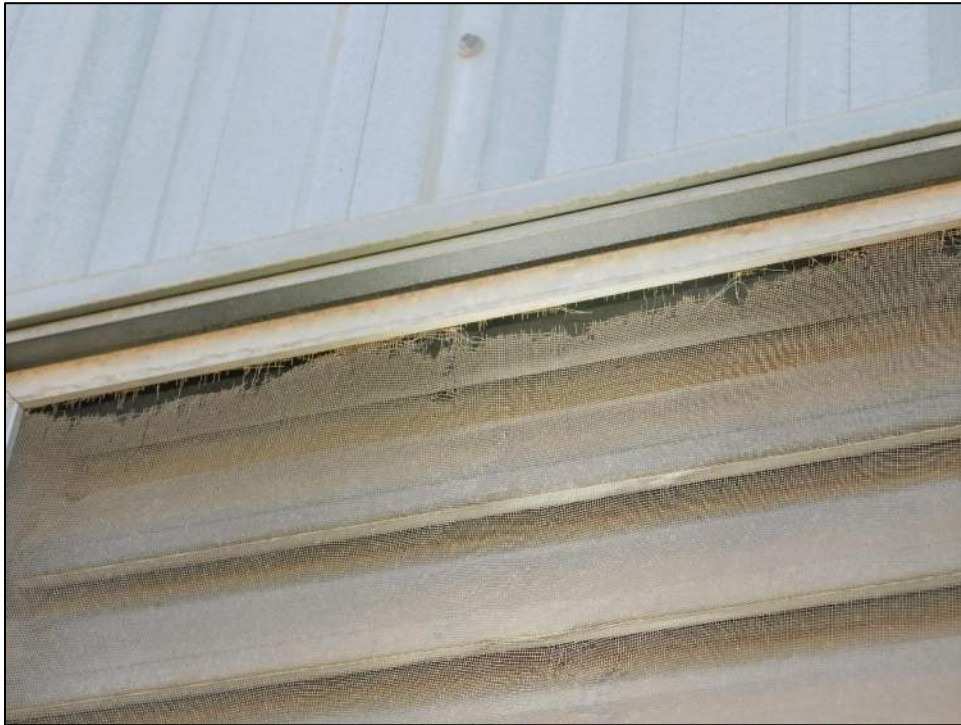
**Photo 58:** Dimpled screen in the north wall were mechanically torn.

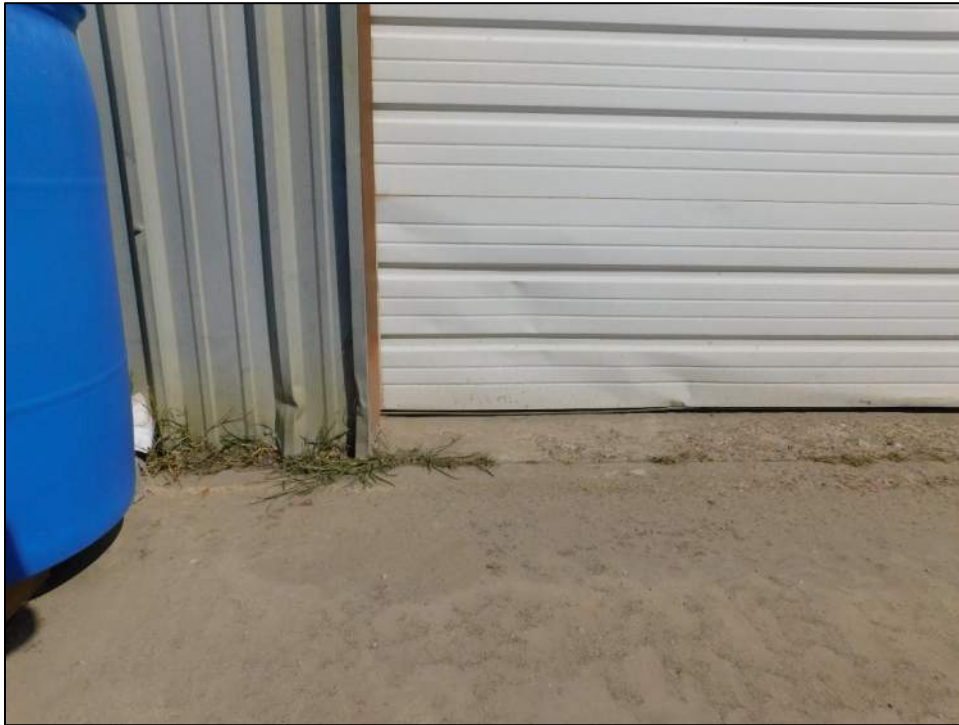
**Photo 62:** Rib creasing on west wall inconsistent with hail impact.

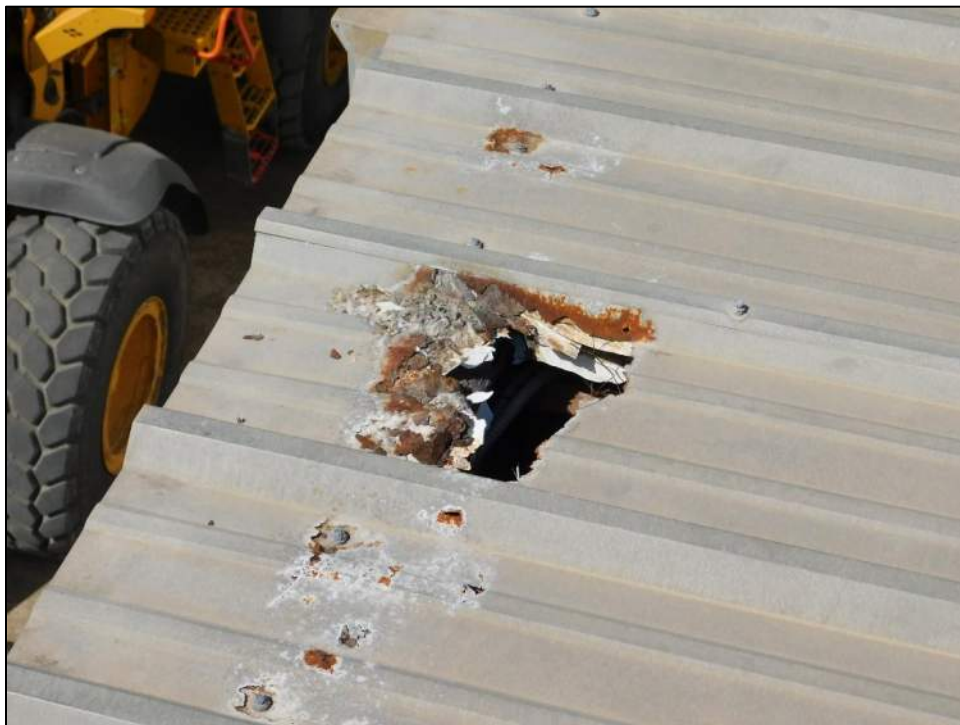
**Photo 65:** Corroded roof eave along front side of roof.

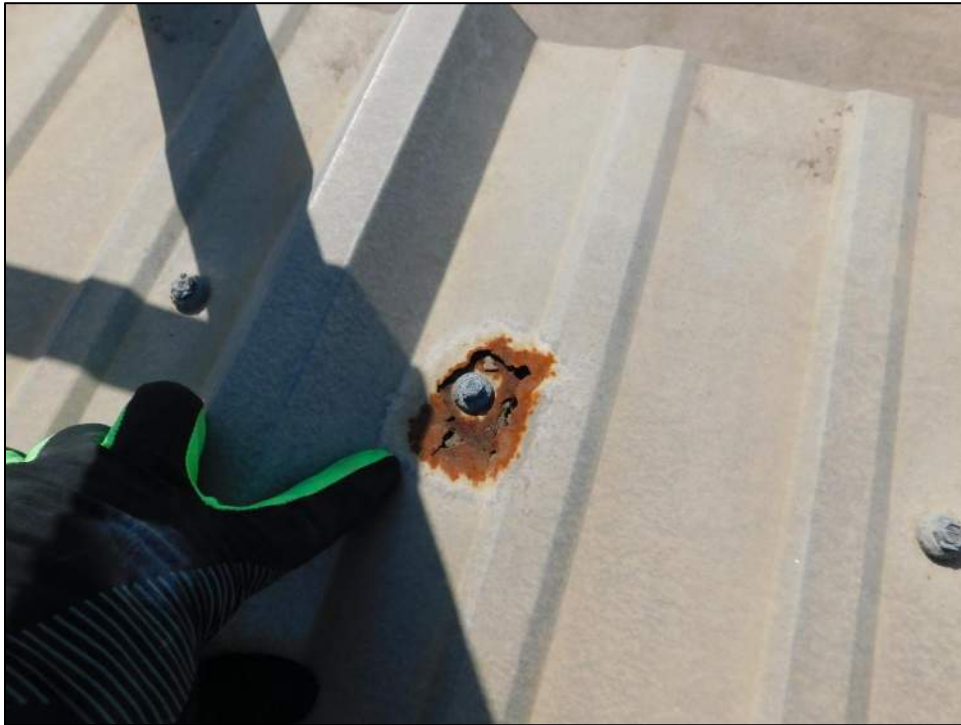
**Photo 66:** Corroded roof eave along front side of roof inconsistent with hail impact.

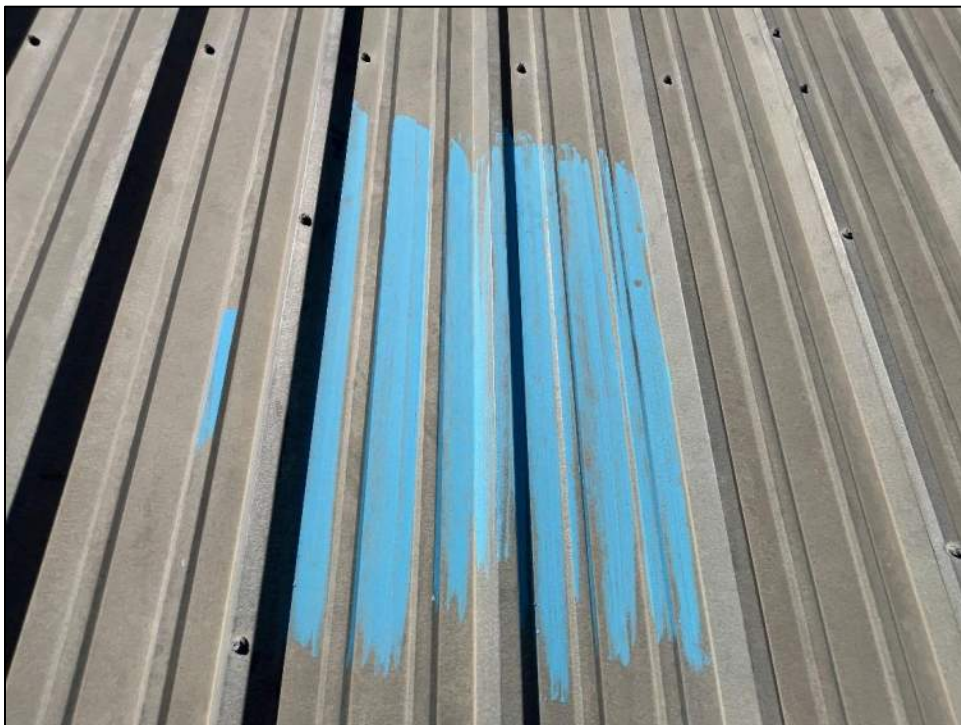
**Photo 67:** Corroded roof deck at fastener locations.

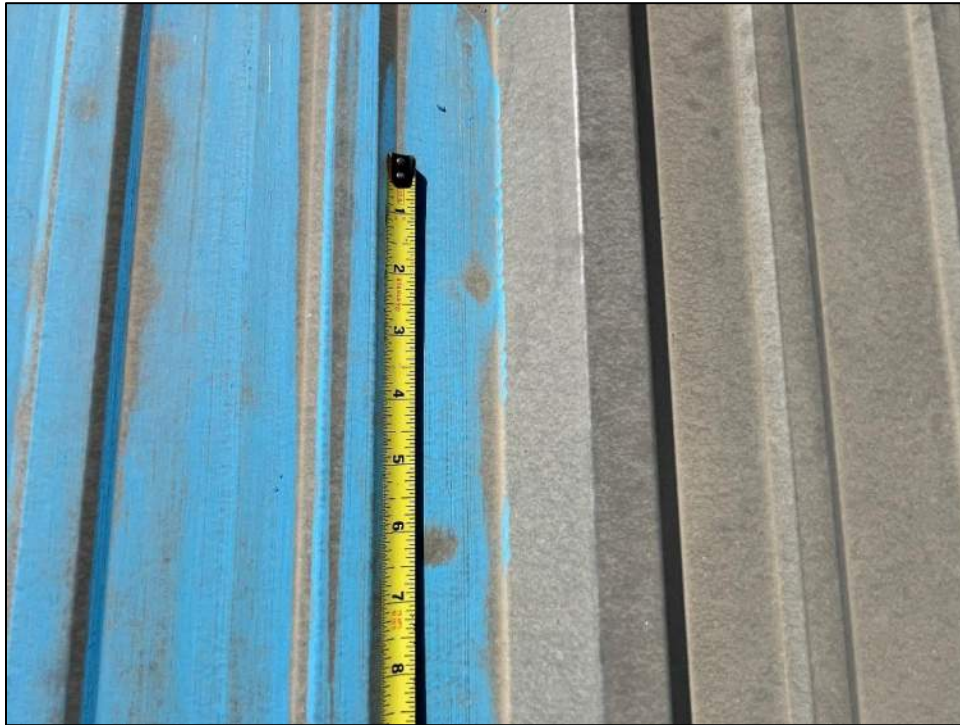
**Photo 69:** Denting in roof panels had inner diameter of less than 3/8 inch.

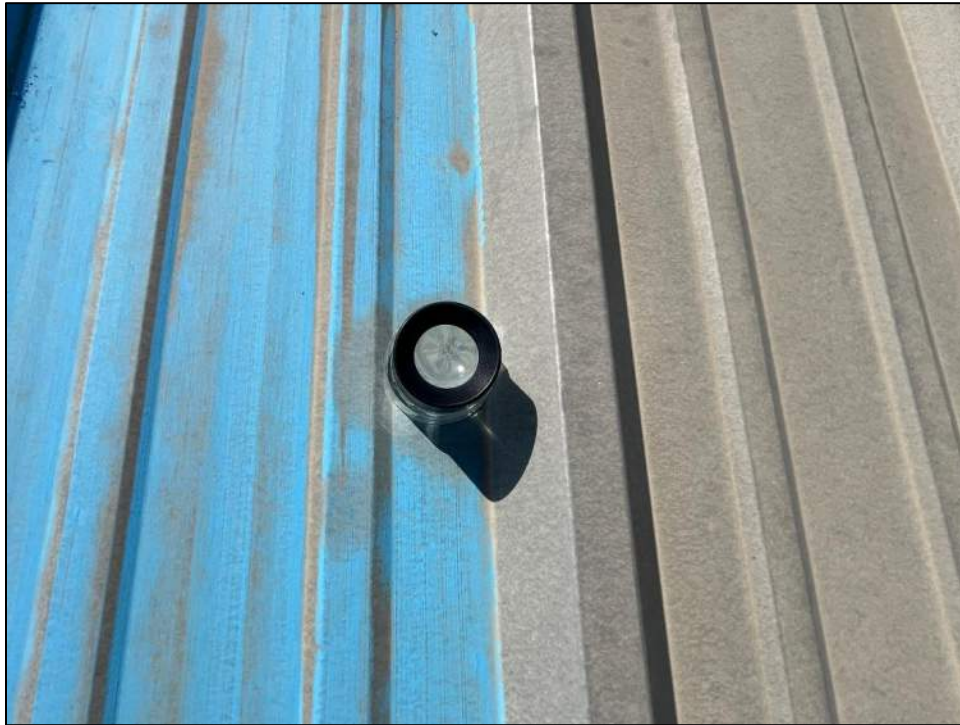
**Photo 71:** No coating disruptions were observed at the hail dents on the roof deck.

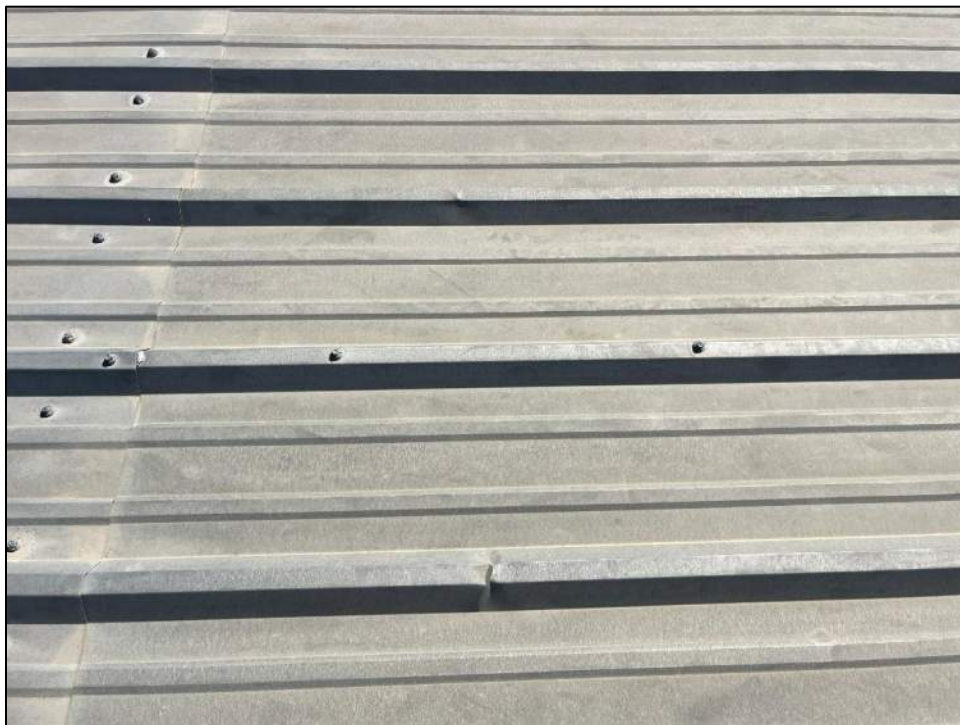
**Photo 72:** Rib creasing on roof unrelated to hail impact and consistent with foot traffic.

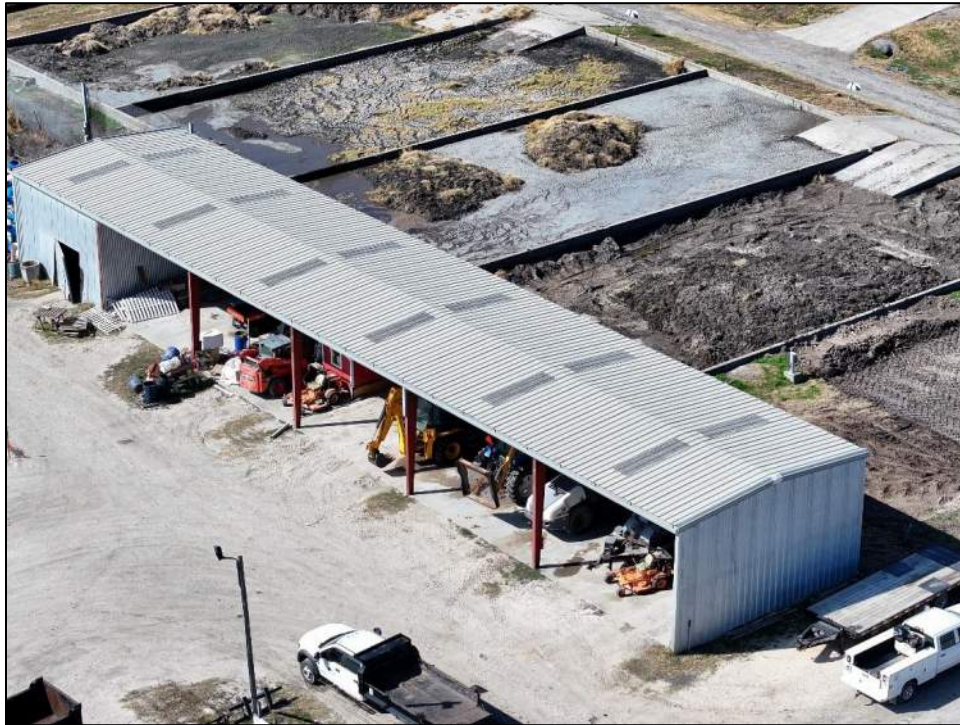
**Photo 73:** Overview of the equipment pole barn building.

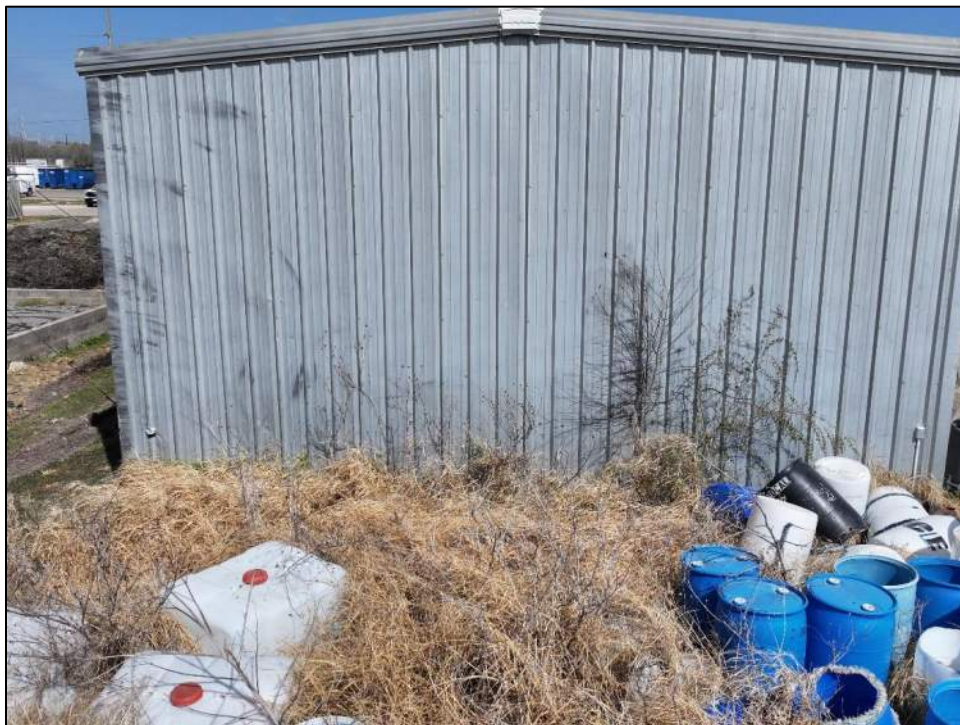
**Photo 74:** South elevation of the vehicle storage building.

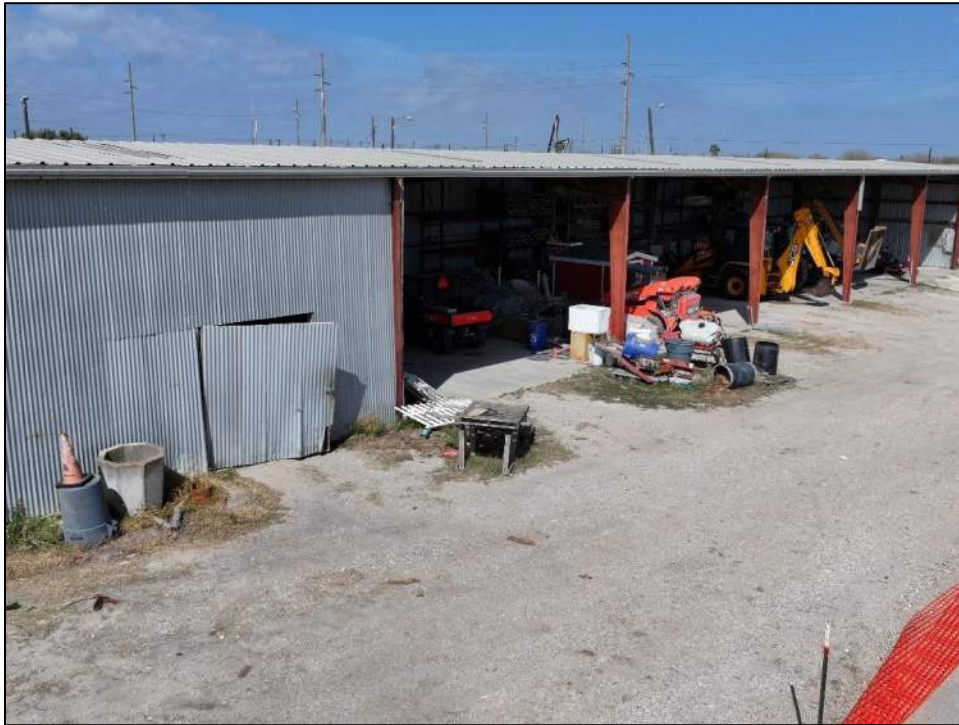
**Photo 75:** East elevation of the vehicle storage building.

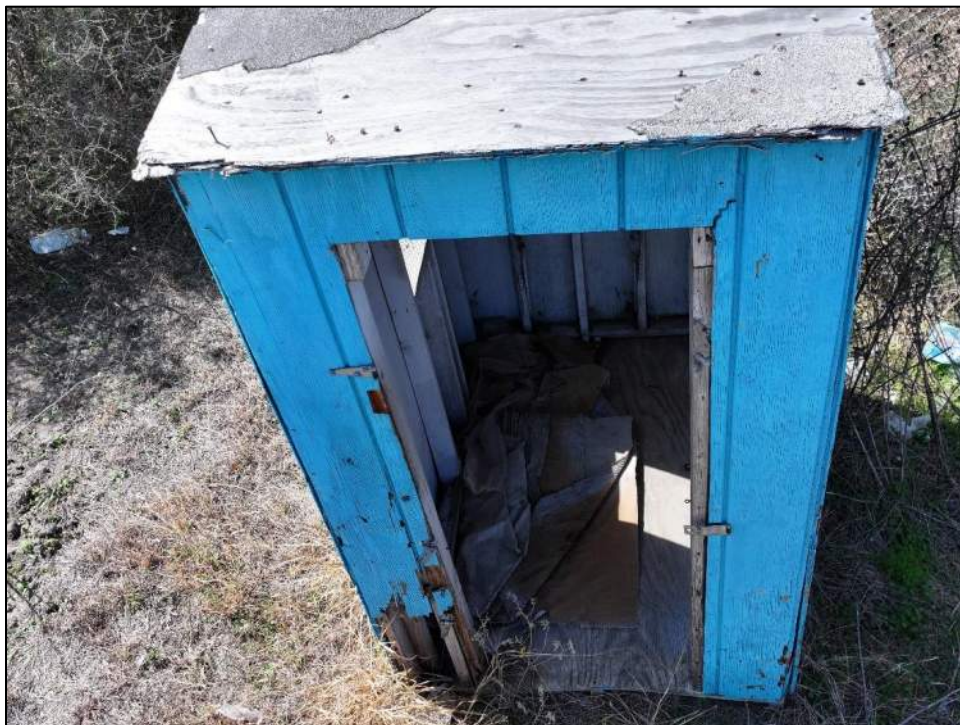
**Photo 78:** A deteriorated shed located to the south of the vehicle storage building.

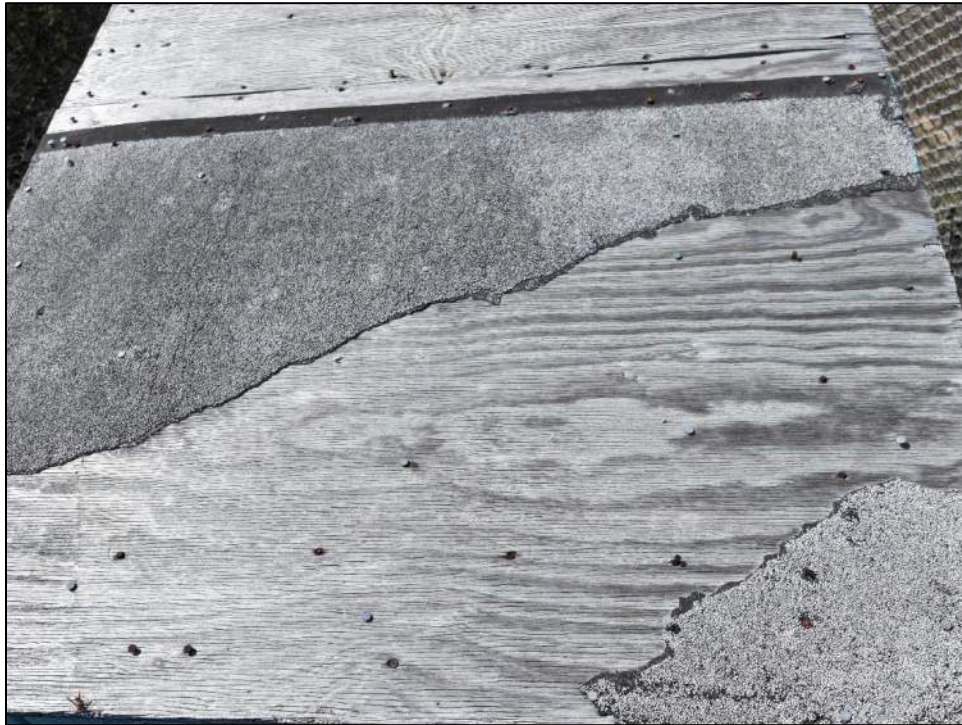
**Photo 79:** No wood grain crushing or disruption observed on the deteriorated shed roof deck (exposed due to rolled-roofing deterioration).

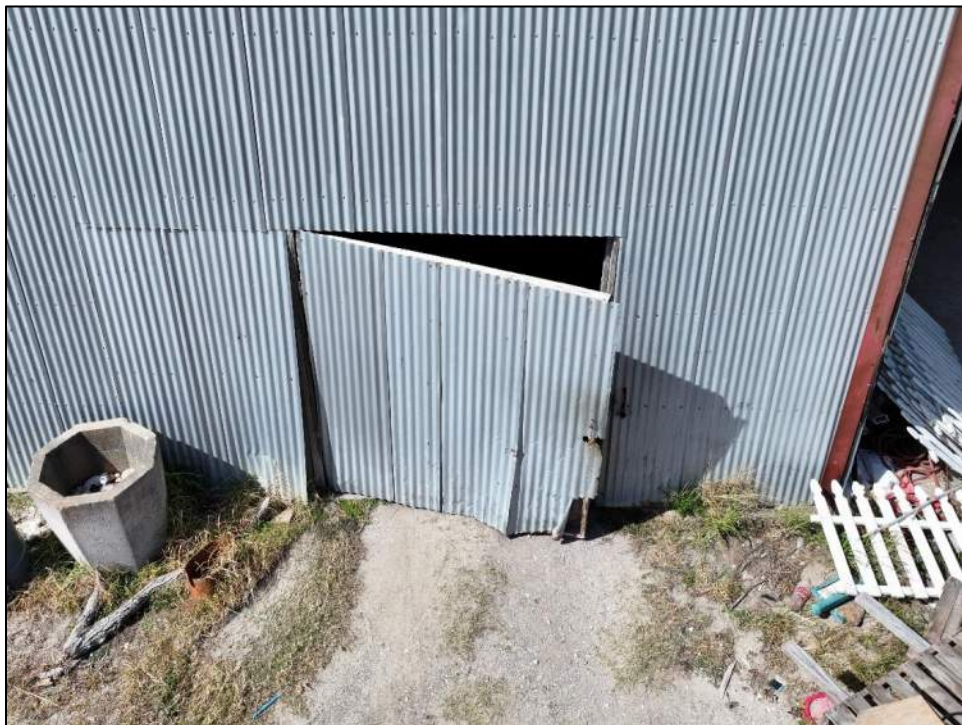
**Photo 80:** Deformed door of the vehicle storage building.

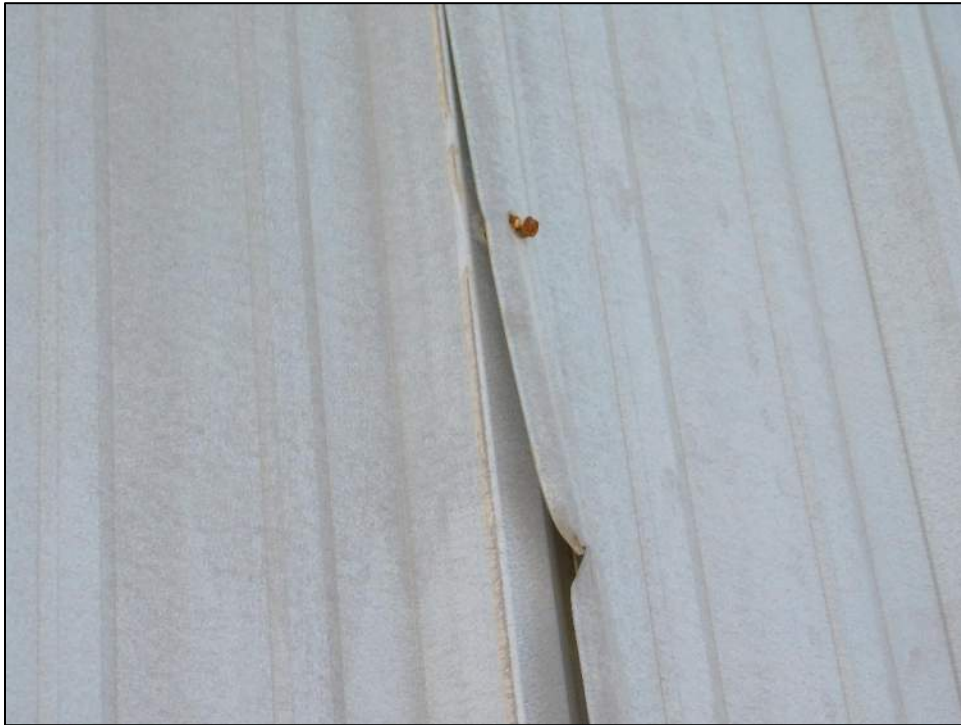
**Photo 81:** Corroded fastener mechanical damage on the north wall.

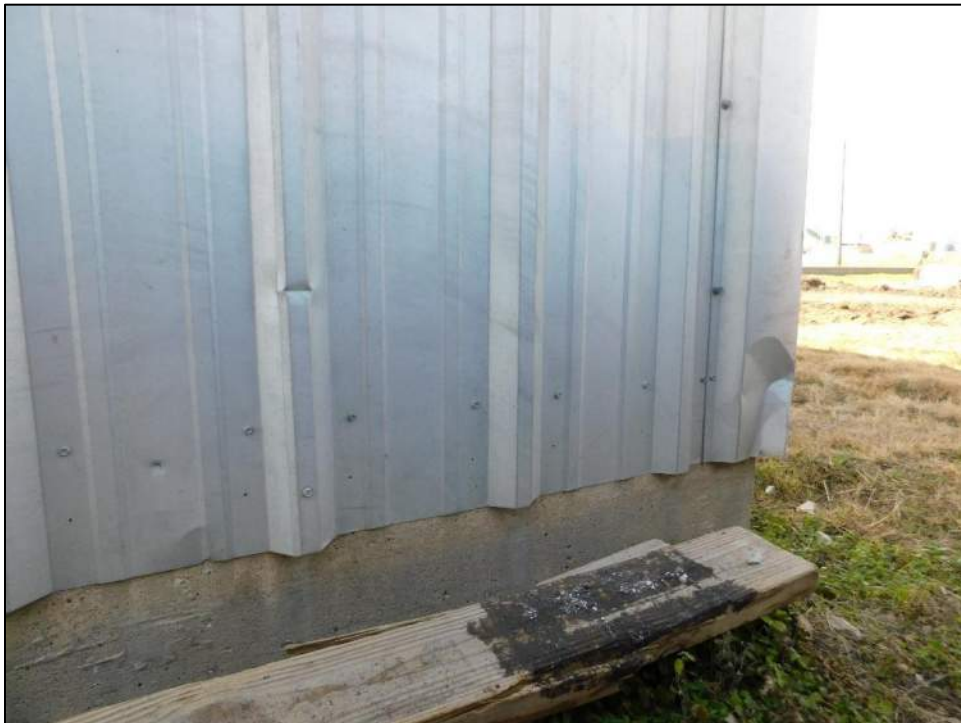
**Photo 82:** Mechanical damage at the bottom portion of the north wall unrelated to hail impact.

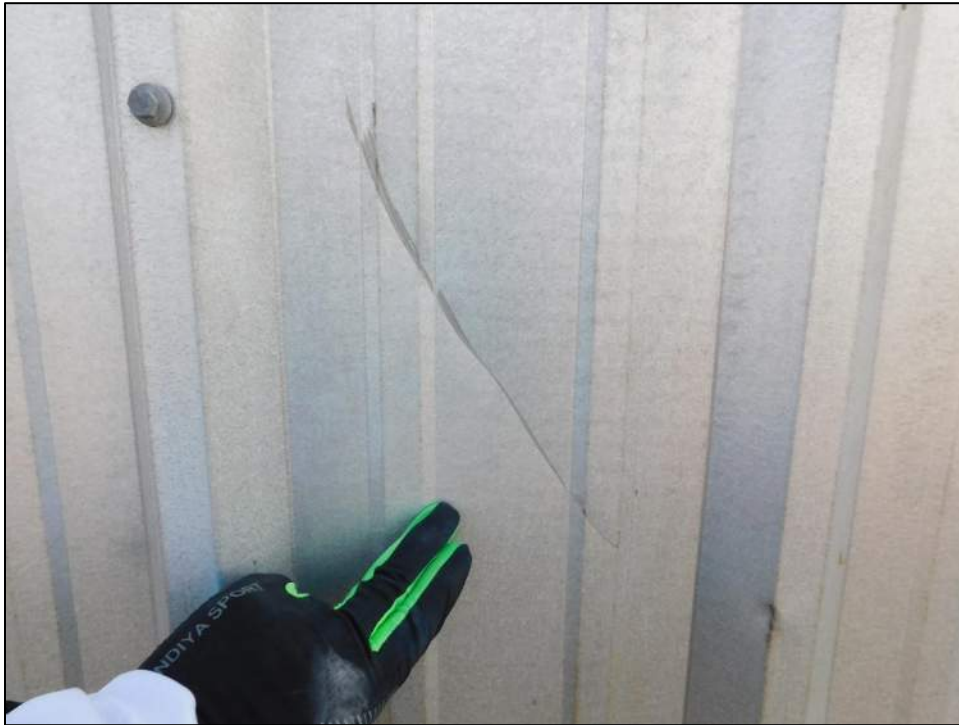
**Photo 83:** Mechanical damage on west wall.

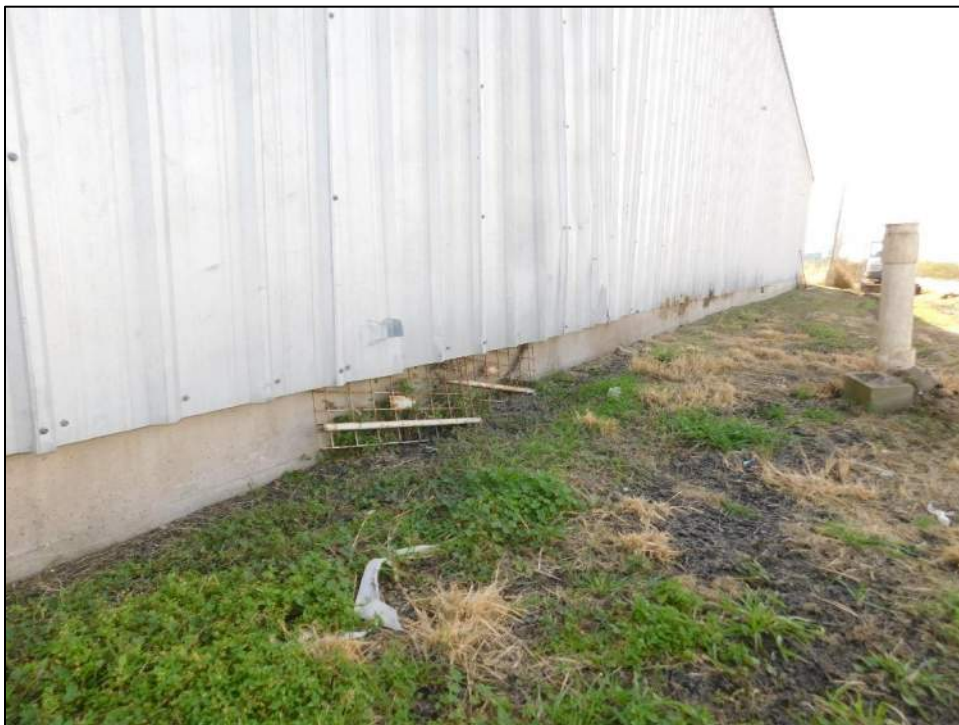
**Photo 84:** Lower section of the west wall bulged out.

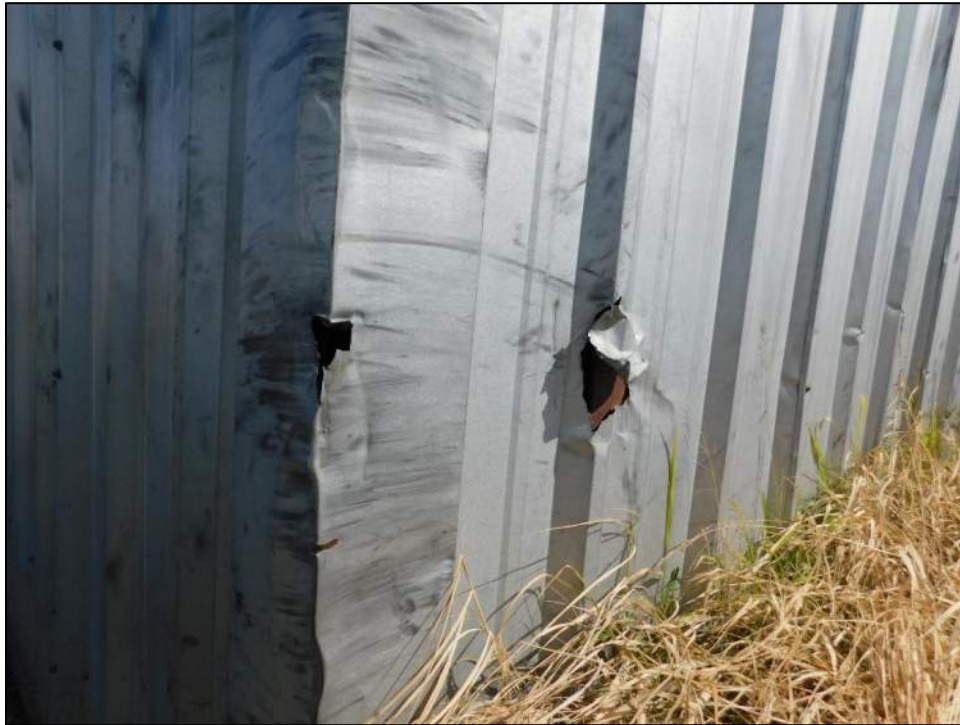
**Photo 85:** Mechanical damage to south wall (southwest corner) unrelated to hail impact.

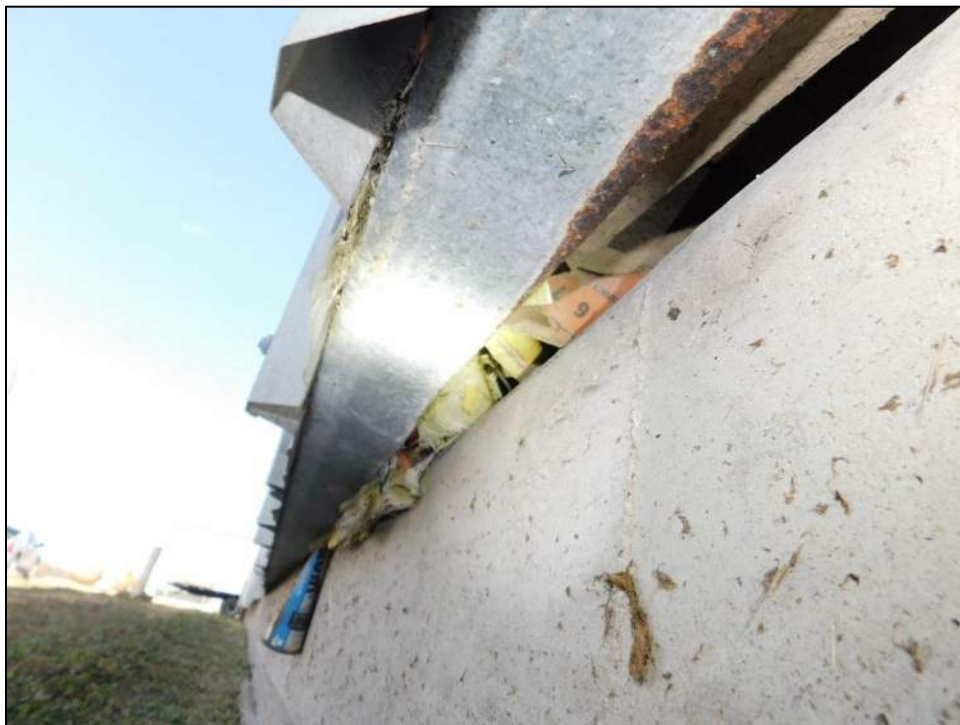
**Photo 86:** Upward view of the bulged-out west wall exhibited debris accumulation and edge corrosion.

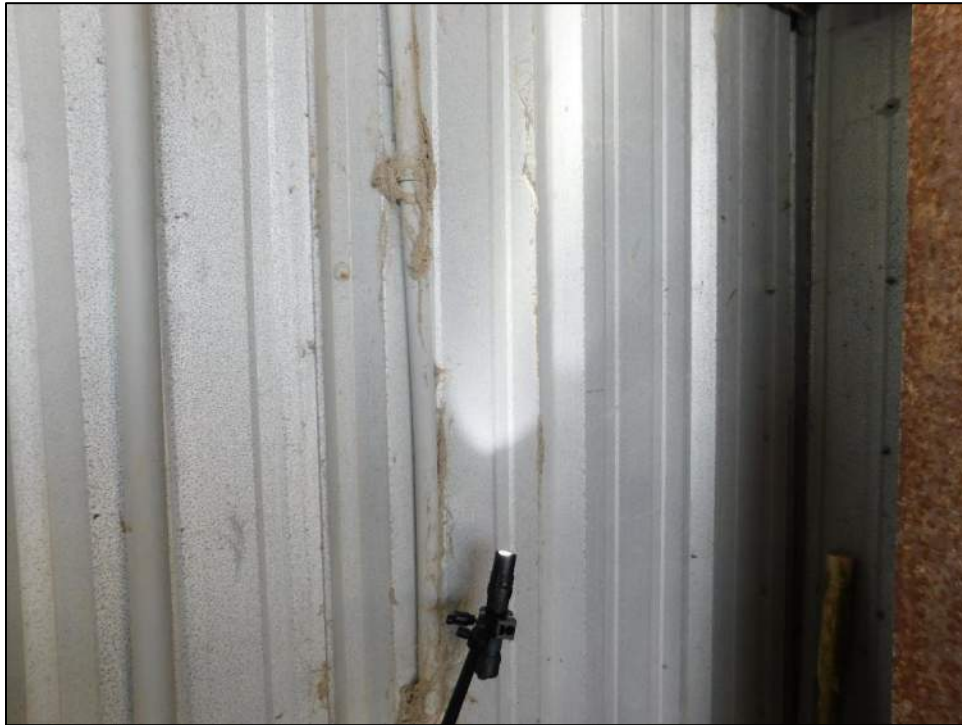
**Photo 87:** No denting observed on the north or west wall (interior surfaces).

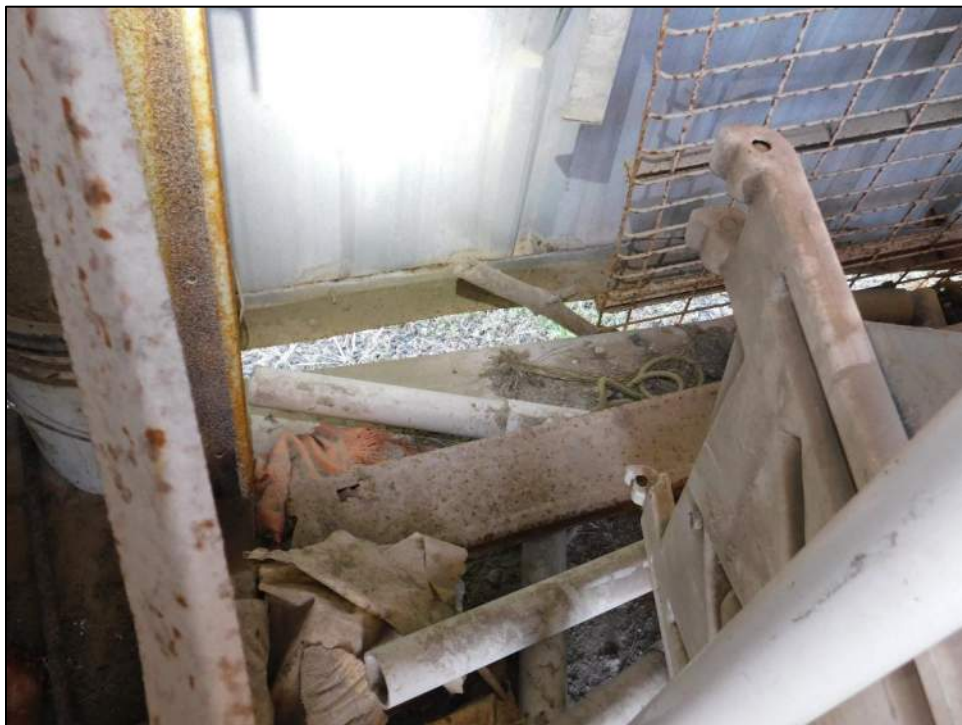
**Photo 88:** Bottom track of the bulged out west wall.

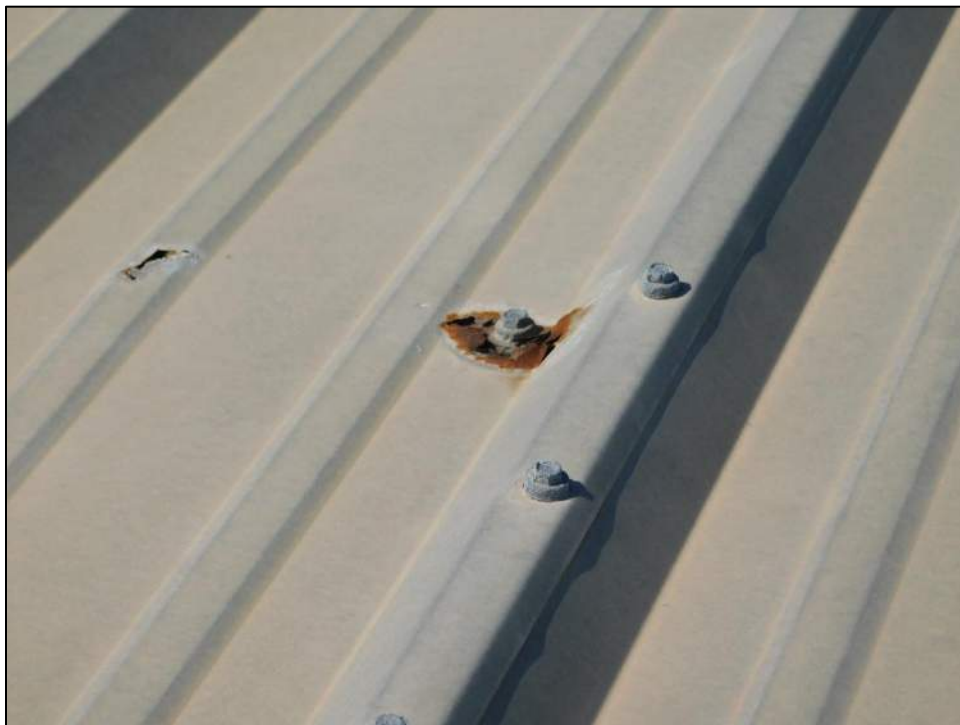
**Photo 90:** Corroded roof deck at fasteners.

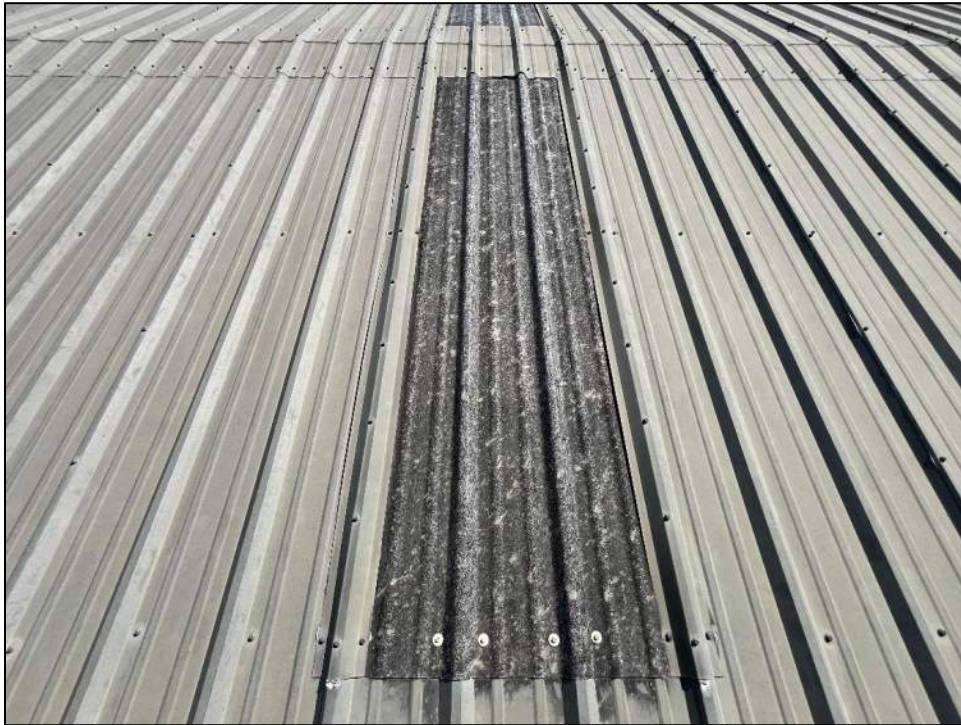
**Photo 93:** Skylight panels were not fractured at the spatters.

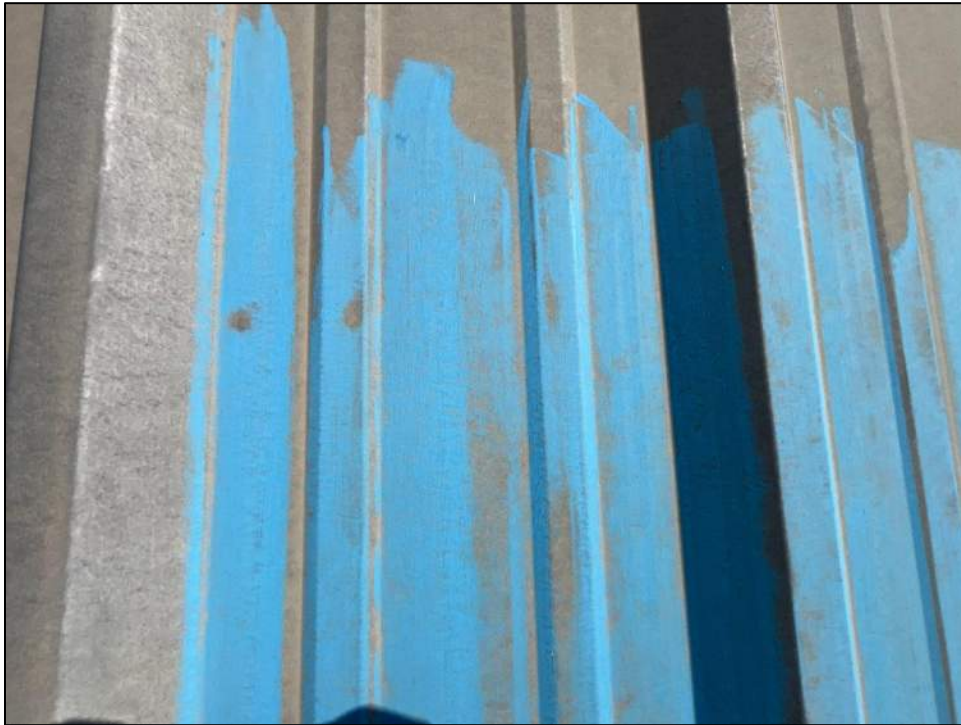
**Photo 95:** Hail denting in the roofing panels had a inner diameter of less than 3/8 inch.

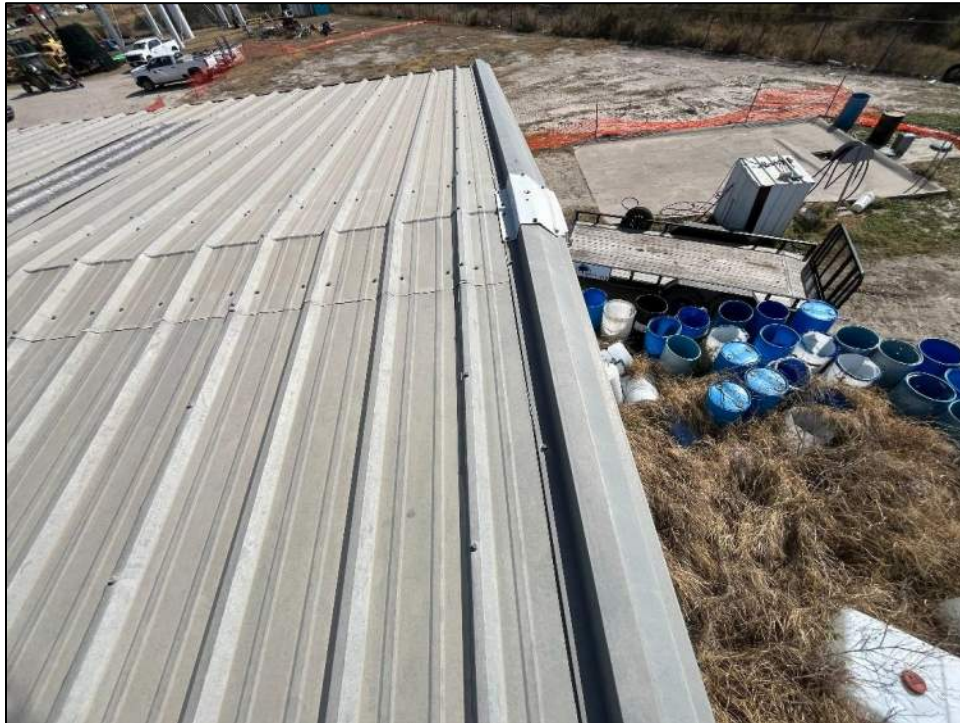
**Photo 98:** Closure metal along the south edge of the vehicle storage building remained attached and linear.

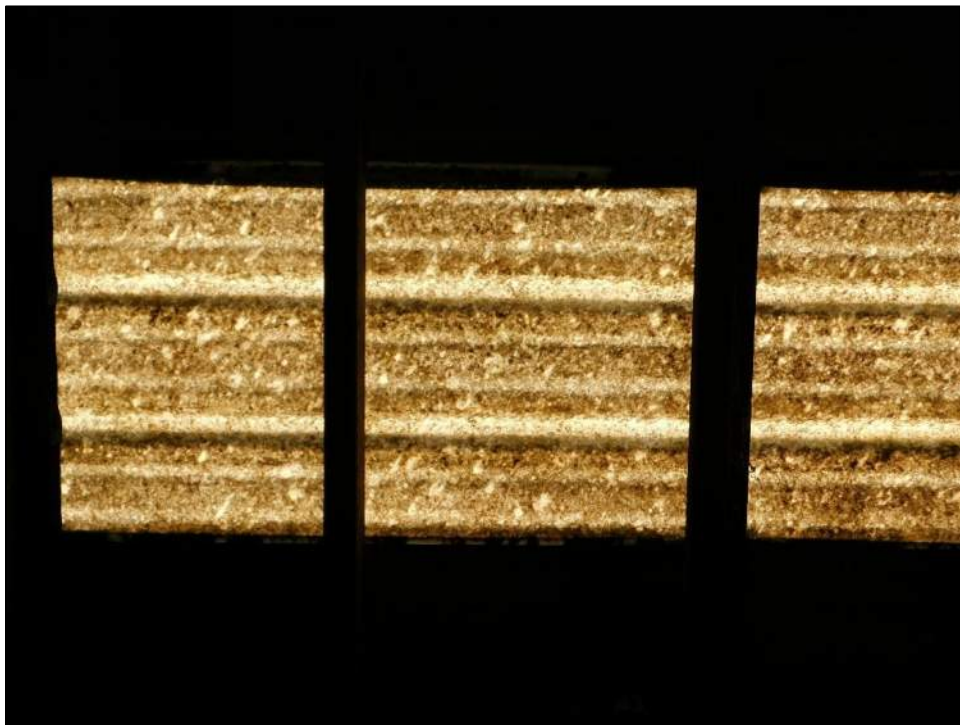
**Photo 99:** No fractures observed on the underside of the skylight panels observed in the enclosed storage room at the south end of the vehicle storage building.

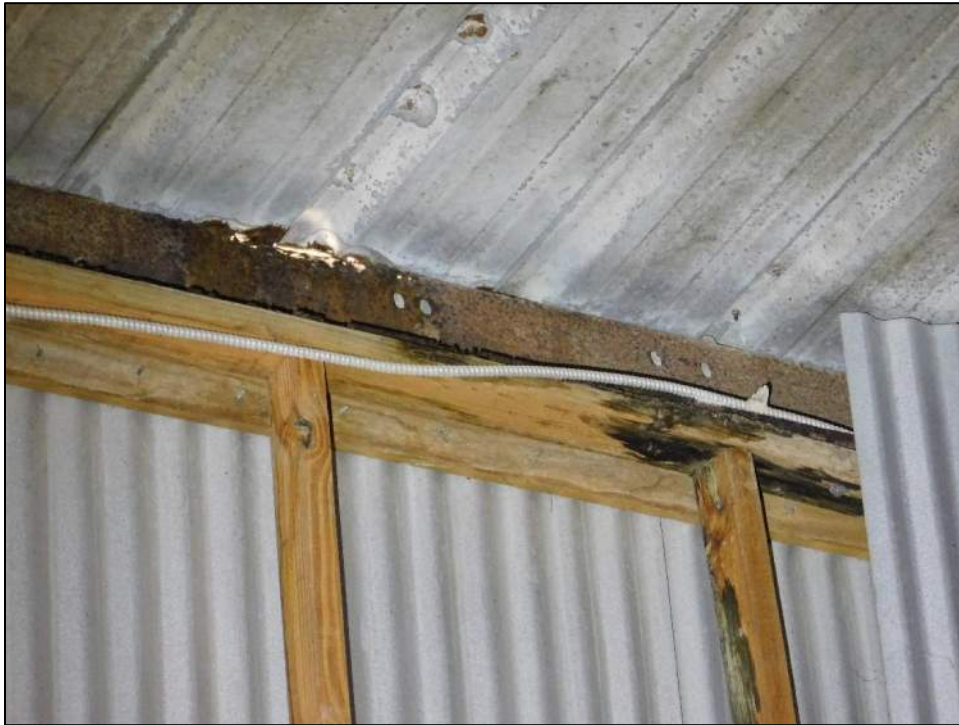
**Photo 100:** Corroded roof deck above the east wall in the enclosed storage room at the south end of the vehicle storage building.

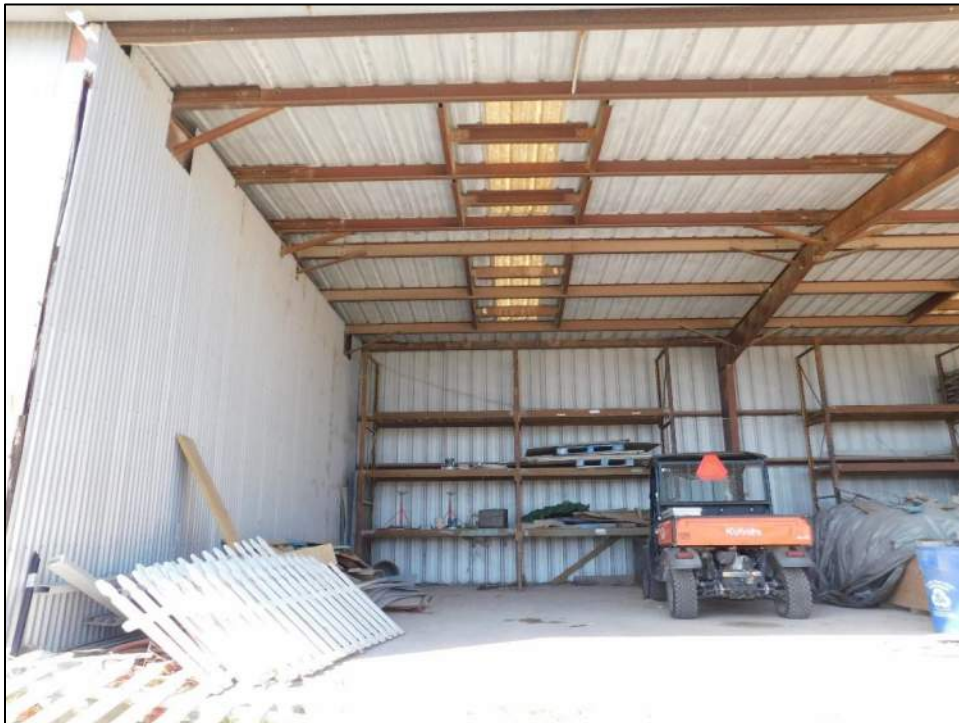
**Photo 101:** Skylight of the vehicle storage building were not fractured.

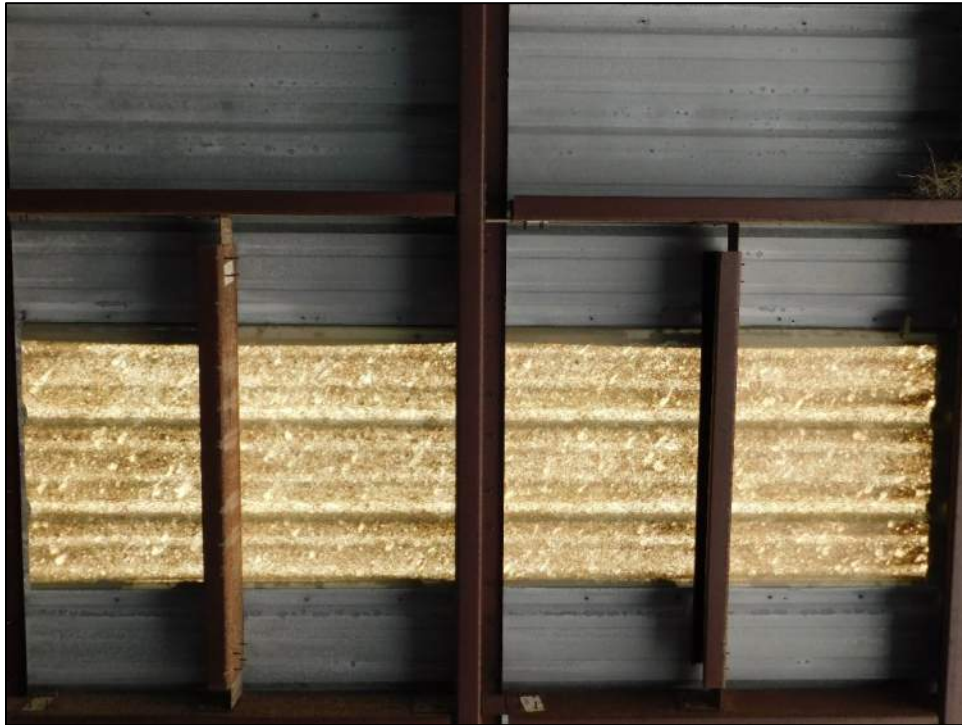
**Photo 102:** Skylight of the vehicle storage building were not fractured.

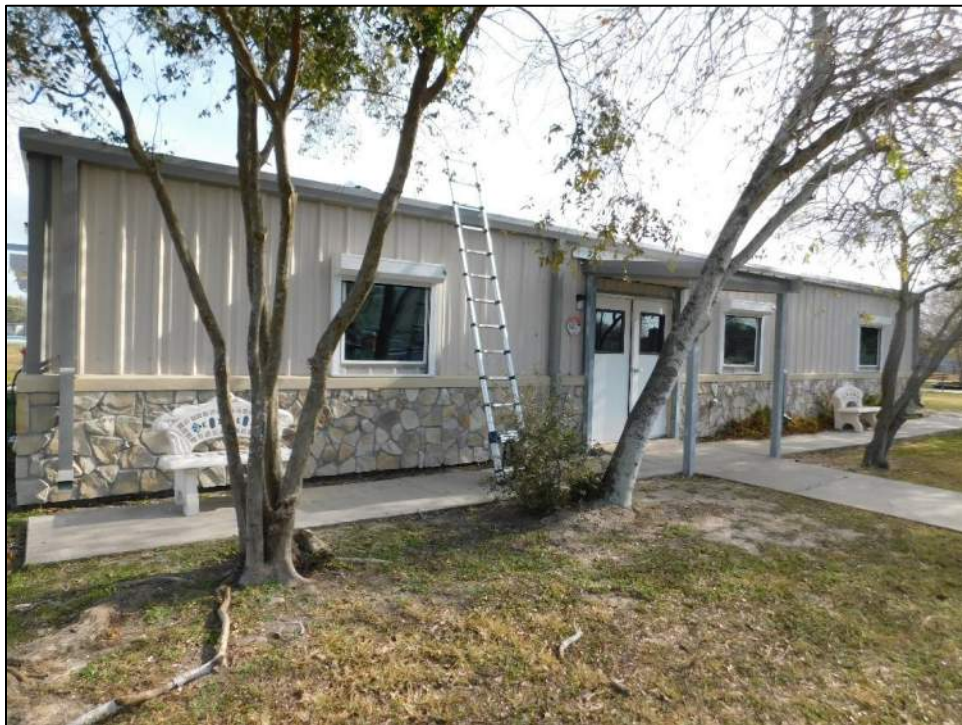
**Photo 2:** South elevation. No window glazing damage observed.

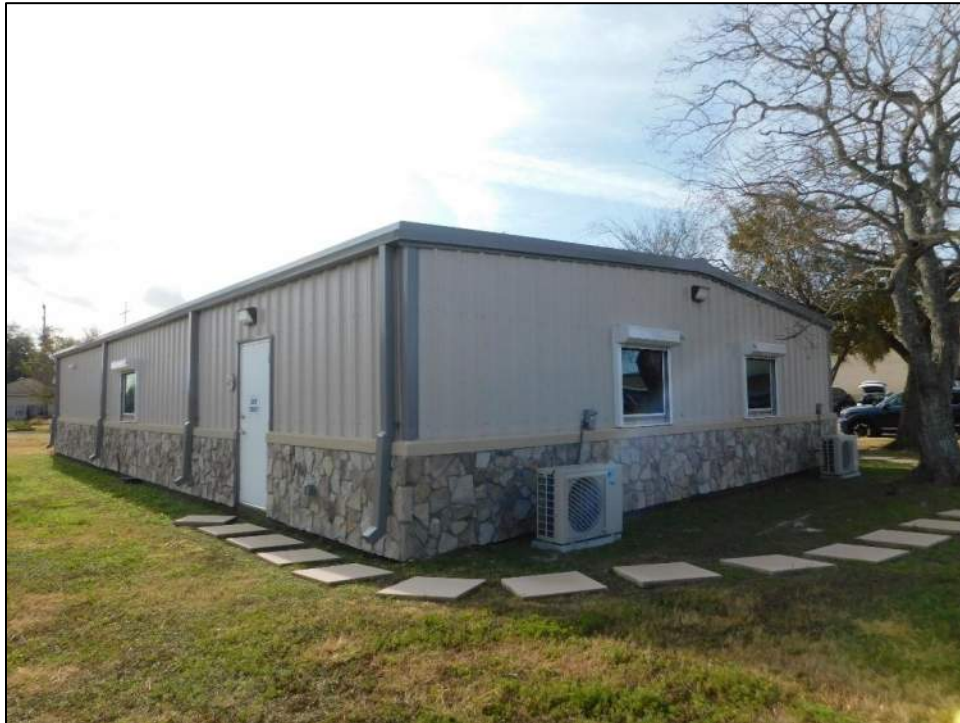
**Photo 3:** West elevation. Windows remained intact
