**CITY OF INGLESIDE  
REGULAR CITY COUNCIL MEETING  
AGENDA  
JUNE 9, 2026  
6:30 PM**

Report on November 01, 2025, Hailstorm Damage to City of Ingleside Buildings.

### Building Damage Analysis Survey and Report

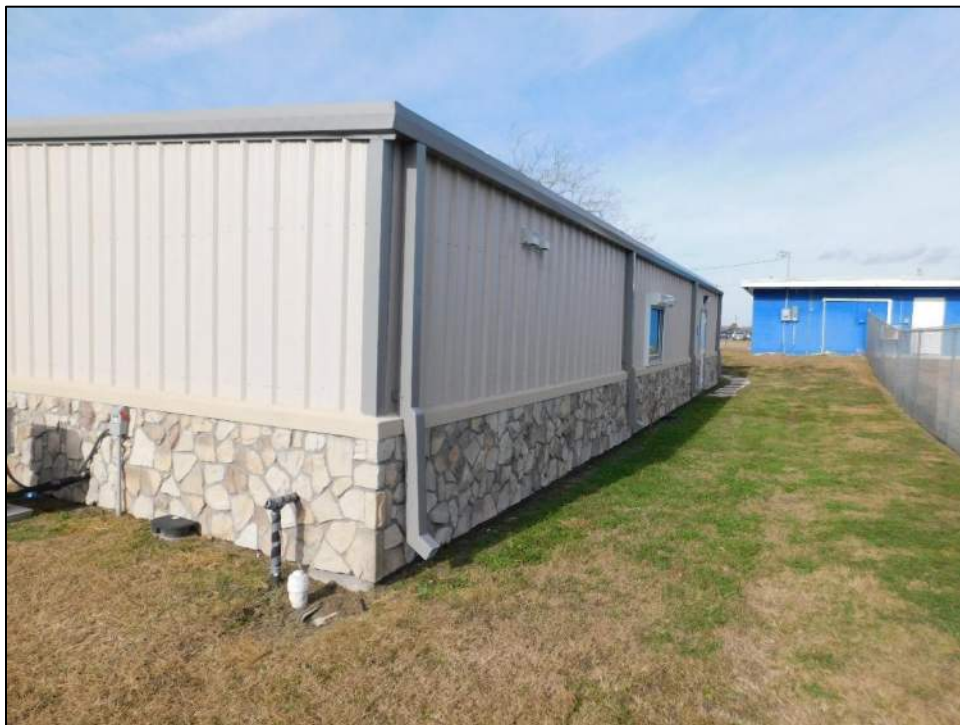
**Photo 4:** North elevation. Window glazing and door remained intact.

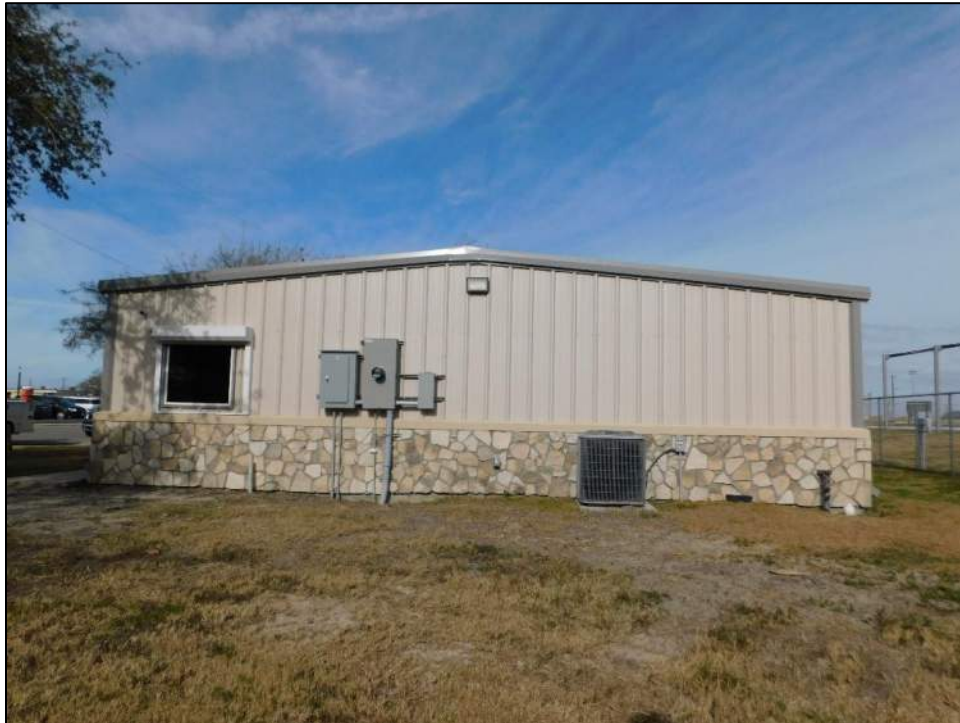
**Photo 5:** East elevation. The window glazing remained intact. No hail spatters were observed on the electrical panels.

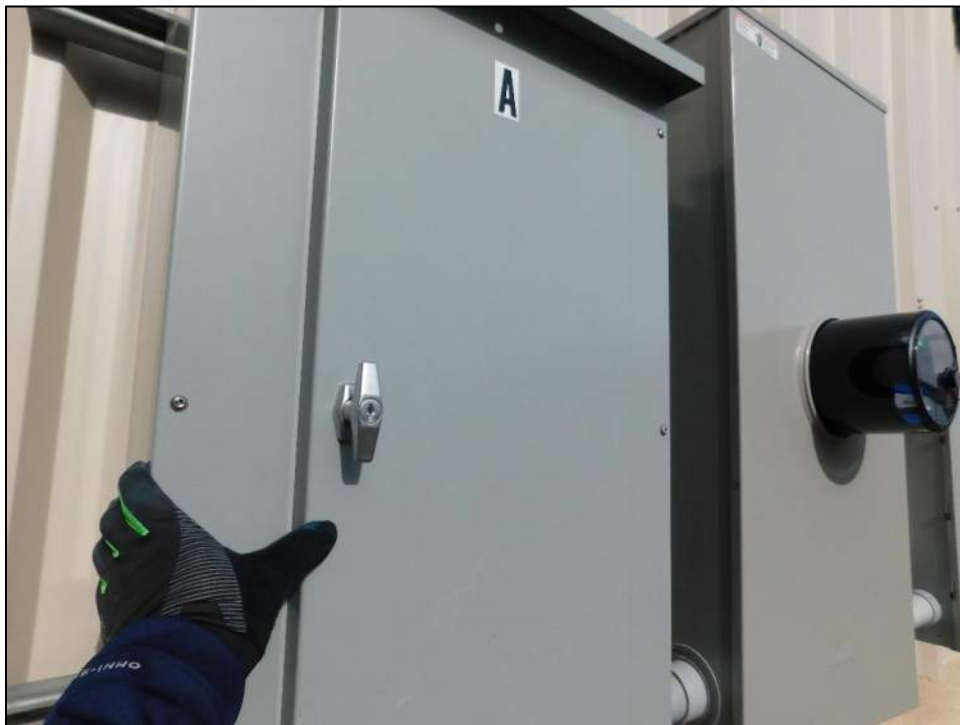
**Photo 6:** No hail spatters were observed on the electrical panels.

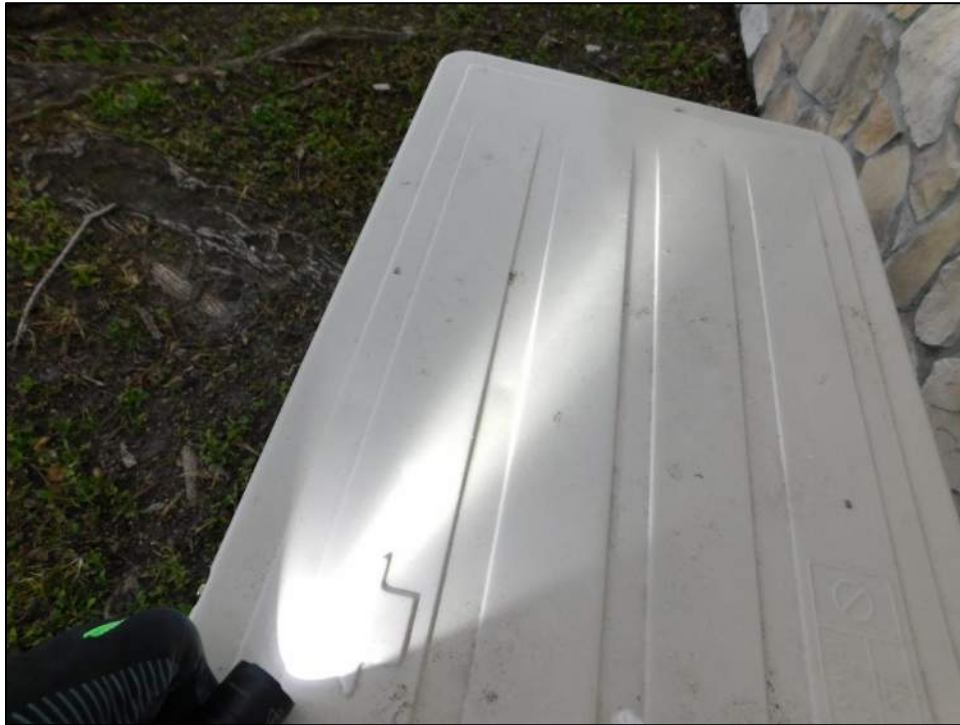
**Photo 7:** Hail denting was observed on the top surface of the split AC unit on the west side of the building.

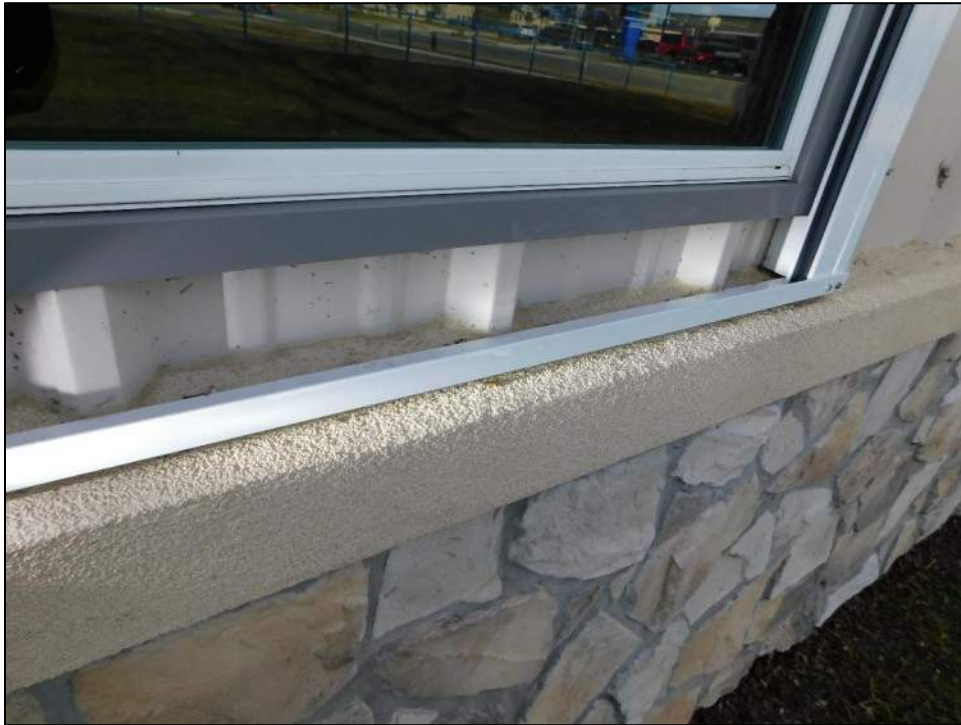
**Photo 9:** No hail impact fractures were observed along the EIFS accent along the west or north walls.

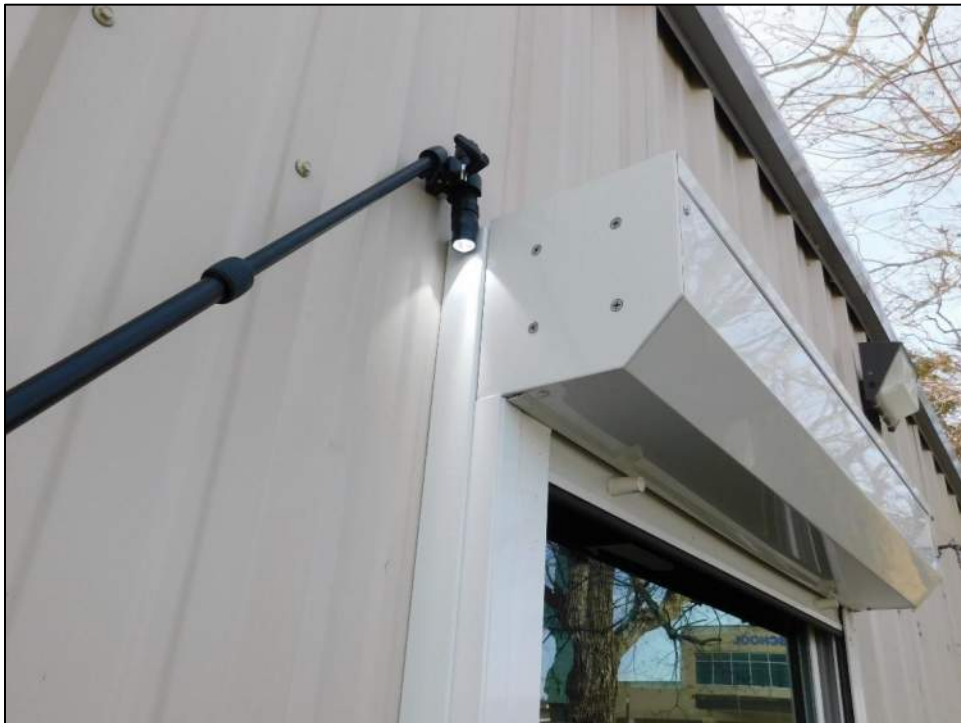
**Photo 10:** No hail denting was present in the window guard housing.

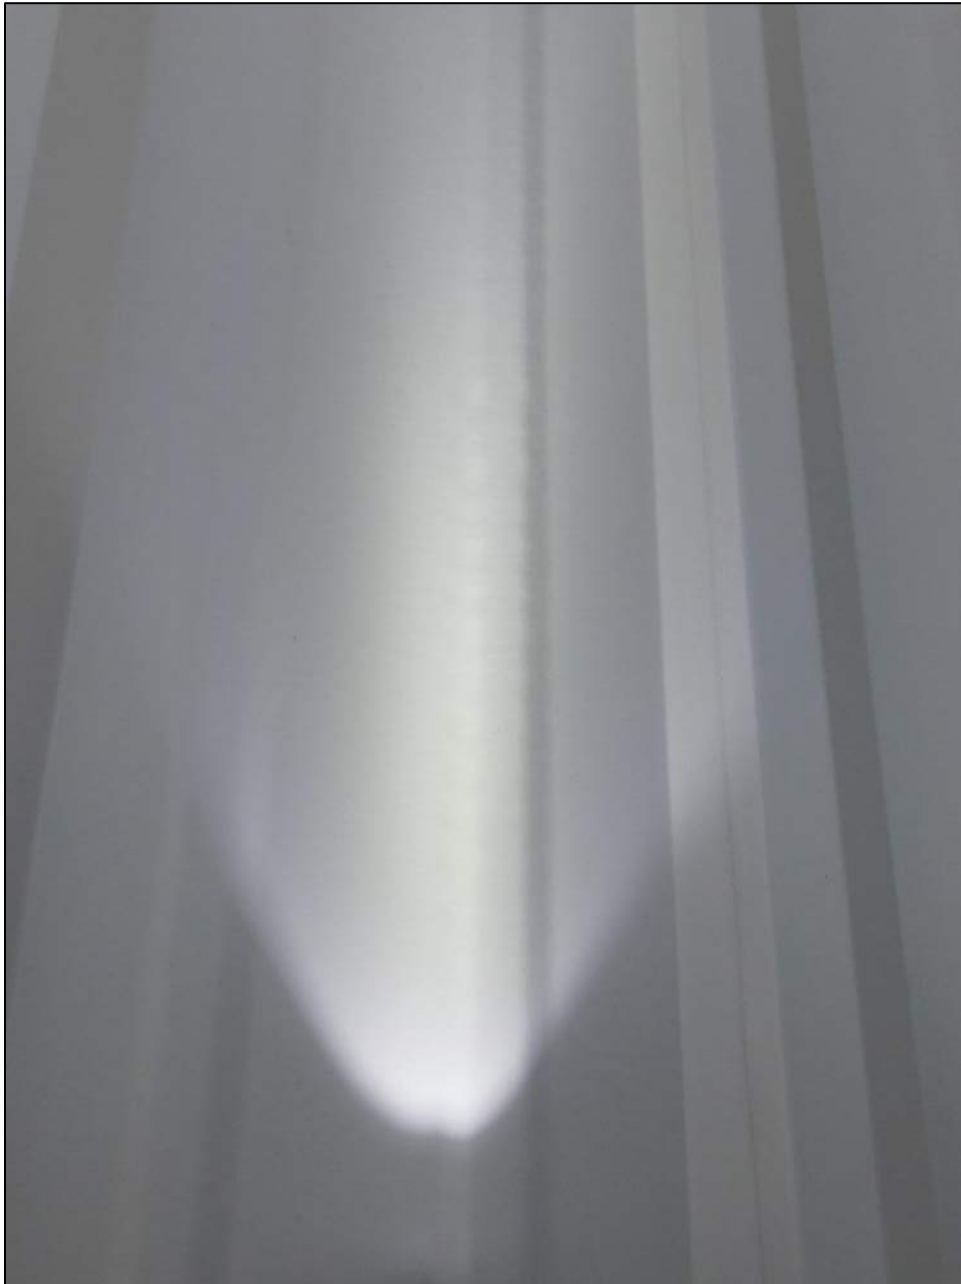
**Photo 11:** Isolated slight denting was observed on the west wall panels under directional lighting.

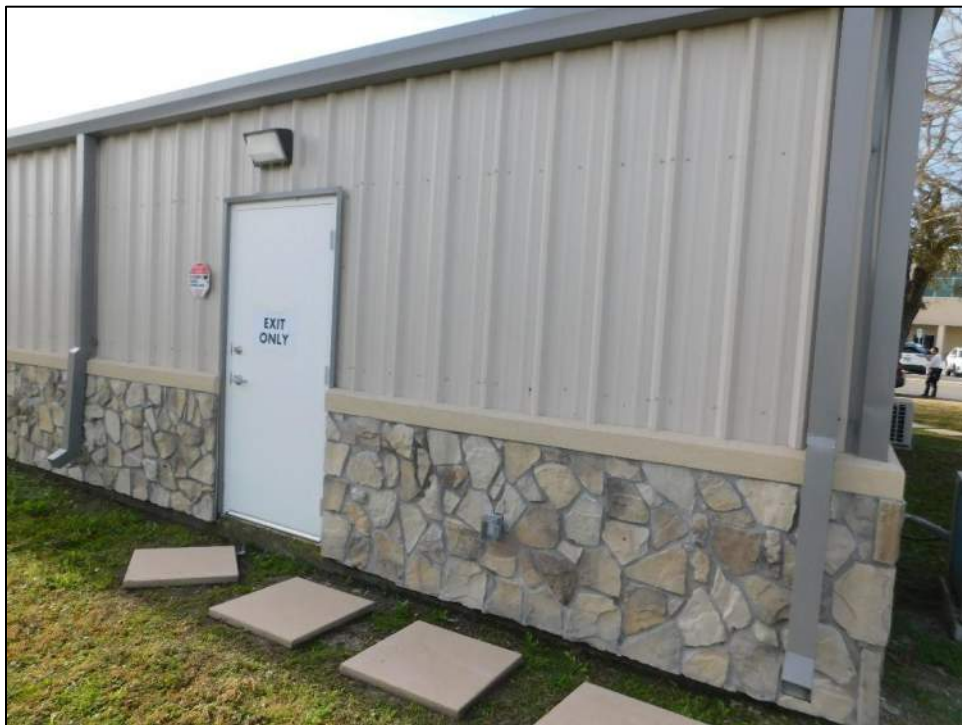
**Photo 14:** Gutter on the north wall exhibited slight hail impact denting.

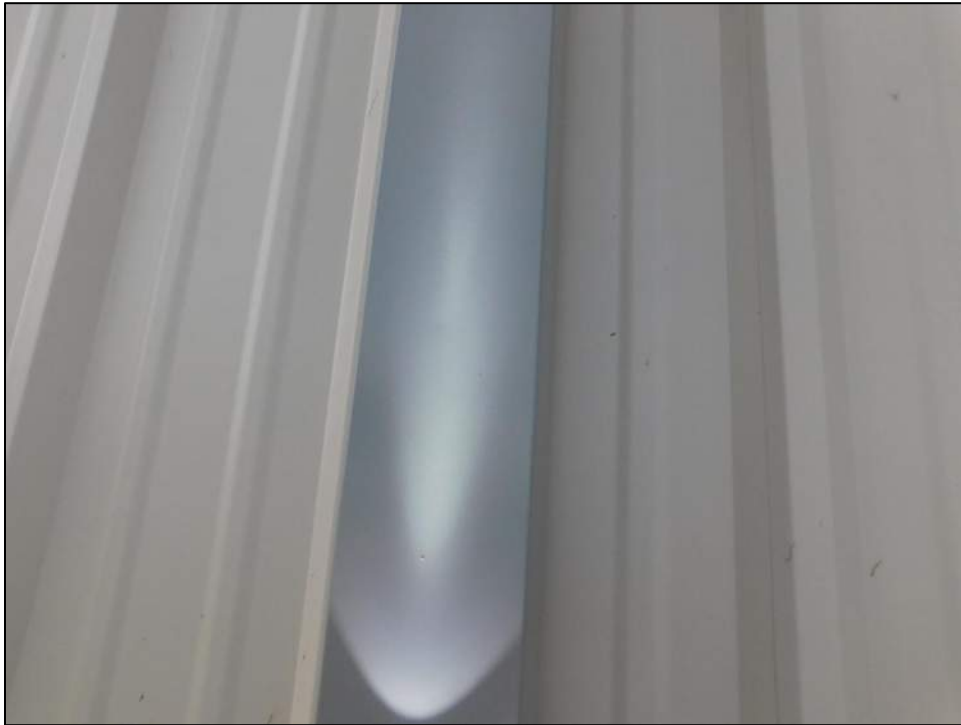
**Photo 16:** Slight isolated denting on the rear gutter downspout.

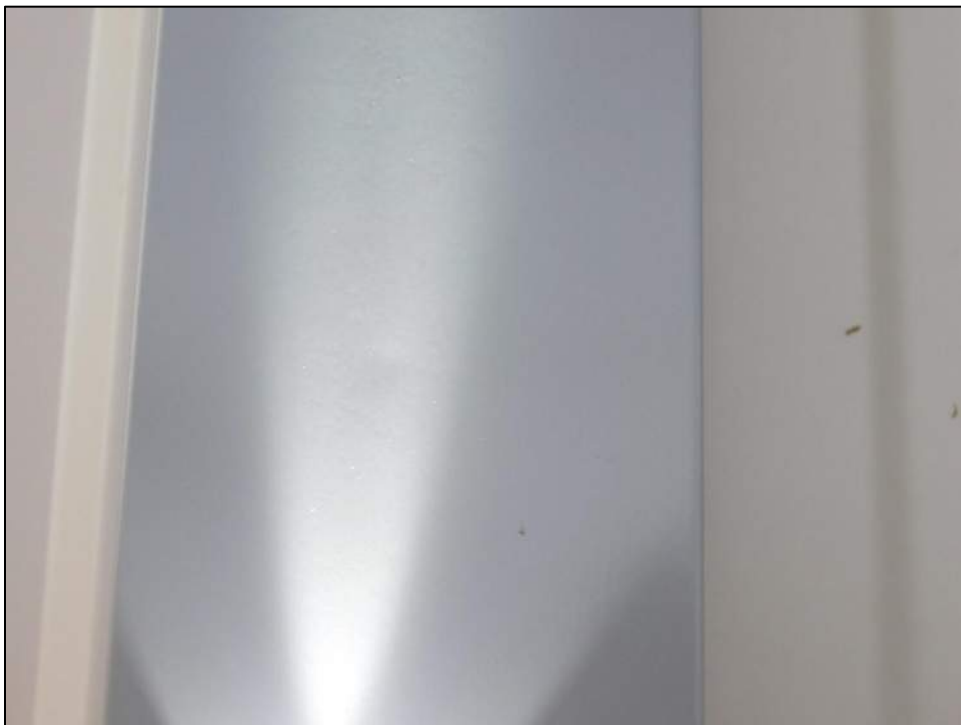
**Photo 17:** No coating disruptions were observed on the hail denting on the rear gutter downspout.

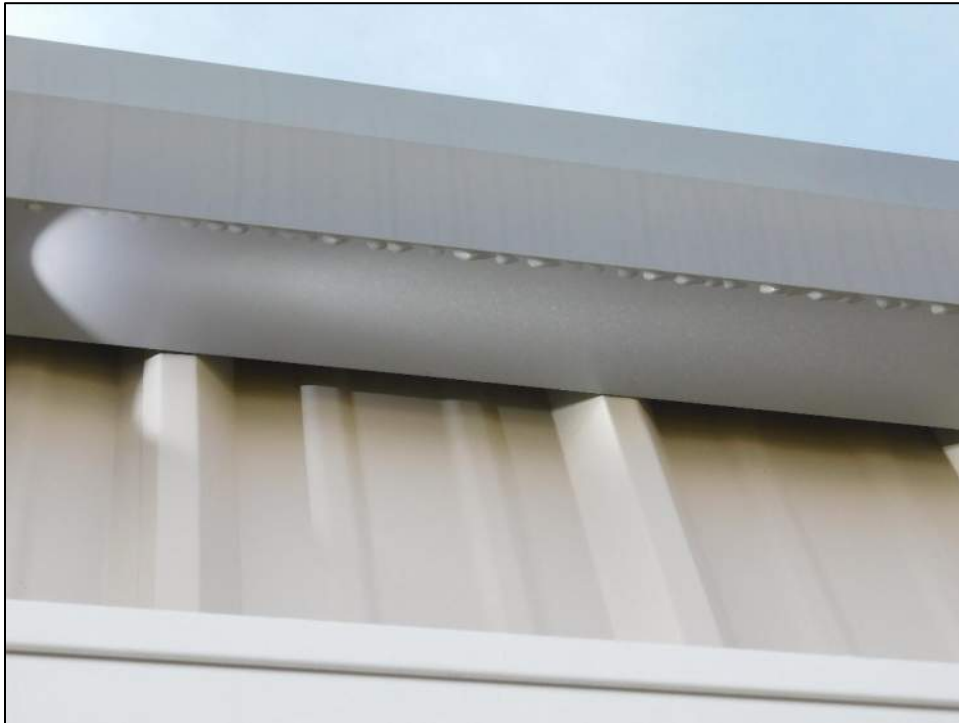
**Photo 18:** No indentations were observed at the bottom of the rear gutter.

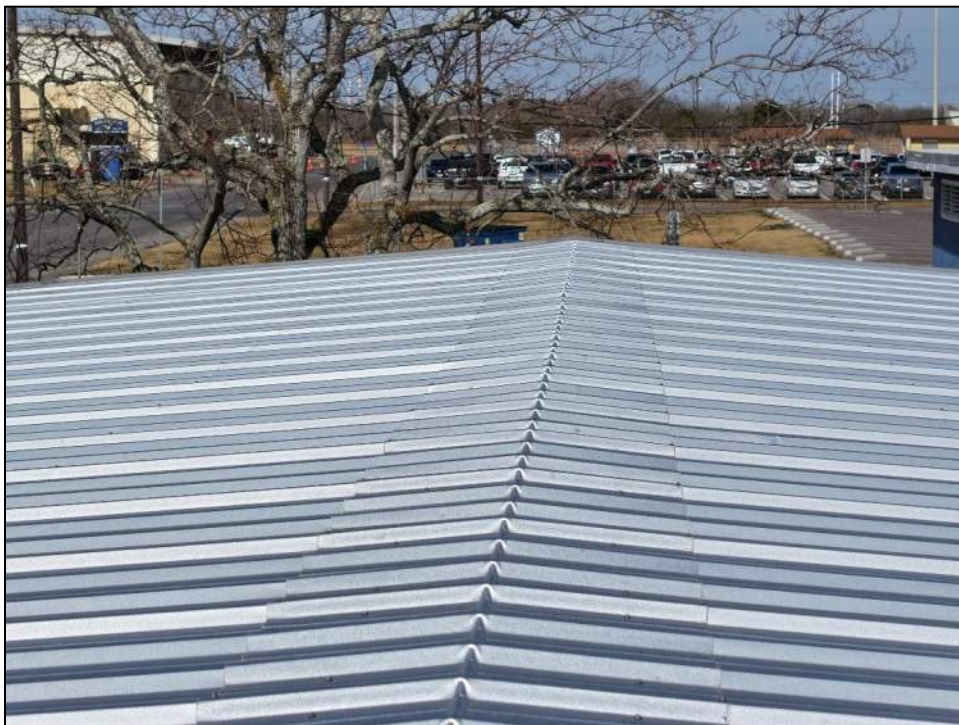
**Photo 19:** Ridge panels was intact.

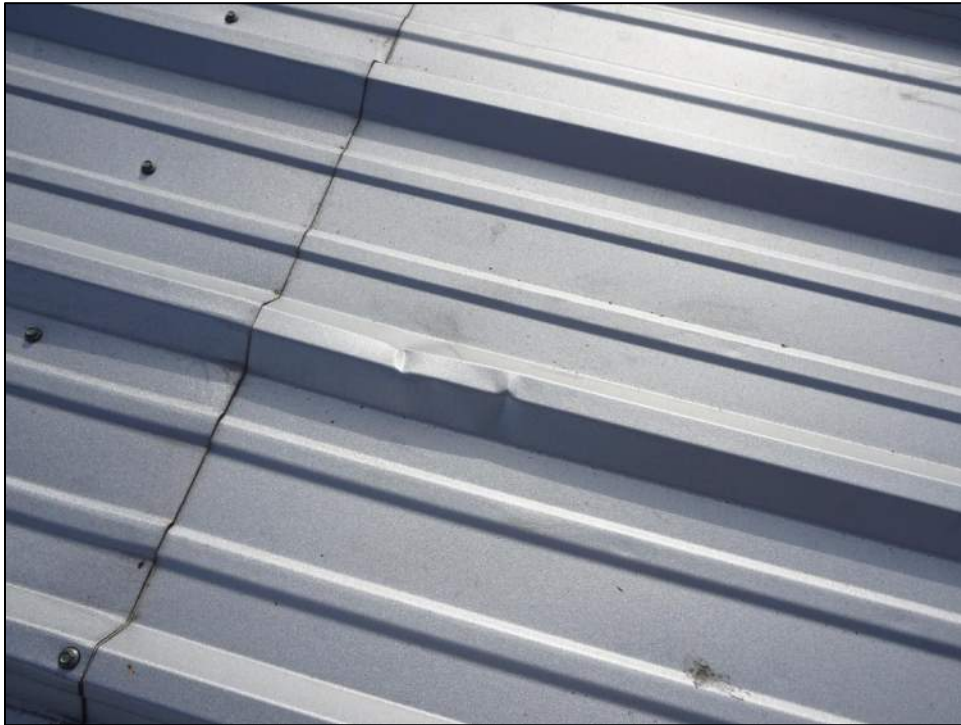
**Photo 20:** Typical creased roof deck ribs consistent with foot traffic and irrelevant to hail.

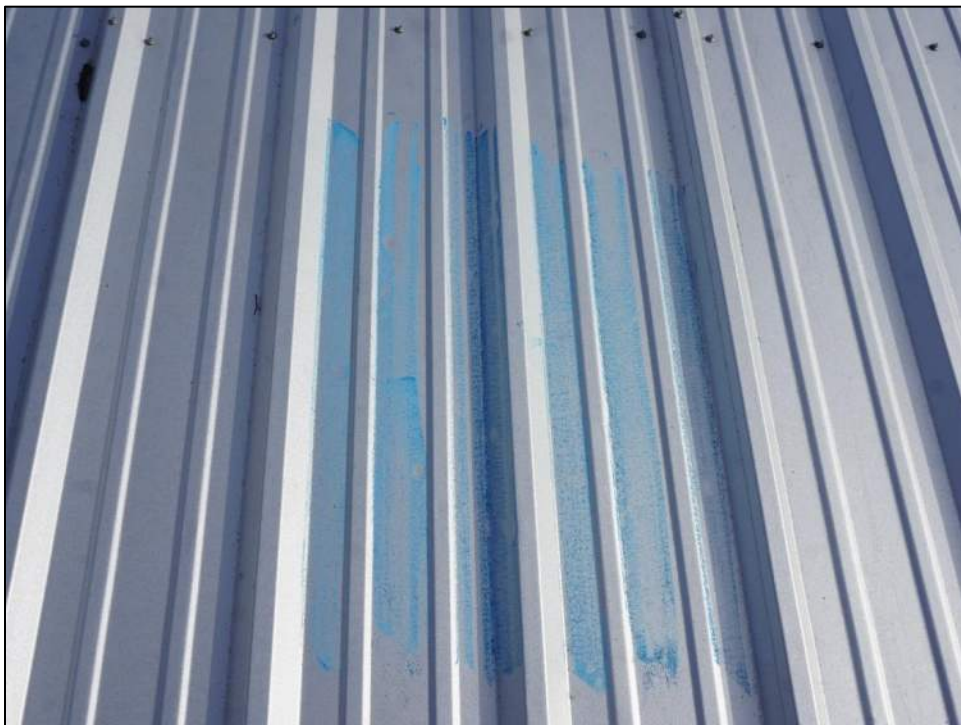
**Photo 21:** Hail denting on south slope had an inner diameter of less than 3/8 inch.

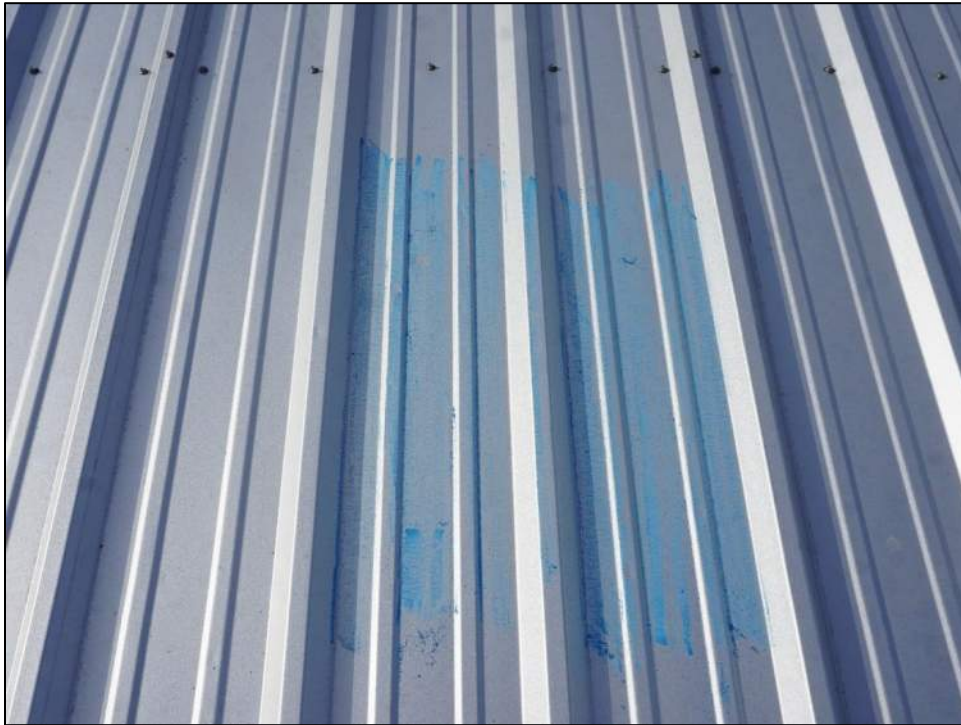
**Photo 24:** Hail denting on north slope had an inner diameter of less than 1/2 inch.

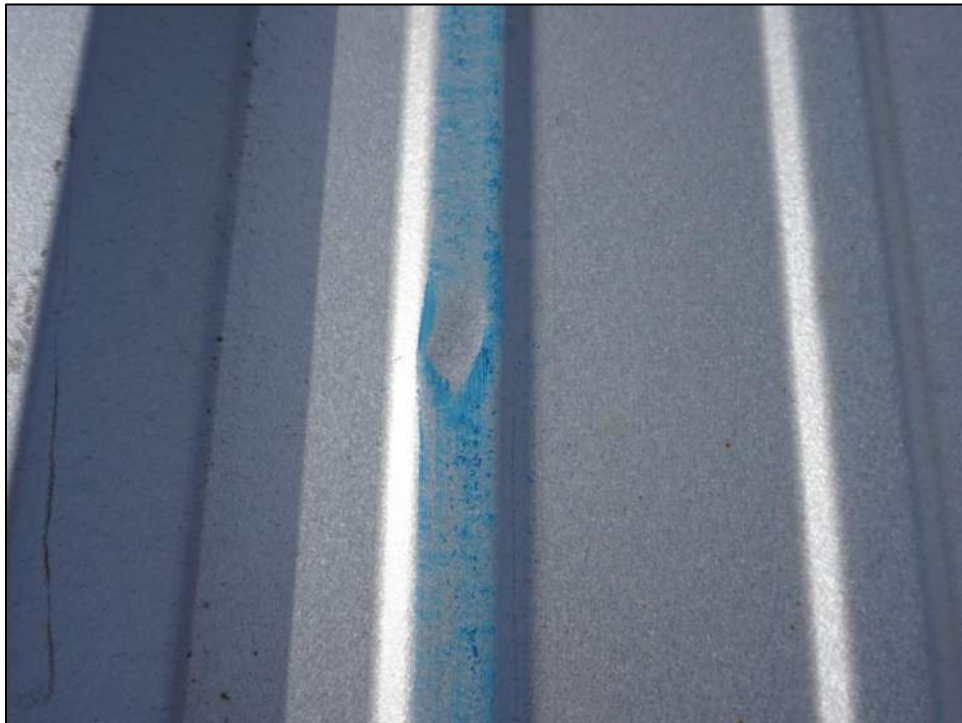
**Photo 27:** No coating disruptions were observed on the galvalume surface of the metal deck at the dents.

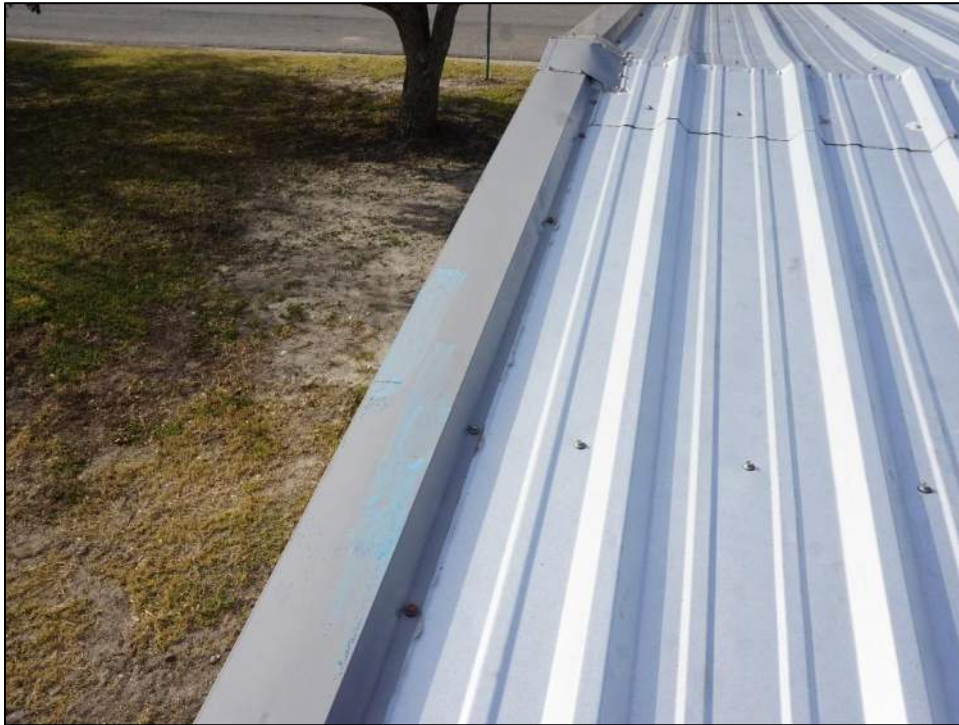
**Photo 28:** Edge enclosure metal along gable end rakes were dented but absent of coating disruptions.

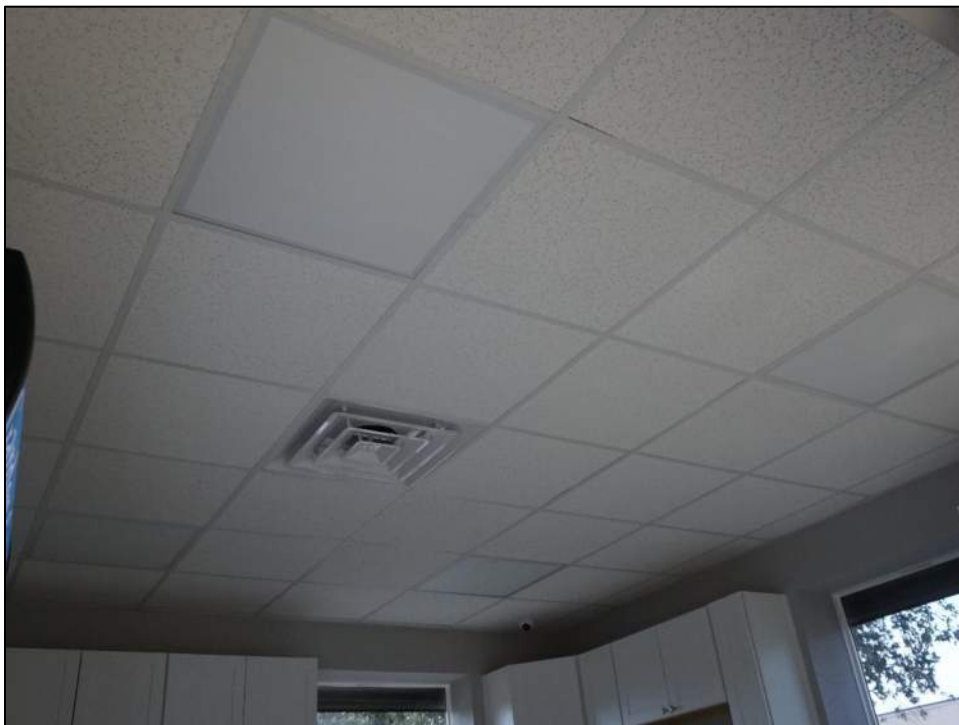
**Photo 29:** No moisture stains observed on ceiling tiles.

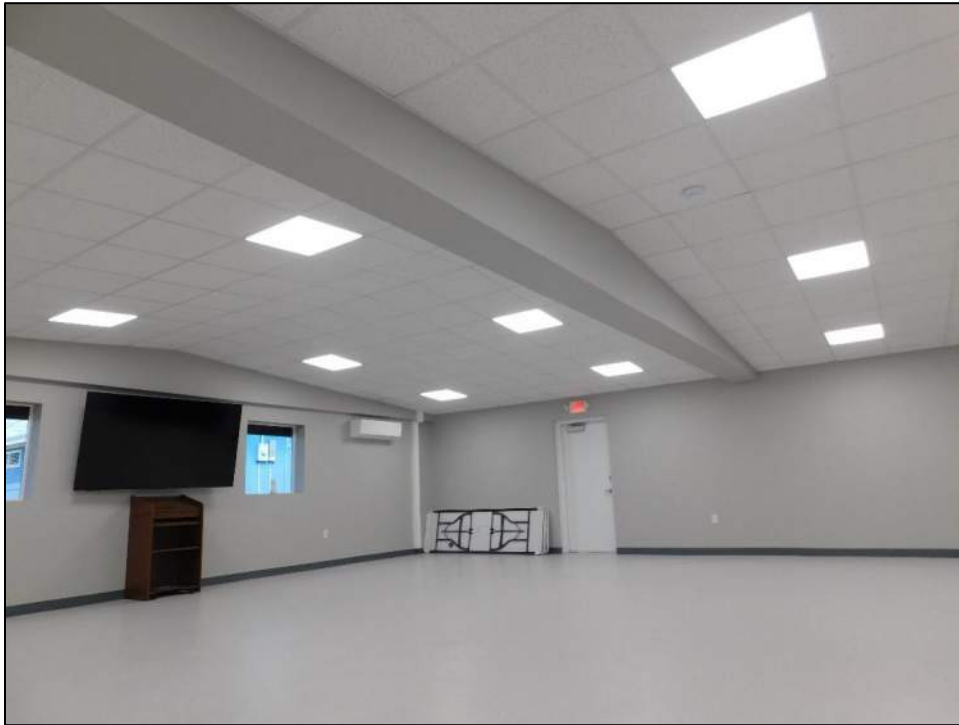
**Photo 30:** Interior finishes remained in sound condition.

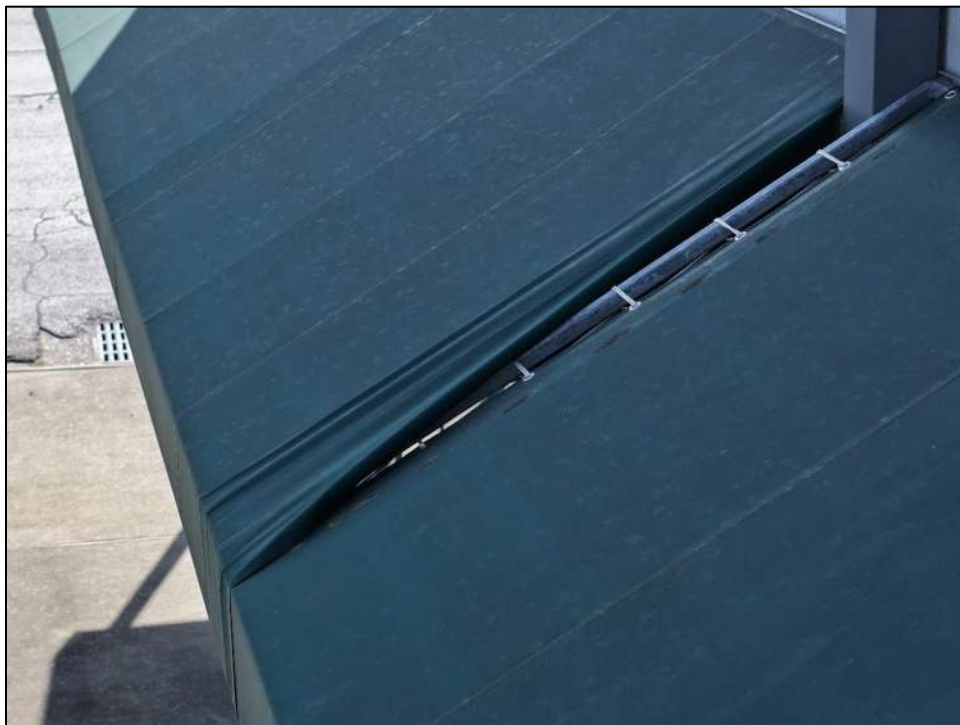
**Photo 5:** Pre-existing awning separation at a downspout.

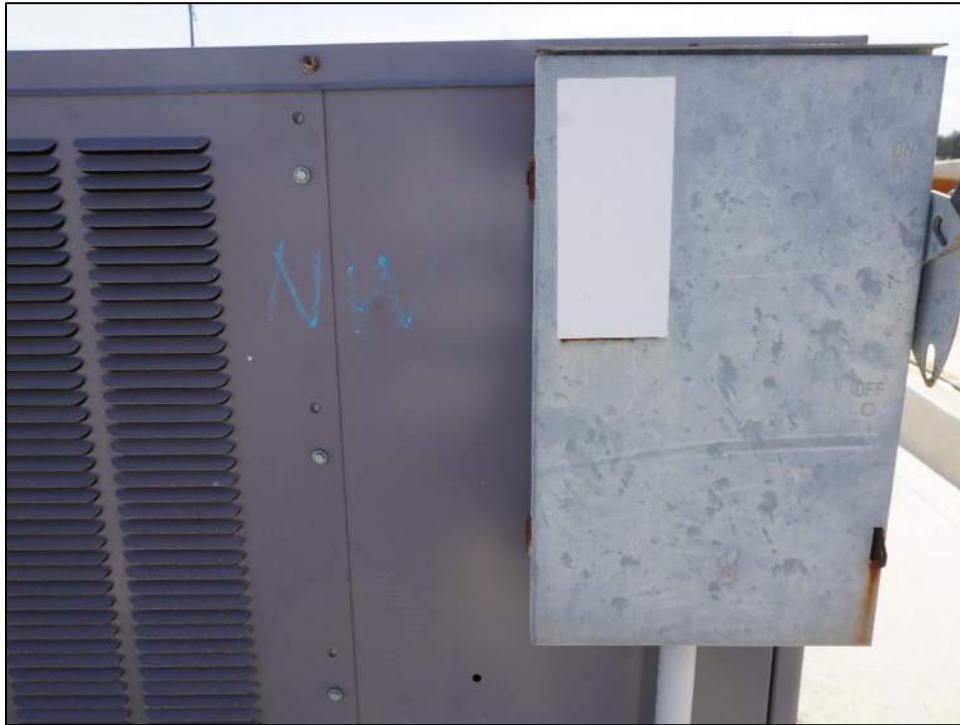
**Photo 8:** Hail spatters on rooftop units reflect 1-inch hail.

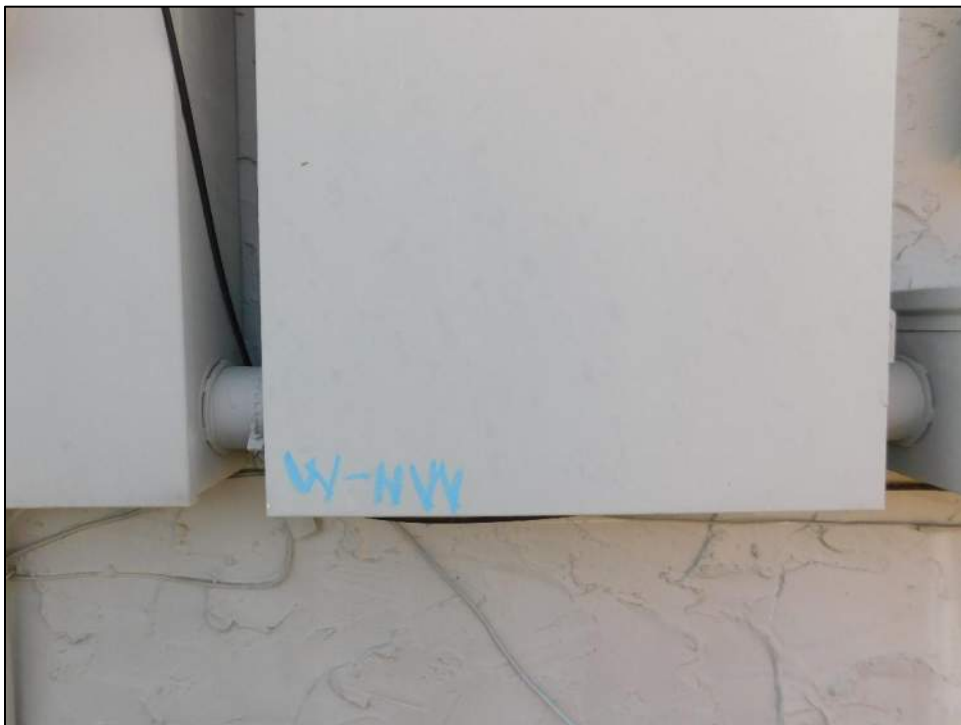
**Photo 15:** Hail spatters on west walls reflected maximum of 1-inch hail.

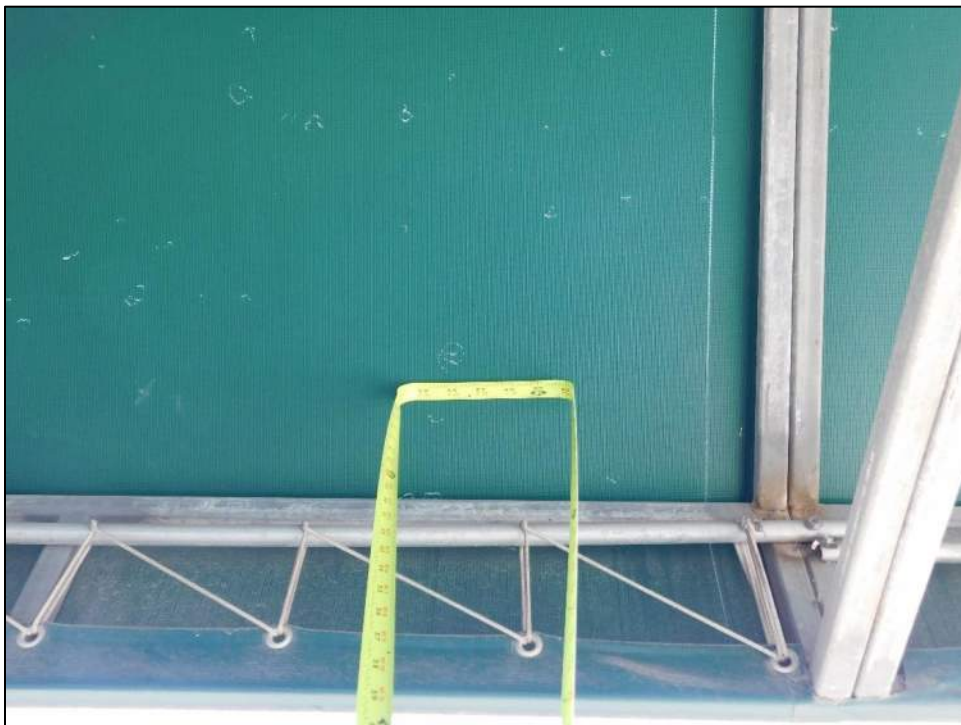
**Photo 20:** Hail impact fractures observed from the underside of the PVC fabric awning.

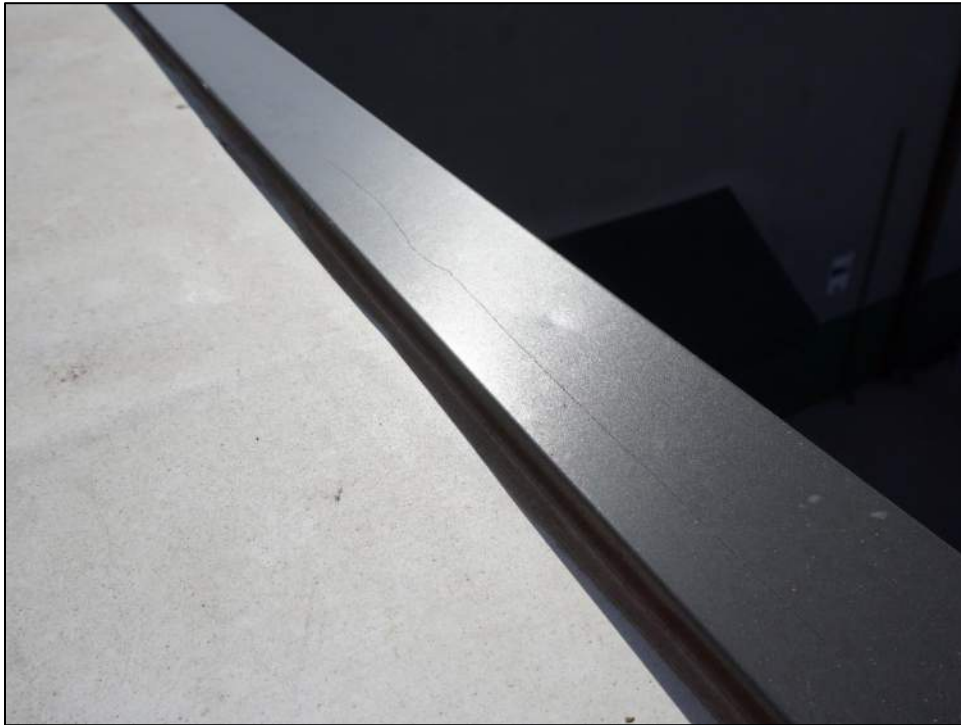
**Photo 21:** Cosmetic denting in coping metal above rear parapet wall.

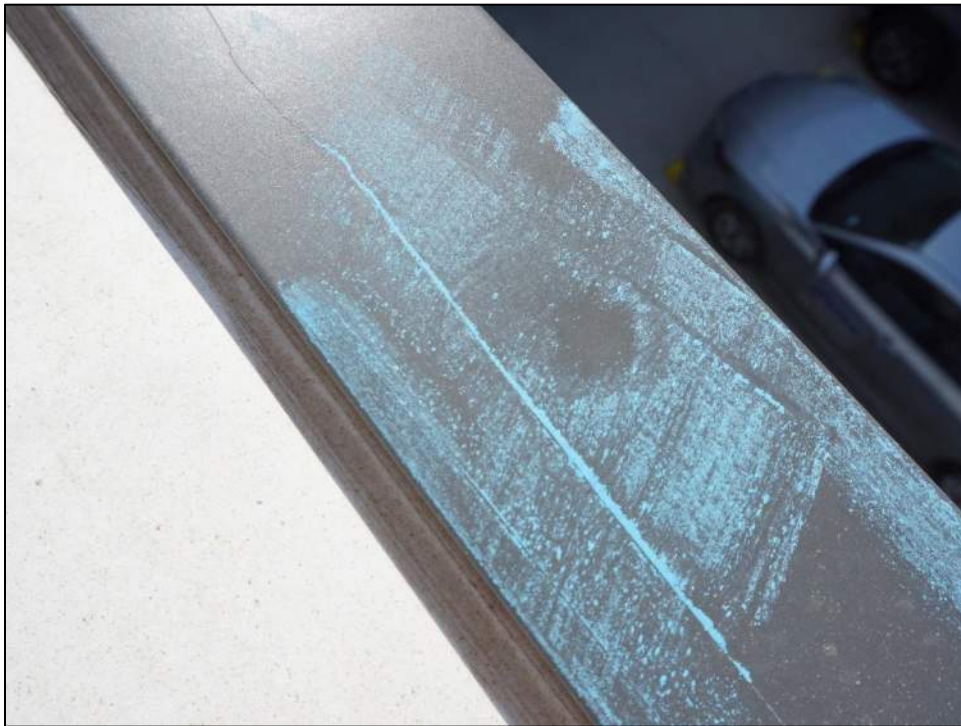
**Photo 22:** No coating disruptions were observed at the dent in the parapet coping.

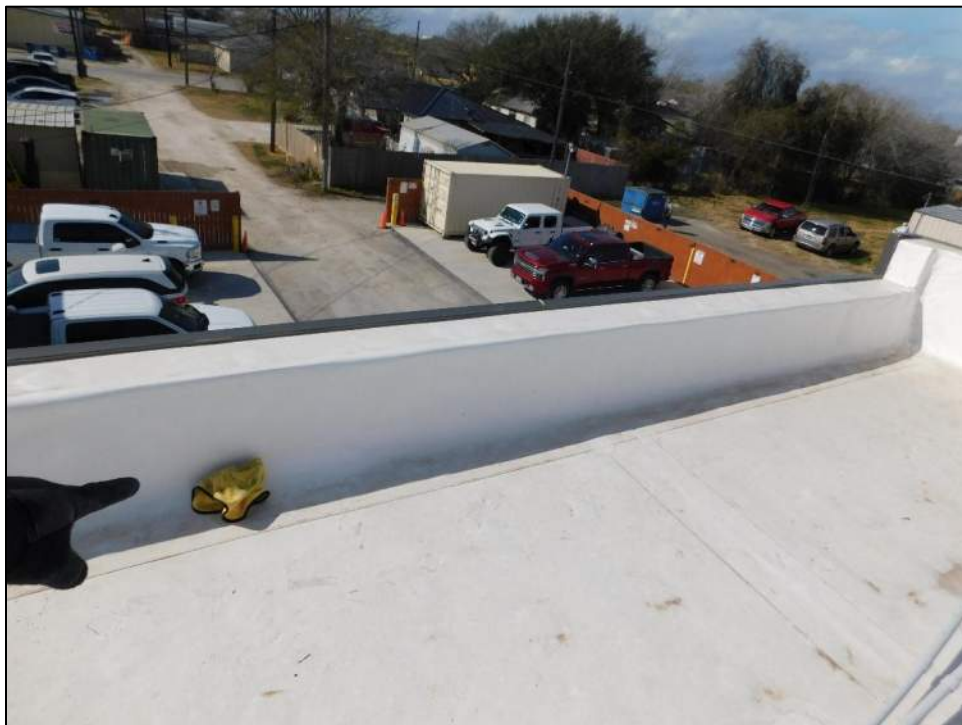
**Photo 24:** Unsupported PVC membranes at the base of parapets facing the direction of the hail were not punctured dimpled or scuffed.

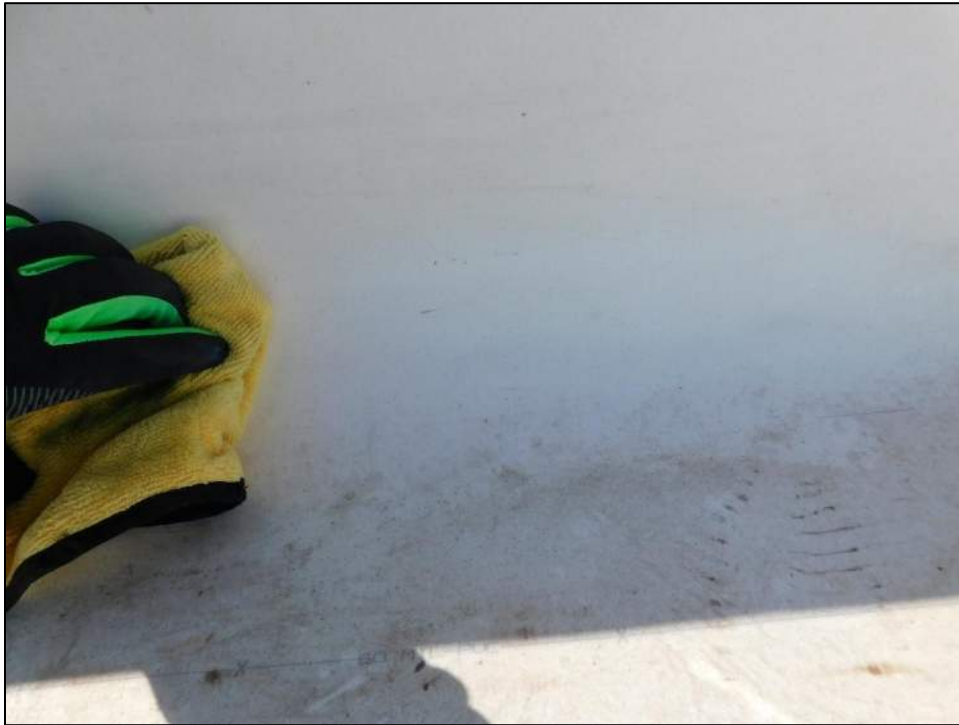
**Photo 25:** Unsupported PVC membranes at the base of parapets facing the direction of the hail were not punctured dimpled or scuffed.

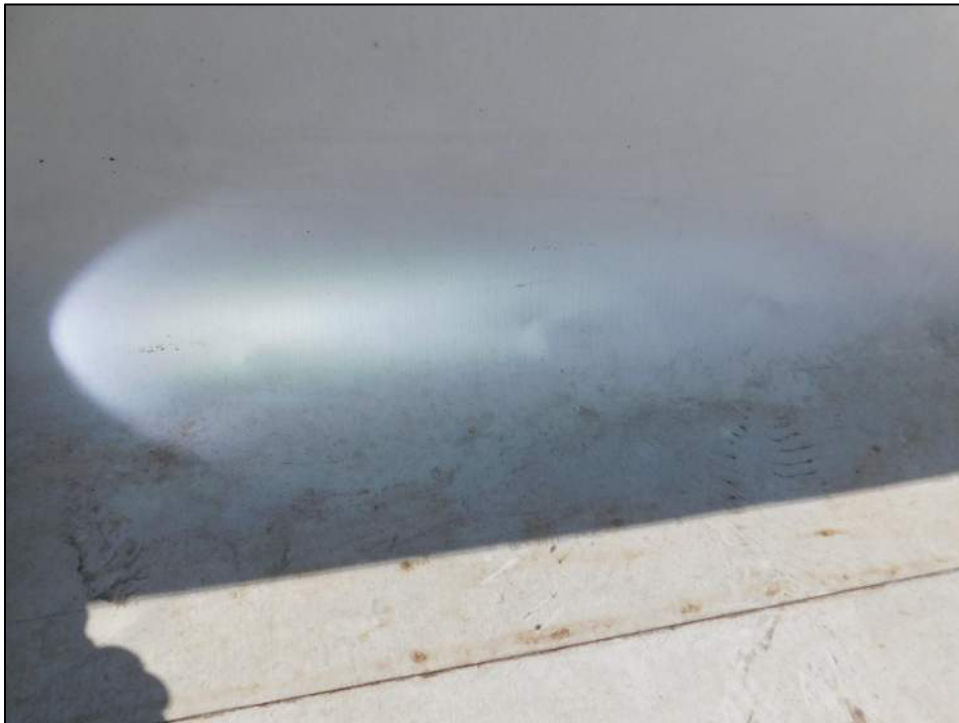
**Photo 26:** Unsupported PVC membranes at the base of parapets facing the direction of the hail were not punctured dimpled or scuffed.

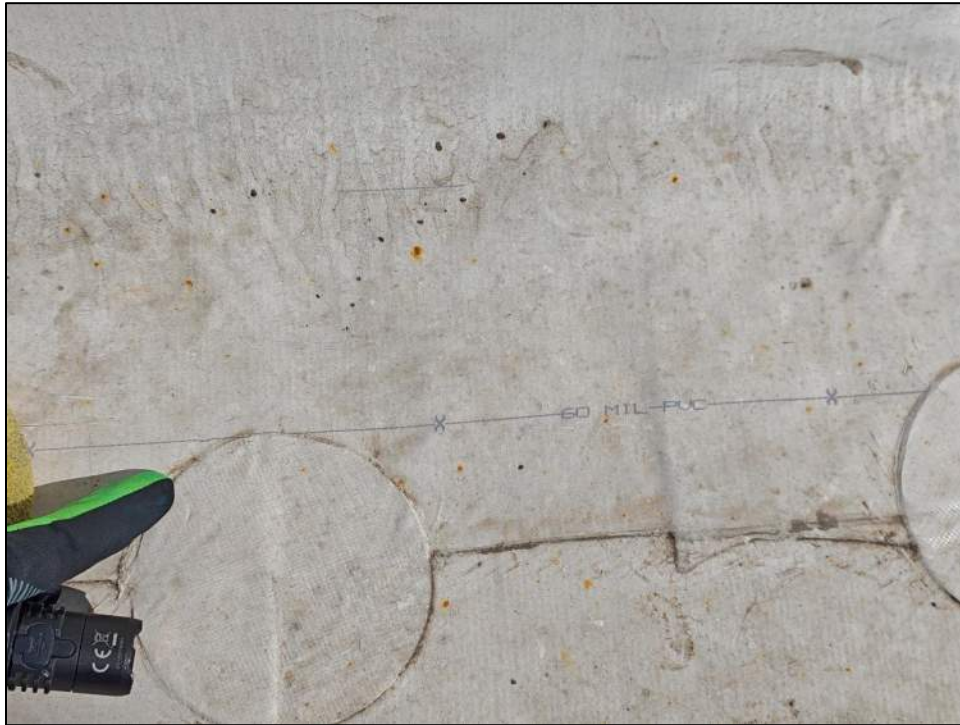
**Photo 27:** The roof was covered with 60 mil PVC membrane roofing.

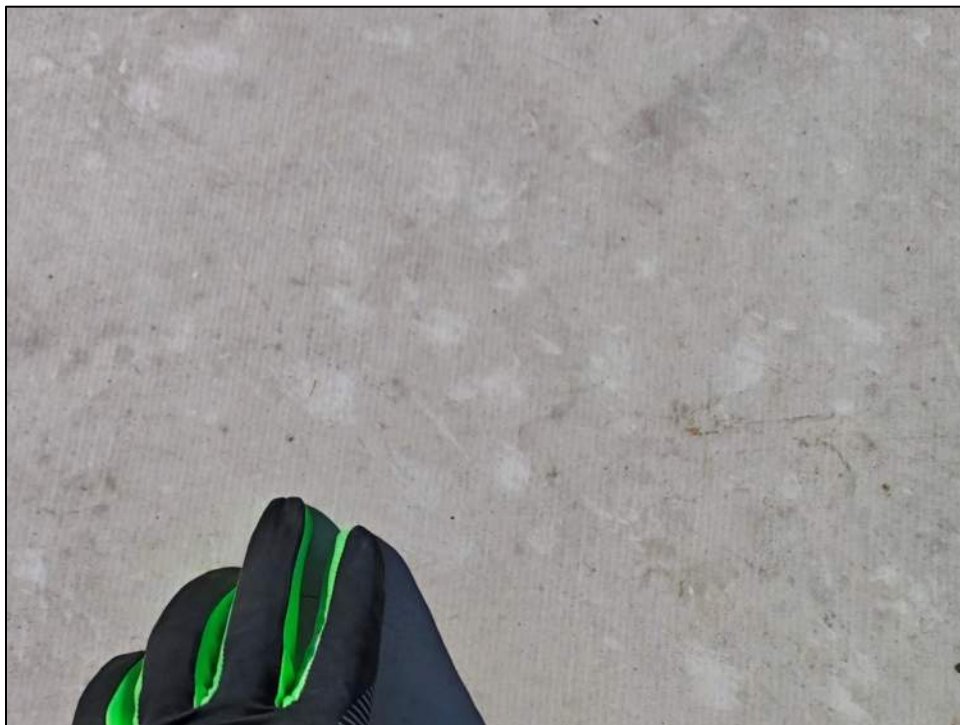
**Photo 28:** Largest hail spatter on the PVC roofing was 1-inch maximum base width.

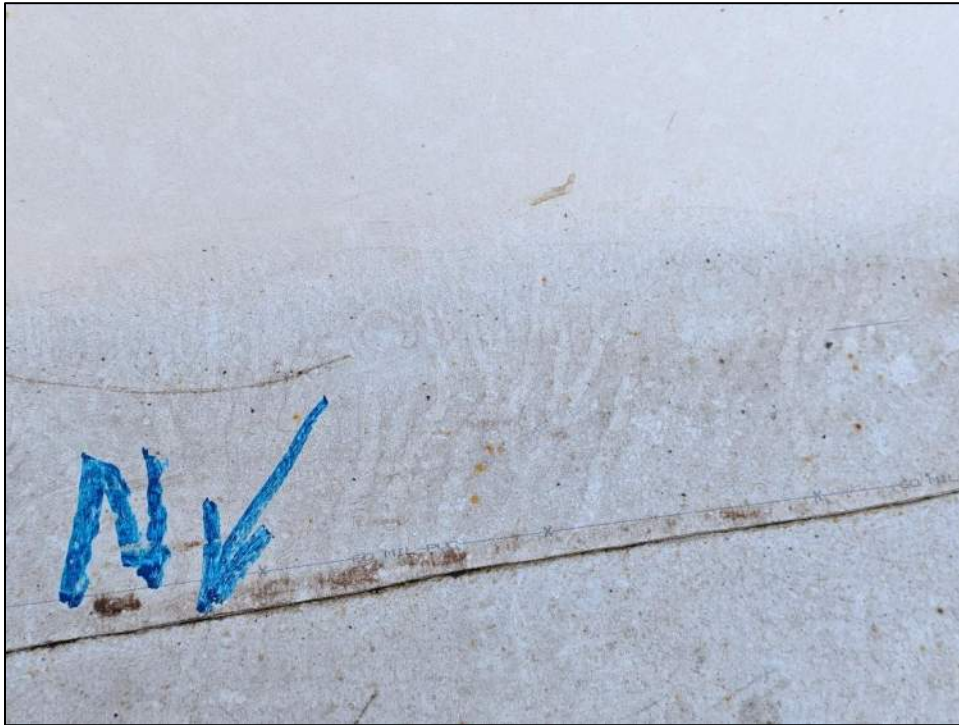
**Photo 31:** Unsupported PVC membranes at the base of parapets facing the direction of the hail were not punctured dimpled or scuffed.
