**CITY OF INGLESIDE  
REGULAR CITY COUNCIL MEETING  
AGENDA  
JUNE 9, 2026  
6:30 PM**

Report on November 01, 2025, Hailstorm Damage to City of Ingleside Buildings.

### Building Damage Analysis Survey and Report

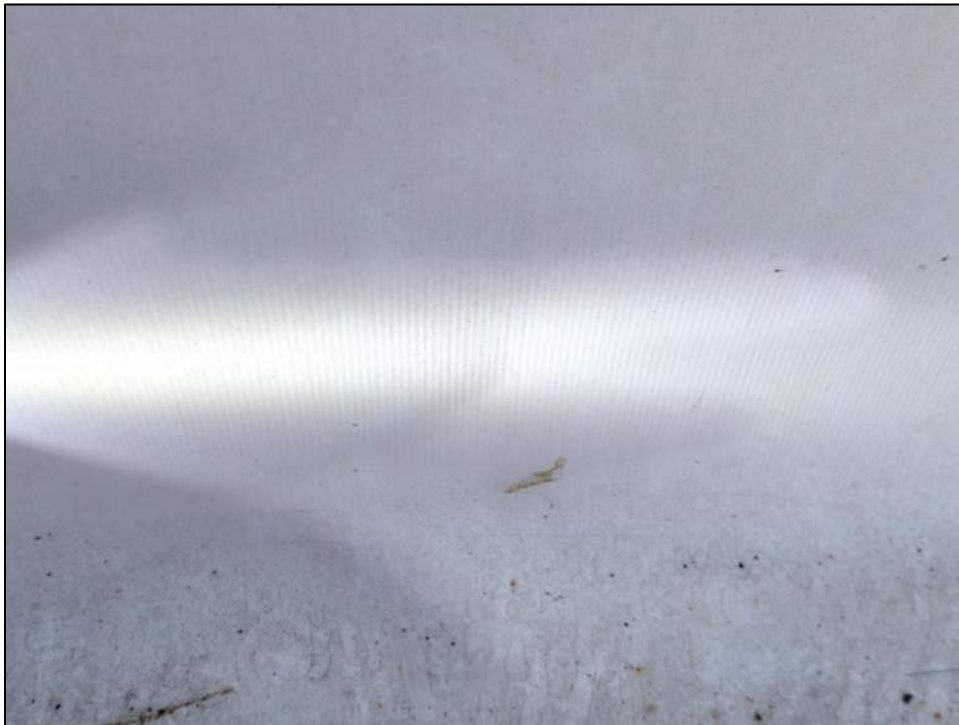
**Photo 32:** Unsupported PVC membranes at the base of parapets facing the direction of the hail were not punctured dimpled or scuffed.

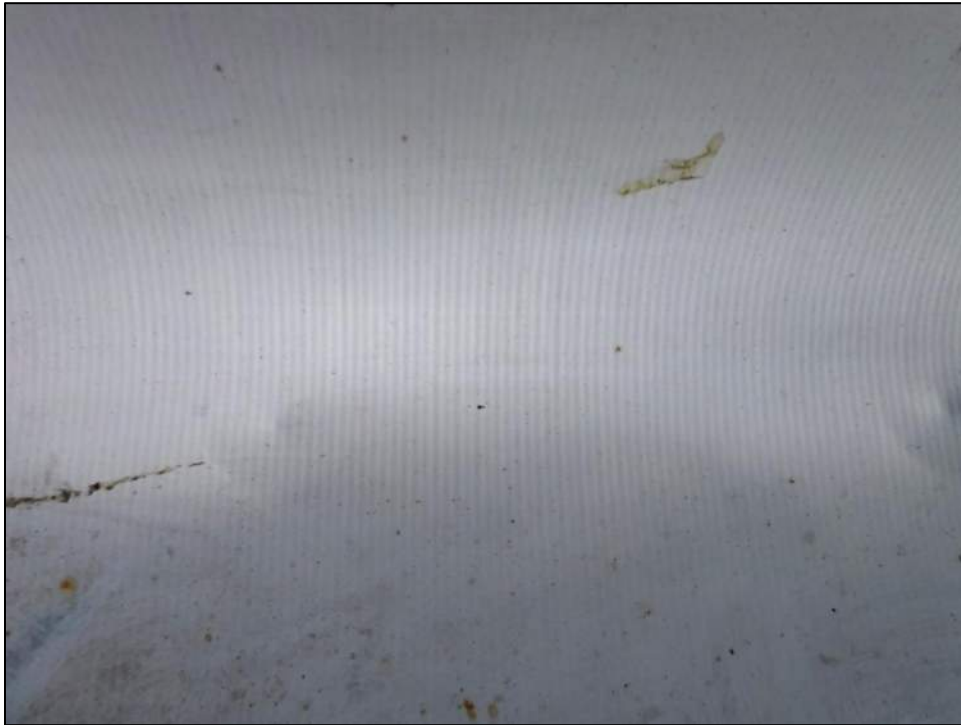
**Photo 33:** Unsupported PVC membranes at the base of parapets facing the direction of the hail were not punctured dimpled or scuffed.

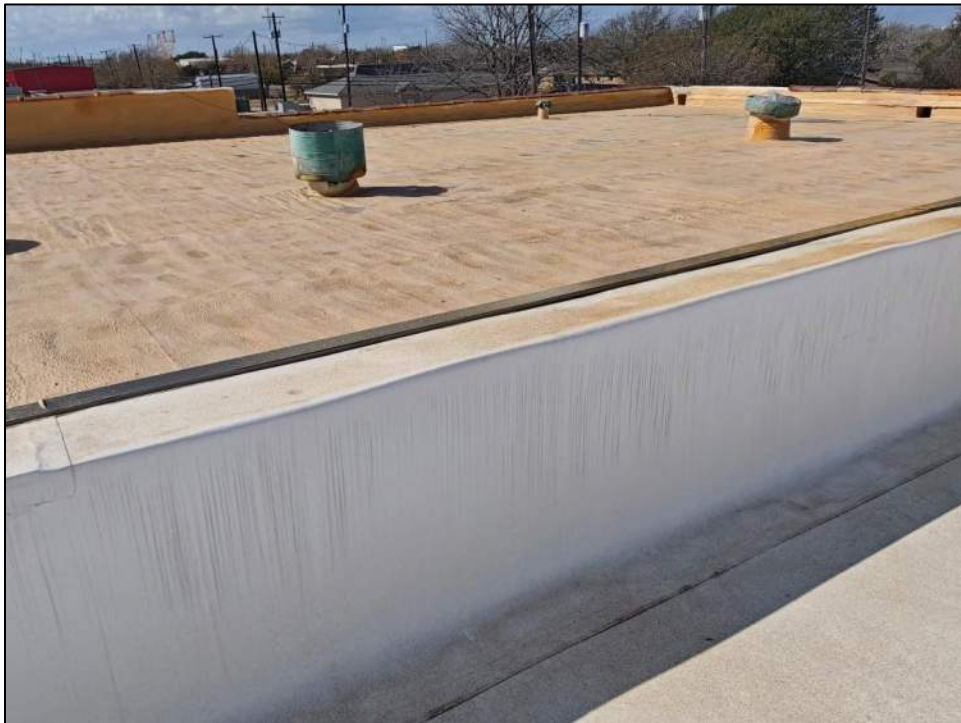
**Photo 34:** Unsupported PVC membranes at the base of parapets facing the direction of the hail were not punctured dimpled or scuffed.

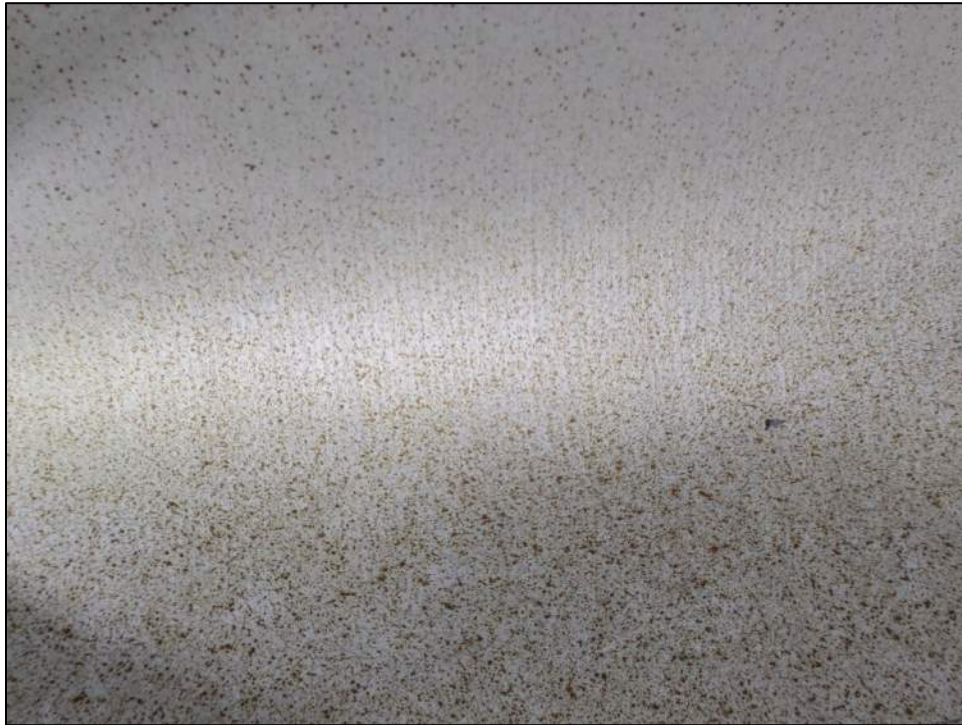
**Photo 35:** Unsupported PVC membranes at the base of parapets facing the direction of the hail were not punctured dimpled or scuffed.

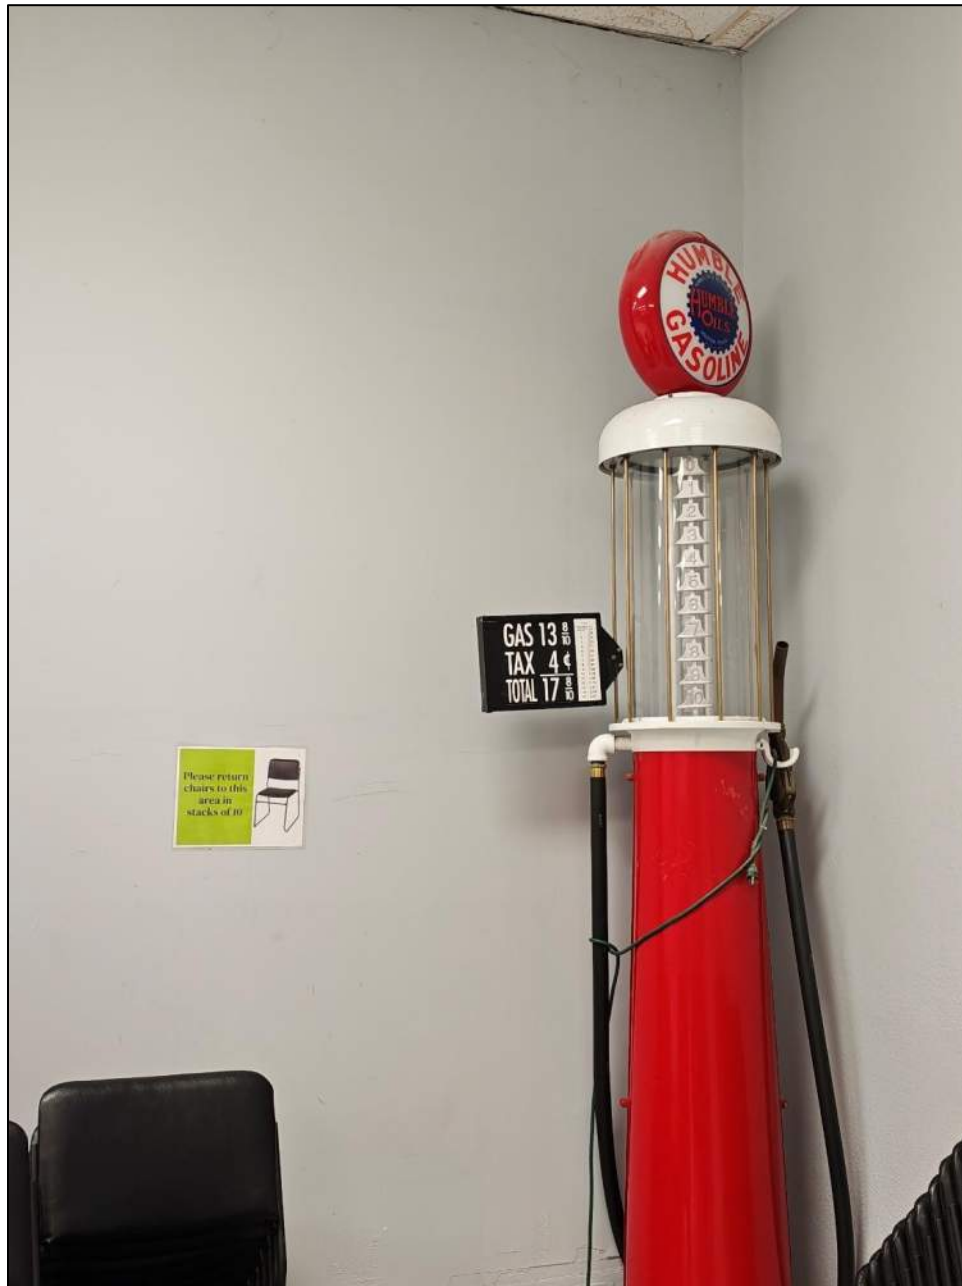
**Photo 36:** A ceiling tile was darkly stained above the central north wall area in the building.

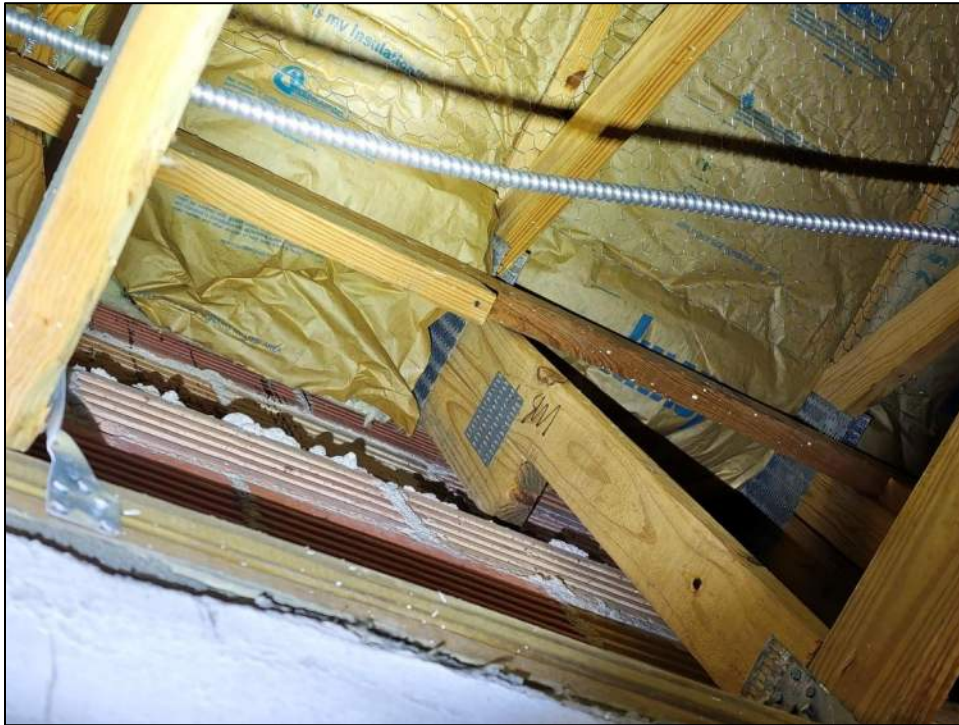
**Photo 37:** Roofing insulation exhibited no moisture distress above the stained ceiling tile.

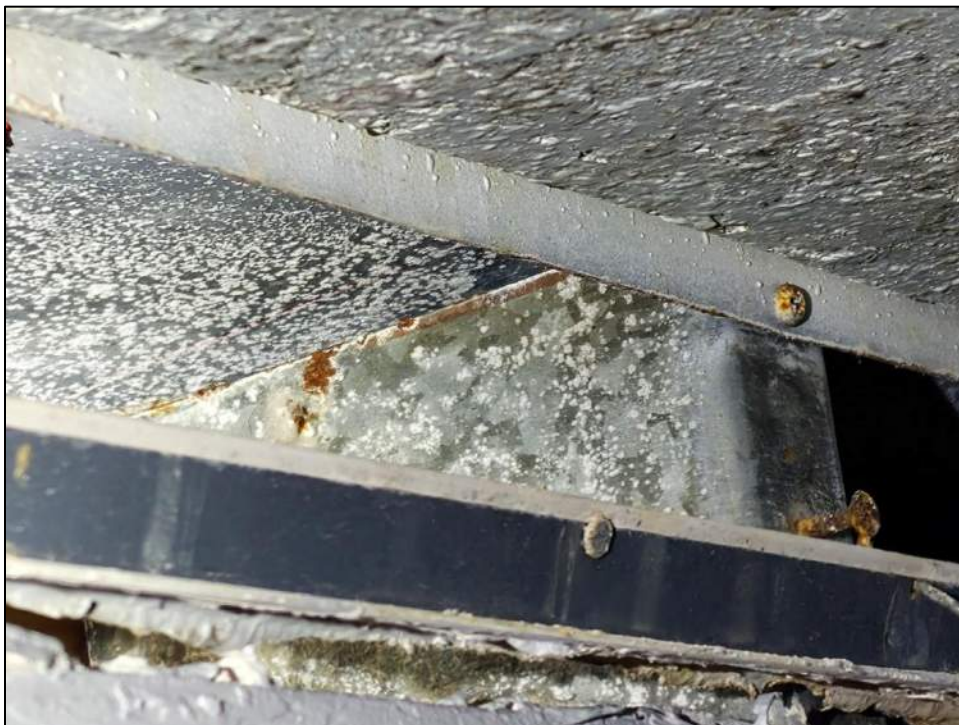
**Photo 38:** Wall stucco corresponding to a wall offset on the exterior were corroded. Note the rusted wall screw.

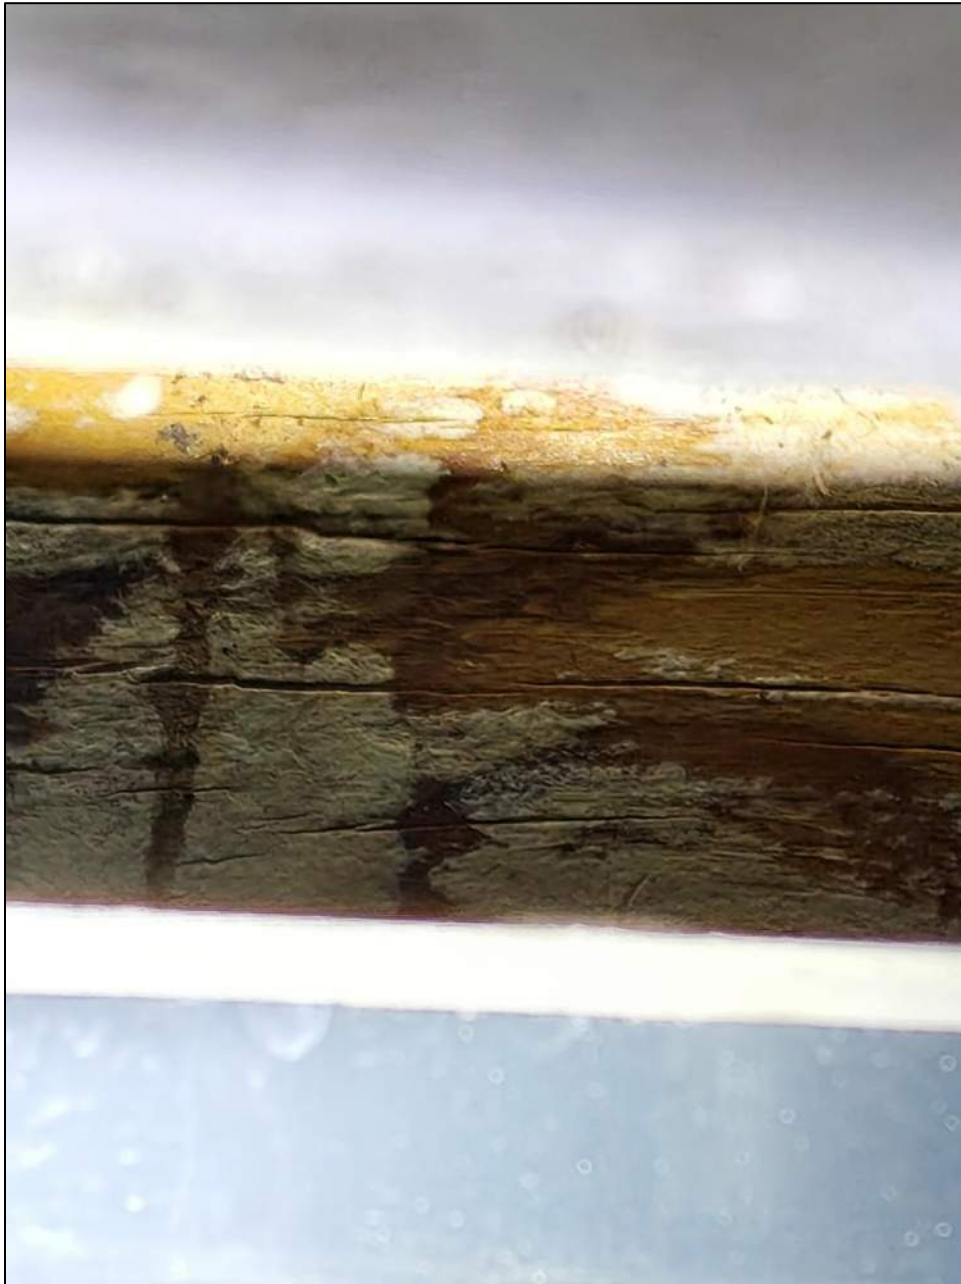
**Photo 42:** Additional view of the darkly stained plywood wall sheathing above the stained ceiling tile.

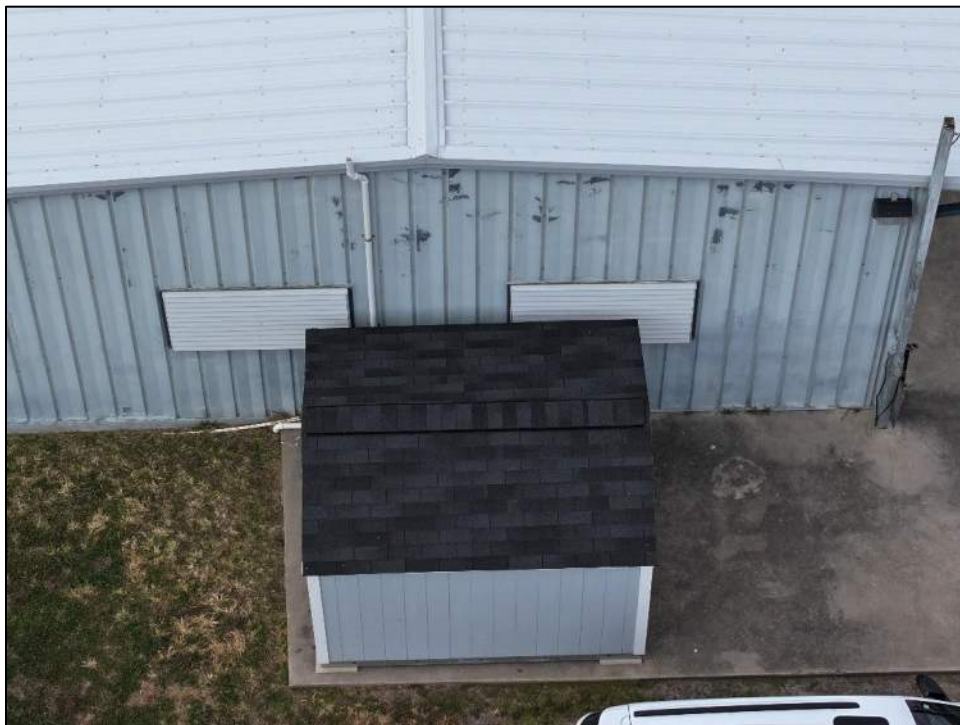
**Photo 2:** Tool shed on east side of the senior citizen building covered with 3-tabs asphalt shingles.

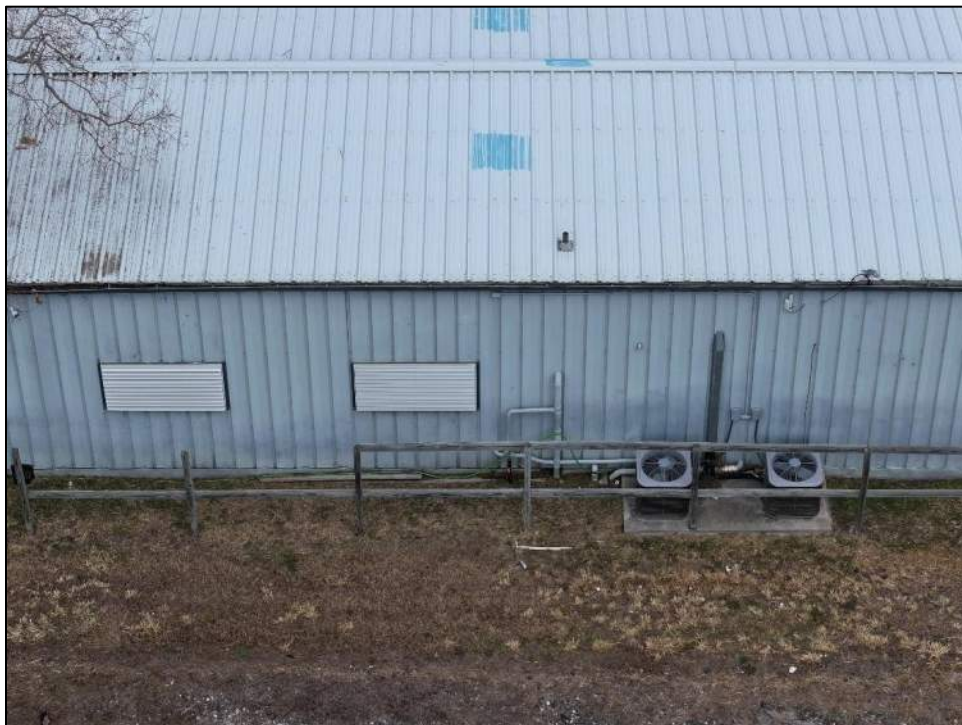
**Photo 4:** South (rear) elevation.

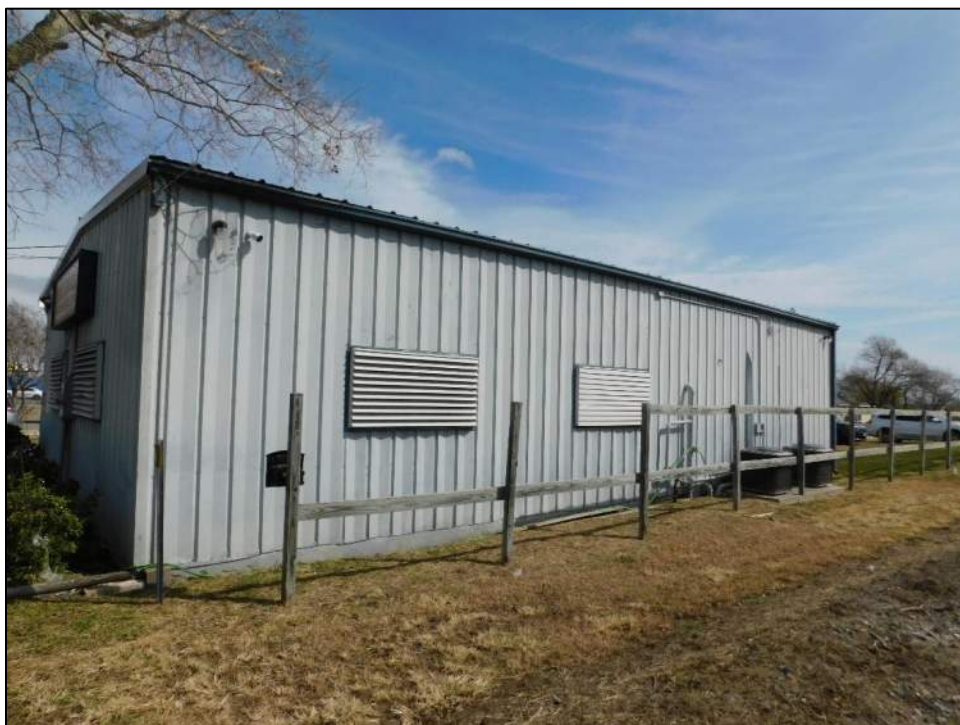
**Photo 6:** South elevation of building was unaffected by hail.

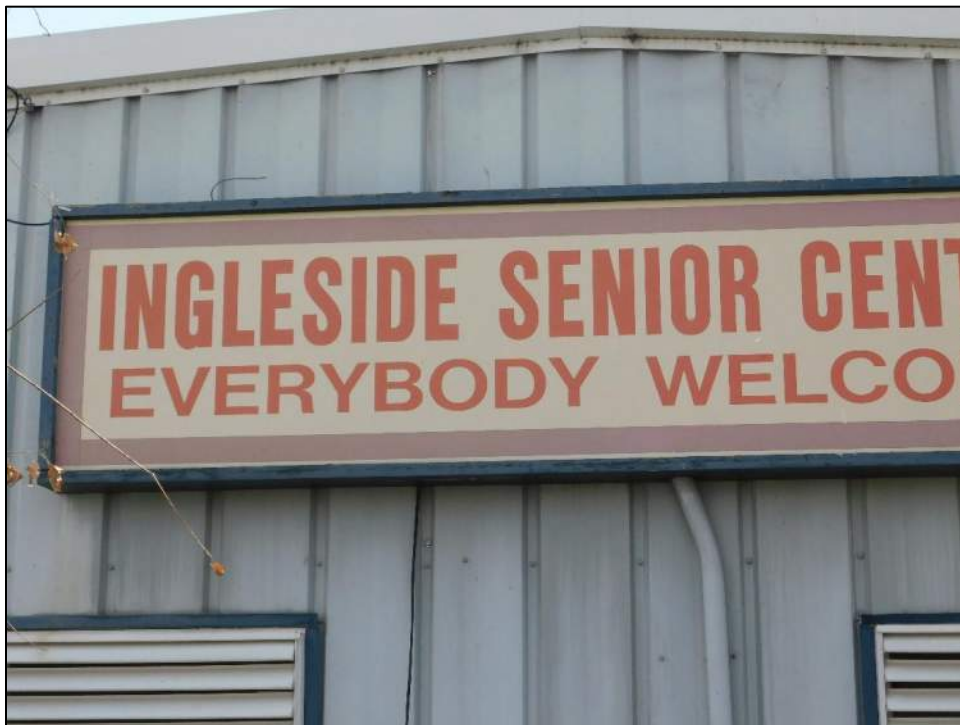
**Photo 8:** No signage impact damage observed on the wall sign on west elevation.

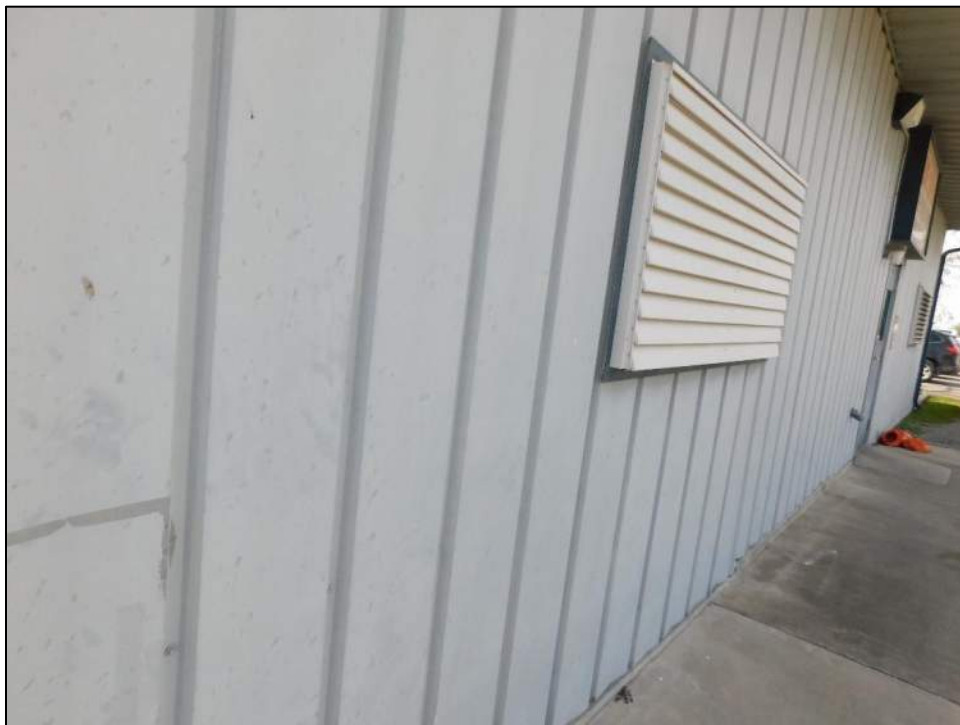
**Photo 10:** Spatters on front wall.

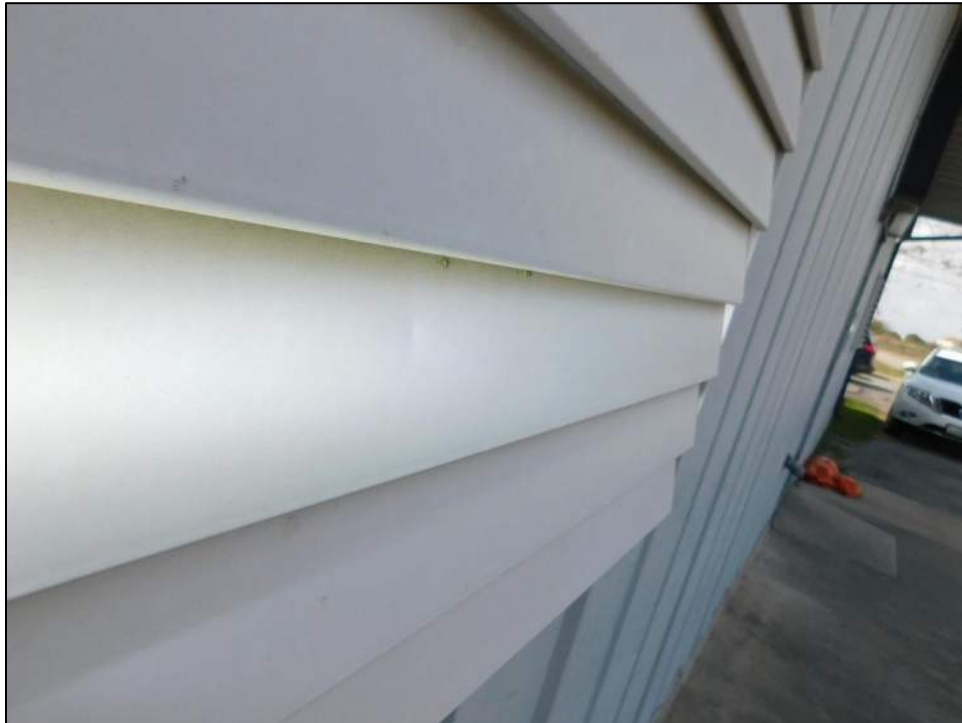
**Photo 11:** Aluminum shutters on front wall exhibited indentations consistent with hail impact.

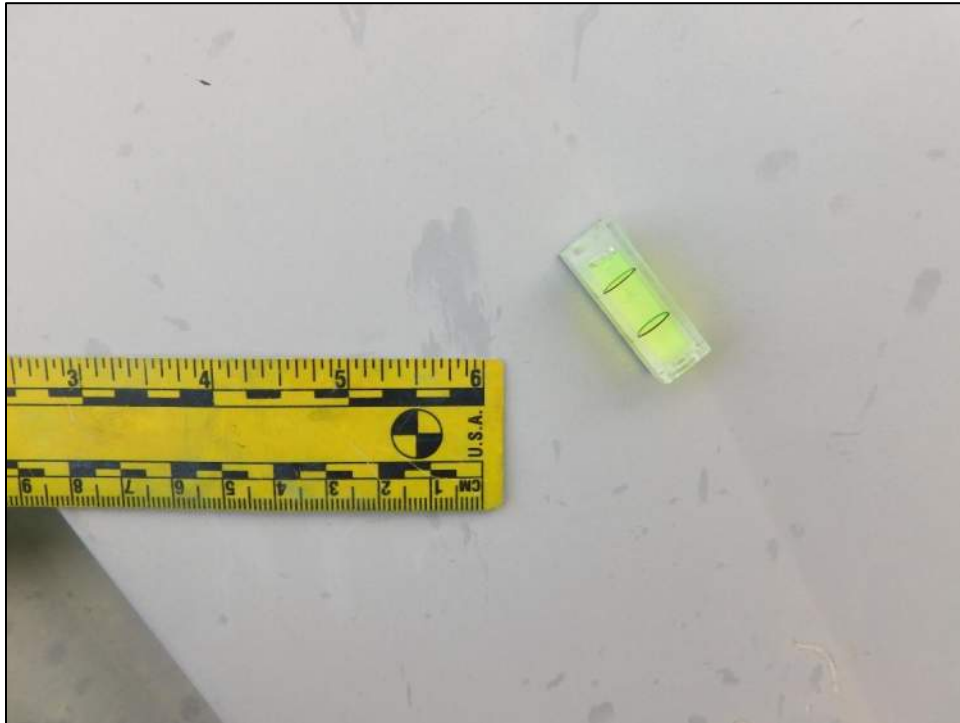
**Photo 13:** Hail spatters on front steel wall panels.

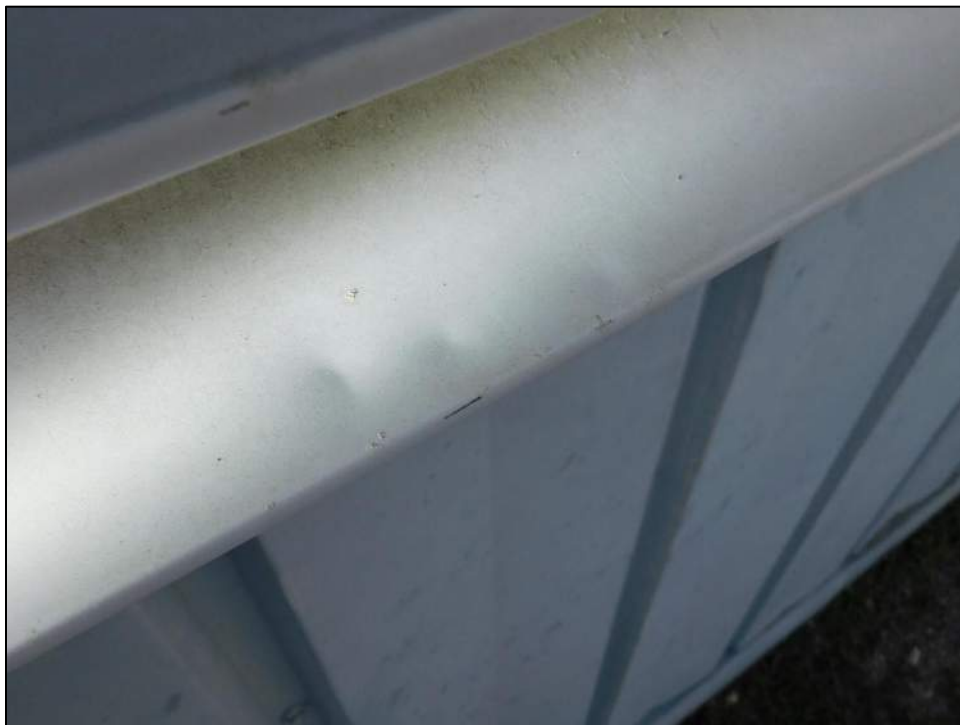
**Photo 14:** Dents in front elevation aluminum shutters consistent with hail impact.

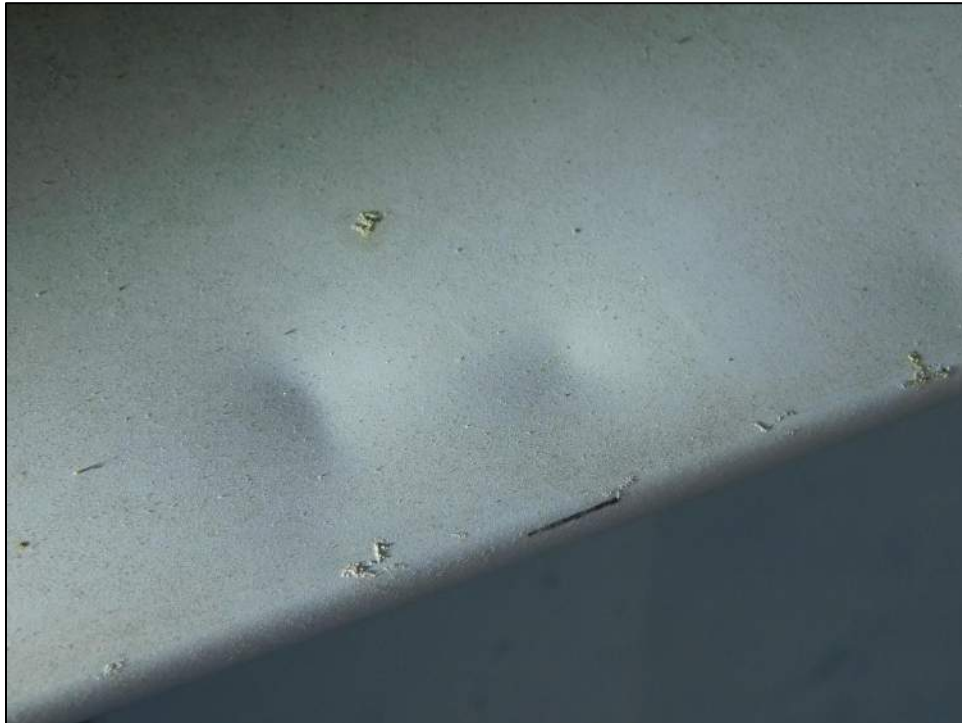
**Photo 15:** No coating disruption at the dents in the front wall aluminum shutters.

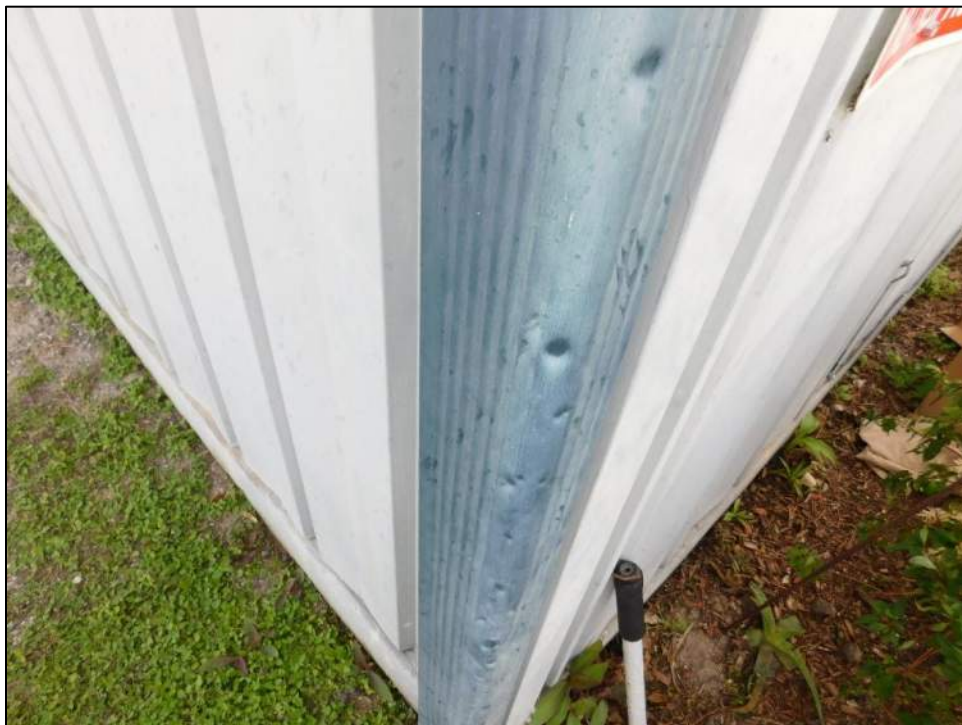
**Photo 16:** Dented aluminum downspout at the northwest wall corner.

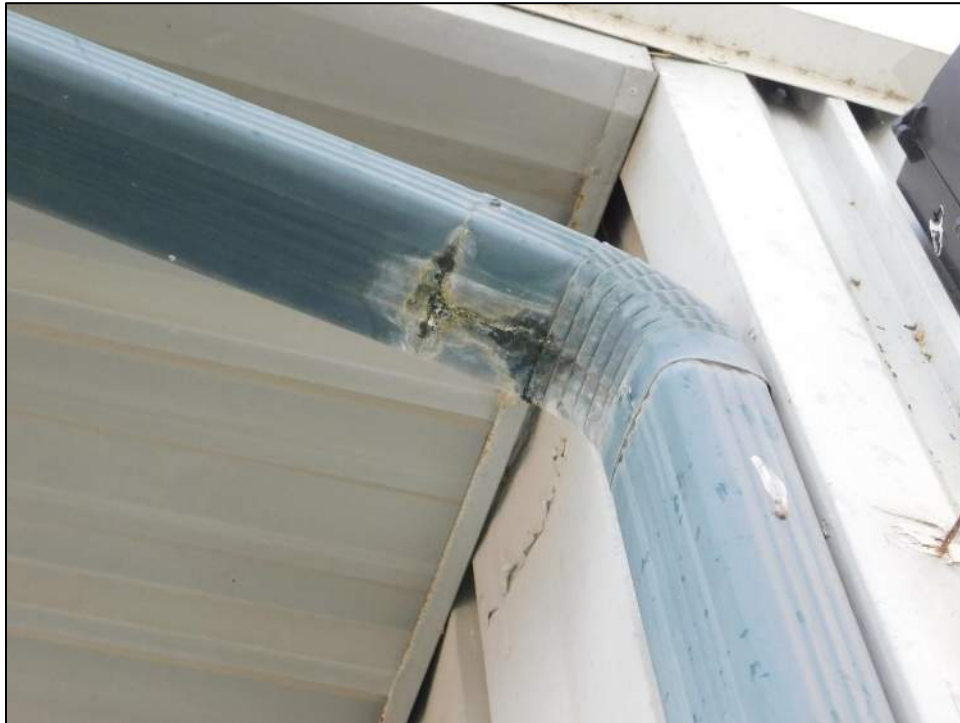
**Photo 17:** downspout corrosion irrelevant to hail impact.

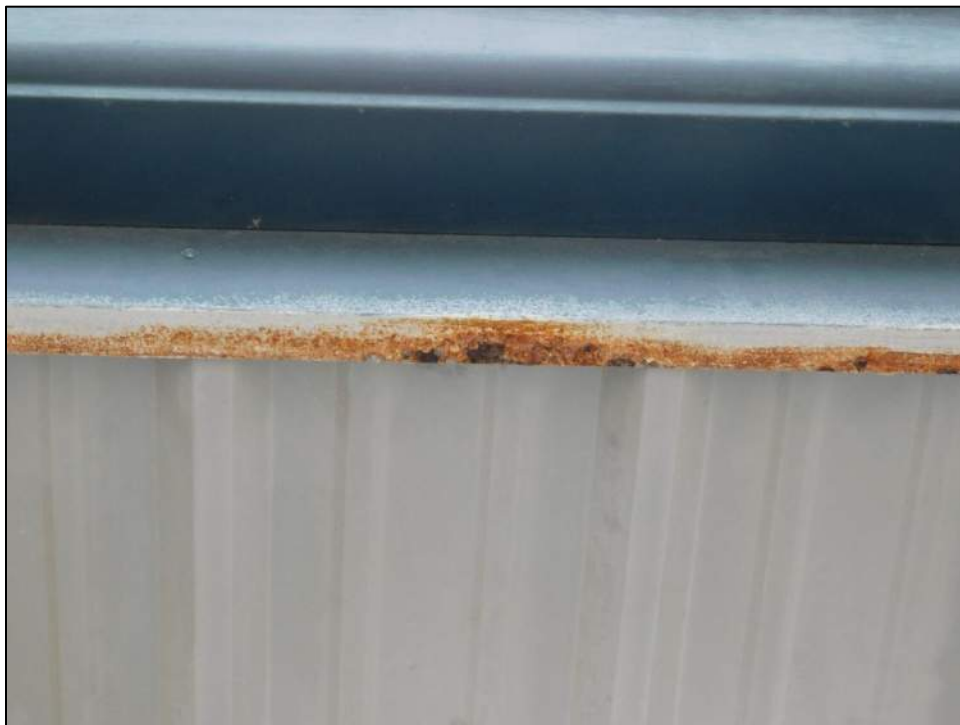
**Photo 18:** Front fascia corrosion.

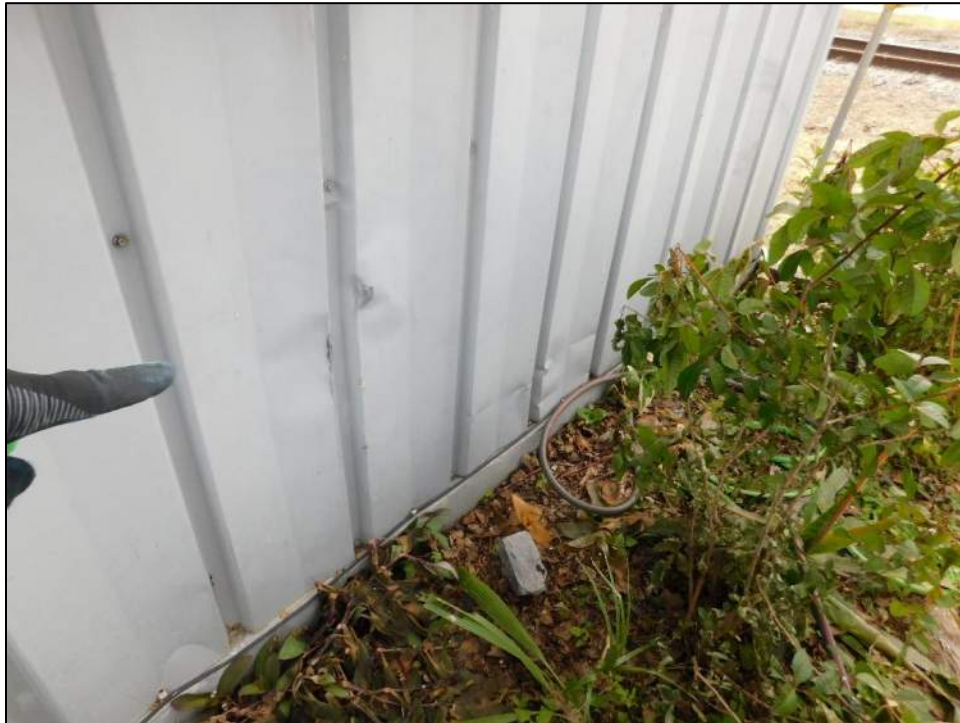
**Photo 19:** Mechanical damage at the lower section of the west wall.

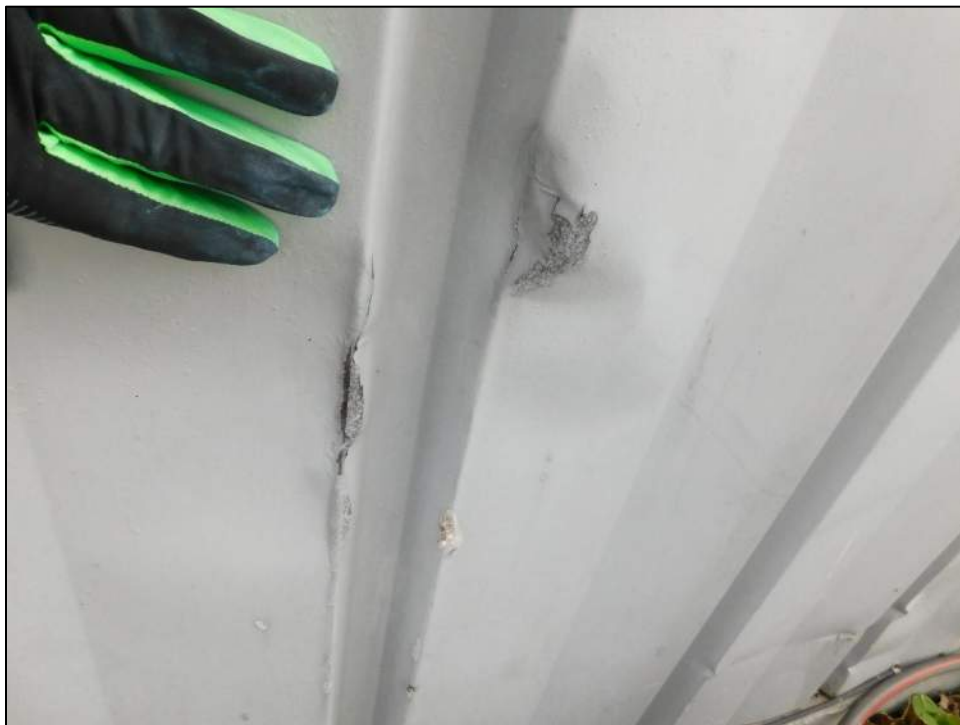
**Photo 20:** Closer view of the mechanical damage to the west wall lower section.

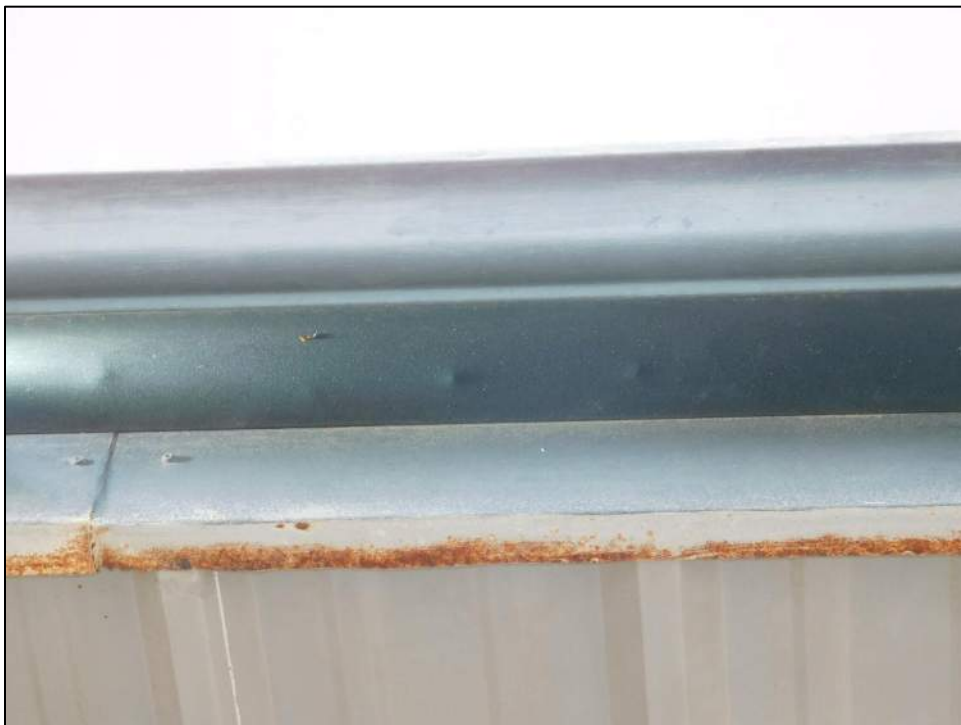
**Photo 22:** Dented gutter bottom (front elevation) consistent with hail impact.

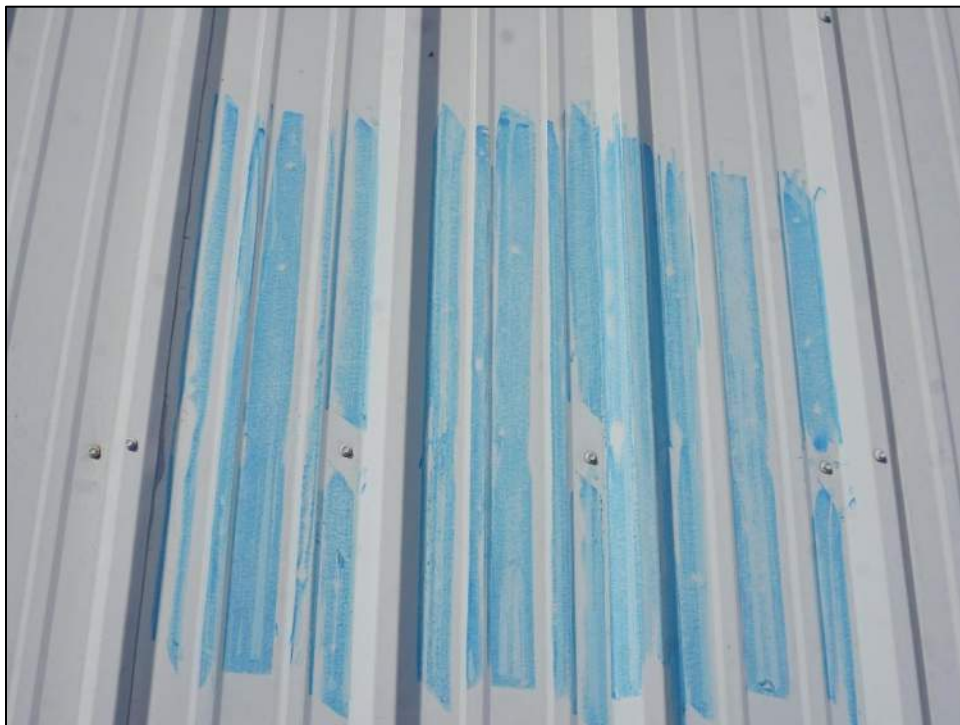
**Photo 24:** North slope hail dents had inner diameter less than 1/2 inch.

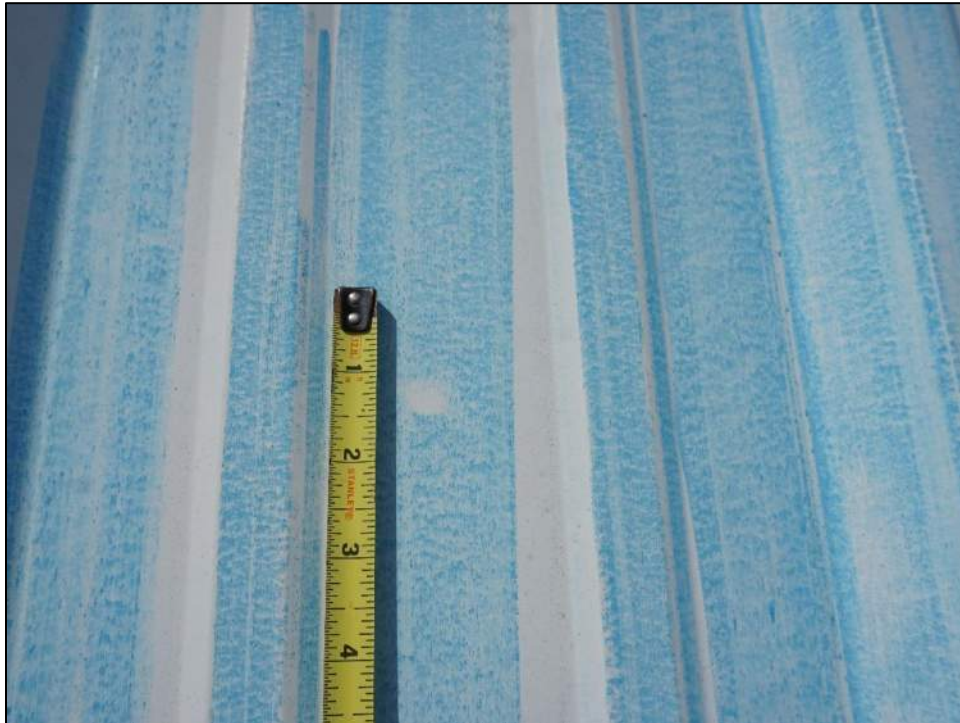
**Photo 25:** North slope hail dents had inner diameter less than 1/2 inch.

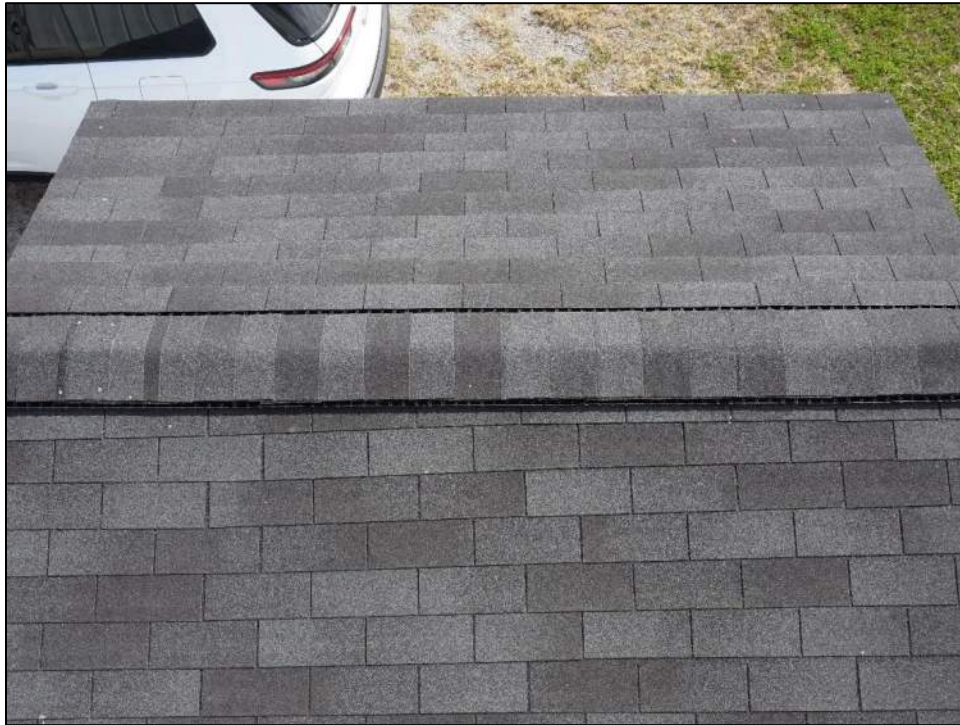
**Photo 27:** 3-Tabs shingles covering the tool shed to the east side of the building did not exhibit hail impact fractures or visible blemishes.

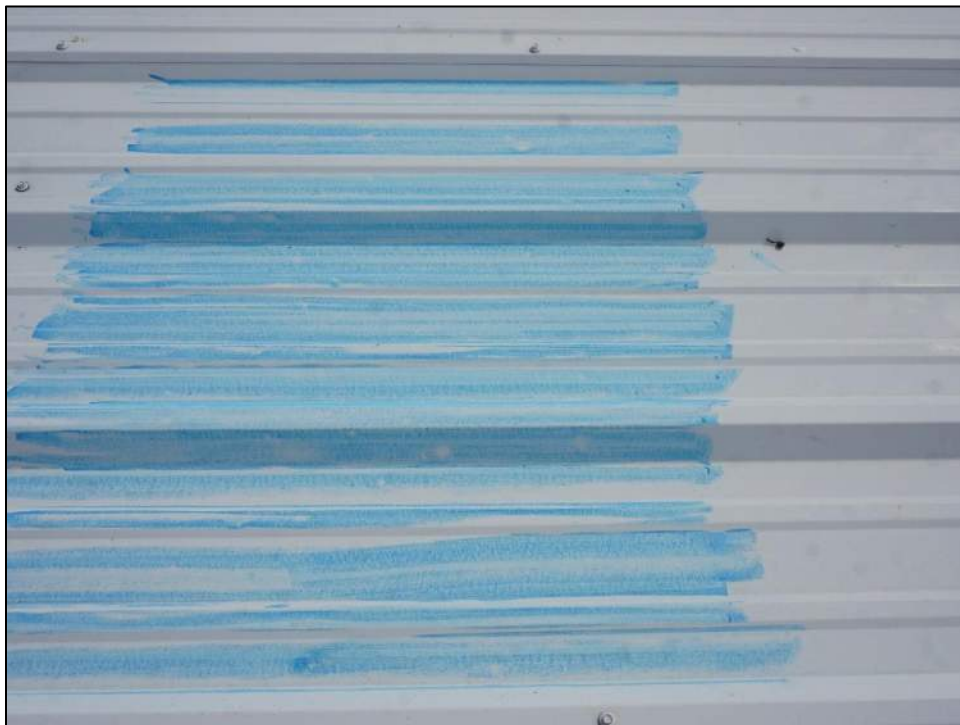
**Photo 28:** South slope panels exhibited indentations with largest inner diameters of less than 1/2 inch.

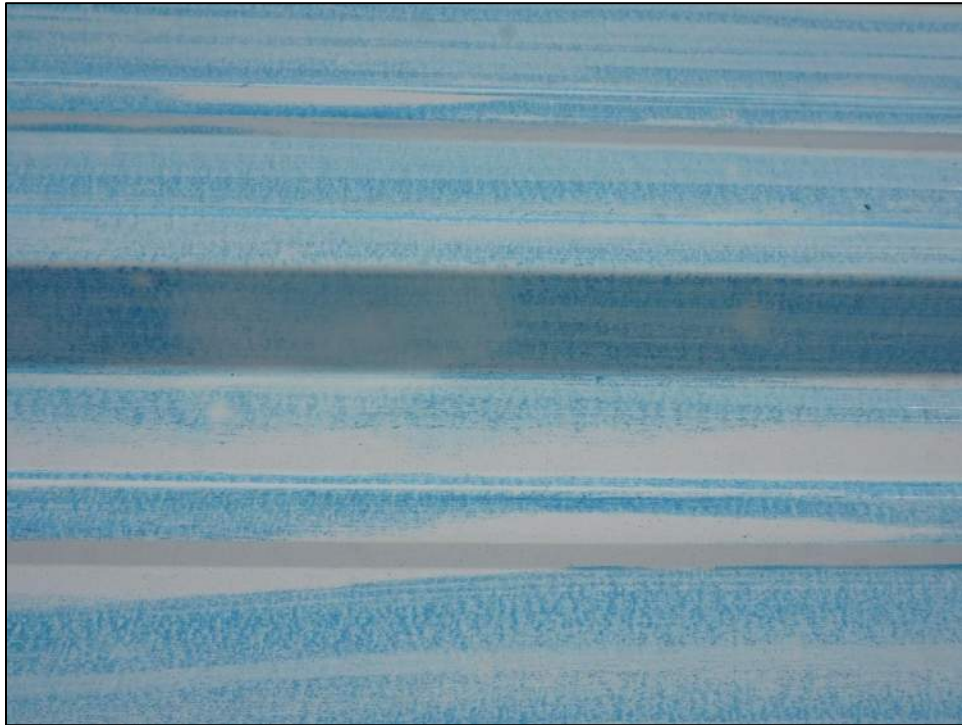
**Photo 29:** No coating disruptions were observed at the hail dents.

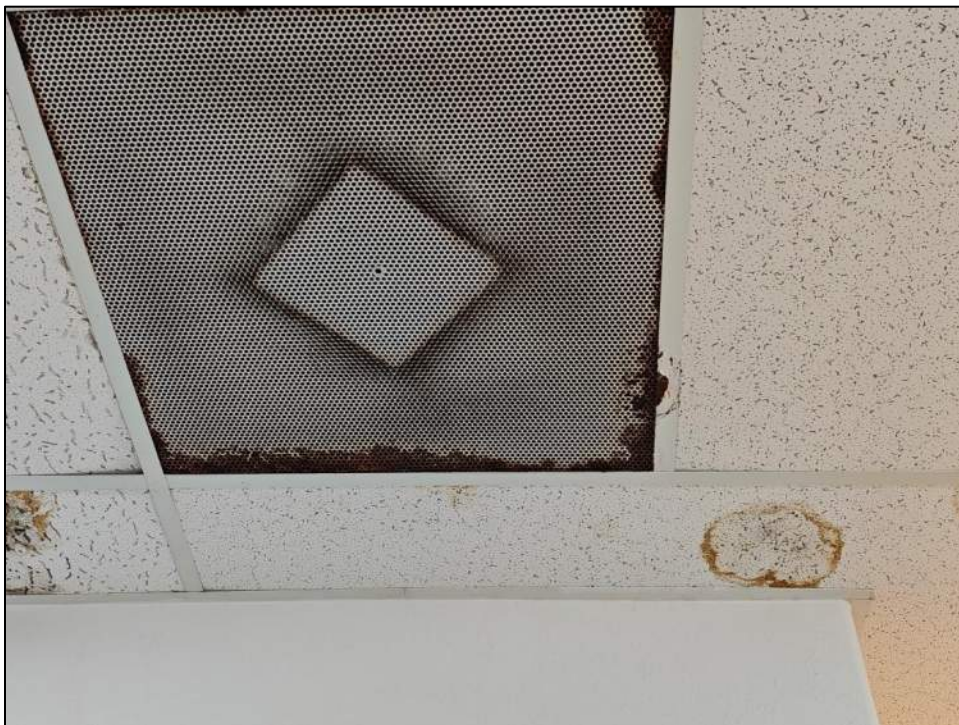
**Photo 32:** Aged stains on ceiling was confirmed by building staff as pre-existing. No additional new roof leaks or stained ceiling tiles were reported since the storm.

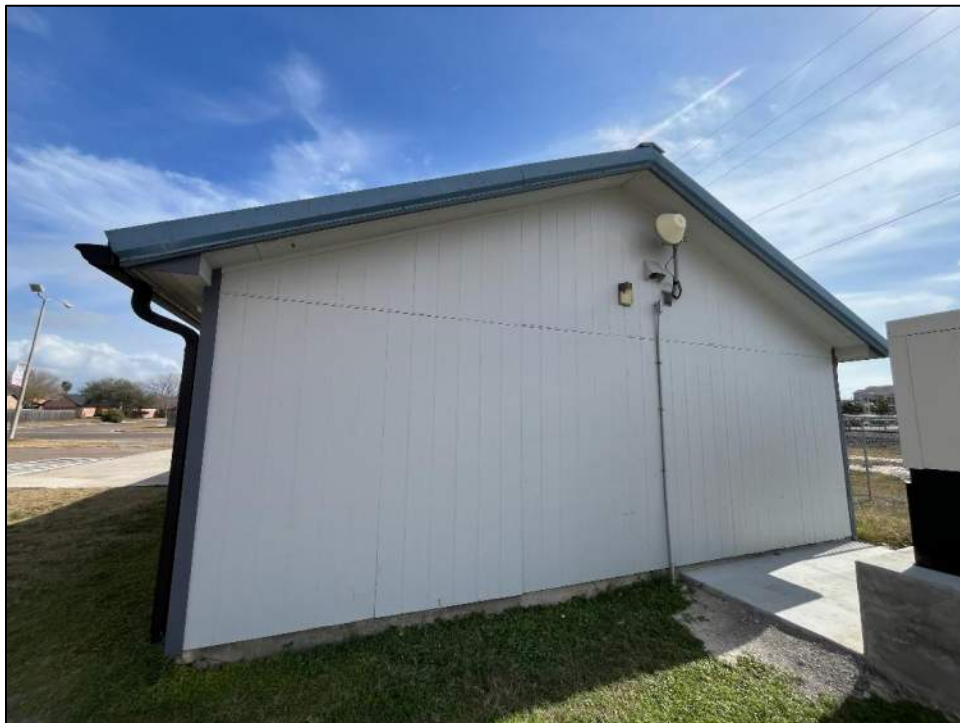
**Photo 2:** West elevation. No hail peck marks were observed on the wall panels.
