**CITY OF INGLESIDE  
REGULAR CITY COUNCIL MEETING  
AGENDA  
JUNE 9, 2026  
6:30 PM**

Report on November 01, 2025, Hailstorm Damage to City of Ingleside Buildings.

### Building Damage Analysis Survey and Report

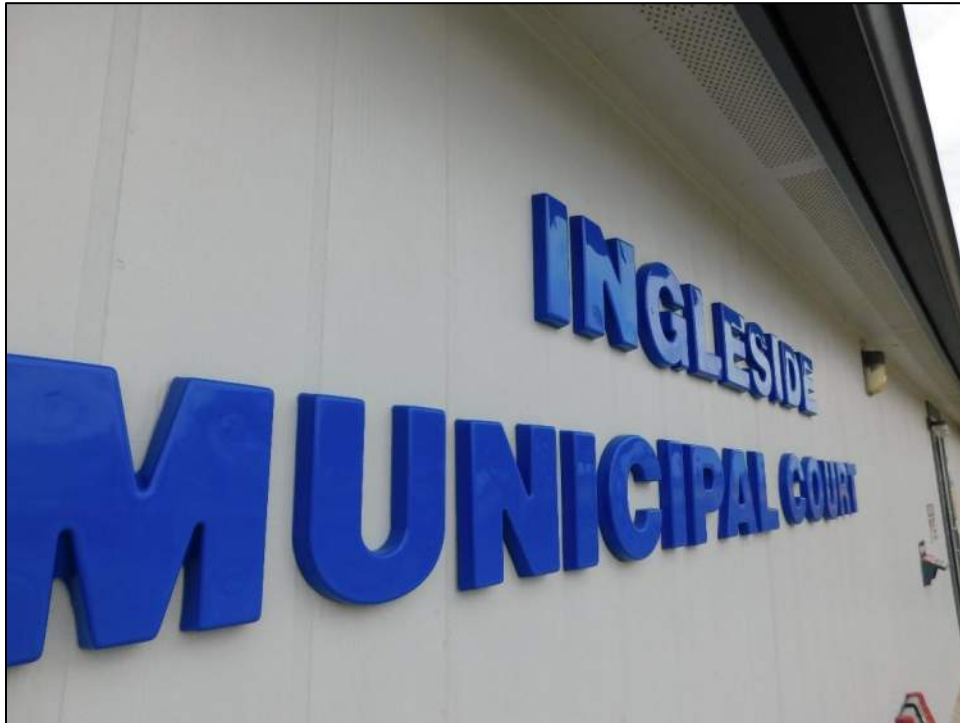
**Photo 5:** Dimensional building signage letters on north (front) wall were not fractured by hail impact.

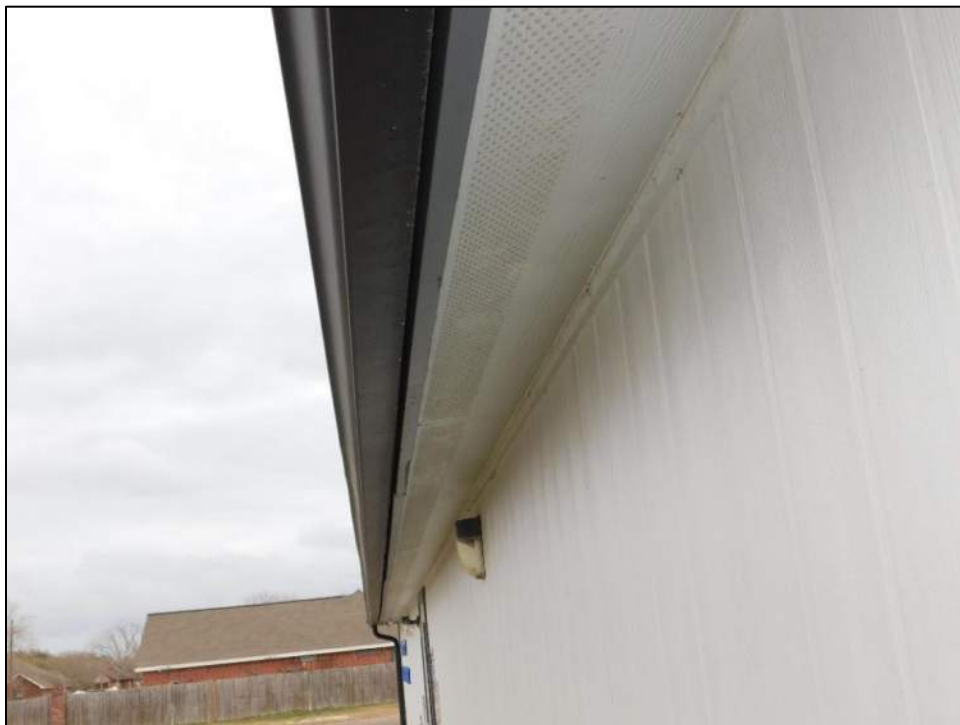
**Photo 6:** Dents were visible in the bottom of the front wall gutters.

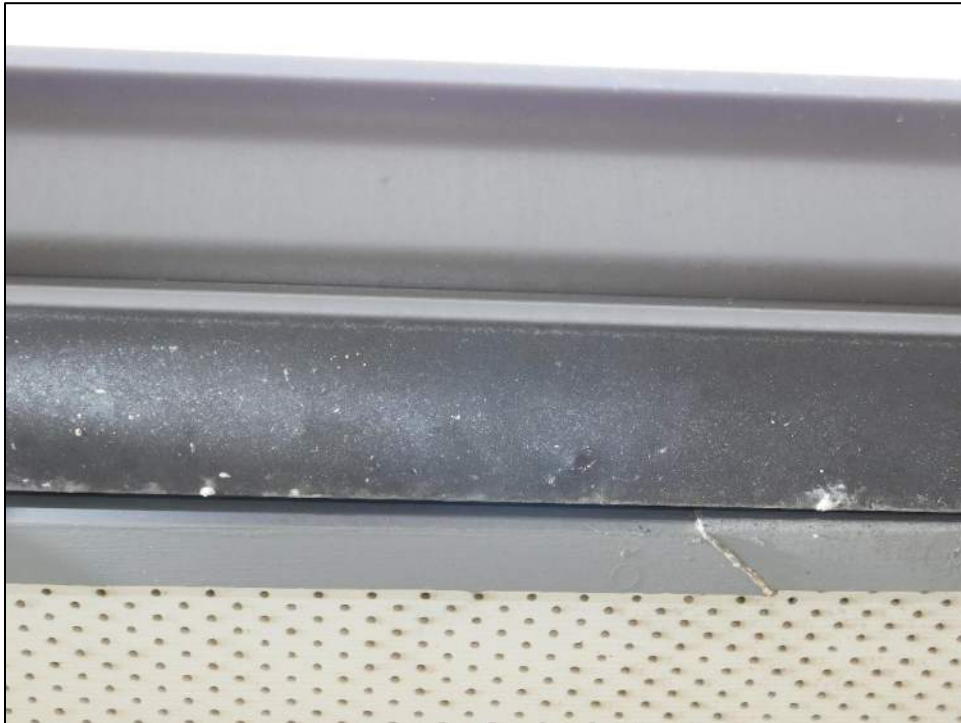
**Photo 7:** Closer view of the hail dents at the bottom of the front aluminum gutter.

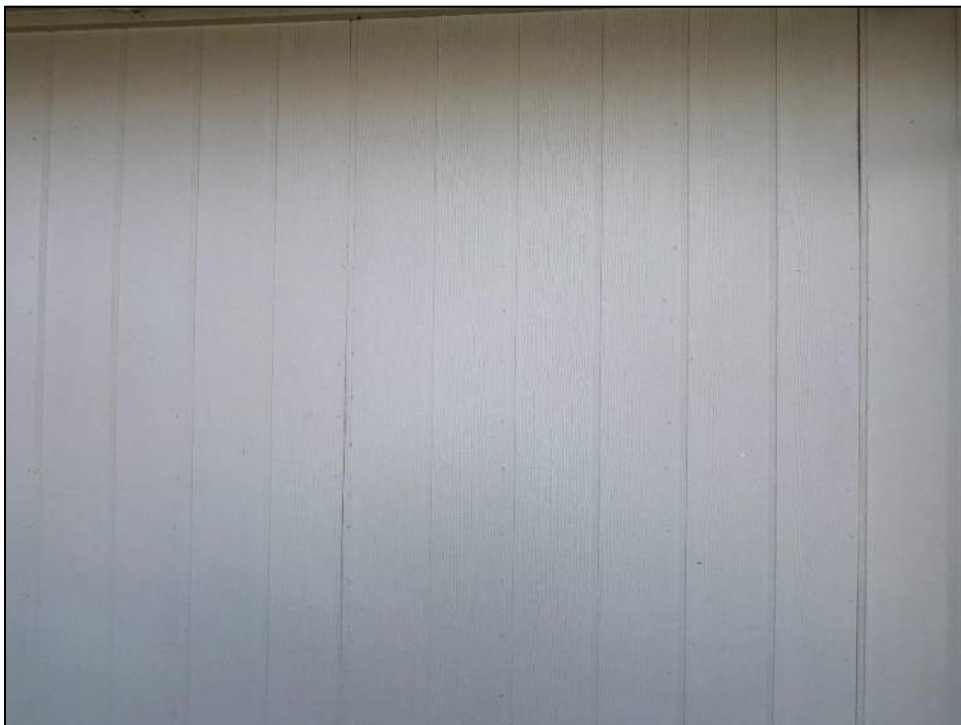
**Photo 8:** Siding panels were absent of hail peck marks.

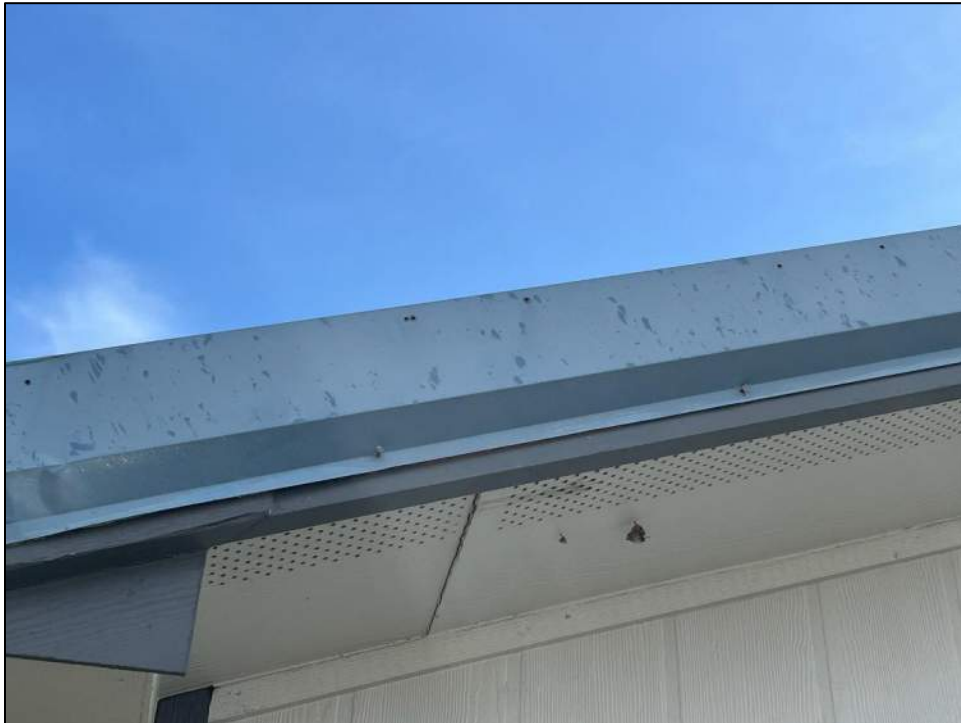
**Photo 9:** Hail spatters visible on the west gable rake closure metal.

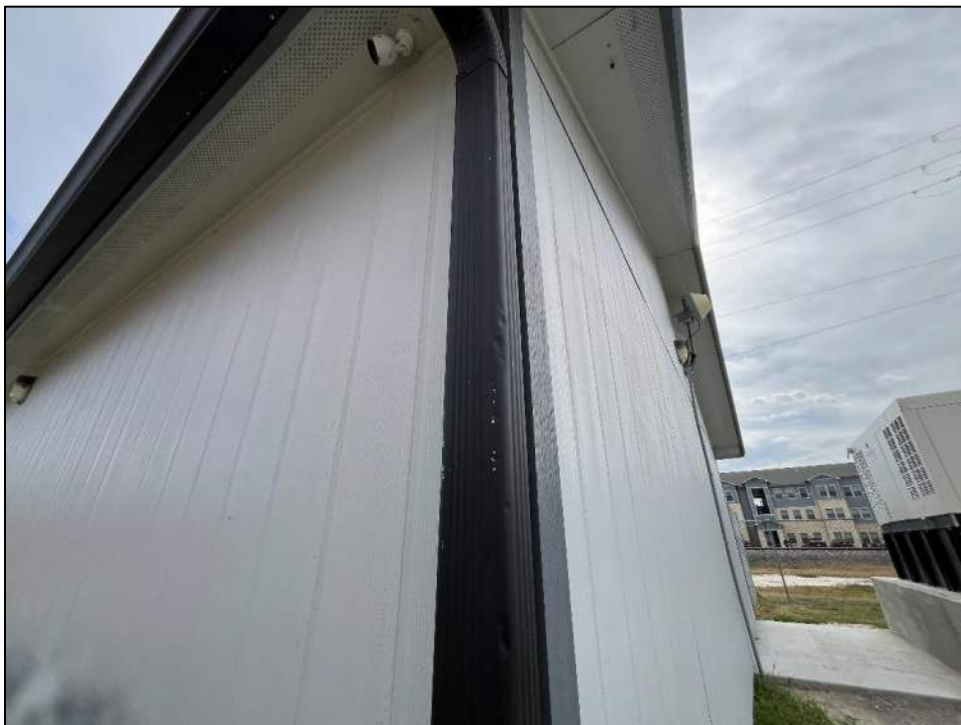
**Photo 10:** dented downspout at northwest building corner.

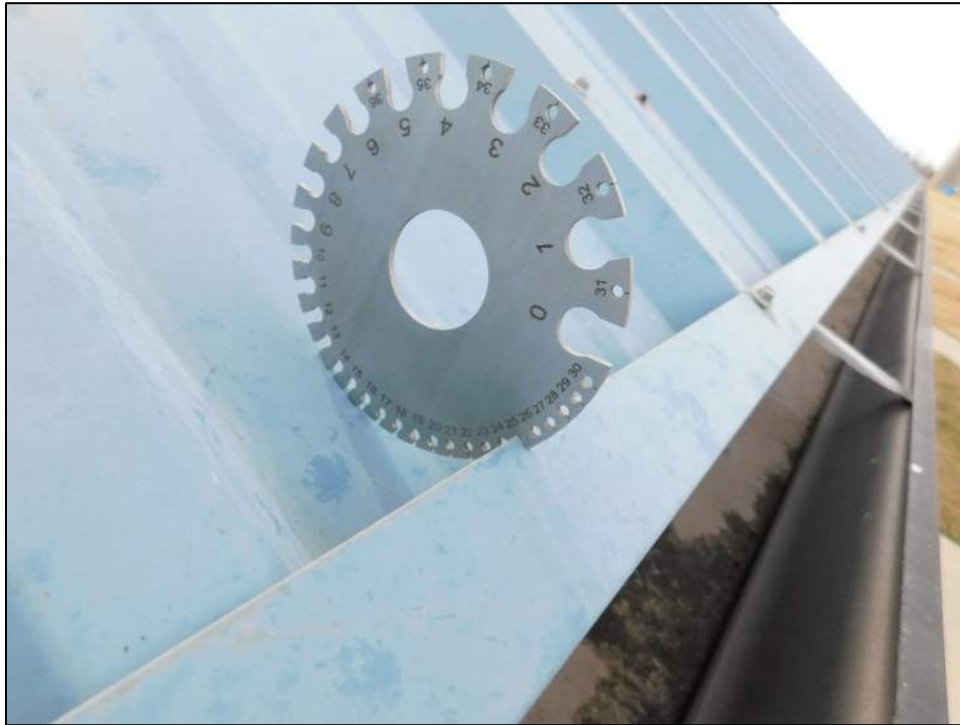
**Photo 11:** Splash guard metal was 25 gauge

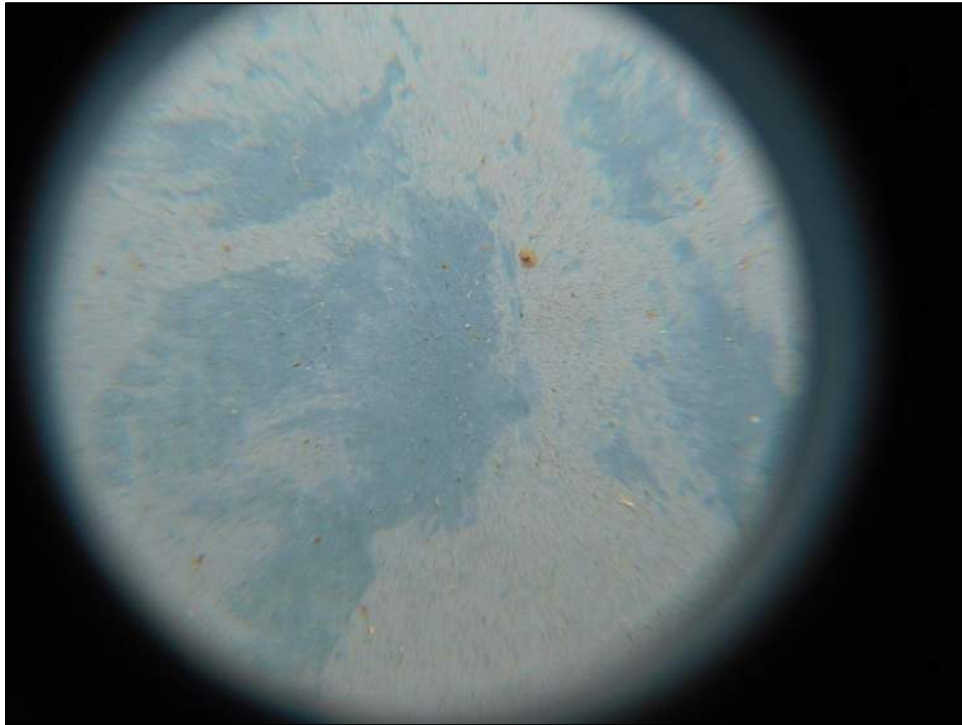
**Photo 13:** No coating disruption was present at the hail spatter.

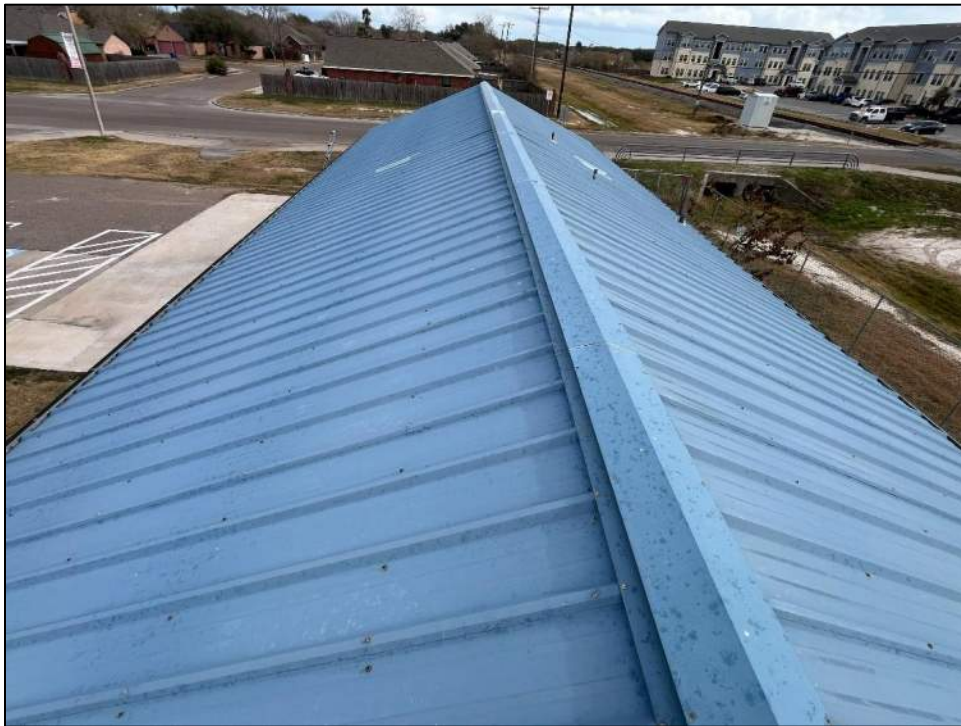
**Photo 16:** Ridge vent remained tightly fastened to roof panels.

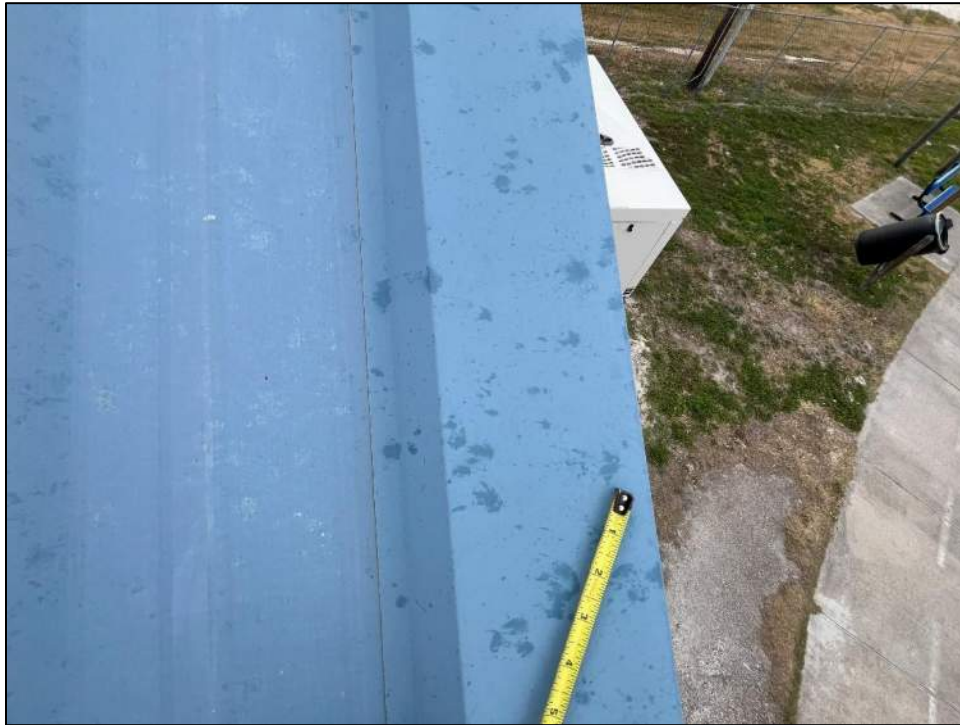
**Photo 17:** Largest hail spatter on west gable rake top surface reflected 1.25 inch hail.

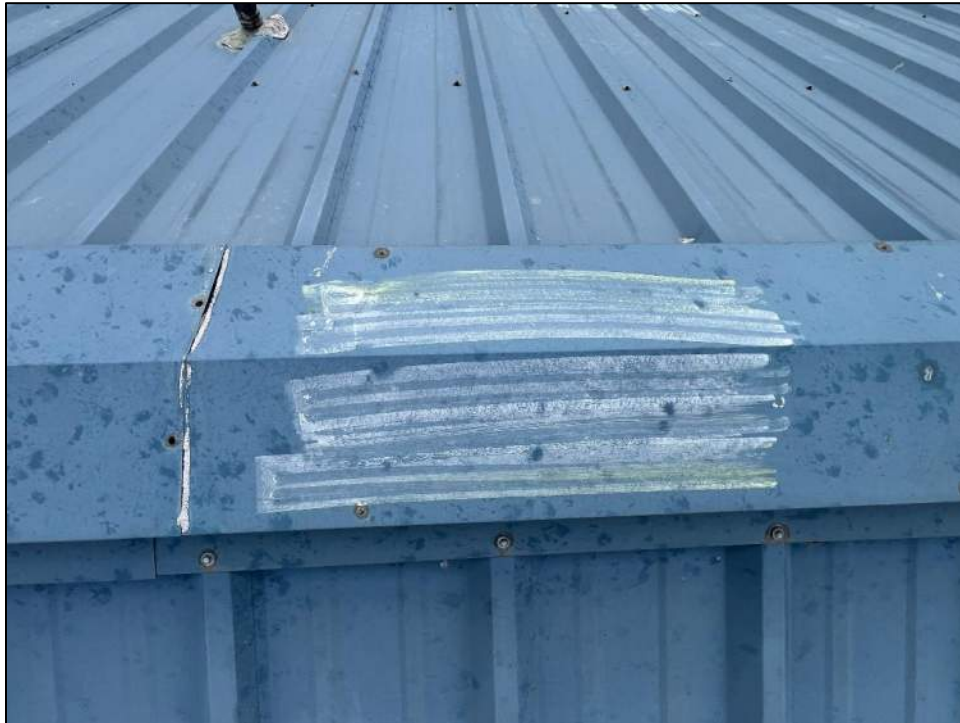
**Photo 20:** Hail-denting along ridge cap had maximum inner diameter of 1/2 inch.

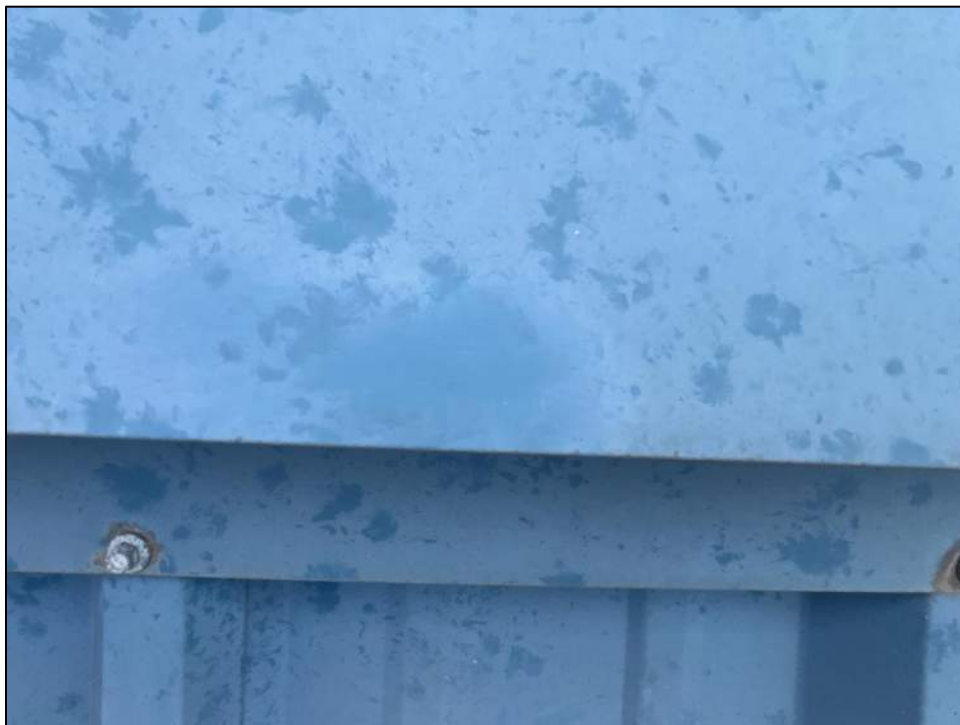
**Photo 21:** No coating disruptions were observed at the hail spatters along the ridge cap.

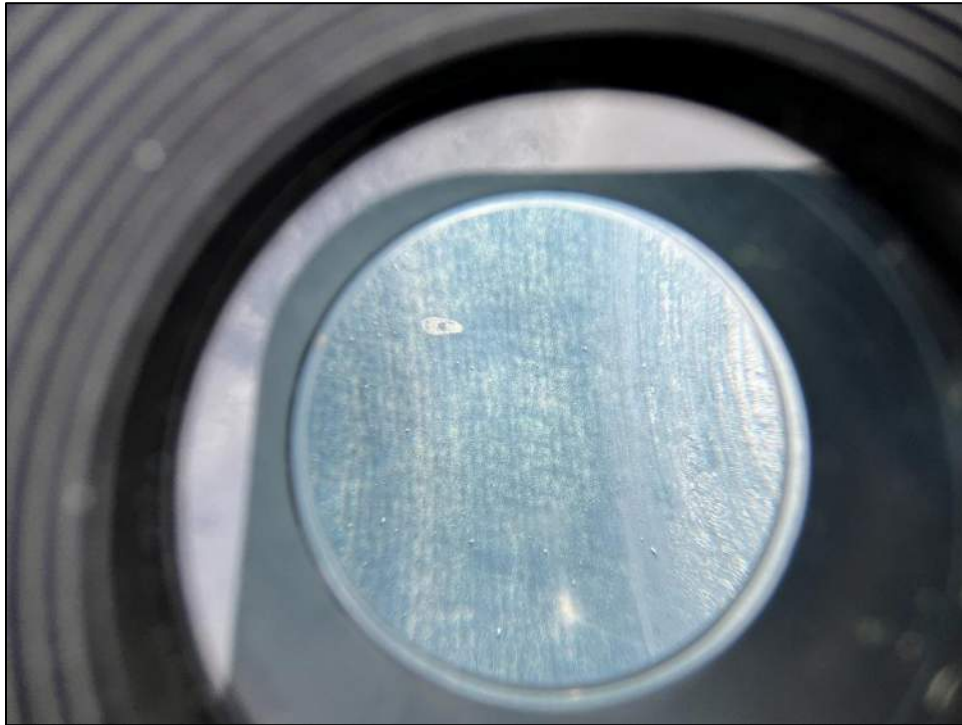
**Photo 24:** No coating disruptions were observed at the hail spatters on front slope.

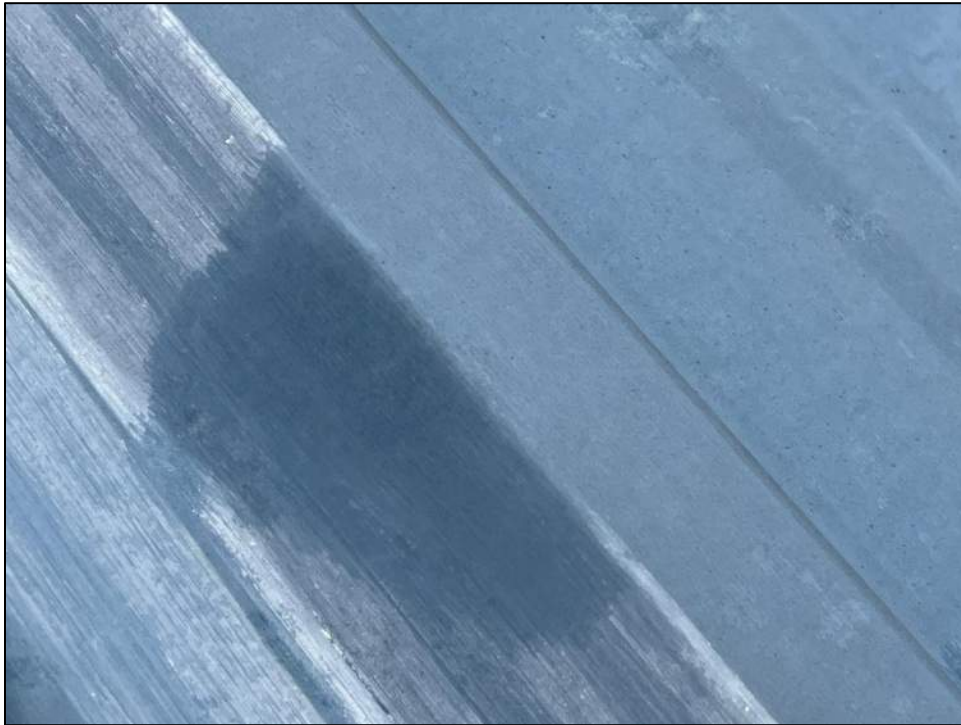
**Photo 26:** No coating disruption at hail spatters on south slope.

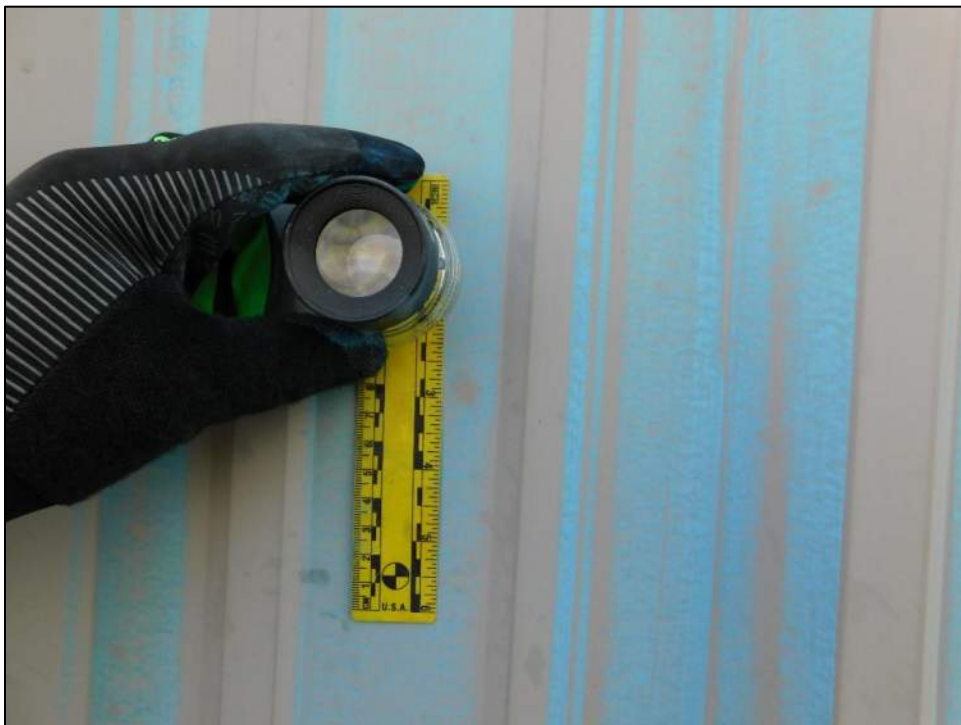
**Photo 6:** Hail denting on west wall were superficial with coating disruptions.

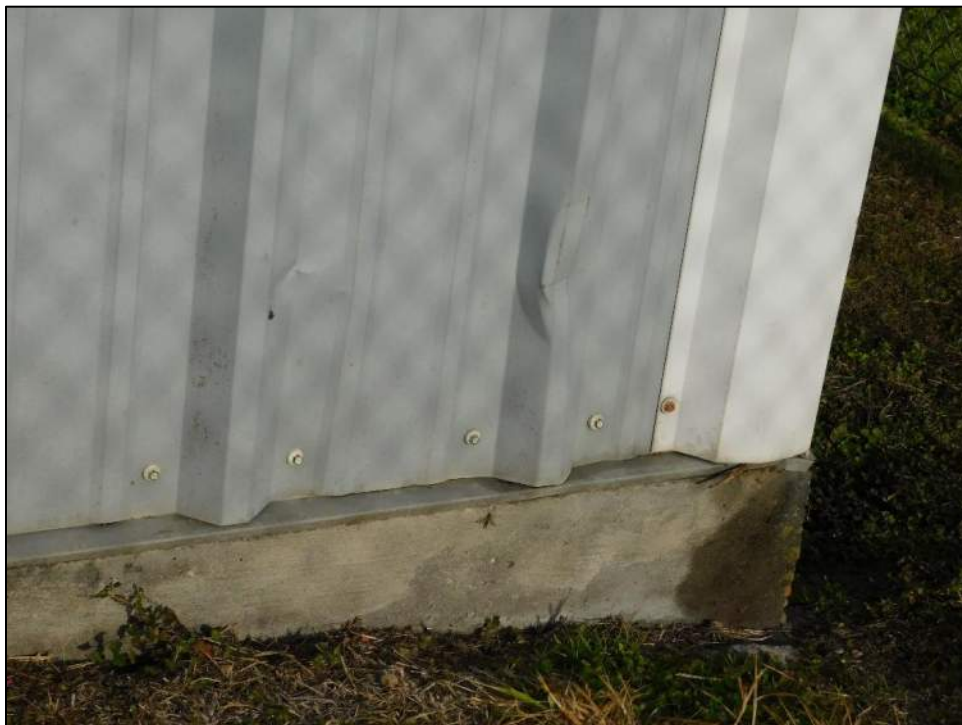
**Photo 8:** Mechanical damage at east elevation lower section.

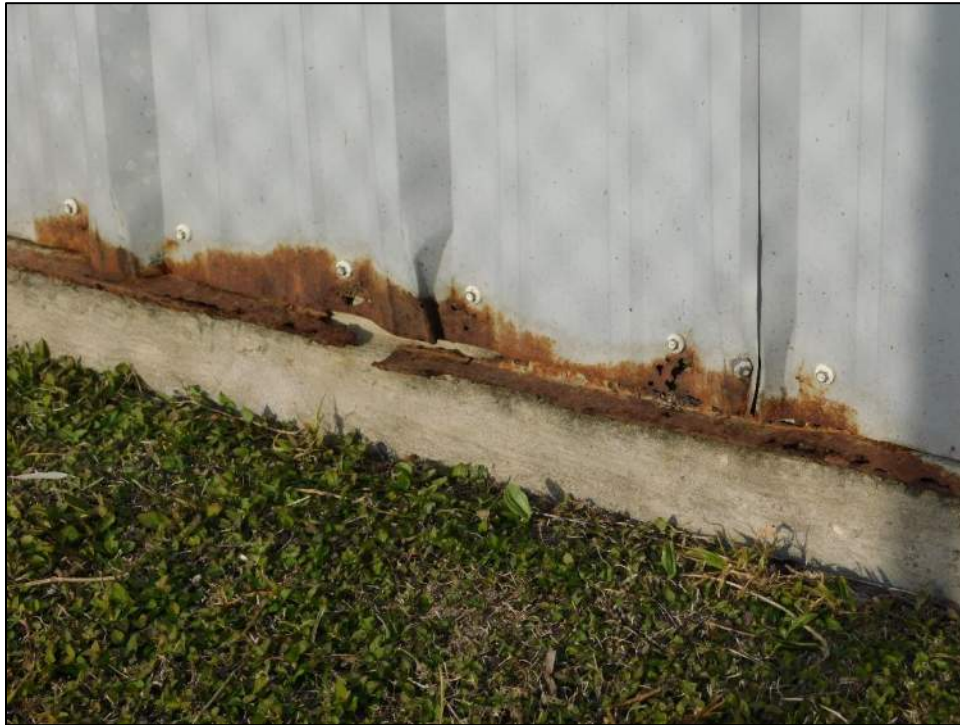
**Photo 9:** Corrosion along the bottom of the east wall.

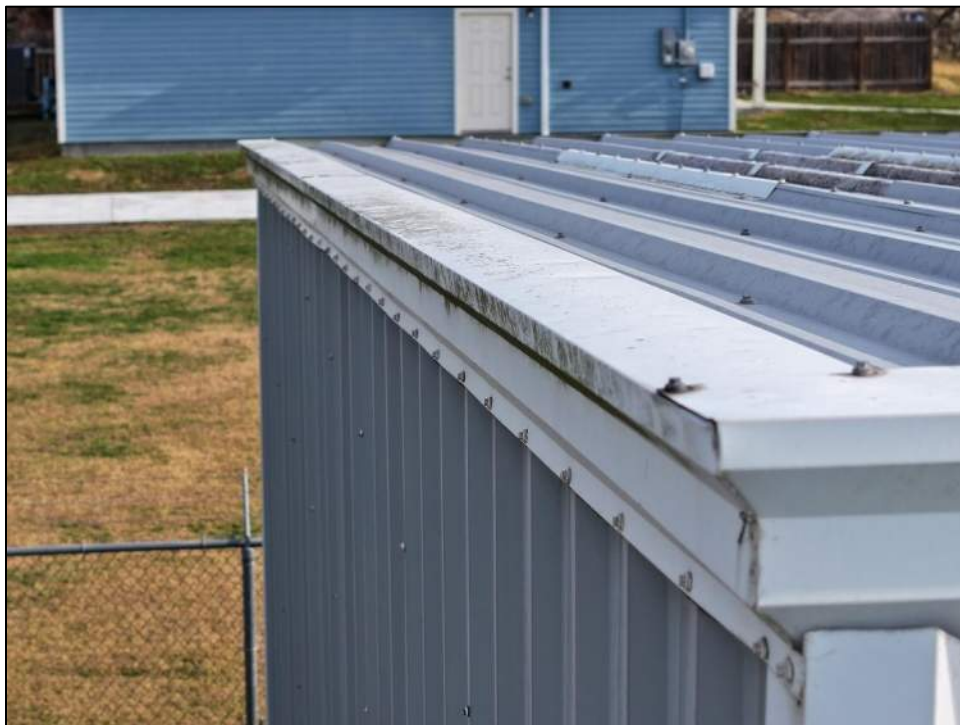
**Photo 10:** West rake closure remained securely fastened. Note surface denting at the top consistent with hail impact.

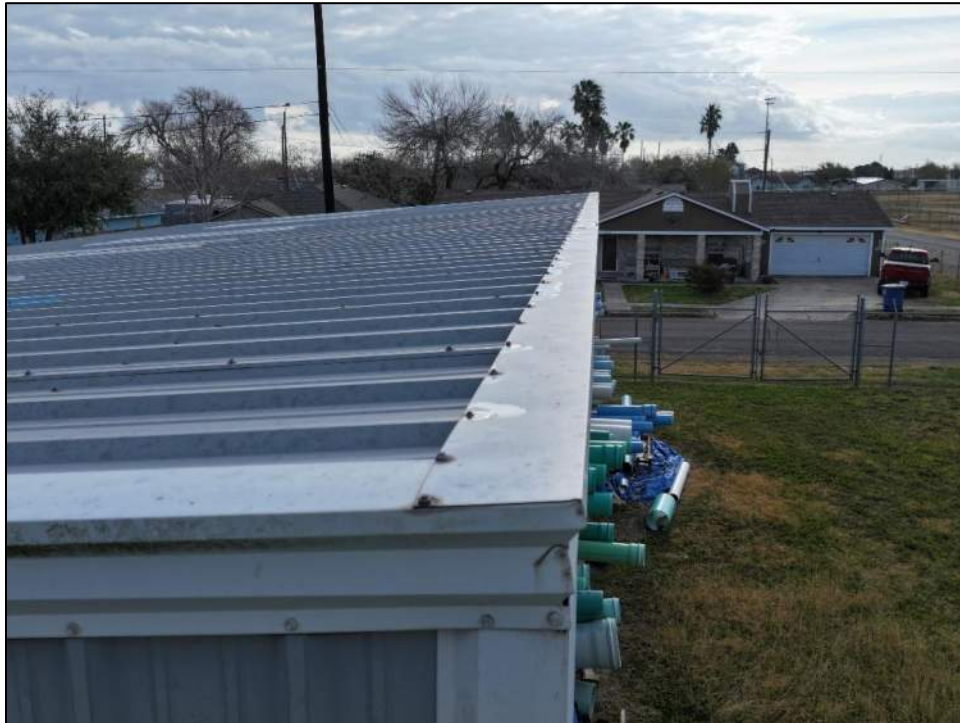
**Photo 11:** Front closure metal remained securely fastened.

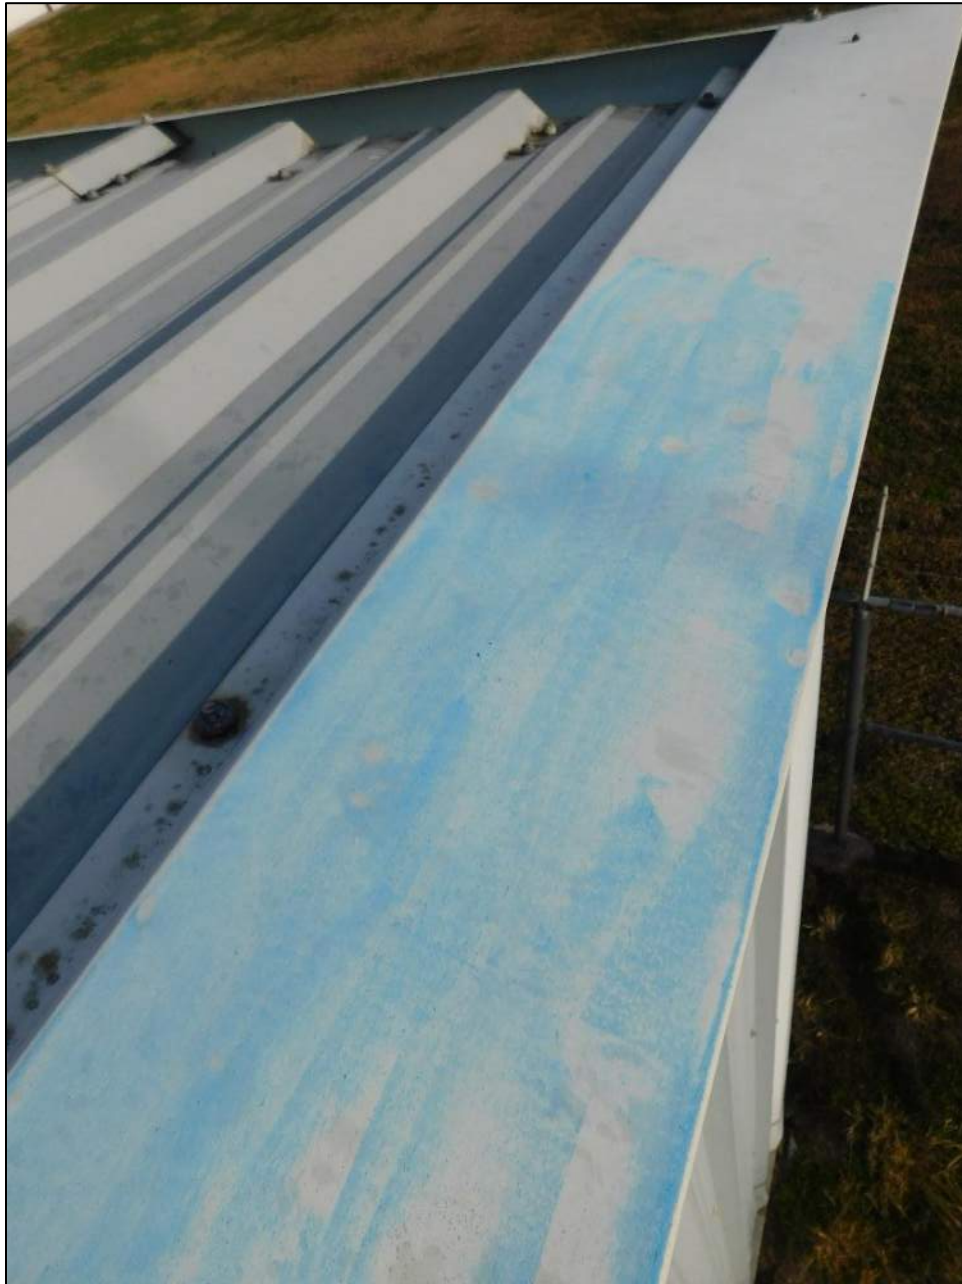
**Photo 12:** Hail denting on the west rake closure metal.

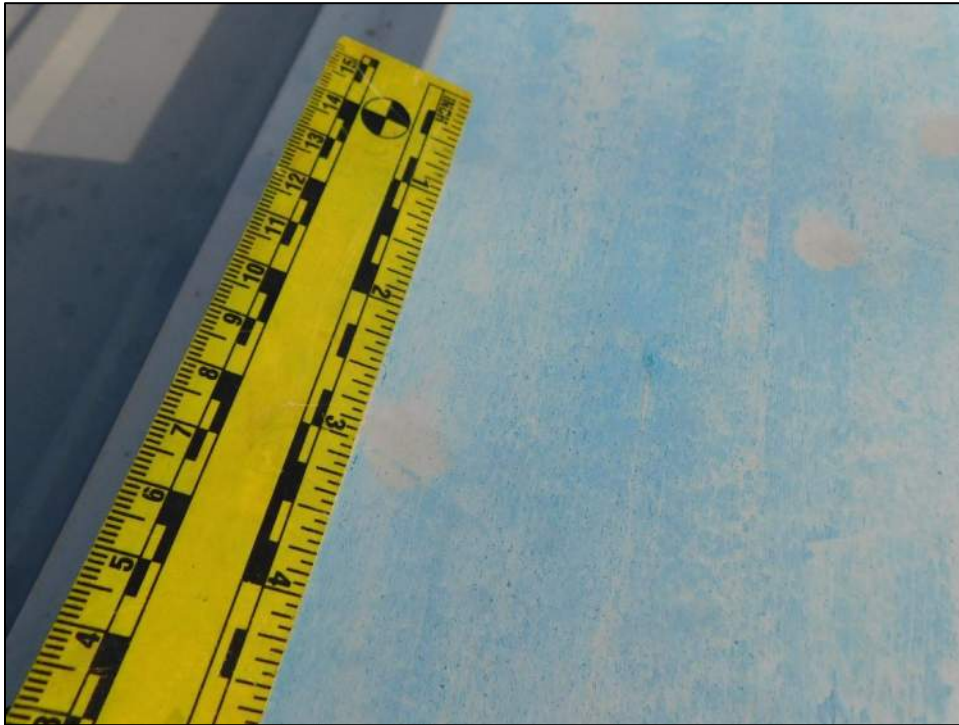
**Photo 13:** Dents on west rake closure metal has inner diameter less than 3/8 inch.

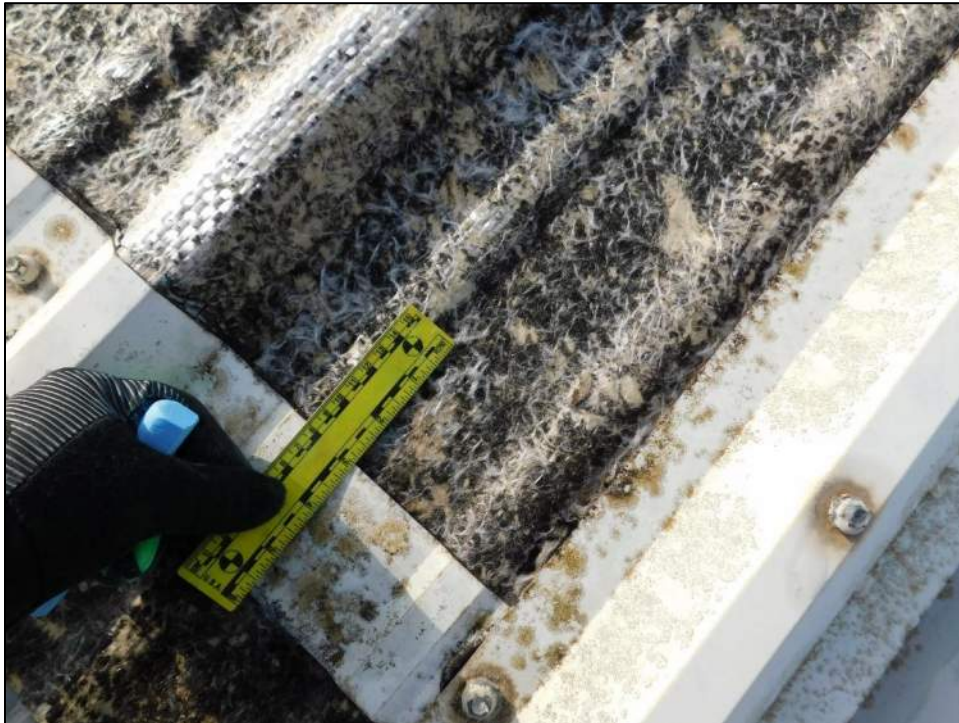
**Photo 15:** No discernible fractures observed at the hail spatters on the skylight panels.

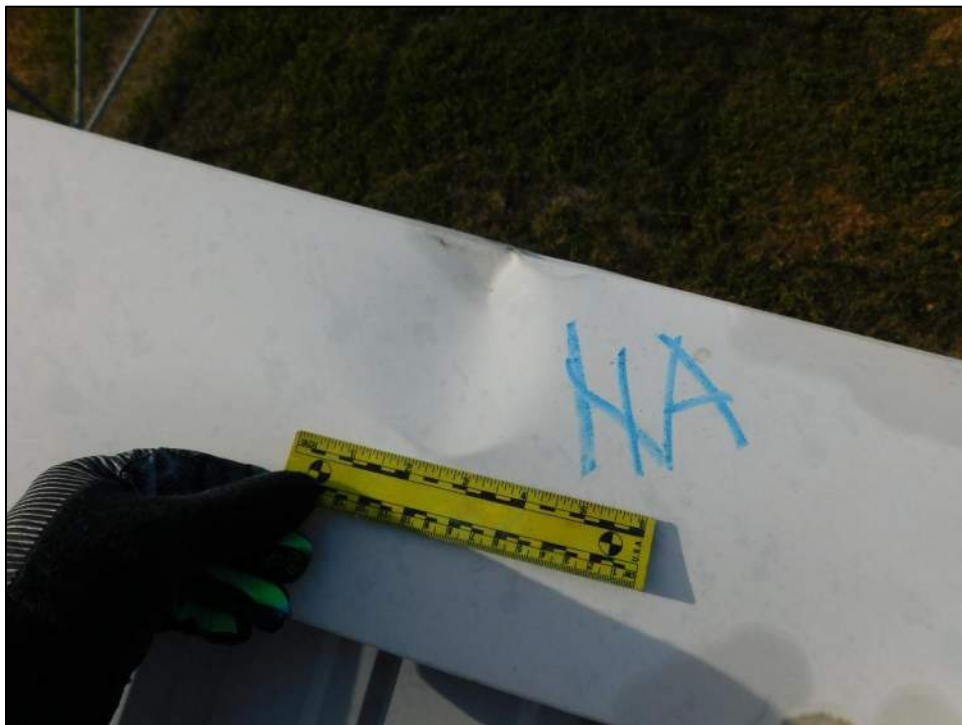
**Photo 18:** Mechanical damage to the front closure metal irrelevant to hail impact.

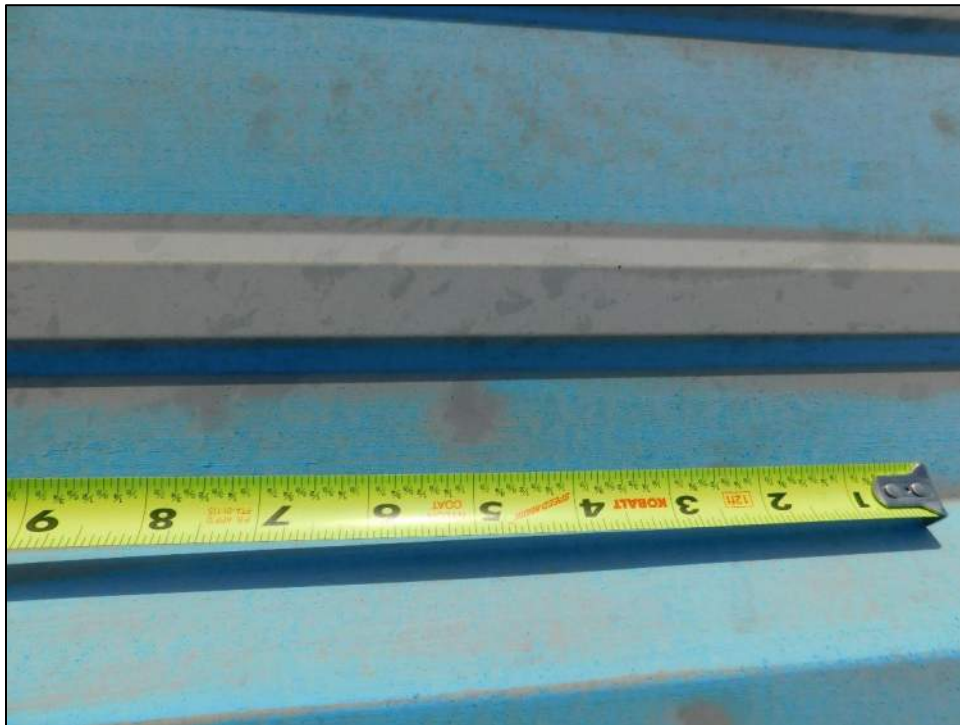
**Photo 21:** No coating disruptions were observed at the hail dents or spatters.

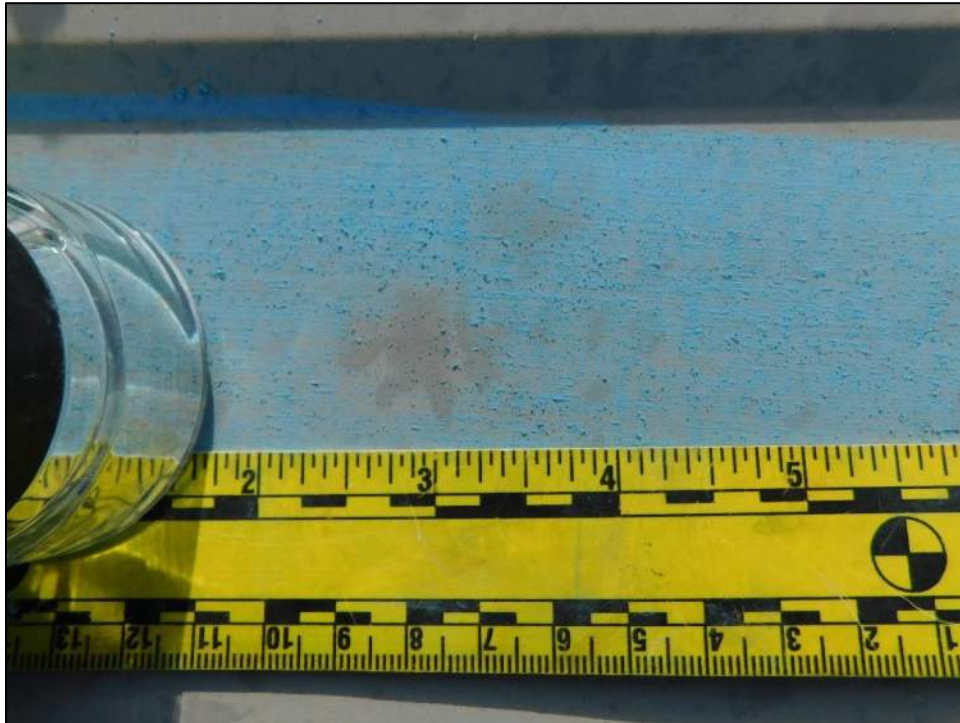
**Photo 23:** No coating disruptions were observed at the hail dents or spatters.

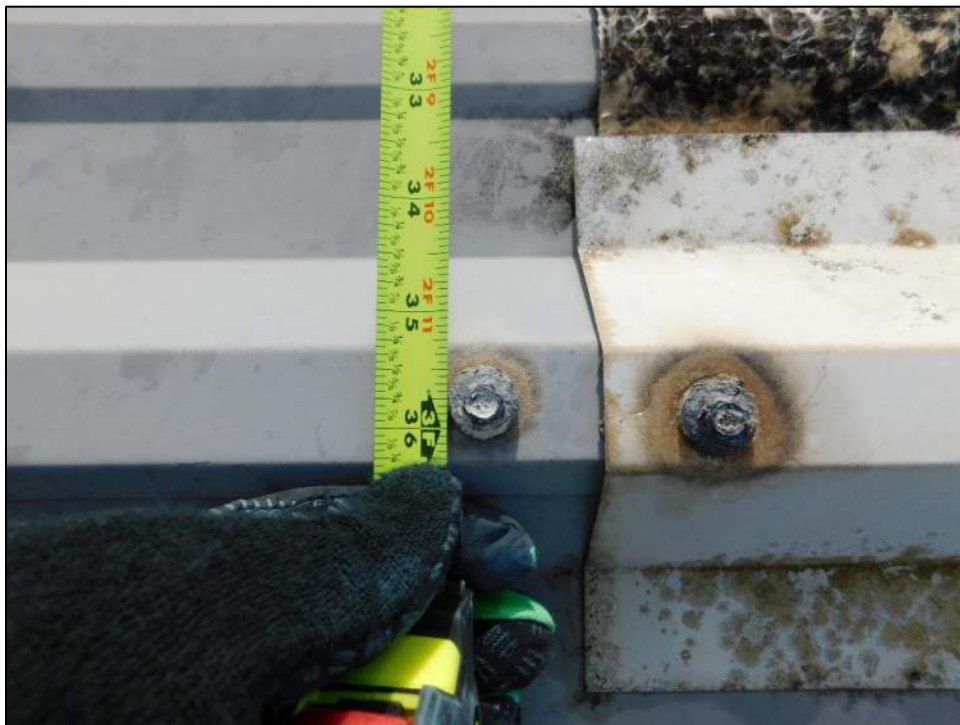
**Photo 24:** Corroded deck fasteners (typical condition).

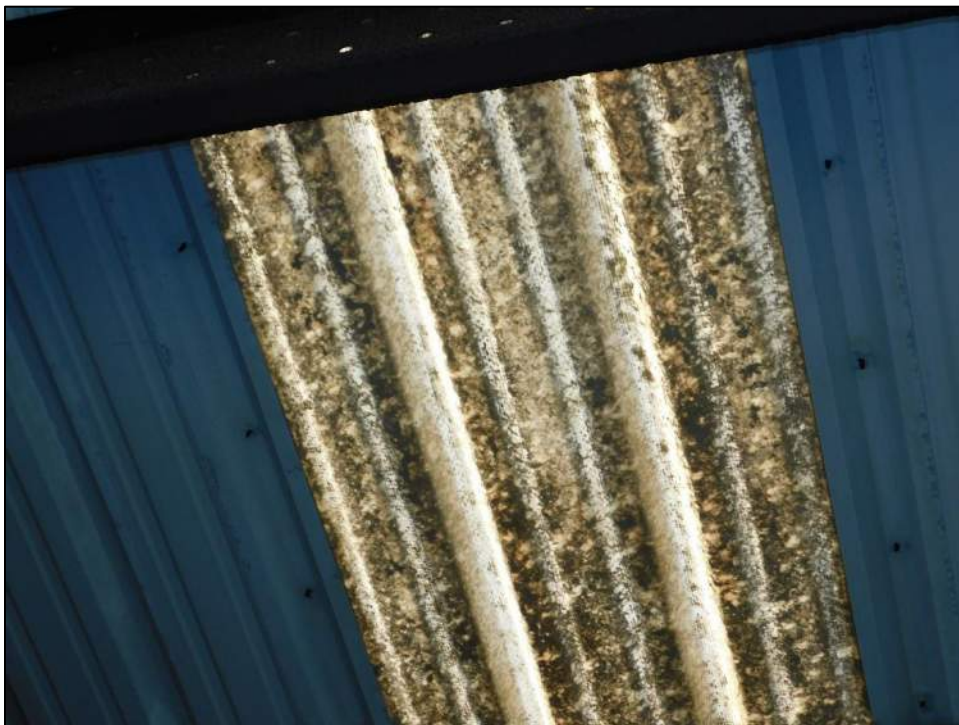
**Photo 26:** No discernible hail impact fracture was observed in the skylight panels.

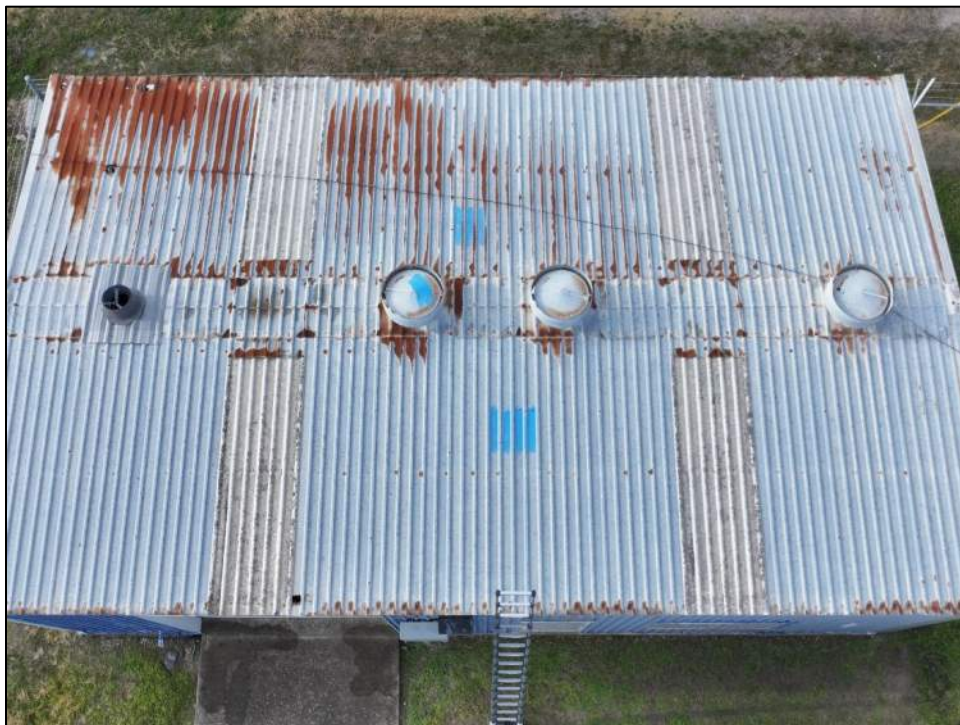
**Photo 28:** Roof overview. The missing ridge vent cover on the east side (left in the picture) was an existing condition since 2017.

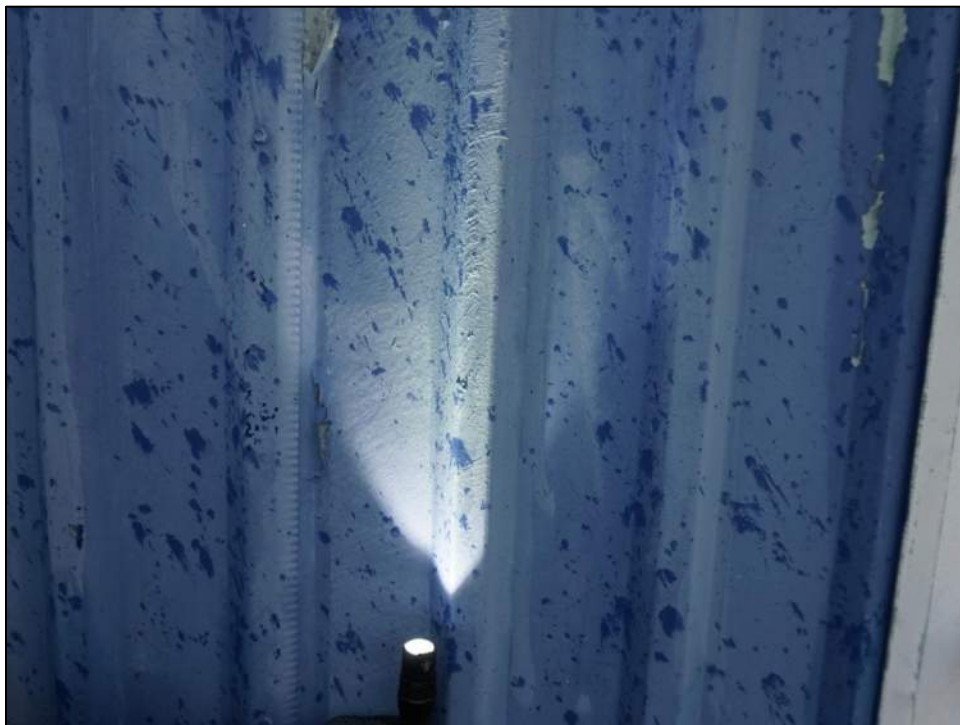
**Photo 34:** No hail denting was observed on the west wall. Existing coating exhibited aged-related peel.

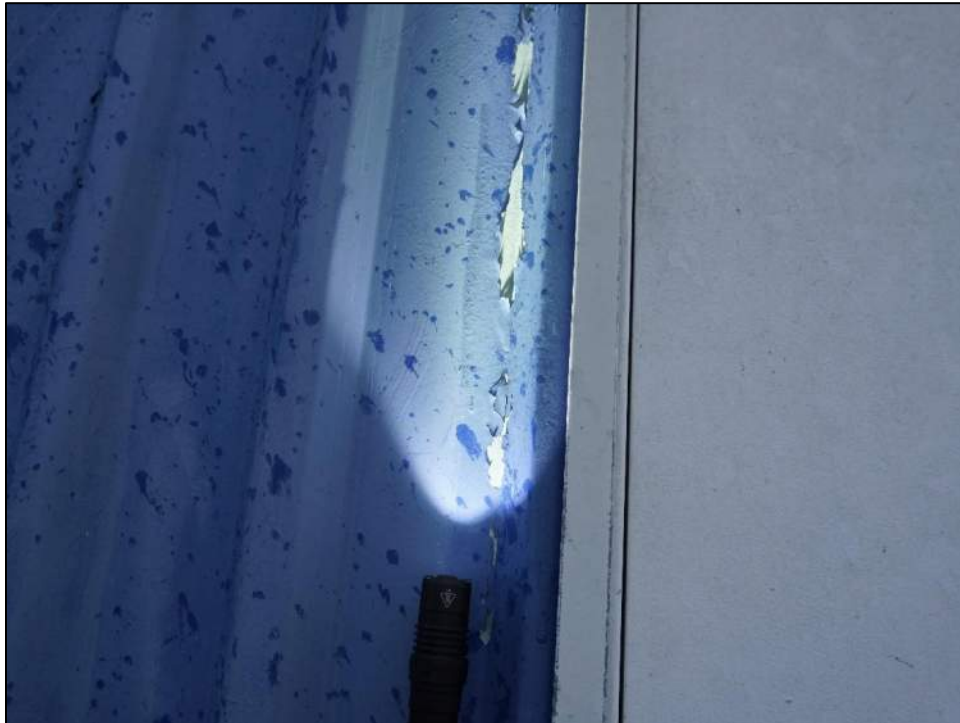
**Photo 35:** No hail denting was observed on the west wall. Existing coating exhibited aged-related peel.

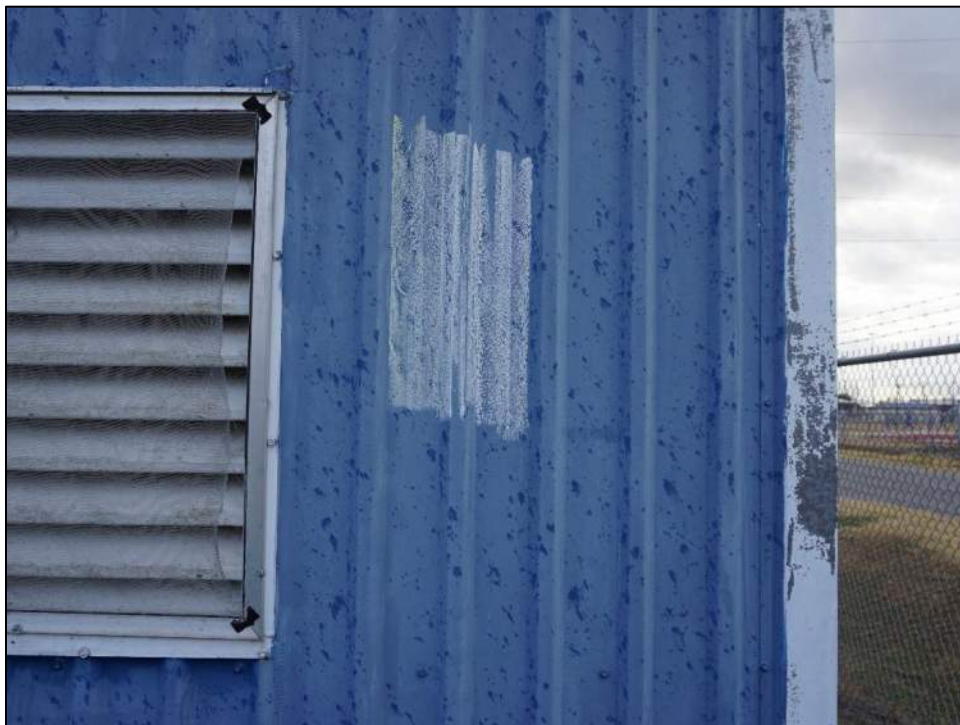
**Photo 36:** No hail denting was observed on the west wall. Existing coating exhibited aged-related peel.
