**CITY OF INGLESIDE  
REGULAR CITY COUNCIL MEETING  
AGENDA  
JUNE 9, 2026  
6:30 PM**

Report on November 01, 2025, Hailstorm Damage to City of Ingleside Buildings.

### Building Damage Analysis Survey and Report

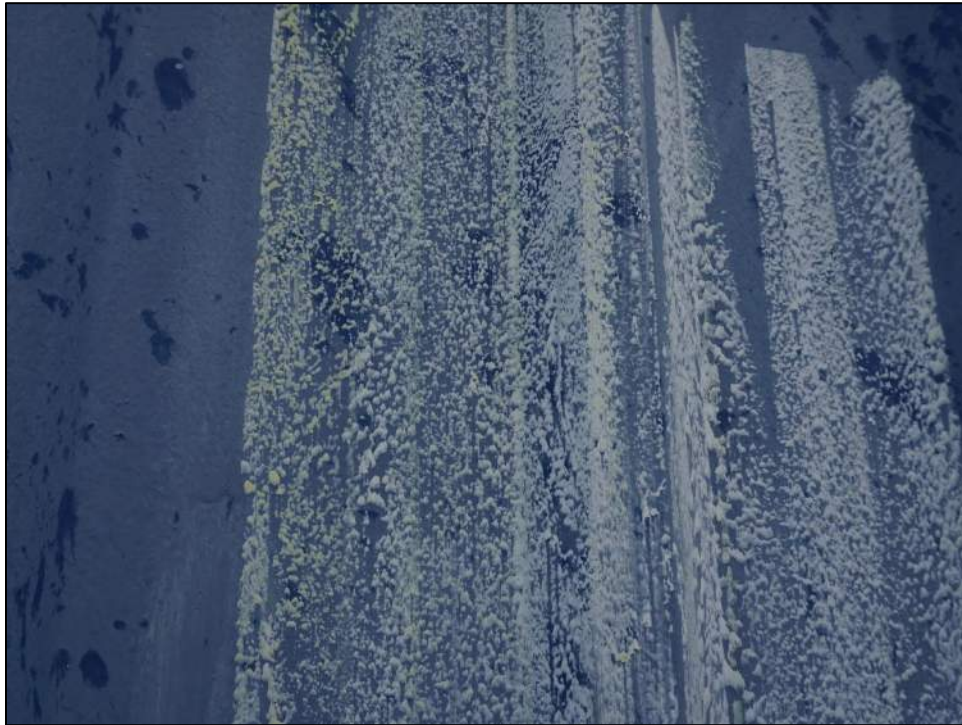
**Photo 37:** No hail denting was observed on the west wall. Existing coating exhibited aged-related peel.

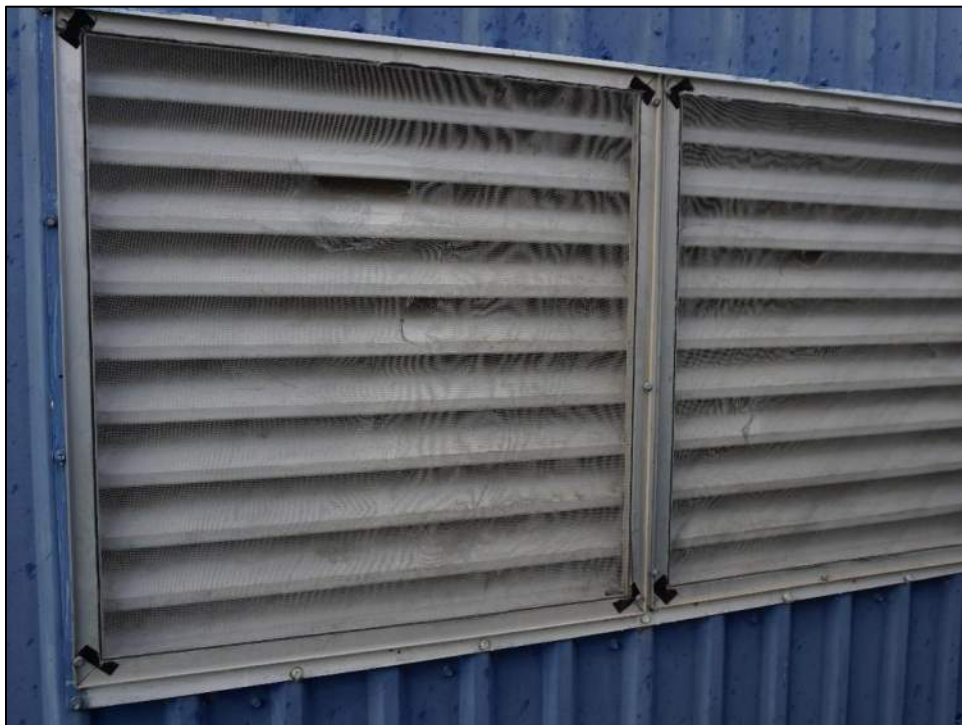
**Photo 38:** Torn screens on north elevation caused by mechanical damage. Hail impact caused additional dimpling damage.

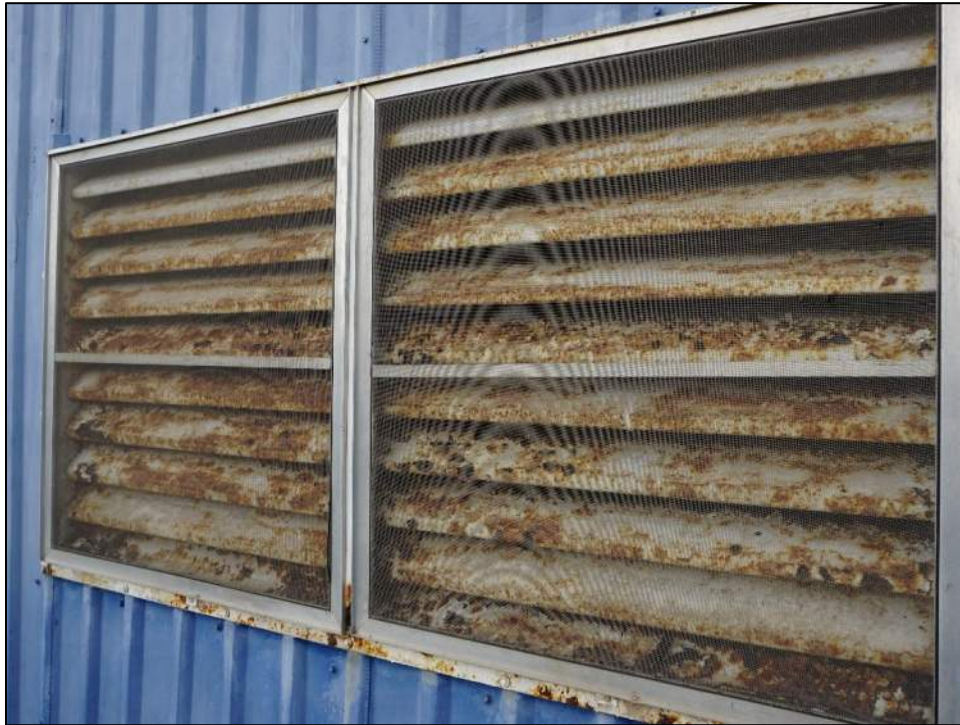
**Photo 39:** Severely corroded louvers on east elevation.

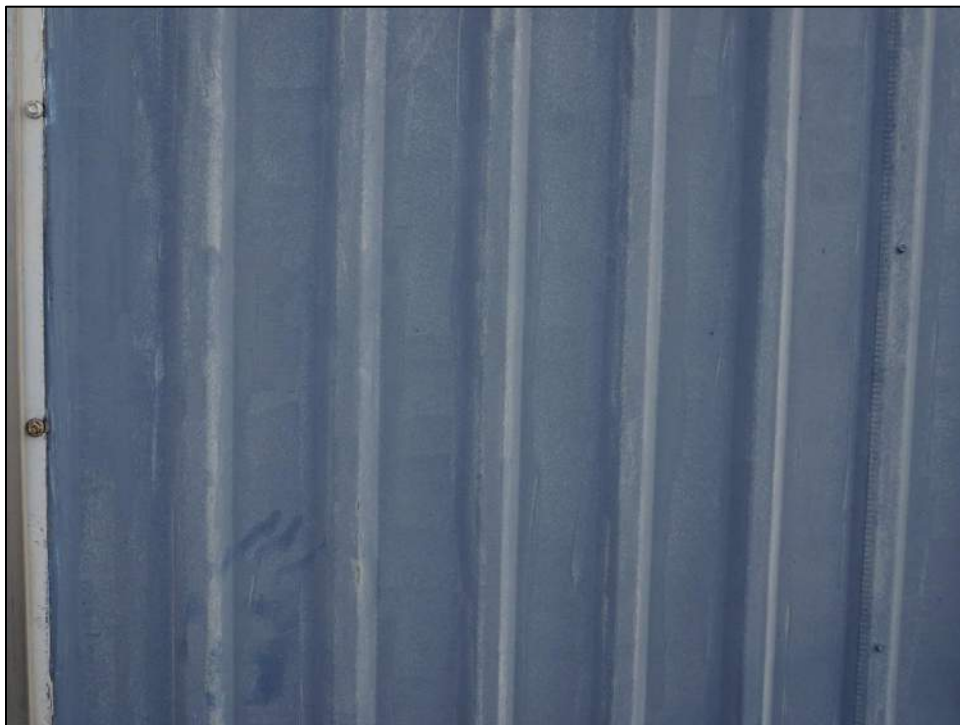
**Photo 40:** South wall was unaffected by the hail impact.

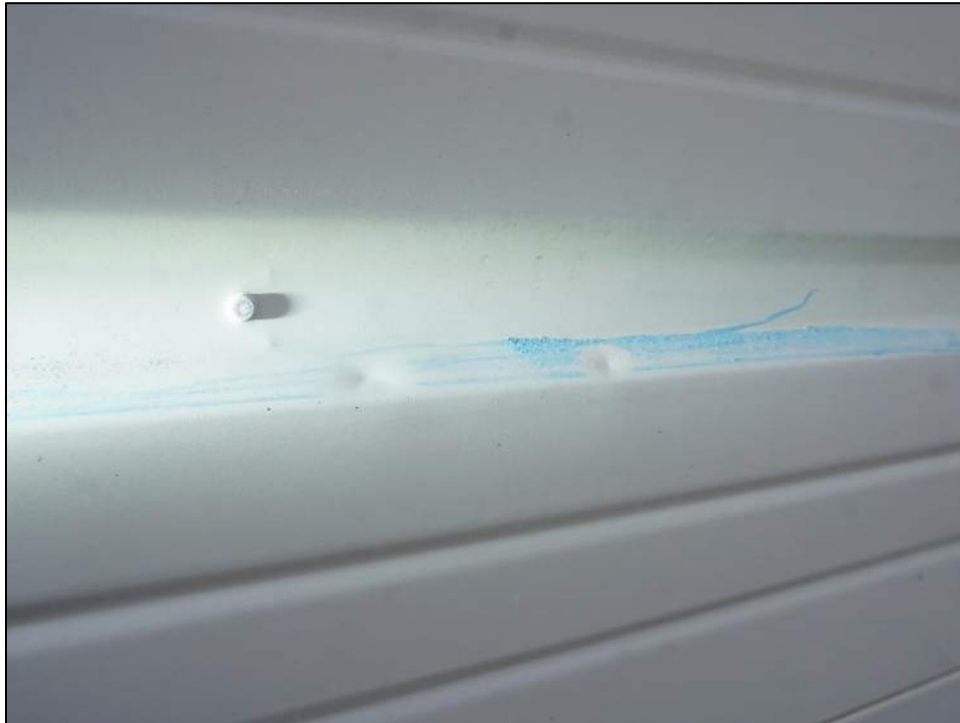
**Photo 41:** Denting along the top surfaces of the roll-up door along the north elevation consistent with hail impact.

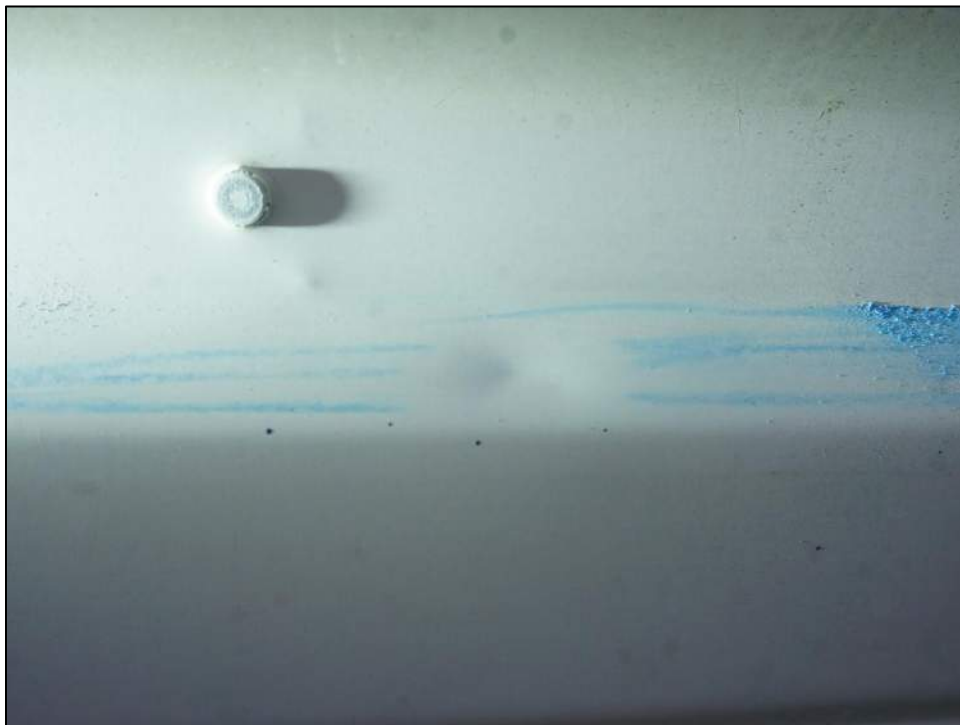
**Photo 42:** Hail denting on the roll-up door was unaccompanied by coating disruptions.

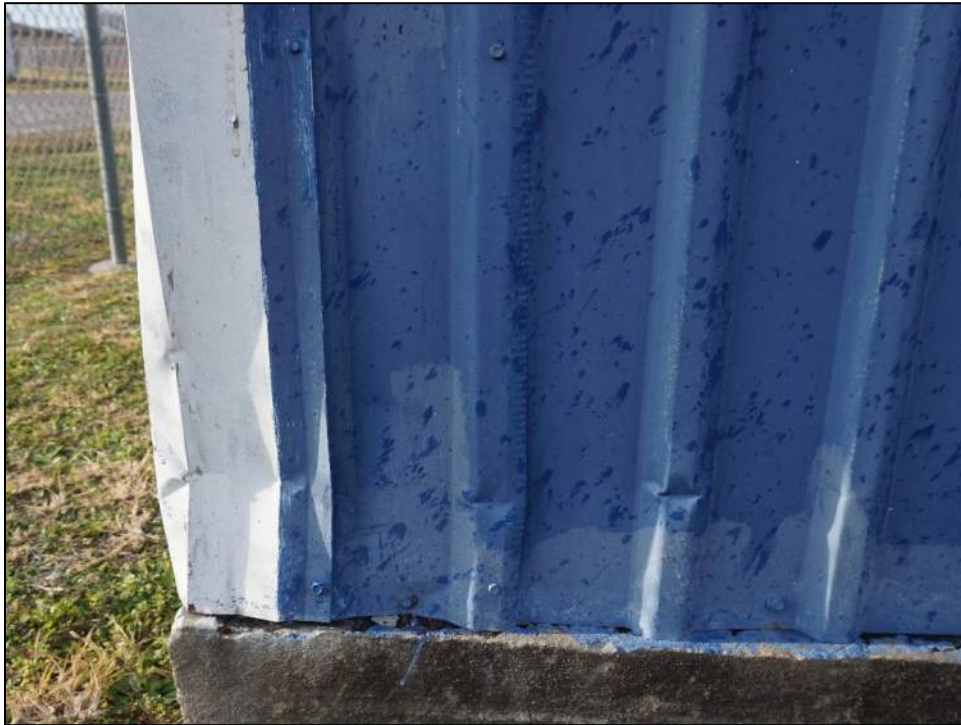
**Photo 43:** Mechanical damage at the lower east corner of the north wall irrelevant to hail effects.

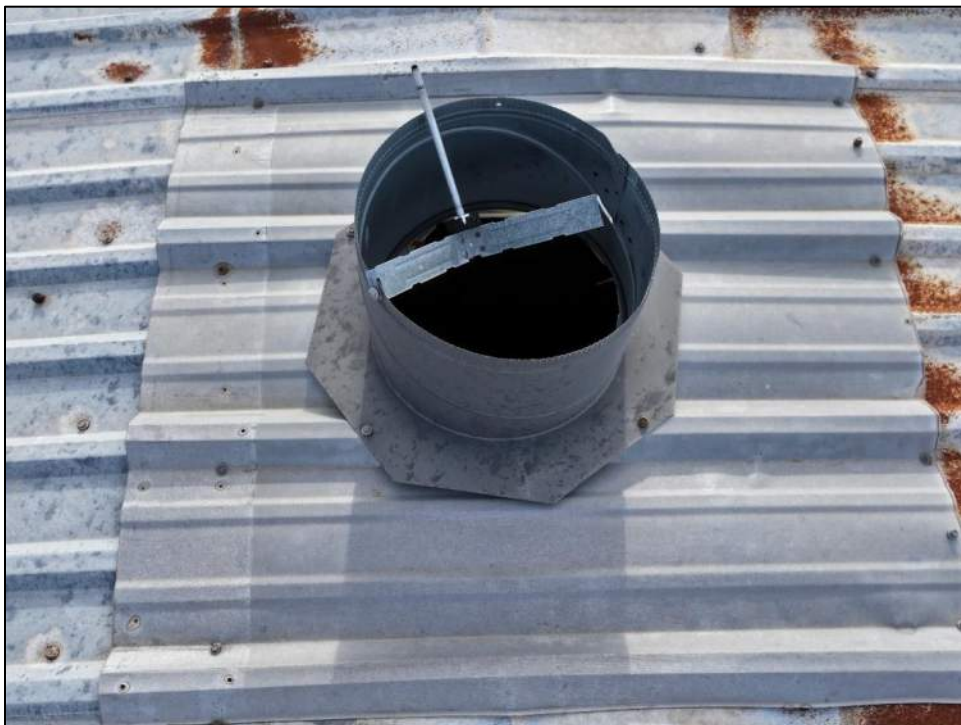
**Photo 44:** The missing ridge vent cover on the east side of the ridge was an existing condition since 2017.

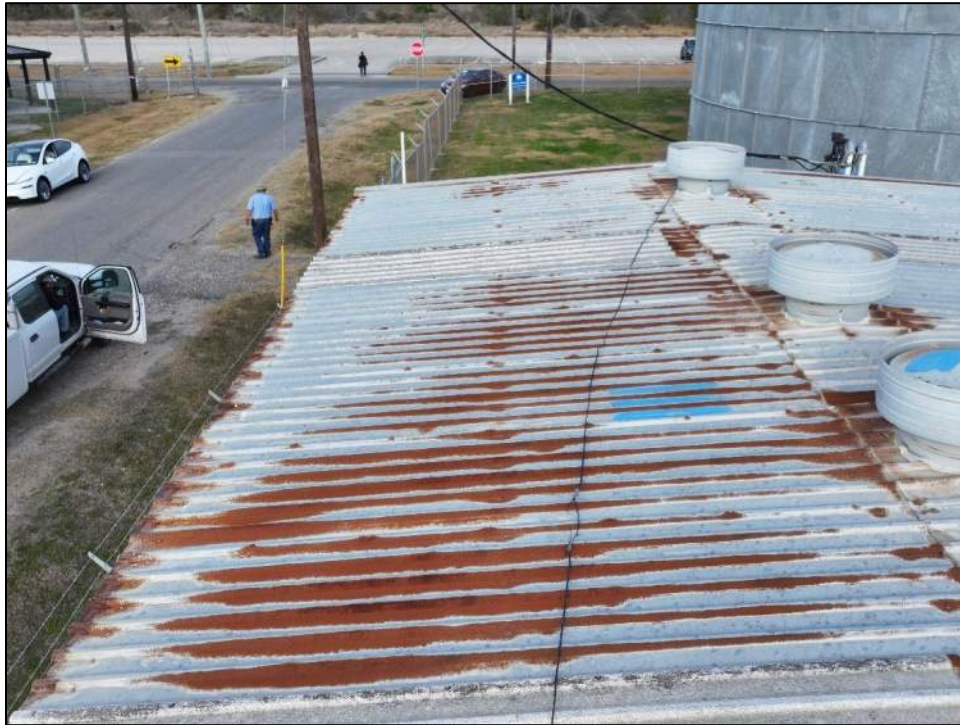
**Photo 45:** Widespread corrosion on the roof deck irrelevant to the subject hail storm.

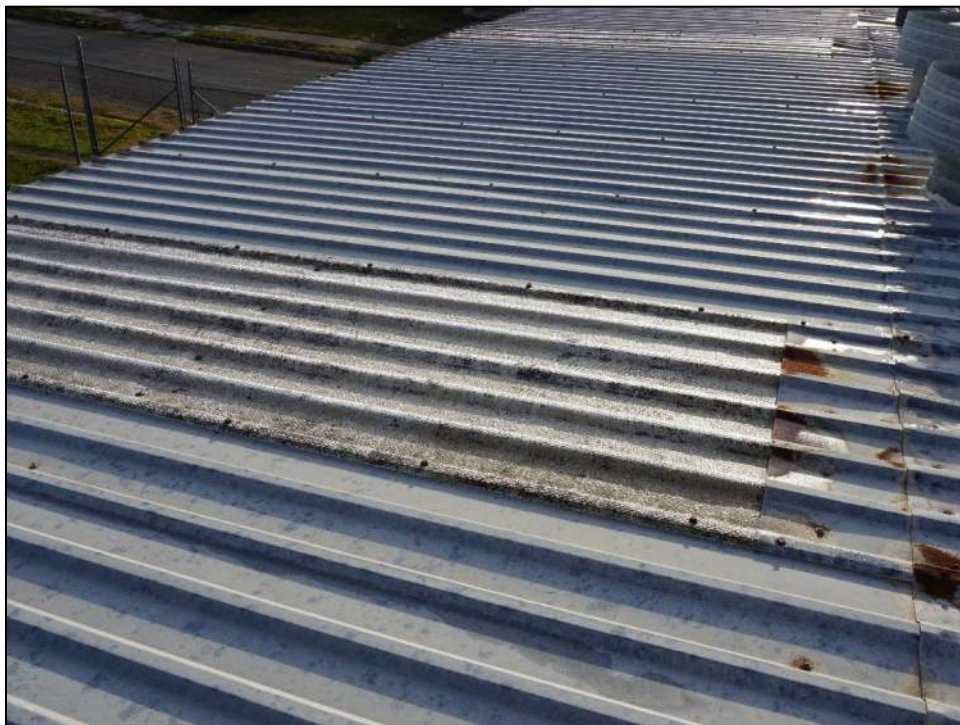
**Photo 46:** Deteriorated skylight panels exhibited isolated hail impact fractures.

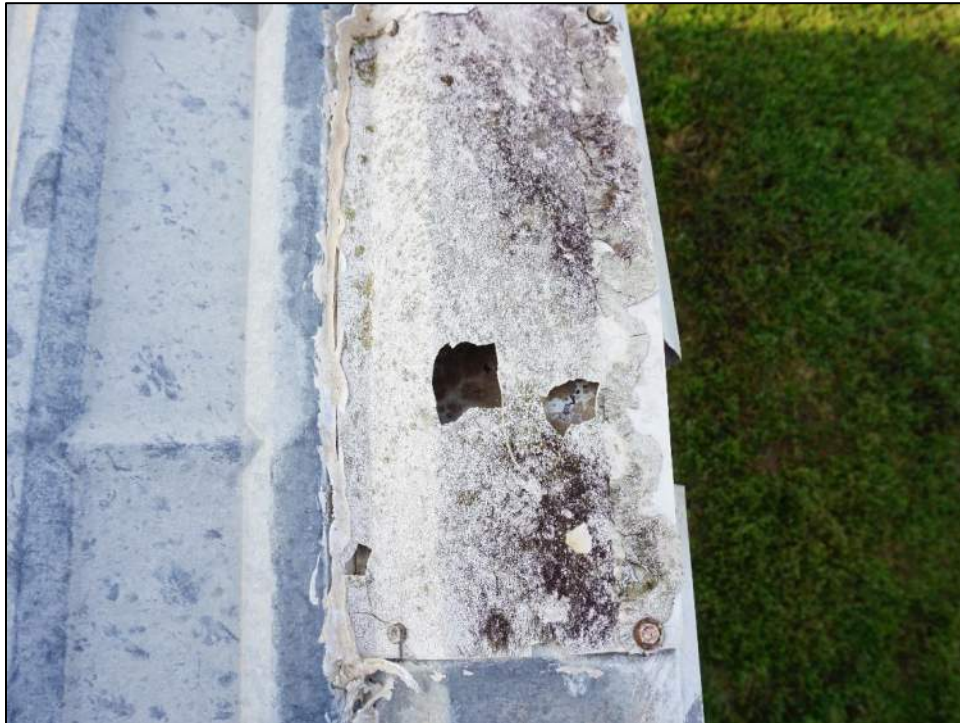
**Photo 47:** Fractured deteriorated vinyl closure flashing at the east and west ridge ends consistent with weathering and recent hail impact.

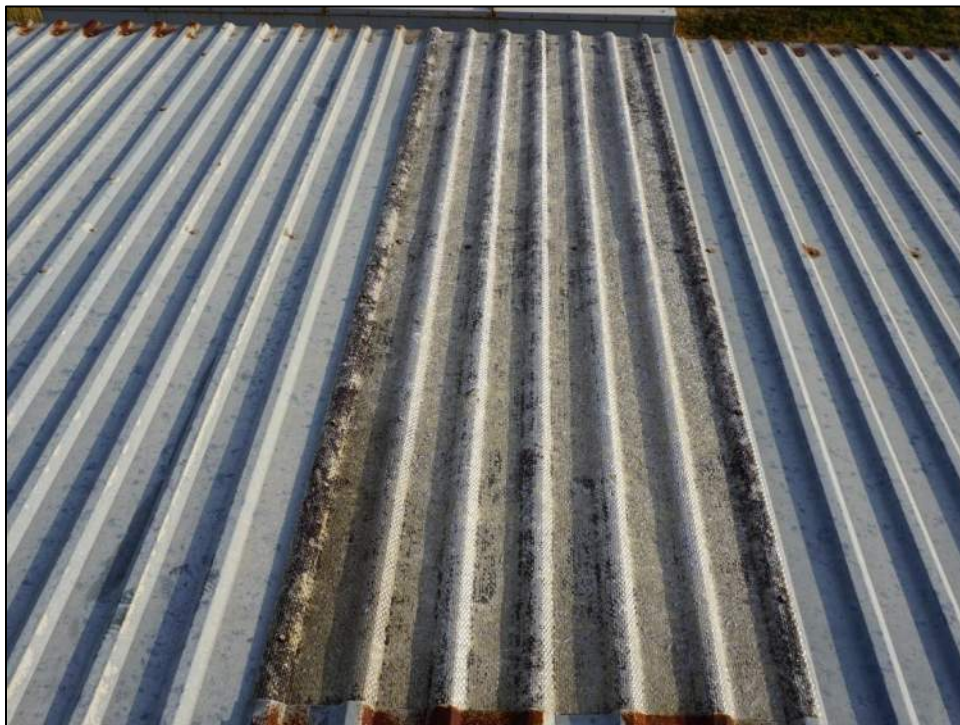
**Photo 48:** Deteriorated skylight panels exhibited isolated hail impact fractures.

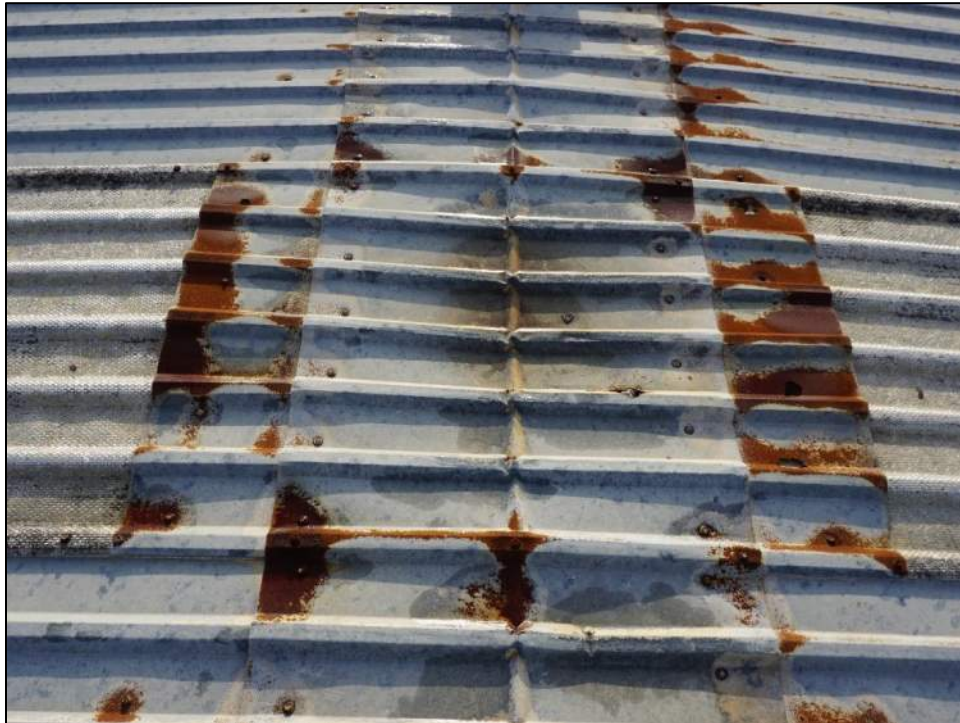
**Photo 49:** Buckled ridge cap at east end of ridge unrelated to hail effects.

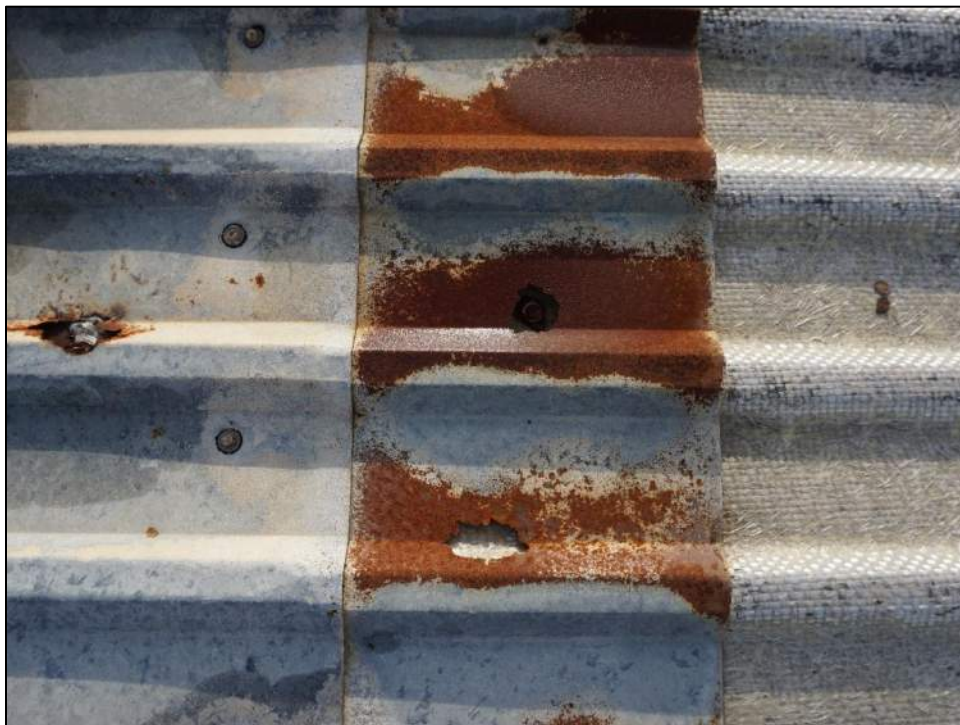
**Photo 50:** Corroded deck at fasteners unrelated to hail effects.

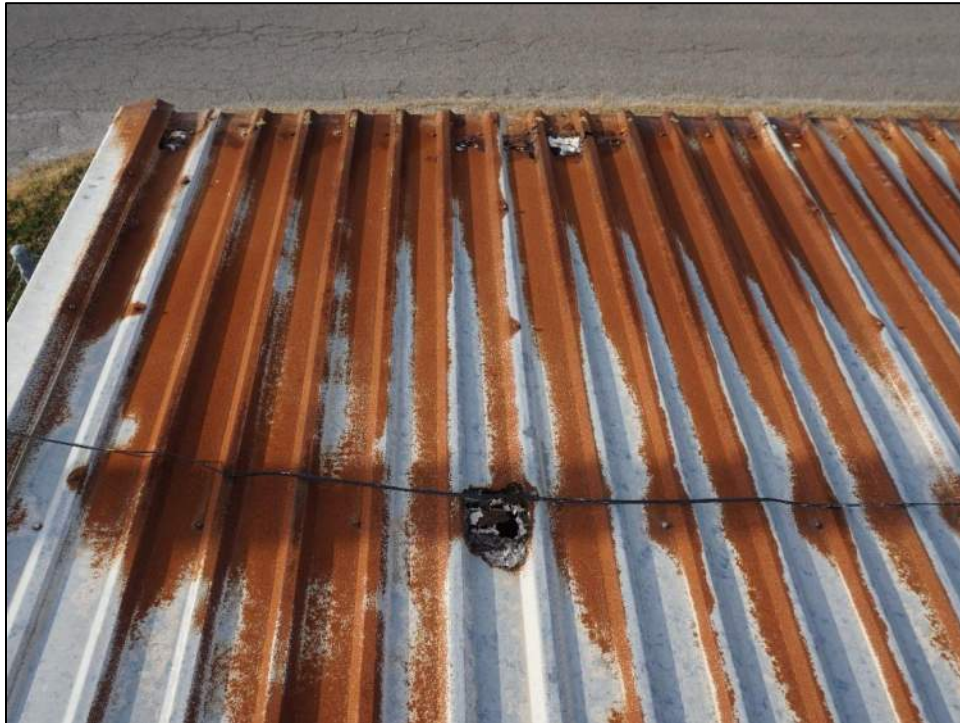
**Photo 51:** Rusty-through deck at south-east quadrant a long-term condition unrelated to recent hail.

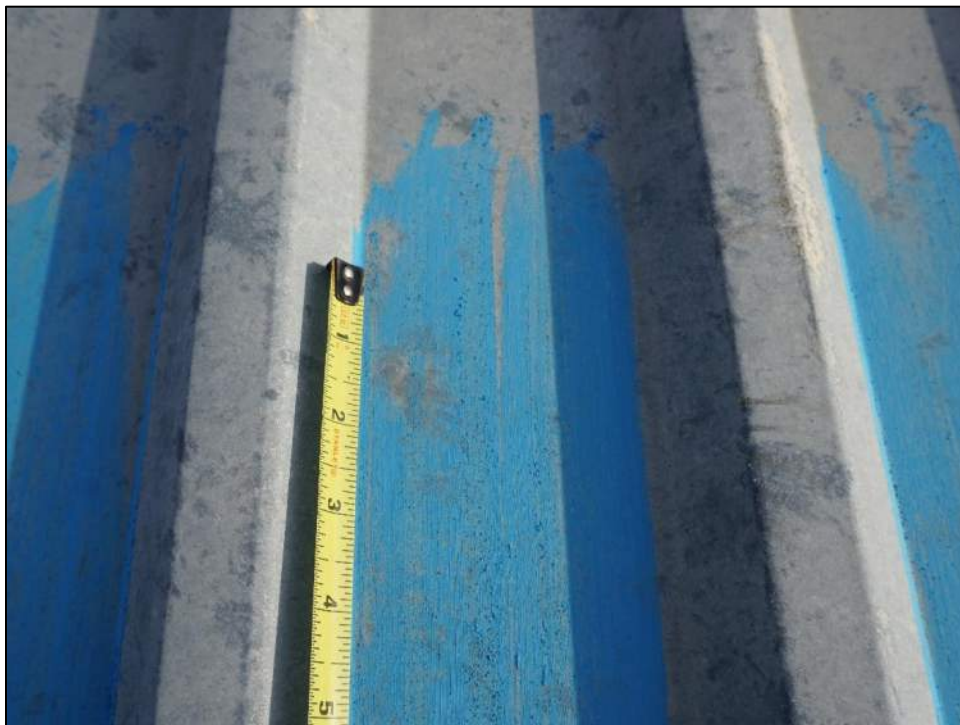
**Photo 52:** Hail denting on metal roof deck.

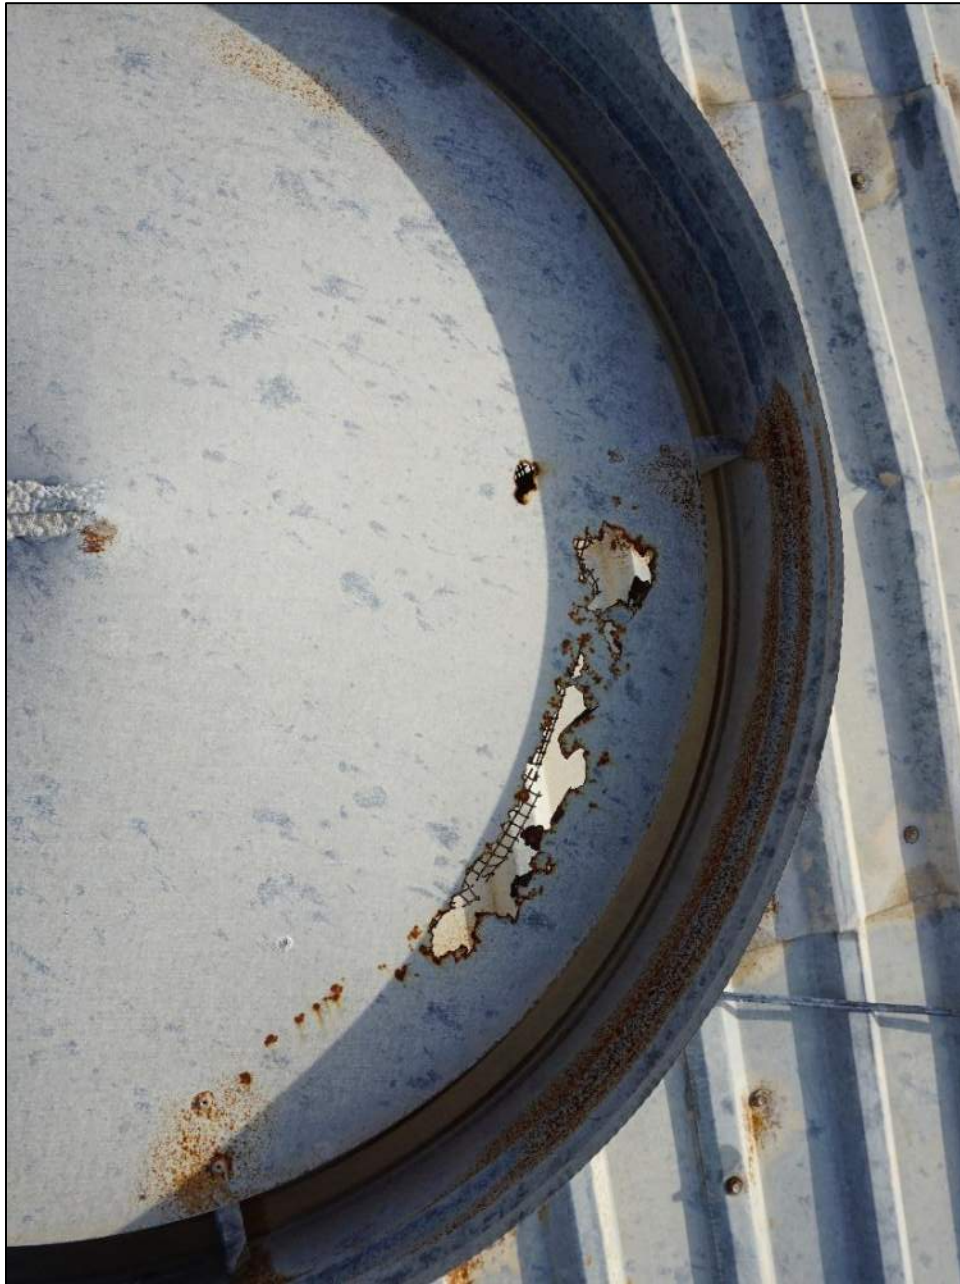
**Photo 54:** Rusting through of other remaining ridge vent covers.

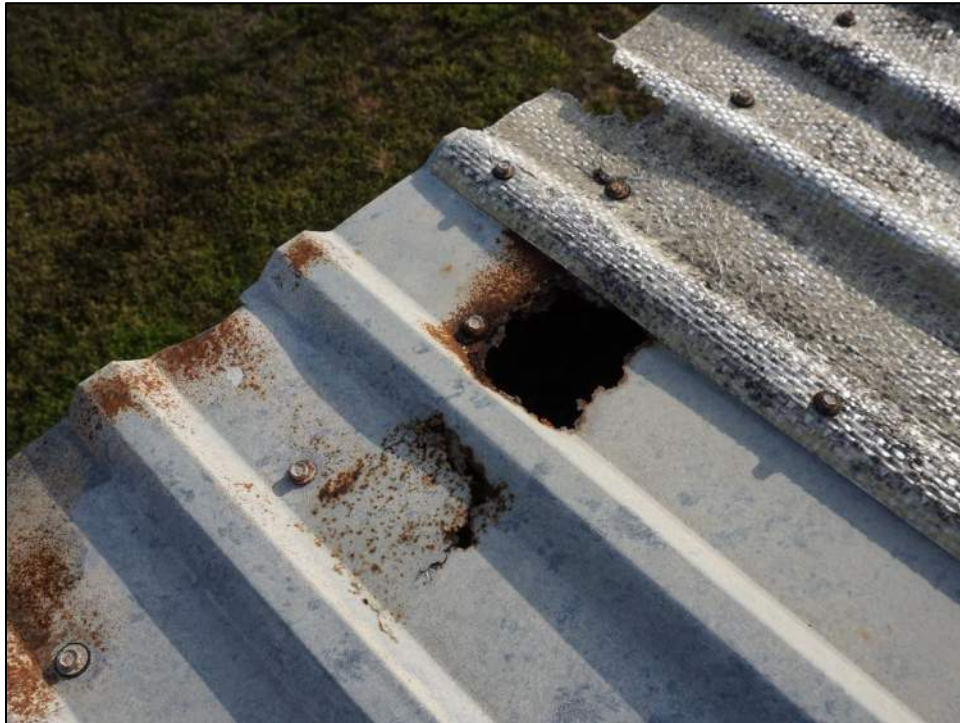
**Photo 57:** Rusting-through of deck at eave area near fasteners.

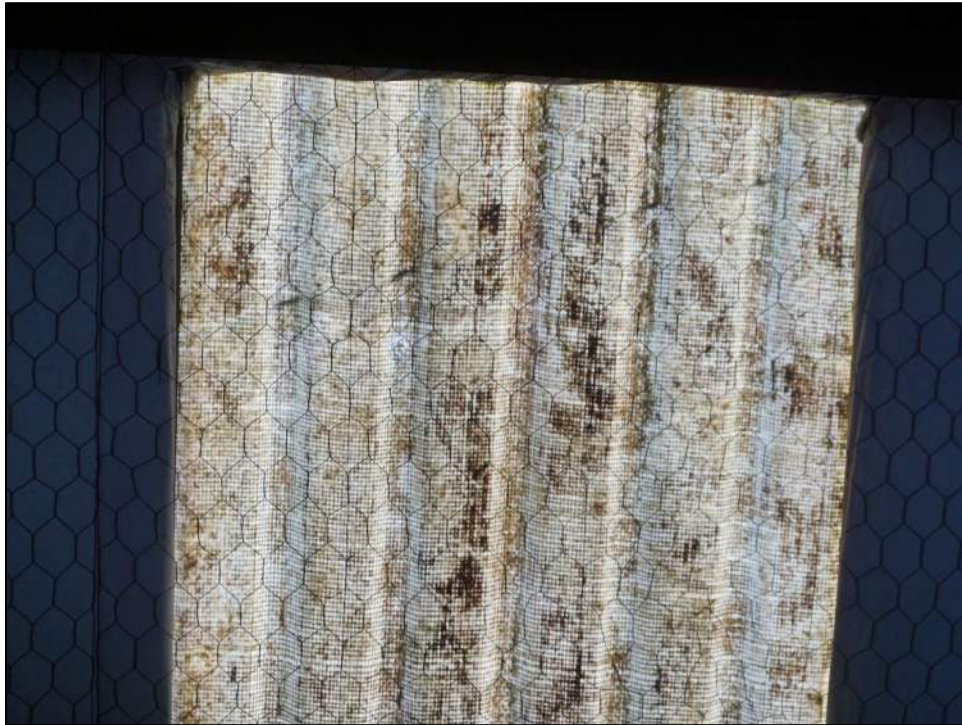
**Photo 59:** Isolate circular fractures in skylight panels consistent with hail impact.

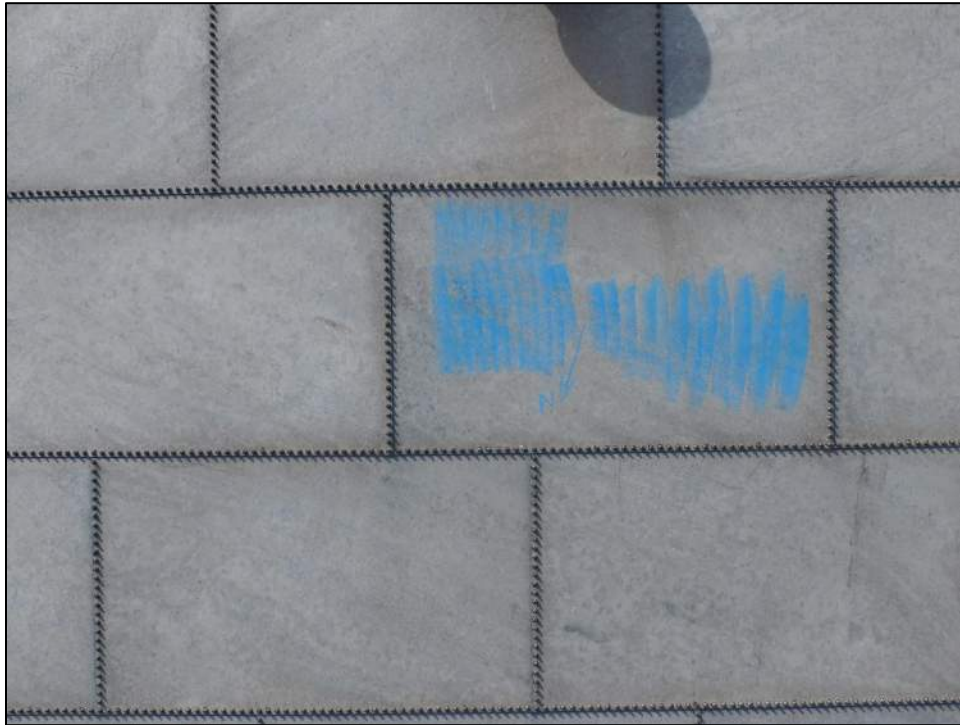
**Photo 63:** Tank walls exhibited no hail denting.

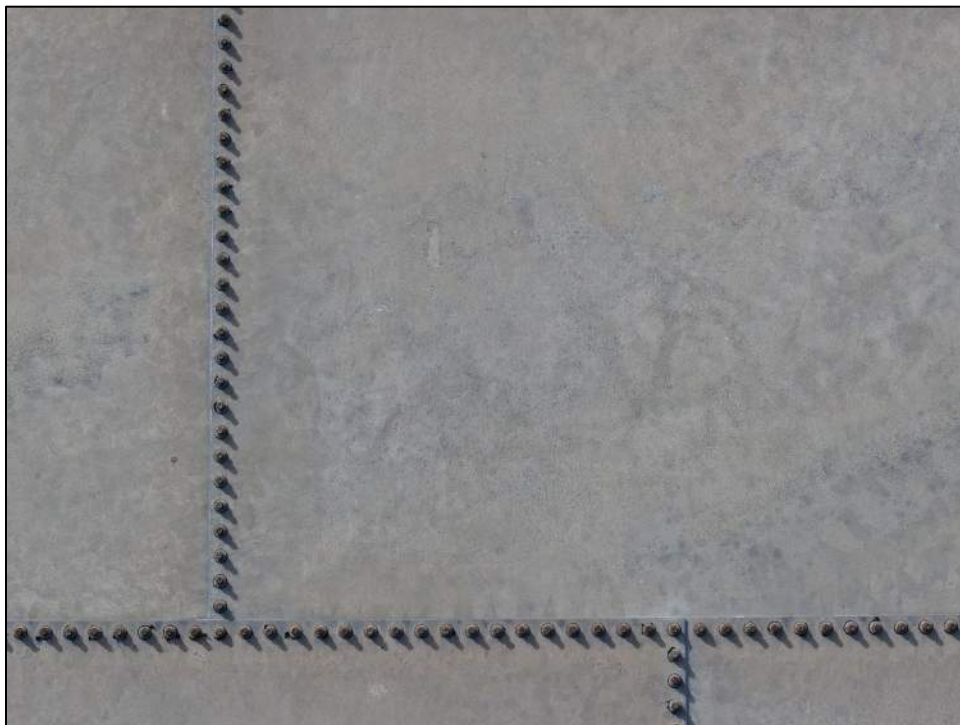
**Photo 64:** Tank wall surface exhibited no galvanization disruption.

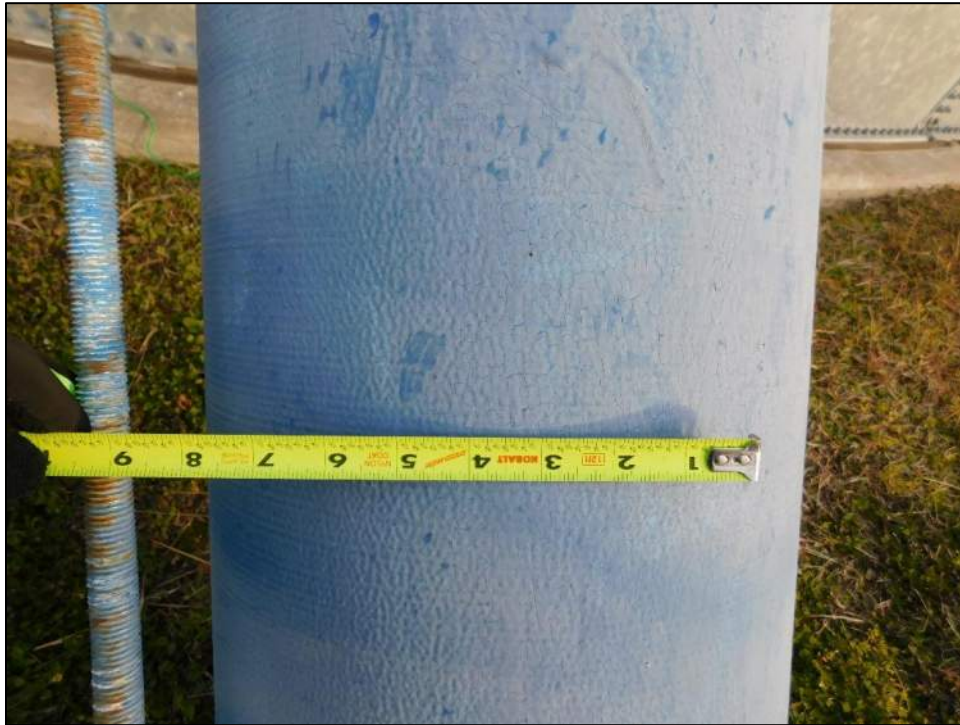
**Photo 65:** Hail spatter on tank piping.

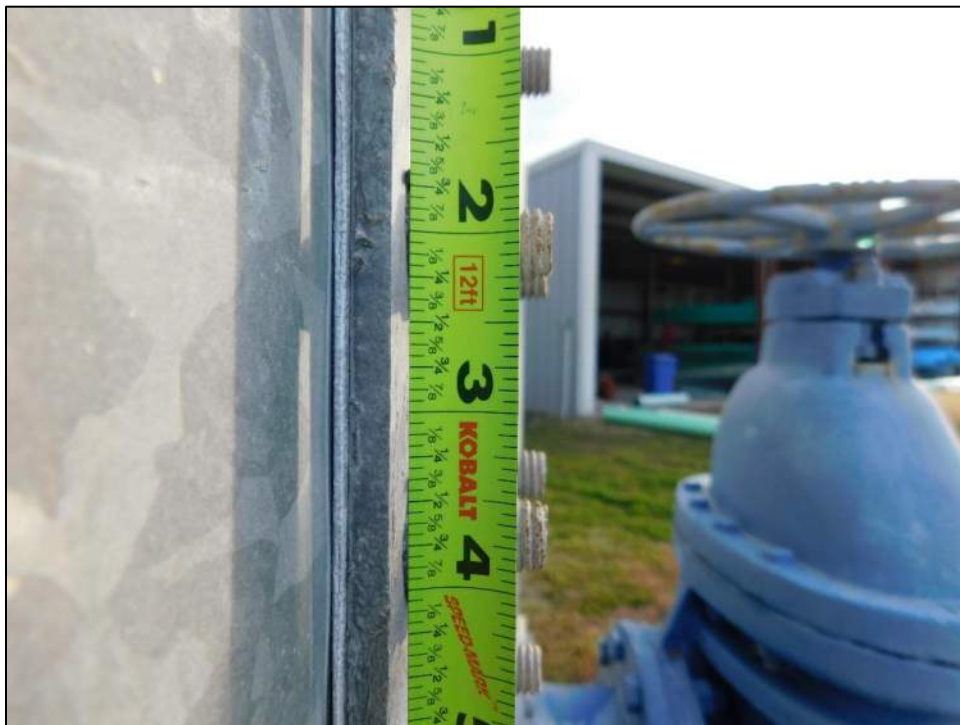
**Photo 66:** Steel wall plates were approximately 1/4-inch thick

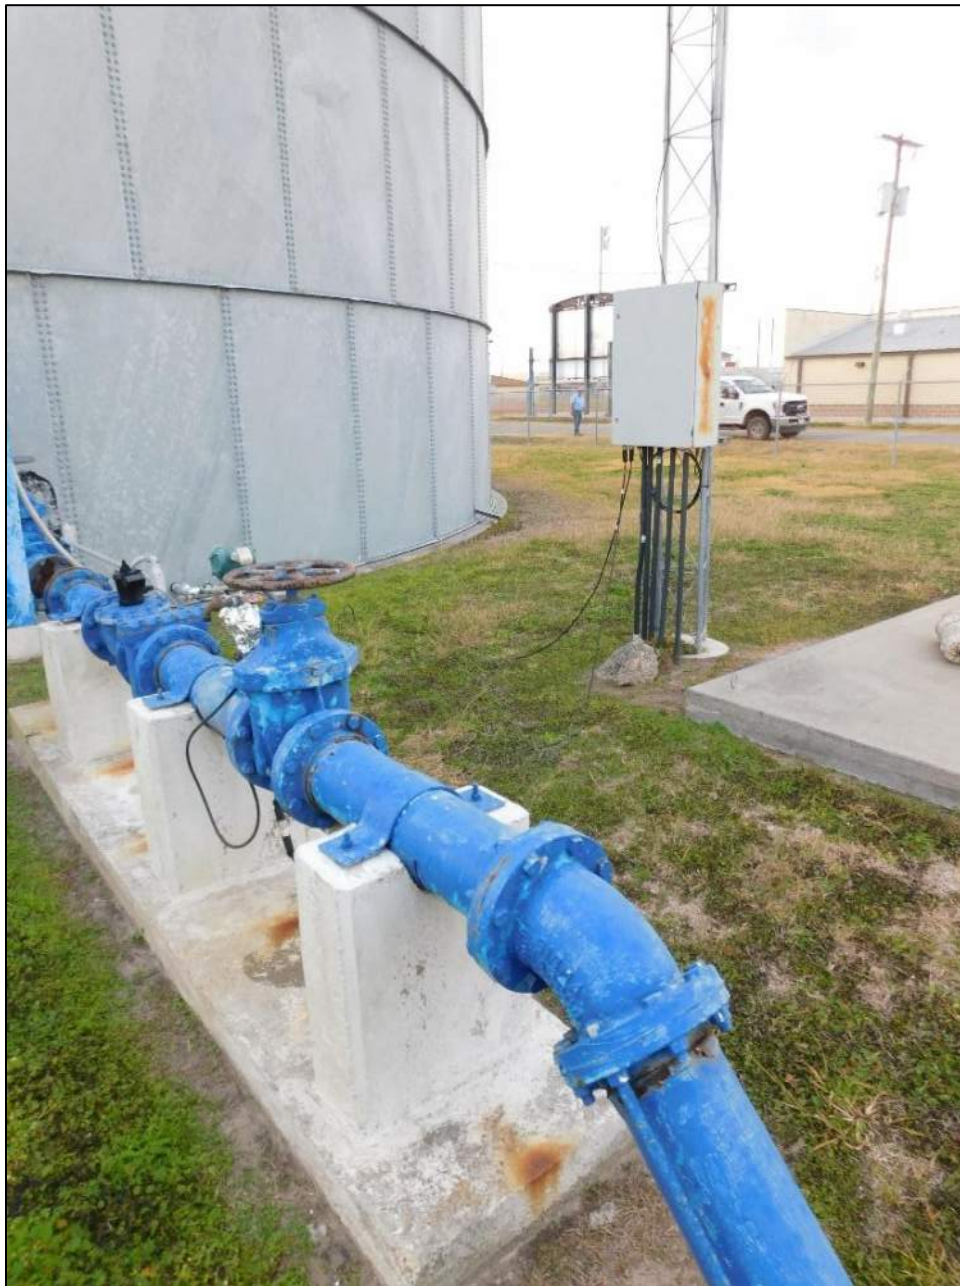
**Photo 67:** Tank pipe exhibited corrosion.

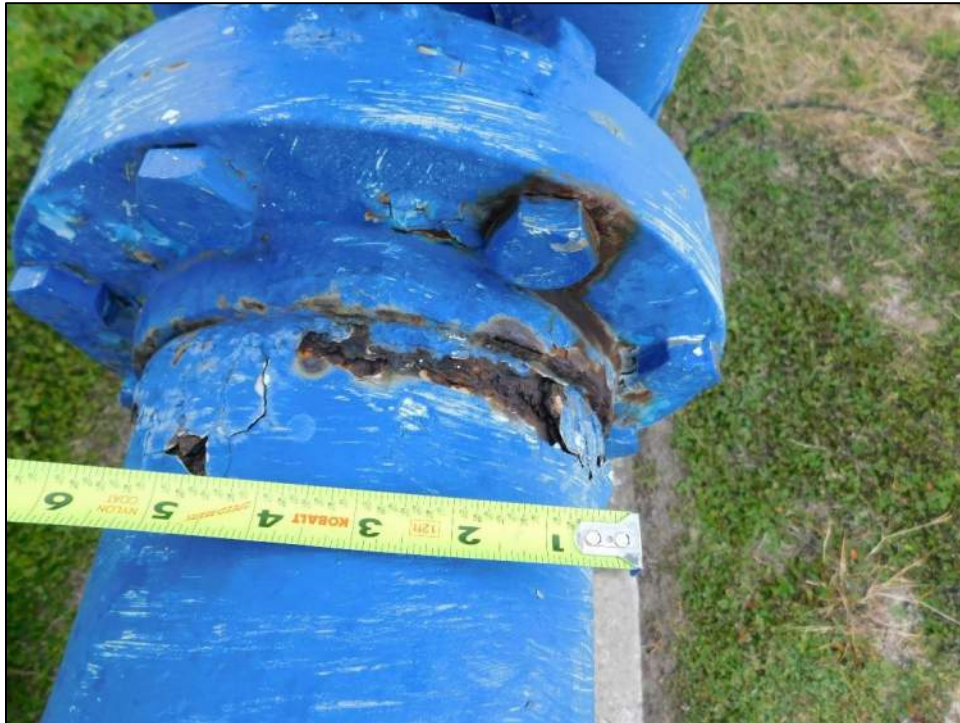
**Photo 68:** Closer view of typical corrosion at pipe flanges and connections.

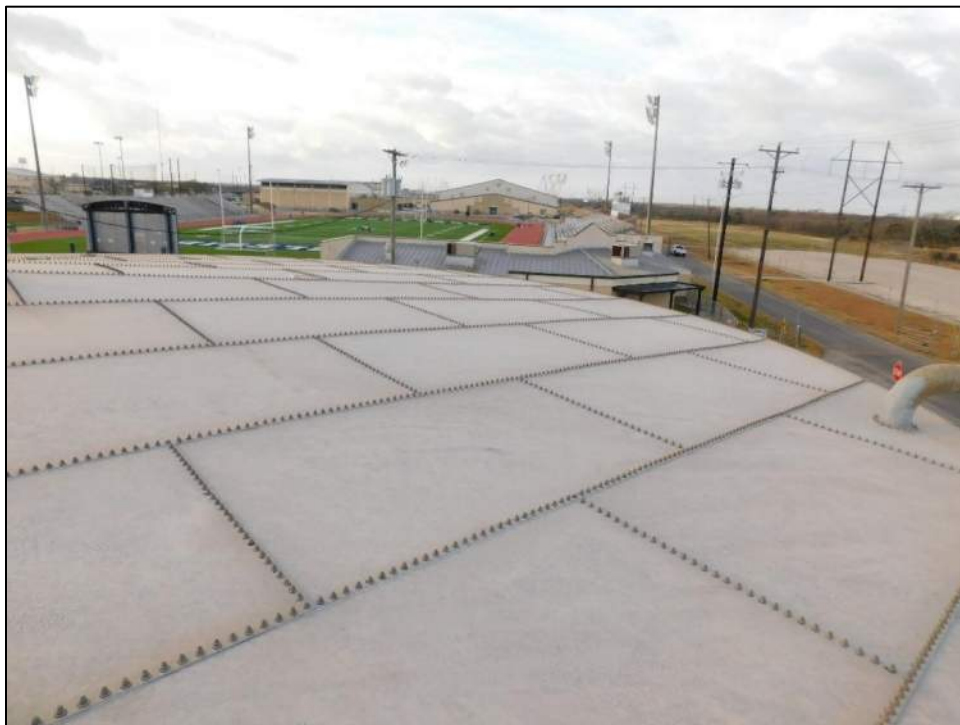
**Photo 69:** Roof top of tank remained structurally intact.

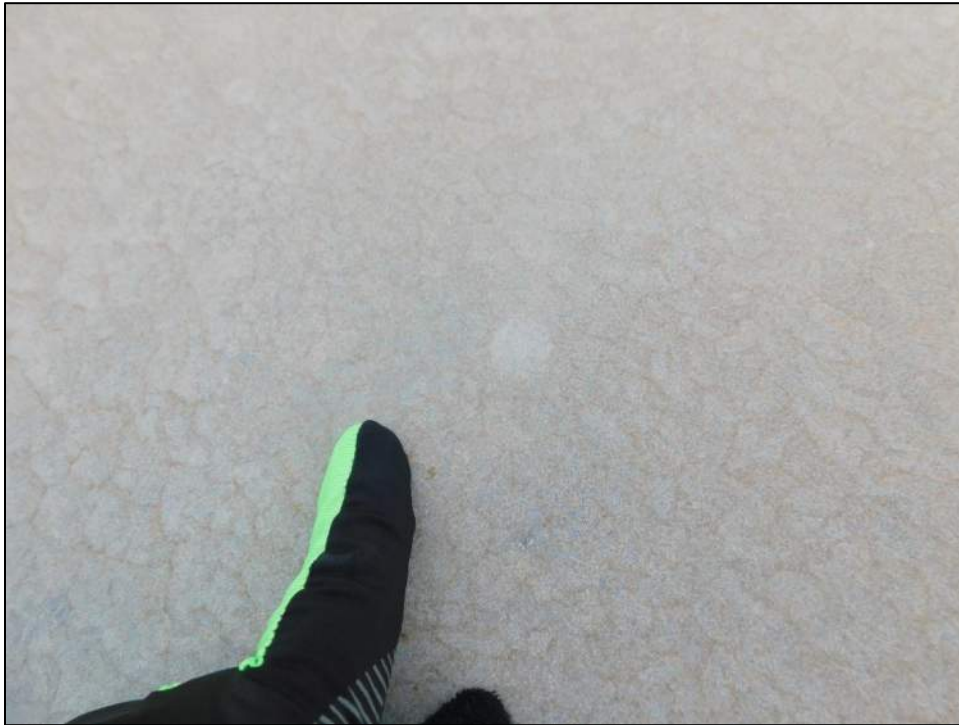
**Photo 70:** No hail impact mark was discernible on the tank roof.

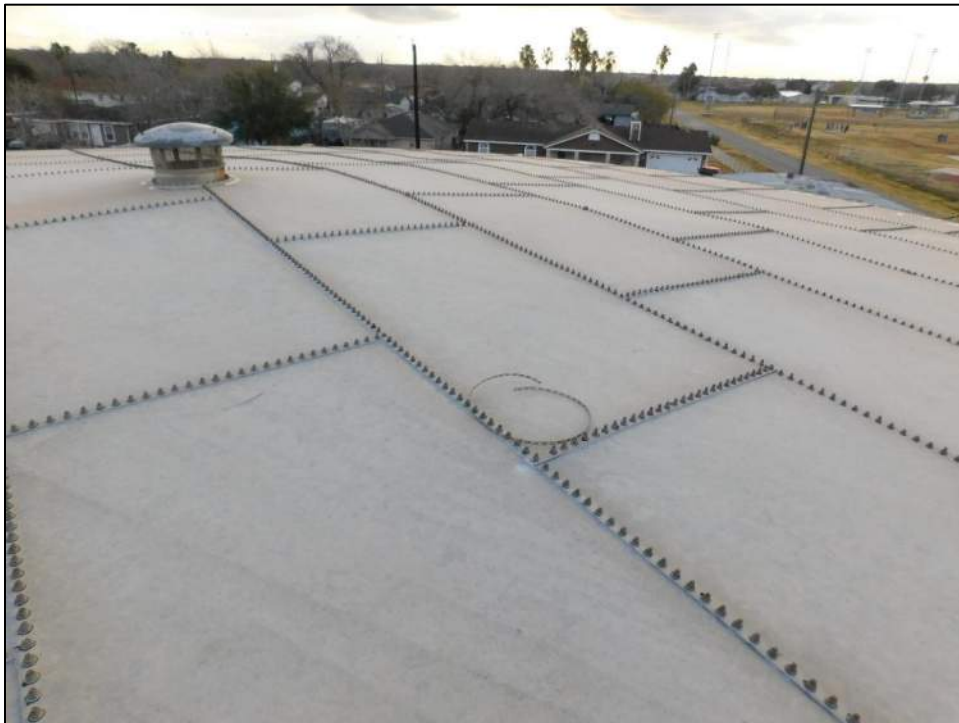
**Photo 71:** Tank roof remained structurally intact.

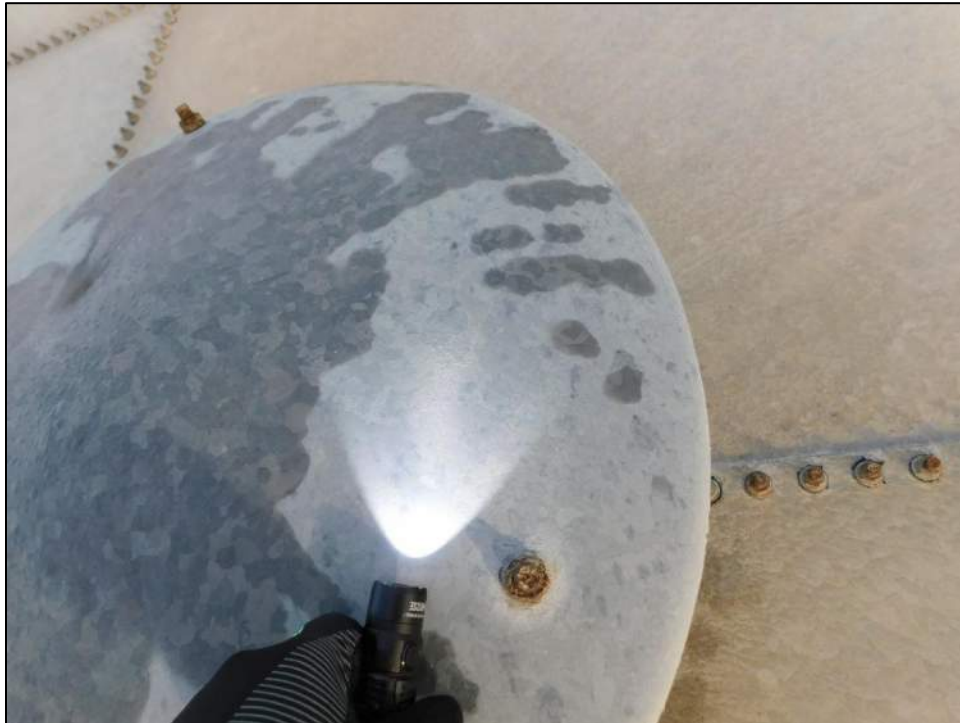
**Photo 72:** Tank roof vent was not dented.

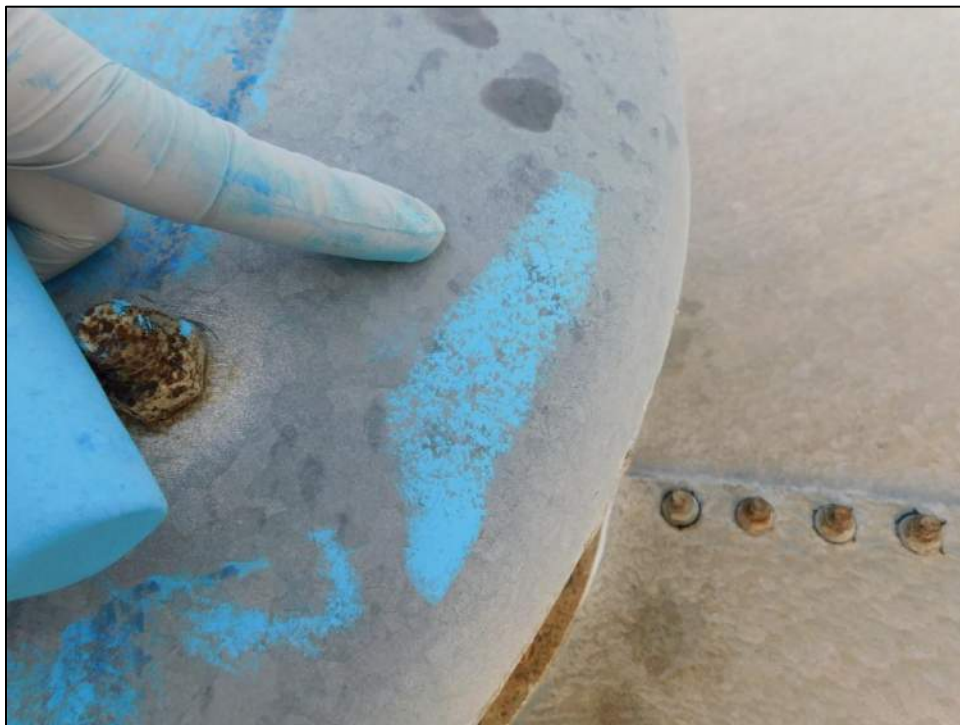
**Photo 73:** Tank roof vent was not dented

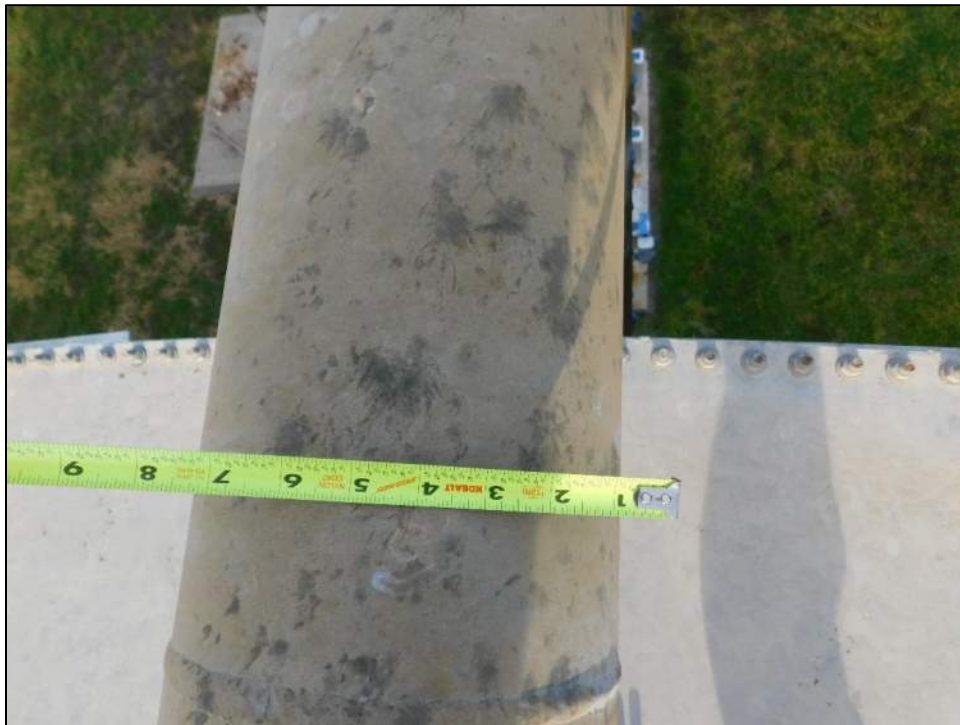
**Photo 74:** Hail spatter on tank rooftop piping reflective of 1.5 inch hail.
