**CITY OF INGLESIDE  
REGULAR CITY COUNCIL MEETING  
AGENDA  
JUNE 9, 2026  
6:30 PM**

Report on November 01, 2025, Hailstorm Damage to City of Ingleside Buildings.

### Building Damage Analysis Survey and Report

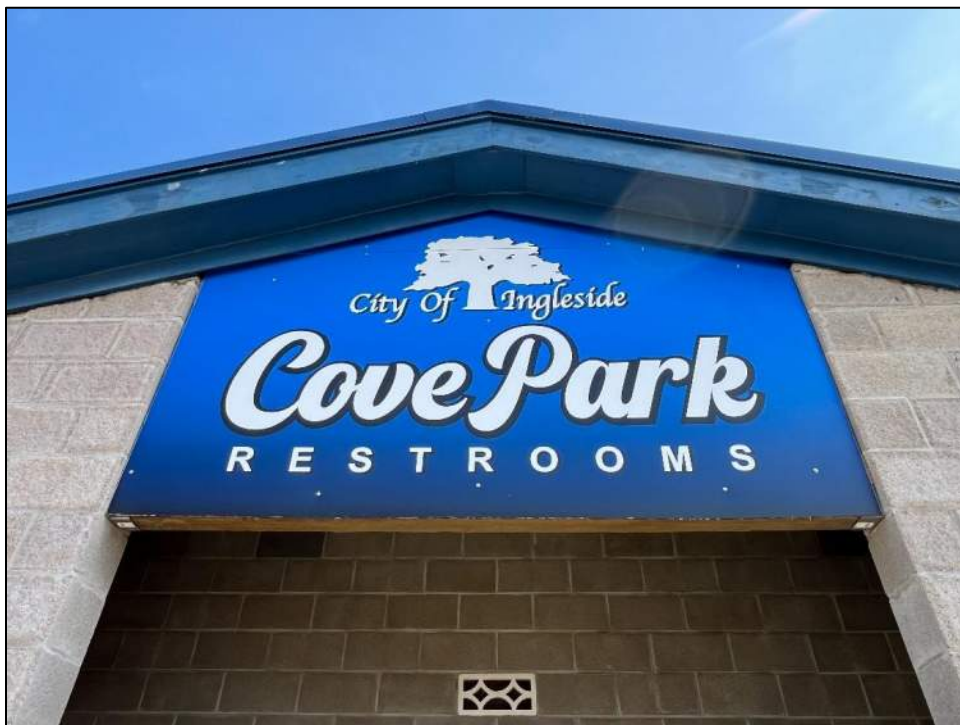
**Photo 2:** Signs above restroom entry exhibited no hail impact scuff marks.

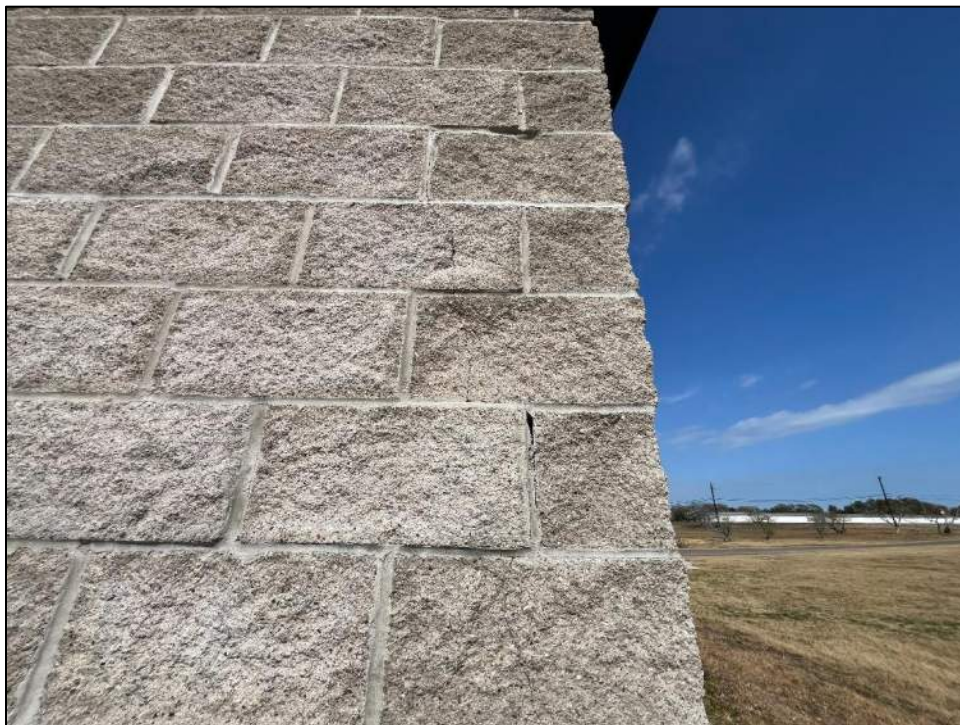
**Photo 6:** Masonry cracking at upper east corner unrelated to hail effects.

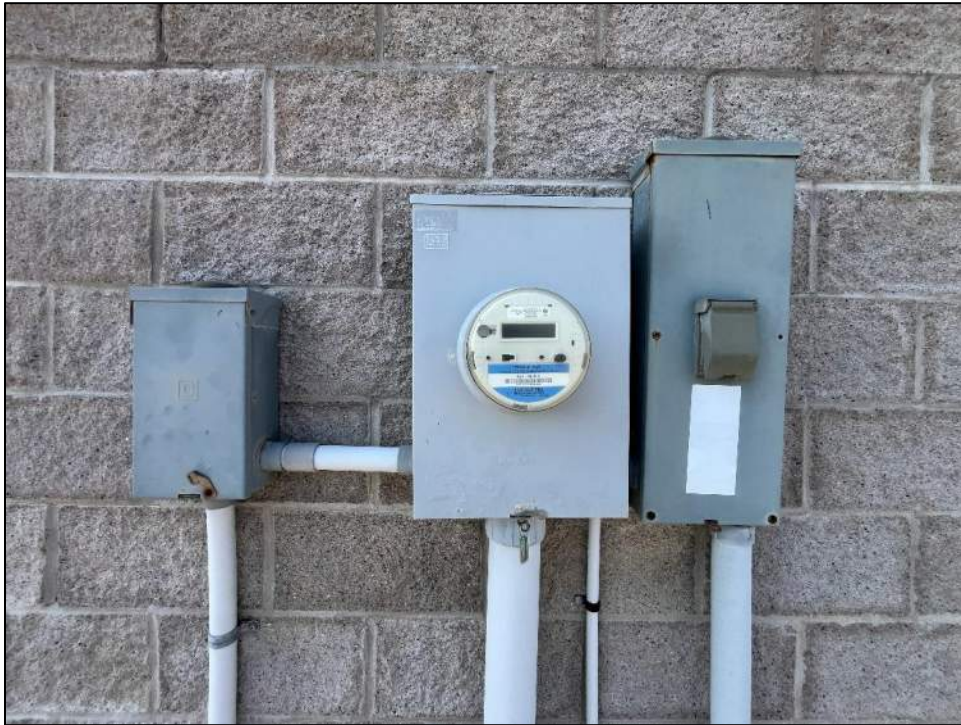
**Photo 7:** East wall was unaffected by hail.

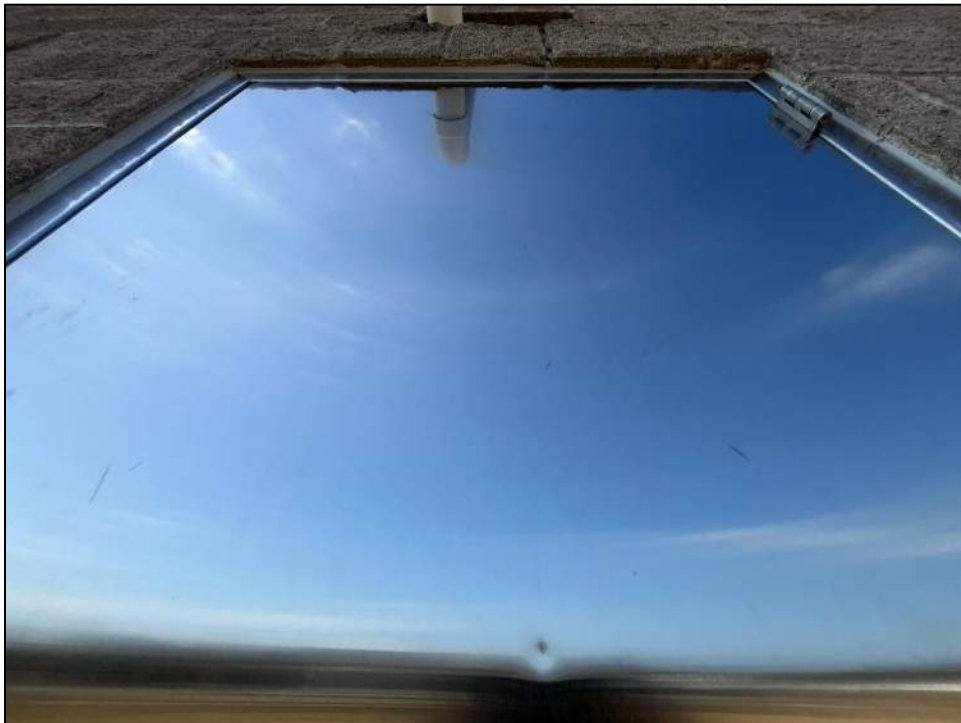
**Photo 8:** Stainless steel door was unaffected by hail.

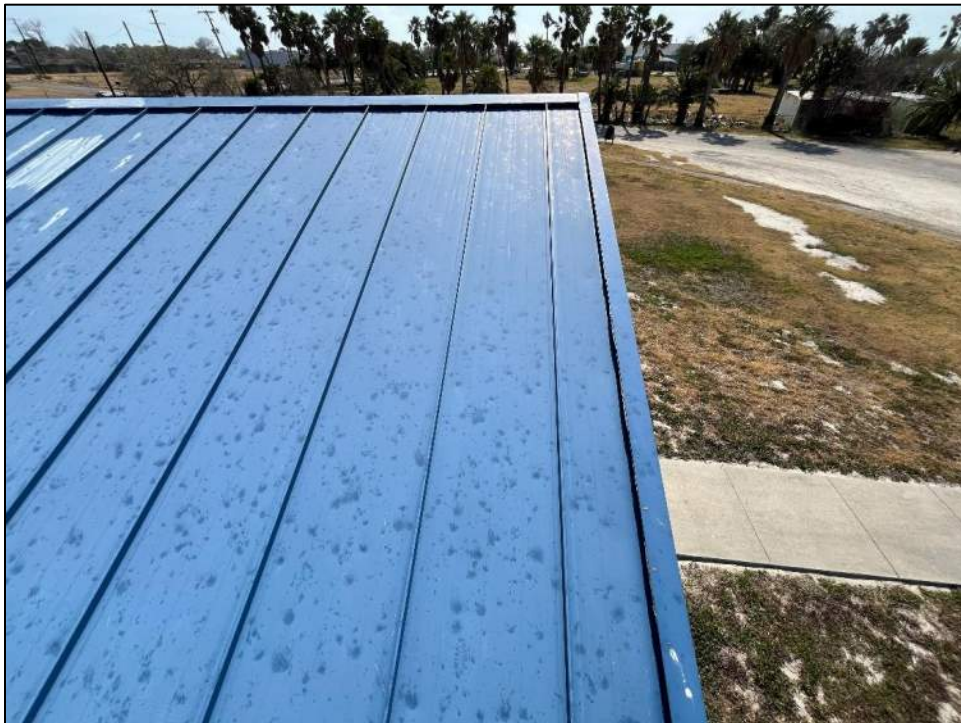
**Photo 10:** Widespread hail spatters on north slope.

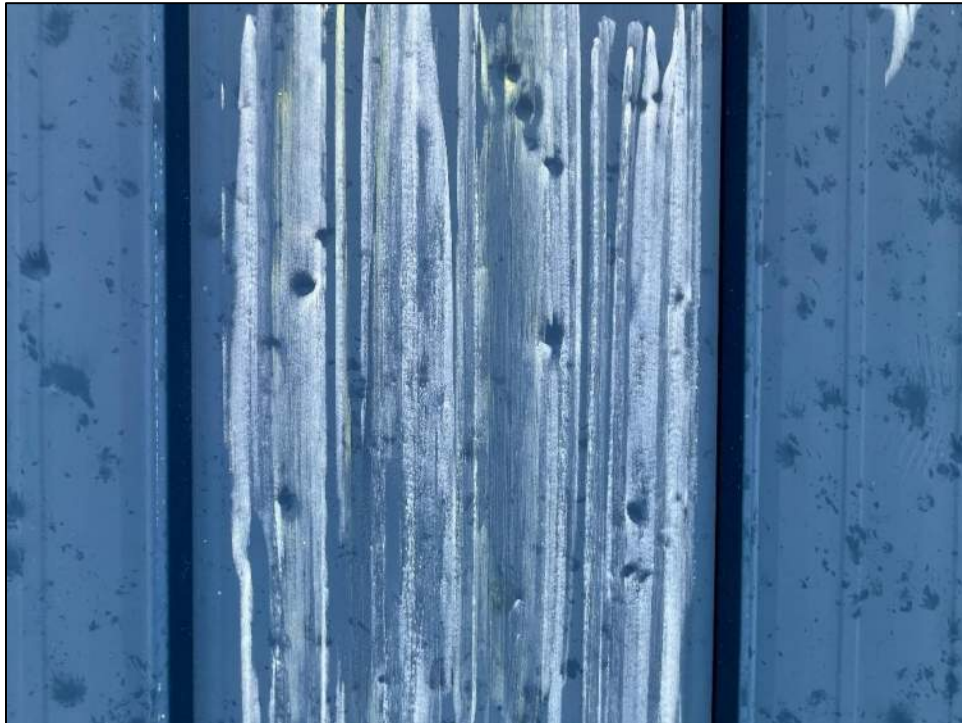
**Photo 13:** Hail denting on north slope had inner diameter of up to 5/8 inch.

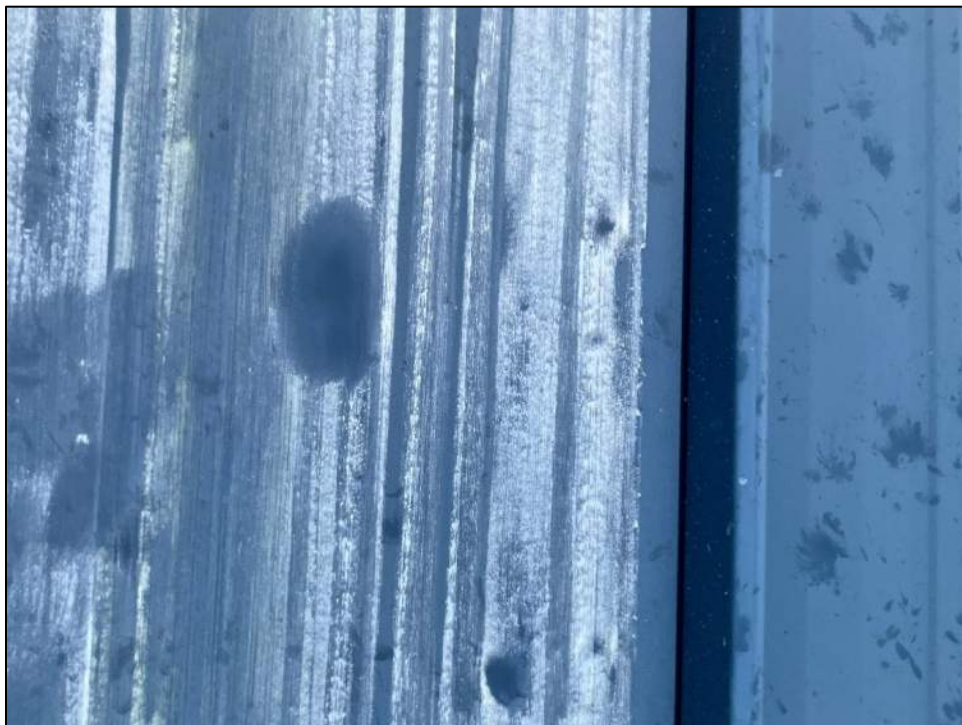
**Photo 14:** No coating disruptions were observed at the hail dents or spatters.

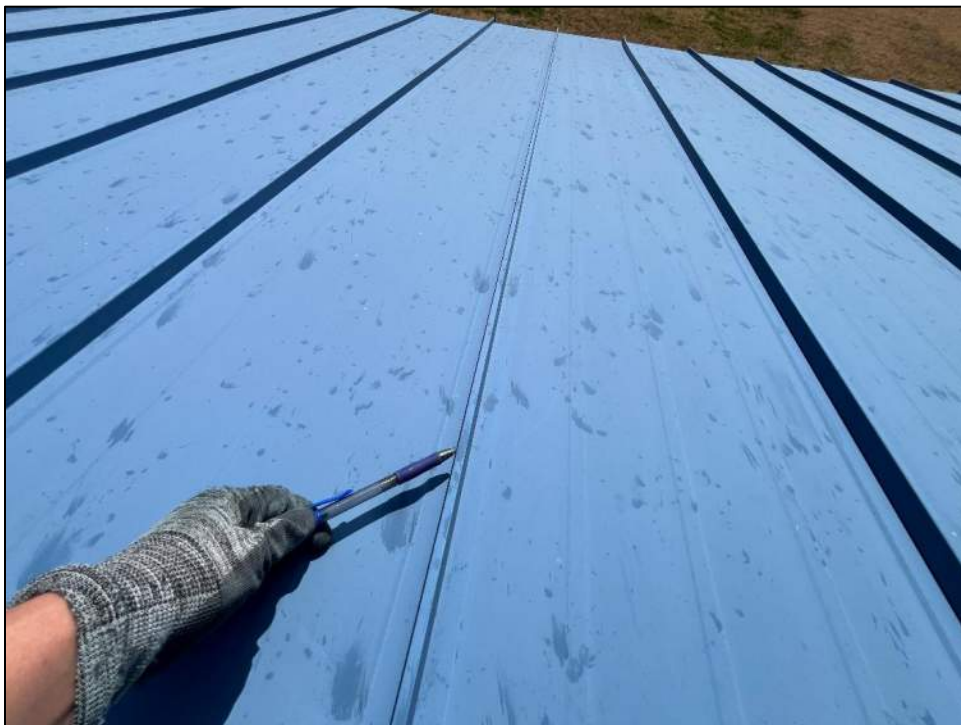
**Photo 22:** Standing seams remained intact.

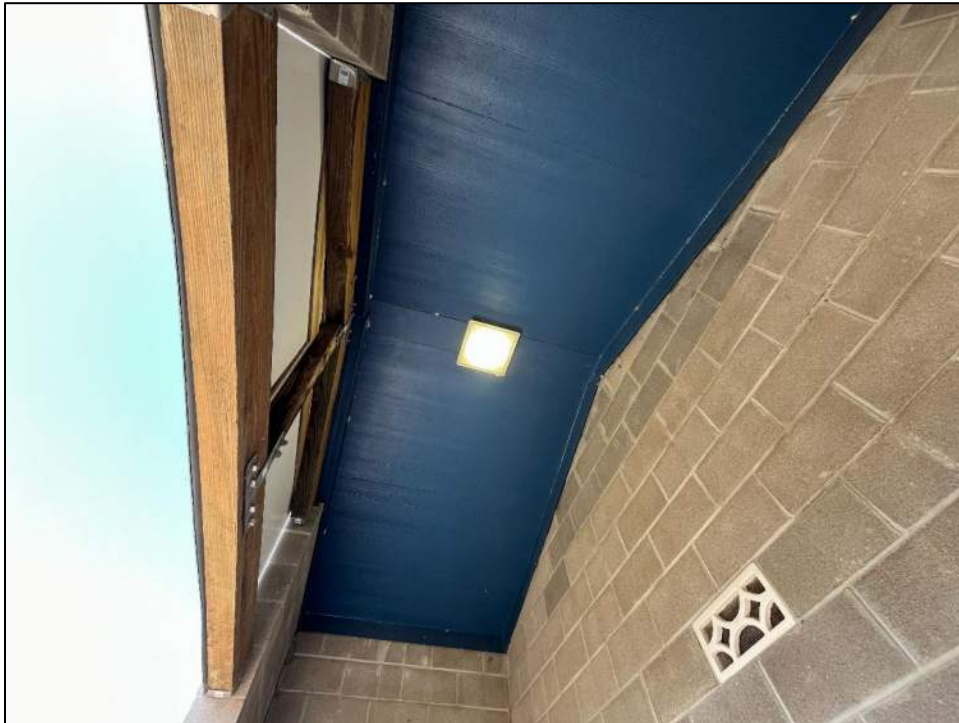
**Photo 23:** No ceiling stains indicative of roof leaks were observed.
