**CITY OF INGLESIDE  
REGULAR CITY COUNCIL MEETING  
AGENDA  
JUNE 9, 2026  
6:30 PM**

Report on November 01, 2025, Hailstorm Damage to City of Ingleside Buildings.

### Building Damage Analysis Survey and Report

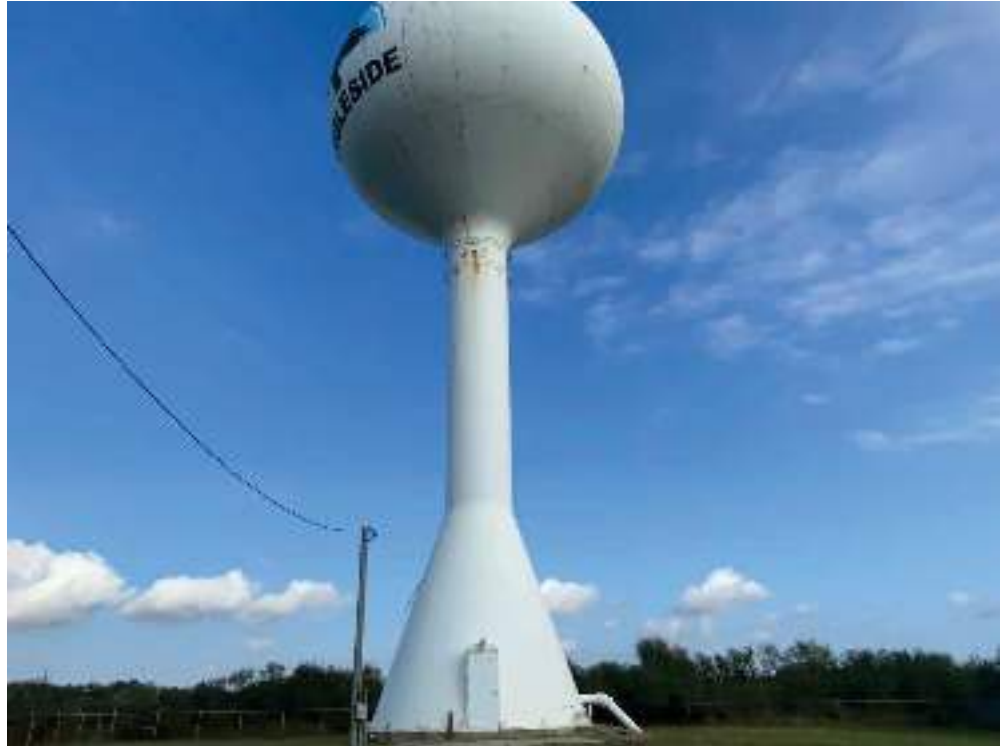
- 1 Location 001/001-001 - 1-IMG\_3026  
Date Taken: 11/25/2025

This elevated water tower was not inspected due to accessibility. Possible damage would be to the paint around the tower. A reinspection with the proper drone would be necessary to inspect the height of the tower.

Water tower

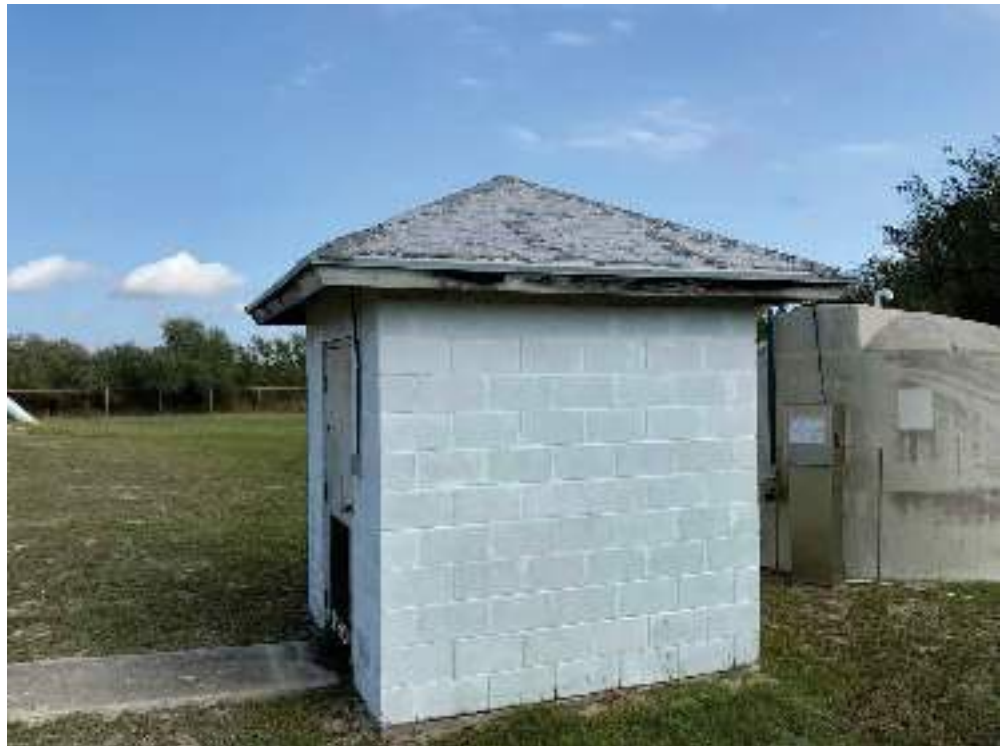
- 2 Location 001/001-002/Roof - 2-IMG\_3029  
Date Taken: 11/25/2025

This structure is a CMU building with an asphalt shingle roof that houses the chlorinator. The damages are to the shingle roof only and are included in the attached ROM.

pump house roof

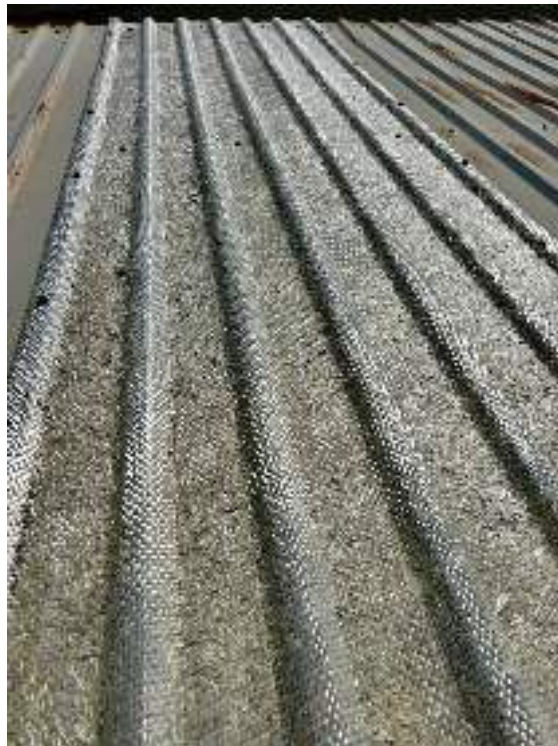
- 4 Location 002/002-001/Roof - 4-  
IMG\_0678  
Date Taken: 11/25/2025

closeup of skylight

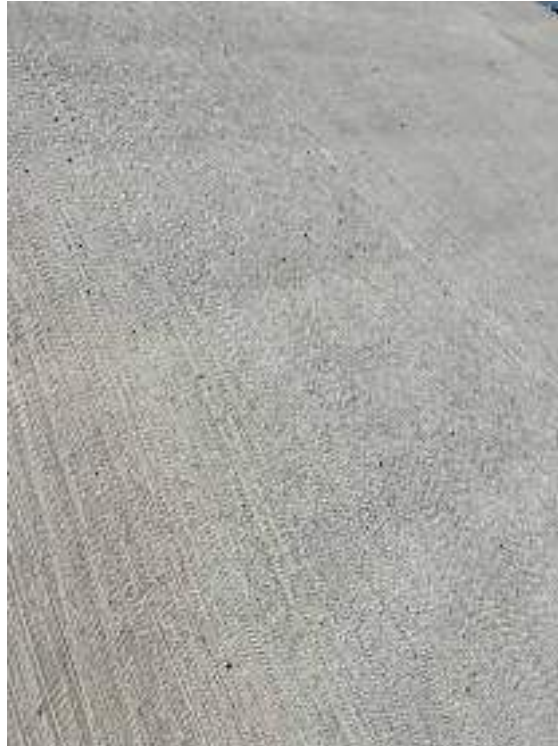
- 7 Location 002/002-002/Roof - 7-  
IMG\_0605  
Date Taken: 11/25/2025

closeup view of roof

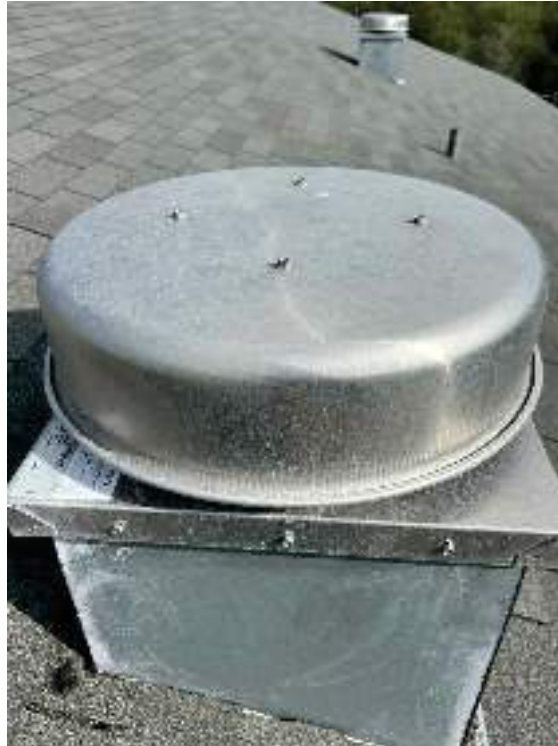
- 9 Location 002/002-003/Roof - 9-  
IMG\_0559  
Date Taken: 11/25/2025

roof vent

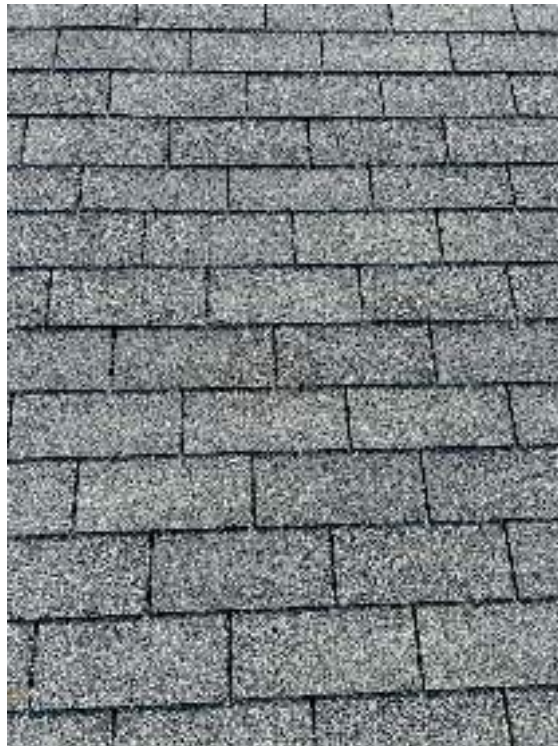
- 10 Location 002/002-003/Roof - 10-  
IMG\_0576  
Date Taken: 11/25/2025

closeup view of shingles

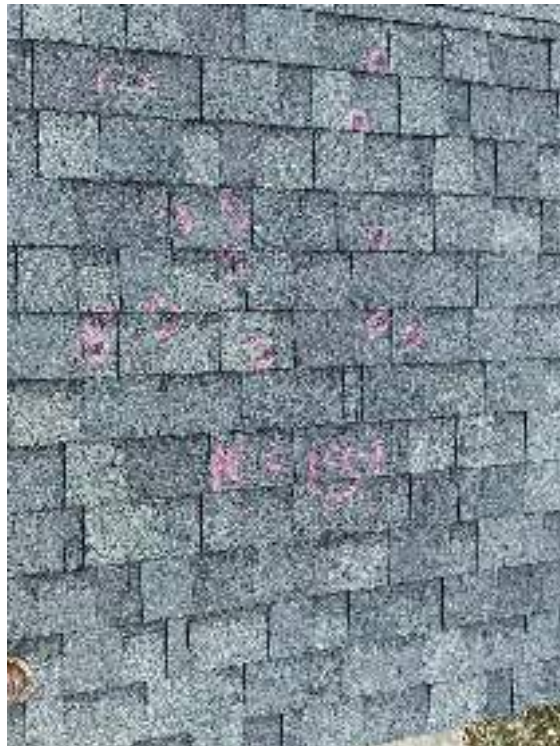
- 14 Location 003/Building 001/Roof -  
14-IMG\_2882  
Date Taken: 11/24/2025

hail damage to shingles

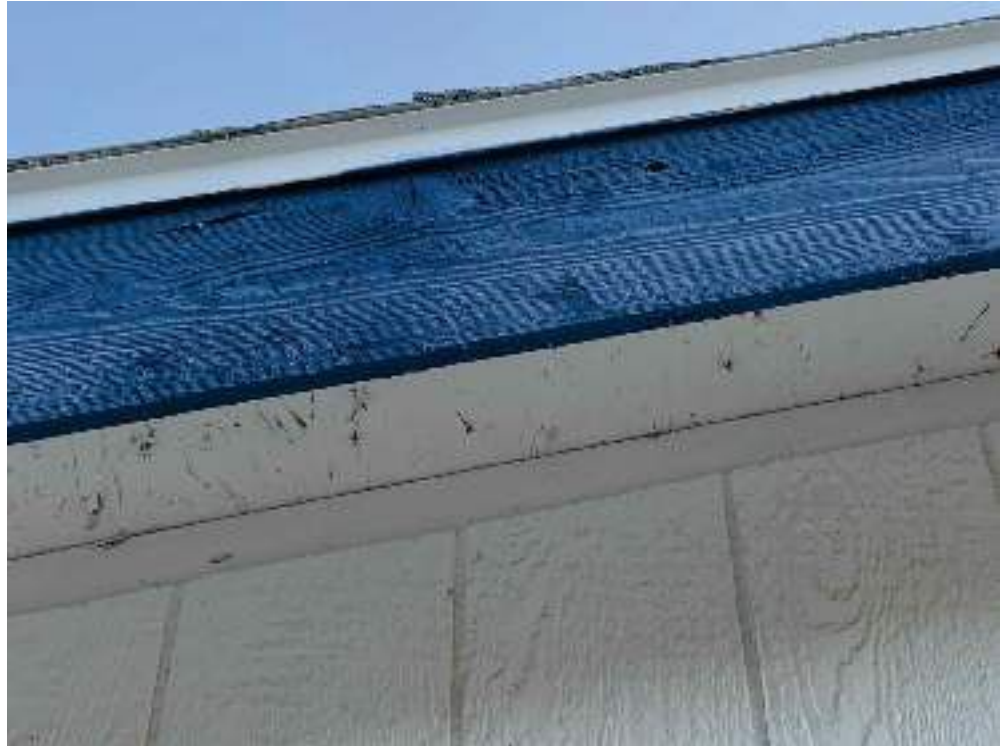
- 15 Location 003/Building  
001/Exterior - 15-IMG\_2812  
Date Taken: 11/24/2025

areas of chipped paint on fascia from  
hail

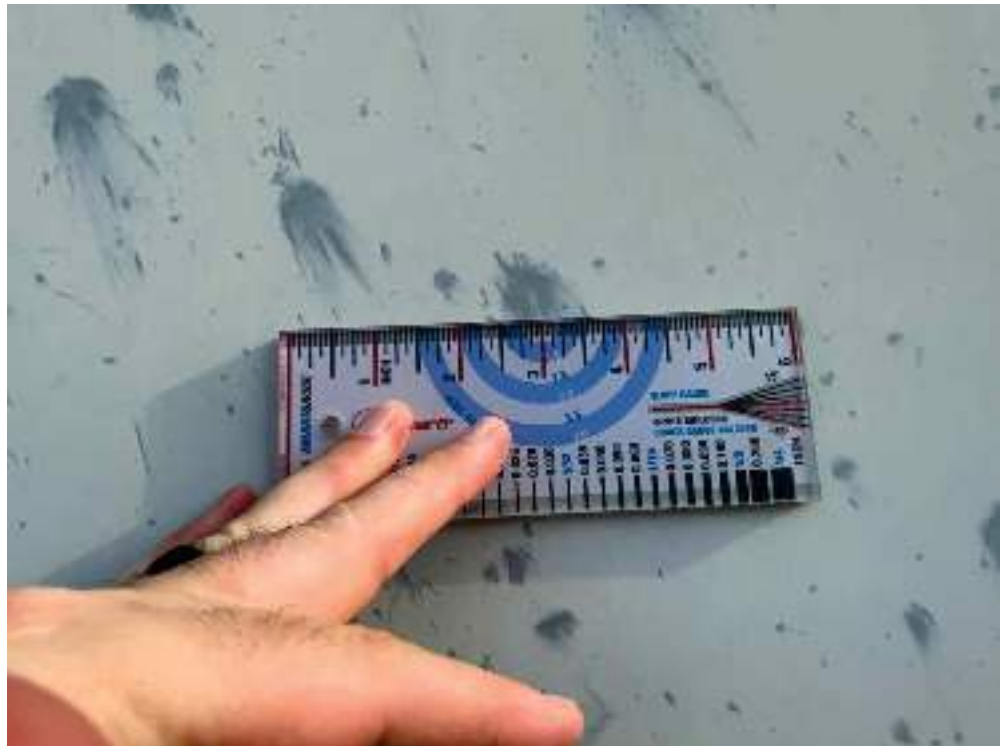
- 16 Location 003/Building  
001/Exterior - 16-IMG\_2803  
Date Taken: 11/24/2025

identification of hail size on electrical  
box

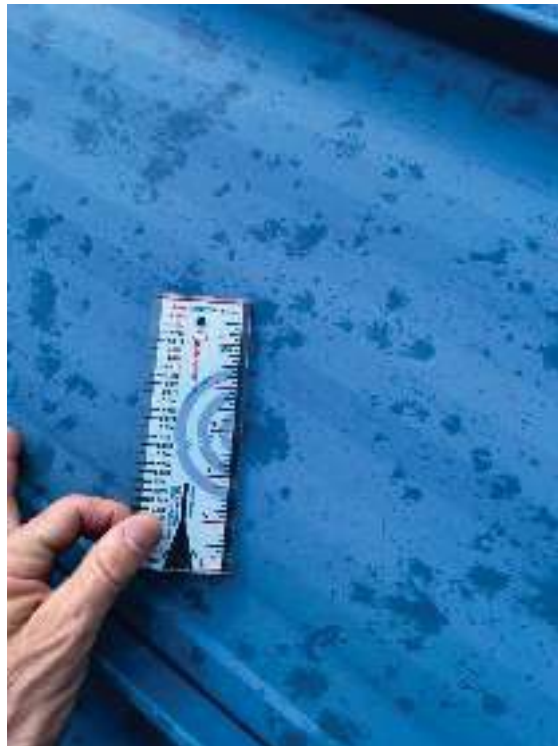
- 18 Location 004/004-003/Roof - 18-  
IMG\_0298  
Date Taken: 11/24/2025

identification of size of hail

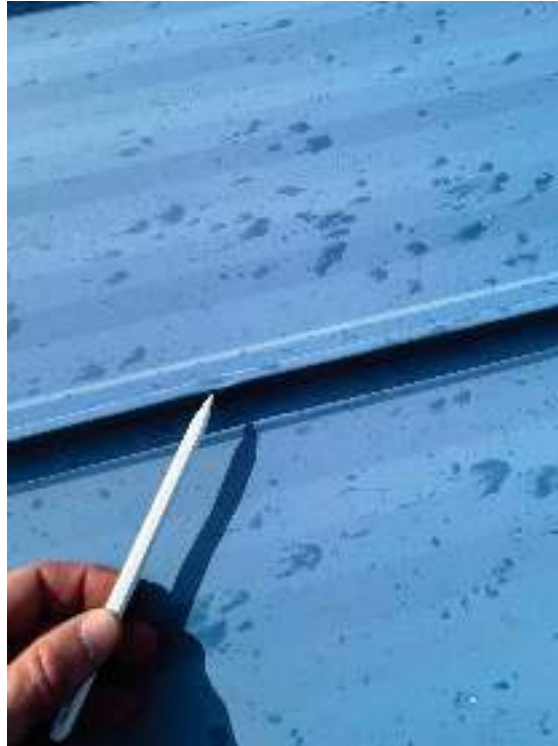
- 19 Location 004/004-003/Roof - 19-  
IMG\_0290  
Date Taken: 11/24/2025

apparent dent on fin of standing seam  
roof

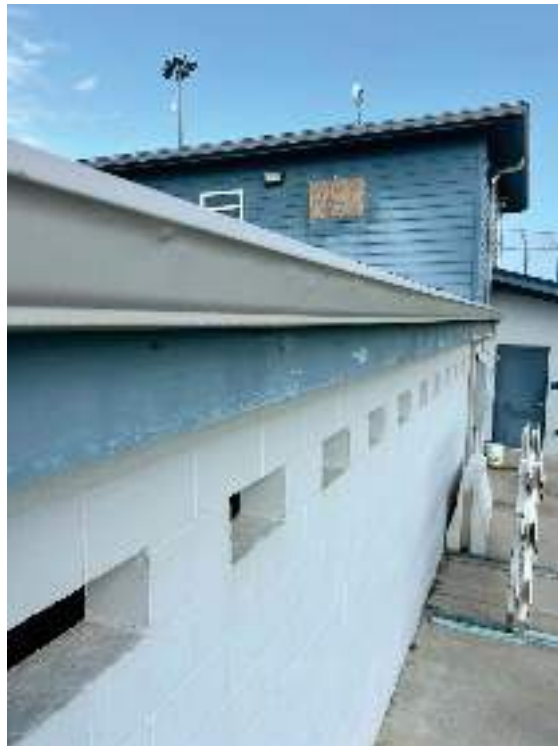
- 20 Location 004/004-003/Roof - 20-  
IMG\_0312  
Date Taken: 11/24/2025

overview of hail damage to gutter  
system

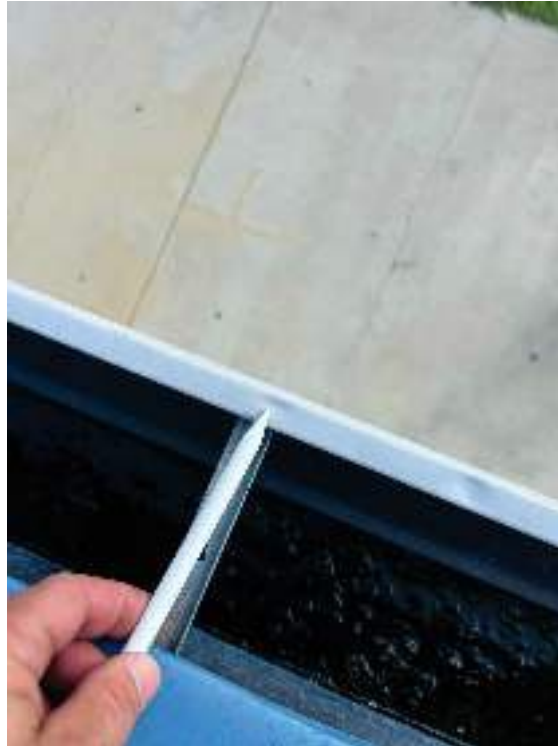
- 21 Location 004/004-003/Roof - 21-  
IMG\_0306  
Date Taken: 11/24/2025

close up of gutter system

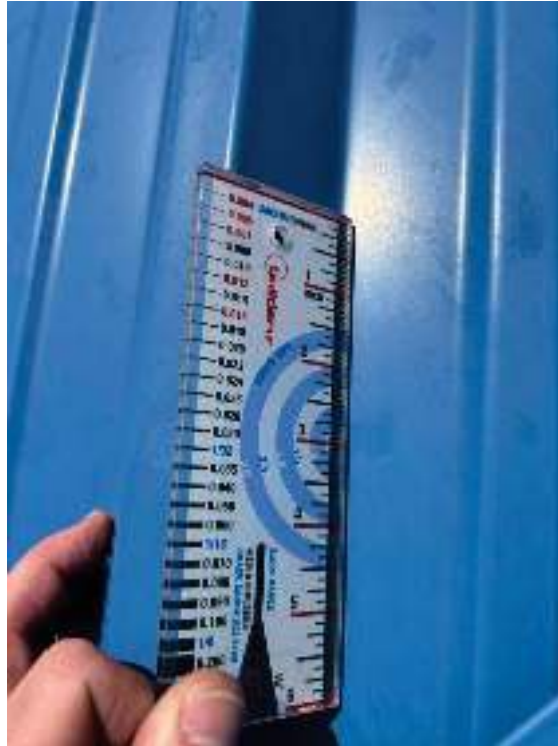
- 25 Location 005/005-001 - 25-IMG\_0063  
Date Taken: 11/24/2025

identification of hail size

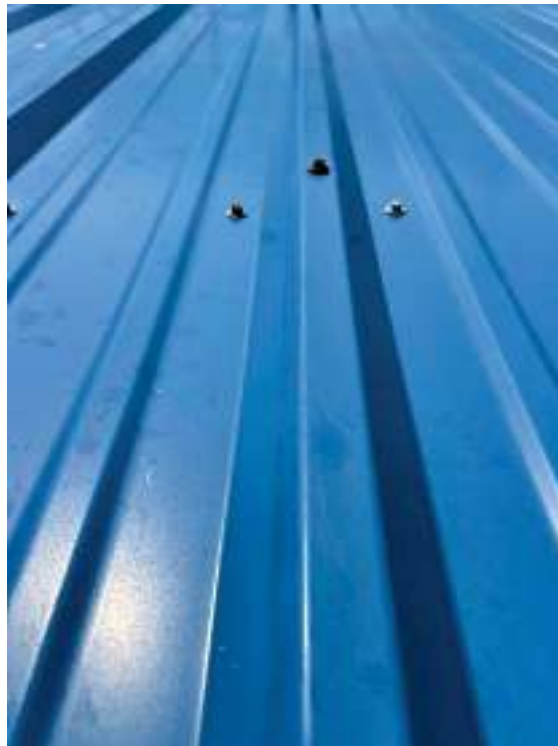
- 26 Location 005/005-001 - 26-IMG\_0067  
Date Taken: 11/24/2025

view of metal panel with hail splatter

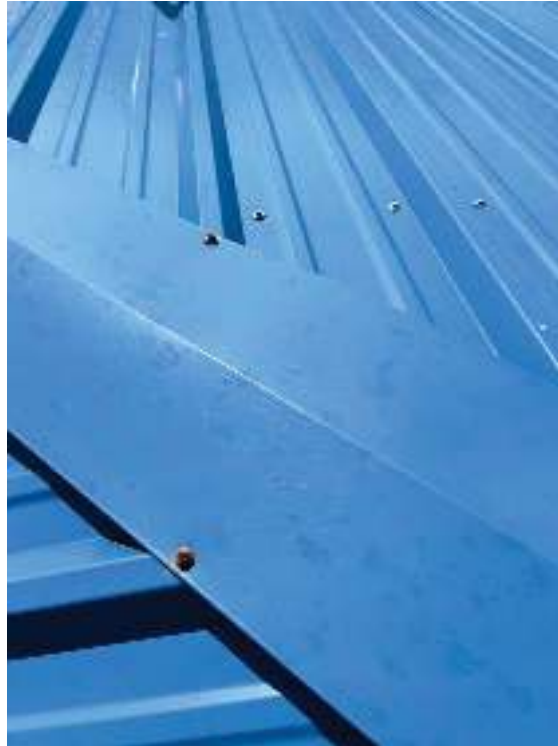
27 Location 005/005-001 - 27-IMG\_0074

view of valley with splatter

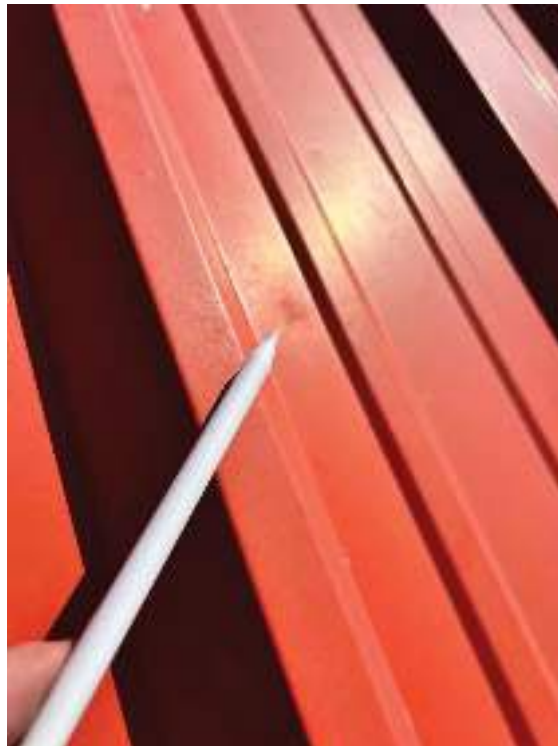
30 Location 005/005-002 - 30-IMG\_0001

dent in metal panel

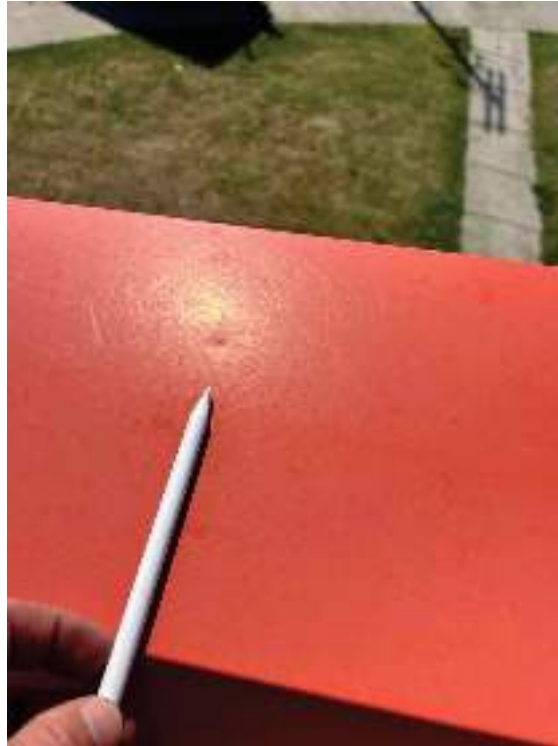
dent in flashing

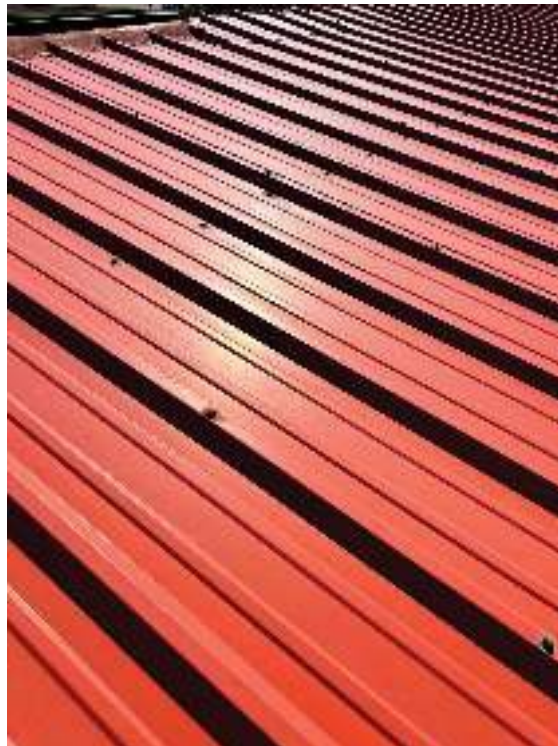
32 Location 005/005-002 - 32-IMG\_9996

panel overview

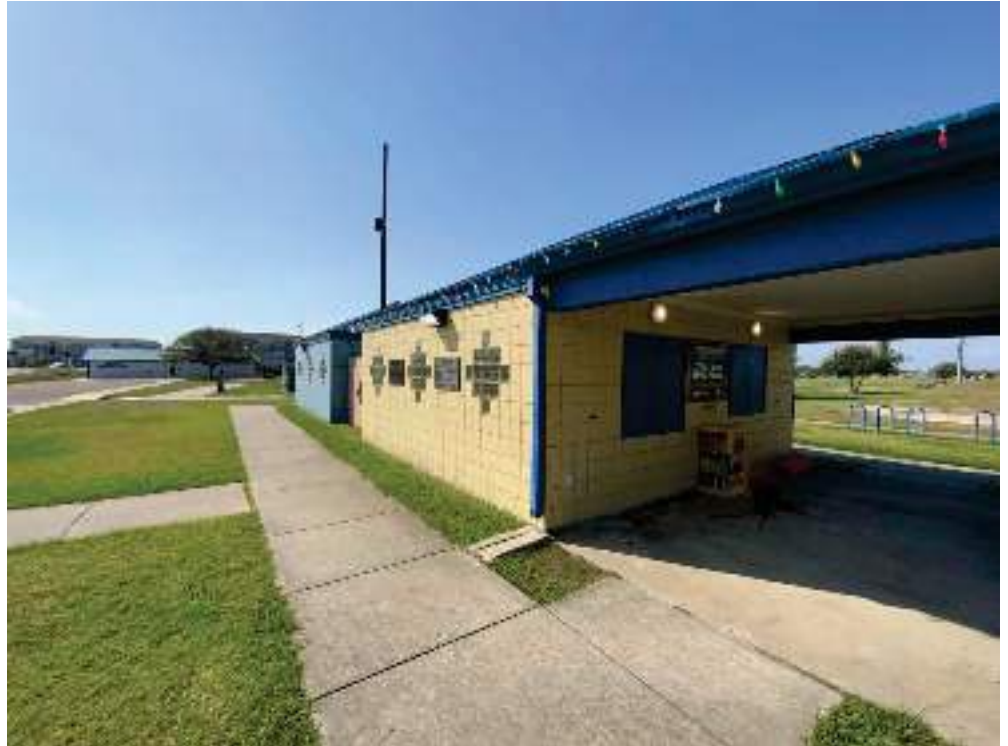
33 Location 005/005-003 - 33-IMG\_2613

overview

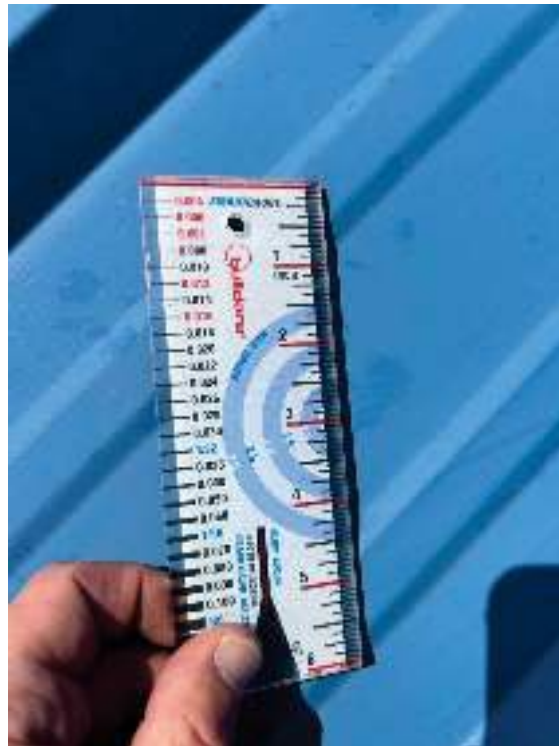
34 Location 005/005-003 - 34-IMG\_9936

identification of hail size

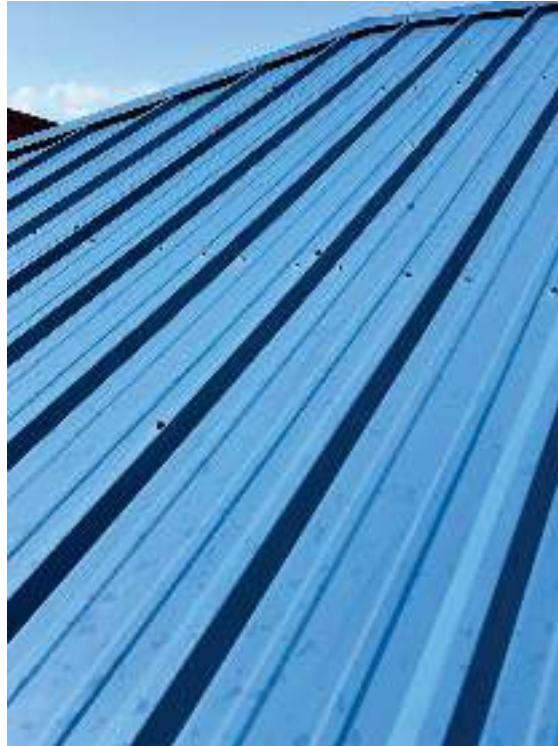
35 Location 005/005-003 - 35-IMG\_9932

overview of panel

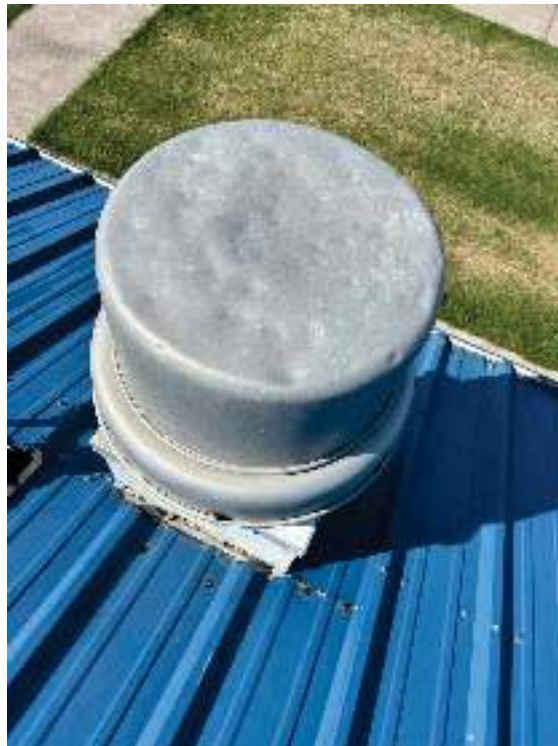
36 Location 005/005-003 - 36-IMG\_9942

exhaust vent on roof

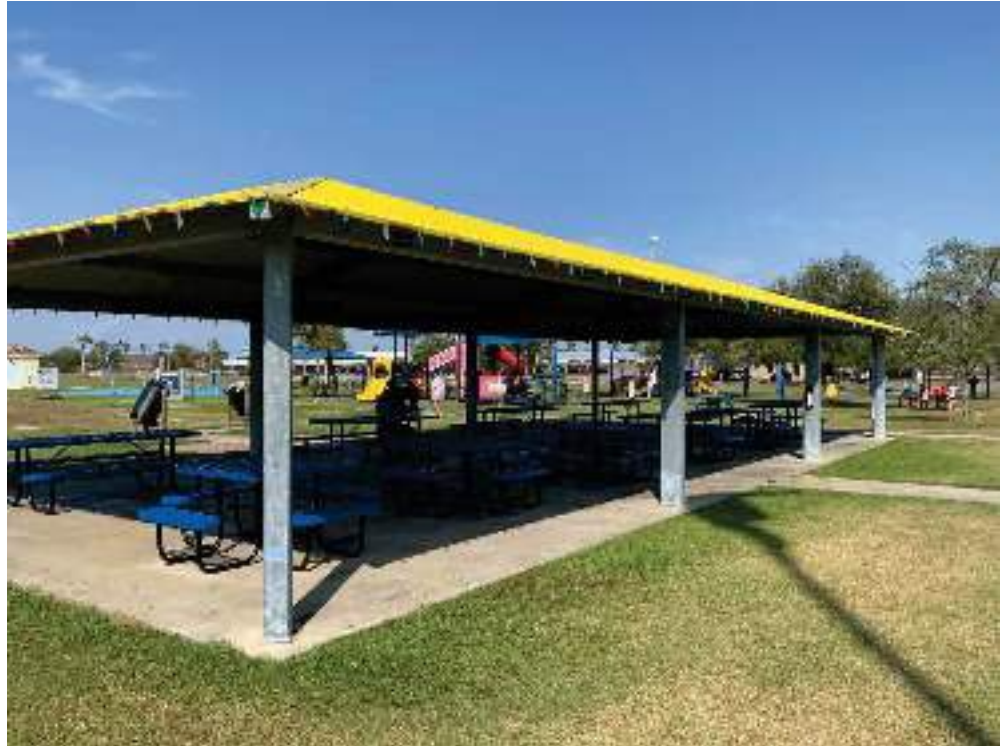
37 Location 005/005-004 - 37-IMG\_2617

overview

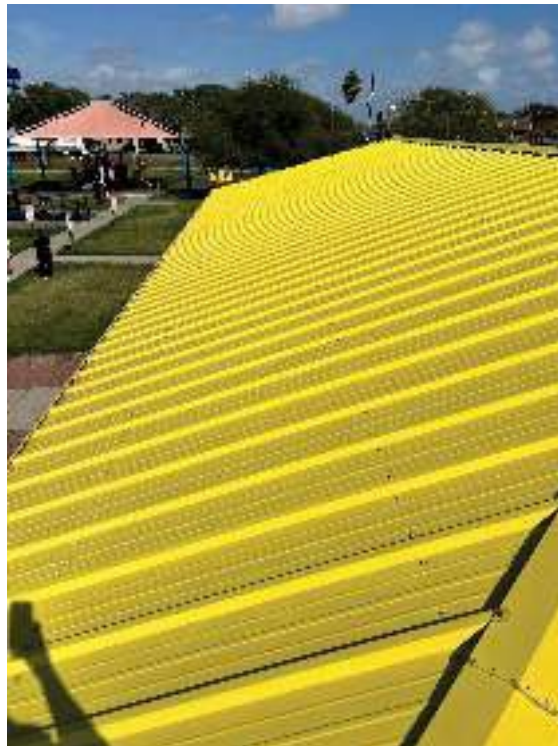
38 Location 005/005-004 - 38-IMG\_0029

overview of roof

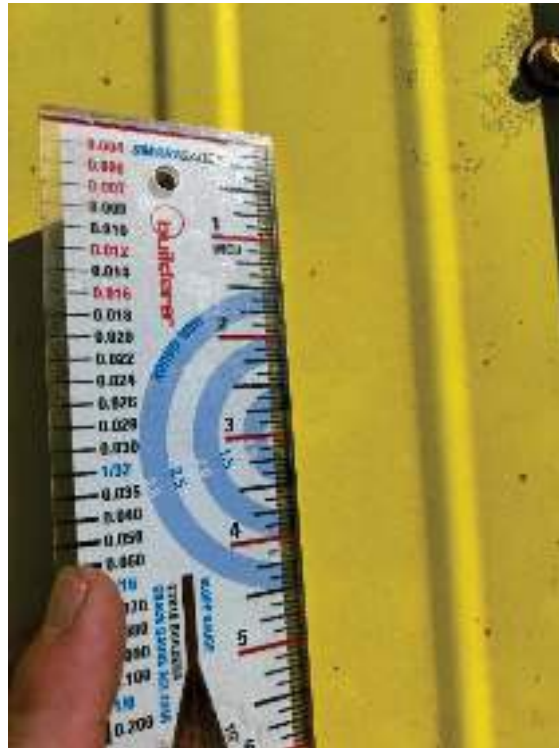
- 39 Location 005/005-004 - 39-IMG\_0050  
Date Taken: 11/24/2025

identification of hail size

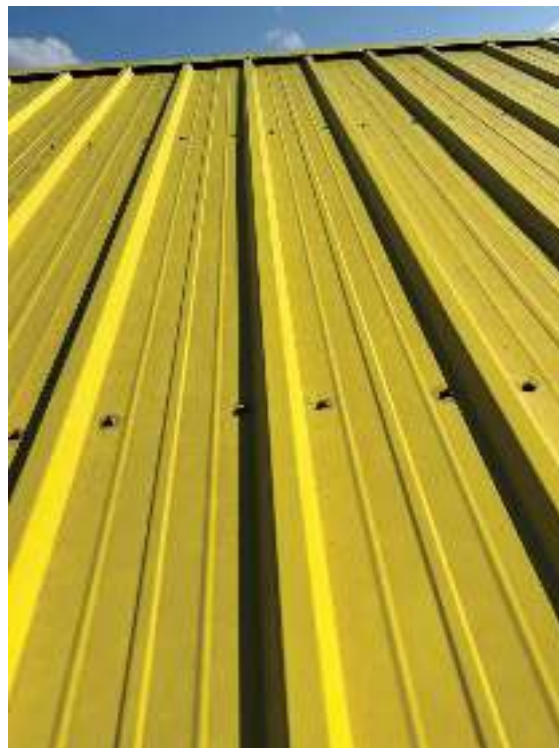
- 40 Location 005/005-004 - 40-IMG\_0049  
Date Taken: 11/24/2025

view of panel

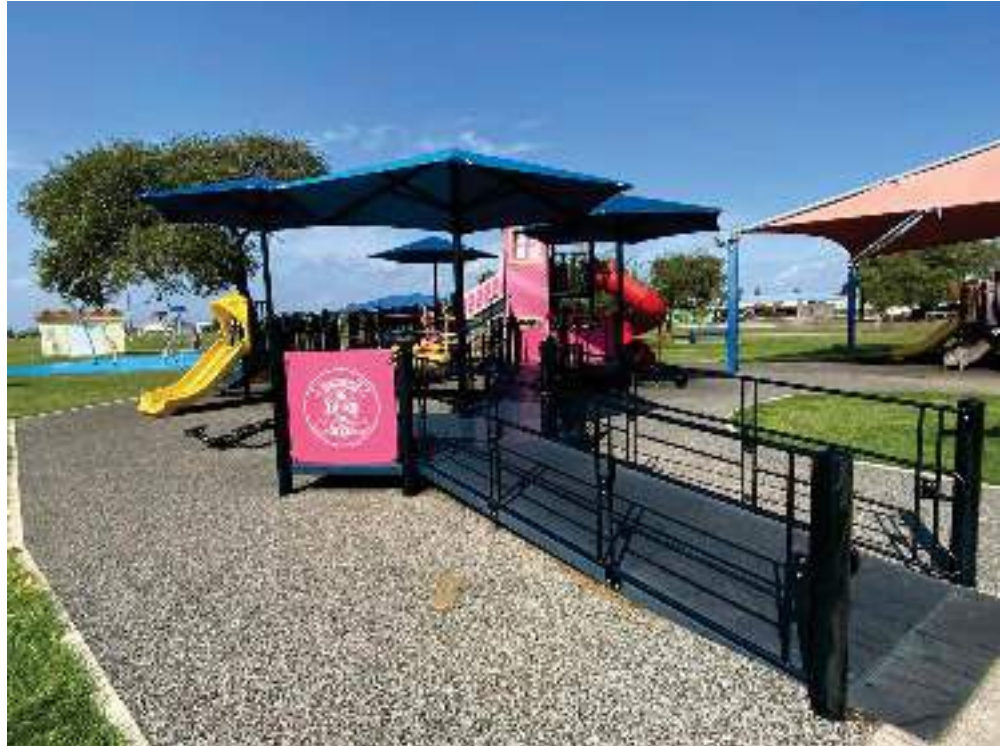
41 Location 005/005-005 - 41-IMG\_2624

overview of playground equipment

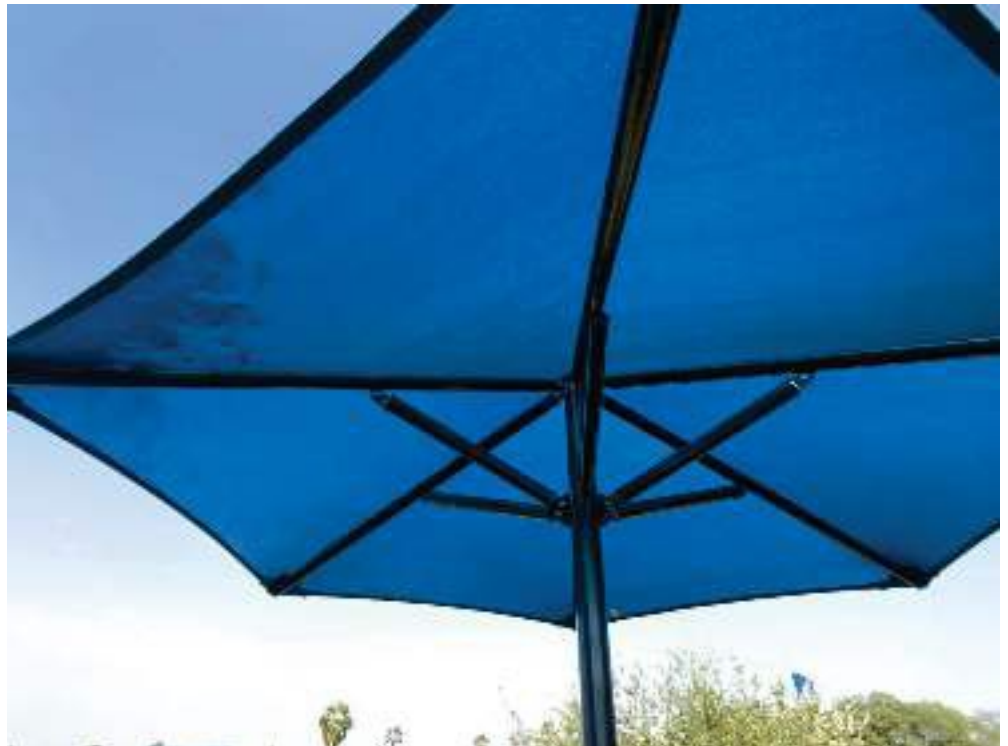
42 Location 005/005-005 - 42-IMG\_2632

playground canopies

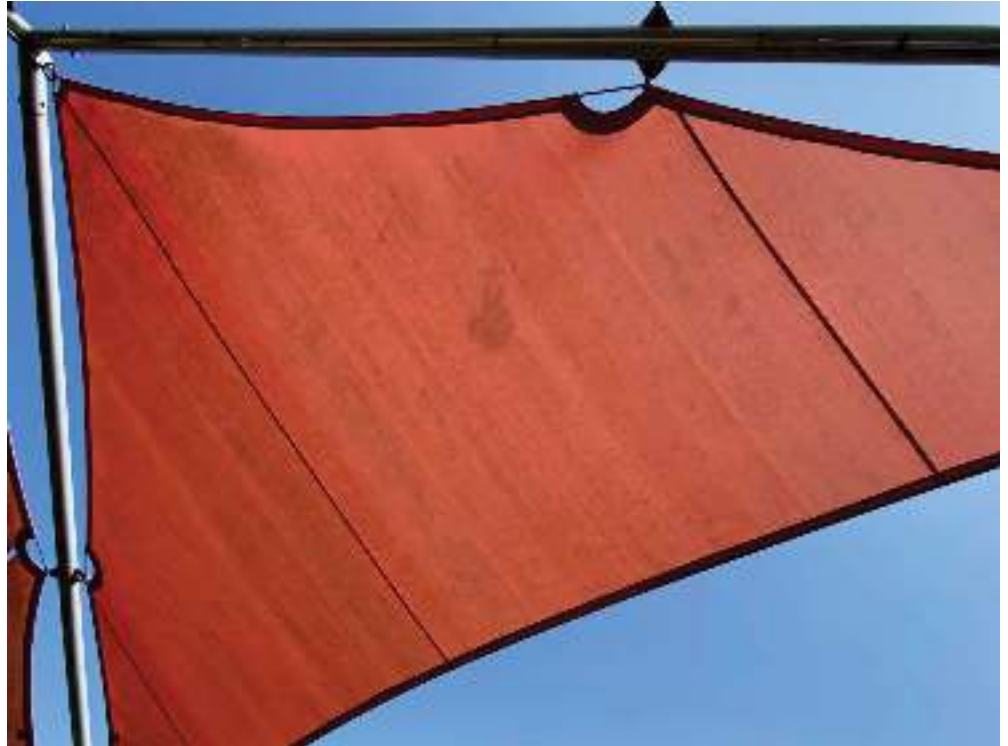
43 Location 005/005-005 - 43-IMG\_2639

playground canopies

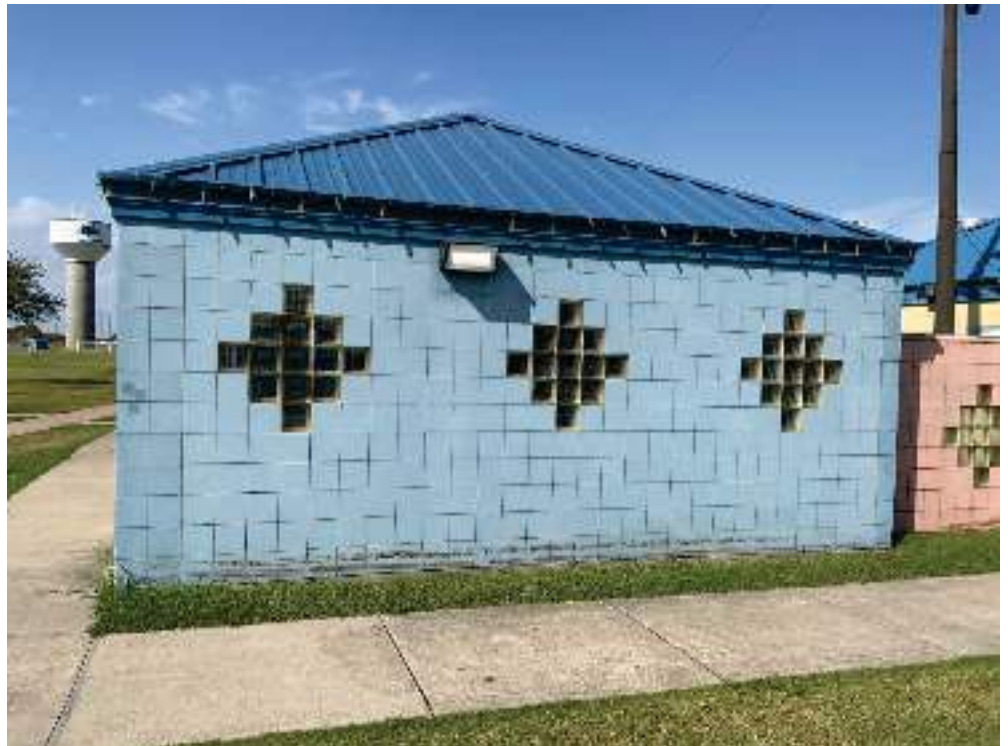
44 Location 005/005-006 - 44-IMG\_2596

overview

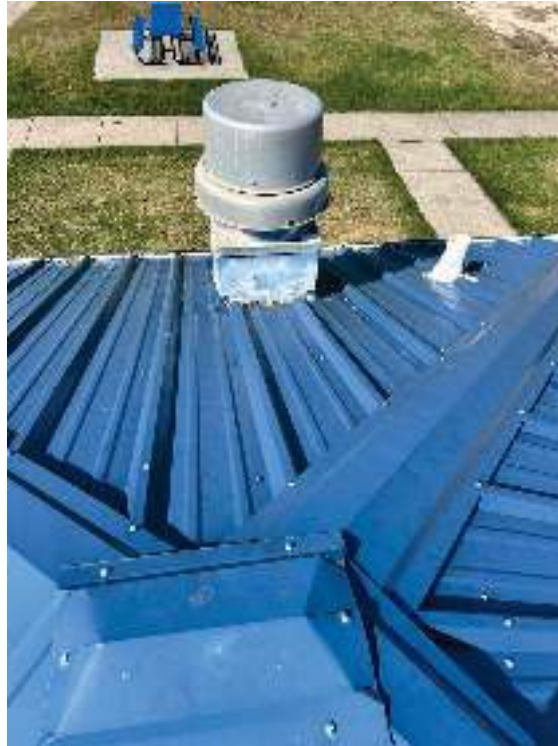
45 Location 005/005-006 - 45-IMG\_9965

roof overview

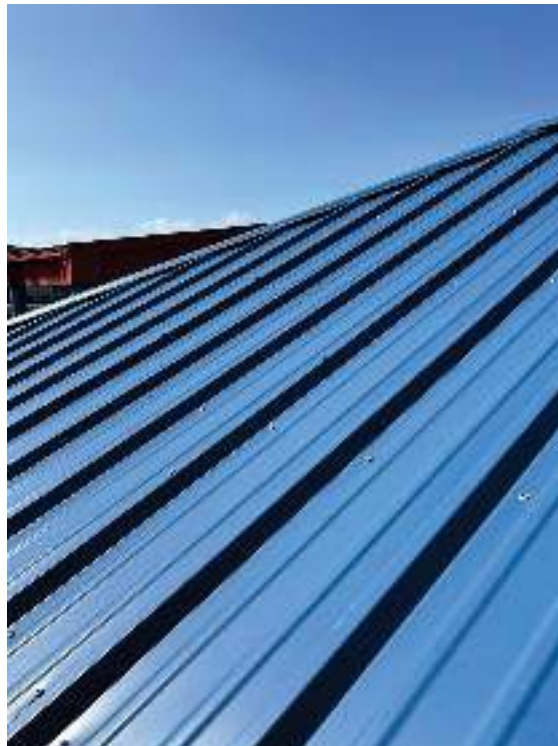
46 Location 005/005-006 - 46-IMG\_9959

close up of panels

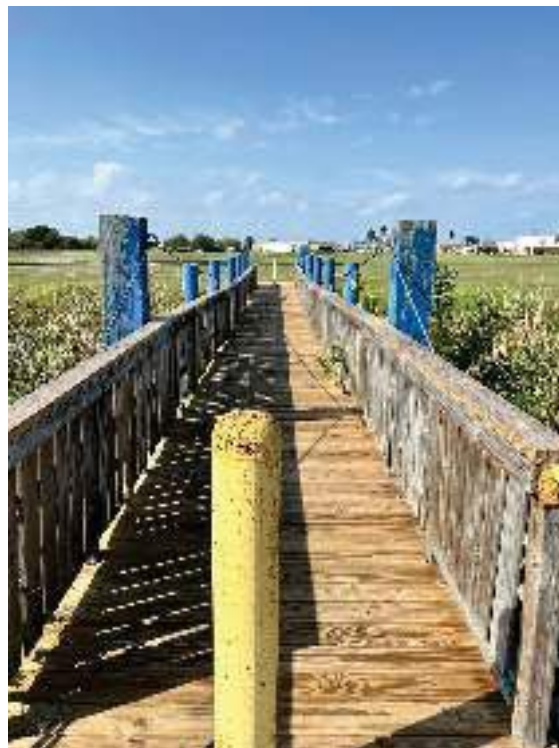
48 Location 005/005-007 - 48-IMG\_0079

overview of bridge

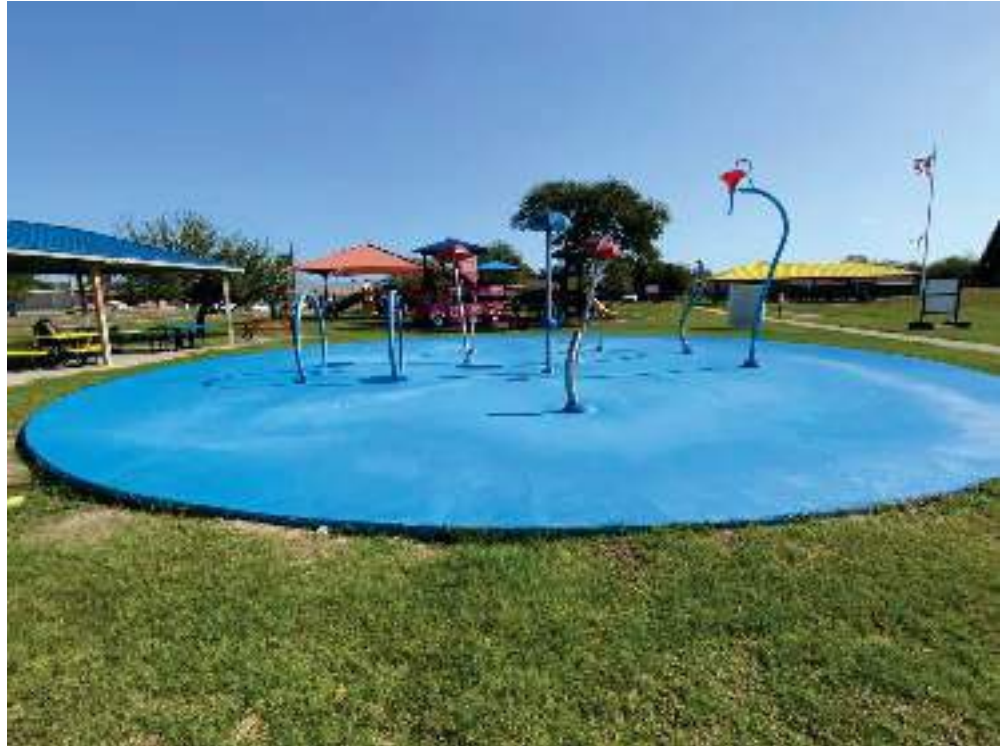
49 Location 005/005-008 - 49-IMG\_2665

overview of splash pad

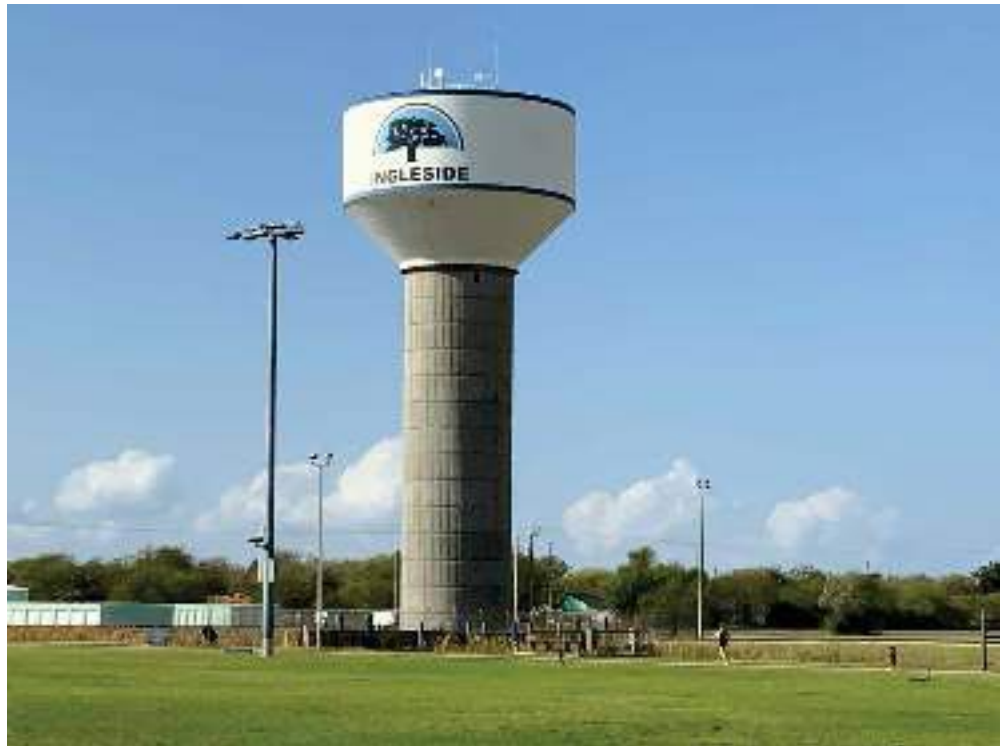
50 Location 006/006-001 - 50-IMG\_3097

overview

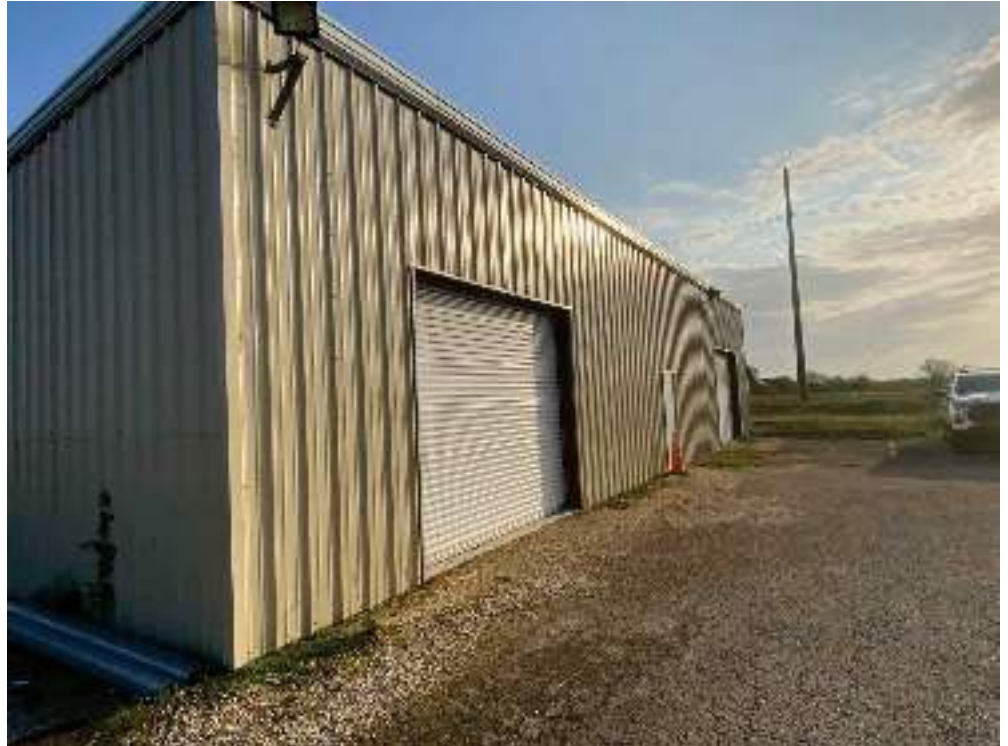
51 Location 007/007-001/Roof - 51-  
IMG\_2843  
Date Taken: 11/24/2025

overview

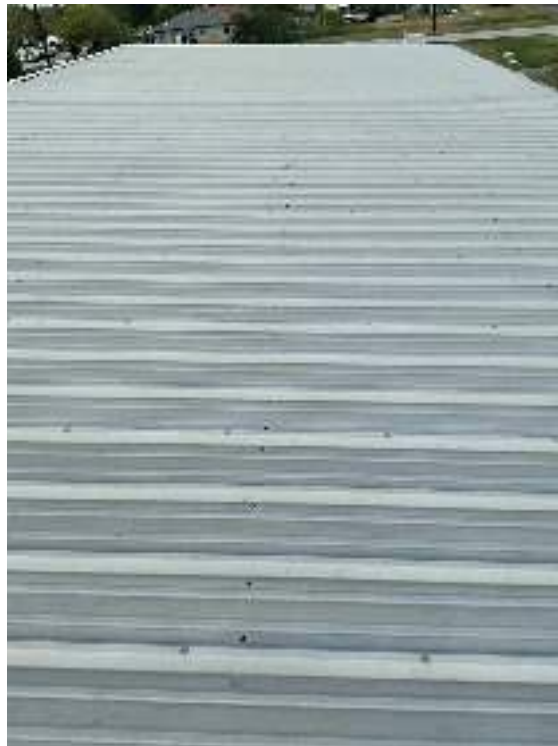
52 Location 007/007-001/Roof - 52-  
IMG\_3034  
Date Taken: 11/24/2025

roof overview

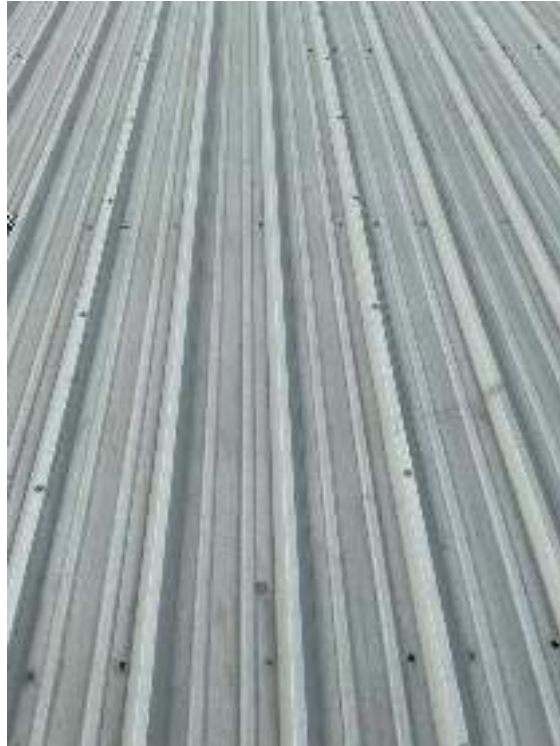
- 53 Location 007/007-001/Roof - 53-  
IMG\_3038  
Date Taken: 11/24/2025

close up of roof panels

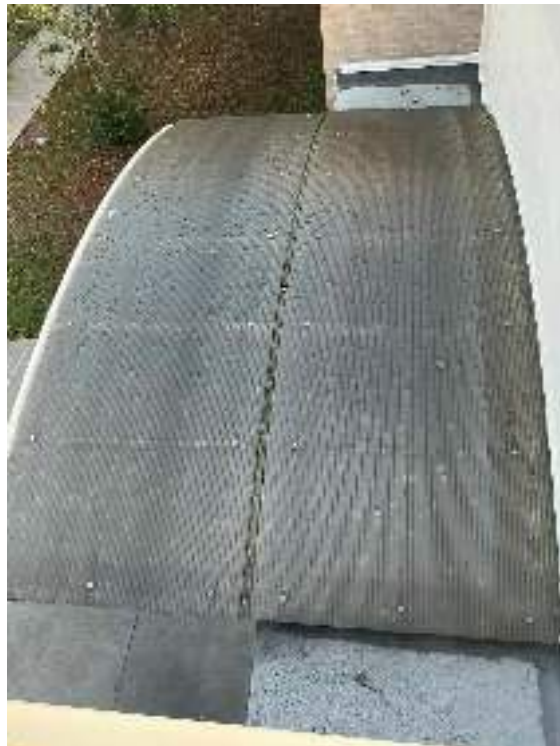
- 54 Location 007/007-002/Roof - 54-  
IMG\_2973  
Date Taken: 11/24/2025

entry canopy

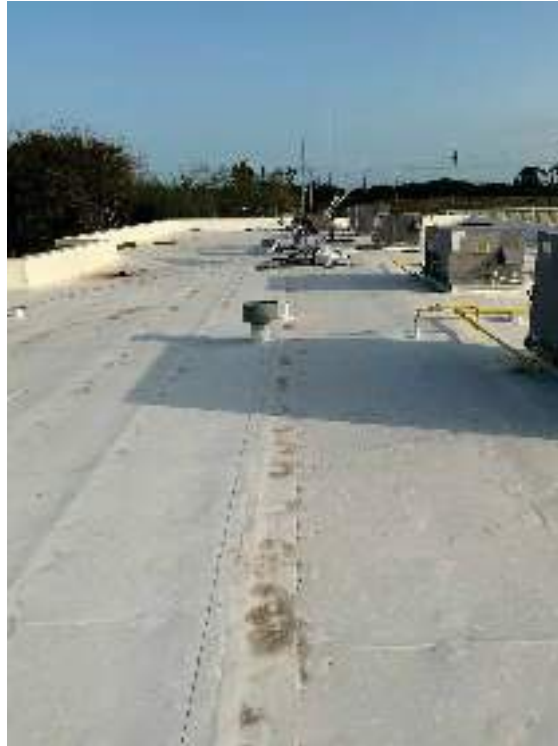
- 55 Location 007/007-002/Roof - 55-  
IMG\_2962  
Date Taken: 11/24/2025

roof overview

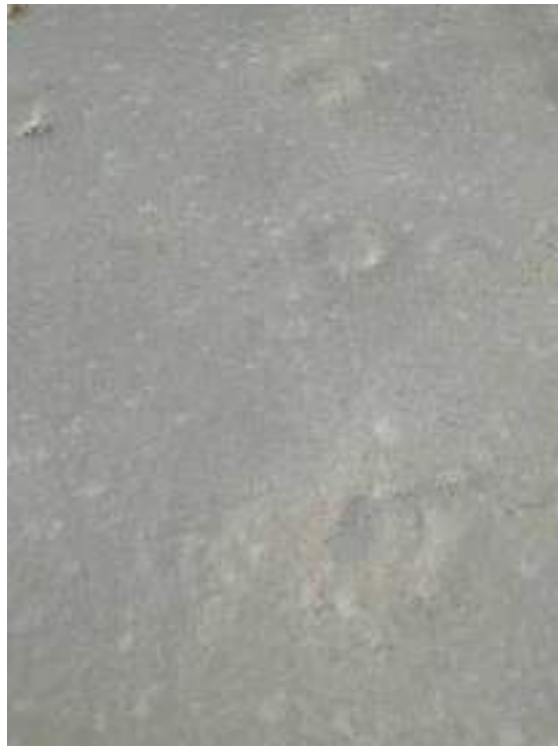
- 56 Location 007/007-002/Roof - 56-  
IMG\_2963  
Date Taken: 11/24/2025

close up of roof membrane

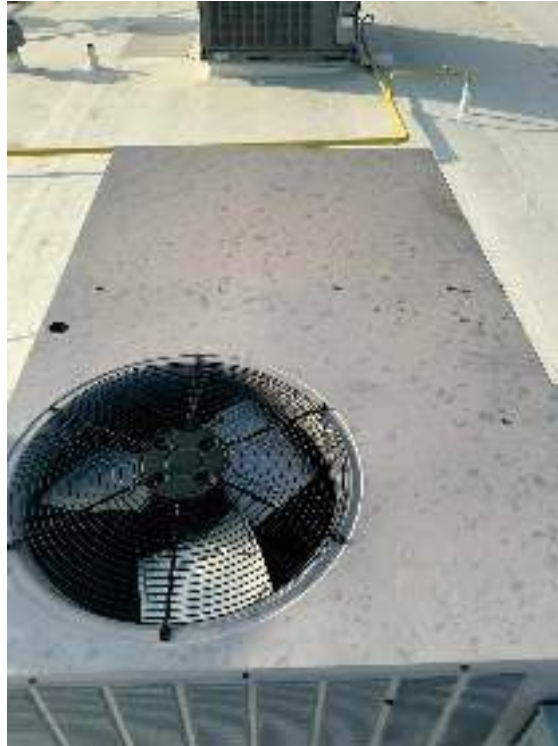
- 57 Location 007/007-002/Roof - 57-  
IMG\_2952  
Date Taken: 11/24/2025

splatter on RTU
