**CITY OF INGLESIDE  
REGULAR CITY COUNCIL MEETING  
AGENDA  
JUNE 9, 2026  
6:30 PM**

Report on November 01, 2025, Hailstorm Damage to City of Ingleside Buildings.

### Building Damage Analysis Survey and Report

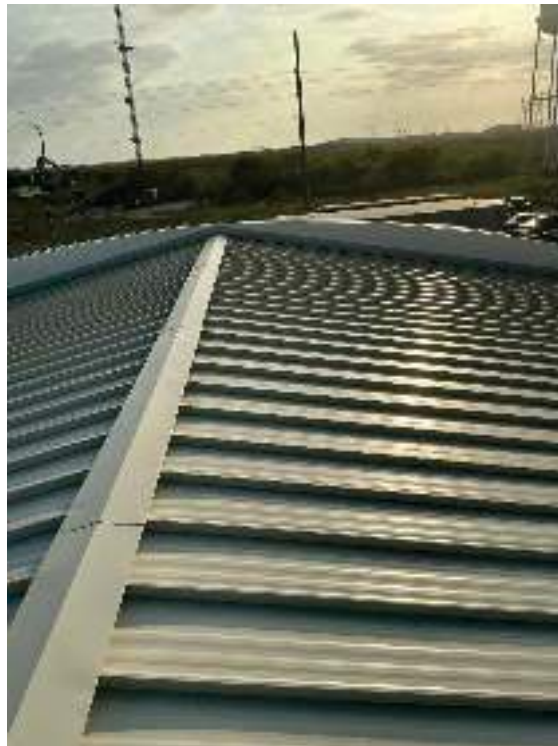
- 58 Location 007/007-002/Roof - 58-  
IMG\_2998  
Date Taken: 11/24/2025

overview of metal roof

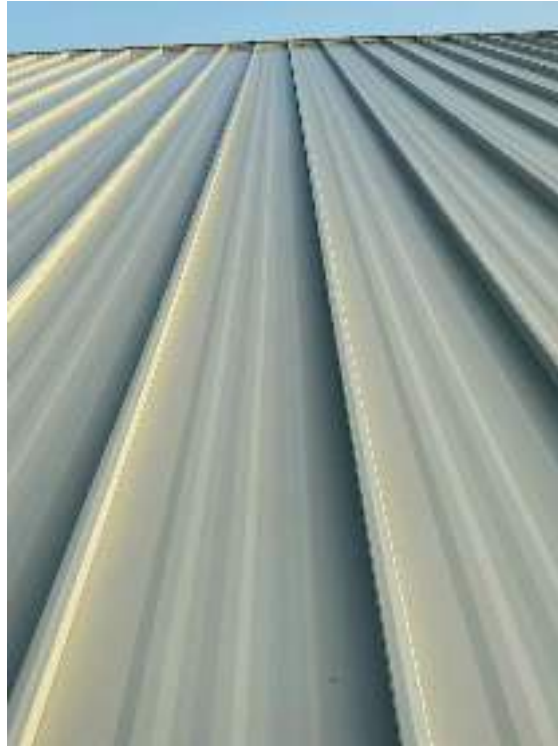
- 59 Location 007/007-002/Roof - 59-  
IMG\_3015  
Date Taken: 11/24/2025

close up of metal panels

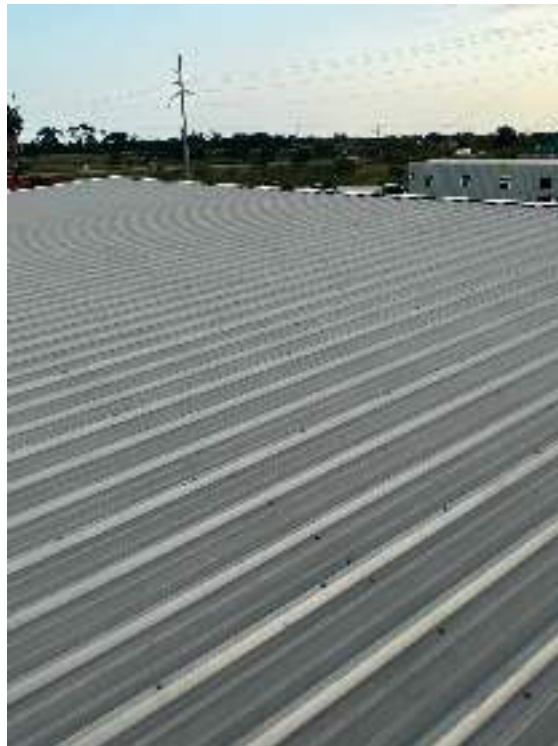
- 60 Location 007/007-003/Roof - 60-  
IMG\_3048  
Date Taken: 11/24/2025

overview of roof

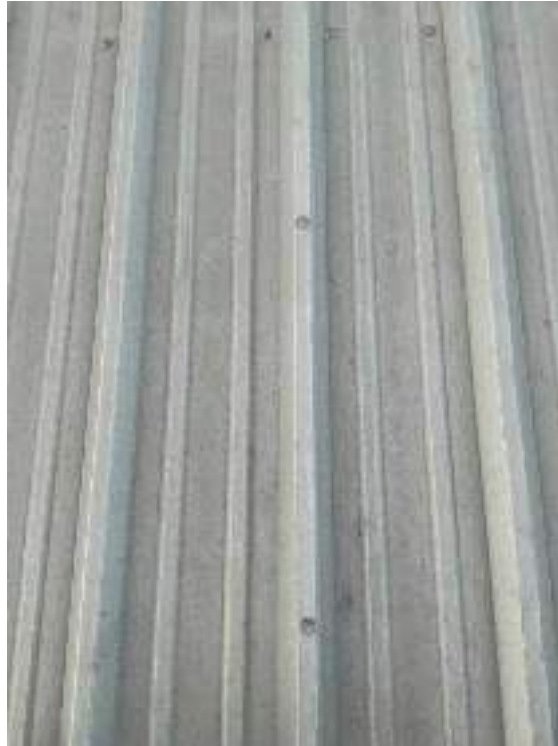
- 61 Location 007/007-003/Roof - 61-  
IMG\_3064  
Date Taken: 11/24/2025

close up of roof panel

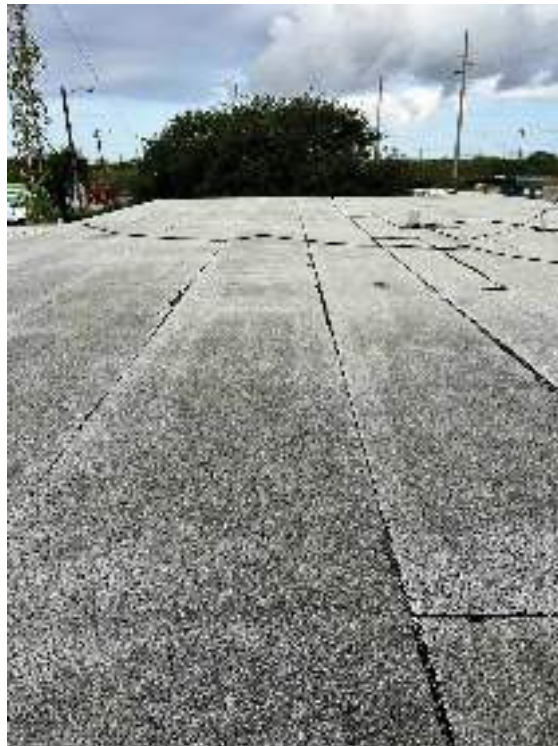
- 62 Location 008/008-001/Roof - 62-  
IMG\_0496  
Date Taken: 11/25/2025

roof overview

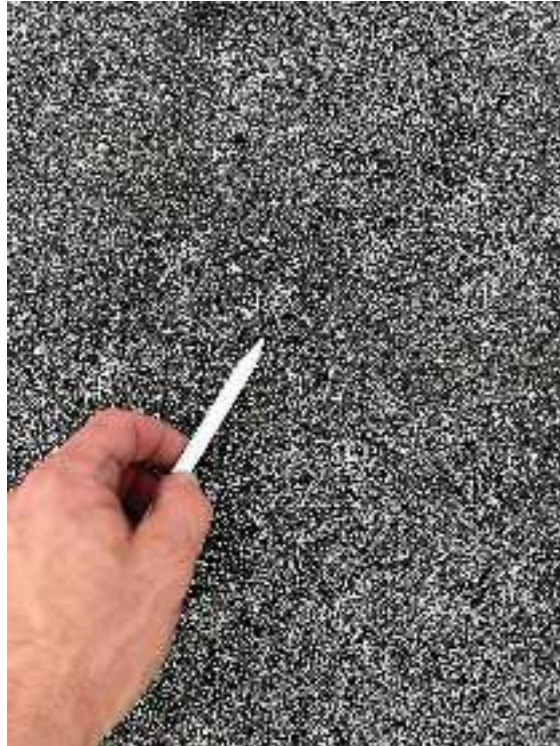
63 Location 008/008-001/Roof - 63-  
IMG\_0494  
Date Taken: 11/25/2025

hail splatter

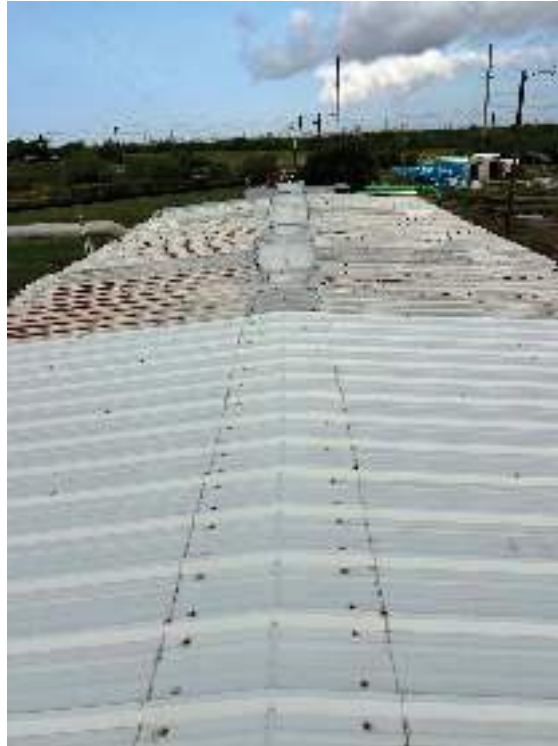
65 Location 008/008-002/Roof - 65-  
IMG\_0404  
Date Taken: 11/25/2025

overview of roof

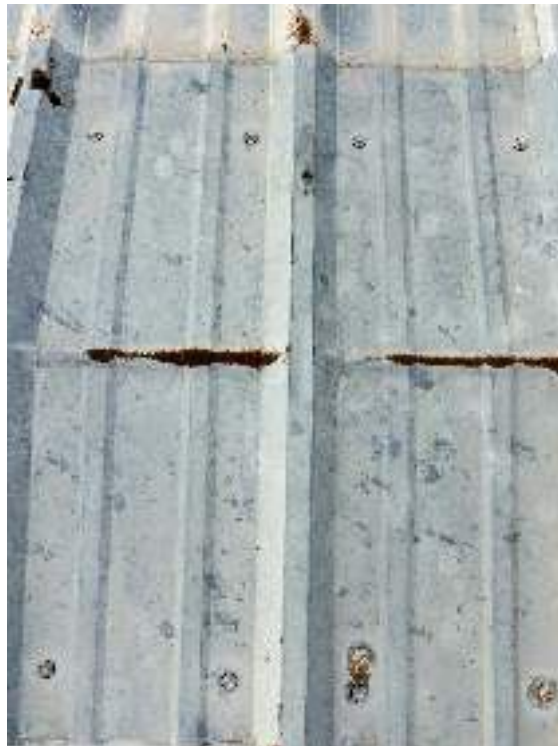
66 Location 008/008-002/Roof - 66-  
IMG\_0439  
Date Taken: 11/25/2025

splatter on ridge

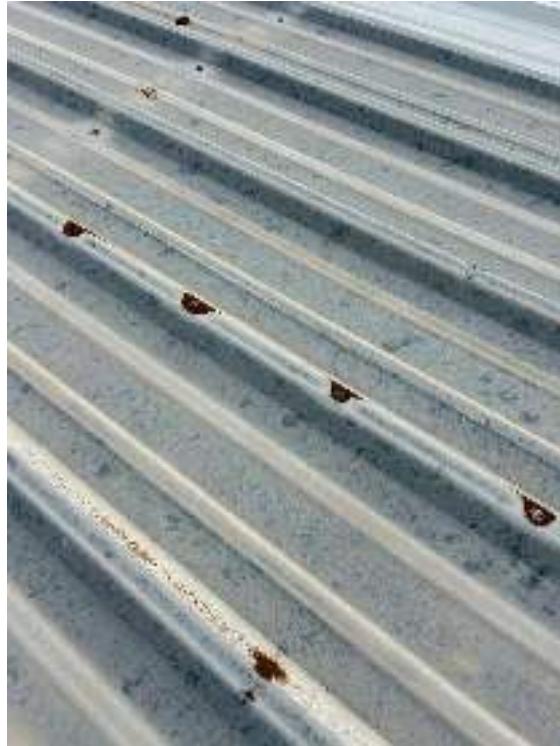
67 Location 008/008-002/Roof - 67-  
IMG\_0438  
Date Taken: 11/25/2025

splatter on panels

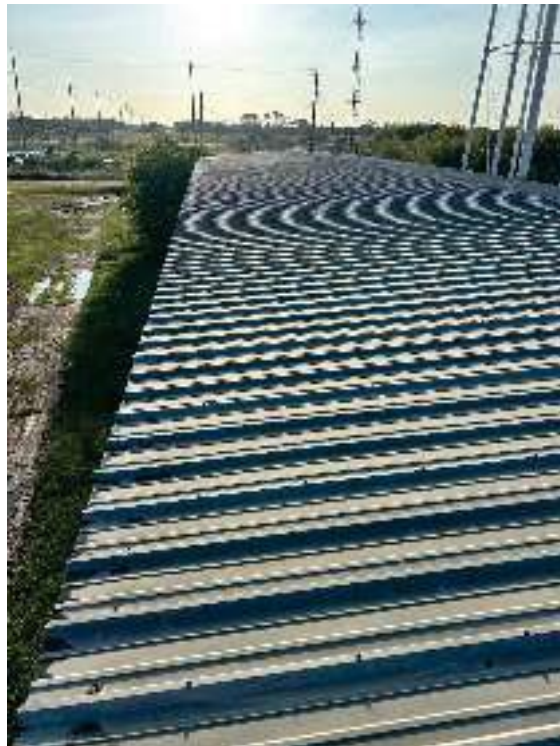
68 Location 008/008-003/Roof - 68-  
IMG\_0338  
Date Taken: 11/25/2025

overview of roof

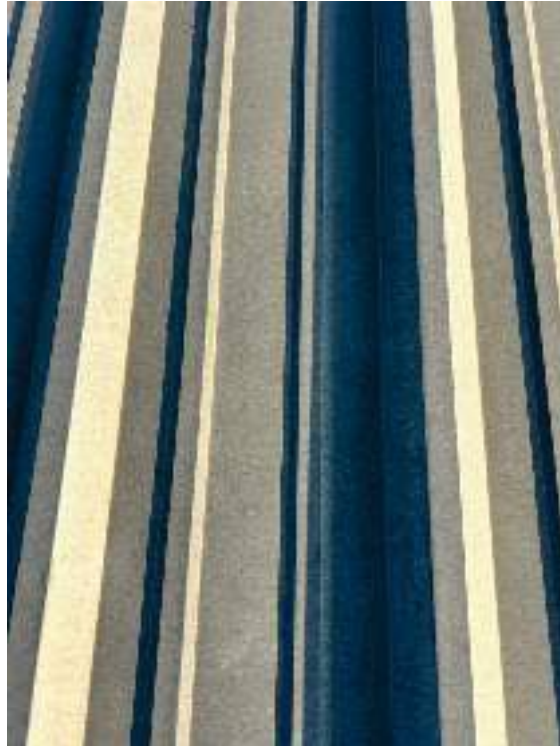
69 Location 008/008-003/Roof - 69-  
IMG\_0351  
Date Taken: 11/25/2025

close up of panels

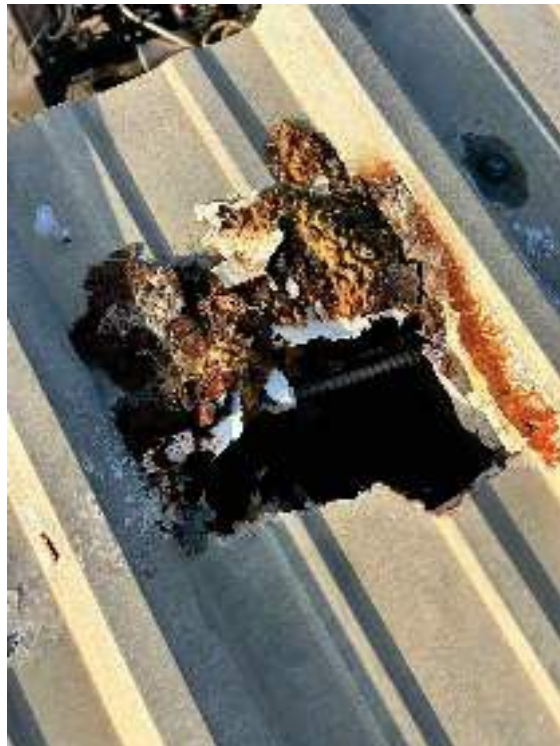
70 Location 008/008-003/Roof - 70-  
IMG\_0359  
Date Taken: 11/25/2025

rusty through area of roof

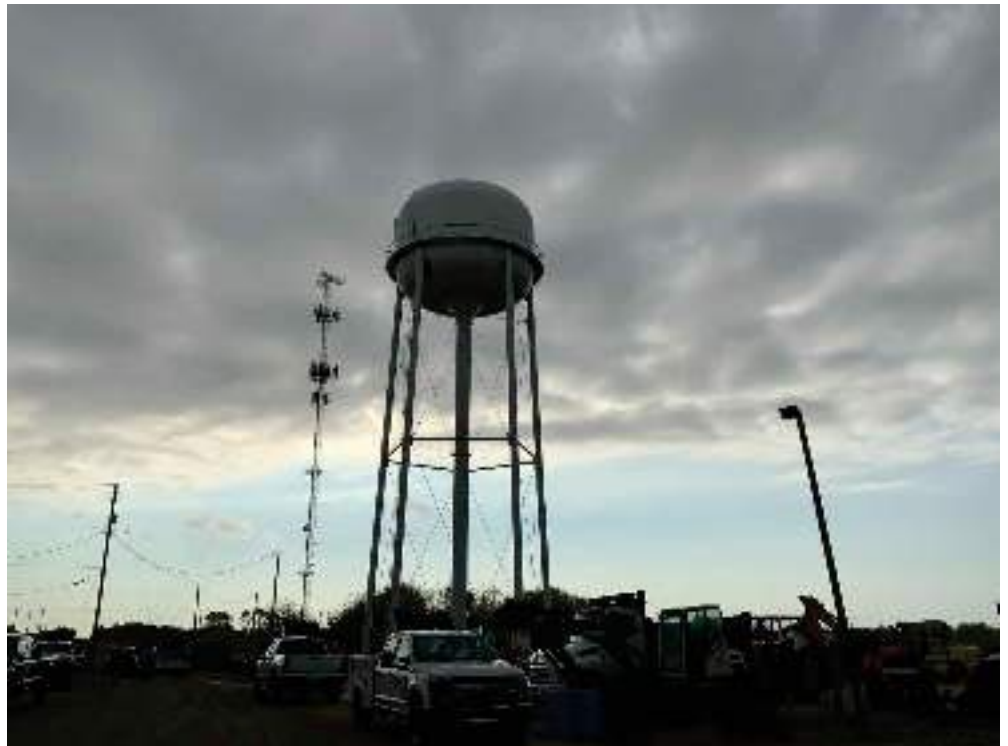
- 74 Location 008/008-005 - 74-IMG\_  
2942  
Date Taken: 11/25/2025

water tower not inspected

This elevated water tower was not inspected due to accessibility. Possible damage would be to the paint around the tower. A reinspection with the proper drone would be necessary to inspect the height of the tower.

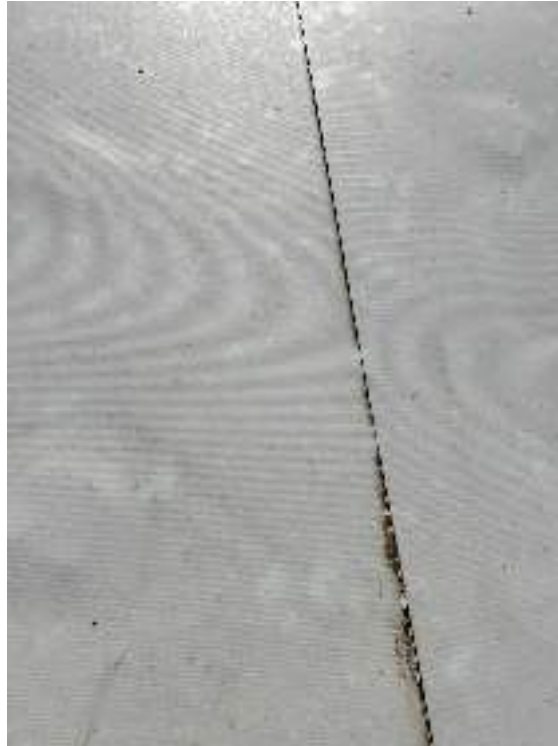
79 Location 009/Roof - 79-IMG\_  
9626

hail splatter on roof

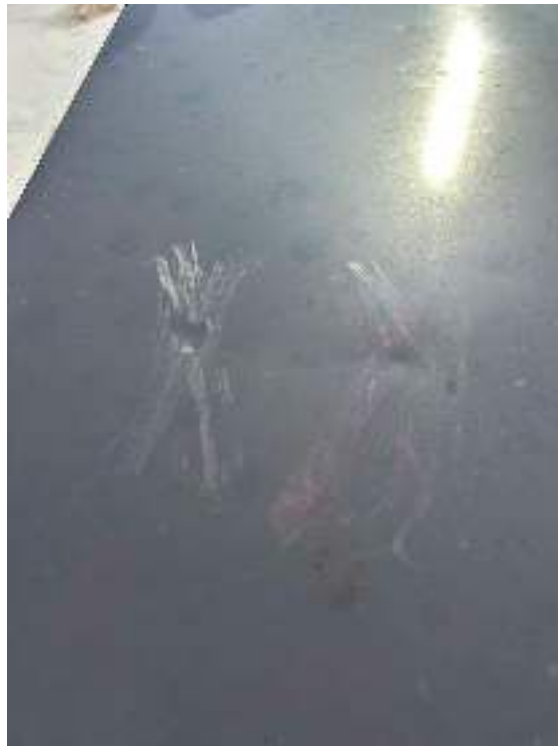
80 Location 009/Roof - 80-IMG\_  
9643

dents on RTU cover

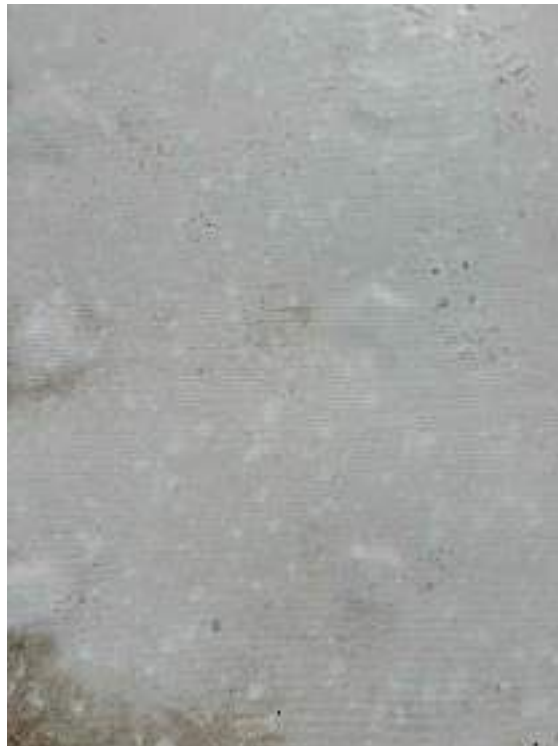
82 Location 009/Roof - 82-IMG\_9680

hail splatter on roof

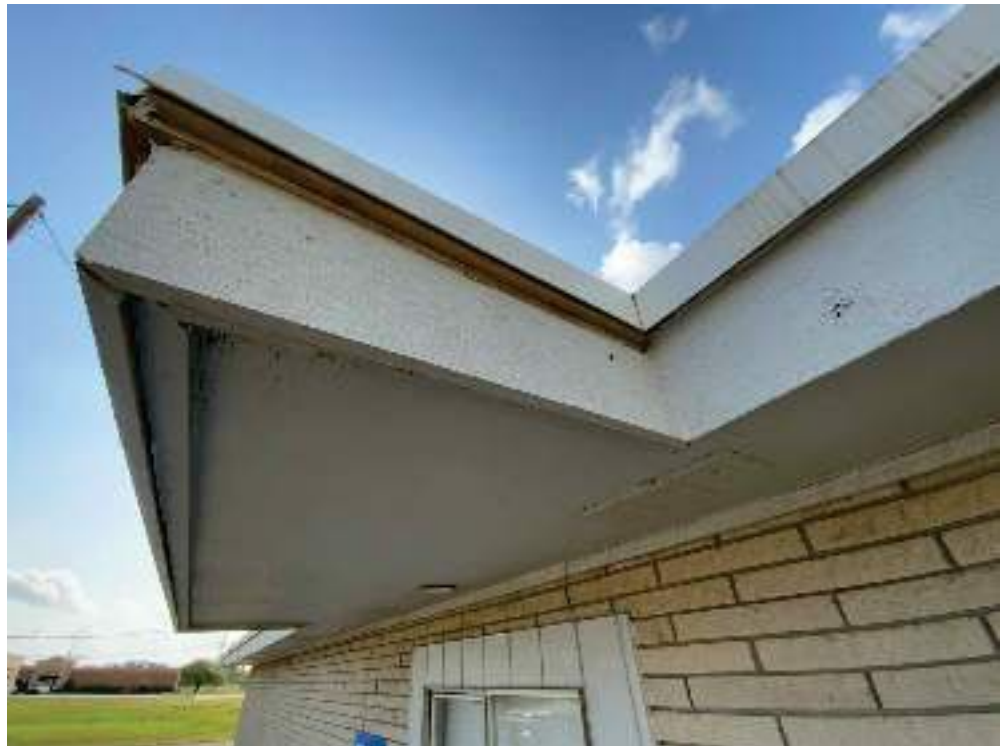
- 86 Location 010/010-001/Exterior -  
86-IMG\_2434  
Date Taken: 11/24/2025

small nicks in paint on fascia

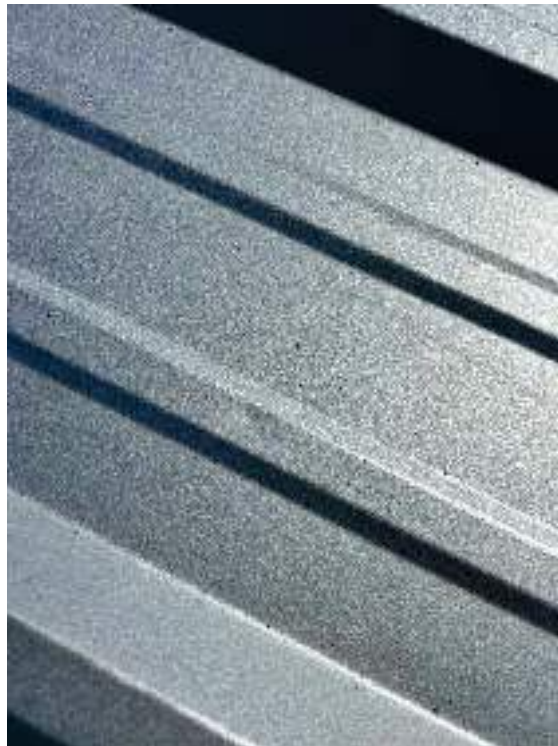
92 Location 011/011-001/Roof - 92-  
IMG\_9908  
Date Taken: 11/24/2025

dent in panel

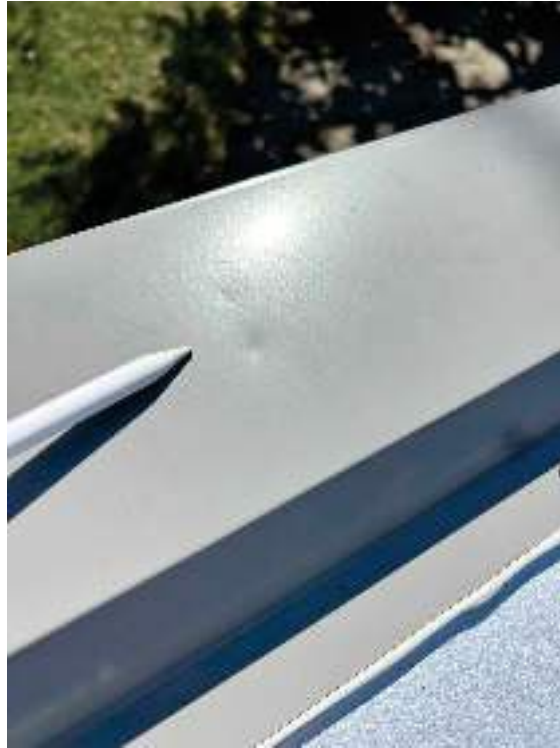
- 93 Location 011/011-001/Roof - 93-  
IMG\_9919  
Date Taken: 11/24/2025

dent in trim

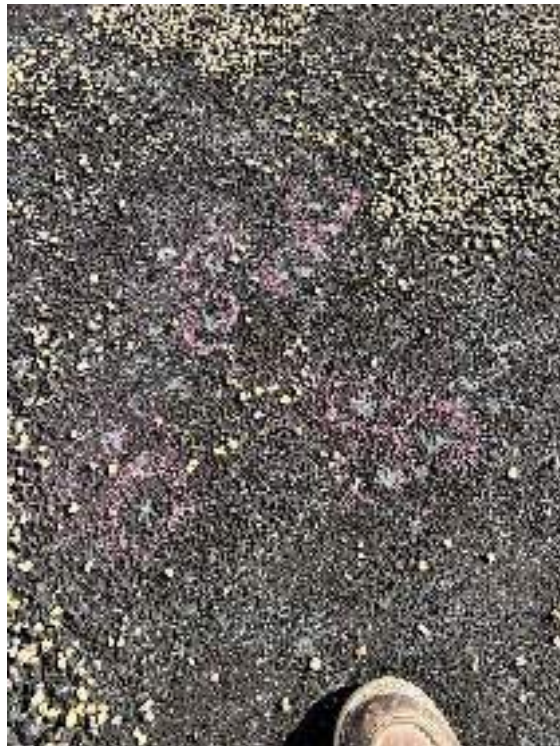
100 Location 012/012-001/Roof - 100-  
IMG\_9850  
Date Taken: 11/24/2025

hail damage to built up roofing

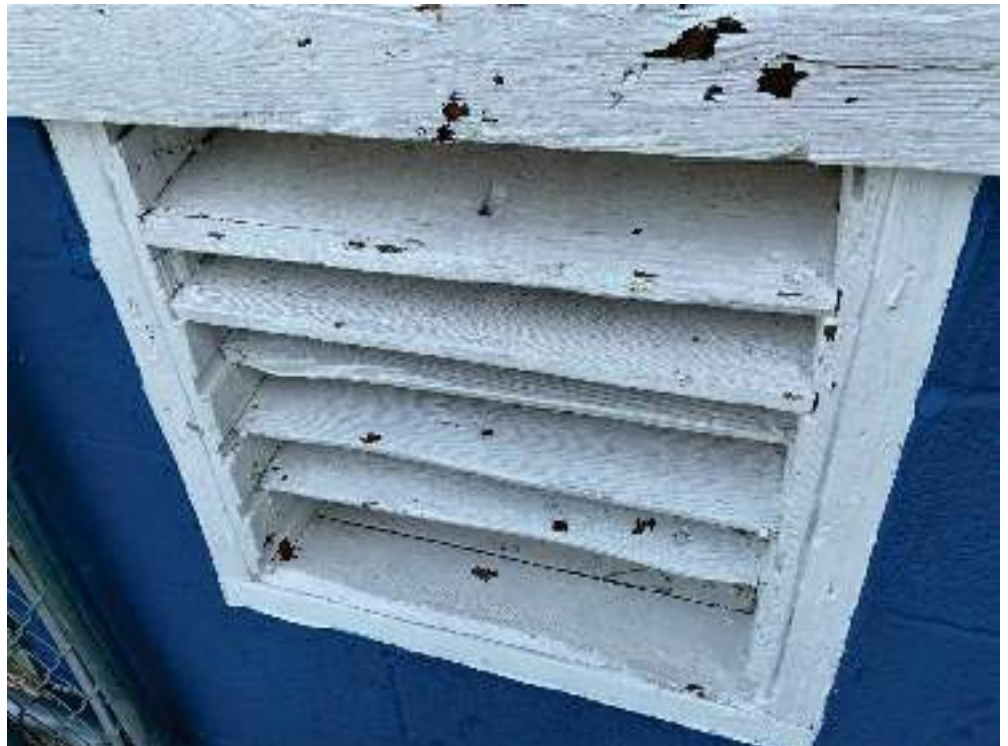
louvered vent paint chipped

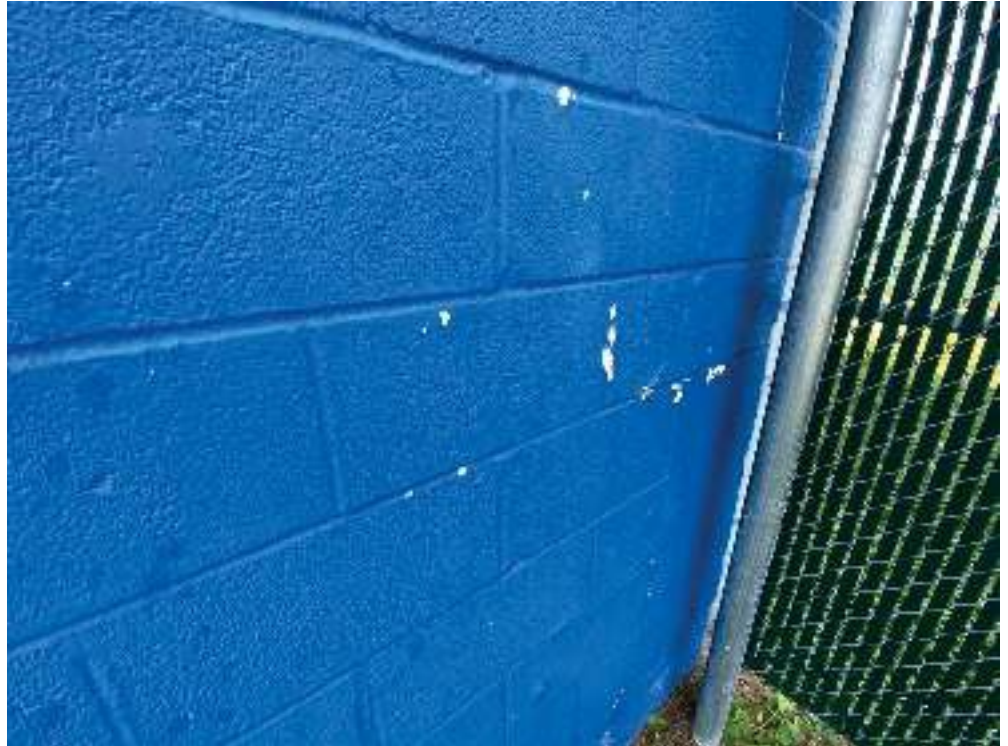
103 Location 012/012-001/Exterior -  
103-IMG\_2526  
Date Taken: 11/24/2025

exterior paint chipped

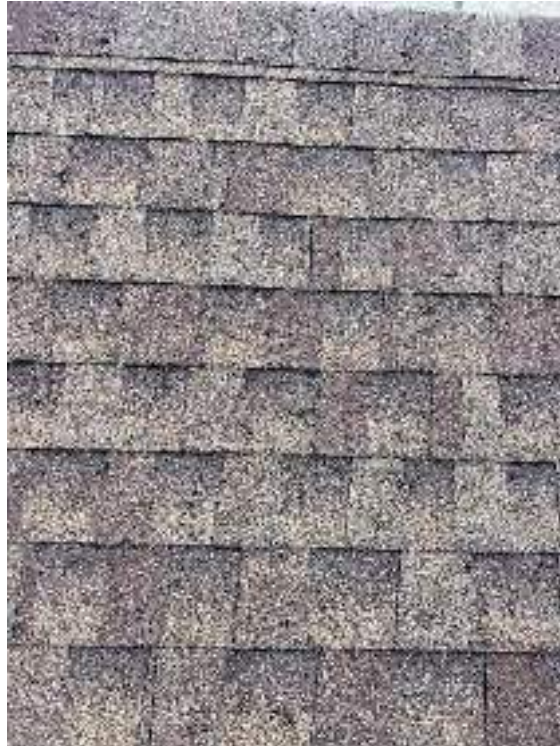
105 Location 013/Roof - 105-IMG\_9794

hail damage to shingles

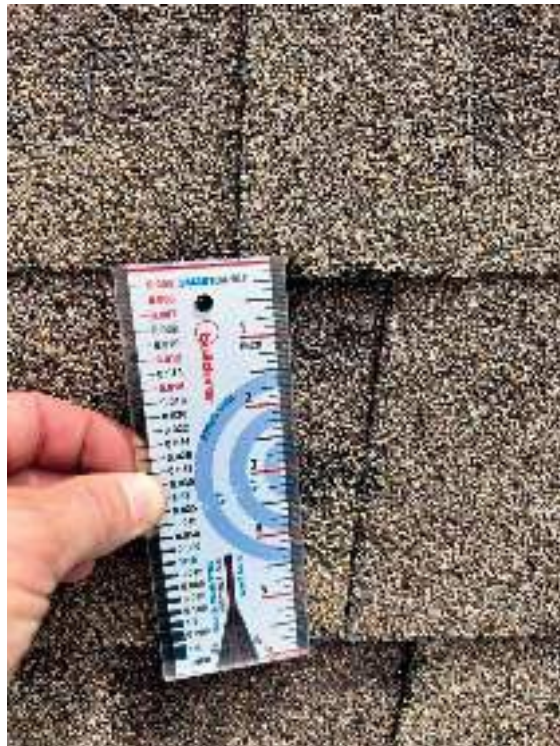
106 Location 013/Roof - 106-IMG\_9802

identification of hail size

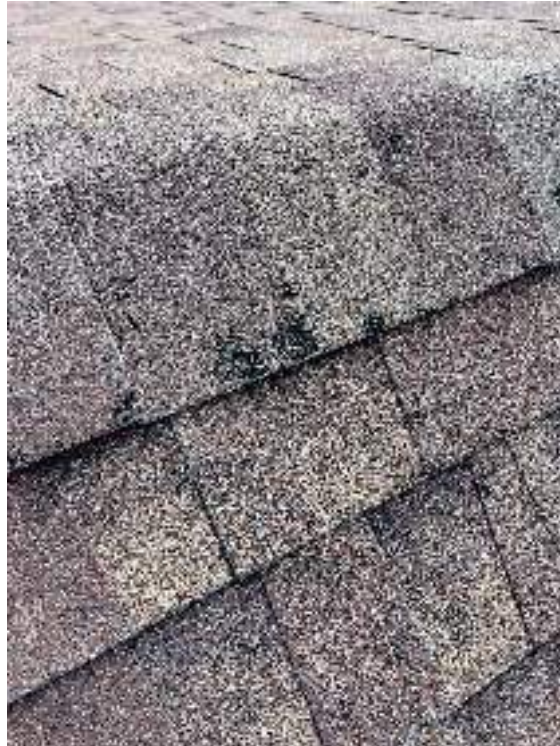
107 Location 013/Roof - 107-IMG\_  
9797

close up of hail damage

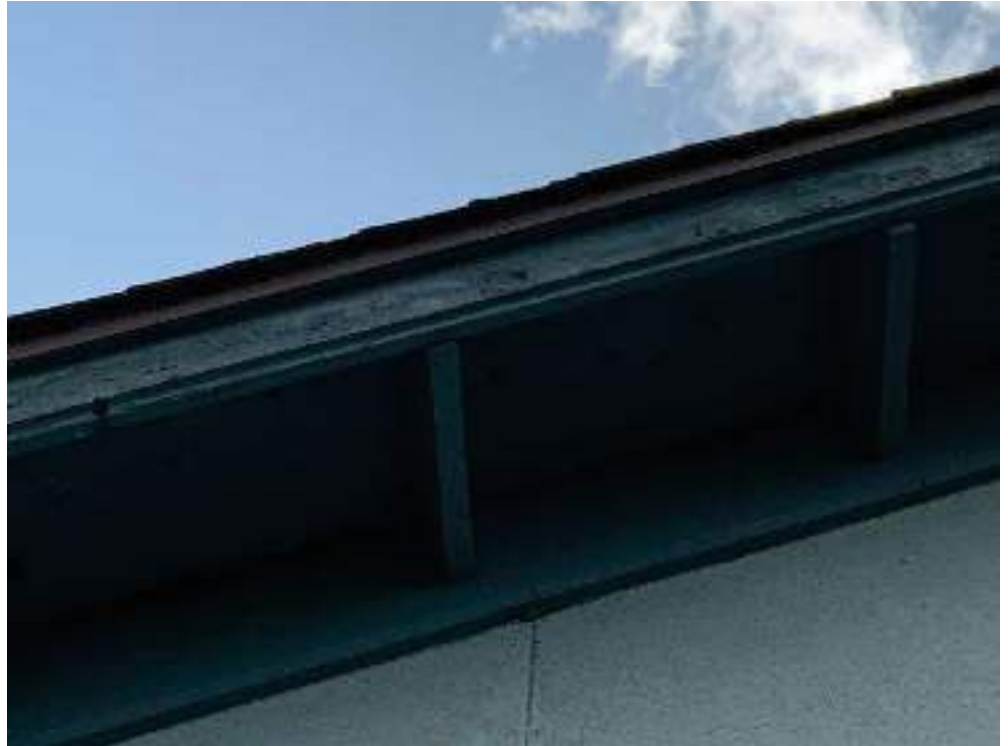
paint chipped on fascia

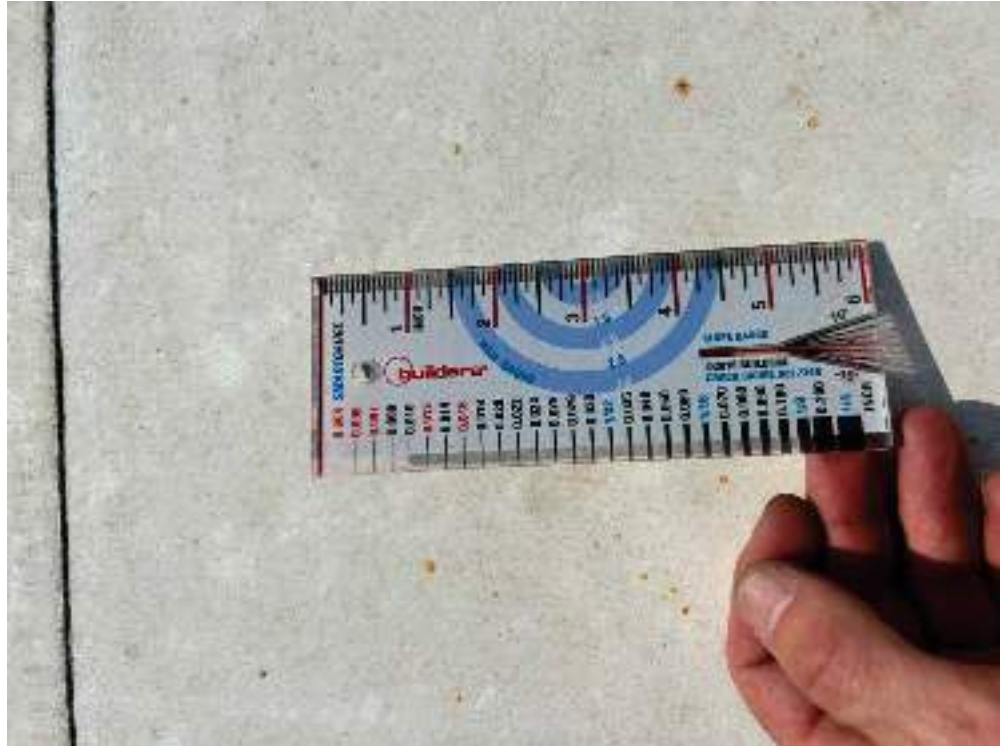
117 Location 014/014-001 - 117-IMG\_0214

identification of hail size

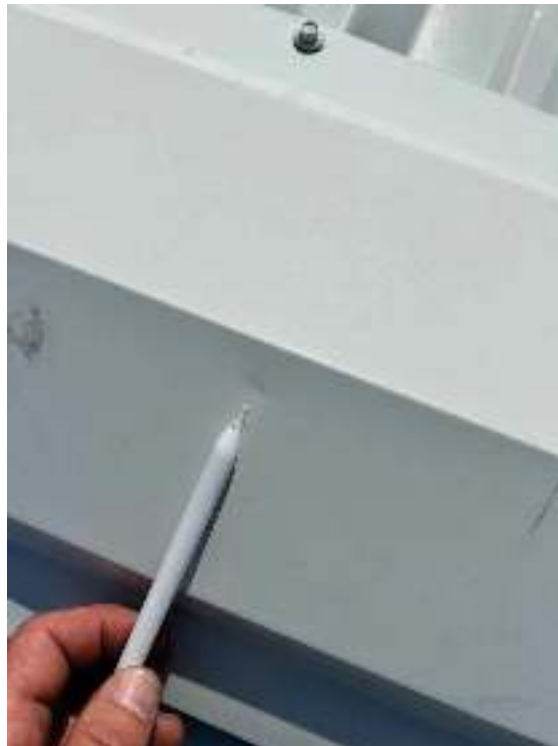
122 Location 015/015-001 - 122-IMG\_0149

dent on ridge

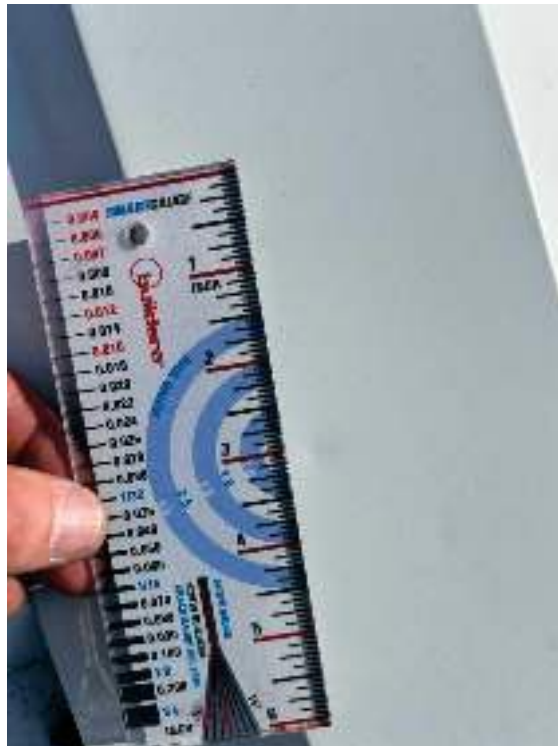
124 Location 015/015-001 - 124-IMG\_0166

identification of hail size

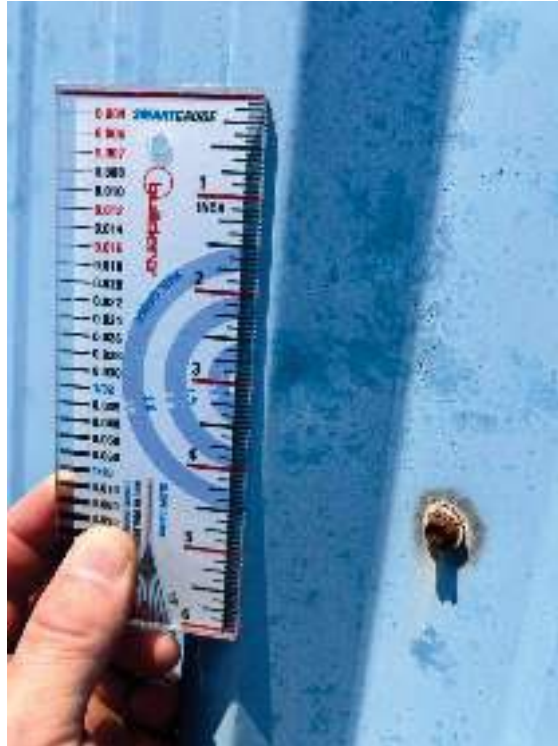
127 Location 016/016-001 - 127-IMG\_0119

identification of hail size

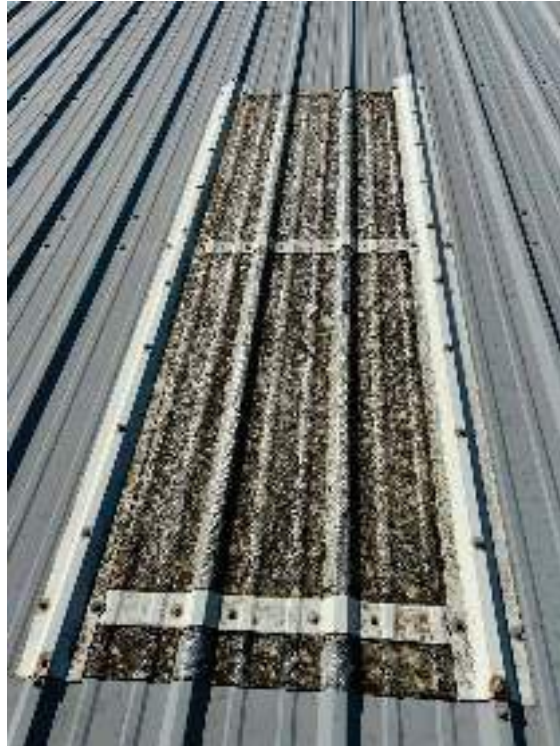
131 Location 017/017-001/Roof - 131-  
IMG\_0775  
Date Taken: 11/25/2025

close up of skylight

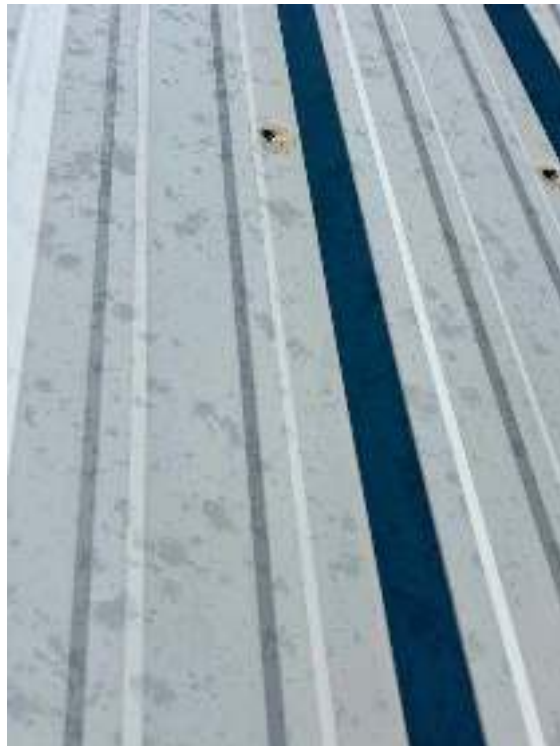
132 Location 017/017-001/Roof - 132-  
IMG\_0786  
Date Taken: 11/25/2025

splatter on panels

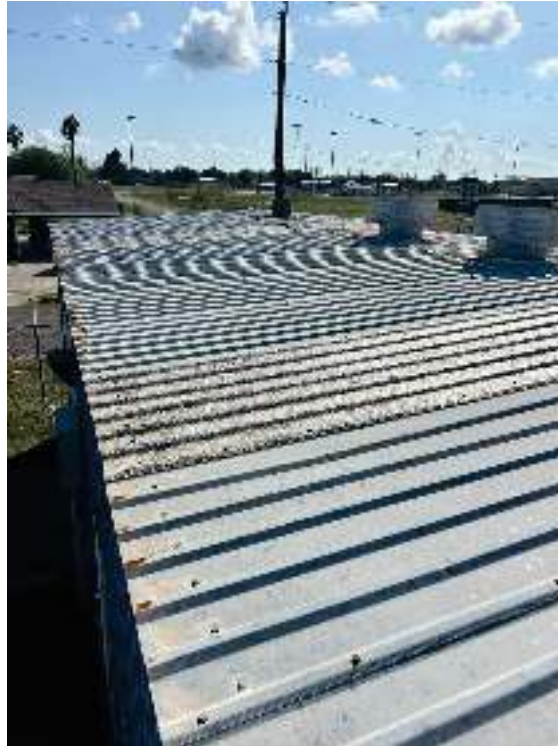
133 Location 017/017-002/Roof - 133-  
IMG\_0736  
Date Taken: 11/25/2025

roof overview

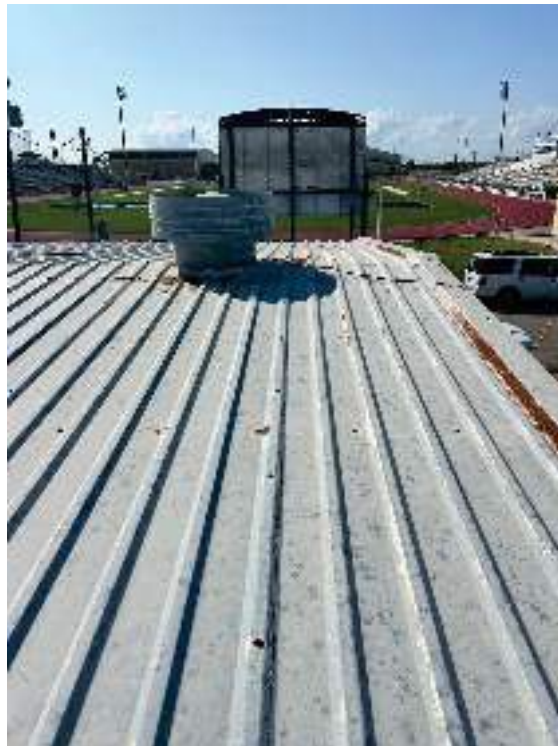
134 Location 017/017-002/Roof - 134-  
IMG\_0737  
Date Taken: 11/25/2025

splatter on roof

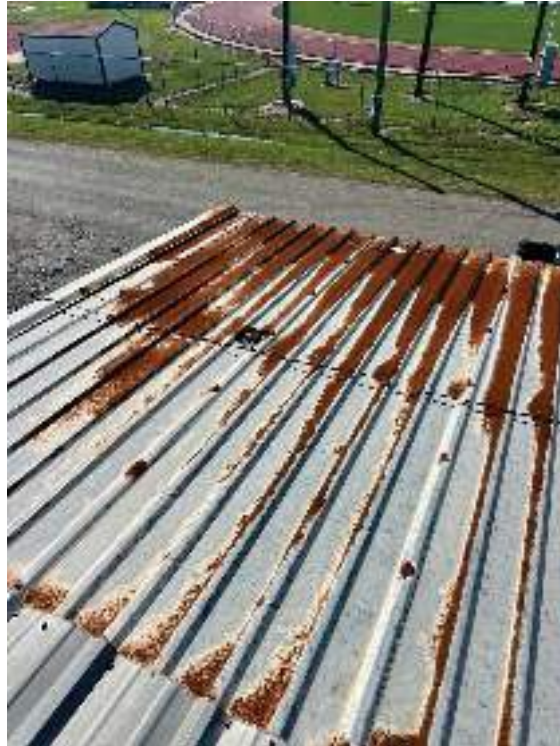
135 Location 017/017-002/Roof - 135-  
IMG\_0750  
Date Taken: 11/25/2025

roof rusted through

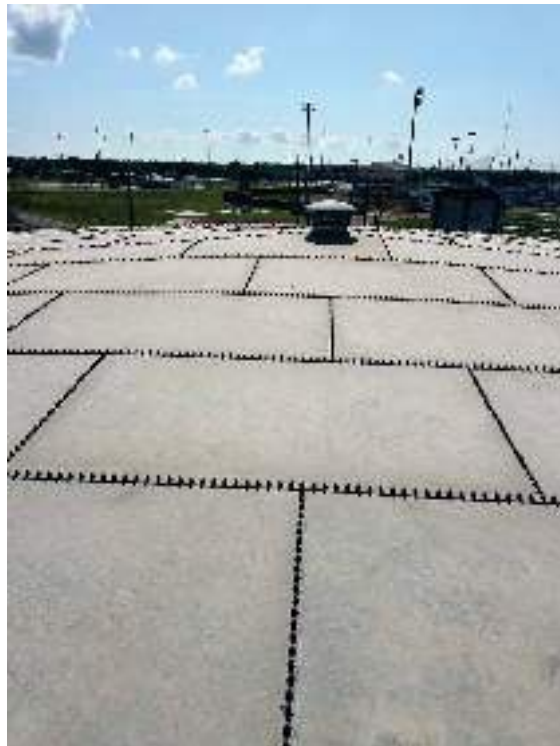
136 Location 017/017-003/Roof - 136-  
IMG\_0698  
Date Taken: 11/25/2025

roof overview

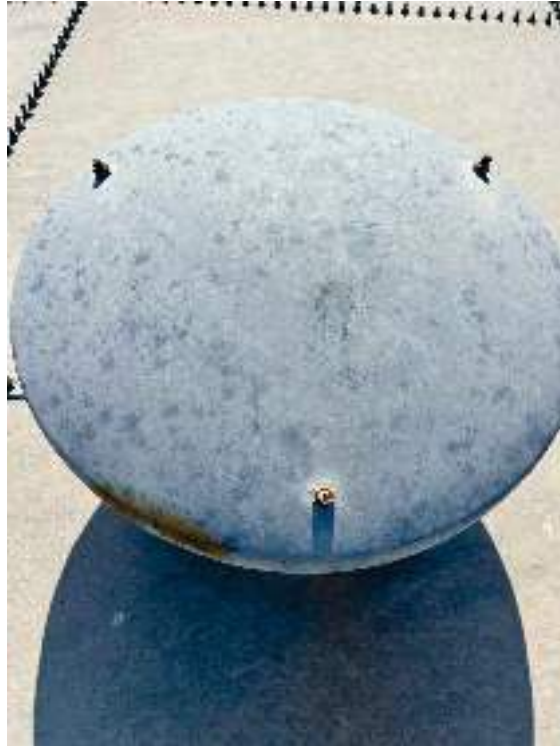
137 Location 017/017-003/Roof - 137-  
IMG\_0705  
Date Taken: 11/25/2025

roof vent with splatter

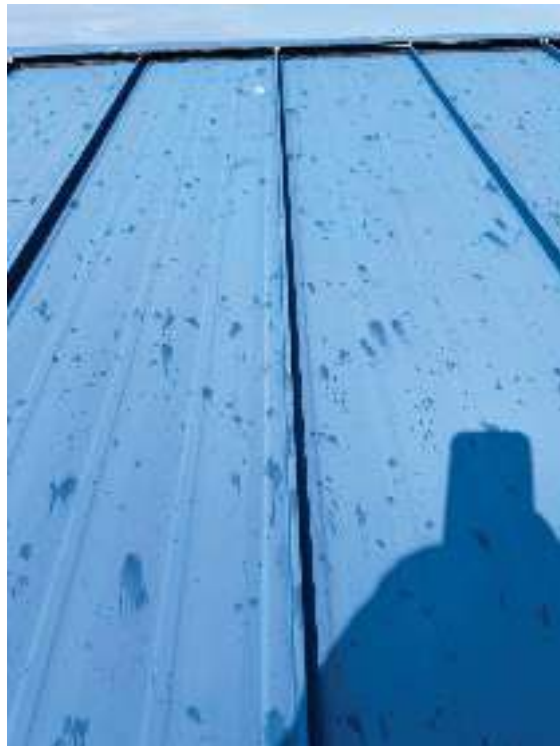
138 Location 018/018-001/Roof - 138-  
IMG\_0255  
Date Taken: 11/24/2025

hail splatter on roof

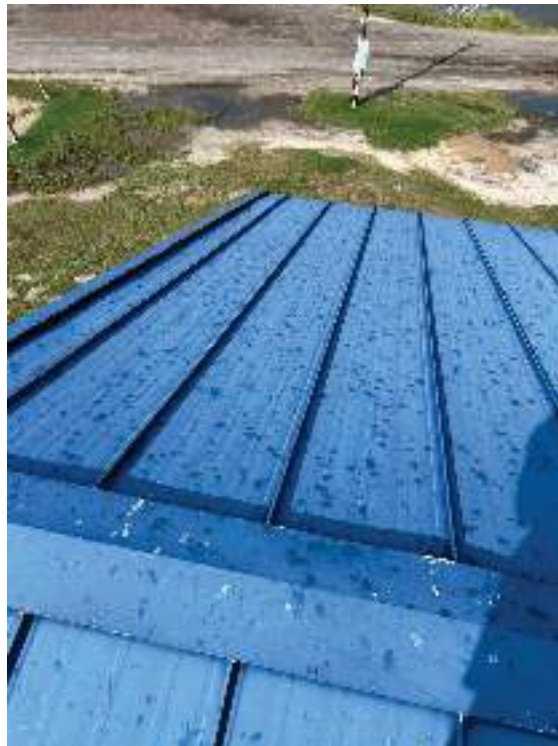
140 Location 018/018-001/Roof - 140-  
IMG\_0257  
Date Taken: 11/24/2025

hail splatter on roof

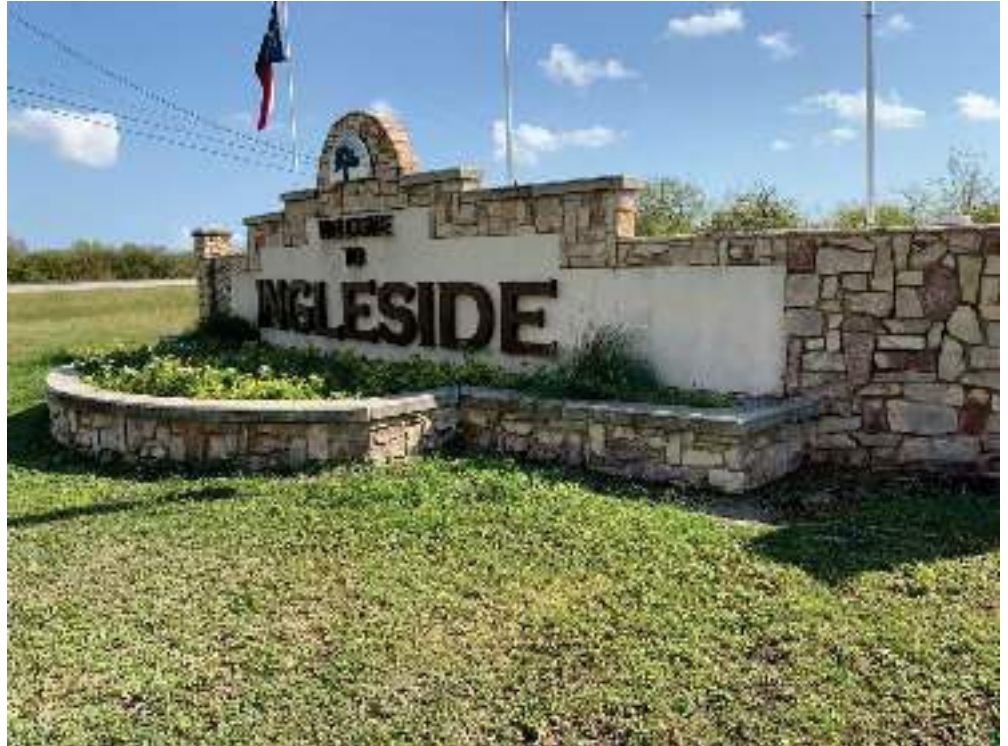
141 Location 019 - 141-IMG\_3136  
Date Taken: 11/25/2025

welcome sign

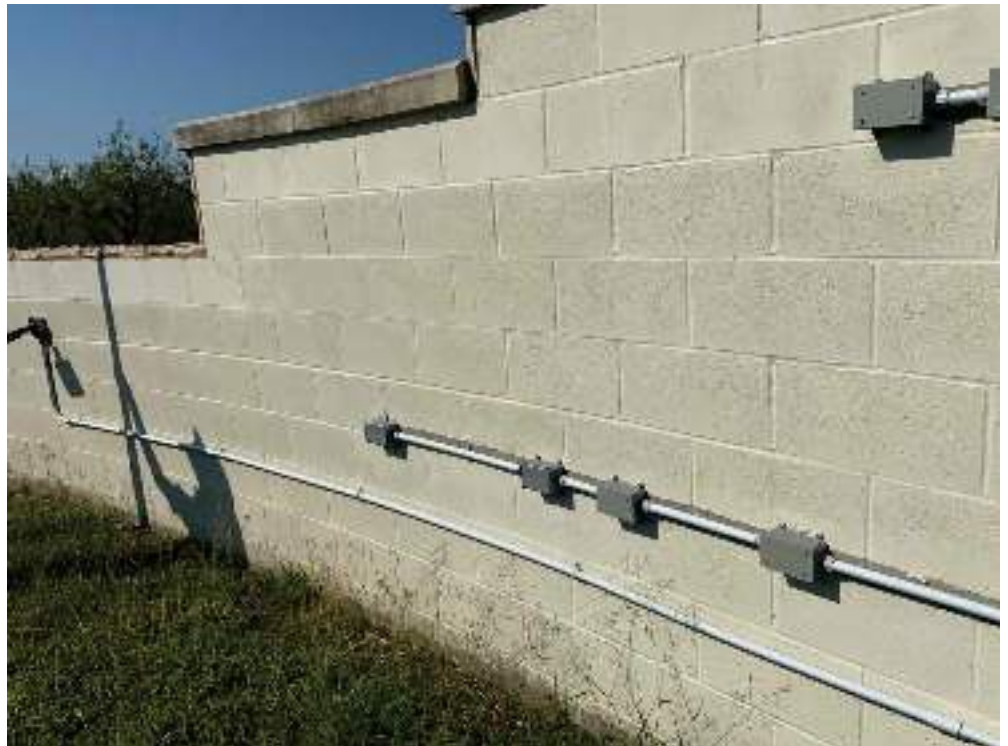
142 Location 019 - 142-IMG\_3145  
Date Taken: 11/25/2025

backside of welcome sign

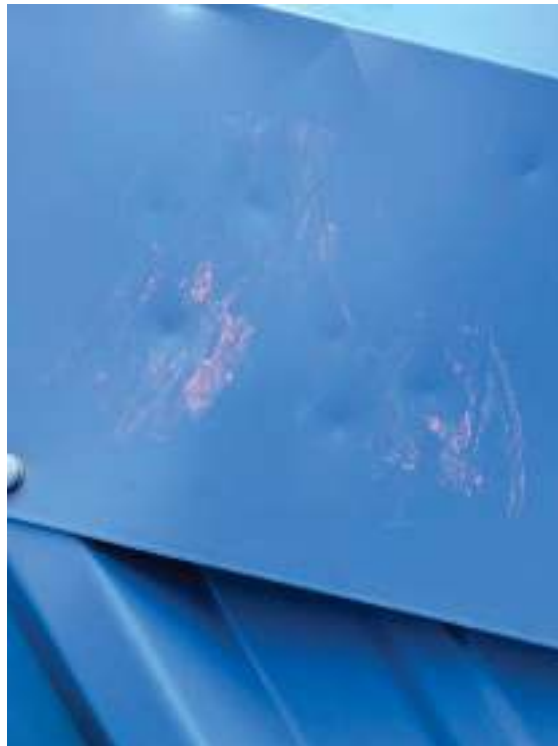
144 Location 020/020-001/Roof - 144-  
IMG\_9881  
Date Taken: 11/24/2025

dents in flashing

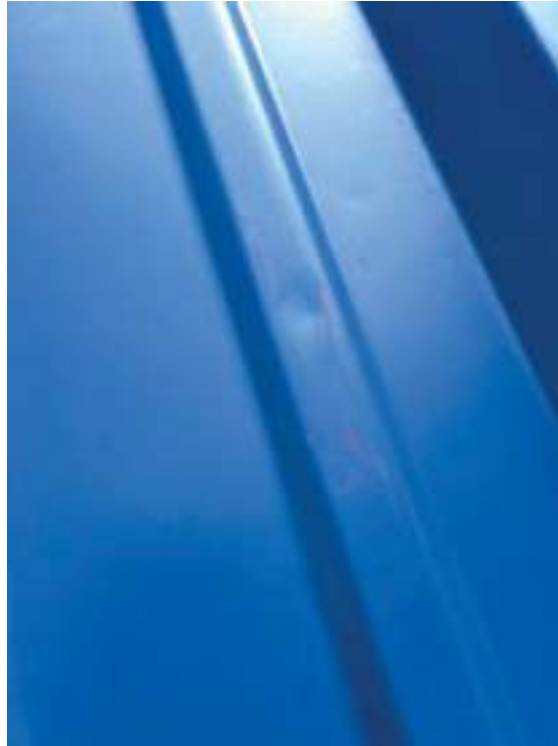
145 Location 020/020-001/Roof - 145-  
IMG\_9882  
Date Taken: 11/24/2025

dent in metal panel

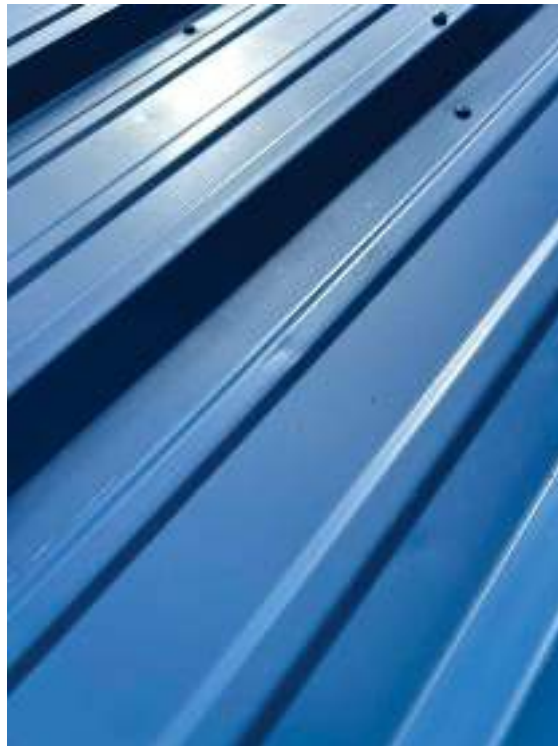
146 Location 020/020-001/Roof - 146-  
IMG\_9890  
Date Taken: 11/24/2025

dents in metal panel

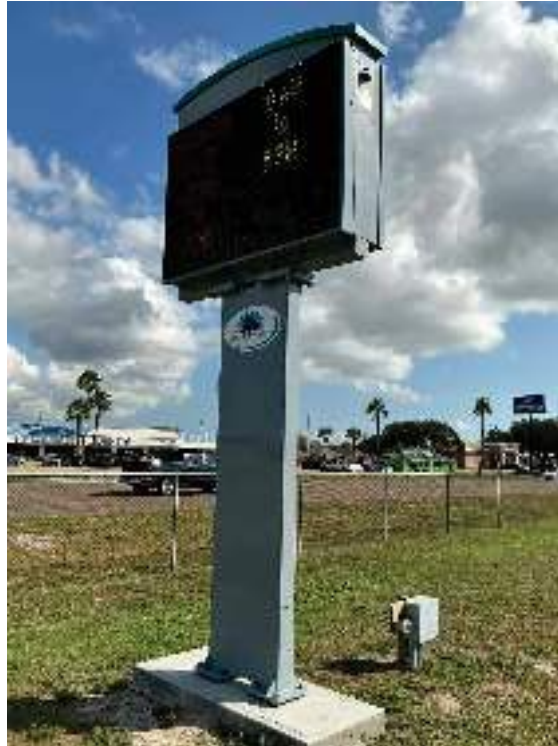
147 Miscellaneous - 147-IMG\_3079

Marquee sign at Bennie Diegel Park

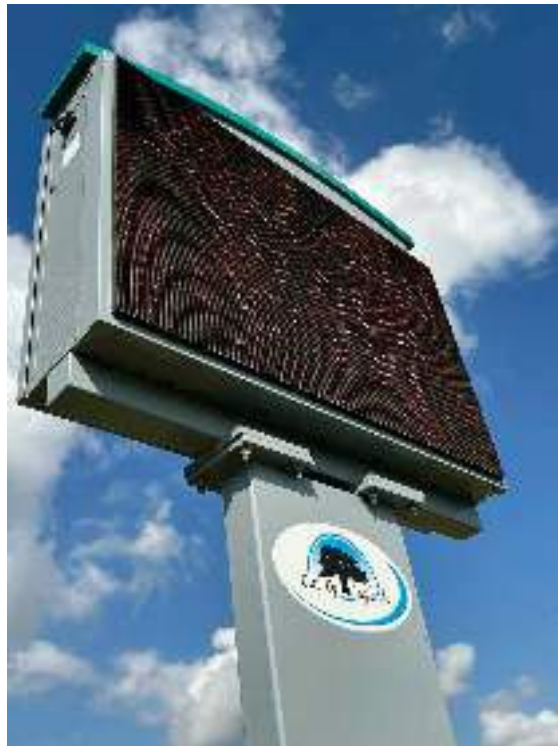
148 Miscellaneous - 148-IMG\_3082

chips in face of sign Benny Diegel  
Park
