**CITY OF INGLESIDE  
REGULAR CITY COUNCIL MEETING  
AGENDA  
JUNE 9, 2026  
6:30 PM**

Report on November 01, 2025, Hailstorm Damage to City of Ingleside Buildings.

### Building Damage Analysis Survey and Report

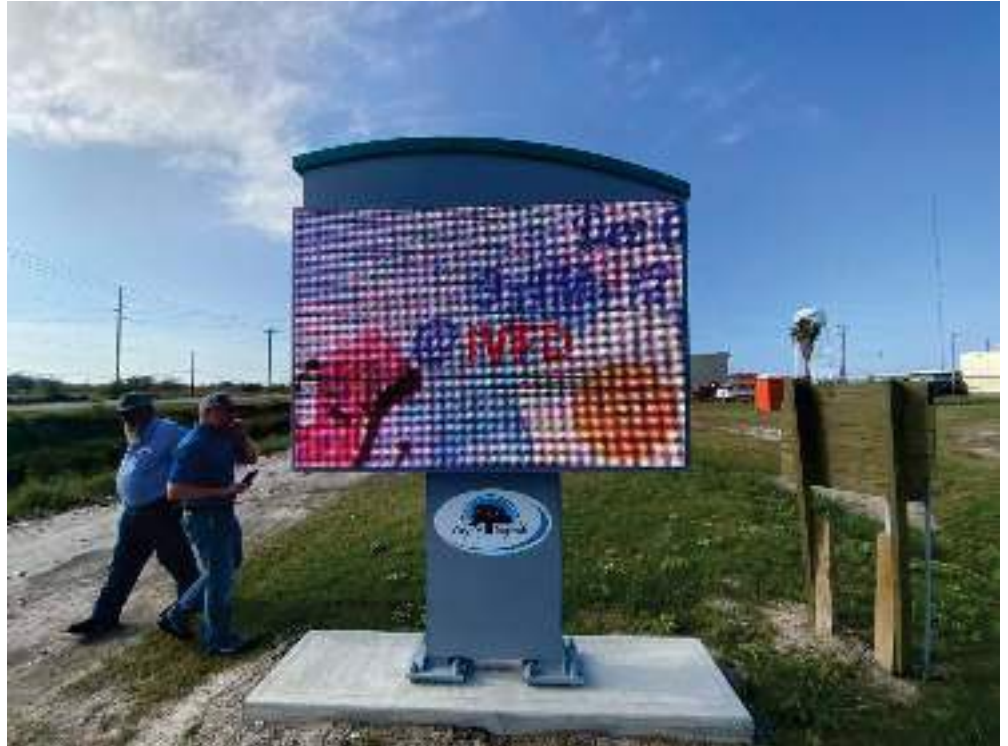
149 Miscellaneous - 149-IMG\_3010  
Date Taken: 11/25/2025

Marquee sign in front of police station

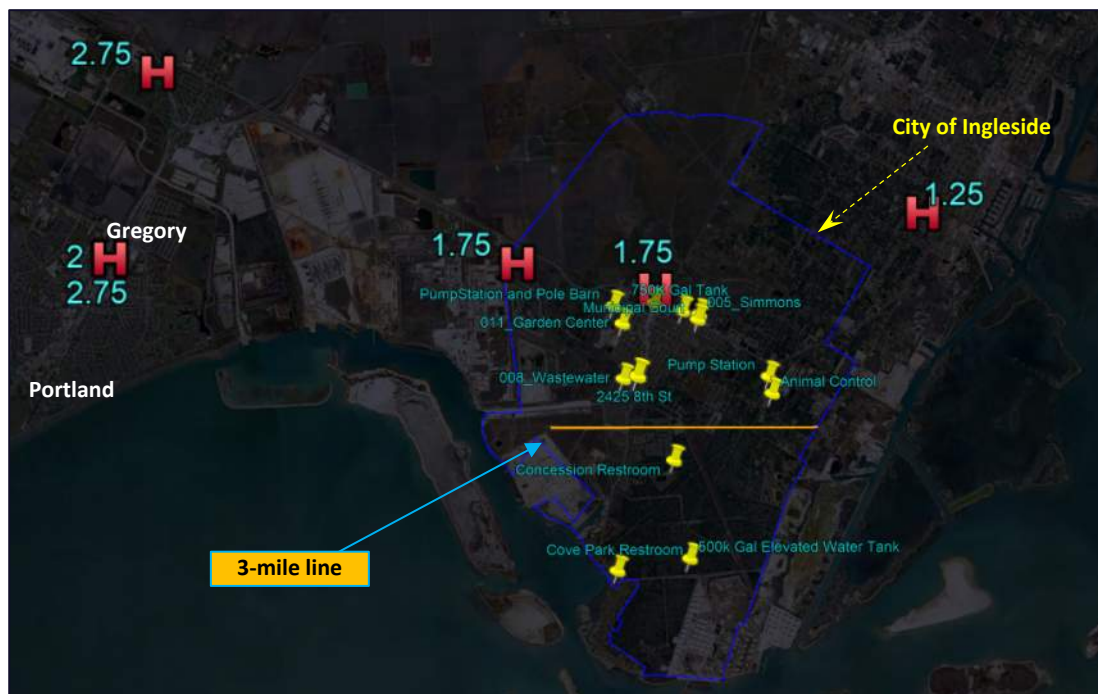
The NOAA Storm Event Database (SED) was queried for hail events occurring between November 1, 2025 and November 30, 2025 within San Patricio County. A total of 10 hail events were documented in the county during this review period, all occurring on November 1, 2025. Hail size during this storm varied from 1.25 inches in **Aransas Pass** to 2.75 inches in **Portland**.

**Figure 14** – NOAA/NWS hail data showing hail of 2.75 inches to 1.25 inches on November 1, 2025, across the northern portion of Ingleside as displayed on Google Earth®

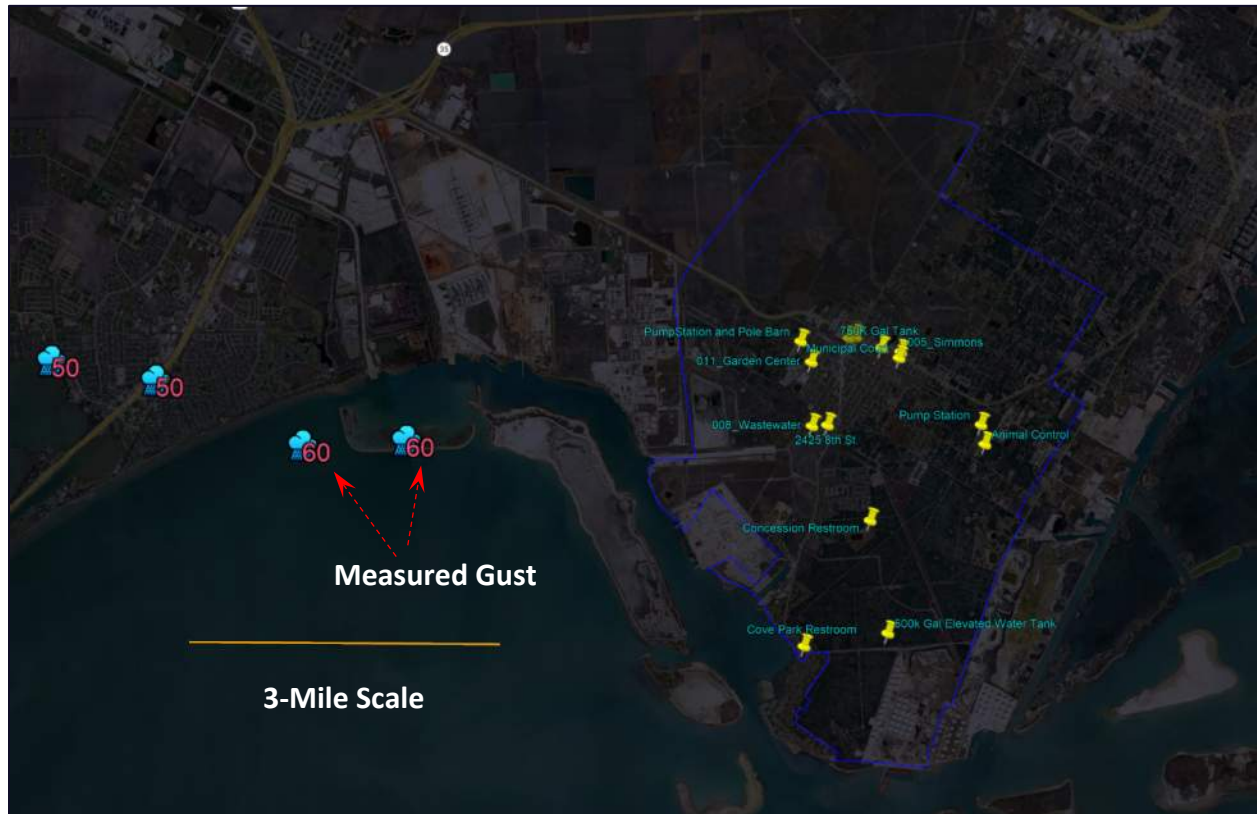
NOAA Storm Event Database (SED) records were reviewed for wind events occurring between Nov 1, 2024 and November 30, 2025 within San Patricio County, Texas. NOAA SED records do not document any wind events meeting or exceeding 58 mph within 1.0 mile of the subject property (see **Figure 17**).

**Figure 17** – NOAA SED wind data showing approximately 69 mph (60 knots) measured wind gusts within 10 miles during the November 1, 2025 storm.

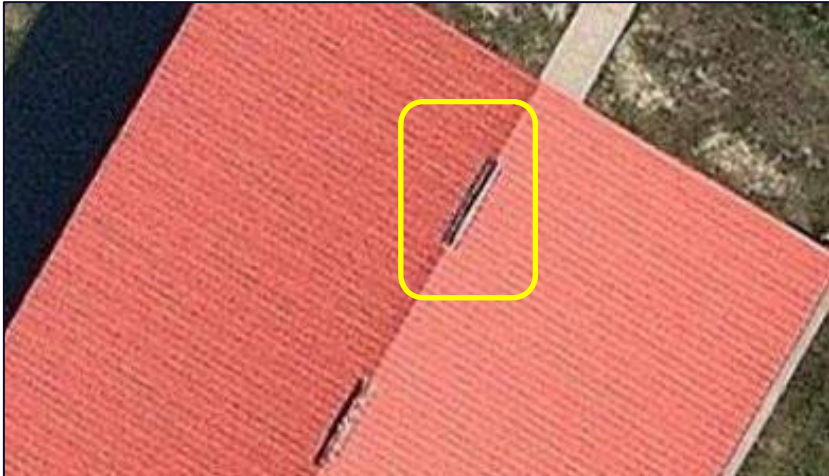
| Historical Aerial Imagery | Date/Observation |
|---|---|
| | <p>8/31/2017</p> <p>Vent-cover missing since the passage of Hurricane Harvey in 2017</p> |

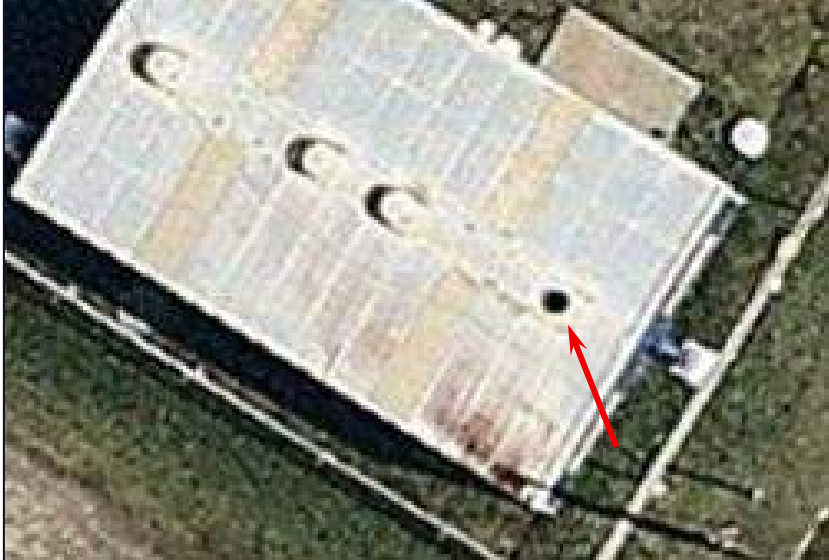
| Historical Aerial Imagery | Date/Observation |
|---|---|
| | <p>8/31/2017</p> <p>East vent cap lost during Hurricane Harvey (2017)</p> |

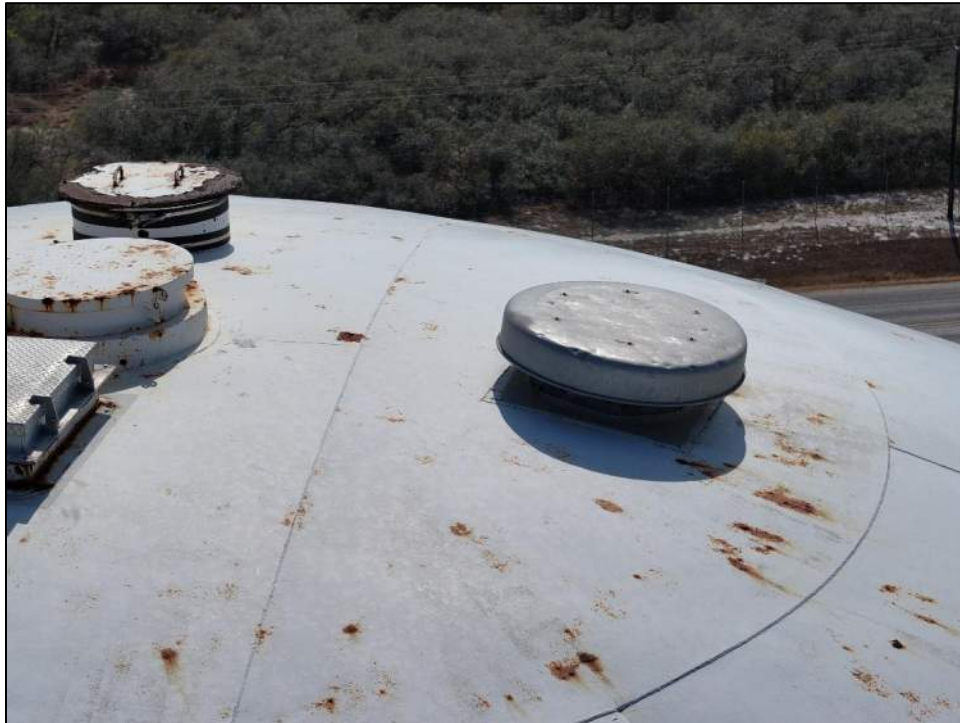
The metal panel dents observed during the inspection did not exhibit coating ruptures, seam separations, fastener displacement, panel deformation affecting drainage geometry, or other conditions typically associated with functional impairment of water-shedding performance. Close-range tactile examination and magnified inspection of representative test square areas and impact-prone transitions (including PVC parapet bases and exposed membrane interfaces) did not identify fractures, punctures, or impact-related openings within the primary roofing membranes.

**Photo 21:** Aluminum vent cover exhibited hail denting.

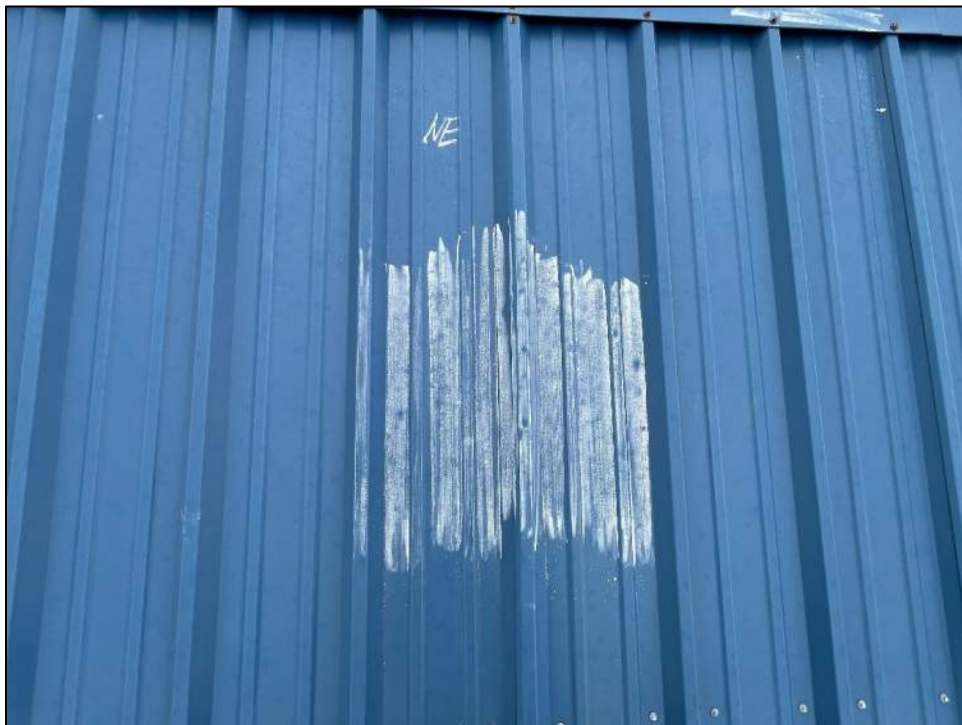
**Photo 10:** Hail spatters and denting observed on north slope indicative of 1-inch hail.

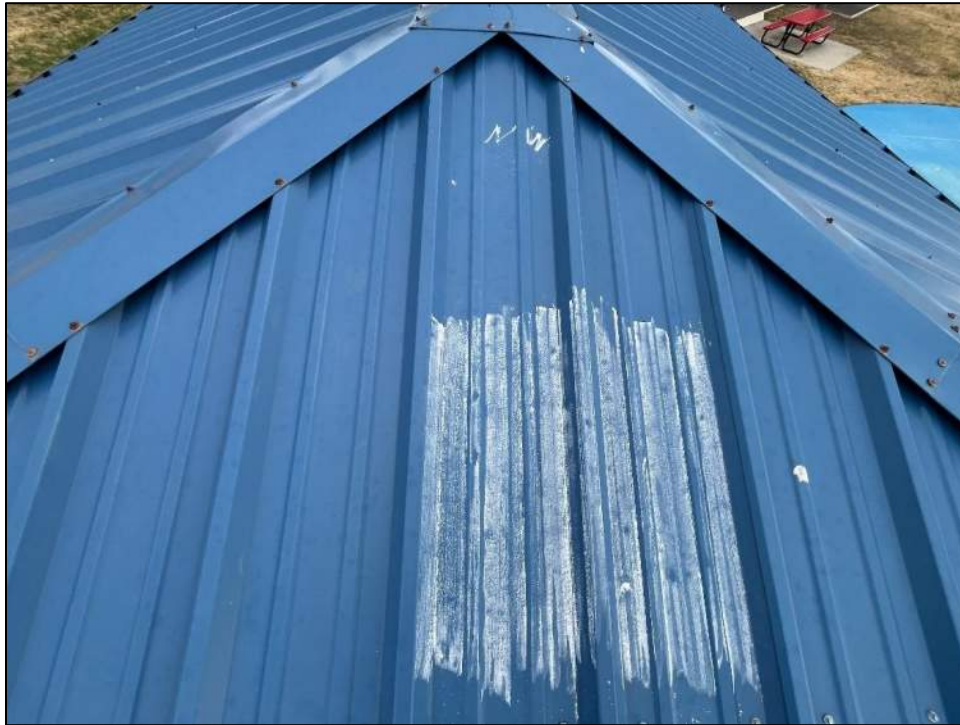
**Photo 13:** Hail spatters and denting observed on west slope indicative of 1-inch hail.

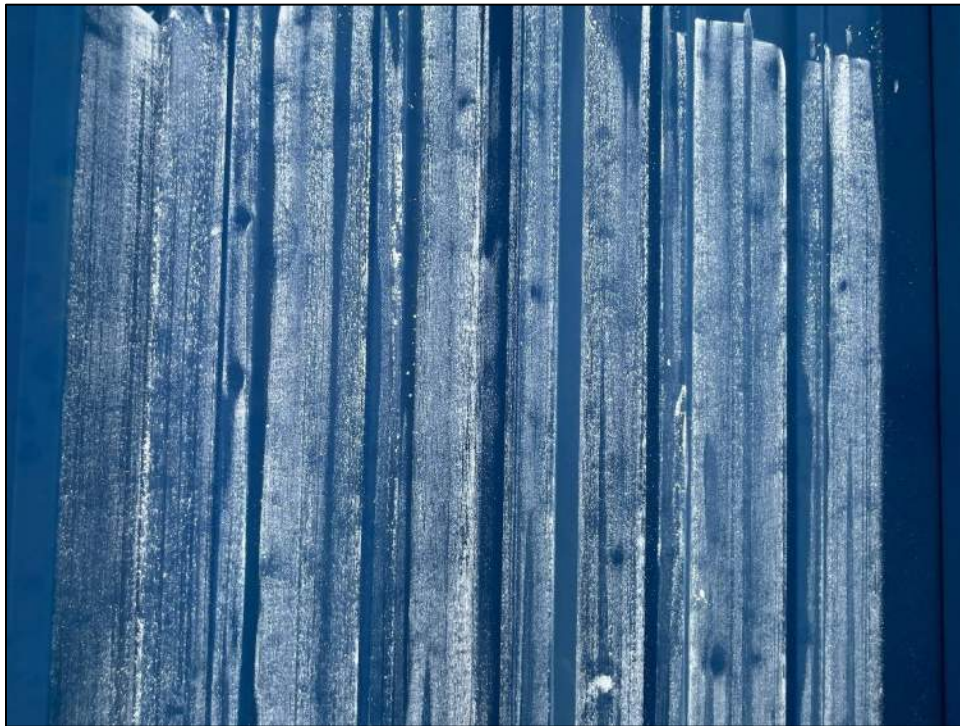
**Photo 14:** Close-up of the hail denting. The dents were generally shallow with an inner diameter of less than 3/8 inch.

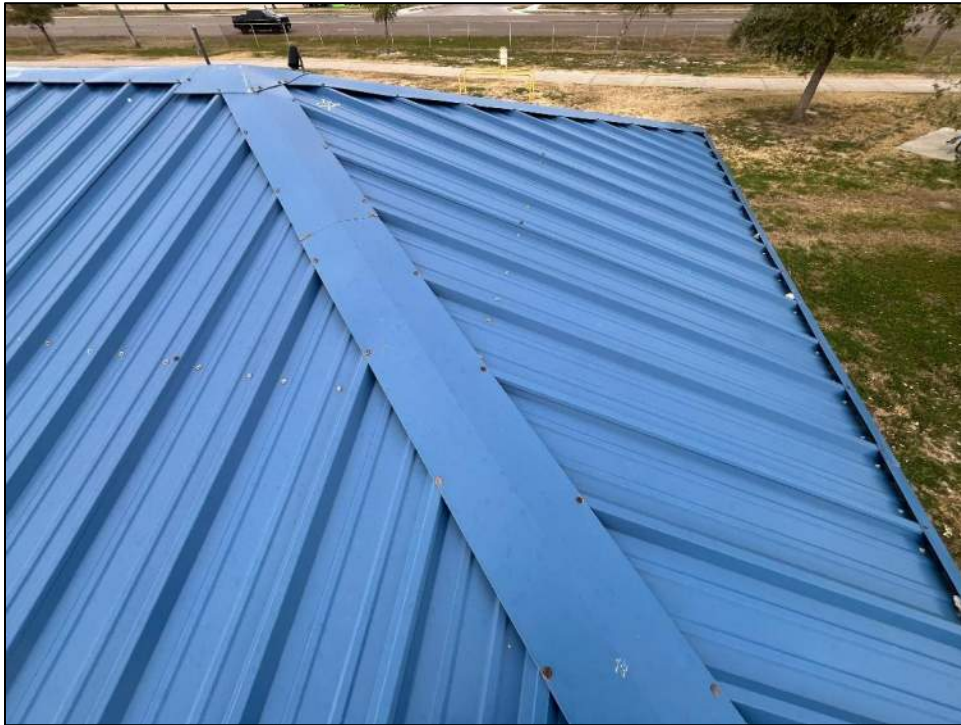
**Photo 15:** East and south slopes sustained significantly less hail denting.

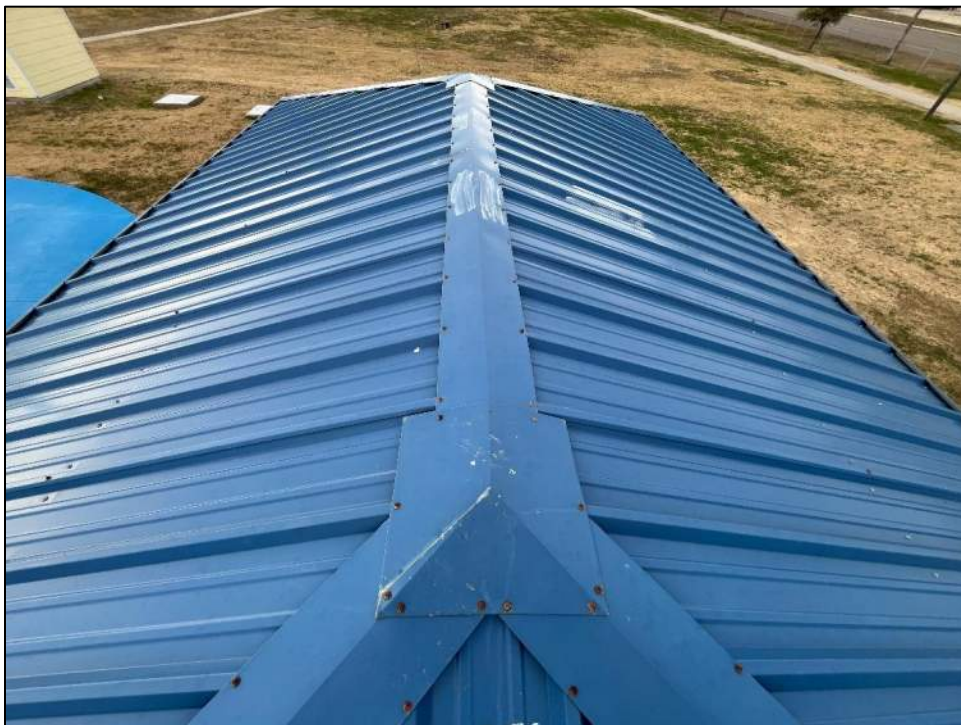
**Photo 16:** Ridge and hip caps were not detached or deformed. Widespread surface rusting was observed on fasteners.

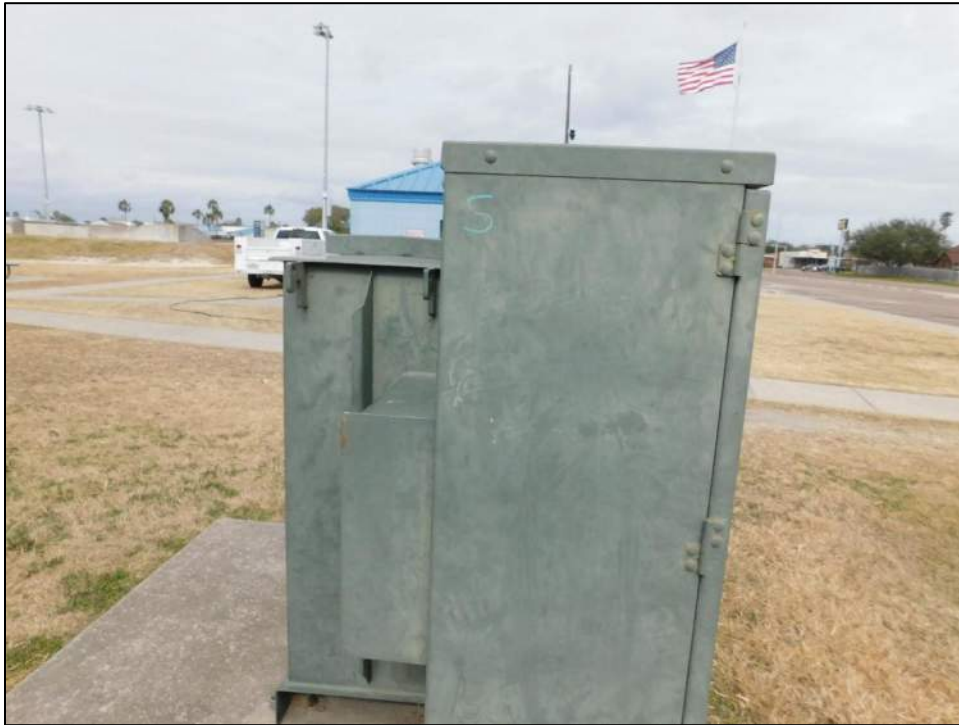
**Photo 25:** No hail spatter on south-facing surface of nearby electrical cabinets.

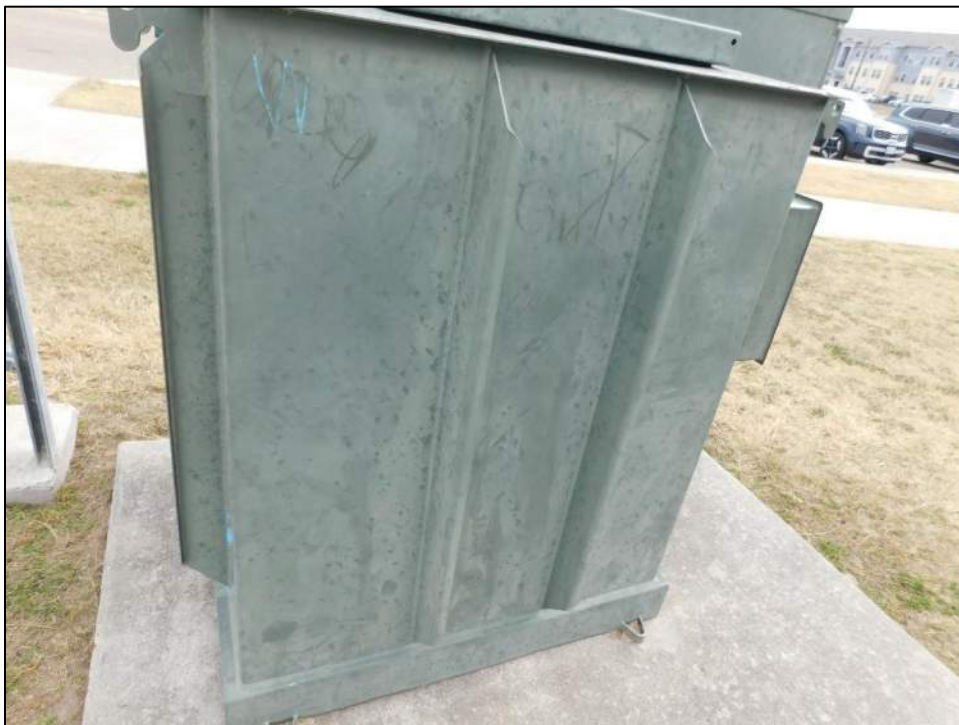
**Photo 26:** Hail spatters consistent with 0.75- to 1.0-inch hail on west-facing surfaces.

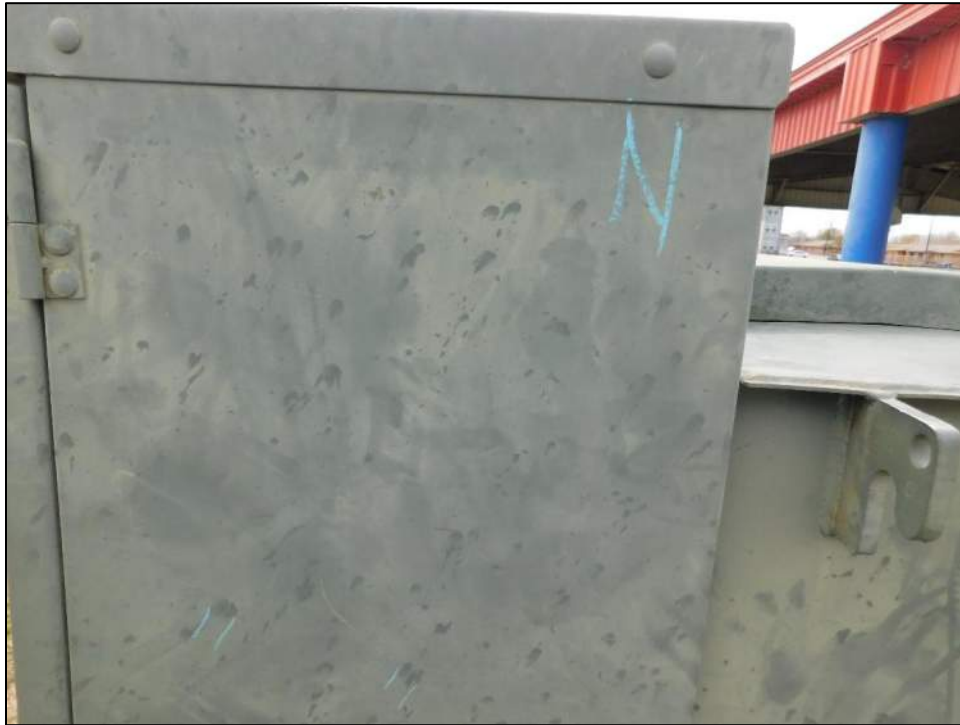
**Photo 27:** Hail spatters consistent with 0.75- to 1.0-inch hail on north-facing surfaces.

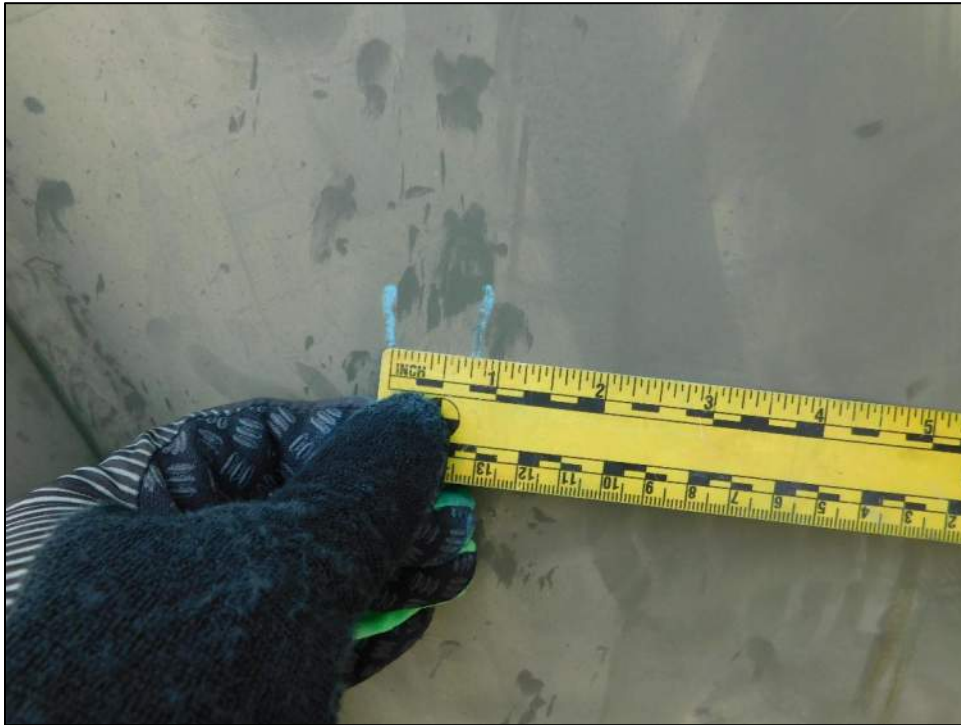
**Photo 29:** Hail spatters consistent with 0.75- to 1.0-inch hail on west-facing surfaces.

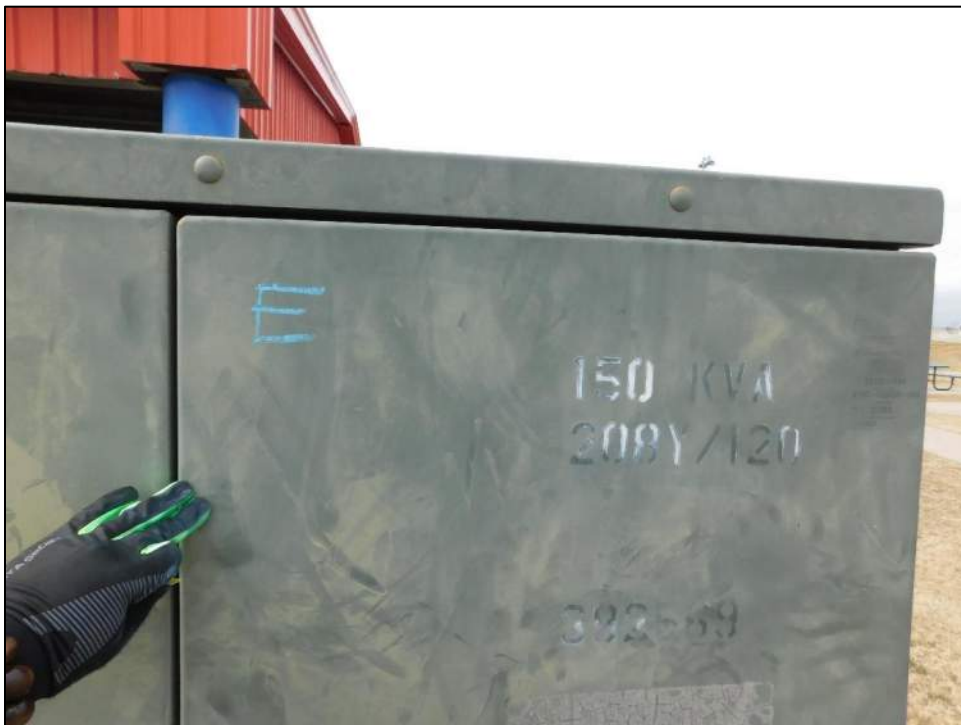
**Photo 30:** No hail spatters on east-facing surfaces.

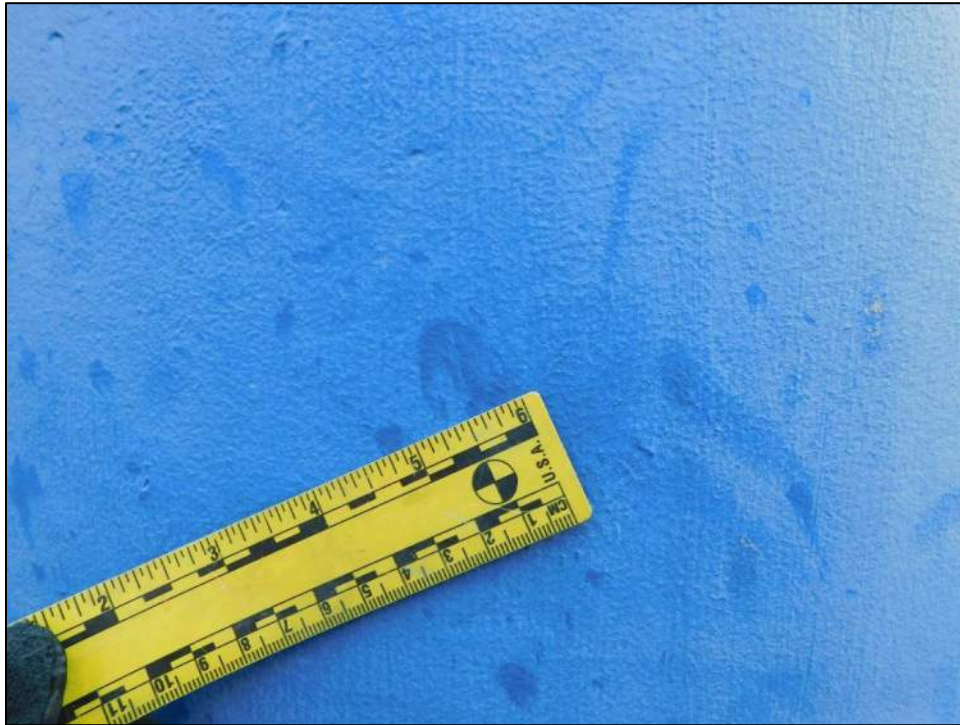
**Photo 31:** Hail spatters consistent with 0.75- to 1.0-inch hail on west-facing concrete column surface.

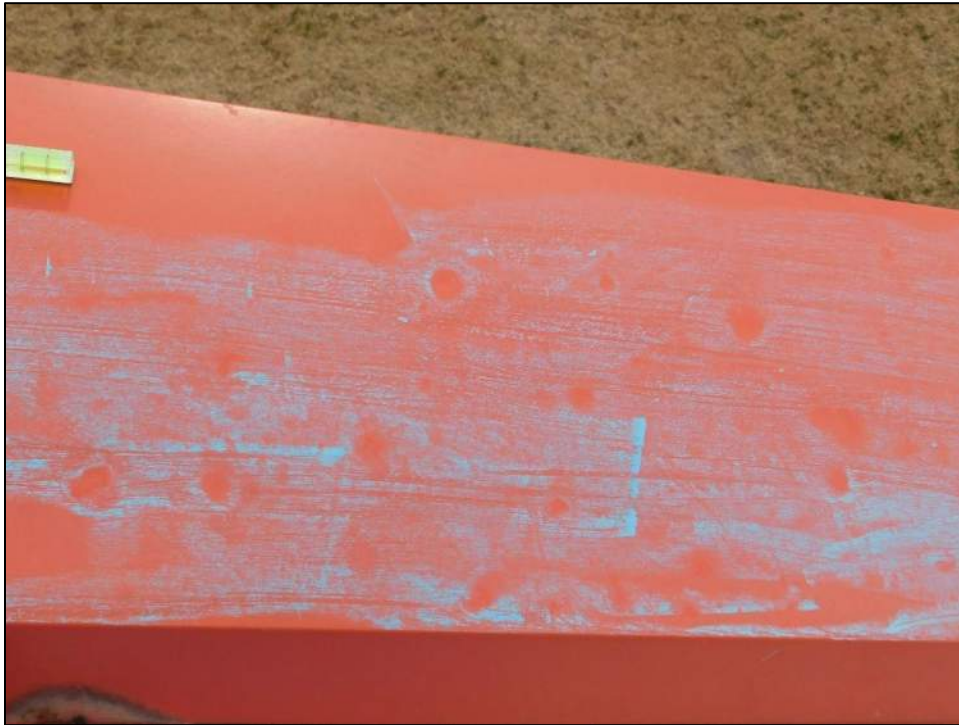
**Photo 50:** Indentations on gable end rake closures were dented absent of coating disruptions.

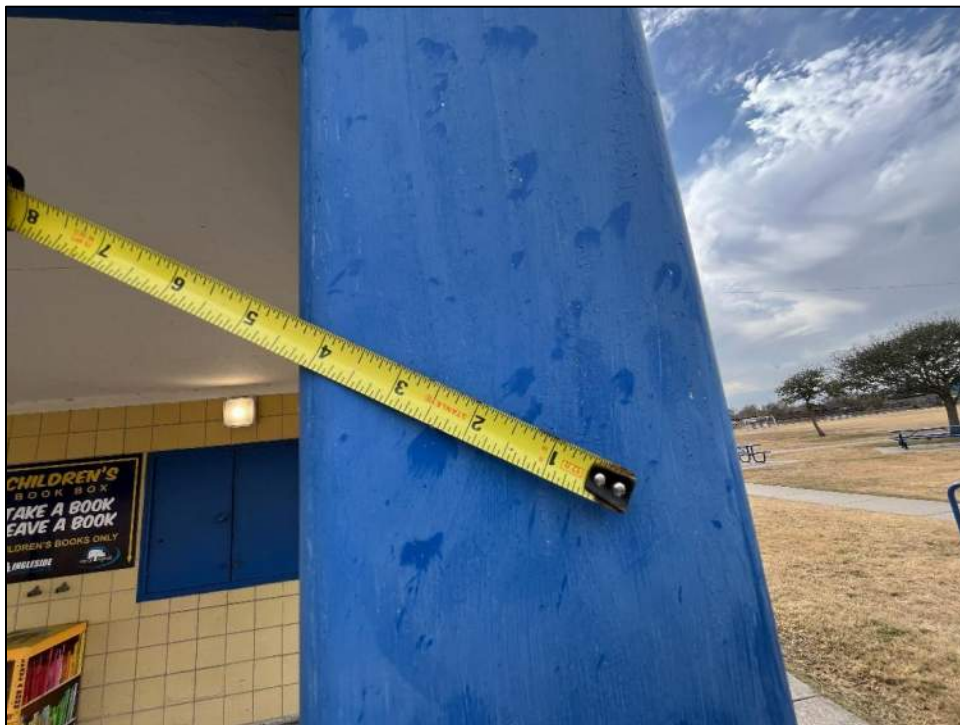
**Photo 61:** Hail spatters indicative of 0.75- to 1.0-inch hail.

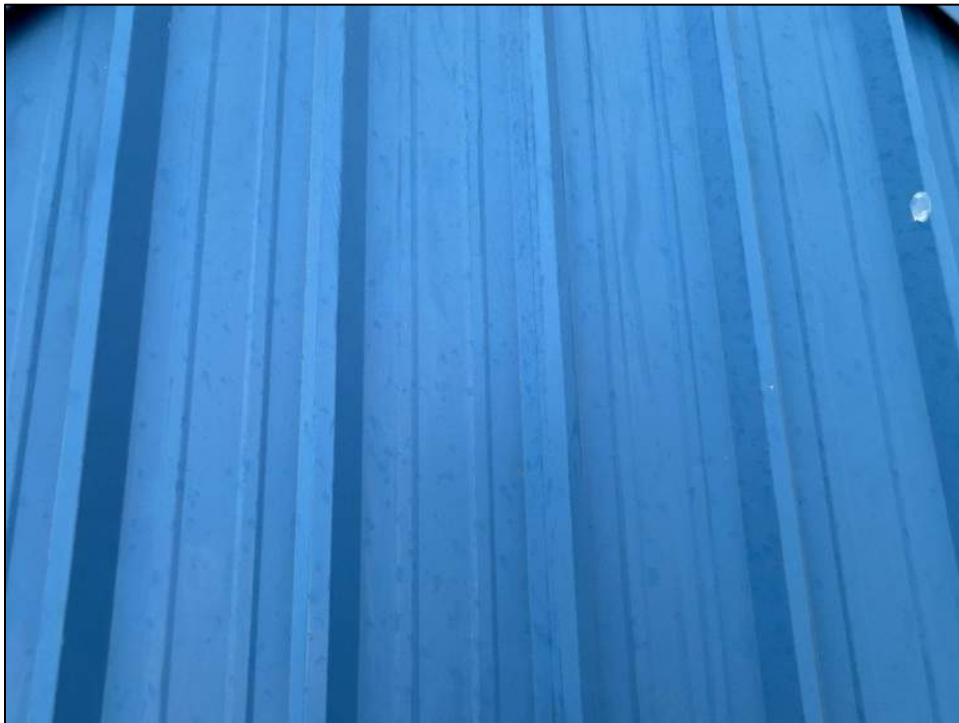
**Photo 71:** Hail spatters on north slope were consistent with 0.75 to 1.0 inch hail.

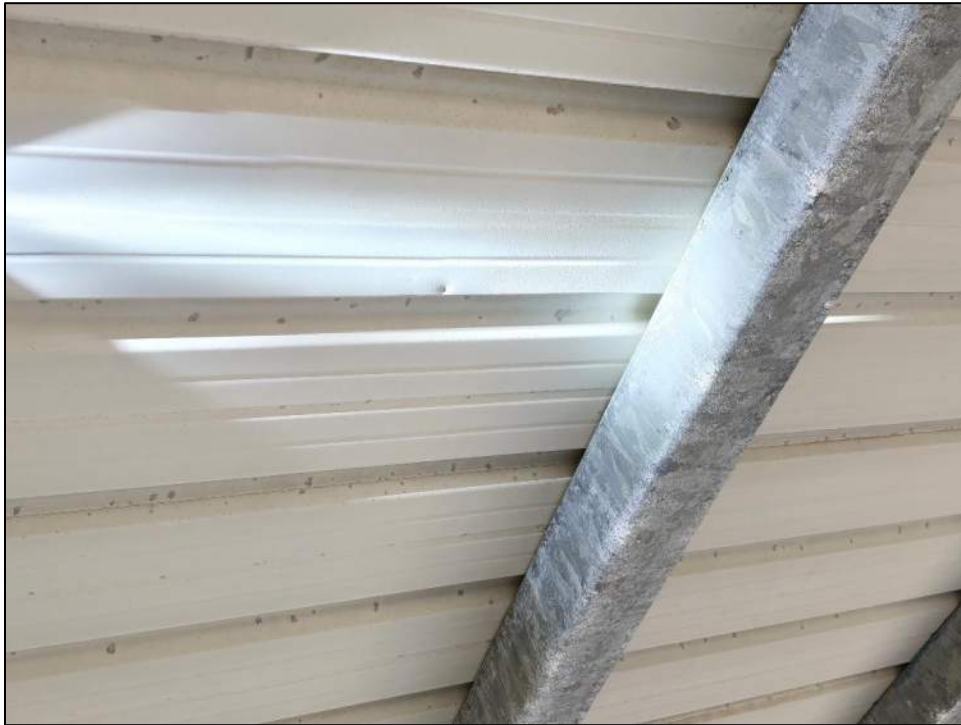
**Photo 88:** Upward denting on the east slope (inconsistent with hail impacts).

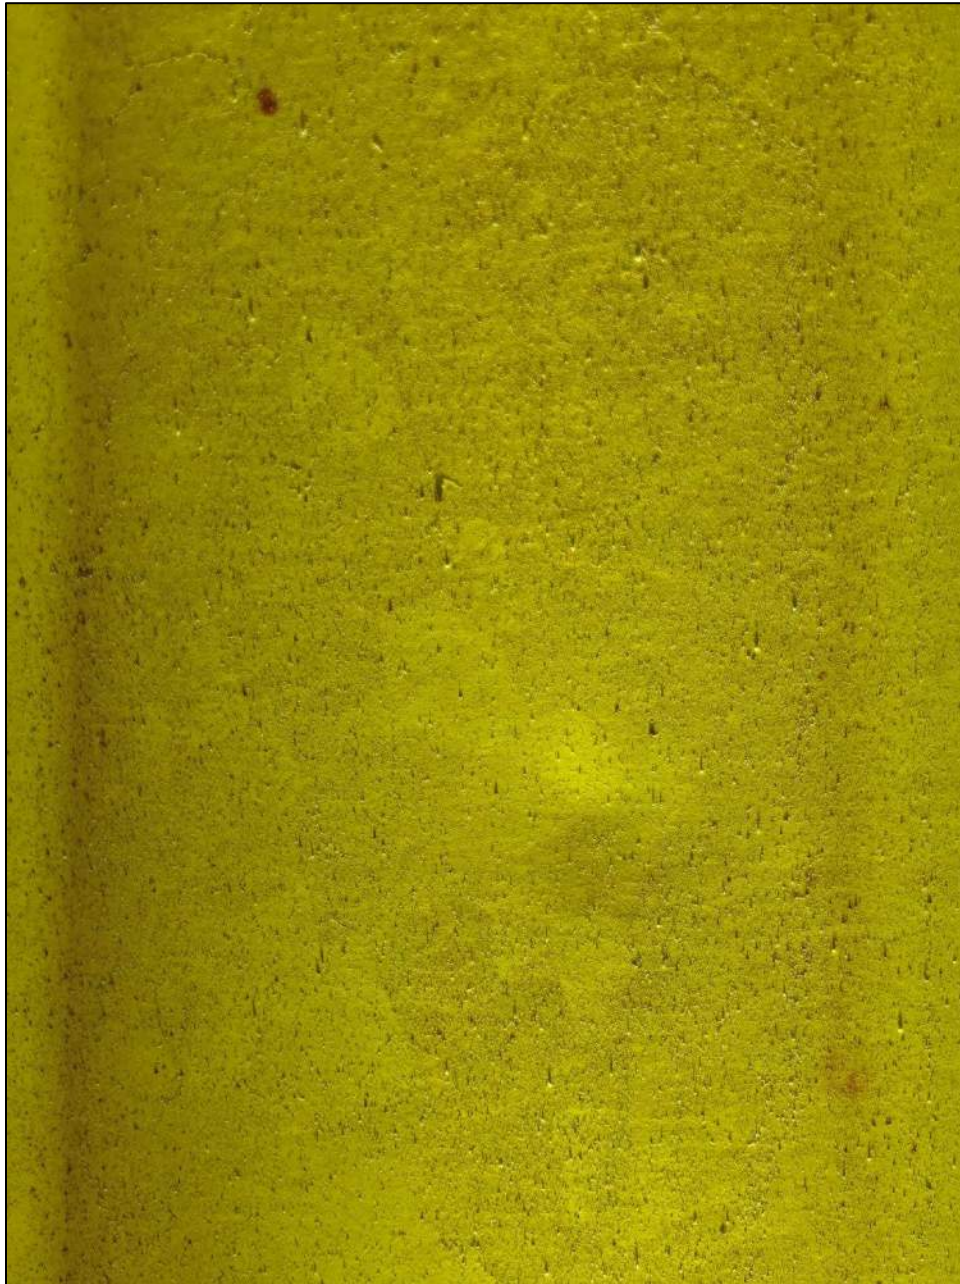
**Photo 92:** Dust pattern remained undisturbed at select dents.

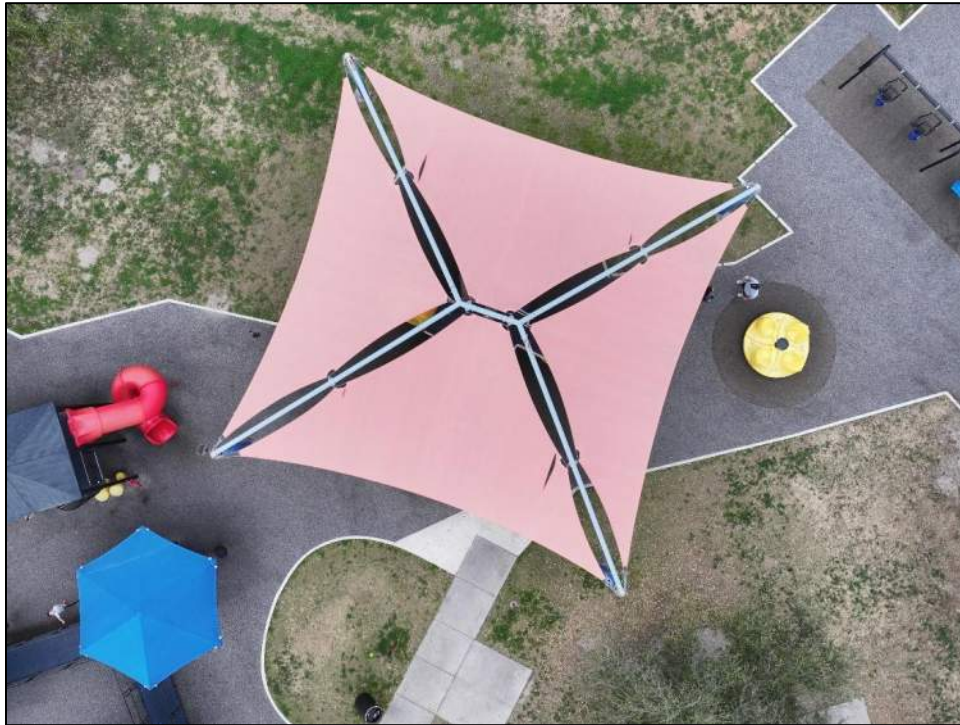
**Photo 97:** Top view of the HDPE fabric canopy. Note three tears at anchorage points.

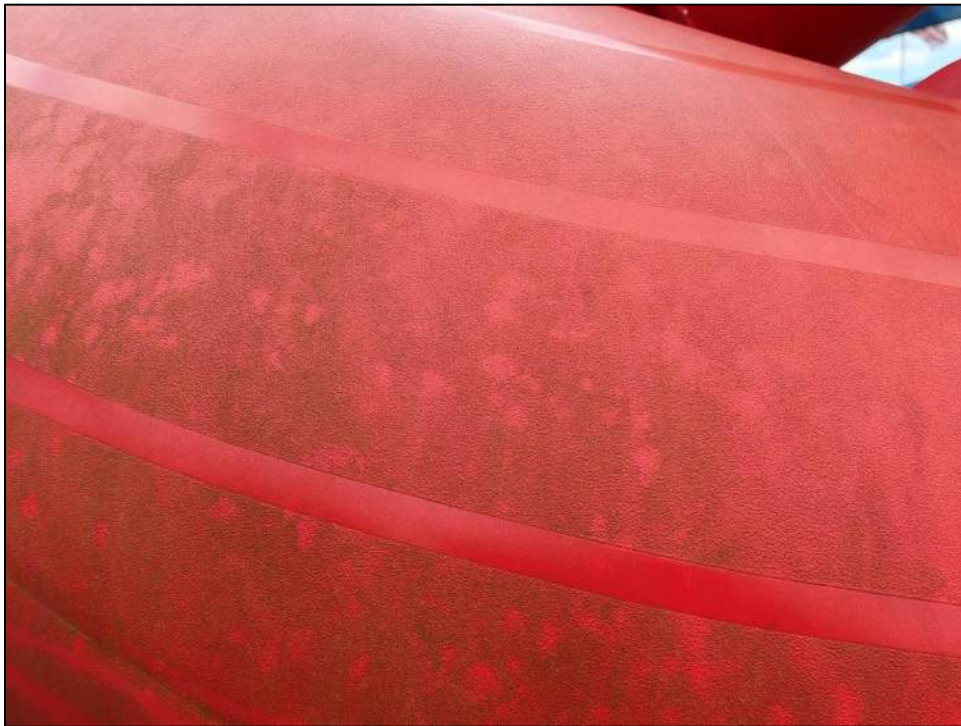
**Photo 118:** Top view of hail spatters on playset slides. No impact fractures were observed.

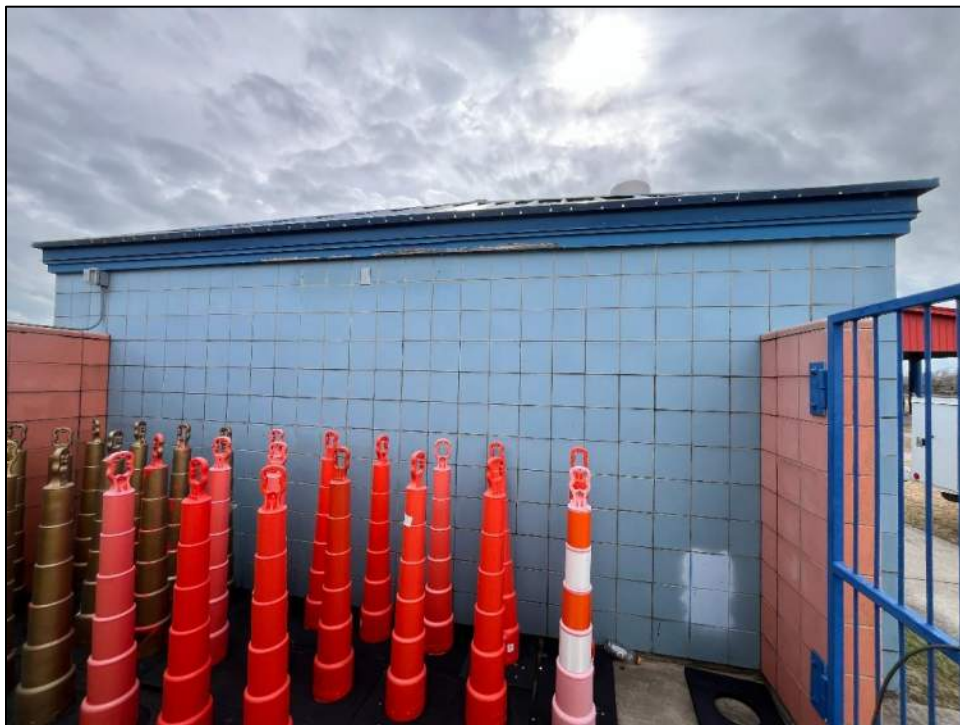
**Photo 124:** North (rear) elevation. No fractured tiles were observed.

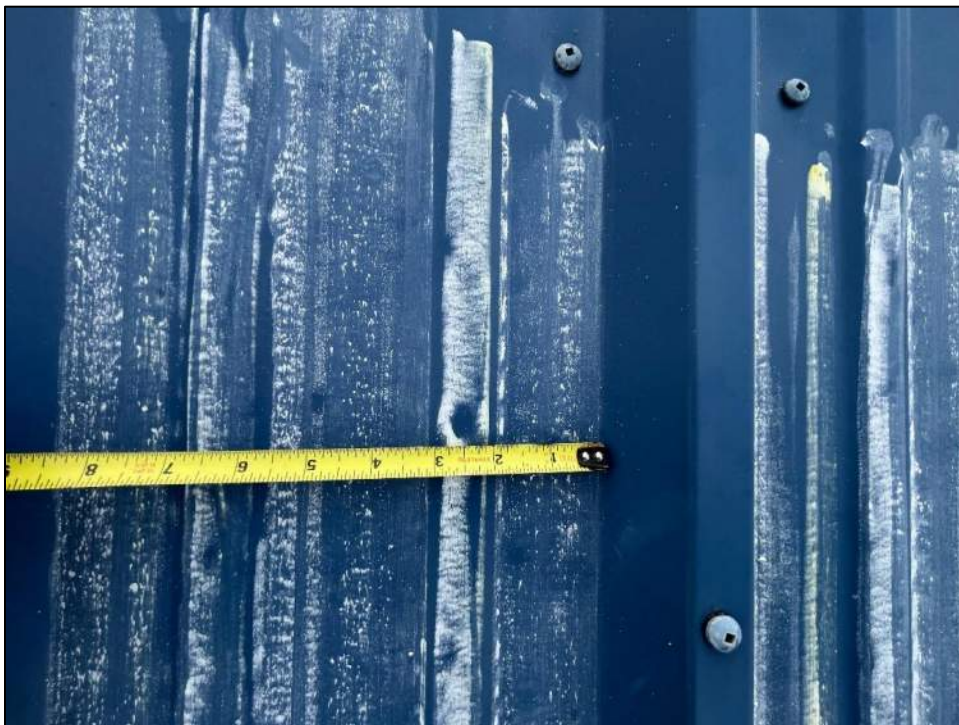
**Photo 128:** Hail denting on north slope had maximum inner diameter of less than 1/2 inch consistent with impact from 1-inch hail.

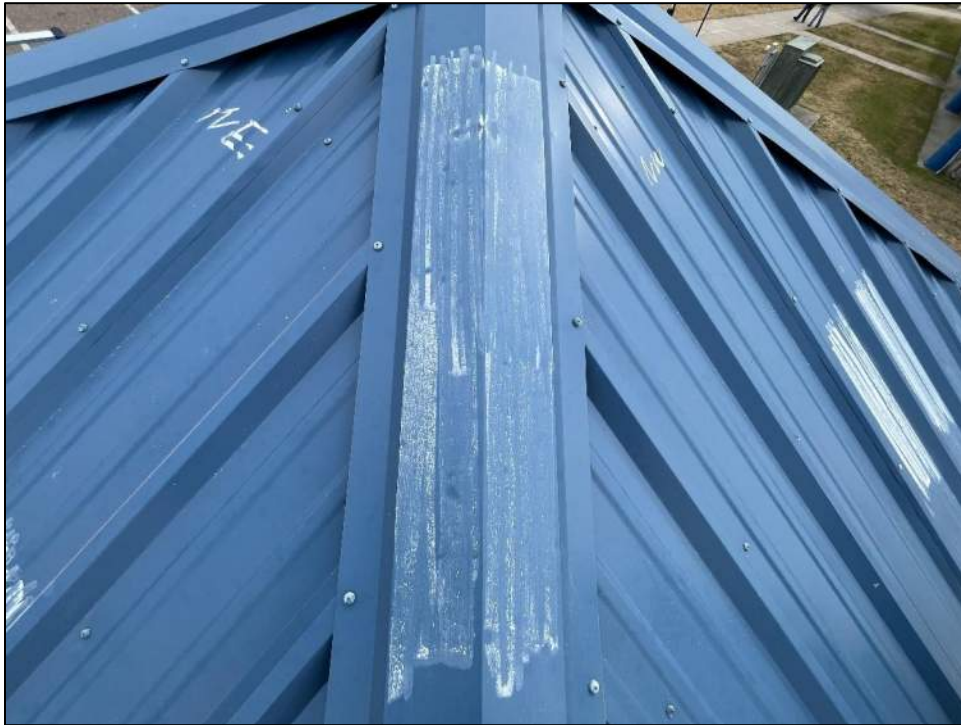
**Photo 130:** Similarly dented hip cap facing north.

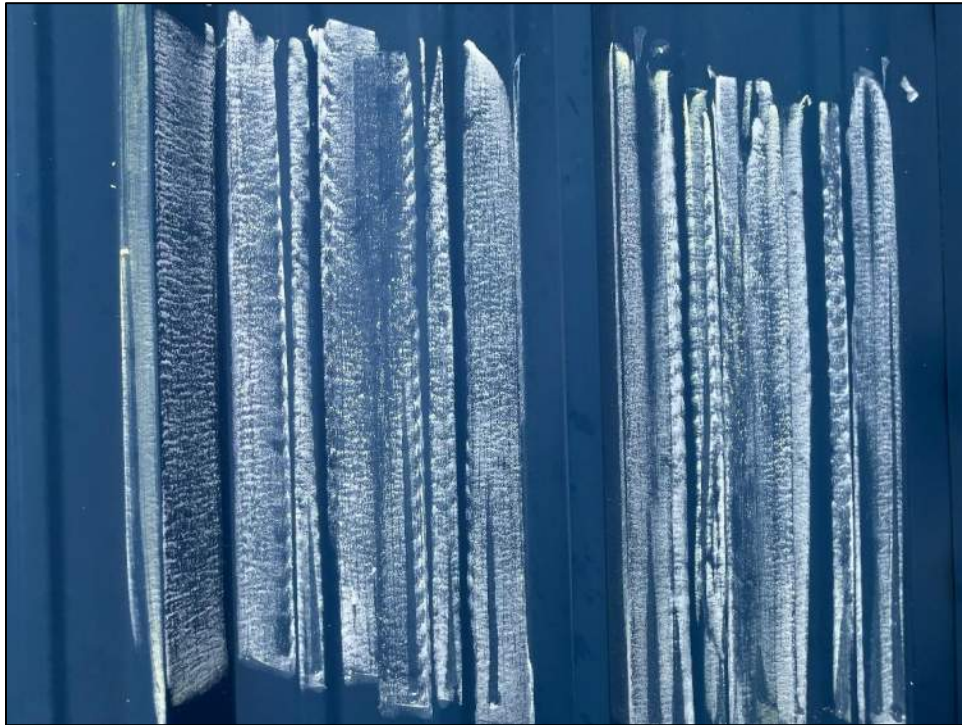
**Photo 134:** Hail denting on south slope was minimum compared to west and north slopes.

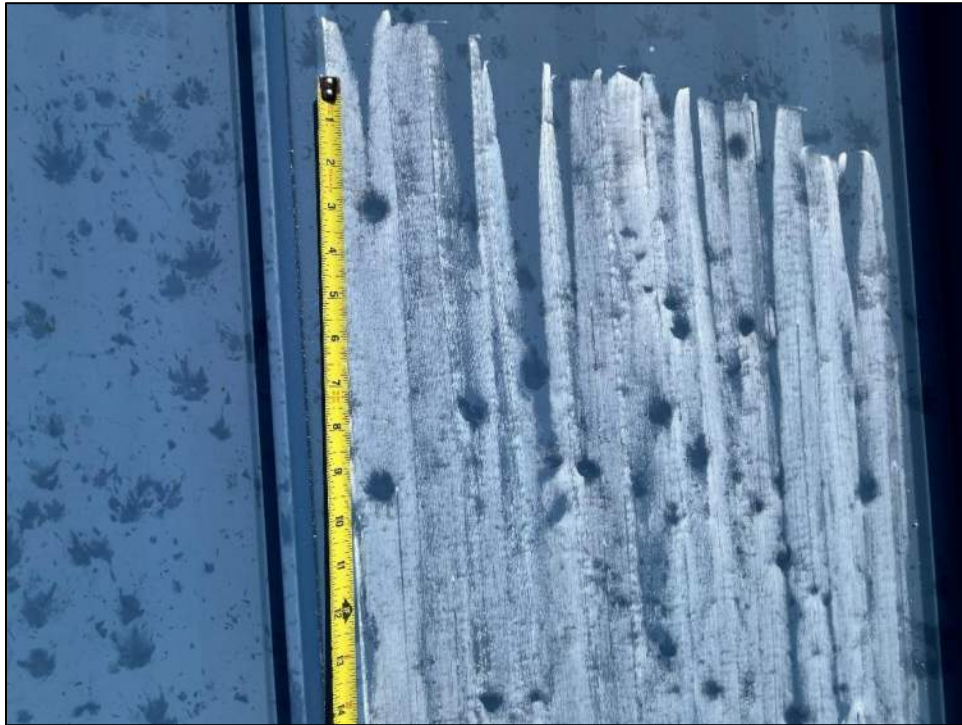
**Photo 13:** Maximum Hail denting measured 1/2 inch in inner diameter.

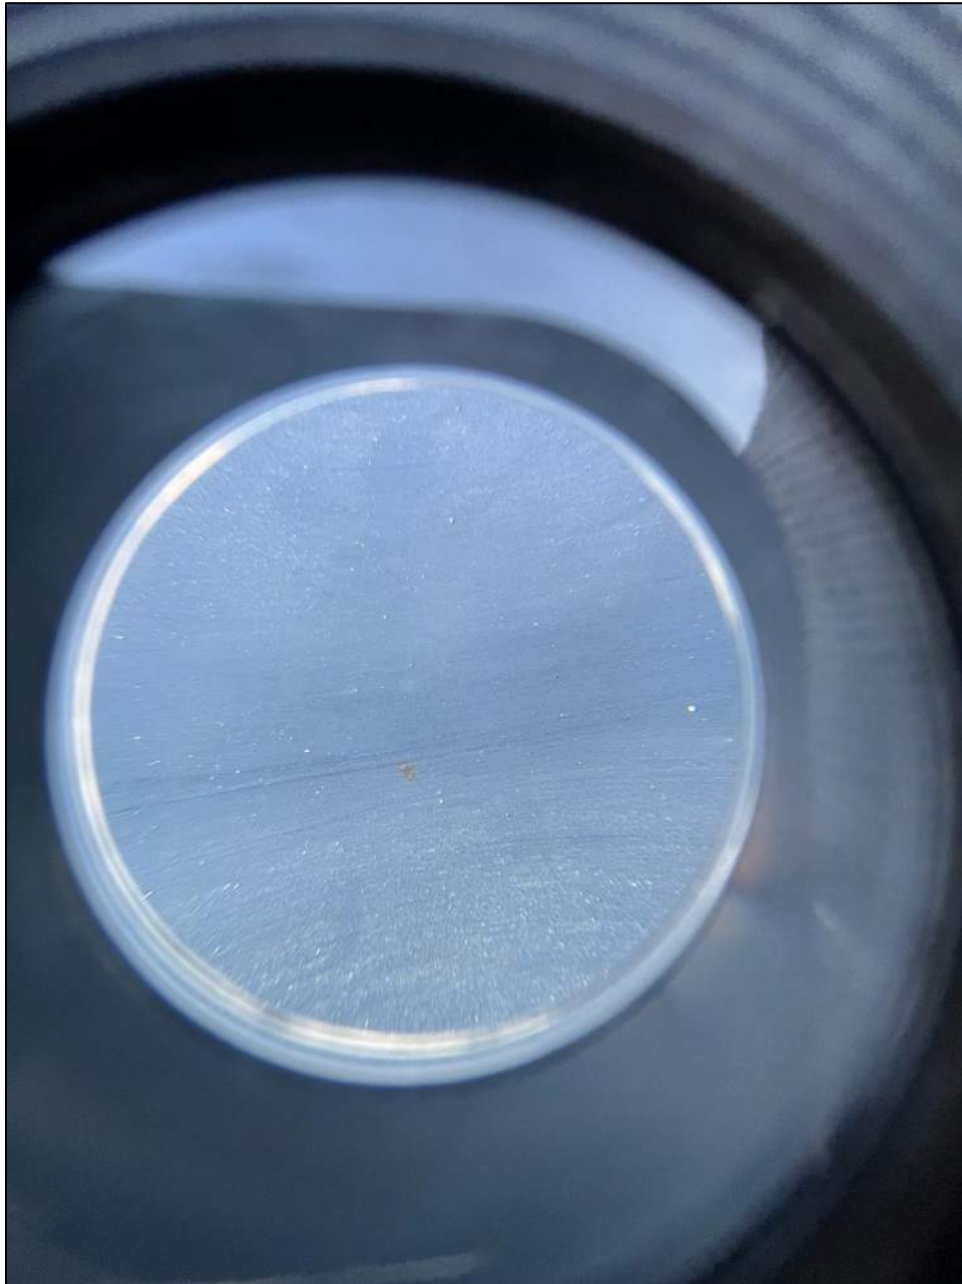
**Photo 16:** No coating disruptions were observed at the hail spatters.
