**CITY OF INGLESIDE  
REGULAR CITY COUNCIL MEETING  
AGENDA  
JUNE 9, 2026  
6:30 PM**

Report on November 01, 2025, Hailstorm Damage to City of Ingleside Buildings.

### Building Damage Analysis Survey and Report

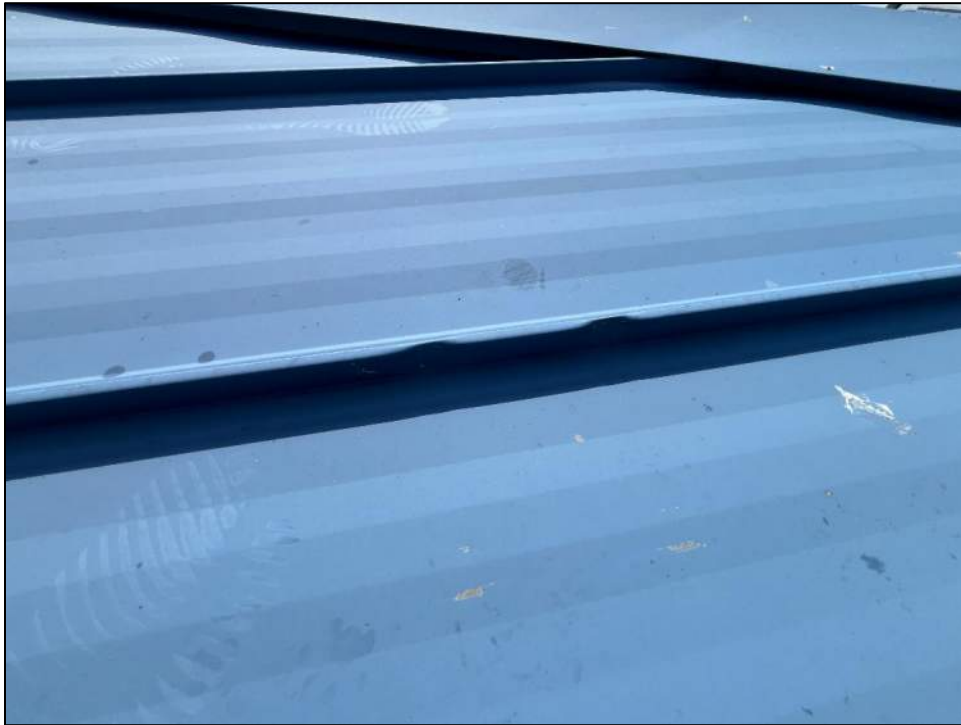
**Photo 27:** Typical seam crimp areas irrelevant to storm effects.

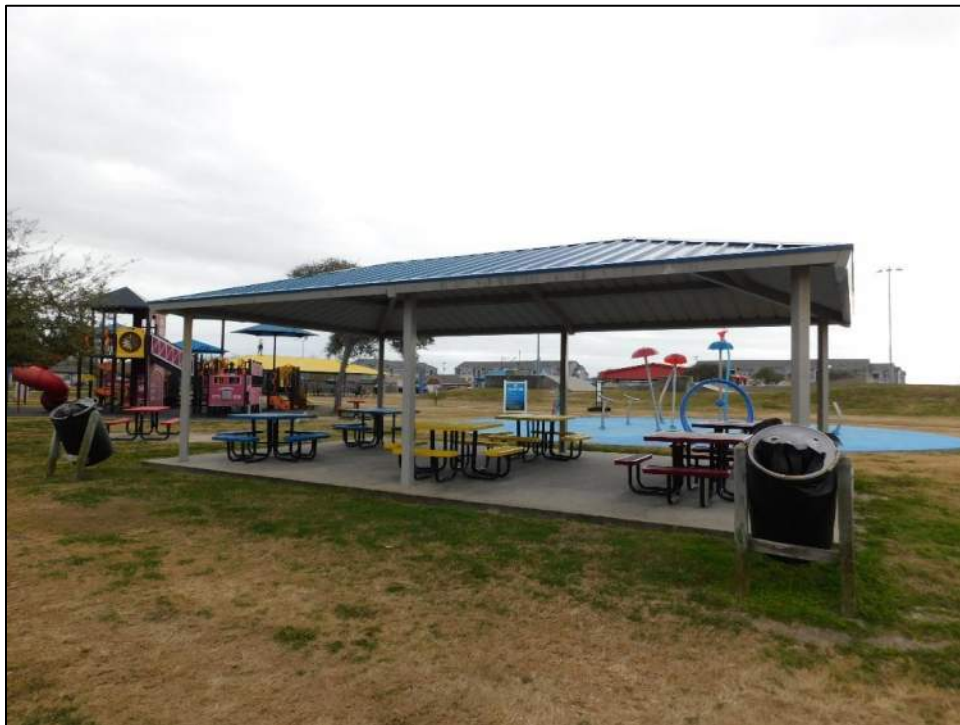
**Photo 2:** North elevation.

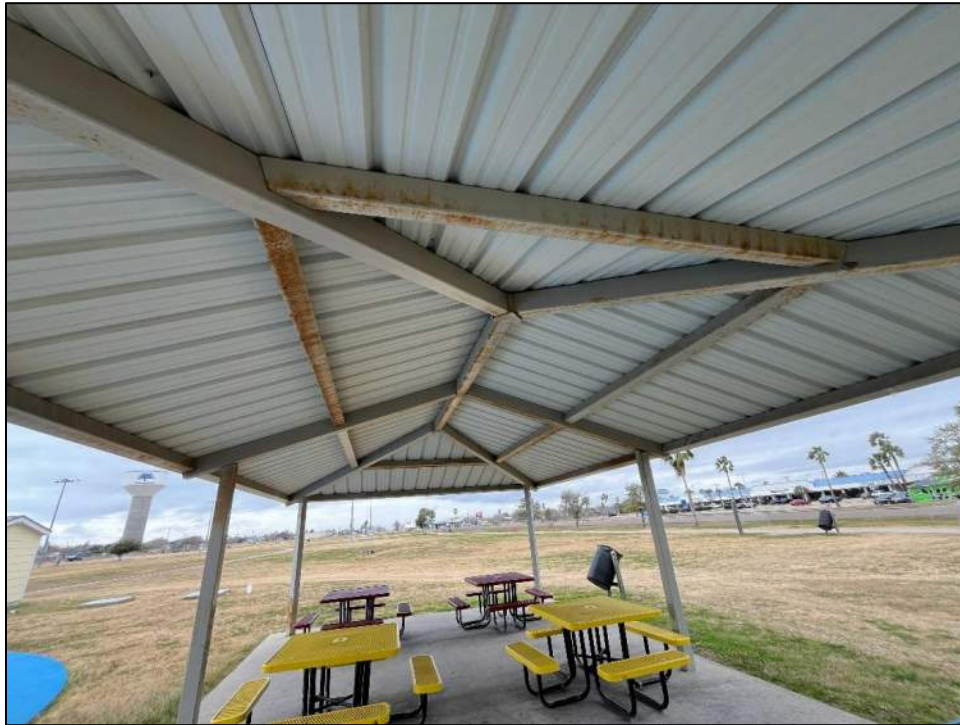
**Photo 9:** Underside view of the pavilion structure. Tube steel frames remained intact in addition to rusting.

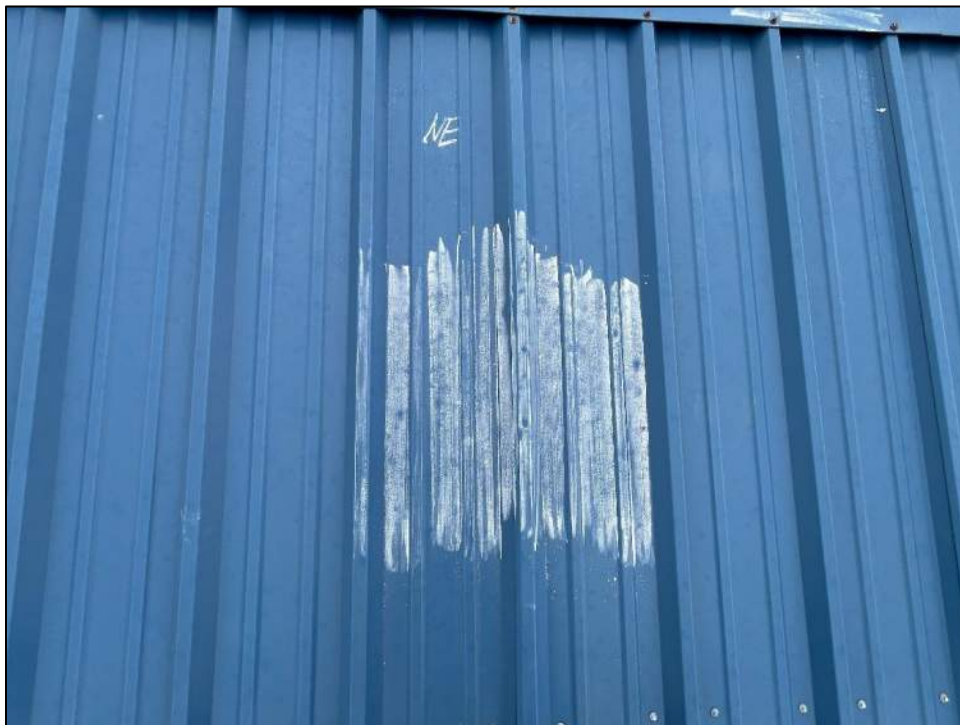
**Photo 10:** Hail spatters and denting observed on north slope indicative of 1-inch hail.

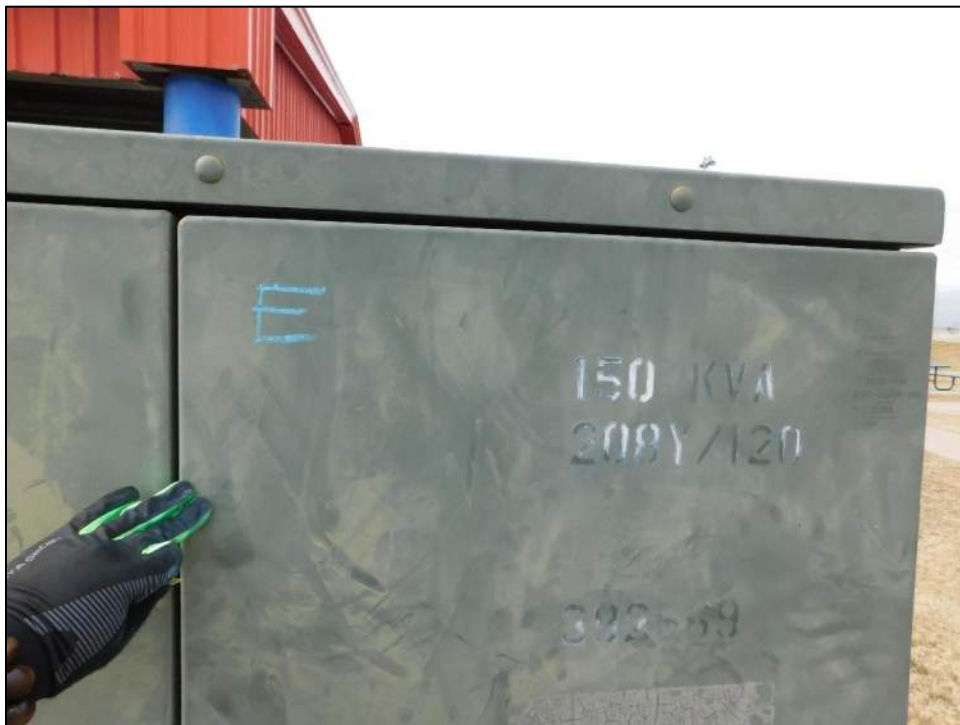
**Photo 30:** No hail spatters on east-facing surfaces.

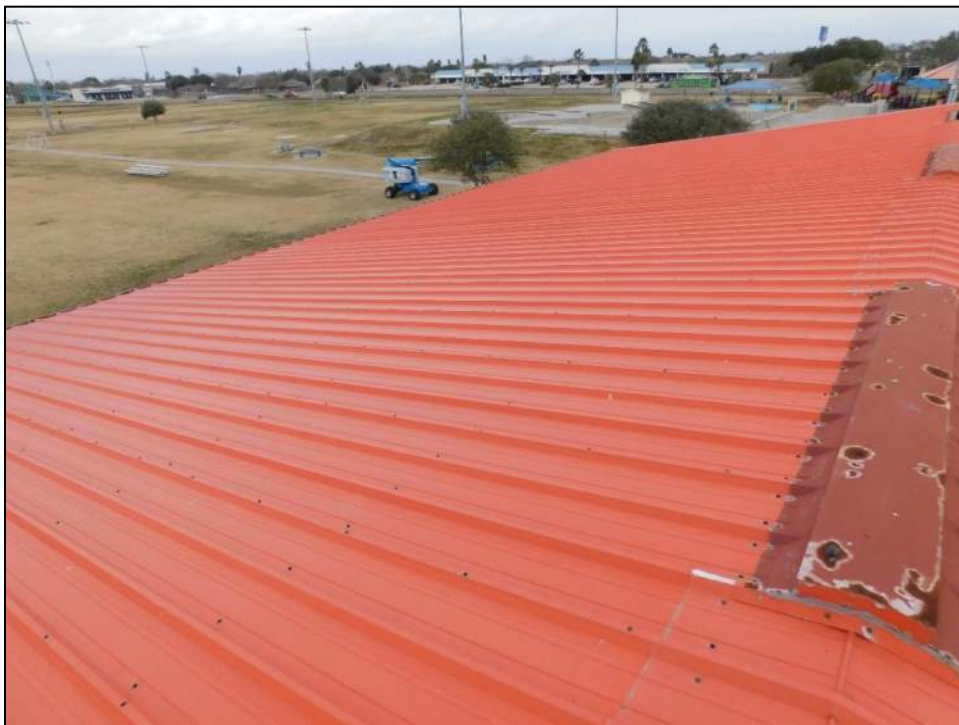
**Photo 32:** West slope overview.

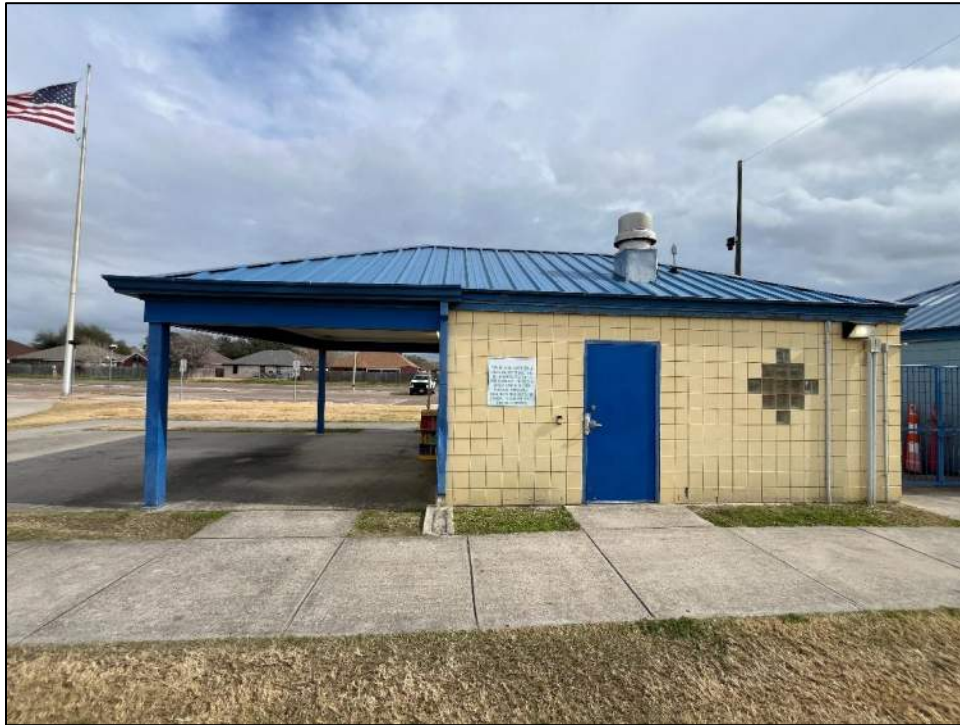
**Photo 62:** West elevation. No glass masonry units were fractured.

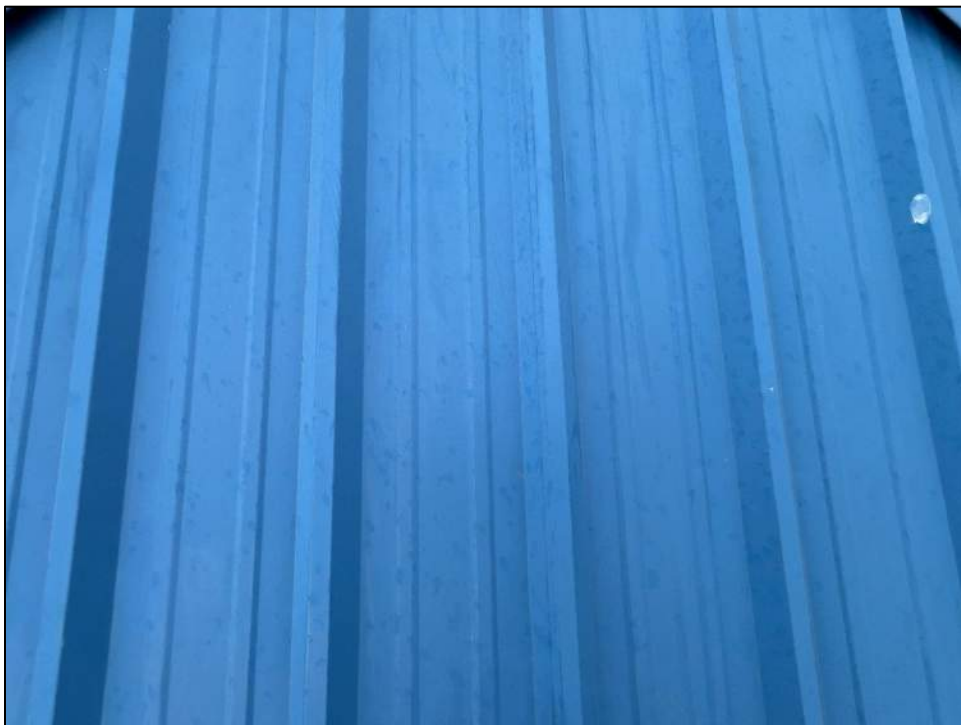
**Photo 71:** Hail spatters on north slope were consistent with 0.75 to 1.0 inch hail.

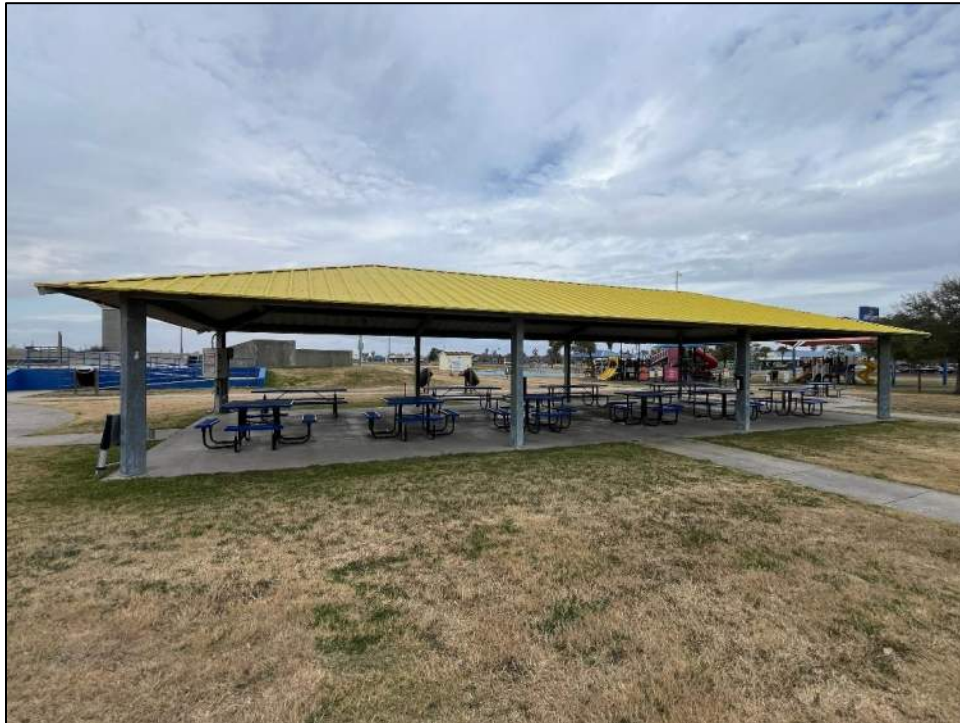
**Photo 76:** West elevation.

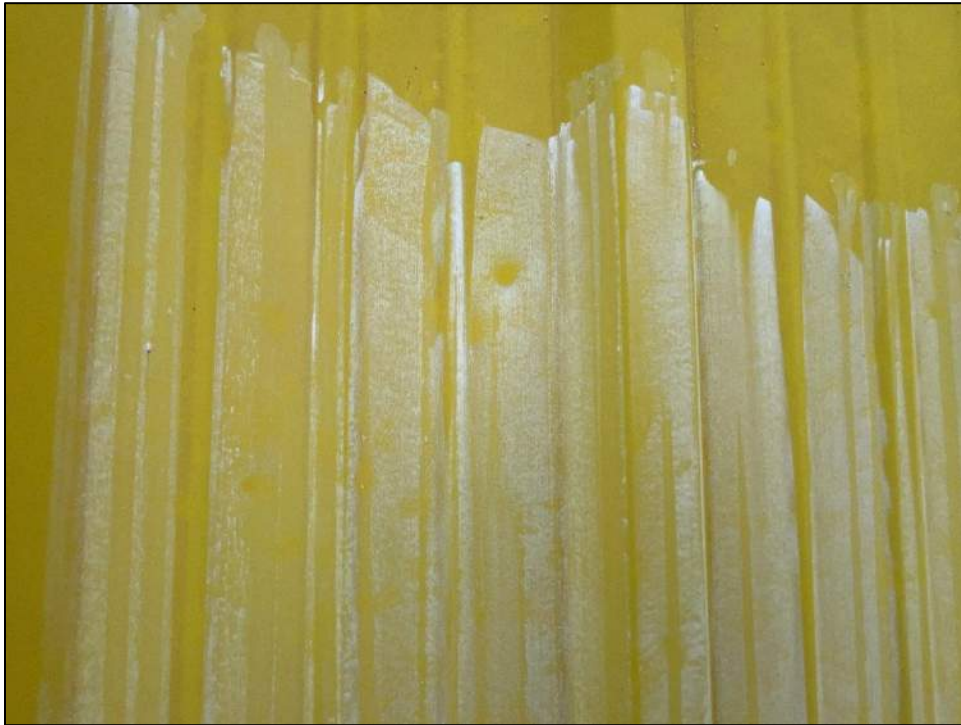
**Photo 84:** Inner diameter of hail dents on north slope were less than 1/2 inch.

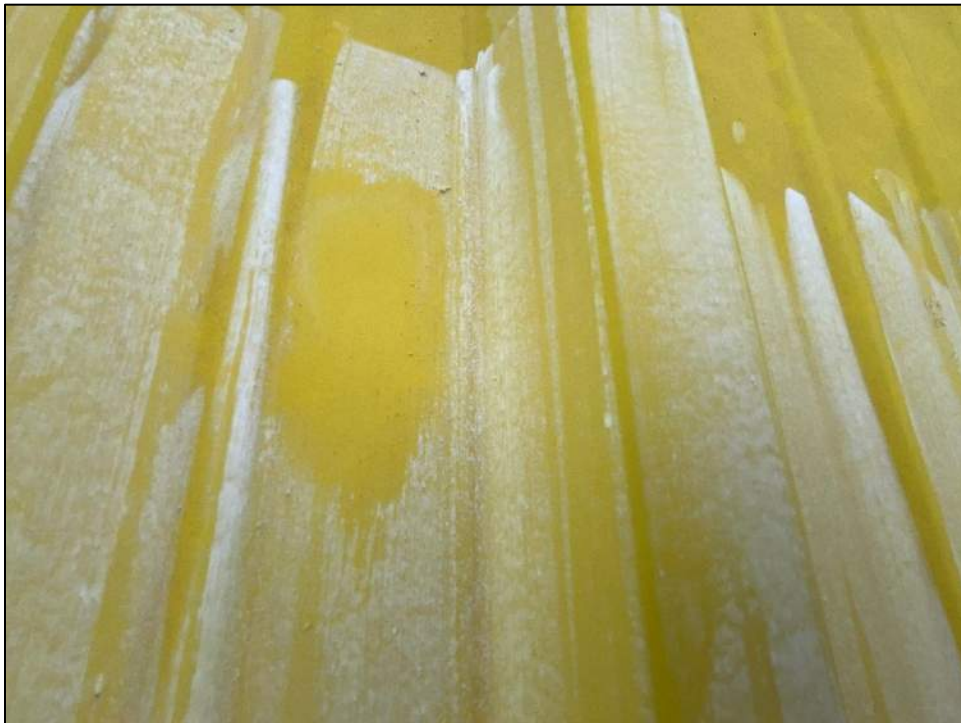
**Photo 85:** No coating disruptions were observed at the hail dents.

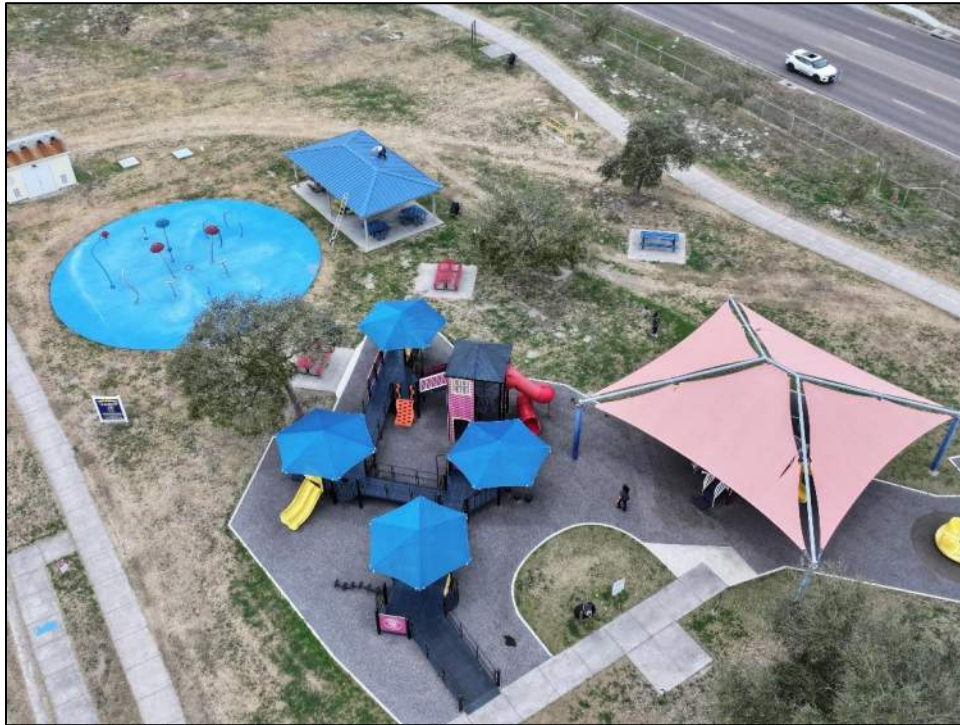
**Photo 95:** Playground overview.

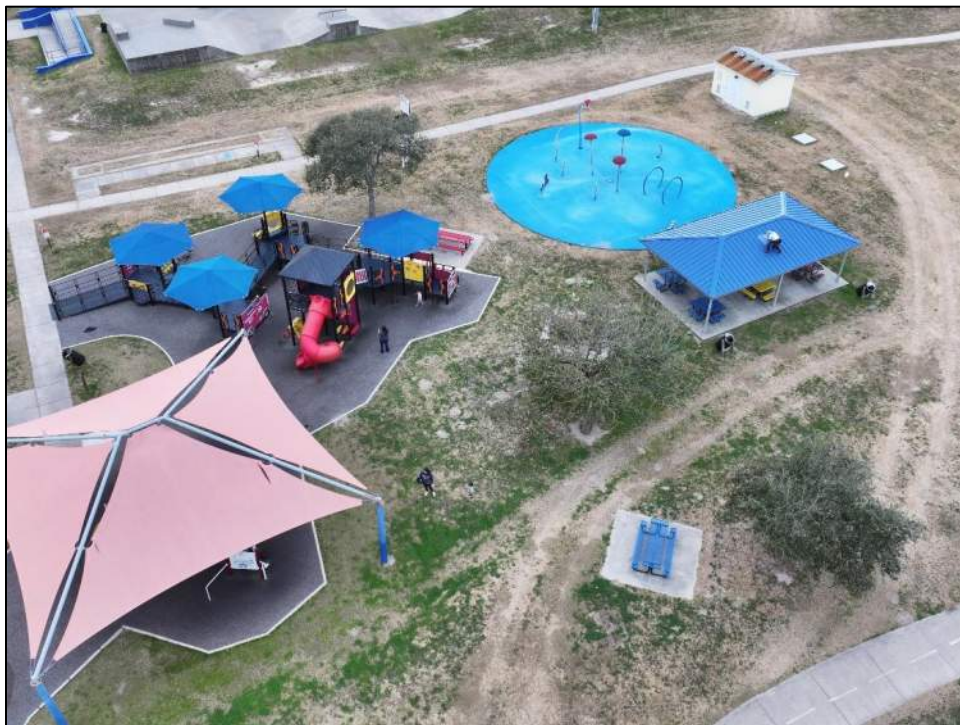
**Photo 96:** Playground overview.

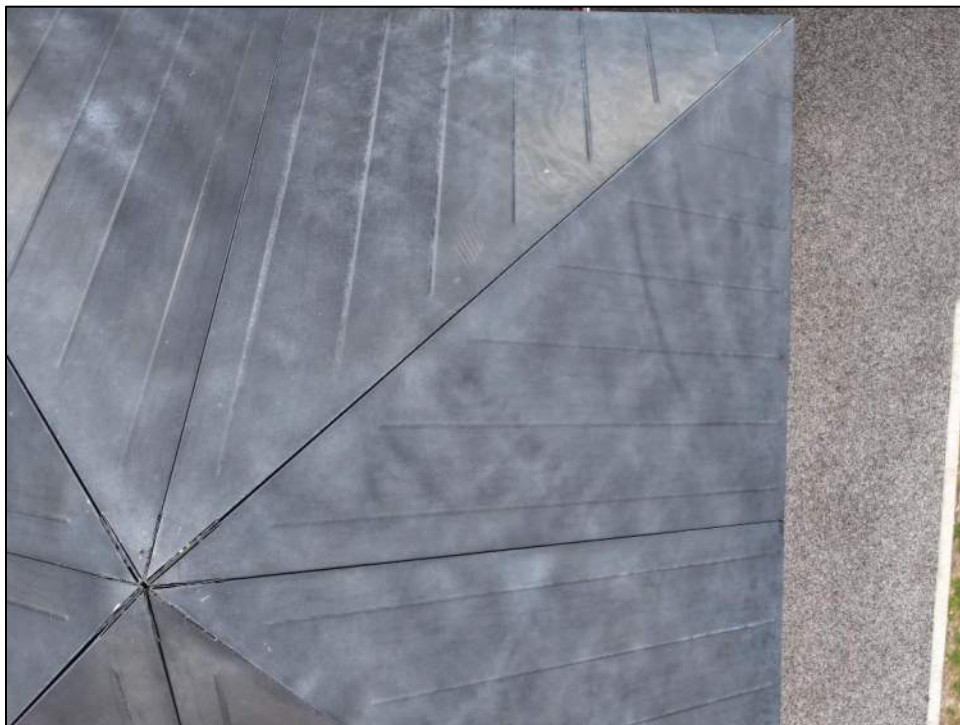
**Photo 104:** The roof is made of steel plates. No hail impact indentations were observed.

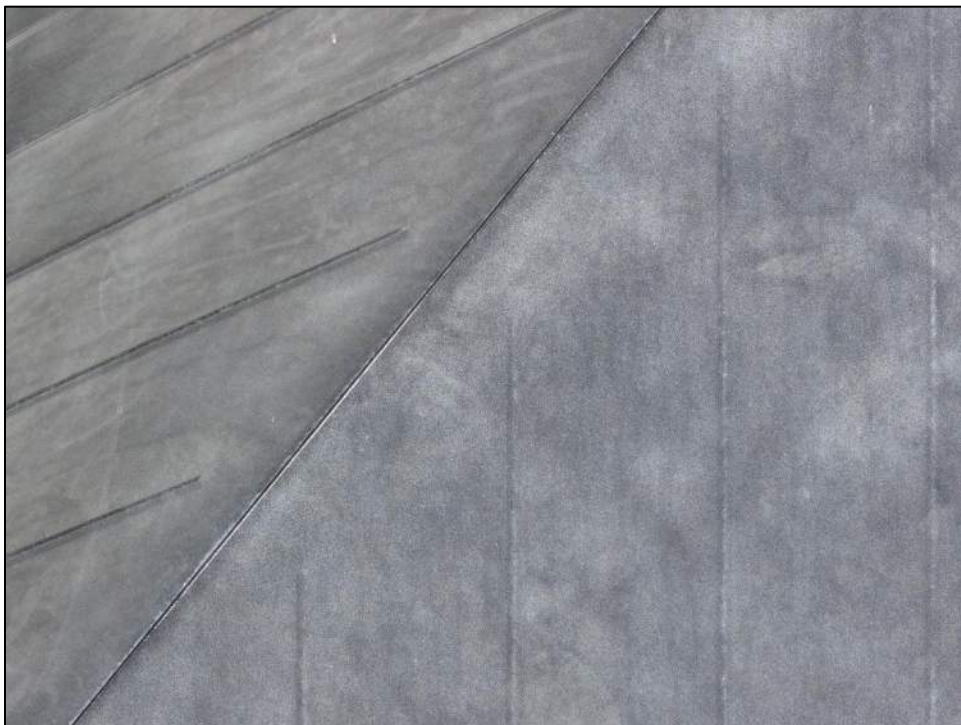
**Photo 106:** The roof is made of steel plates. No hail impact indentations were observed.

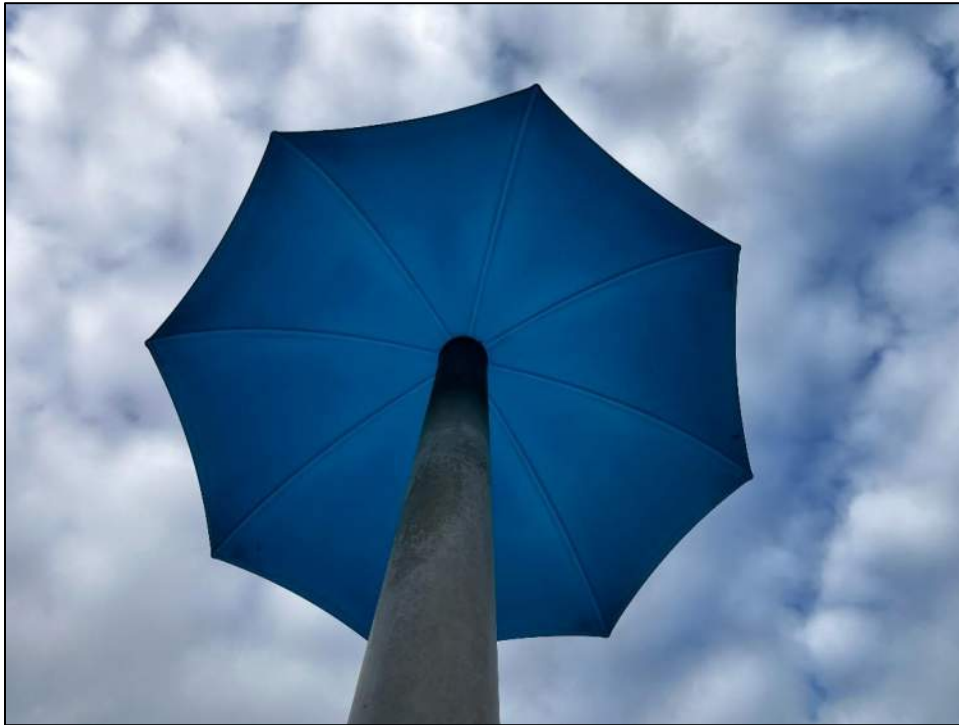
**Photo 117:** No fractures observed under the vinyl water features at the splashpad.

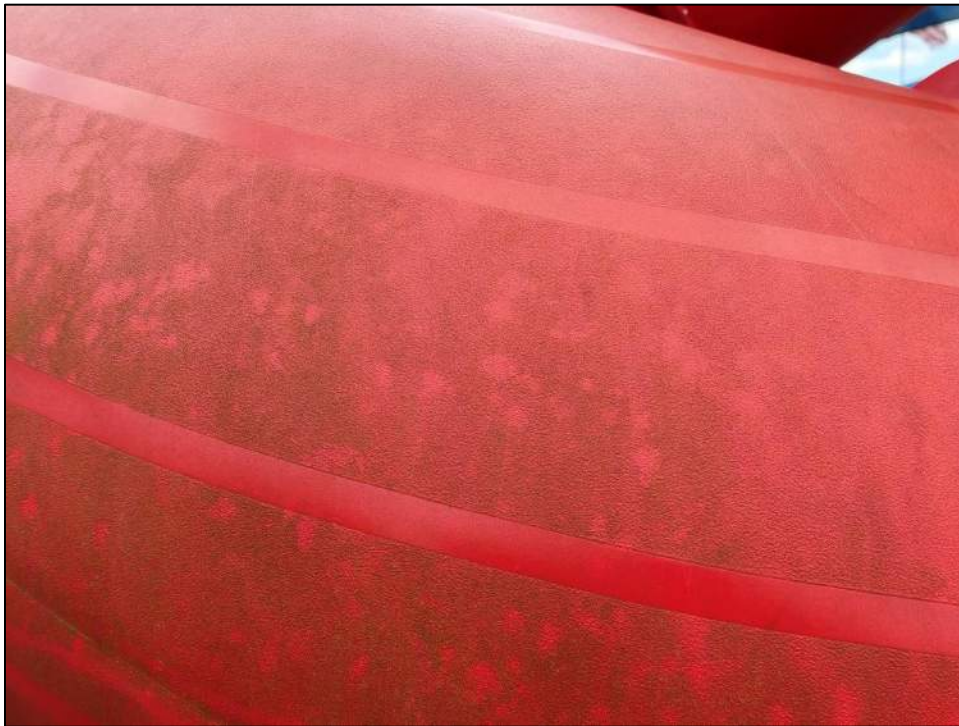
**Photo 118:** Top view of hail spatters on playset slides. No impact fractures were observed.

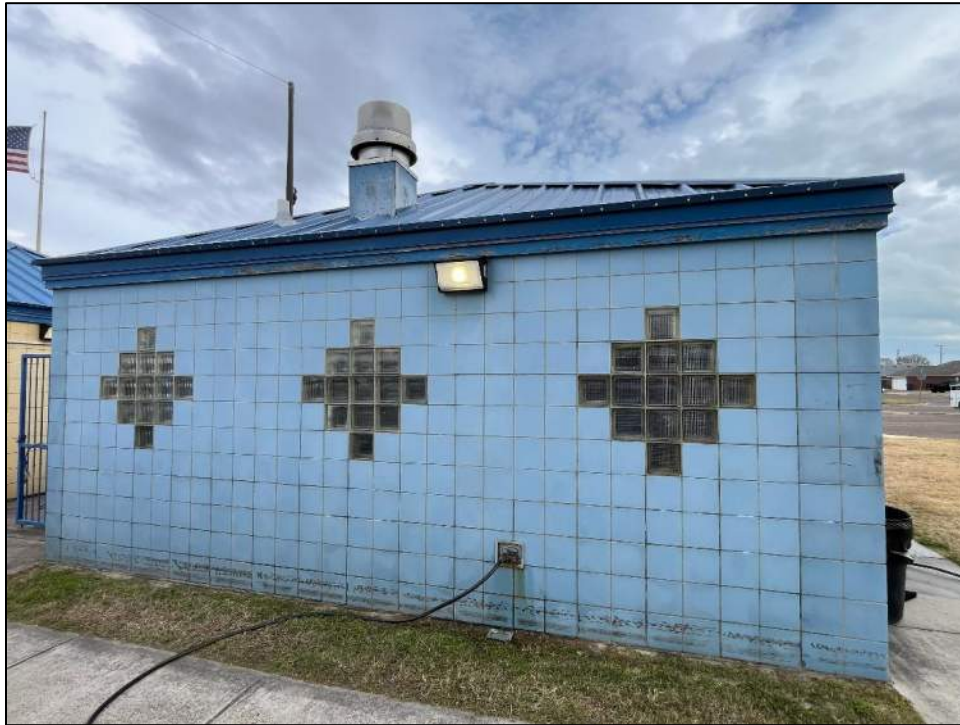
**Photo 123:** West elevation.

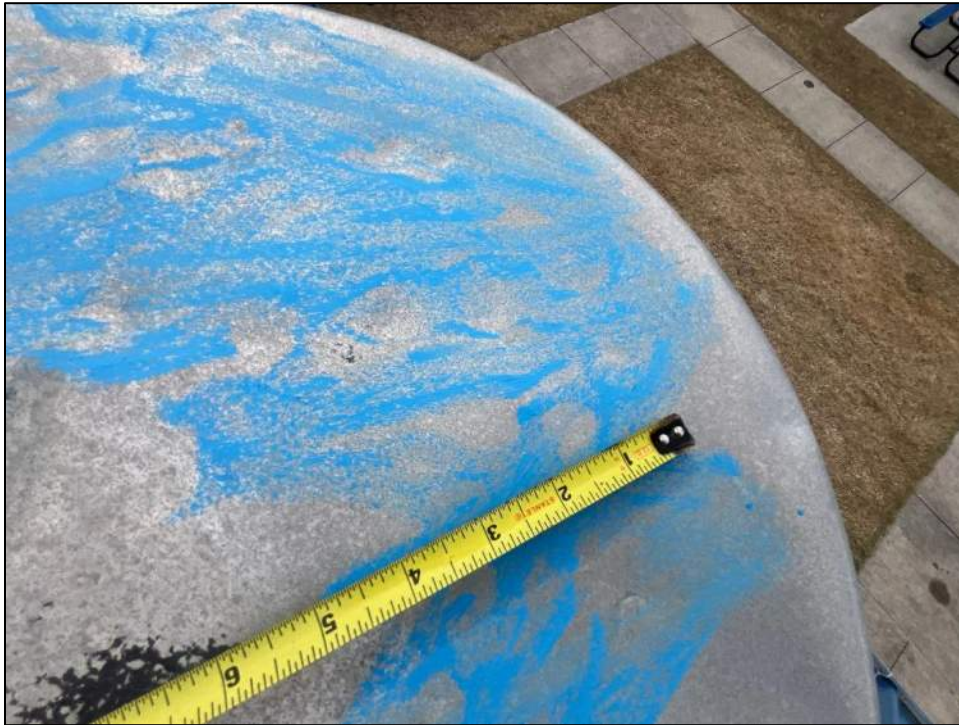
**Photo 132:** Hail dents on the top of the aluminum vent hood.

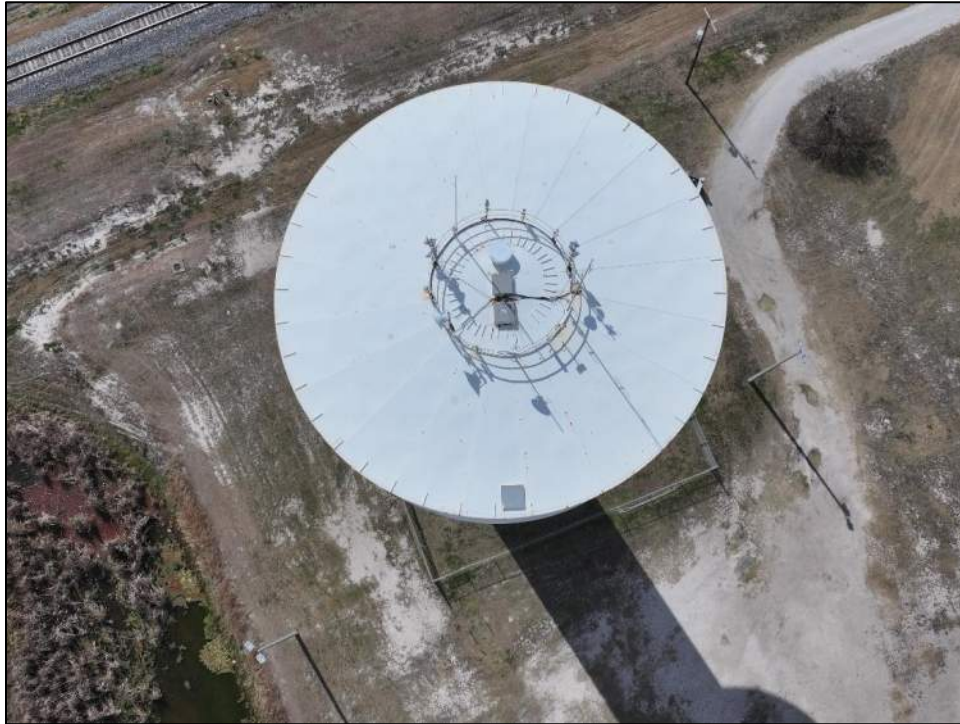
**Photo 1:** Top-down view of the water tower.

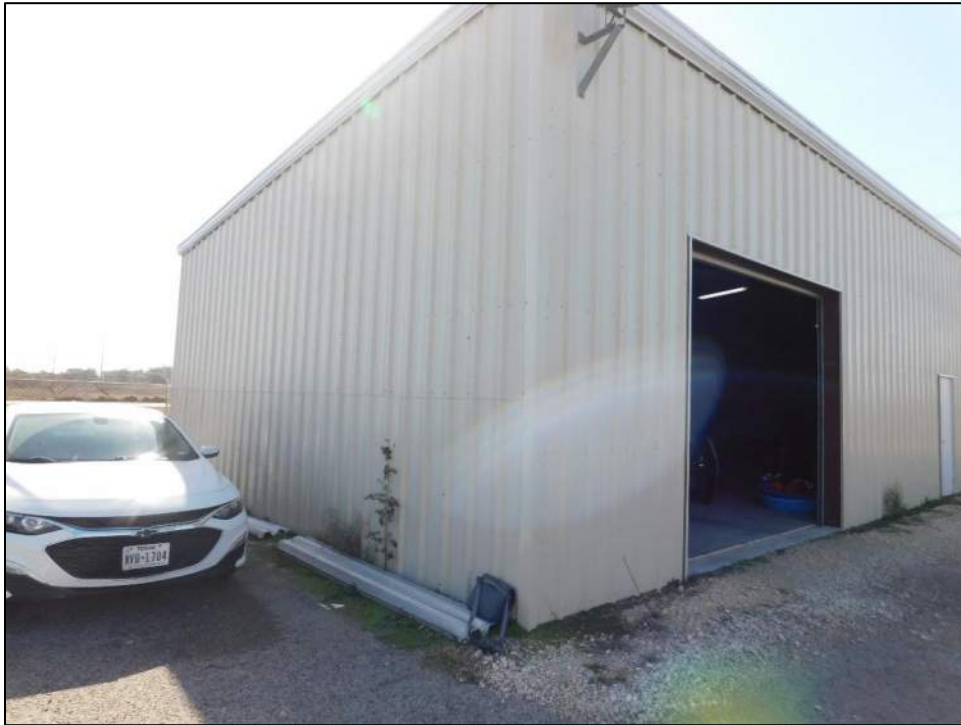
**Photo 5:** North elevation.

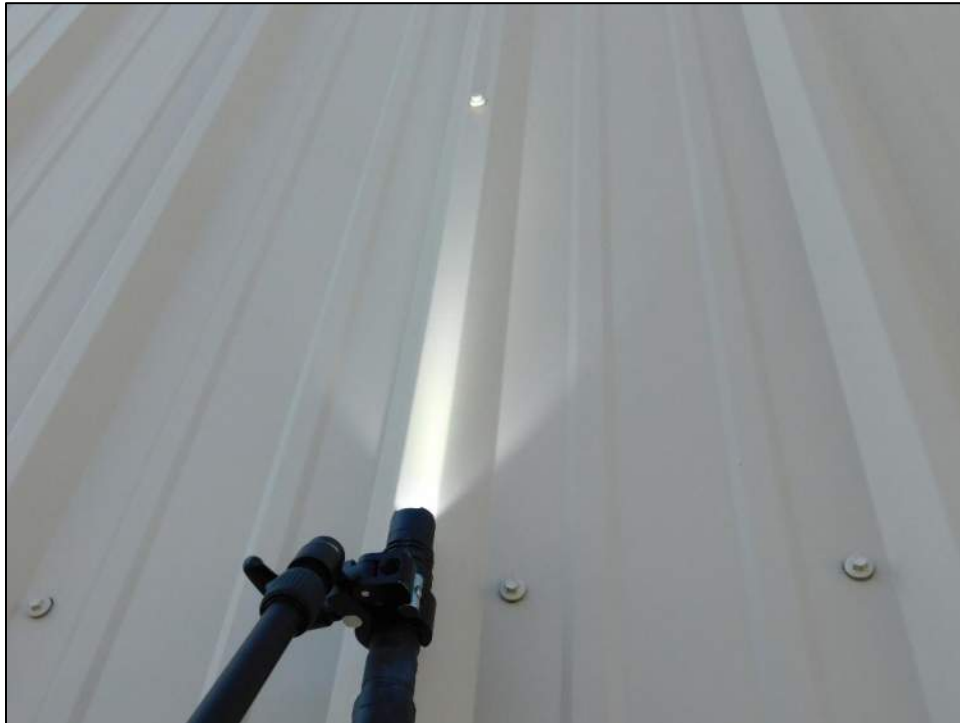
**Photo 7:** No hail denting visible on north or west walls.

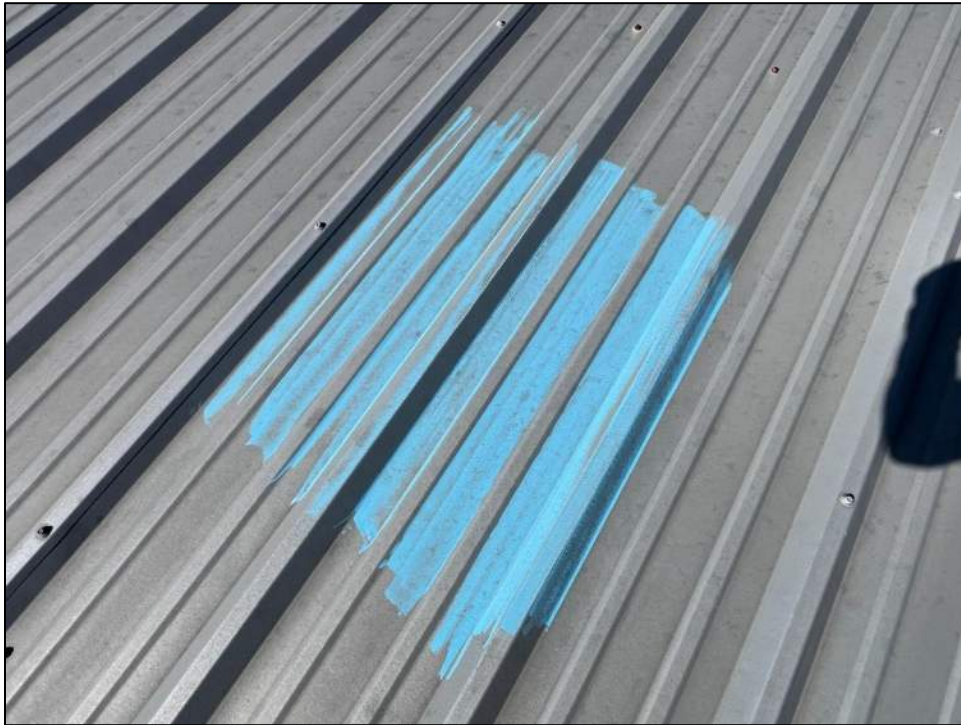
**Photo 17:** Denting consistent with hail impact was observed on the galvalume metal R-panel.

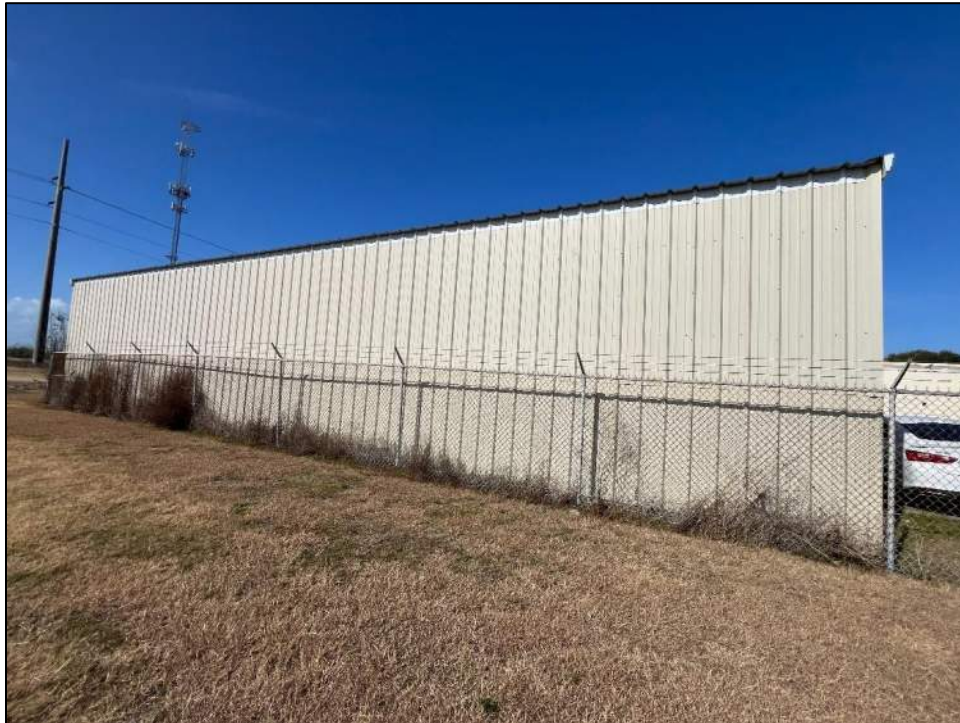
**Photo 23:** East elevation.

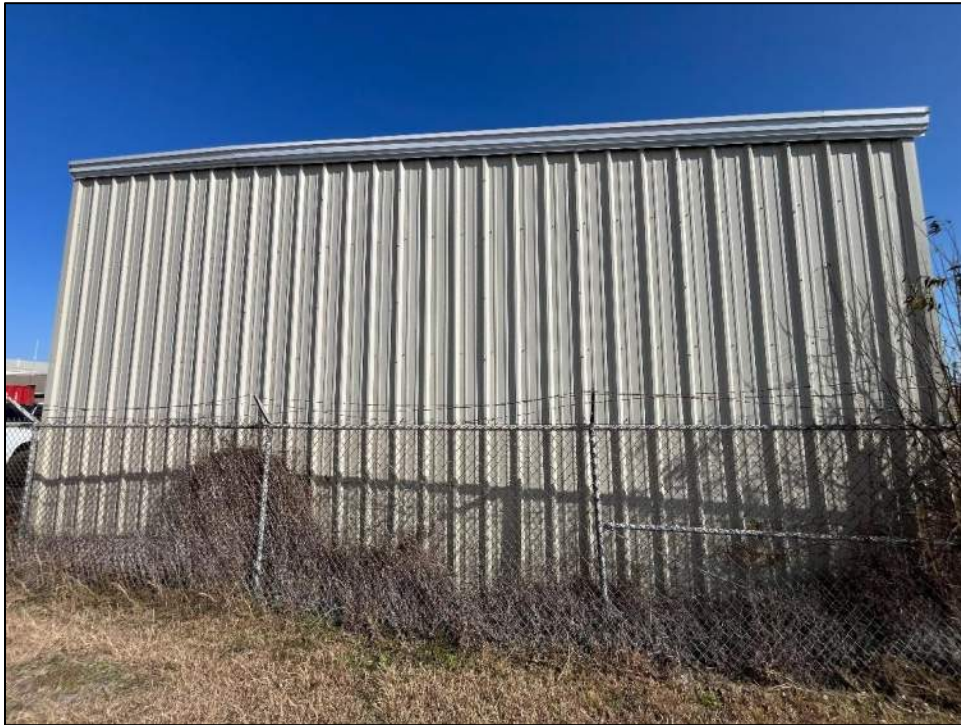
**Photo 25:** South elevation.

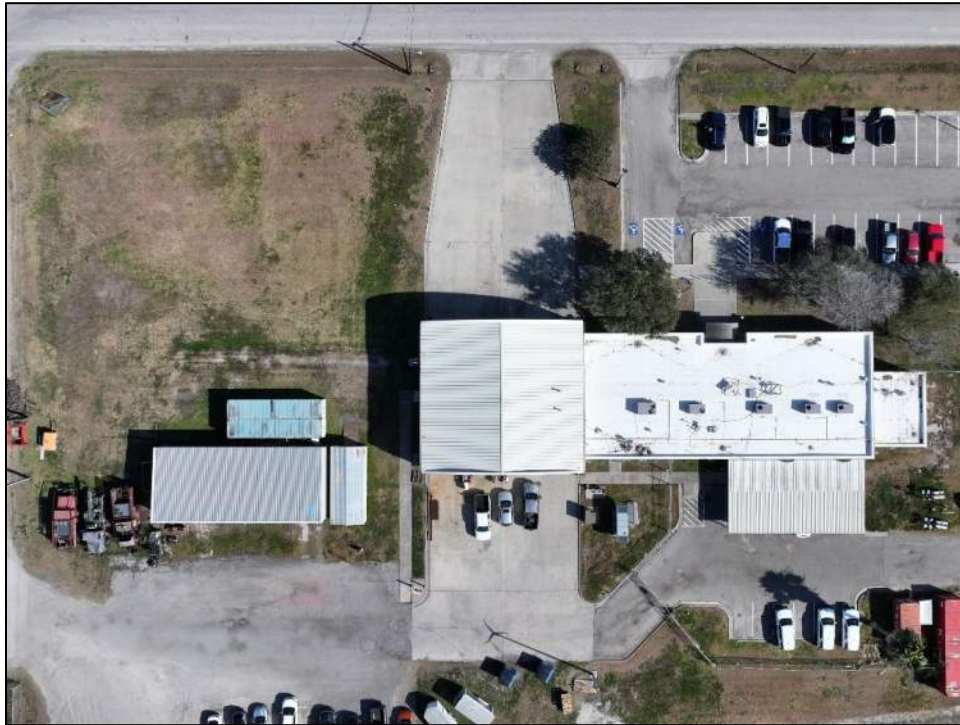
**Photo 27:** Top-down view of the police and fire department building (storage building on the left).

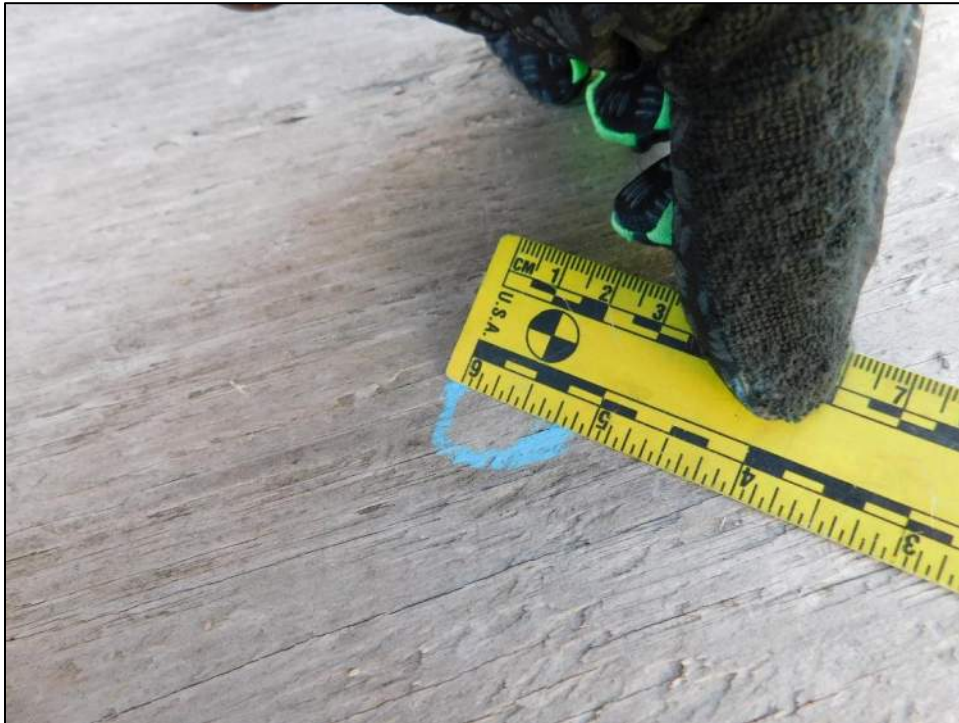
**Photo 39:** Hail spatters on nearby horizontal plywood surface resulted in no peck marks or wood grain disruptions.

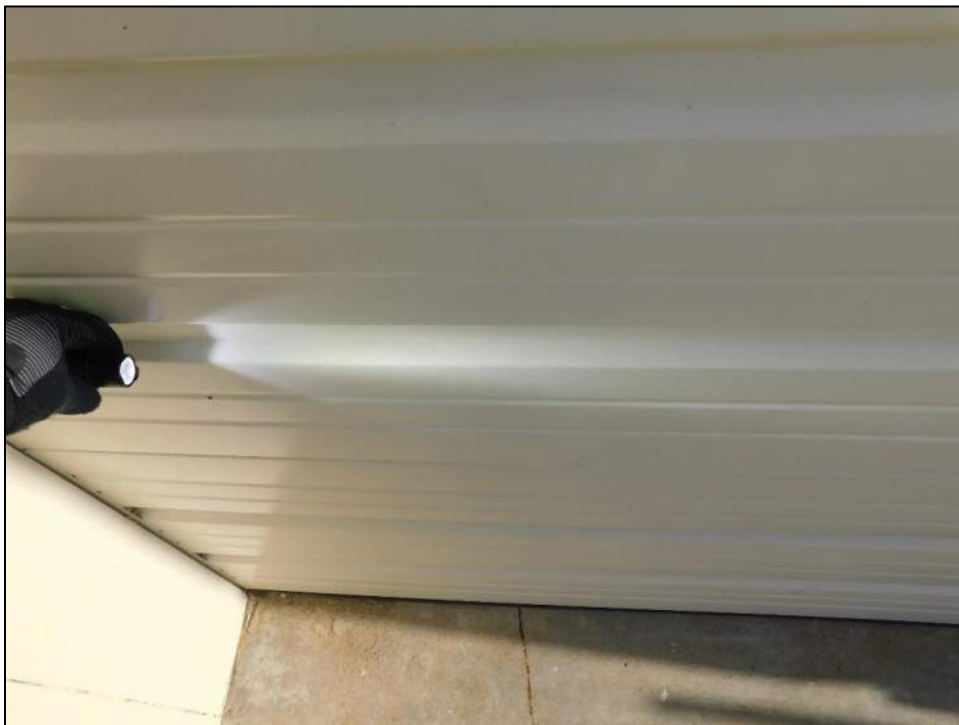
**Photo 40:** Rear roll-up doors exhibited no hail denting.

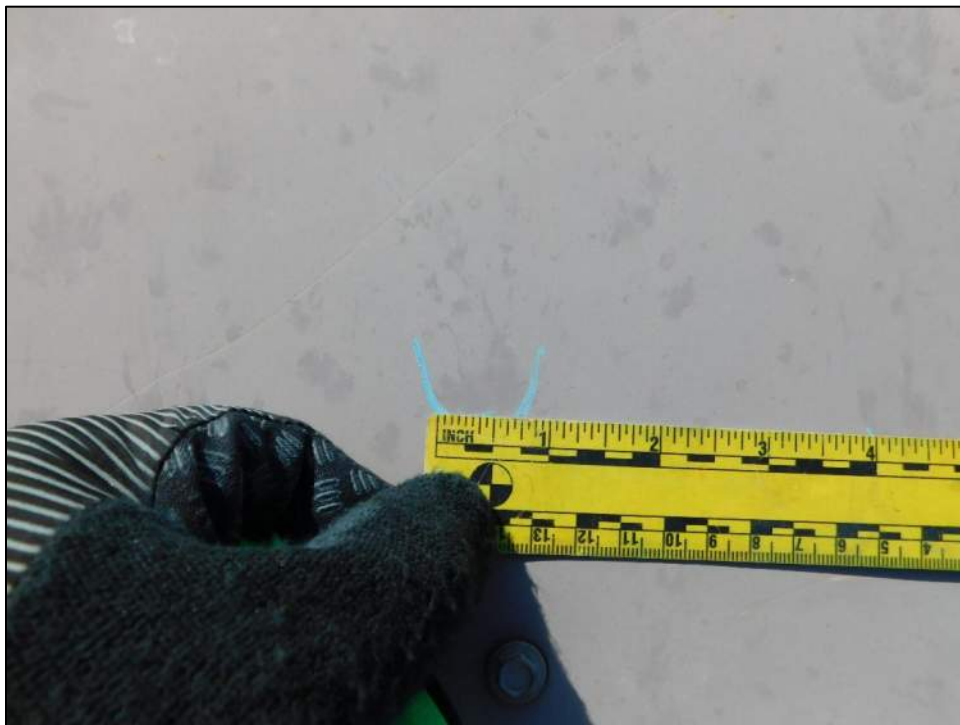
**Photo 58:** maximum hail spatter marks reflect 1.0-inch hail at the site.

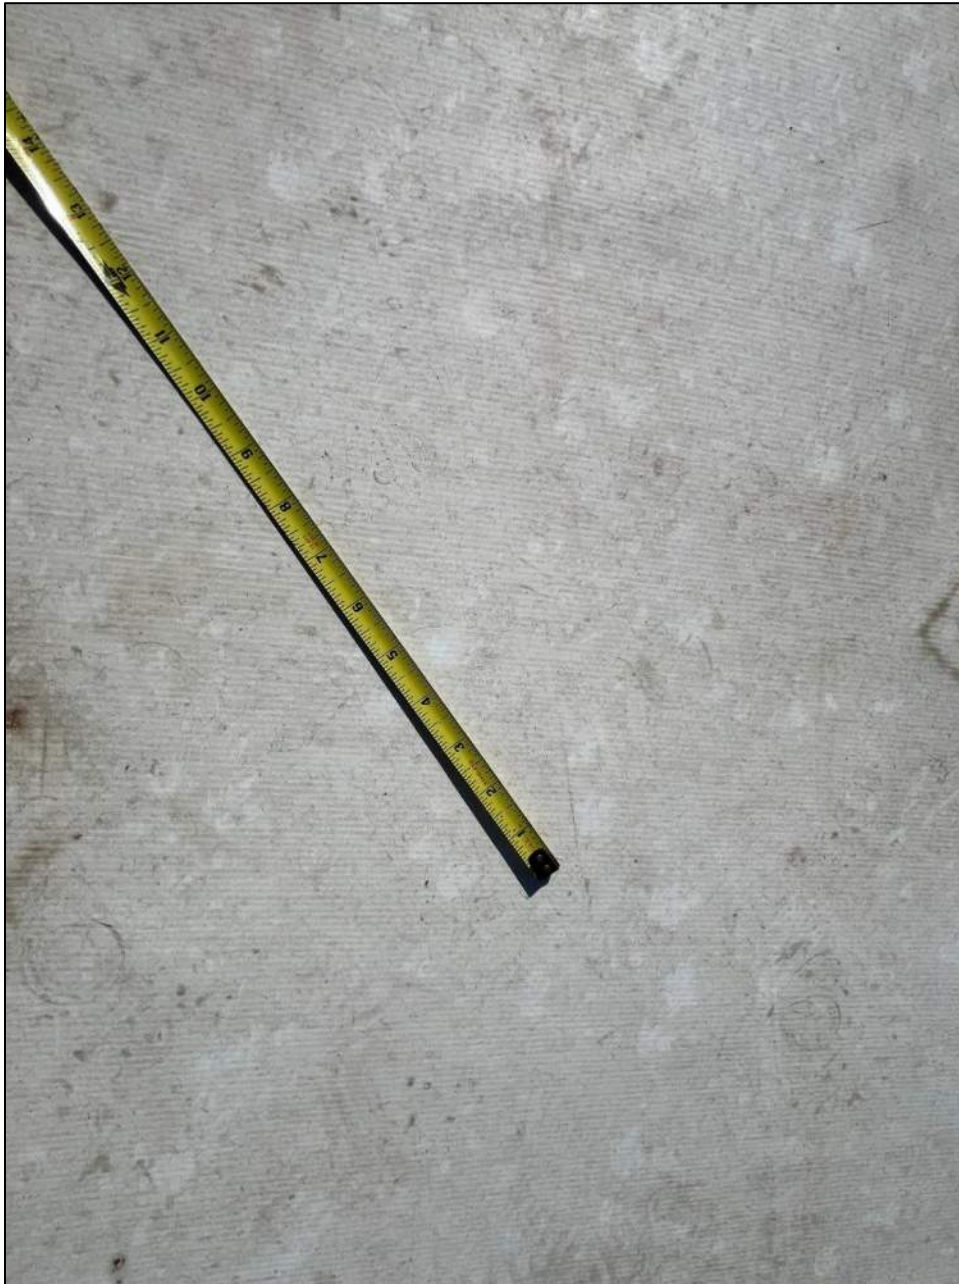
**Photo 74:** Largest hail spatters measured 1.0 inches in base width within the test square.

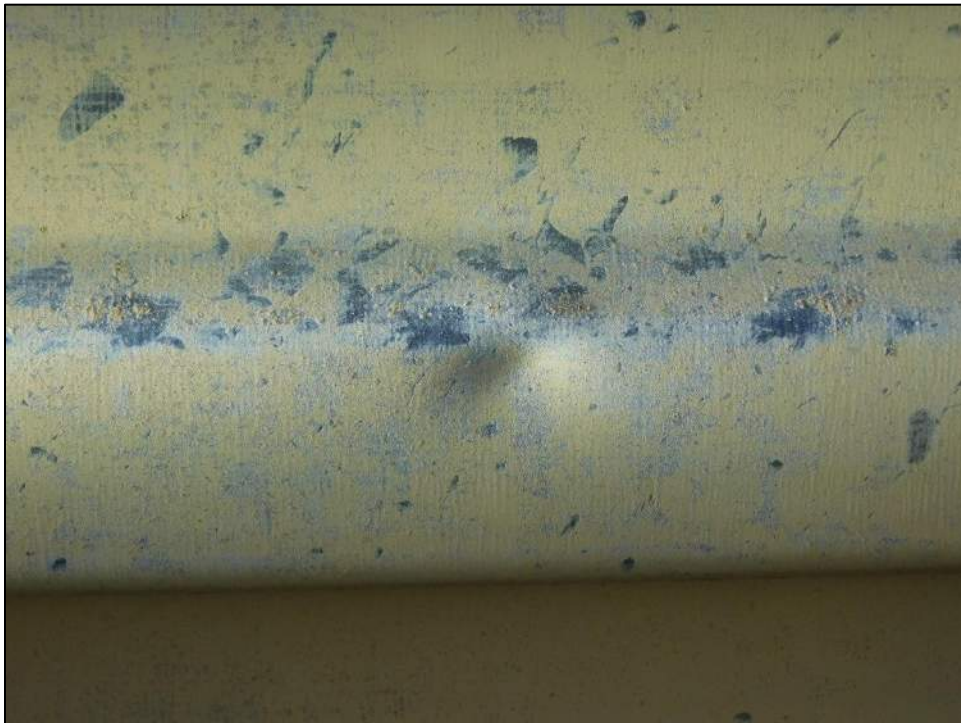
**Photo 95:** Denting on the front wall of the storage building unaccompanied by hail spatter.
