**CITY OF INGLESIDE  
REGULAR CITY COUNCIL MEETING  
AGENDA  
JUNE 9, 2026  
6:30 PM**

Report on November 01, 2025, Hailstorm Damage to City of Ingleside Buildings.

### Building Damage Analysis Survey and Report

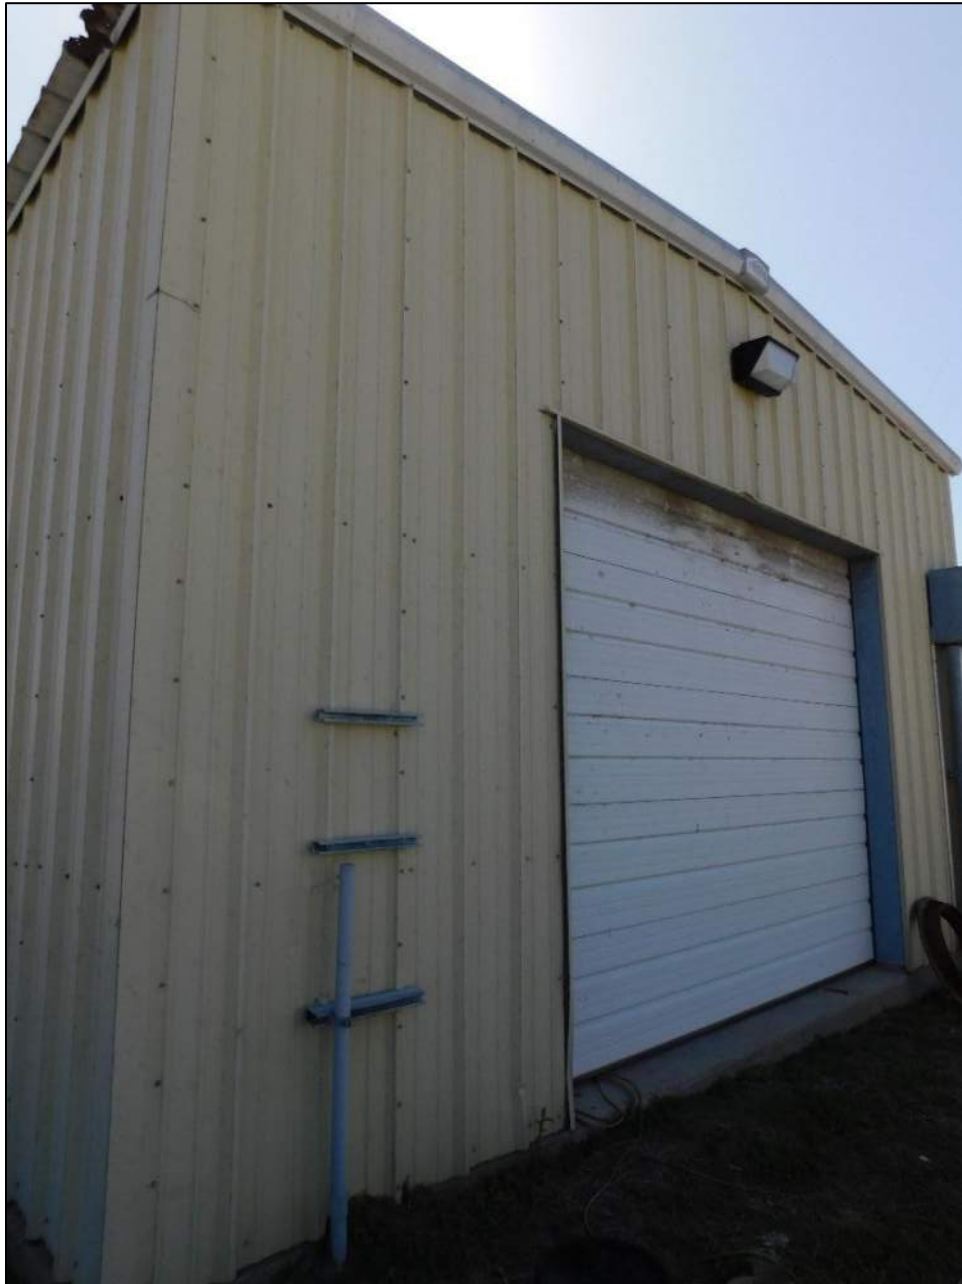
**Photo 4:** West elevation.

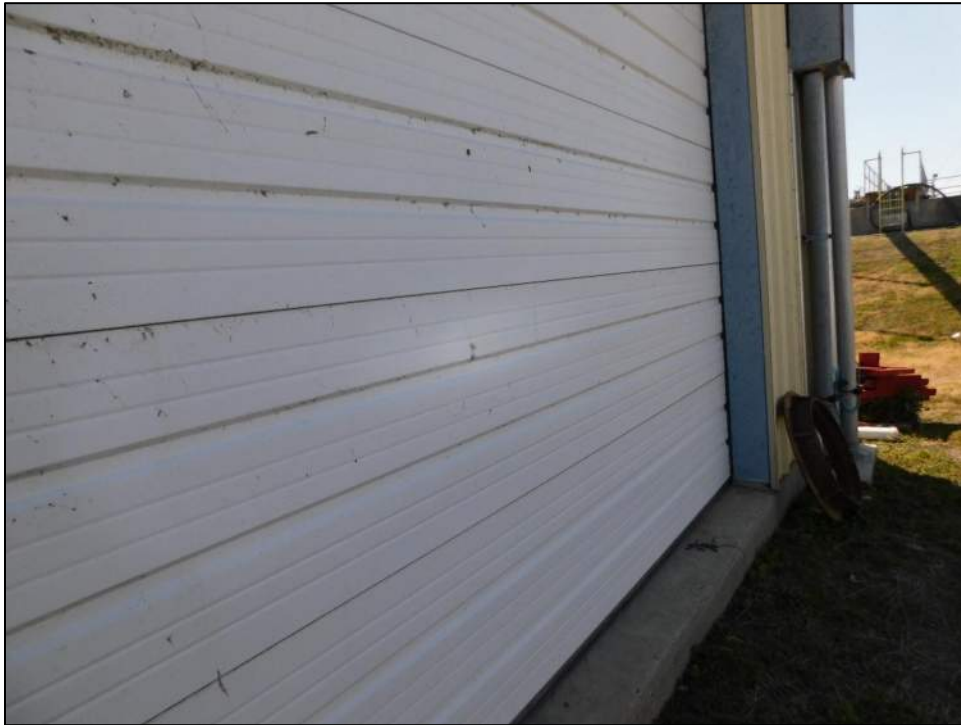
**Photo 10:** No hail denting was observed on the west wall roll-up door panels.

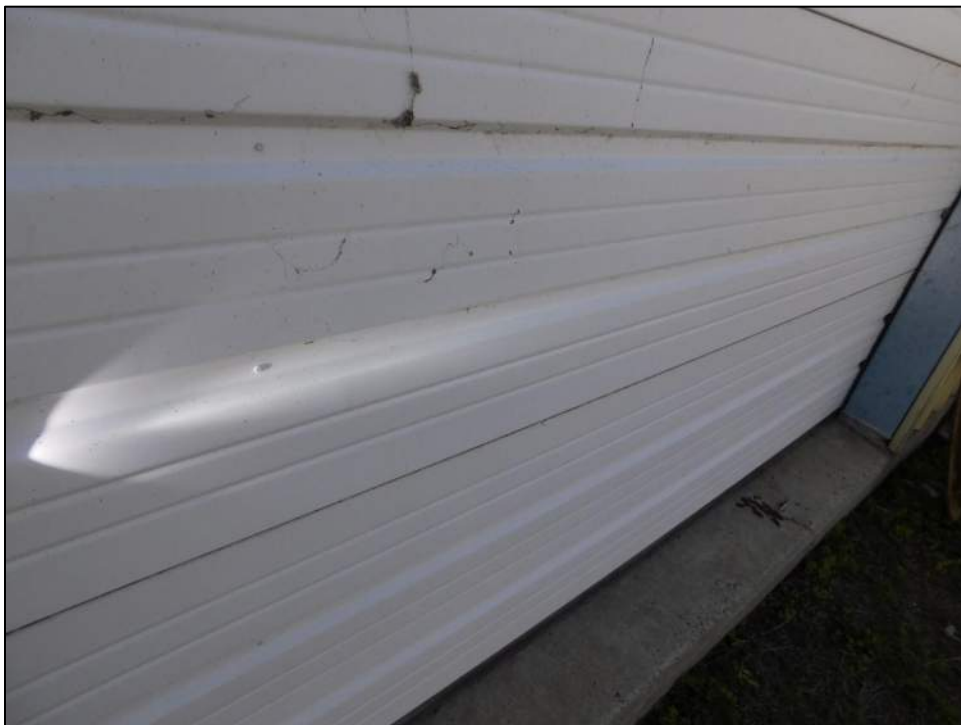
**Photo 11:** No hail denting was observed on the west wall roll-up door panels.

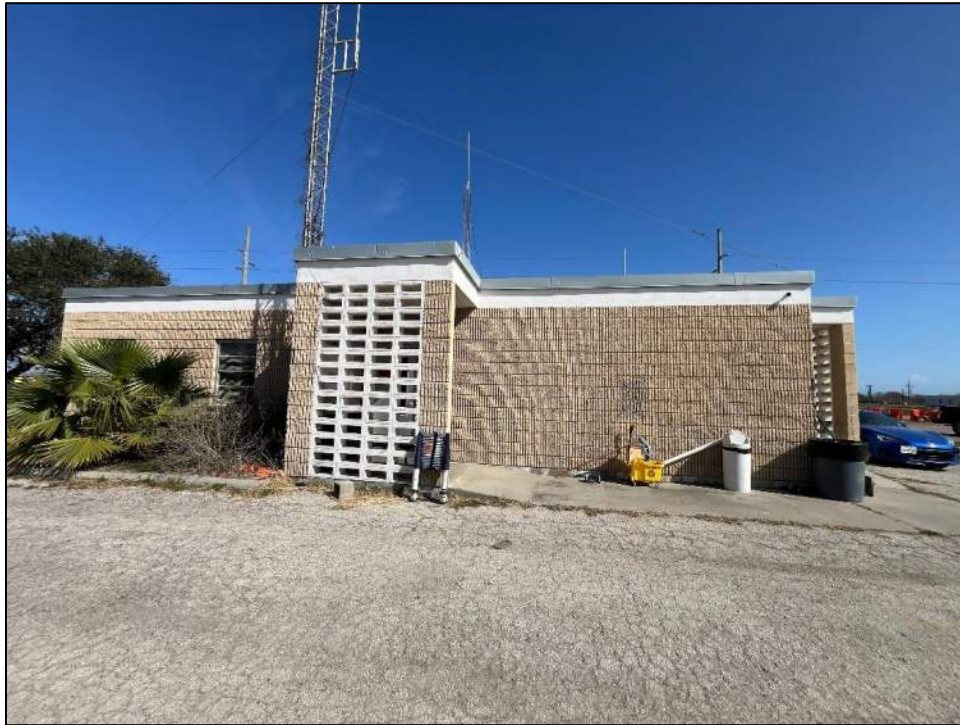
**Photo 35:** Crumbled southwall masonry wall corner unaffected by hail impact.

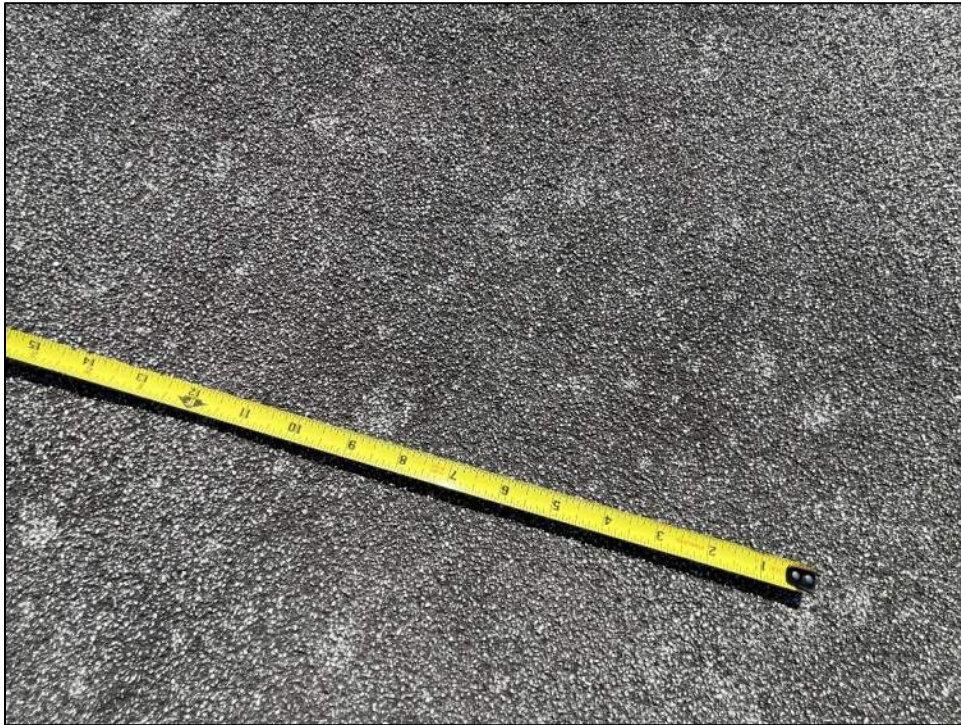
**Photo 43:** Spatters consistent with recent hail was observed on the algae-covered mod-bit roofing.

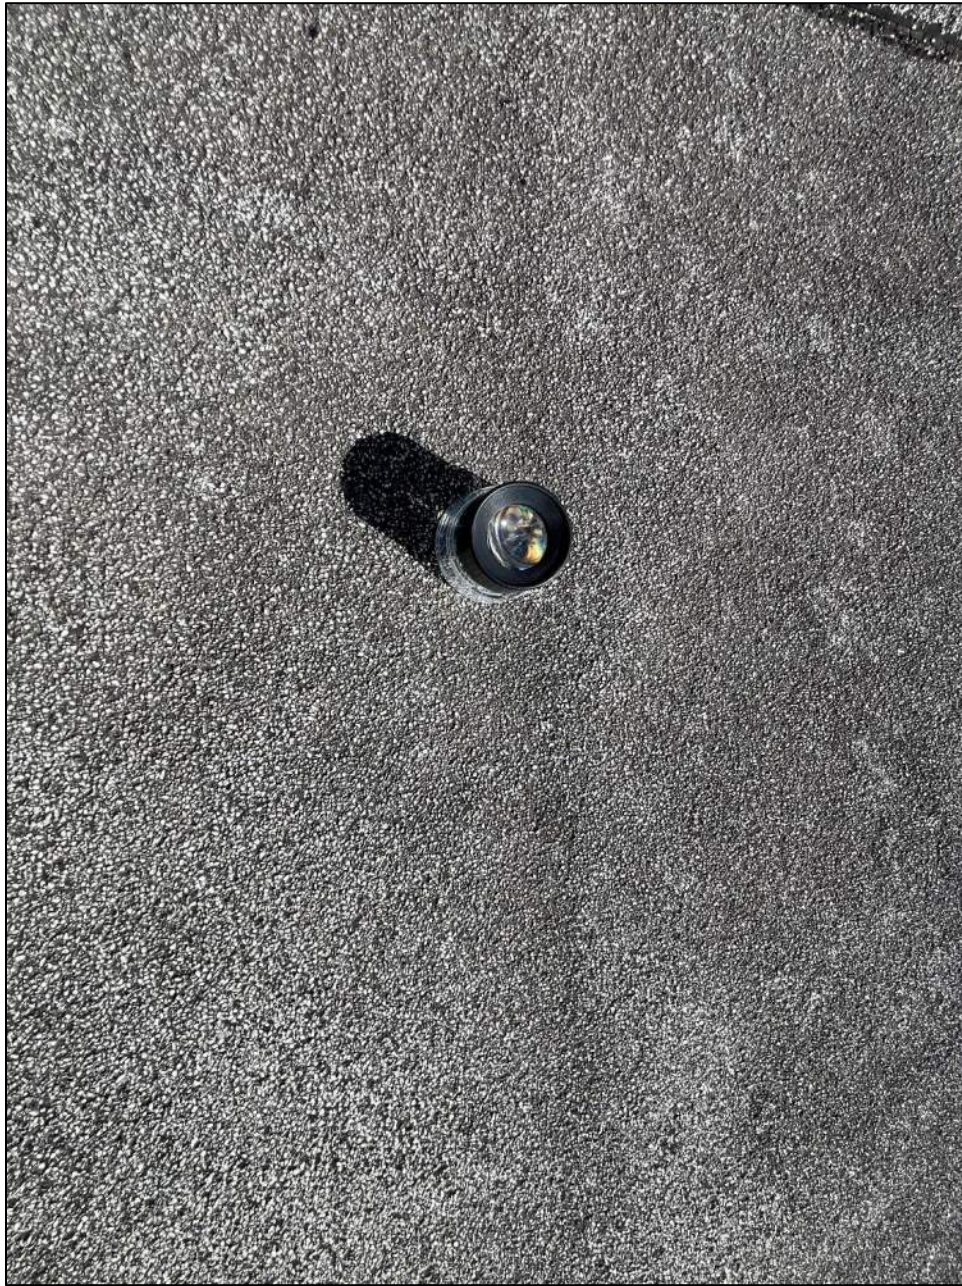
**Photo 47:** No granule displacement was observed at the largest hail spatters.

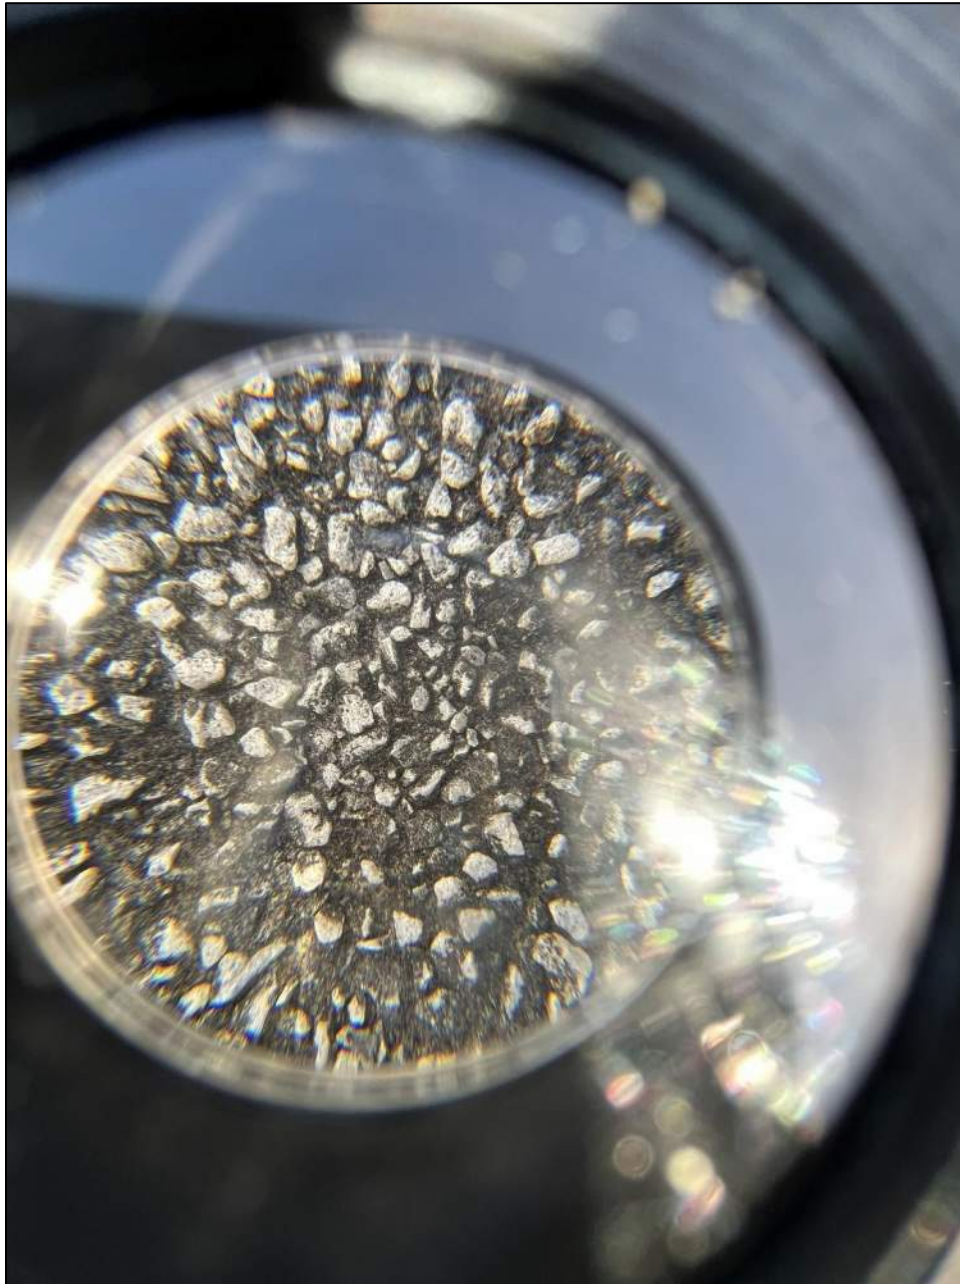
**Photo 48:** Microscope examination of the hail spatter exhibited granule displacement.

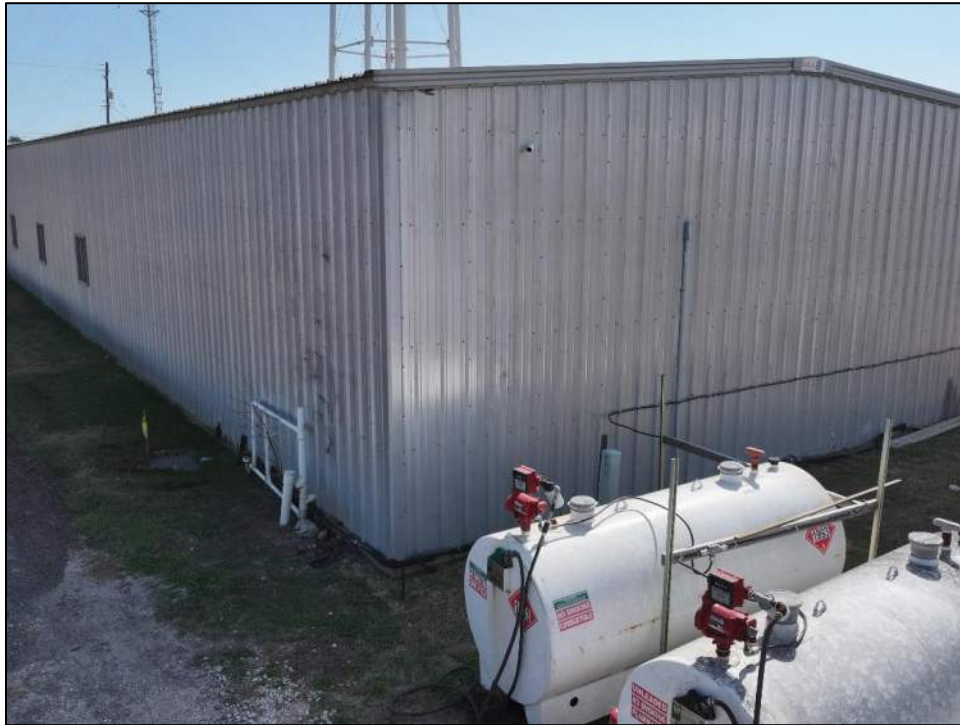
**Photo 51:** Rear elevation of the vehicle repair building. Screen covered louver windows were present along this elevation.

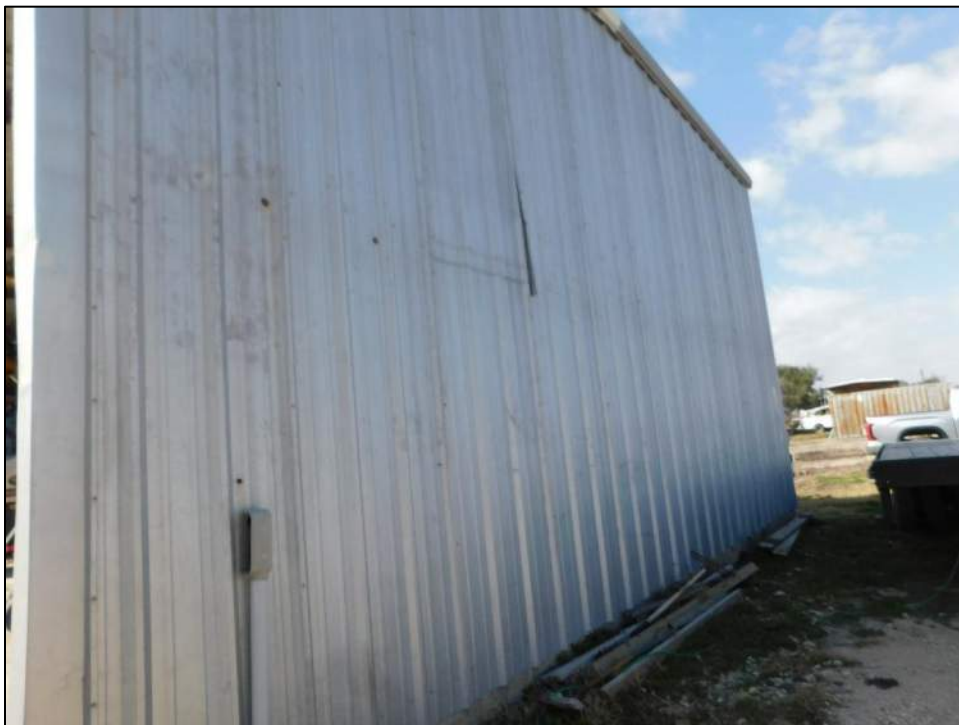
**Photo 76:** North elevation.

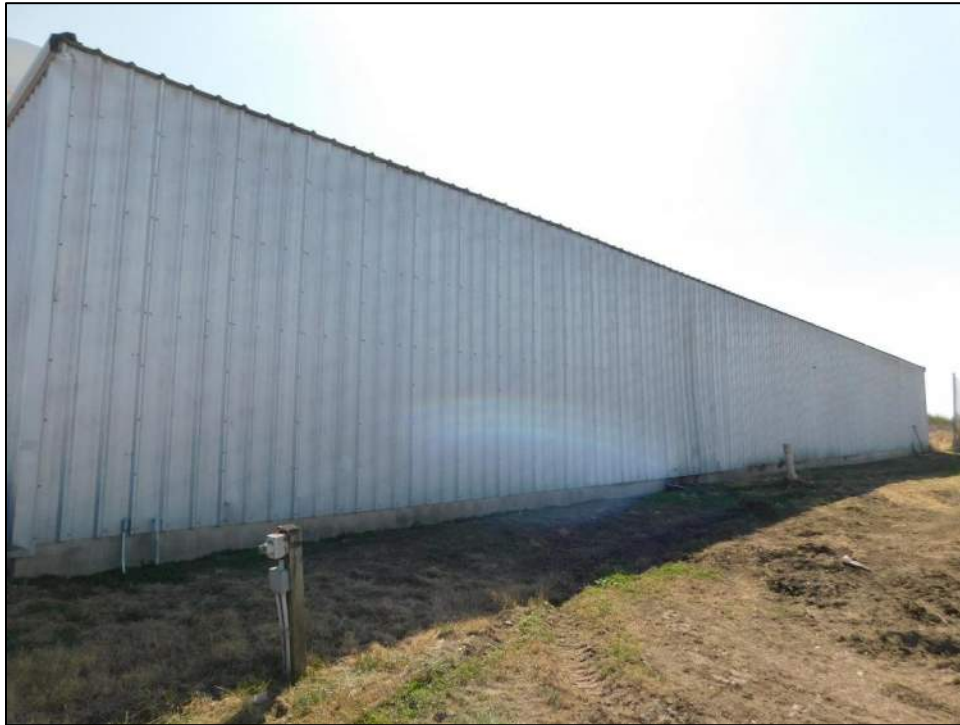
**Photo 77:** West elevation.

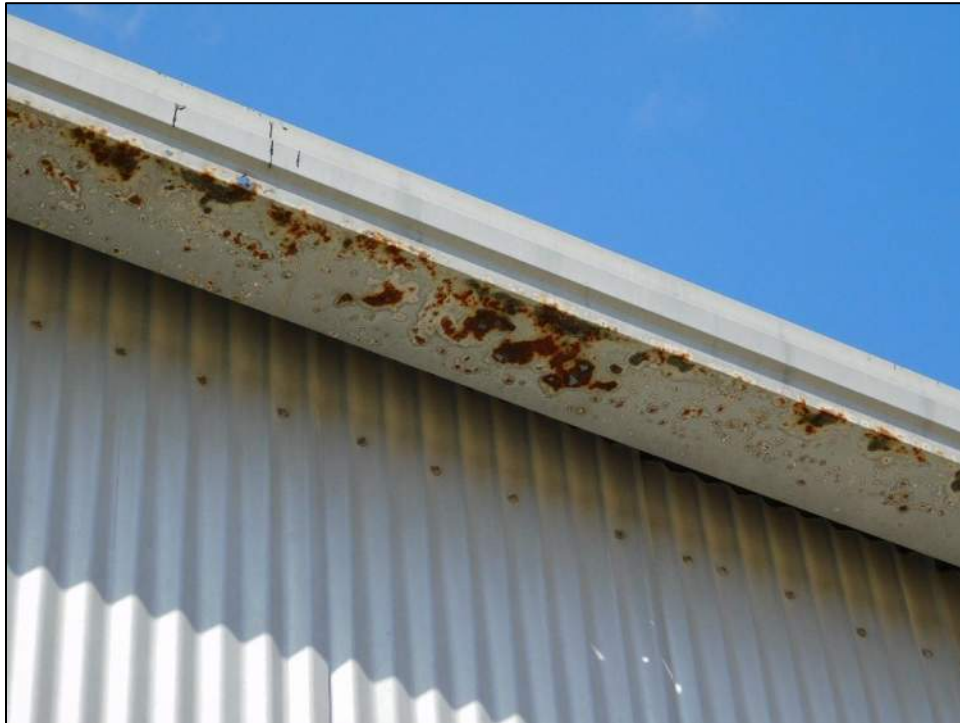
**Photo 89:** Corroded gutter.

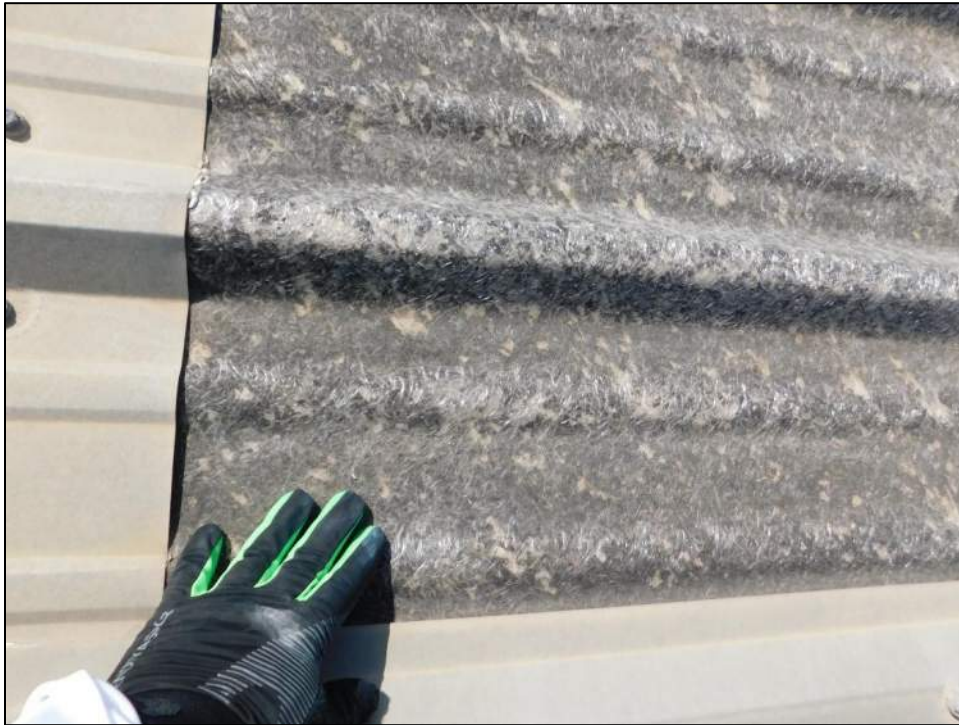
**Photo 91:** Skylight panels were not fractured at the spatters.

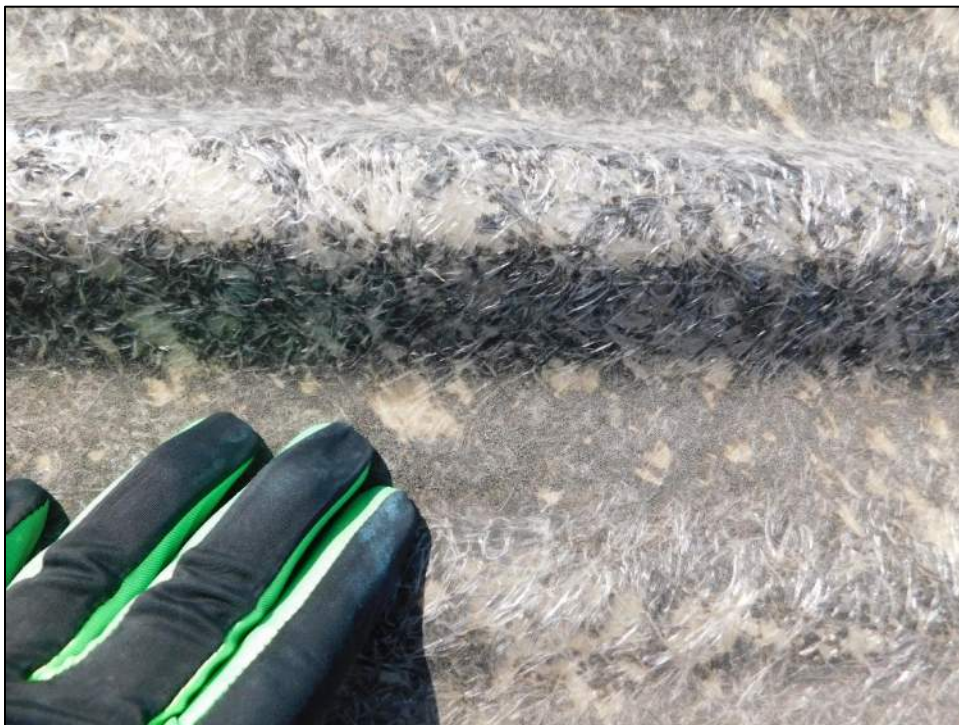
**Photo 92:** Skylight panels were not fractured at the spatters.

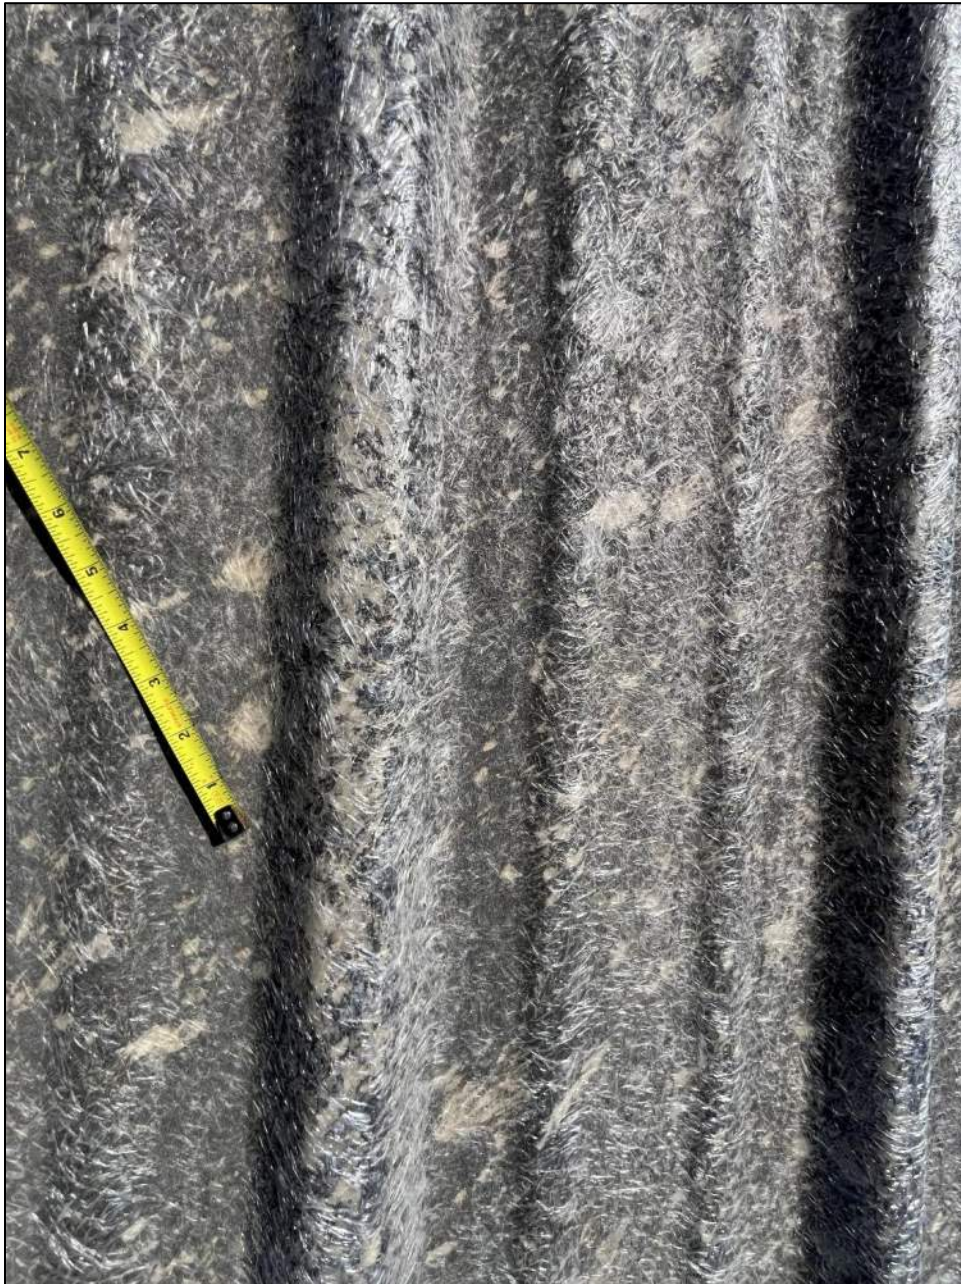
**Photo 94:** Skylight panels were not fractured at the spatters.

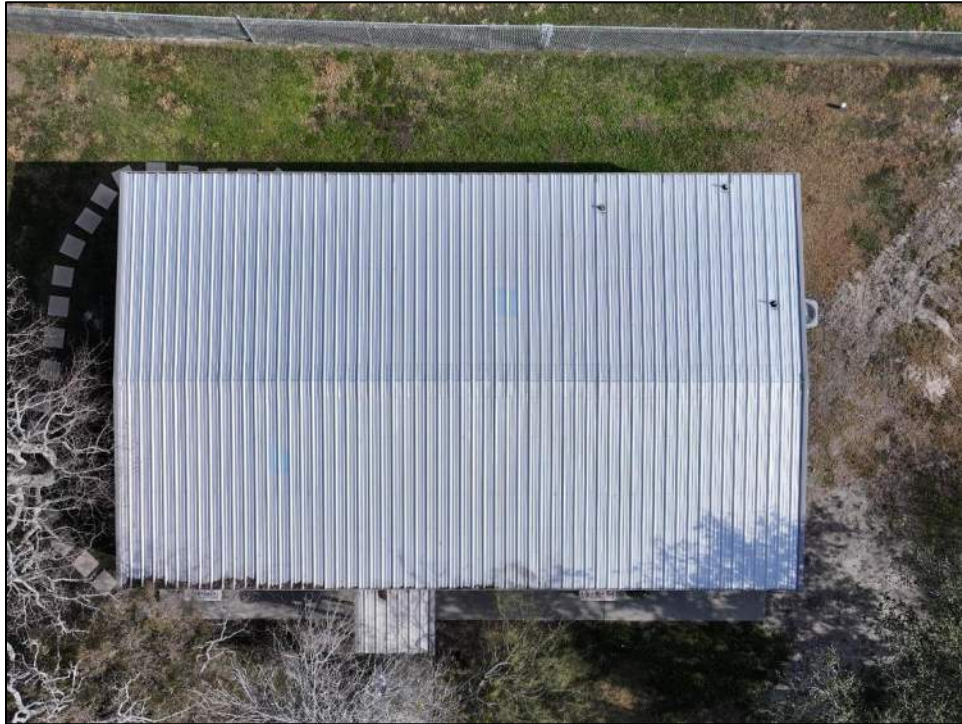
**Photo 1:** Roof overview.

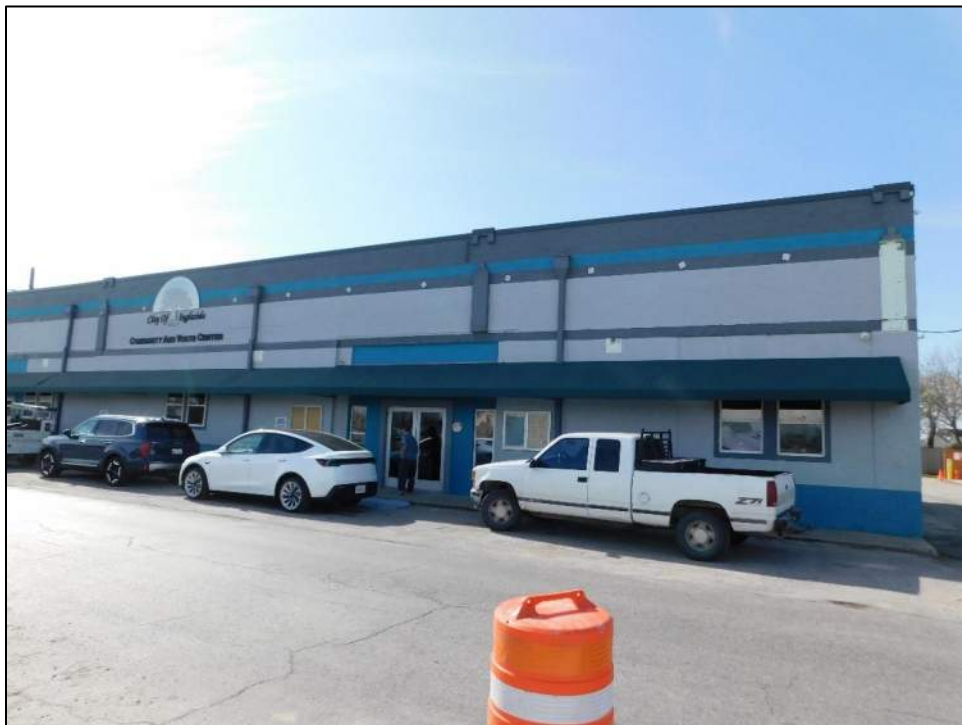
**Photo 3:** North wall. Separated roof decorative feature was a pre-existing condition.

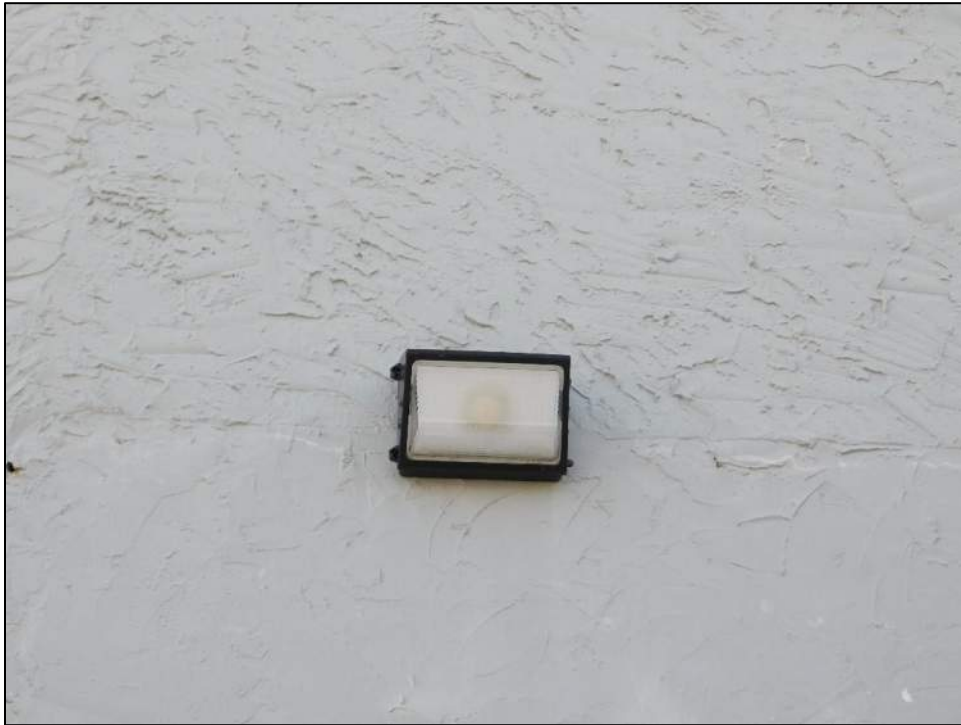
**Photo 14:** Slight hail spatters on west wall.

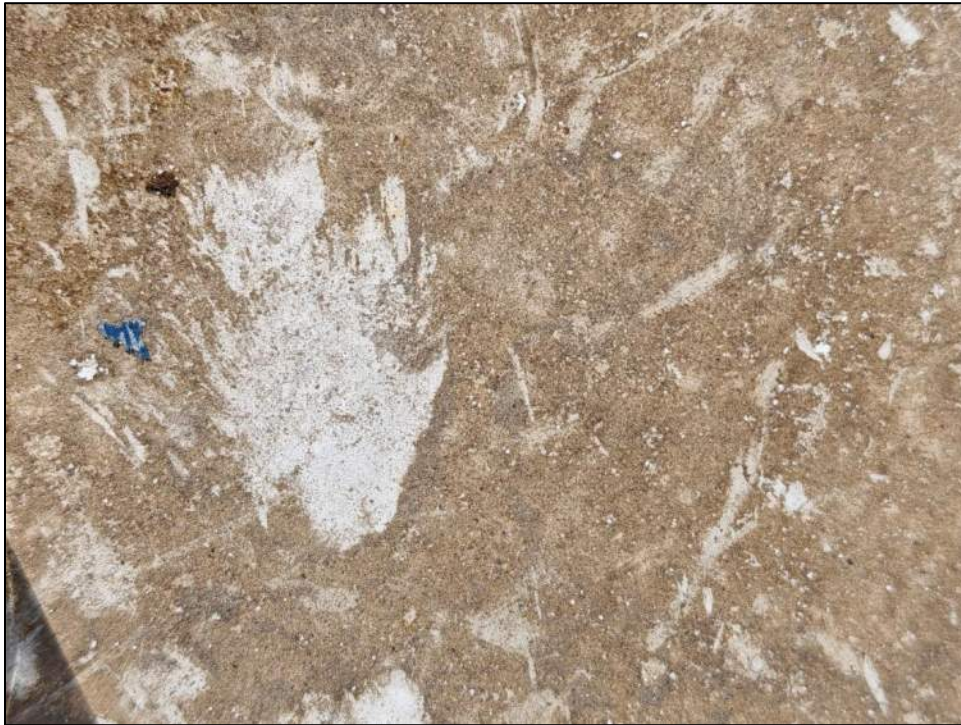
**Photo 29:** Close-up of a hail spatter.

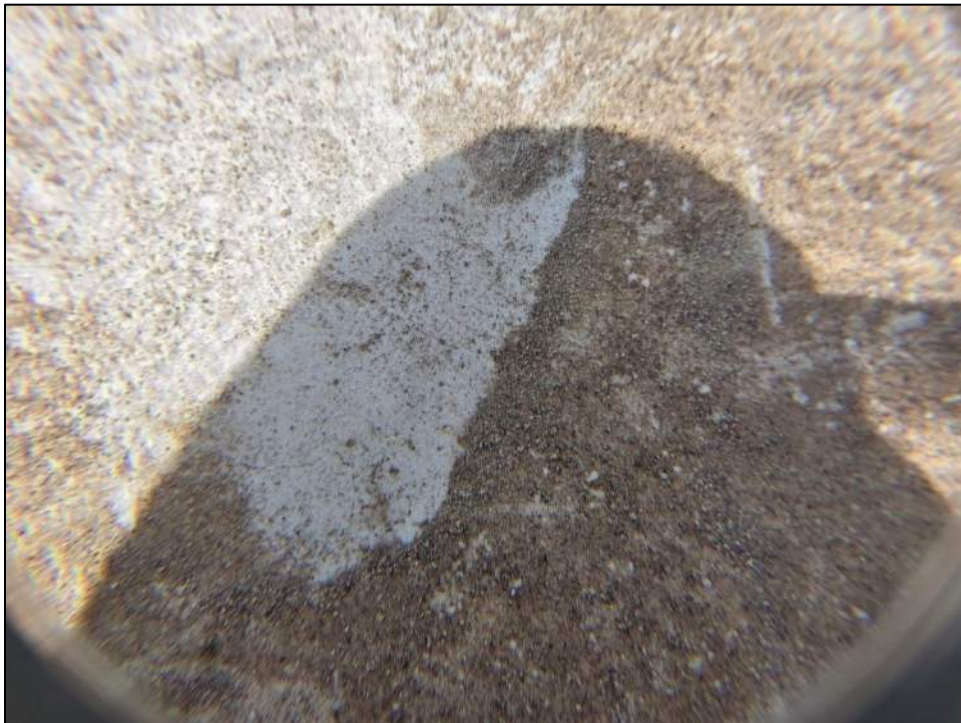
**Photo 30:** Microscope examination indicates no surface disruption at the spatter except for oxidation and grime displacement.

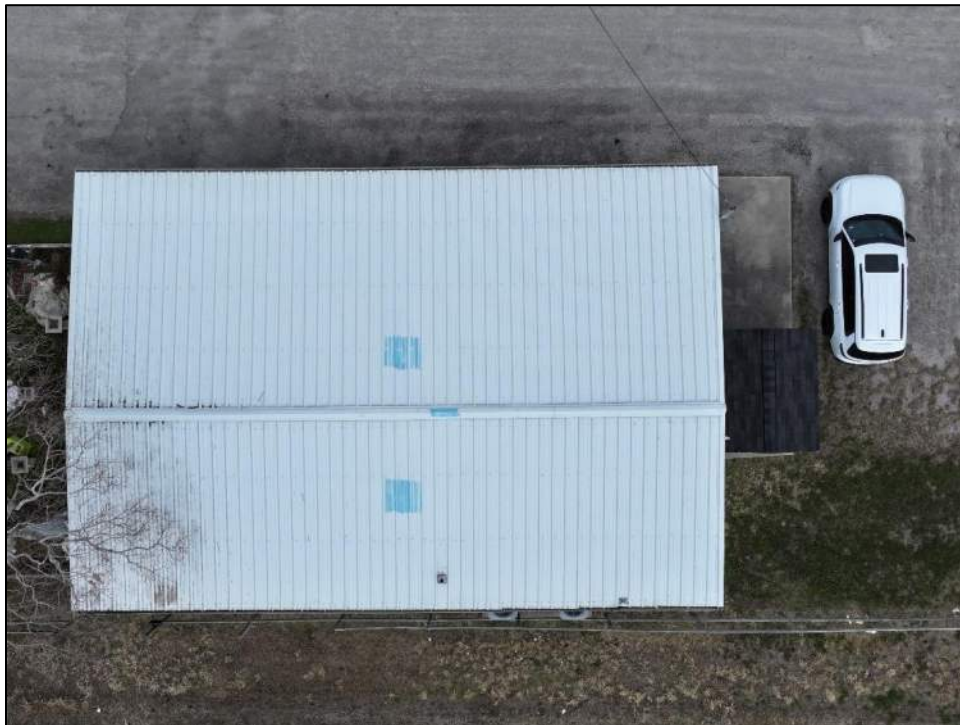
**Photo 1:** Roof overview.

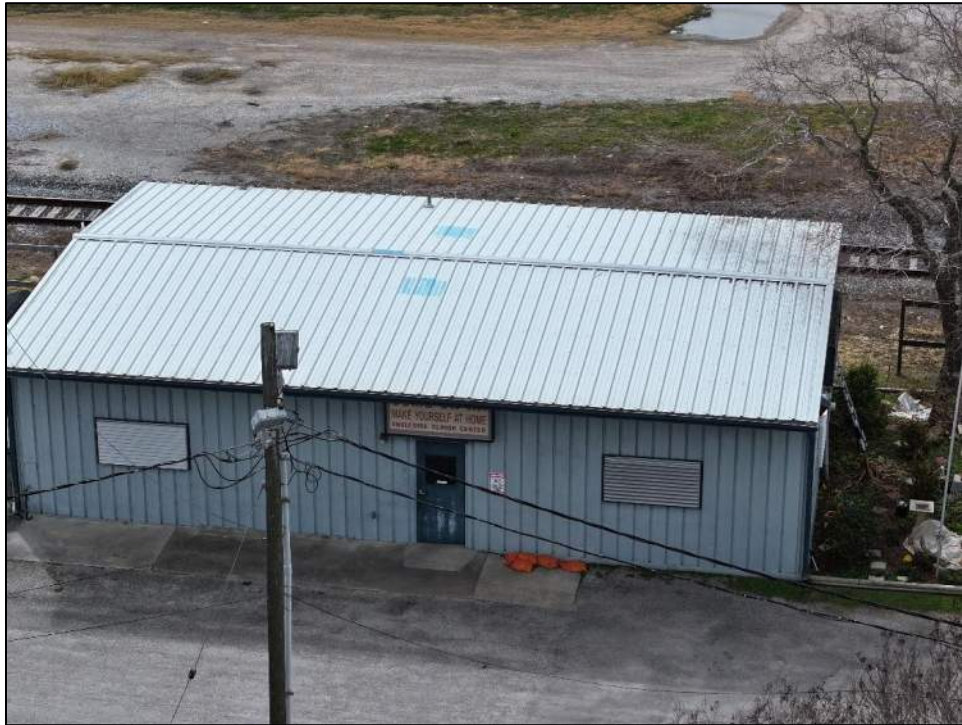
**Photo 3:** Front (north) elevation.

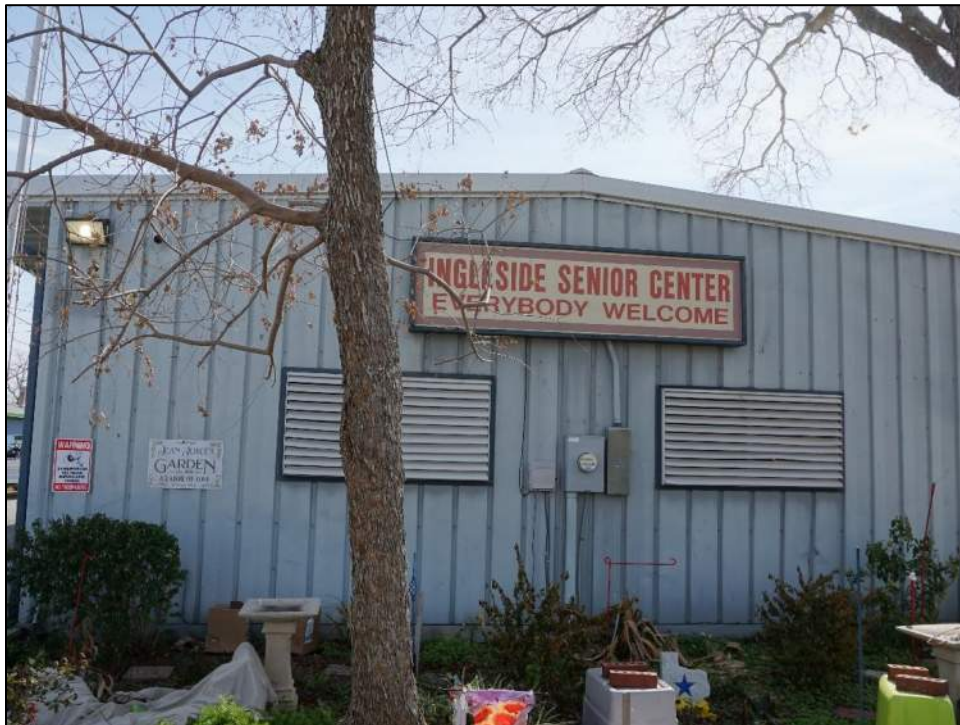
**Photo 5:** West elevation.

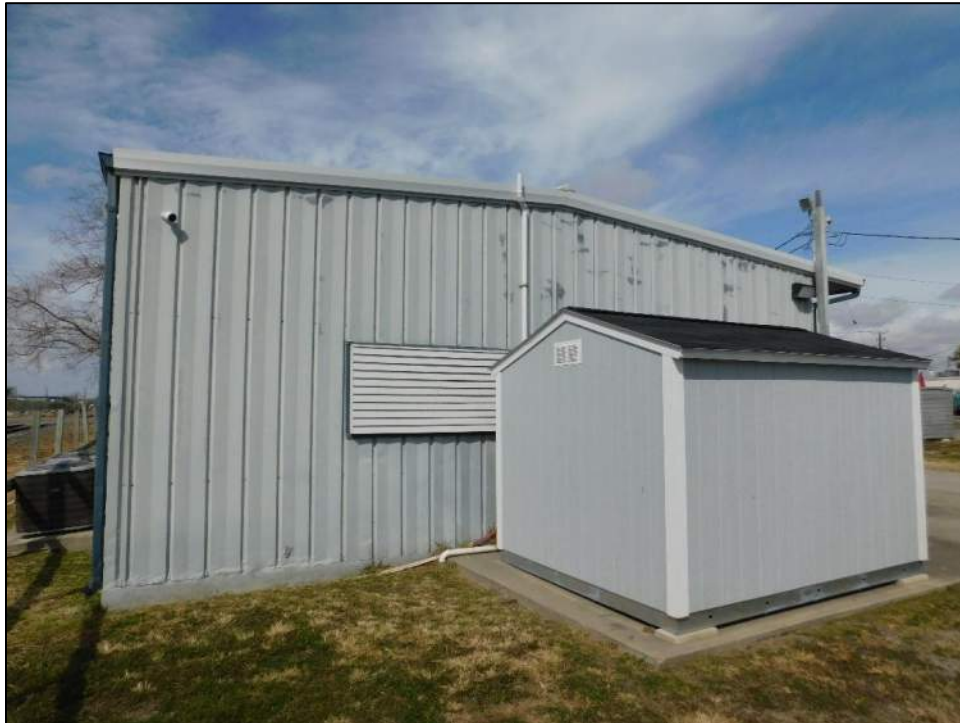
**Photo 7:** East elevation wall panels exhibited no hail spatters.

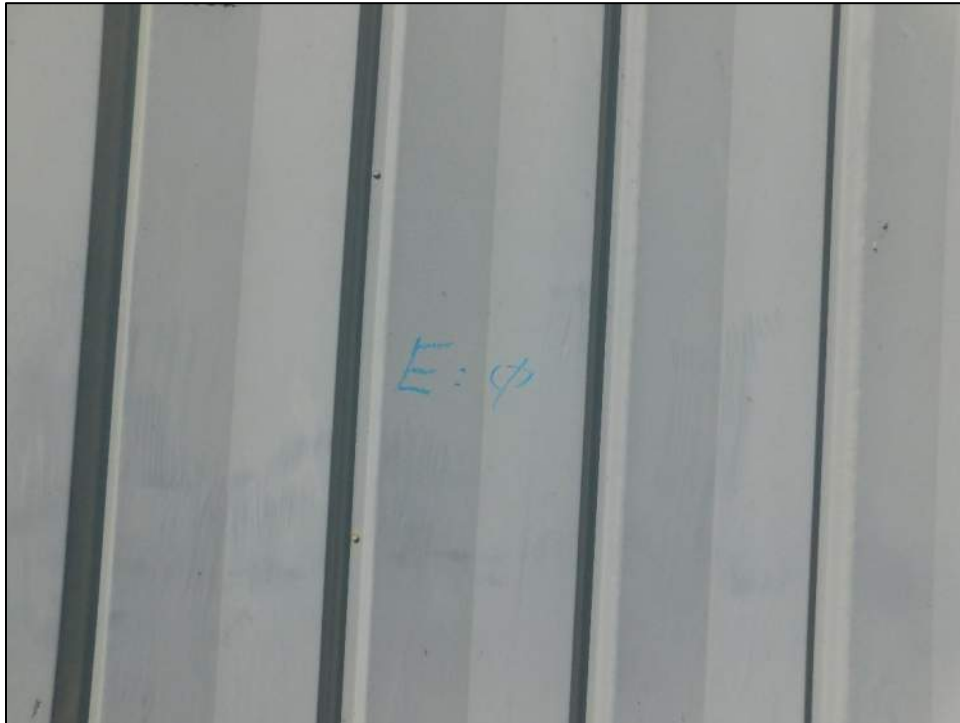
**Photo 9:** East elevation wall panels exhibited no hail spatters.

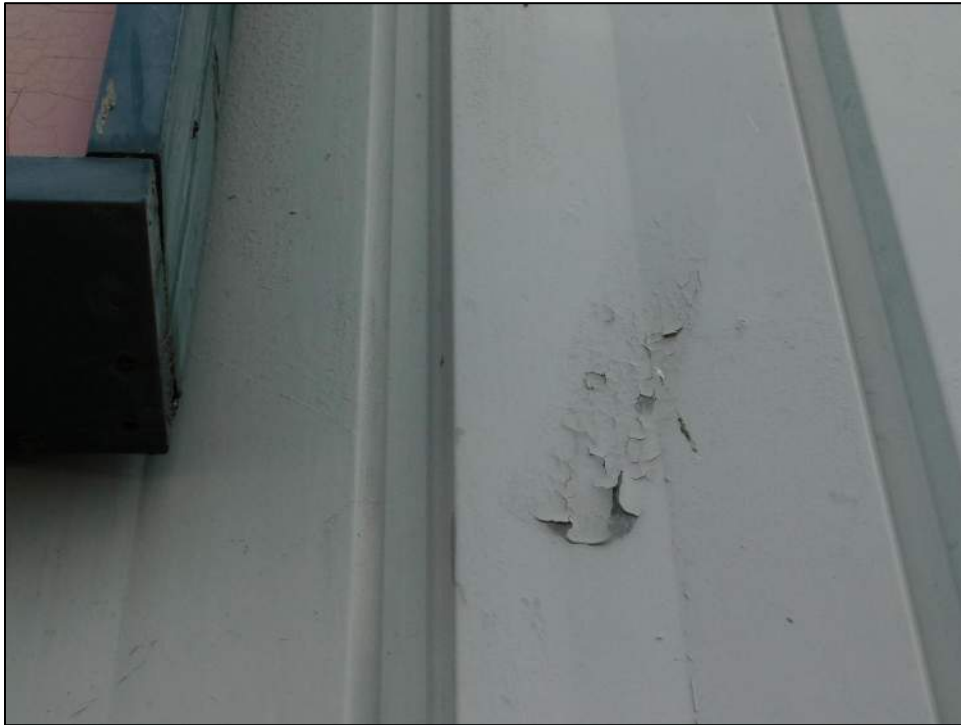
**Photo 21:** Paint peel near the west wall sign irrelevant to hail impact.

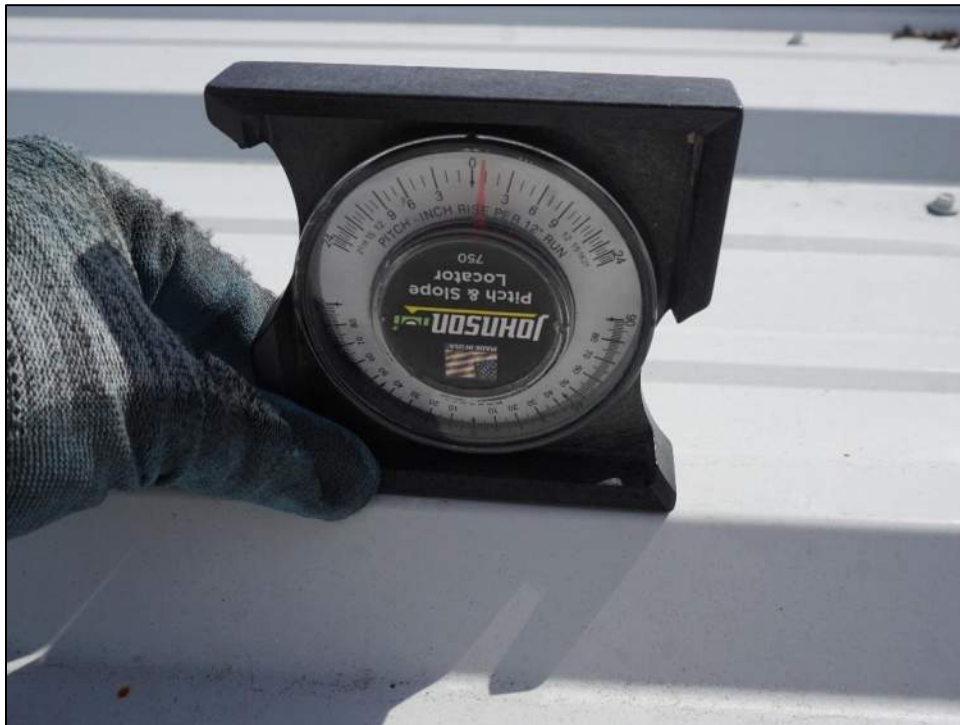
**Photo 23:** 1:12 roof pitch.

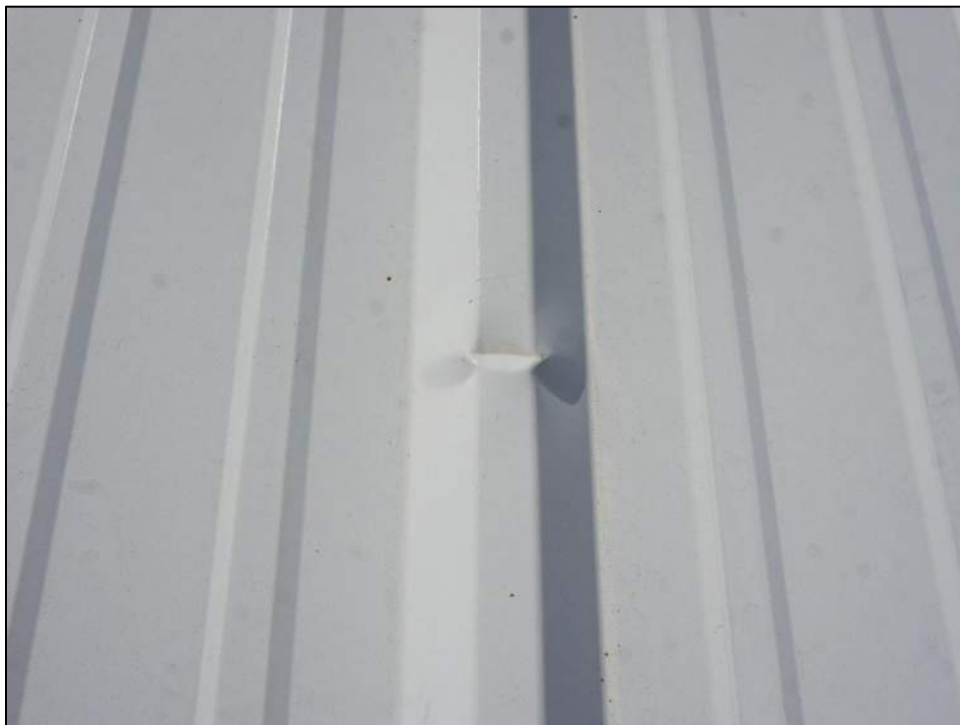
**Photo 26:** Roof panel rib creases inconsistent with effects of hail impact.

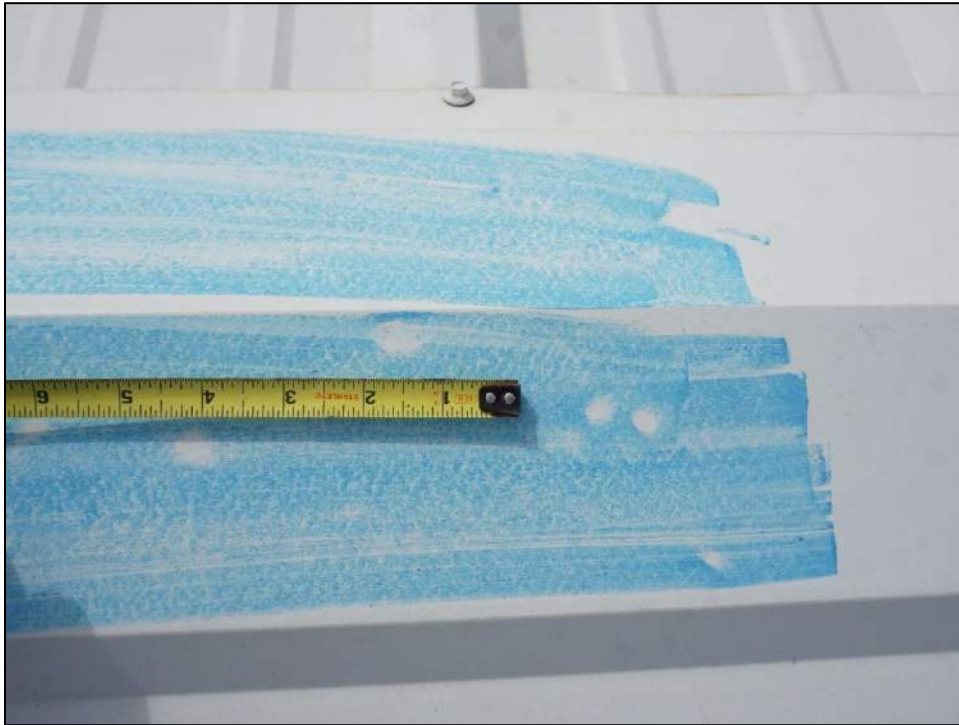
**Photo 31:** Hail indentations on ridge cap.

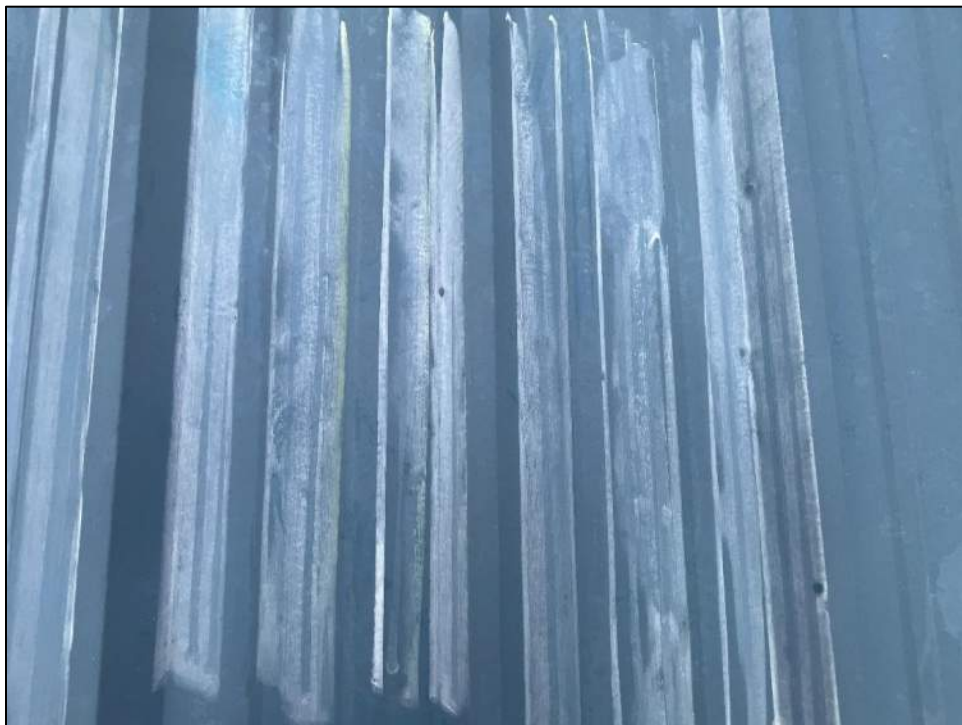
**Photo 25:** No discernible hail denting to south slope due to steep slope.
