**CITY OF INGLESIDE  
REGULAR CITY COUNCIL MEETING  
AGENDA  
JUNE 9, 2026  
6:30 PM**

Report on November 01, 2025, Hailstorm Damage to City of Ingleside Buildings.

### Building Damage Analysis Survey and Report

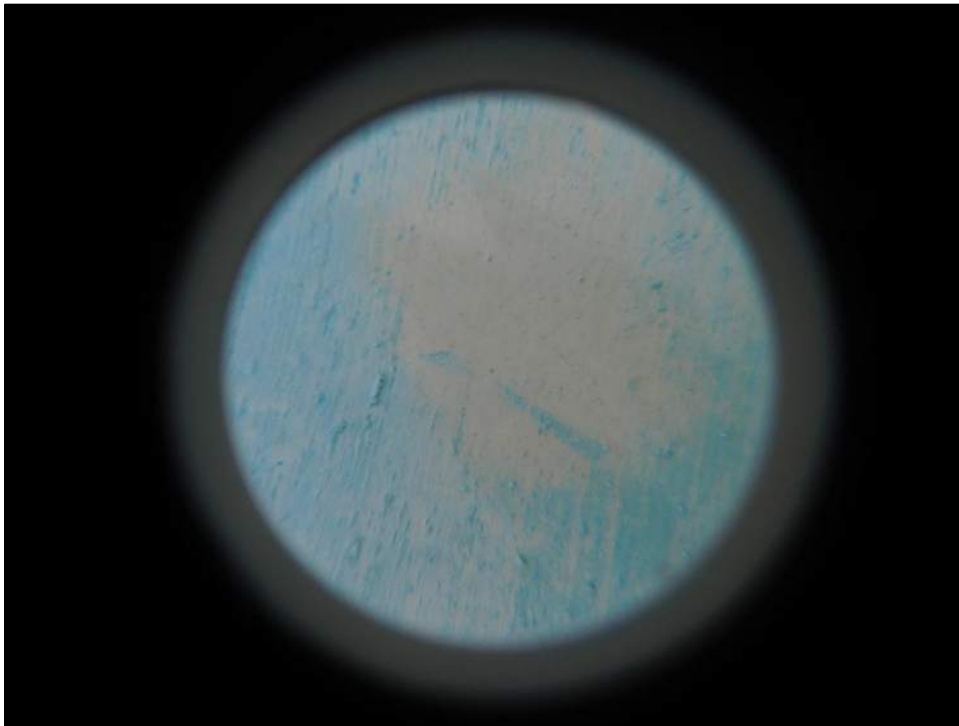
**Photo 14:** No coating disruption accompanied the hail denting in the closure metal surfaces.

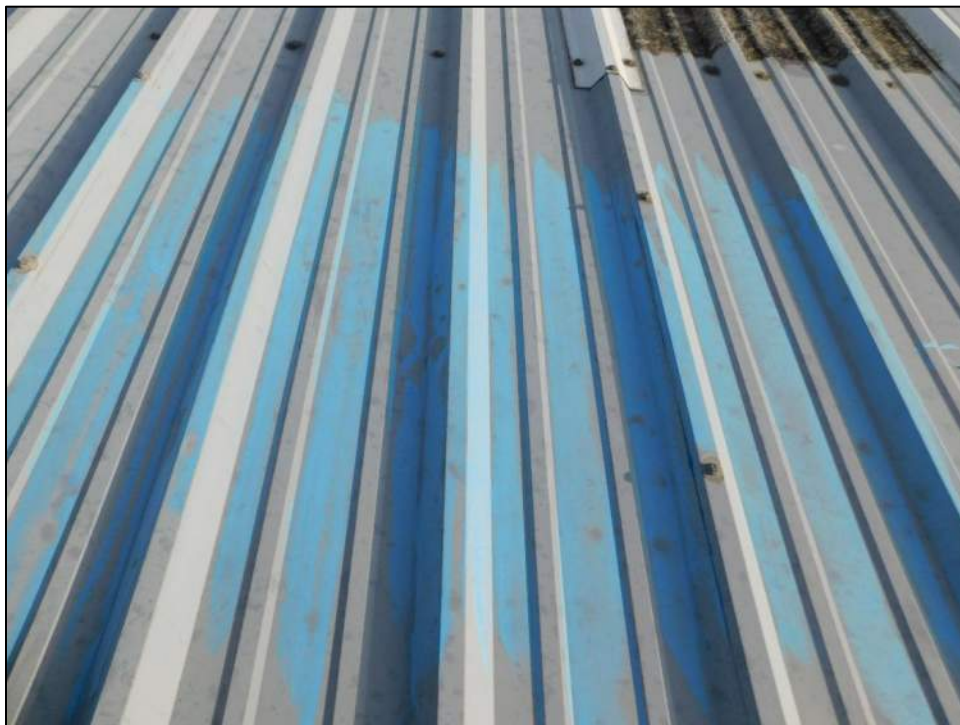
**Photo 20:** Hail denting to metal R-panels had largest inner diameters of 1/2 inch.

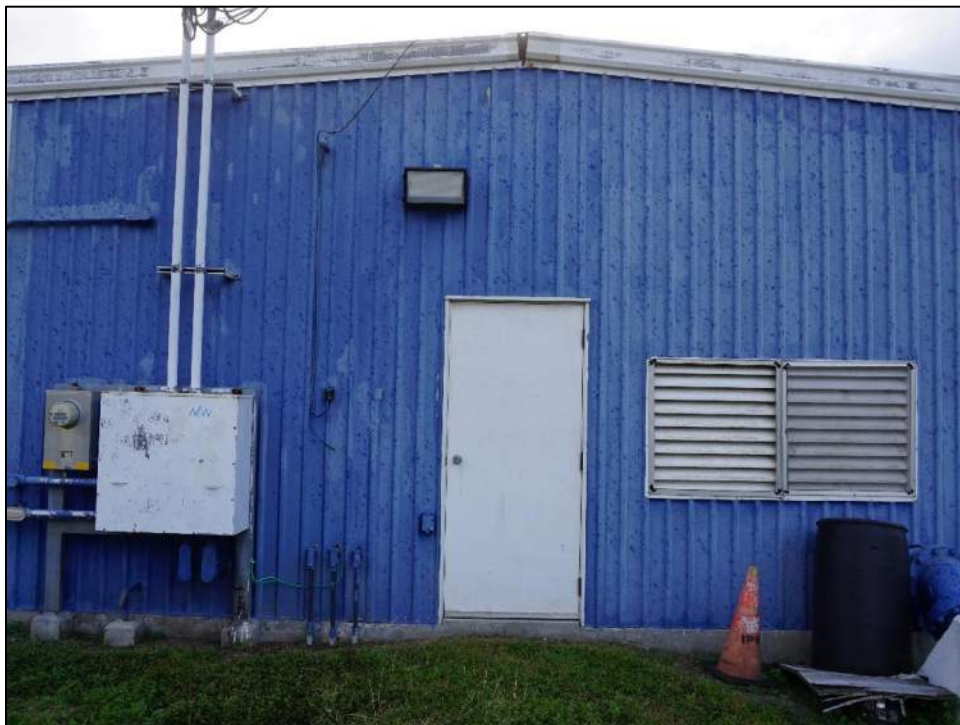
**Photo 32:** West elevation exhibited dense spatter marks.

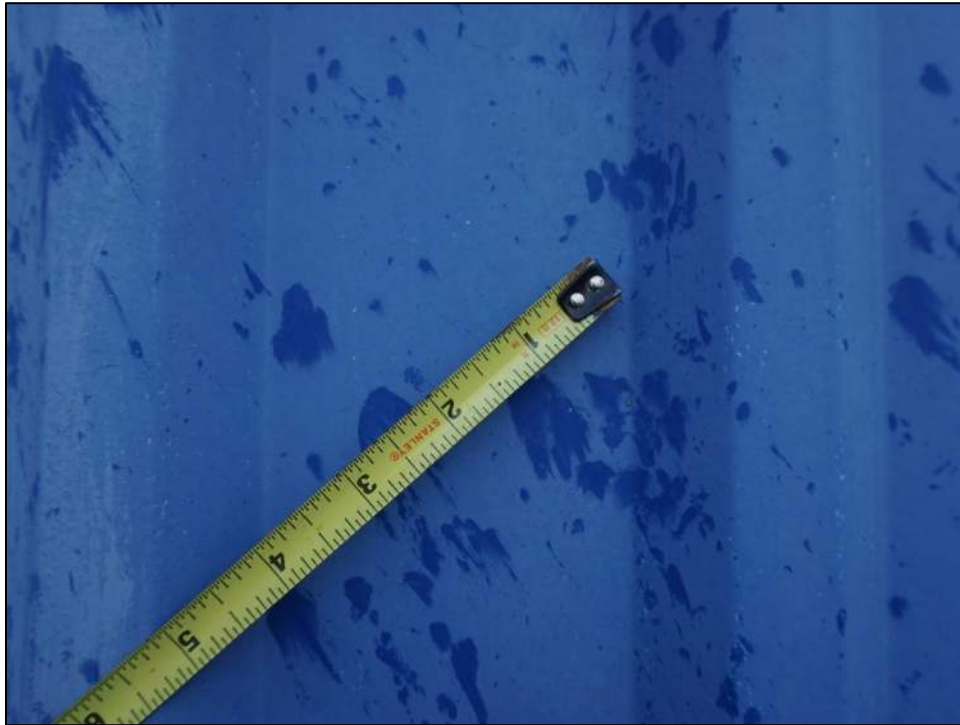
**Photo 33:** Largest hail spatter reflect hail of 1.5-inch hail.

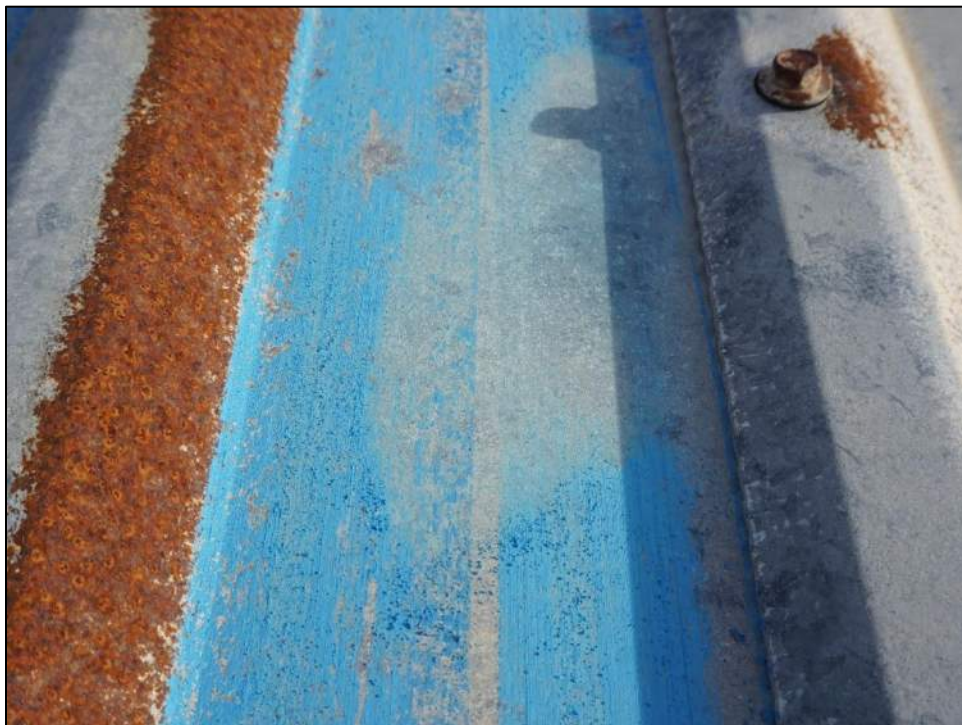
**Photo 56:** Deck denting was unaccompanied by coating disruptions.

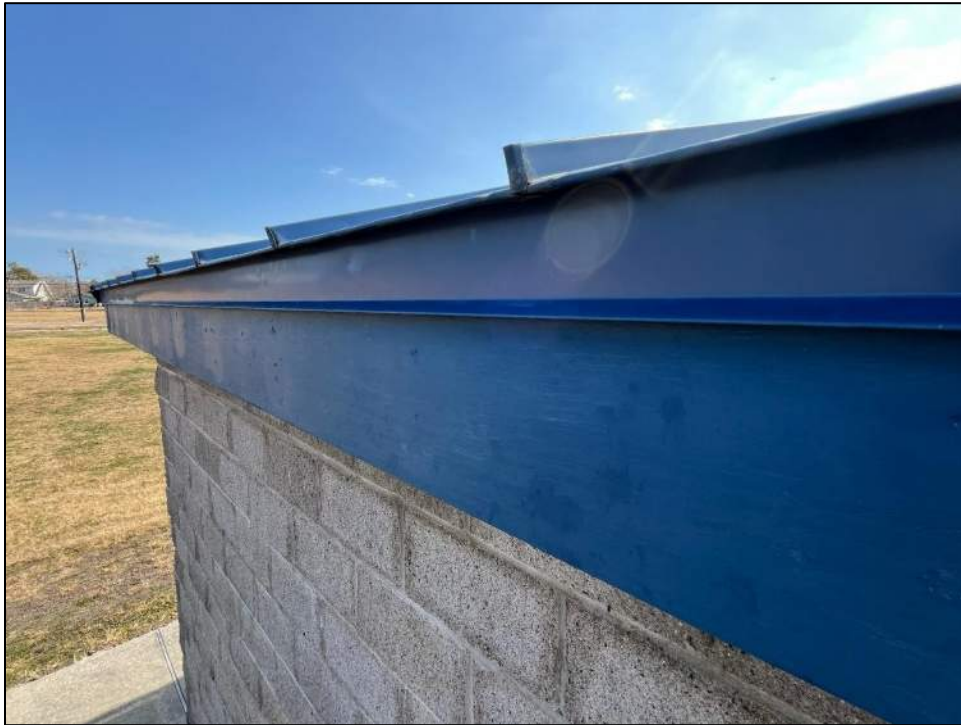
**Photo 9:** West gable end rake drip edges remained securely attached.

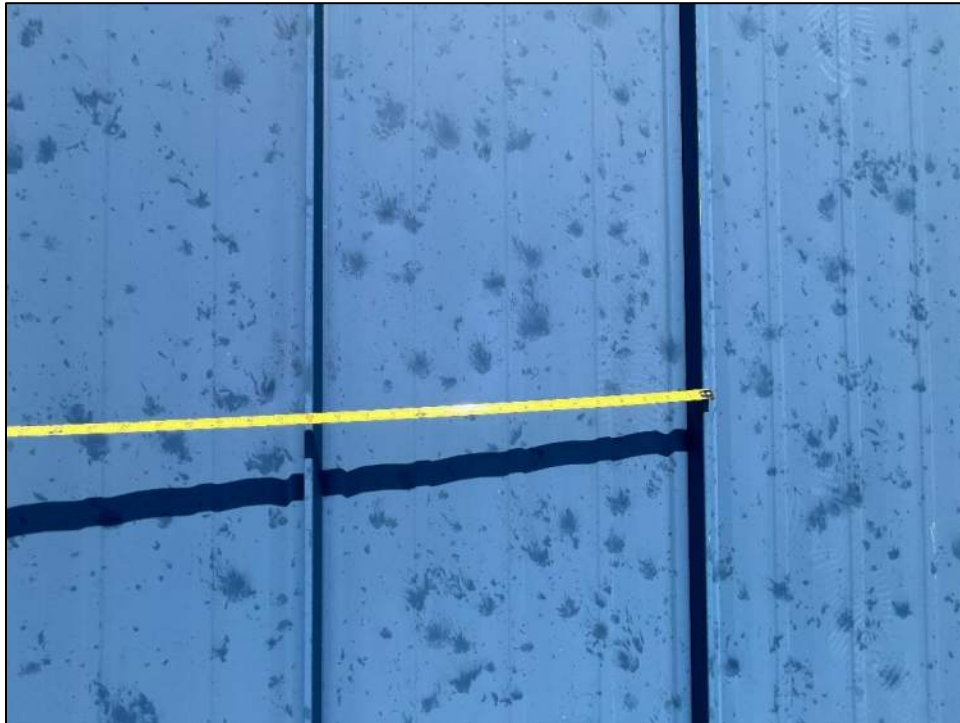
**Photo 11:** Largest hail spatter reflected up to 1.5-inch hail at this site.

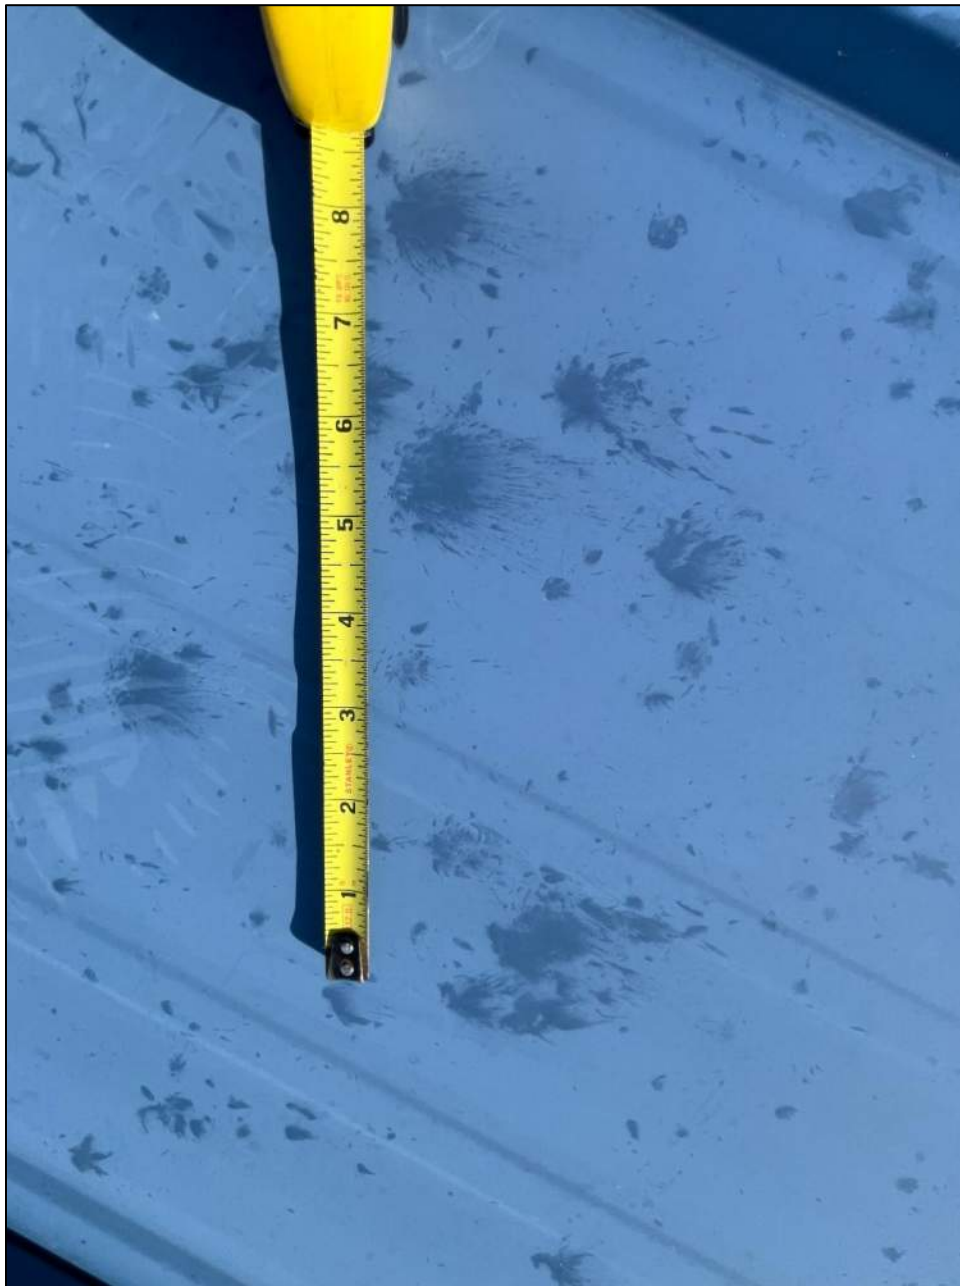
**Photo 12:** Largest hail spatter reflected up to 1.5-inch hail at this site.

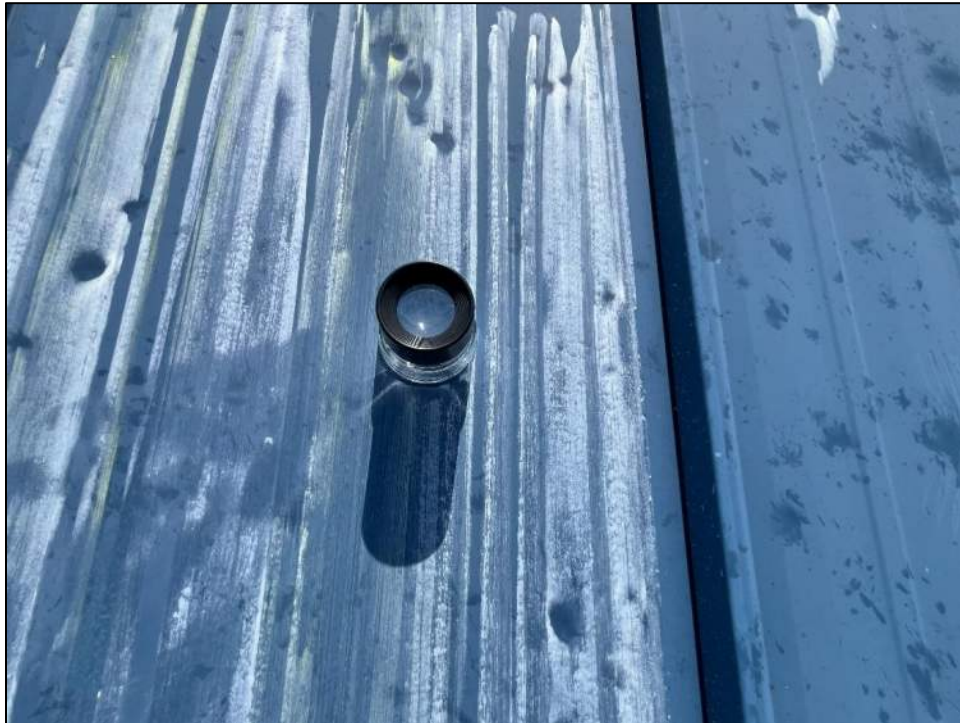
**Photo 15:** Microscope inspection indicated no coating disruption at hail dents or spatters.

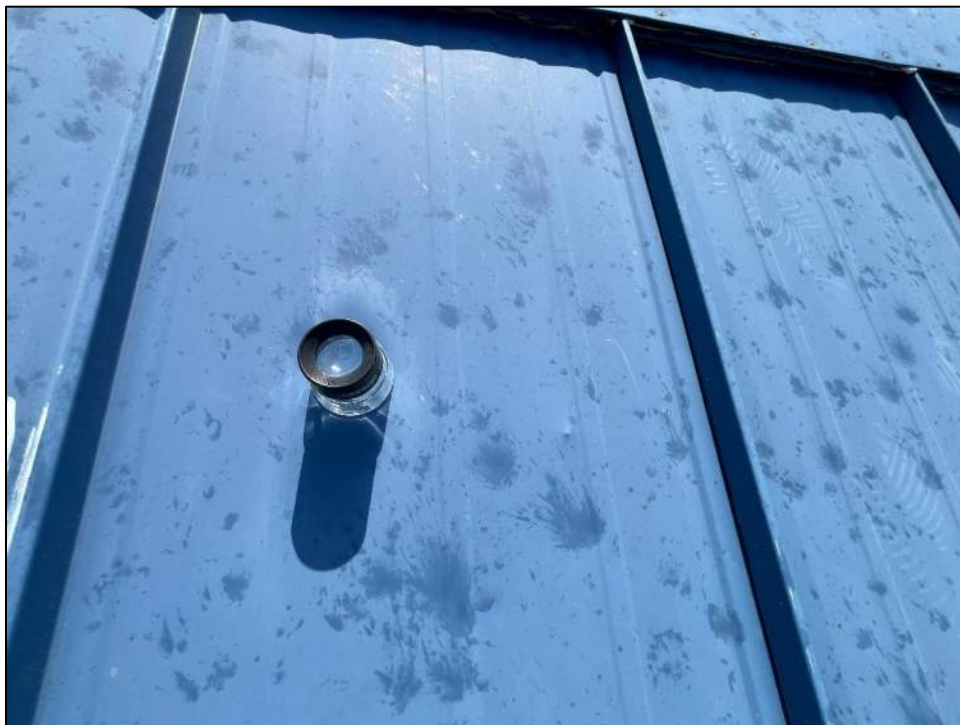
**Photo 16:** Microscope inspection indicated no coating disruption at hail dents or spatters.

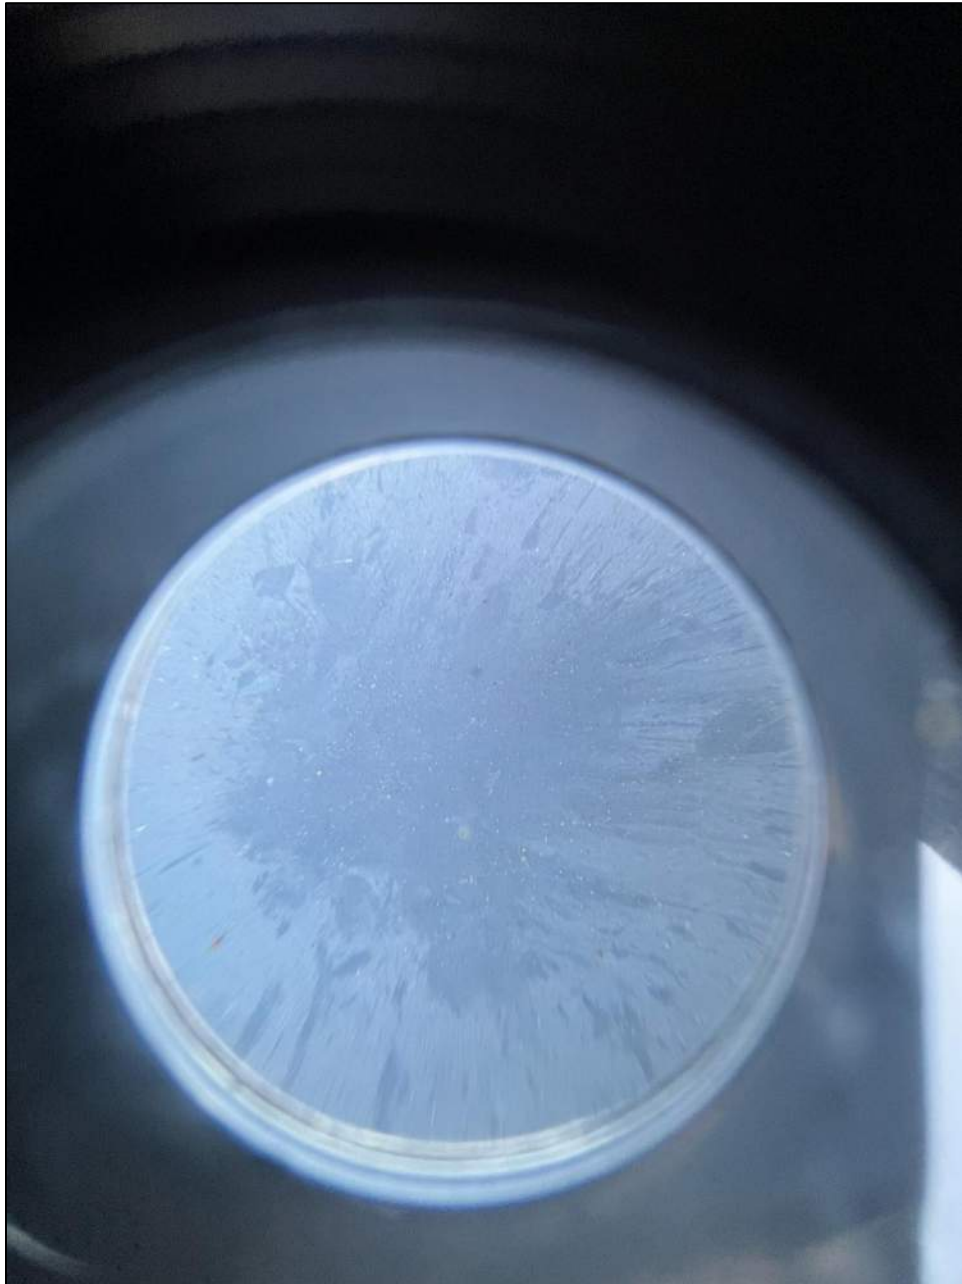
**Photo 18:** Microscope inspection indicated no coating disruption at hail dents or spatters.

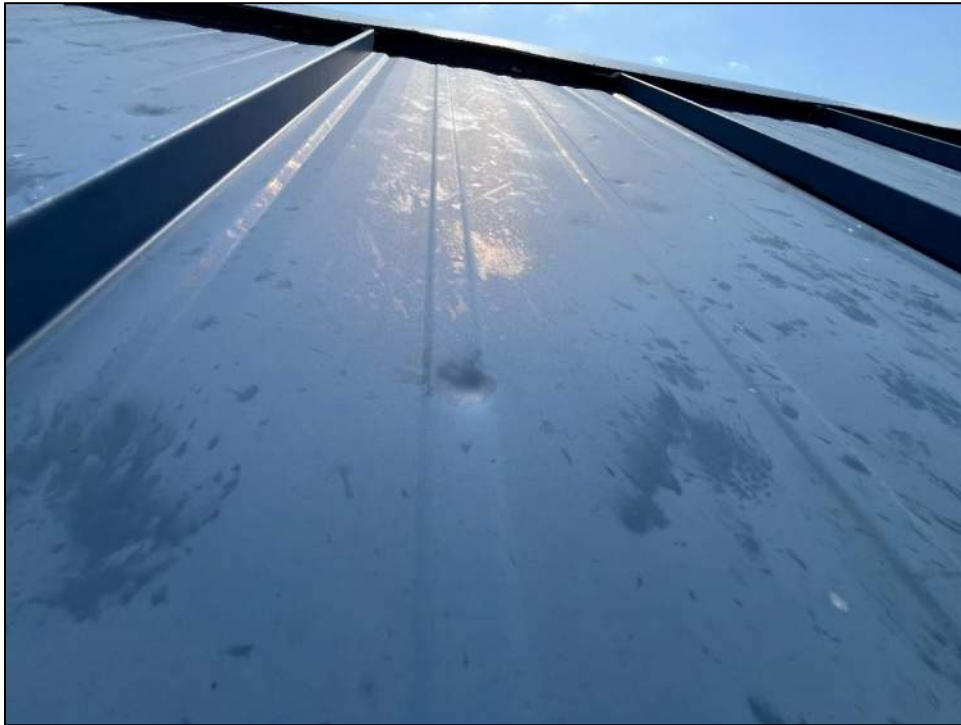
**Photo 19:** Microscope inspection indicated no coating disruption at hail dents or spatters.

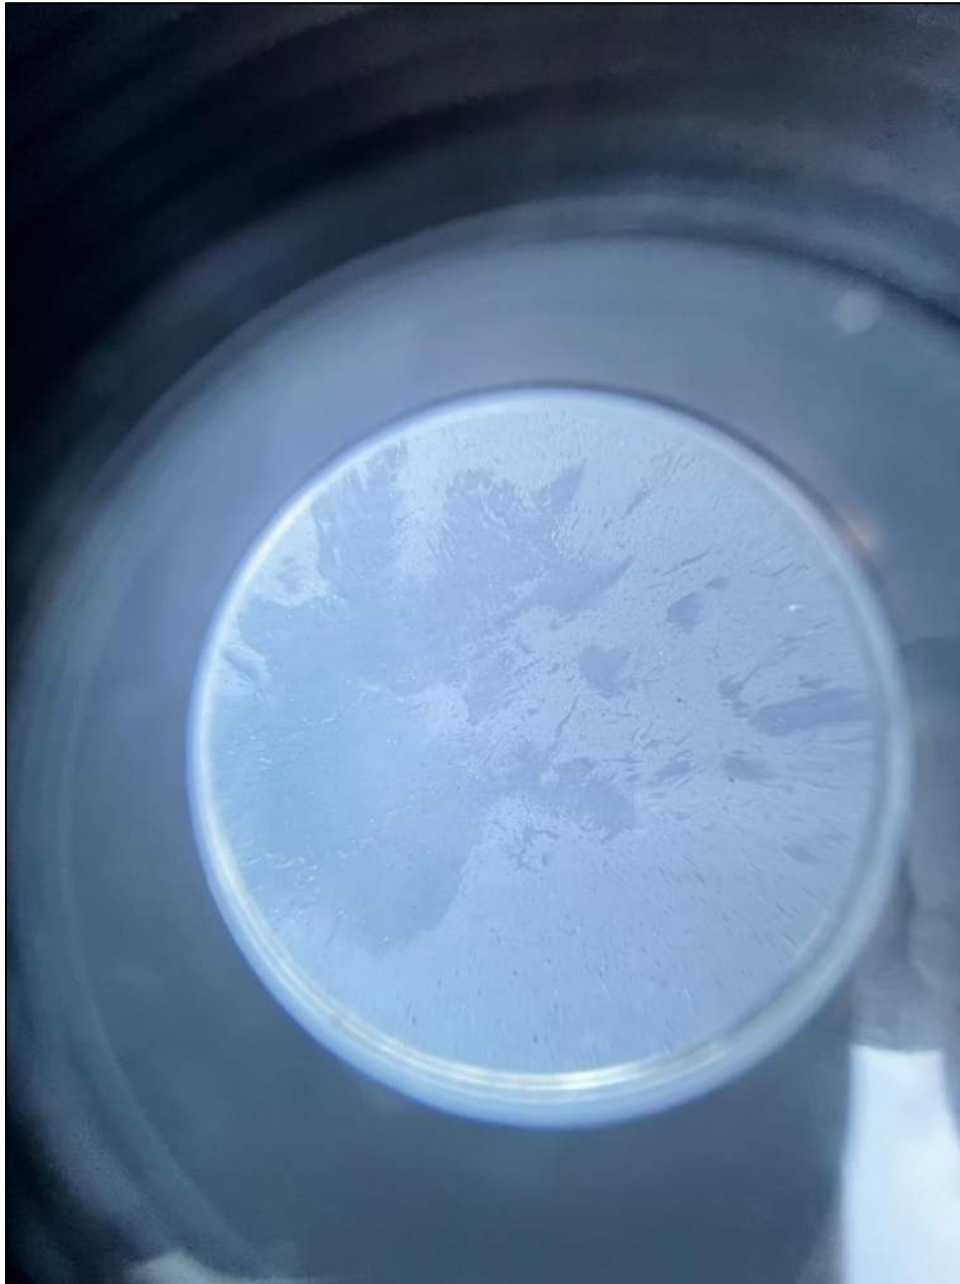
**Photo 20:** Microscope inspection indicated no coating disruption at hail dents or spatters.

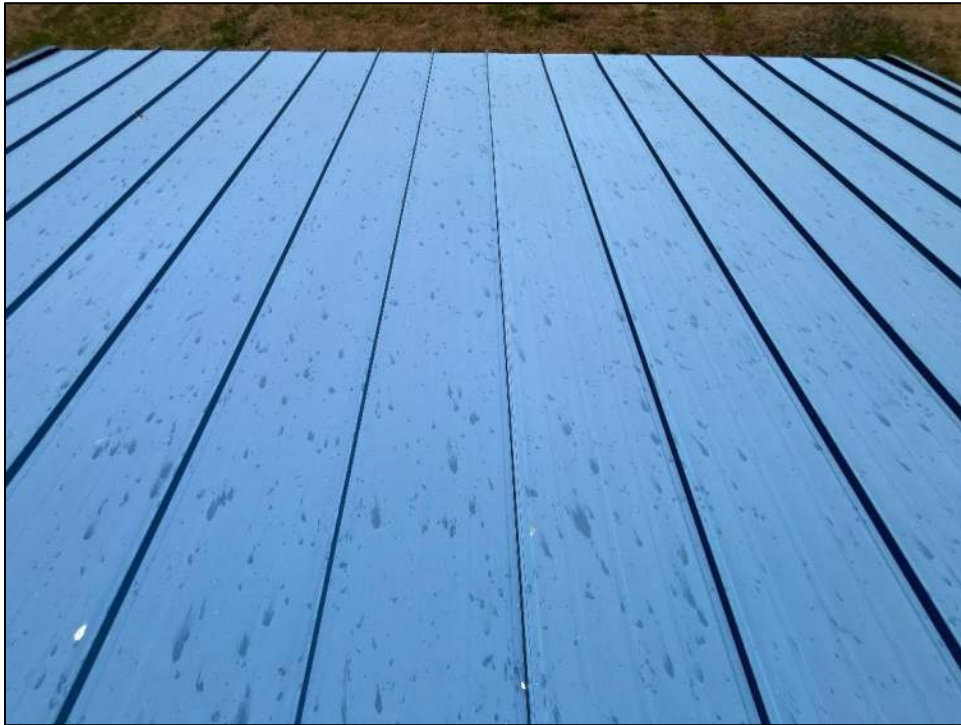
**Photo 21:** Significantly less dense spatters found on south slope.
